## WERNECKE TAILINGS

Site #80

Public Works And Government Services Canada	Travaux publics et Services gouvernementaux Canada	designed by: _____ date: _____
		drawn by: C.S. Nov. / 99
Architectural & Engineering Services Western Region		approved by: _____
		revisions: _____
Drawing title: Wernecke Tailings Site #80 Site Assessment Yukon Territory		project no. no. du projet: 125-12.01
		dwg. no. dessin no.: 1 of 1

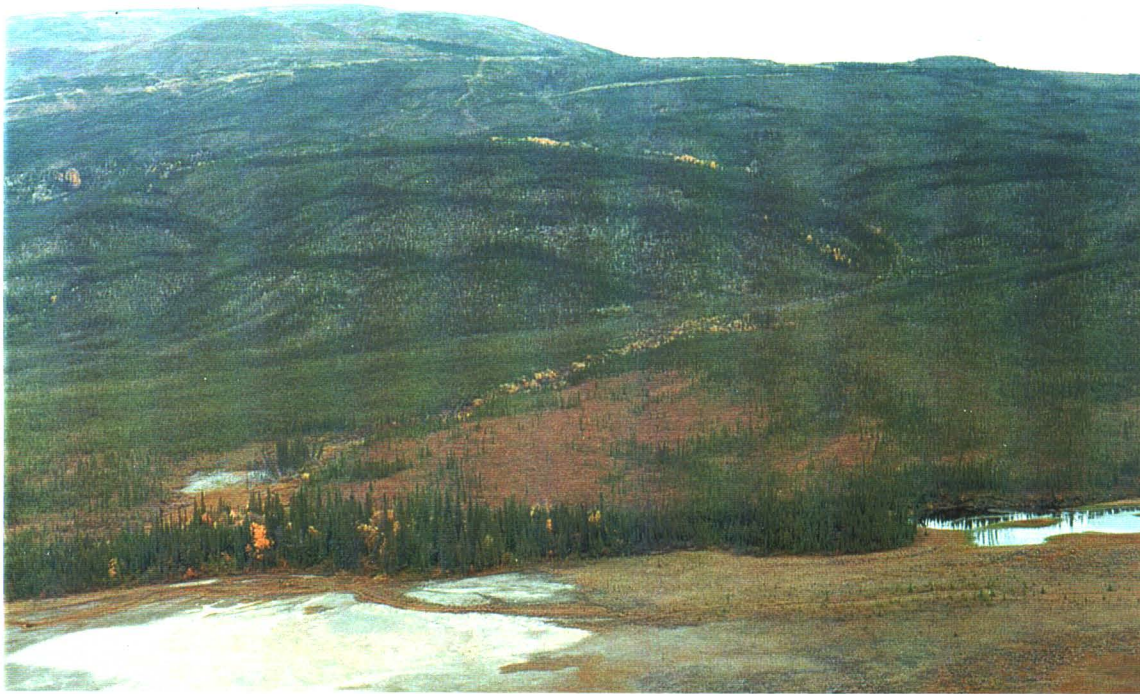
Photo 80-1. View of small creek (visible by line of yellow willows) which carried tailings into the lake.

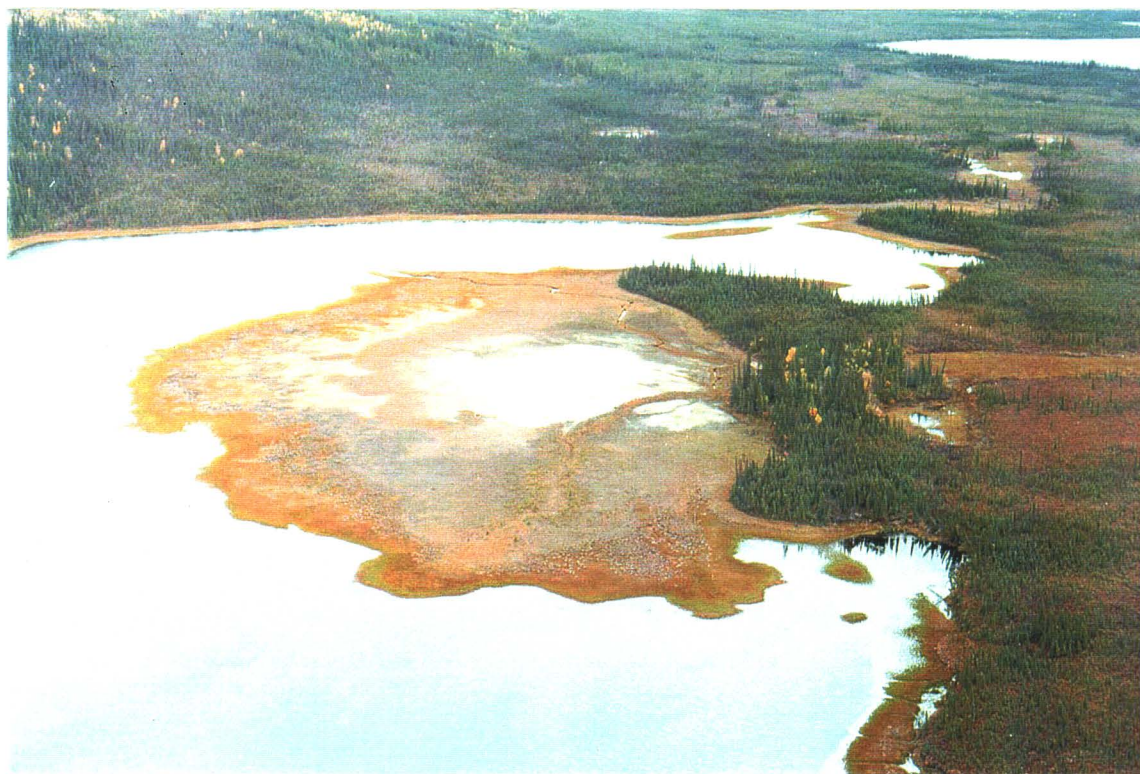
Most of the approximately 45,000m<sup>2</sup> area of the tailings that is exposed has revegetated naturally with some type of grass or moss, and up to 8 cm of organic matter has accumulated beneath the grasses. It is only an area of approximately 10,000 m<sup>2</sup>, near the top of the alluvial fan, that has no vegetation cover. The reason for the exposed tailings in the alluvial fan is thought to be twofold. First, the tailings at the top of the fan are above the water level and are, therefore, dryer. Secondly, tailings are likely re-deposited in this area during each spring freshet, disturbing any vegetation that tries to take hold.

Photo 80-2. Aerial view of tailings, looking eastward. Note that much of the tailings fan is submerged or has naturally revegetated.

No active reclamation has taken place.
