POTATO HILLS (PAN)
SITE #92
(MINFILE #106D 026)

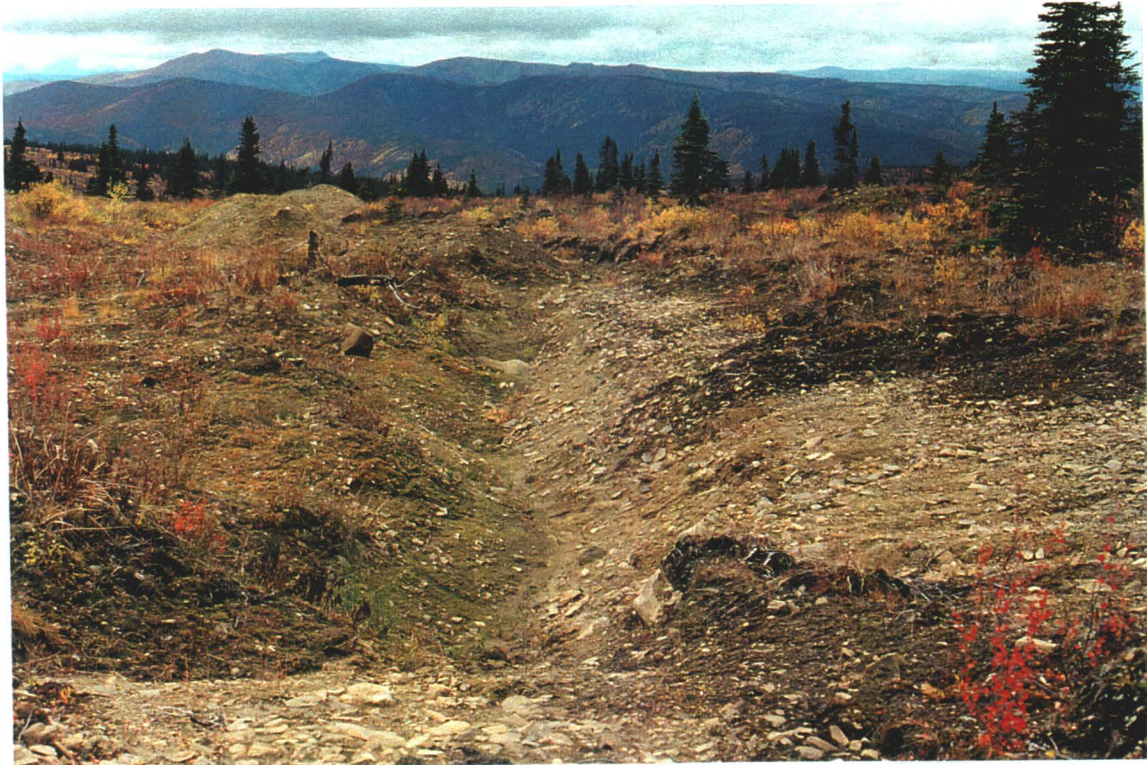
Small number of bulldozed trenches along the southwest side of Dublin Gulch Road (Photo 92-1).

Dimensions: (L x W x H): ~ 100 m x 3 m x 0.75 m

Condition: loose packed overburden; appears to be stable; small piles of overburden in the vicinity; no watercourses in area of site.

Photo 92-1 : Potato Hill (proper) showing extensive trench work along access road (over-burden) looking S.

Natural revegetation is beginning to occur in the trench areas and other disturbed locations of the site along Dublin Gulch Road (see Photo 92-1). No evidence of any reclamation measures at this site.
