GARNET (RAY GULCH)

SITE #93

(MINFILE #106D 027)

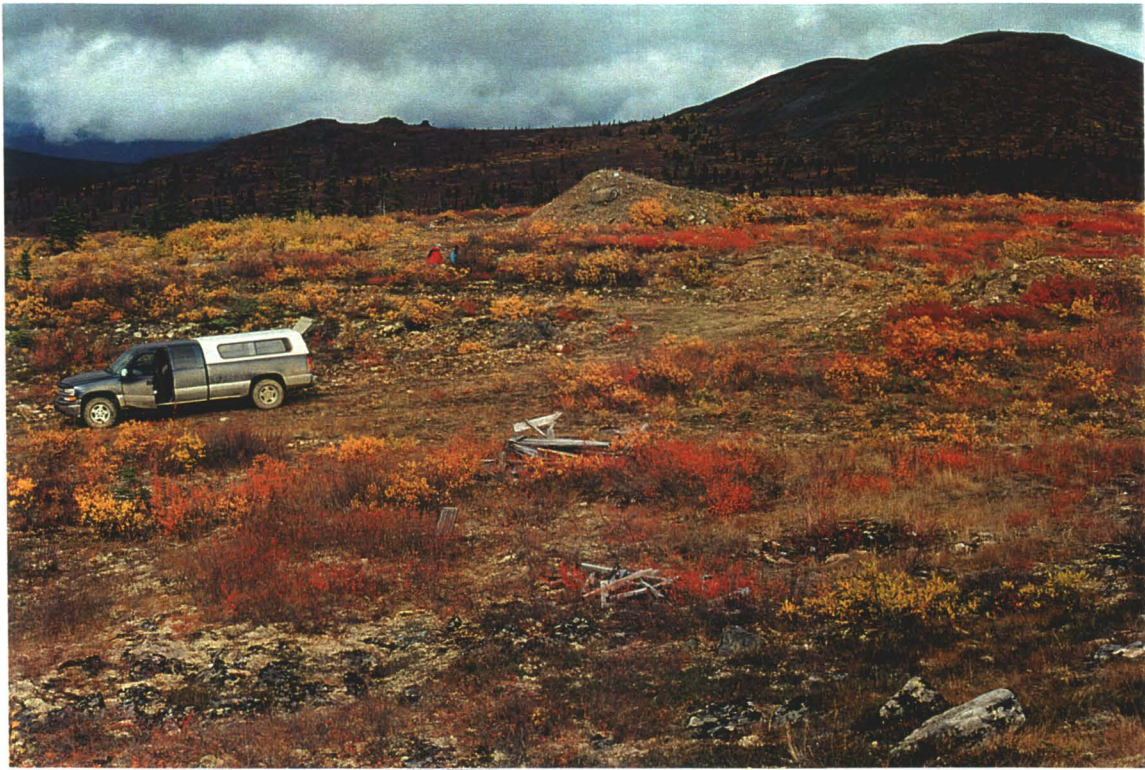
The site faces north along the edge of a plateau along at the top of the west slope of Ray Gulch, which drops to the south where it eventually meets Lynx Creek. Garnet is above the treeline, located in a relatively dry alpine tundra with characteristic vegetation. Raised frost-heave areas, polygons and the high altitude suggest the presence of continuous permafrost in the area (Photo 93-1).

Location: Along Dublin Gulch road approximately 80 m northeast of surveying peak (see Photo 93-1).

Photo 93-1 : Garnet. Looking N. rom peak to camp debris, wash rock pile & Potato Hill (background).

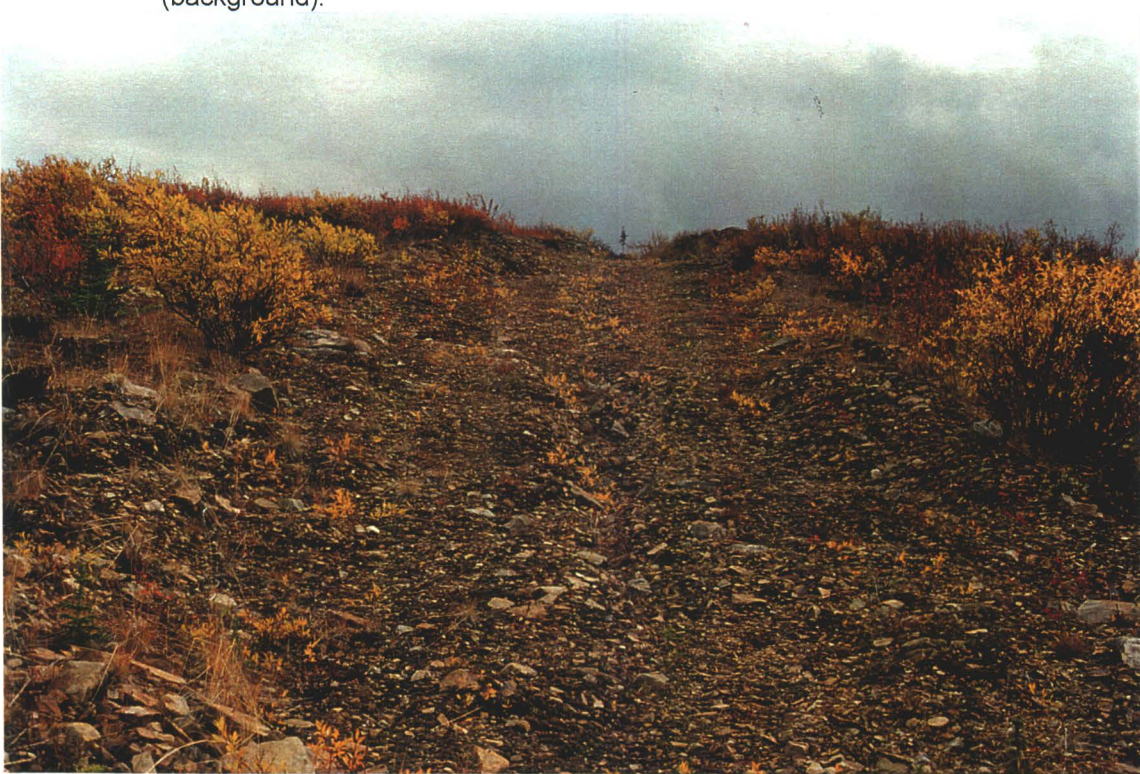
Extensive bulldozer trenching and shallow test-pitting has occurred throughout this site along the access road particularly through the early 1960s. The two largest are located near the surveying peak at the site near the top edge of Ray Gulch. (Photos 93-2 and 93-3).

Dimensions: (L x W x H): ~ 60 m x 3 m x 1 m

Condition: loose packed overburden; some natural re-colonization evident, appear to be stable

Photo 93-2 : Garnet. One of numerous bulldoze trenches along access road (looking N.E.).

Natural re-vegetation is beginning to occur at the site in the trench areas around site (Photo 93-3). The trench area along the east slope of the gulch, however, remains bare (see Photos 93-2 and 93-3). No evidence of any reclamation measures at this site.

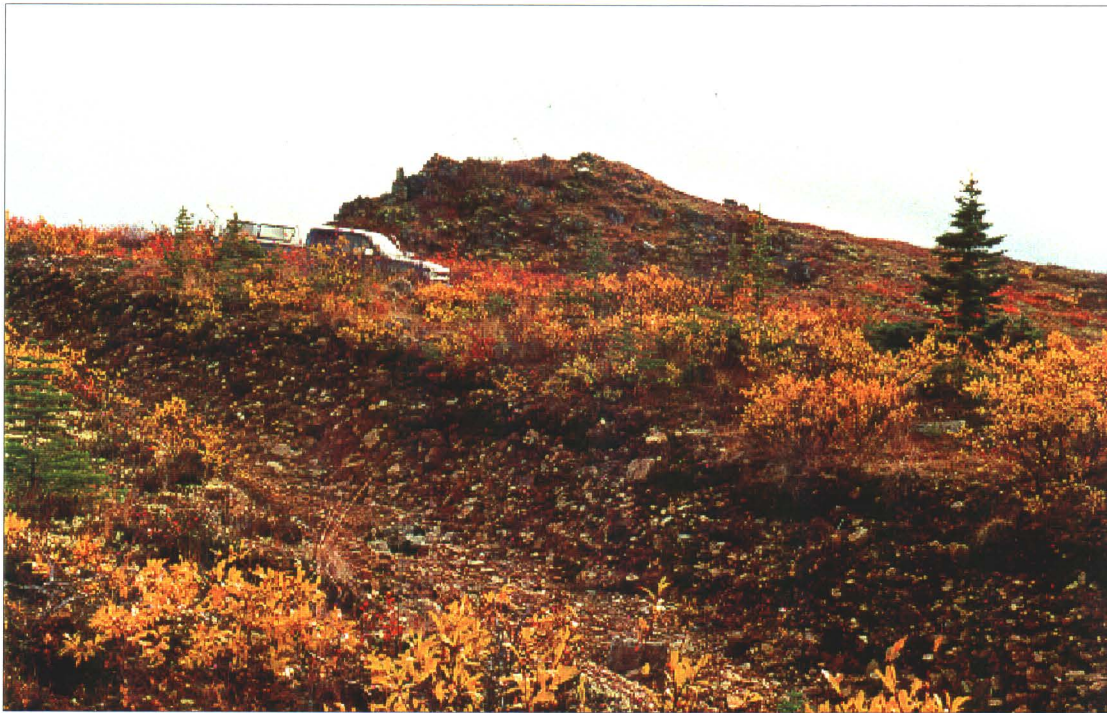
Photo 93-3 : Garnet. Bulldoze trench along access road looking S.E. to peak.
