# **SÄ DENA HES OPERATING CORPORATION**

## **SÄ DENA HES MINE**

### **DETAILED DECOMMISSIONING & RECLAMATION PLAN**

### **JANUARY 2012 UPDATE**

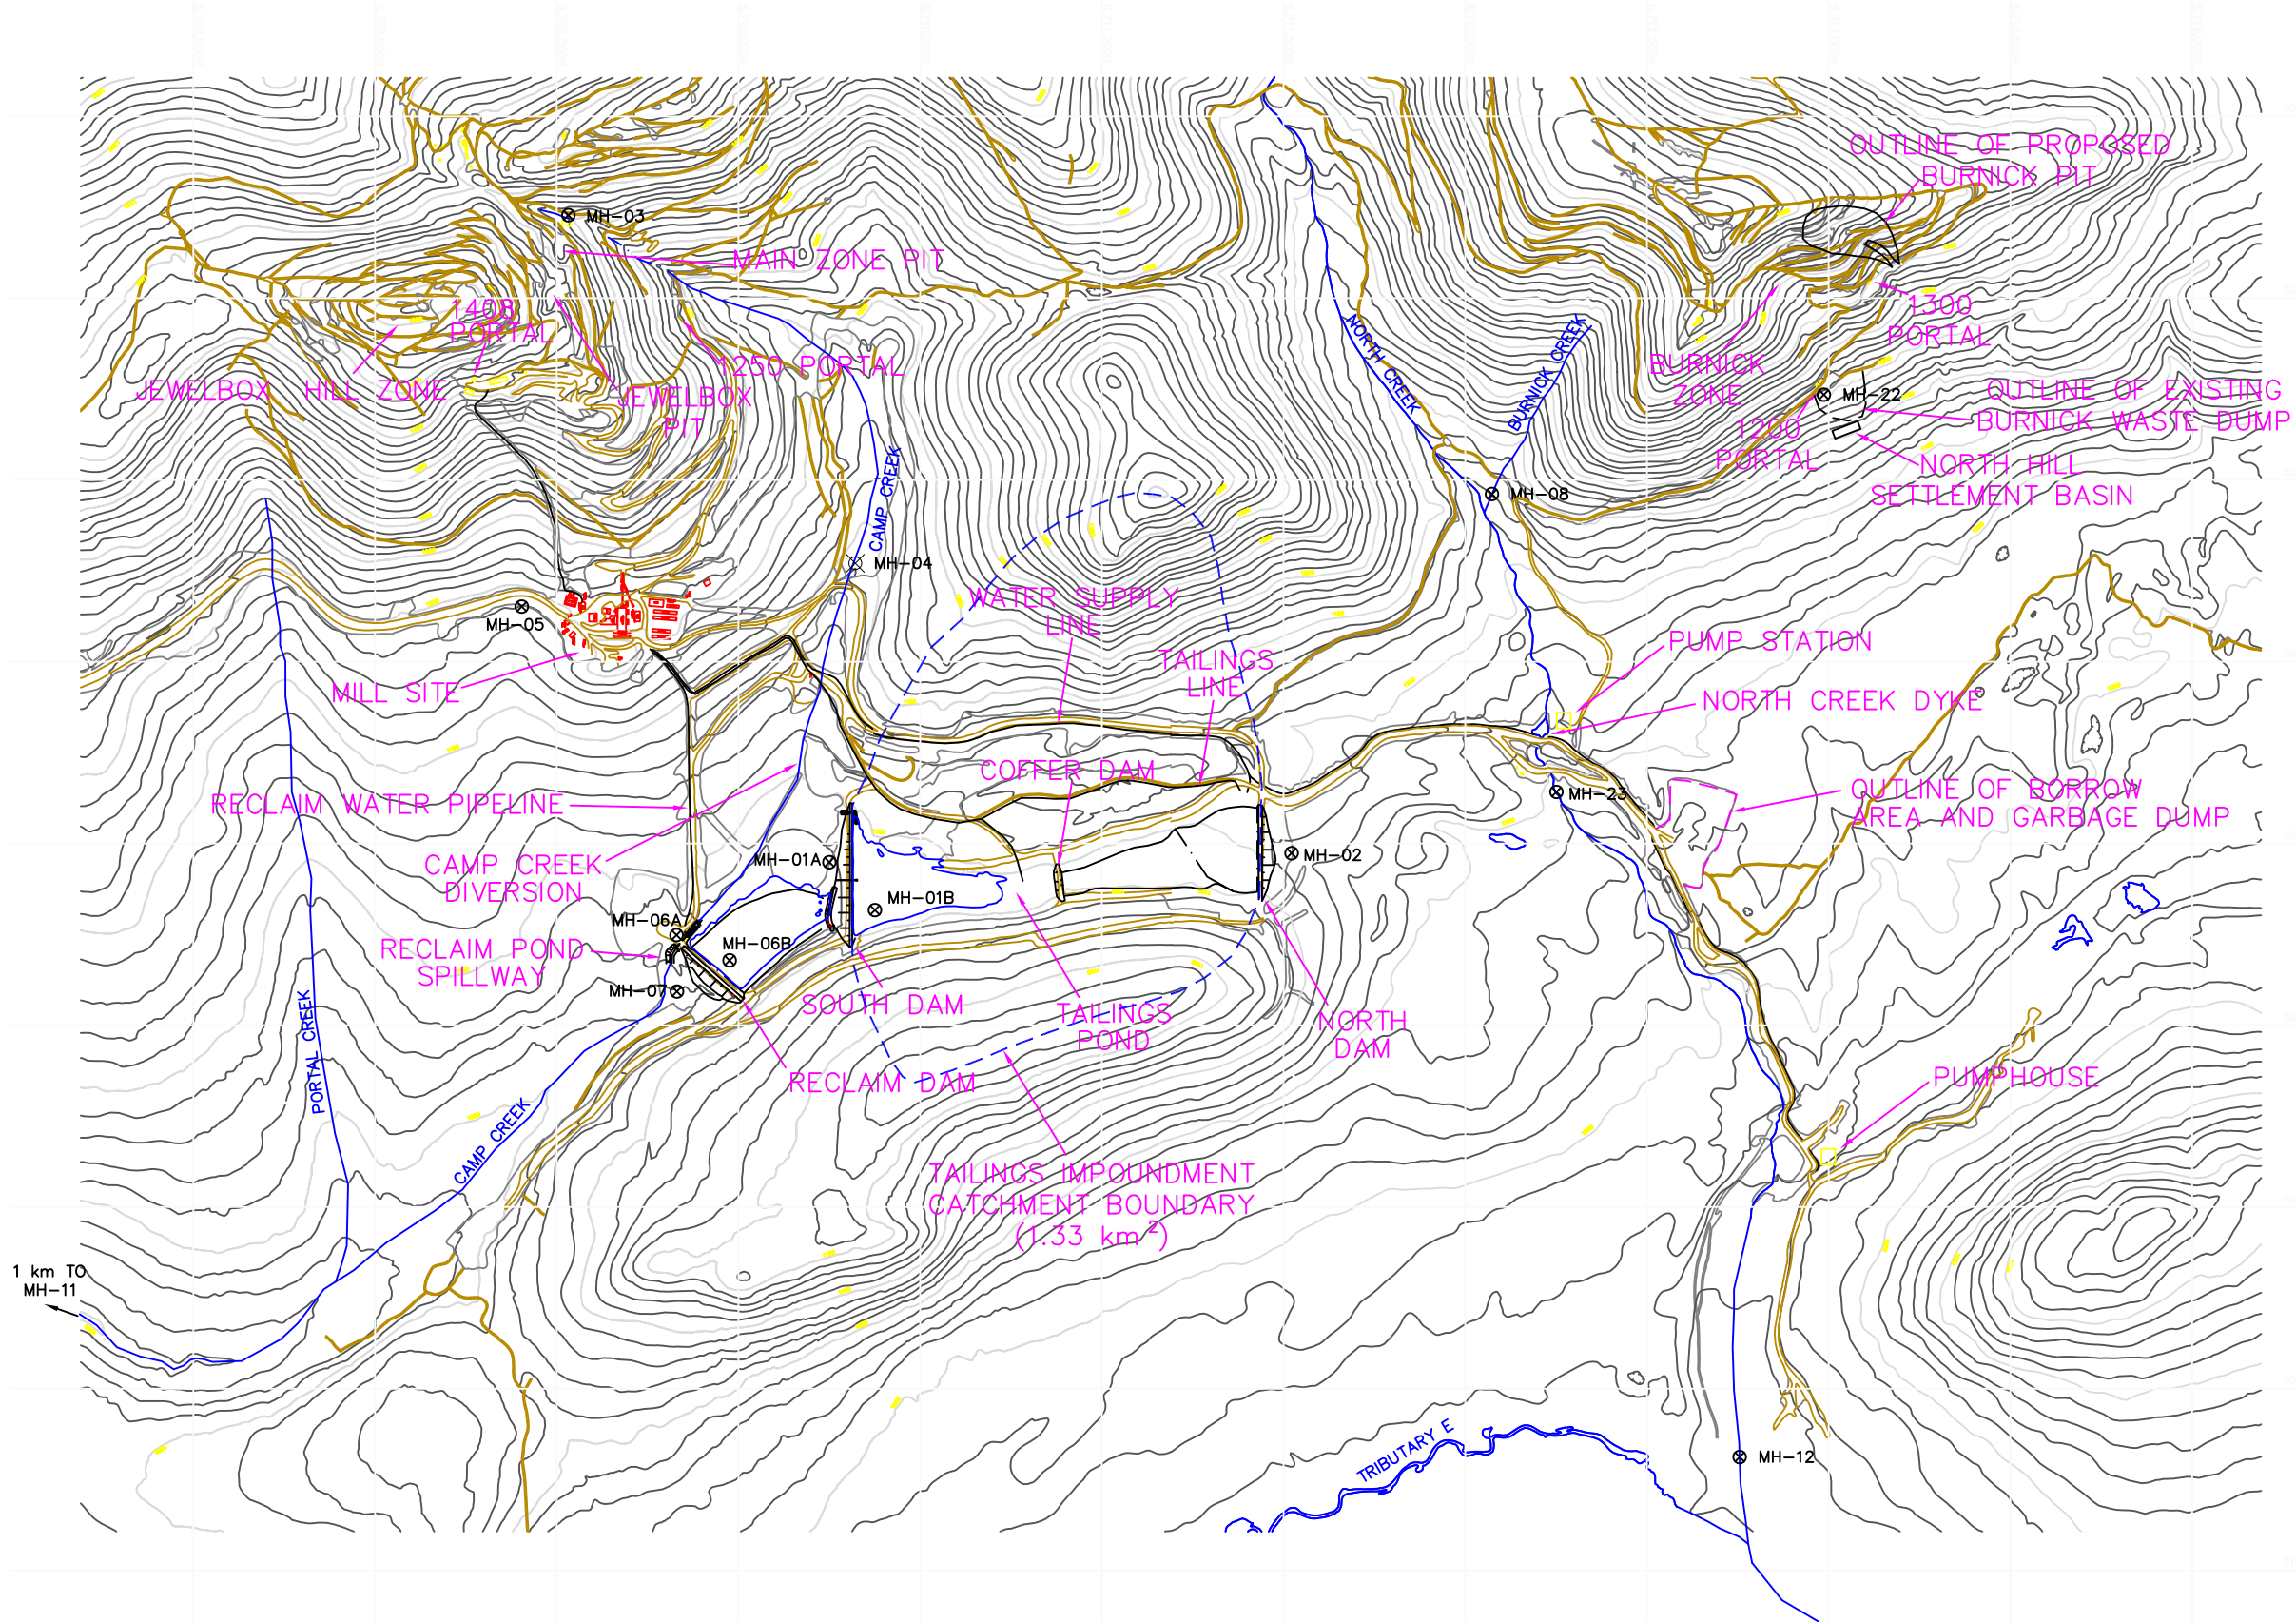
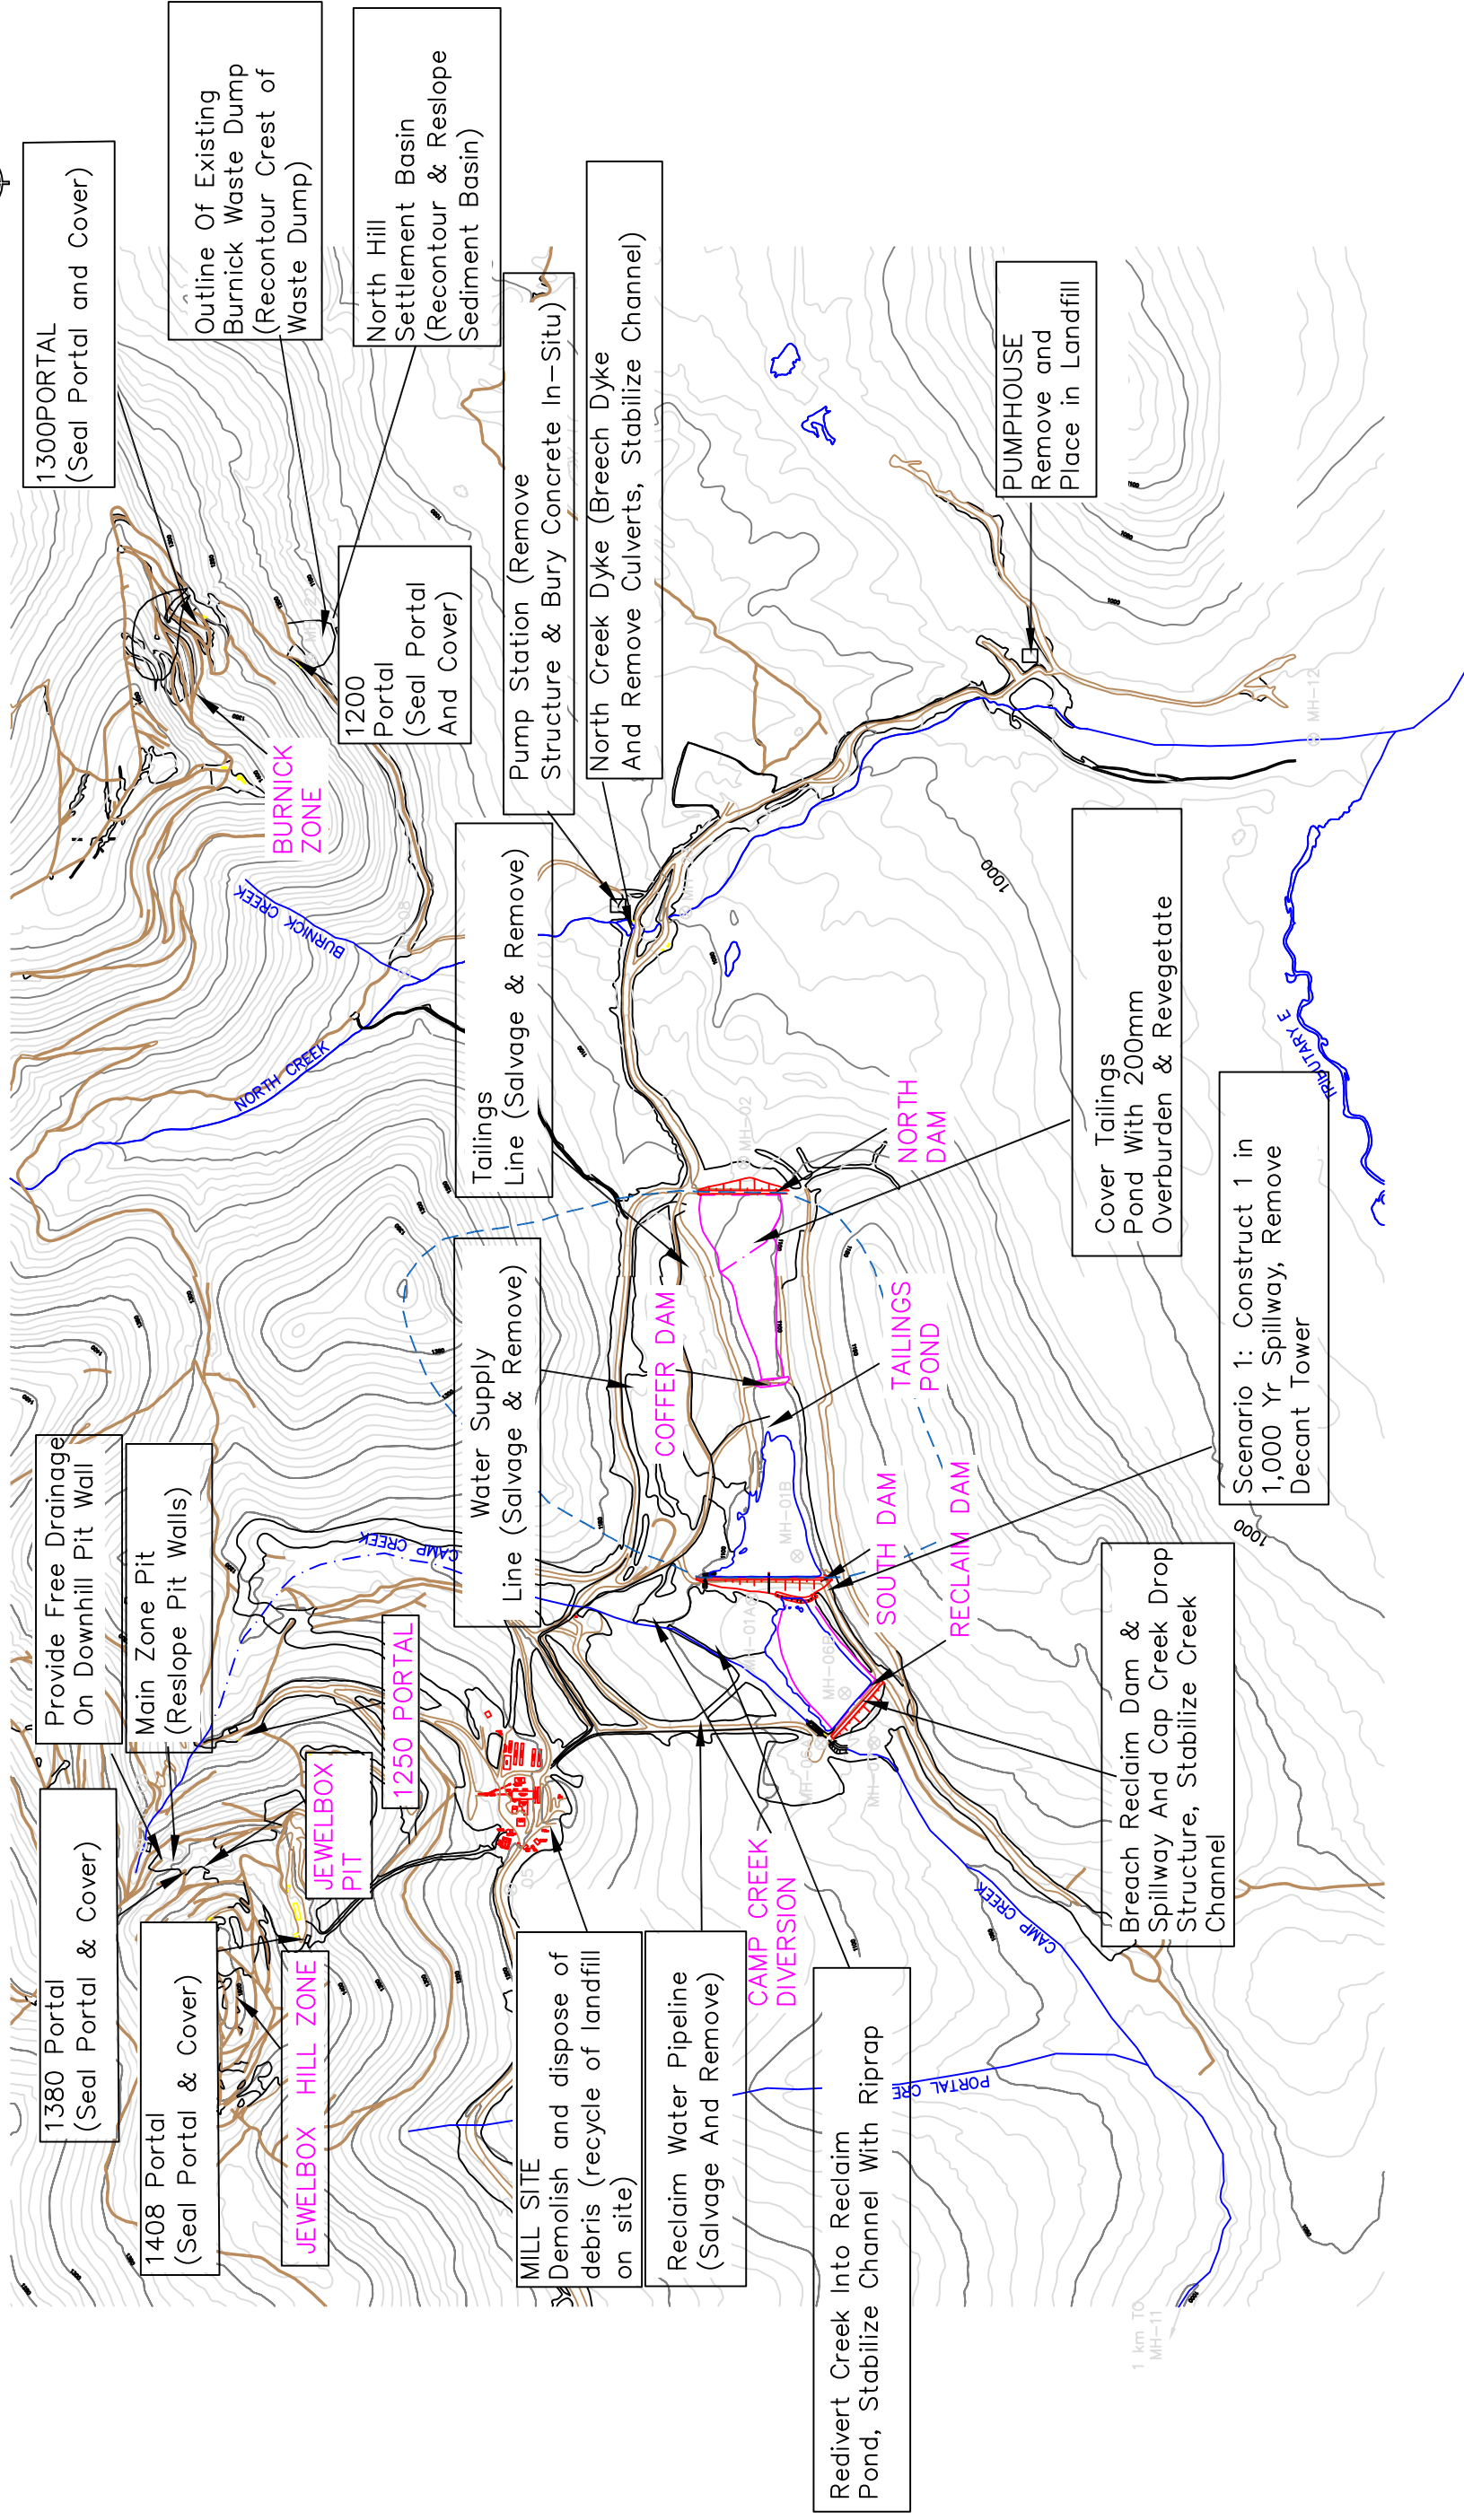
## GENERAL ARRANGEMENT PLAN CURRENT CONDITIONS

Finally, planned closure measures are presented. Each section is supported with detailed figures and tables as required. Where needed, references are made to previous reports or supporting documentation. Figure 3-1 provides a general arrangement plan for current conditions at the site. Figure 3-2 presents a summary of the various closure measures for features on the general arrangement plan.

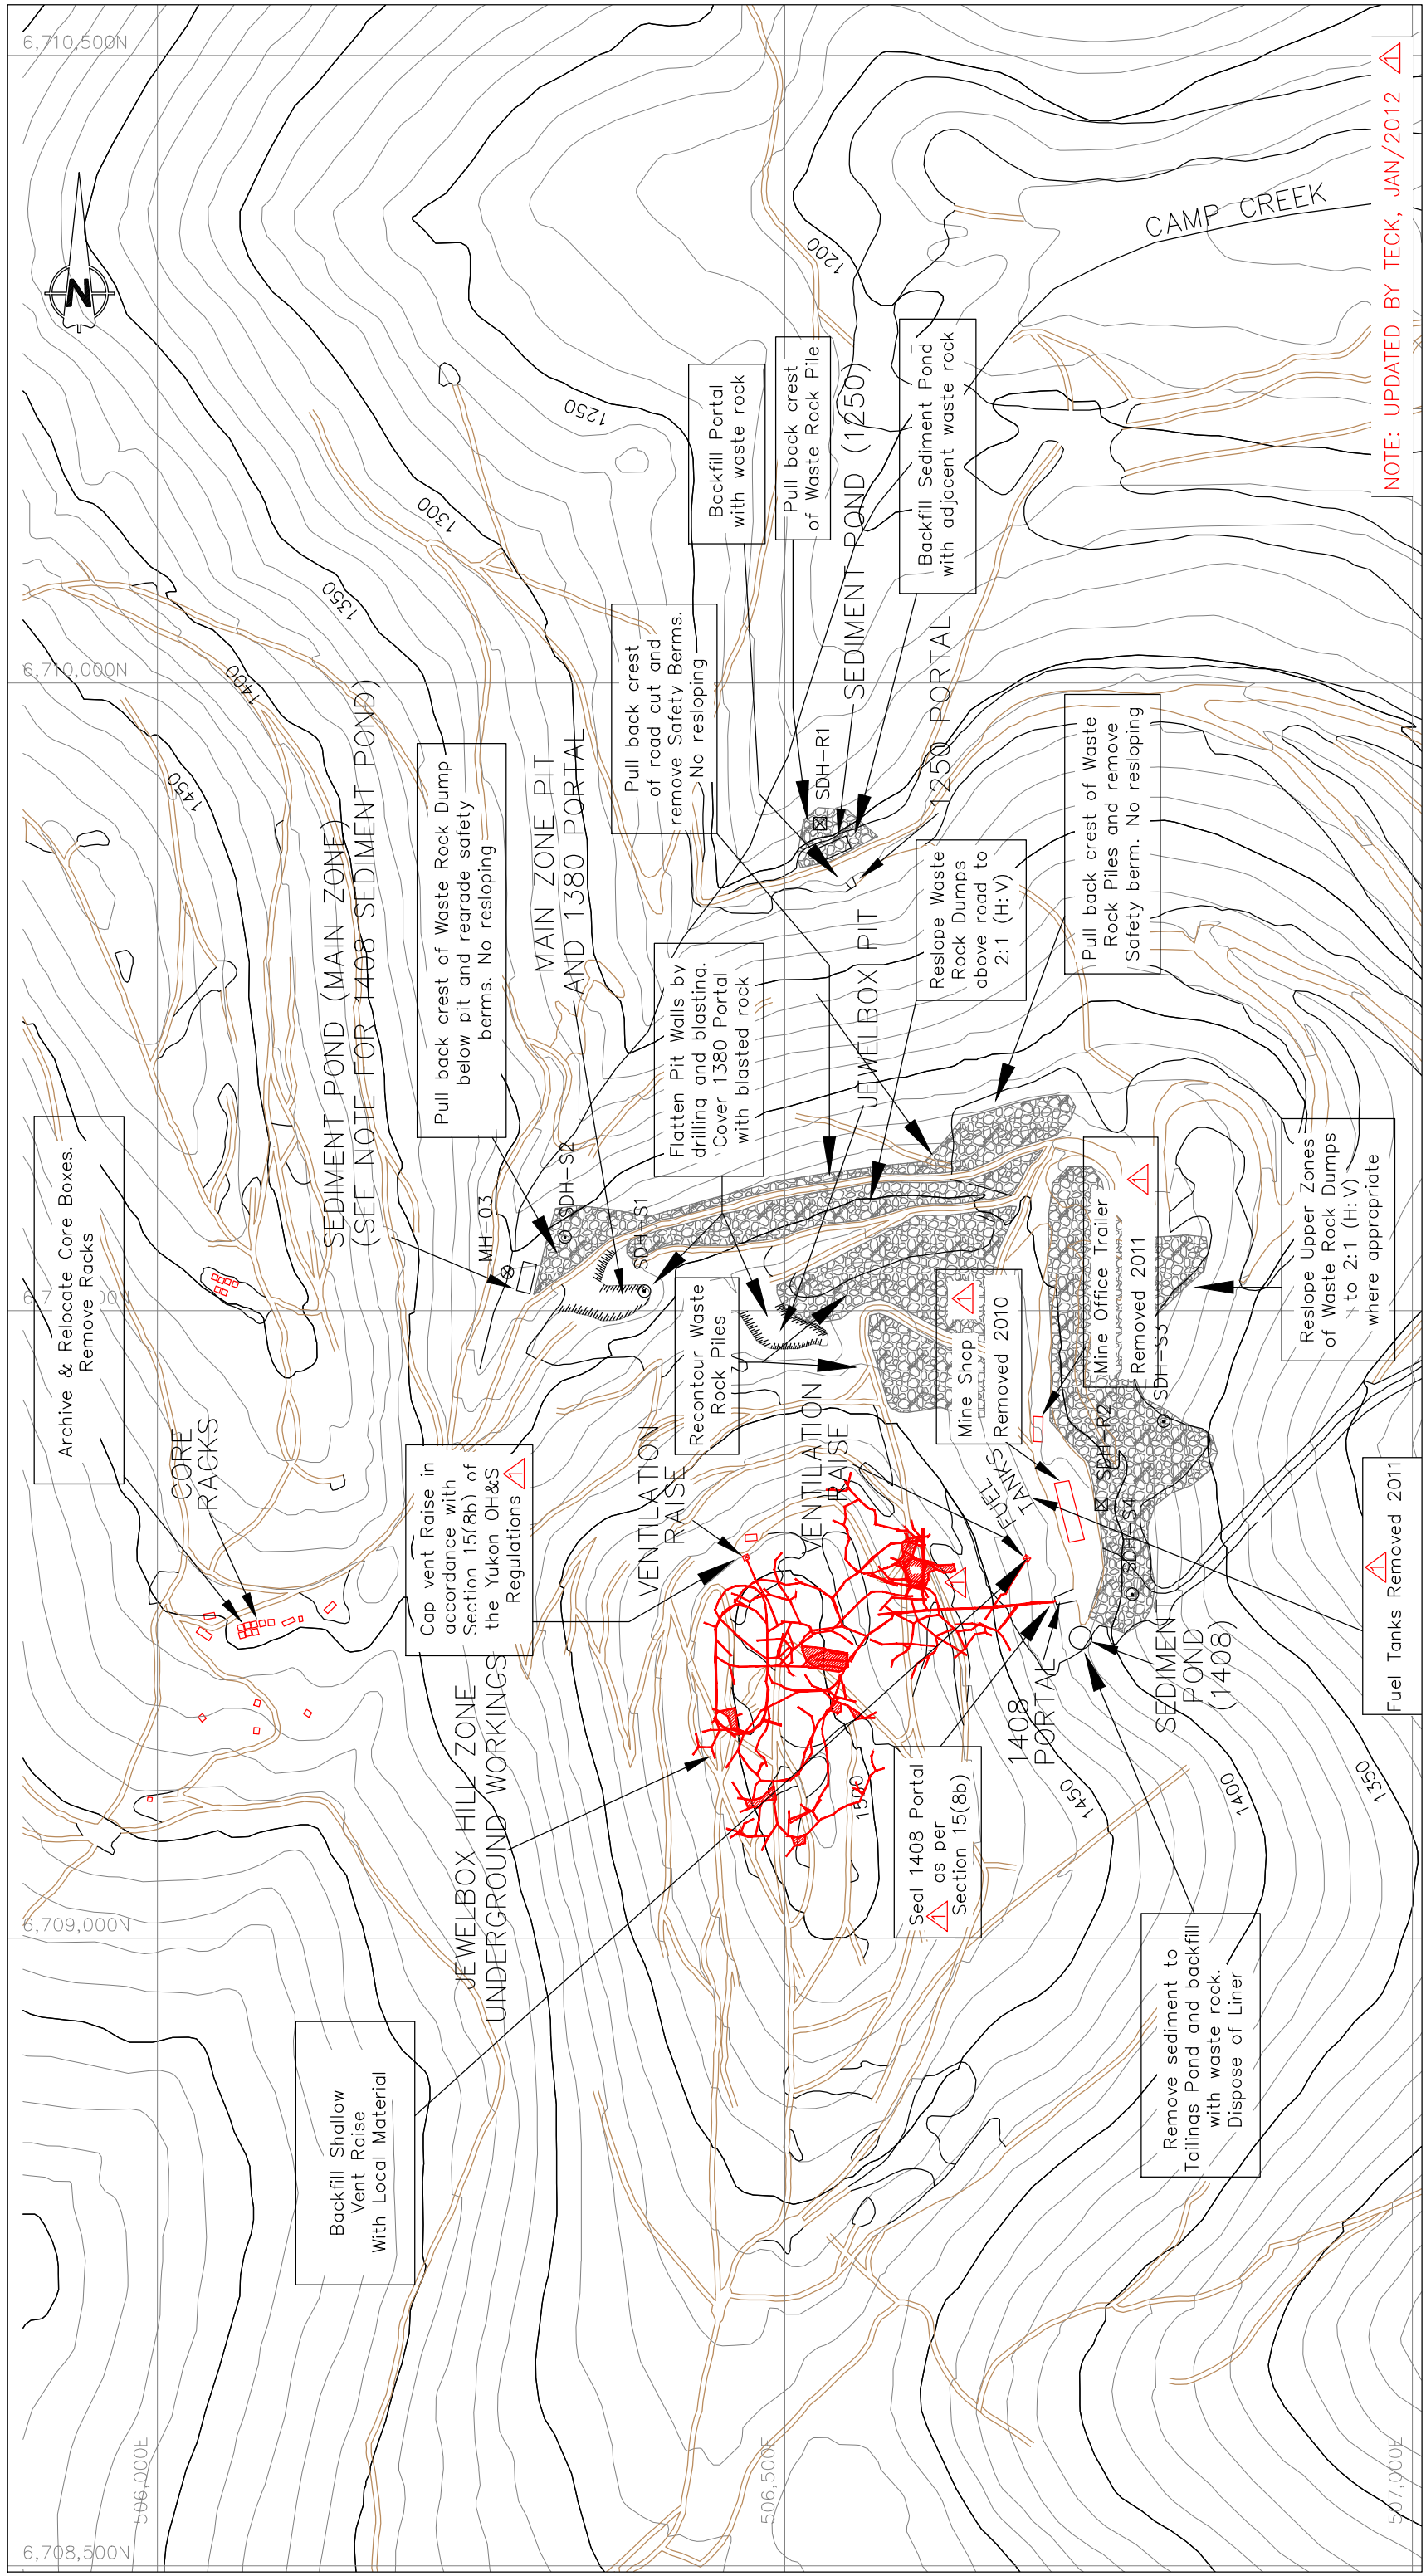
The Jewelbox pit is located above the Main zone pit as shown on Figure 3-3. The pit bottom is at an elevation of 1400m and rises steeply to 1430m. The pit is not free draining but seepage through the fractures in the rock causes the ponded water levels in the bottom of the pit to fluctuate. Weathering of the pit walls results in rock gradually loosening and falling into the pit.

The 1380 Portal is located within the Main Zone Pit as shown on Figure 3-3. The portal is approximately 4.5 m by 4.5 m in section and is collared in limestone and skarn. This portal does not connect with any other underground workings. The mining of this tunnel (adit) was apparently stopped due to very poor ground conditions. Water drains from this portal through the snow free period. It likely flows for at least part of the winter but it is not safe during Temporary Closure periods to access this area during winter due to avalanche hazards in the area. Water discharges from a fault in within the adit. The ground water flows onto the adit floor where it comes into contact with weathered mineral rich skarns which creates neutral mine drainage containing high zinc concentrations (>30mg/L). The water from the portal flows down through the adjacent waste dump and joins a surface water flow in the gully. Currently the zinc concentrations are being amended by contact with the water rock. Attenuation continues as the drainage water mixes with the alkaline surface water. The surface water goes into the ground approximately 500 m before Camp Creek. Steven Day of SRK prepared a letter report dated Marcy 12, 2007 titled "Sa Dena Hes Mine – 1380 Portal. This report is included in Appendix D

Waste from the Main Zone pit was end-dumped on hillside slopes below the pit floor and above the headwaters of Camp Creek (Figure 3-3). The slope of the dump is about 1.3:1 and consists of very coarse, broken rock. The dump covers an area of about 0.3 ha. The waste rock is composed primarily of limestone with some ore-type skarn material. Some of the skarn has weathered resulting in the release of coarse sphalerite and galena-rich sand. Water was seen flowing through the dump presumably originating from the Main Zone pit or the Jewelbox pit.

The pit walls will be stabilized by resloping them by drilling and blasting. The blasted rock material will partially fill the pit. A channel filled with coarse rock (French drain) will be made to ensure that if water levels within the pit were to increase, that it would have a safe route to discharge out of the pit. Water quality from this discharge is expected to meet acceptable levels. This will ensure that there is no free standing pool of water within the pit and reduces the potential for this water to flow into the 1380 Portal through fractures in the rock.

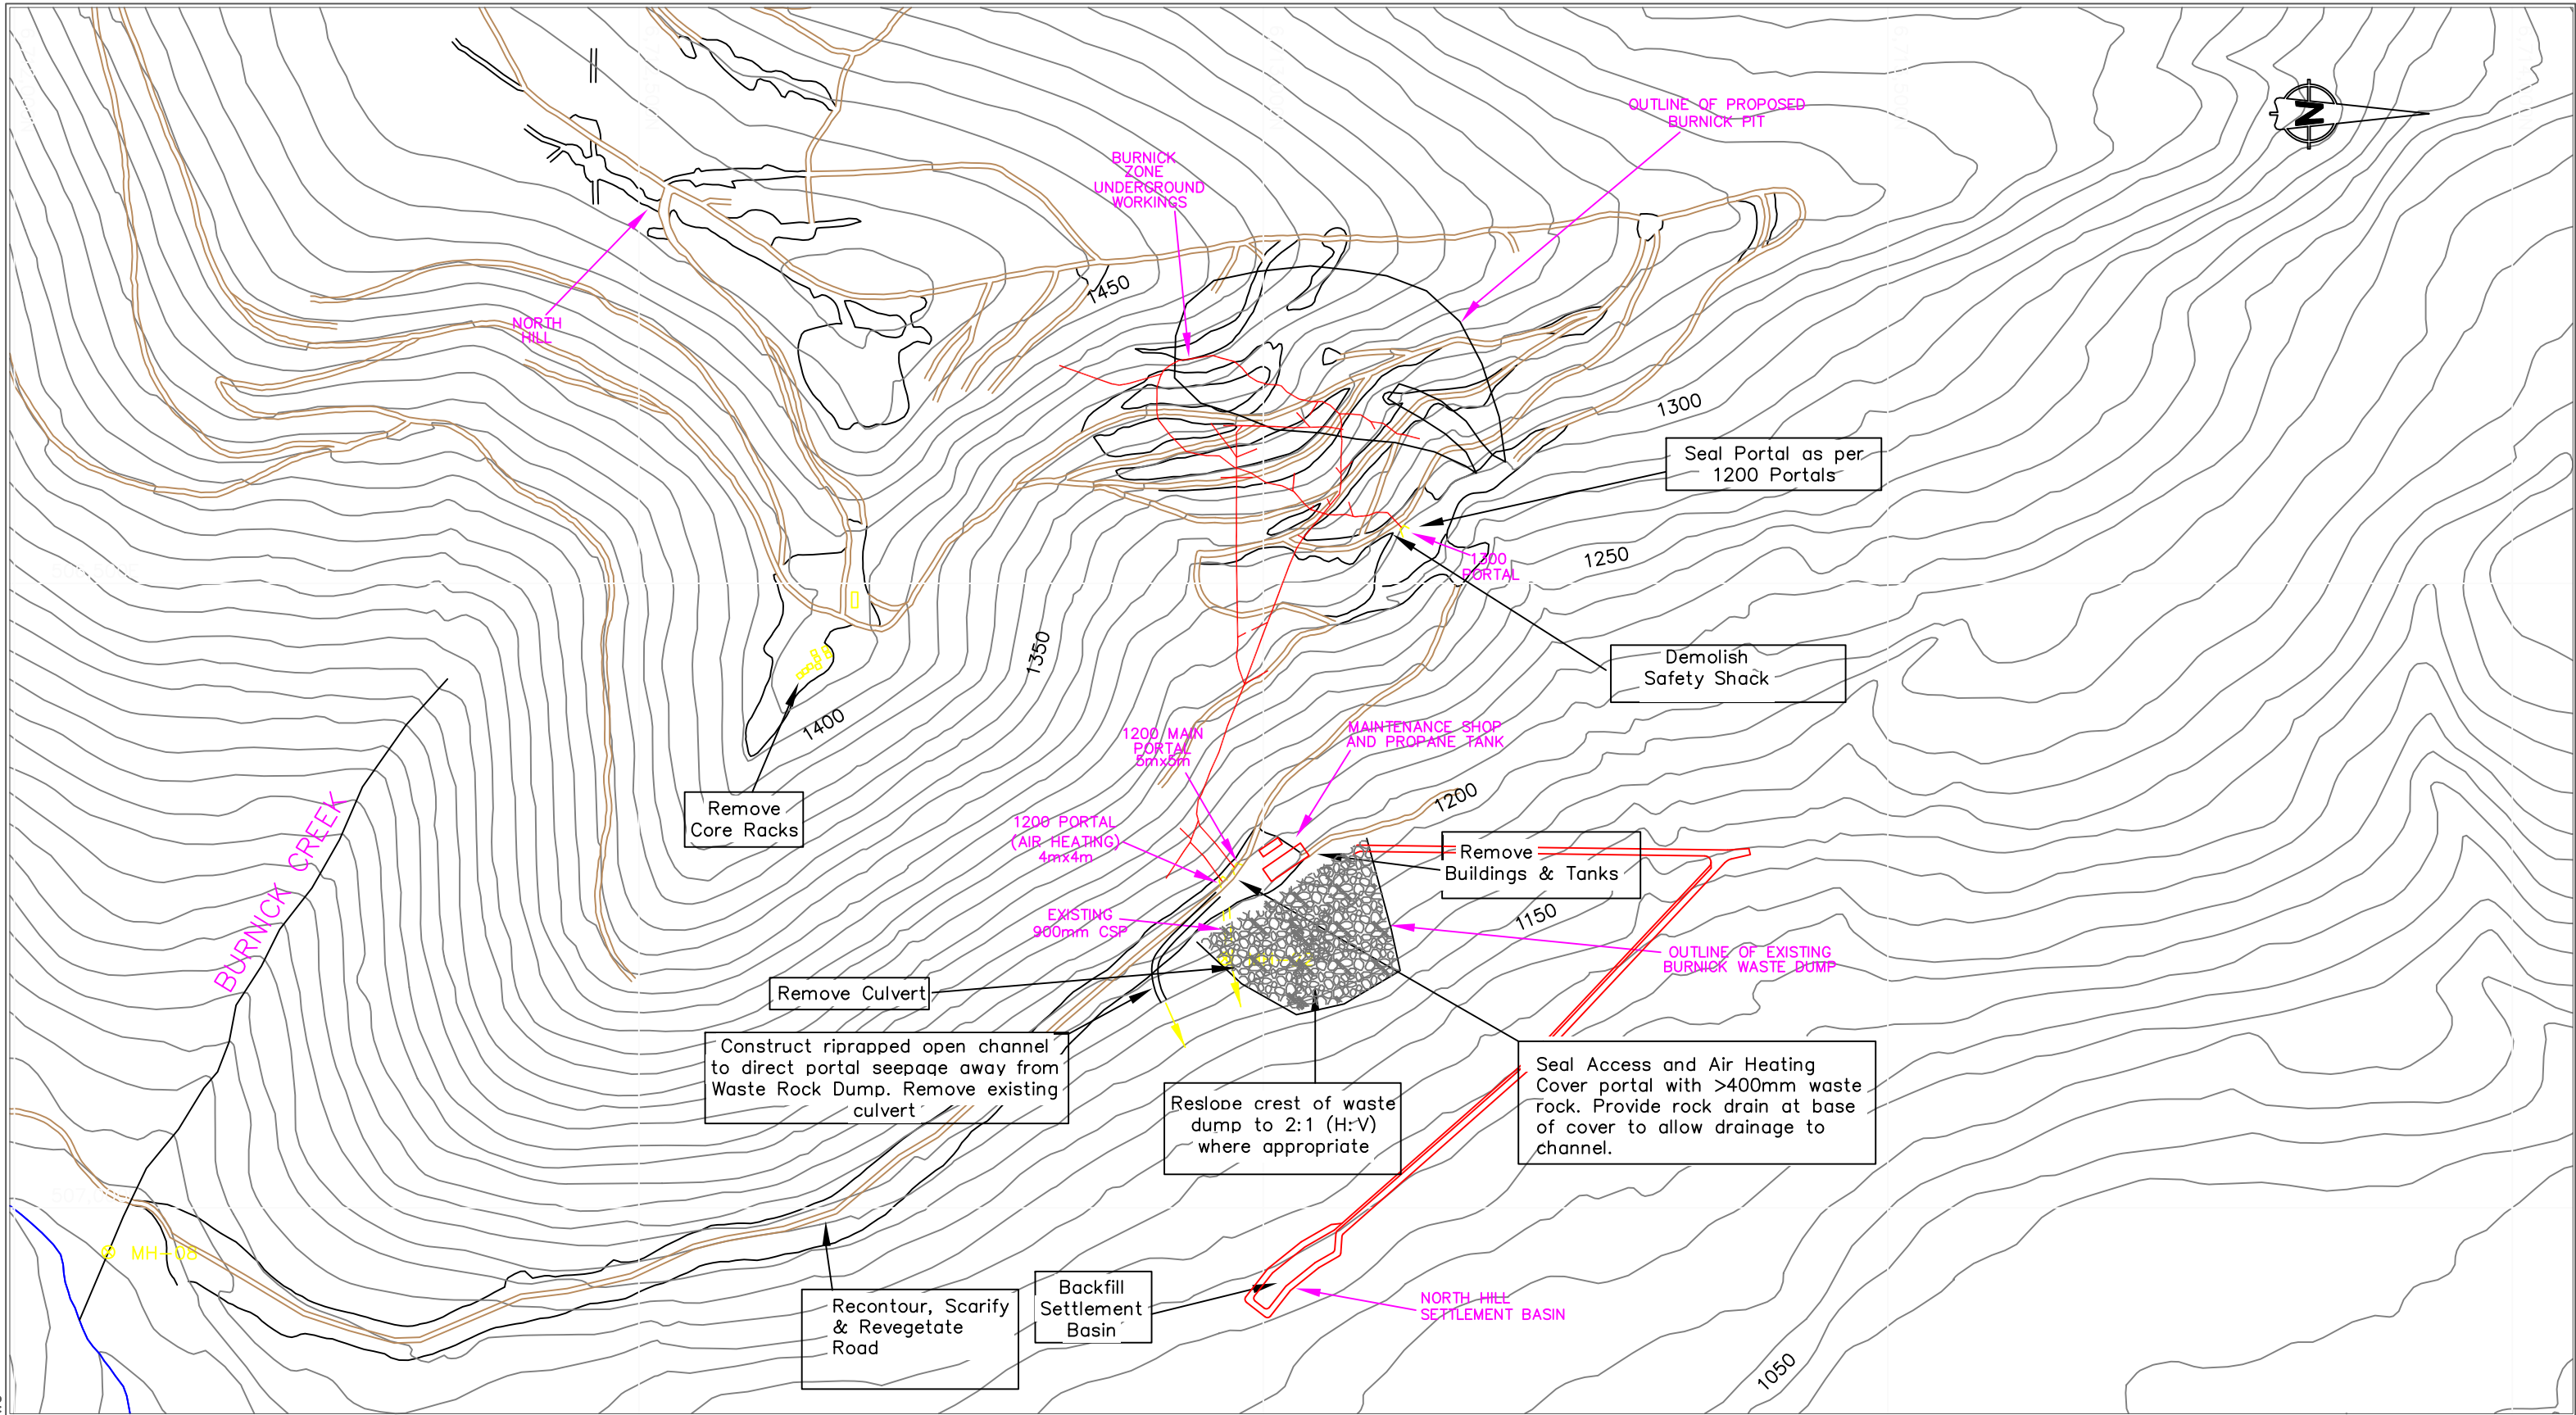
BURNICK ZONE  
CLOSURE MEASURES

At the 1200 Level of Burnick, there are two portals separated by several meters. They are shown on Figure 3-4. One of the portals is the main access to the Burnick ore body and the second portal provides propane heating for the ventilation air. Water from the mine drains the ventilation portal. In 1998, a temporary shotcrete dam was instructed inside the ventilation portal to create a settling sump to contain any sediment in the discharge. The flow rate of this water ranges from approximately 800 L/min during spring to 15 L/min during winter low flows. The water flows into a culvert beneath the portal pad which directs it over the existing waste rock dump.

The source of most of this water appears to originate from fractures and drill holes located near the entrance of the 1300 Portal. It flows down slope from this portal, exiting the mine from the 1200 Level. Because there has only been preliminary development completed at Burnick the underground workings are not extensive. A plan view of the present workings at Burnick is shown in Figure 3-4.

The two portals at the 1200 Level must be sealed to prevent public and wildlife from accessing the mine workings. The portals will be sealed in a manner that allows the max flow of 800 L/min to be free draining in order to prevent water from backing up into the mine workings and creating a safety hazard. Water from the portals will be redirected around the waste dump.

Any sediment collected in the sump behind the shotcrete dam will be removed to the tailings pond. Both portals will be securely sealed and covered with coarse waste (in the same manner described for the Jewelbox 1408 Portal in Section 3.2.1.1). The waste rock will be taken from the Burnick waste dump. An engineered rock drain will be placed at the base of the waste rock fill to provide free drainage from the portal.

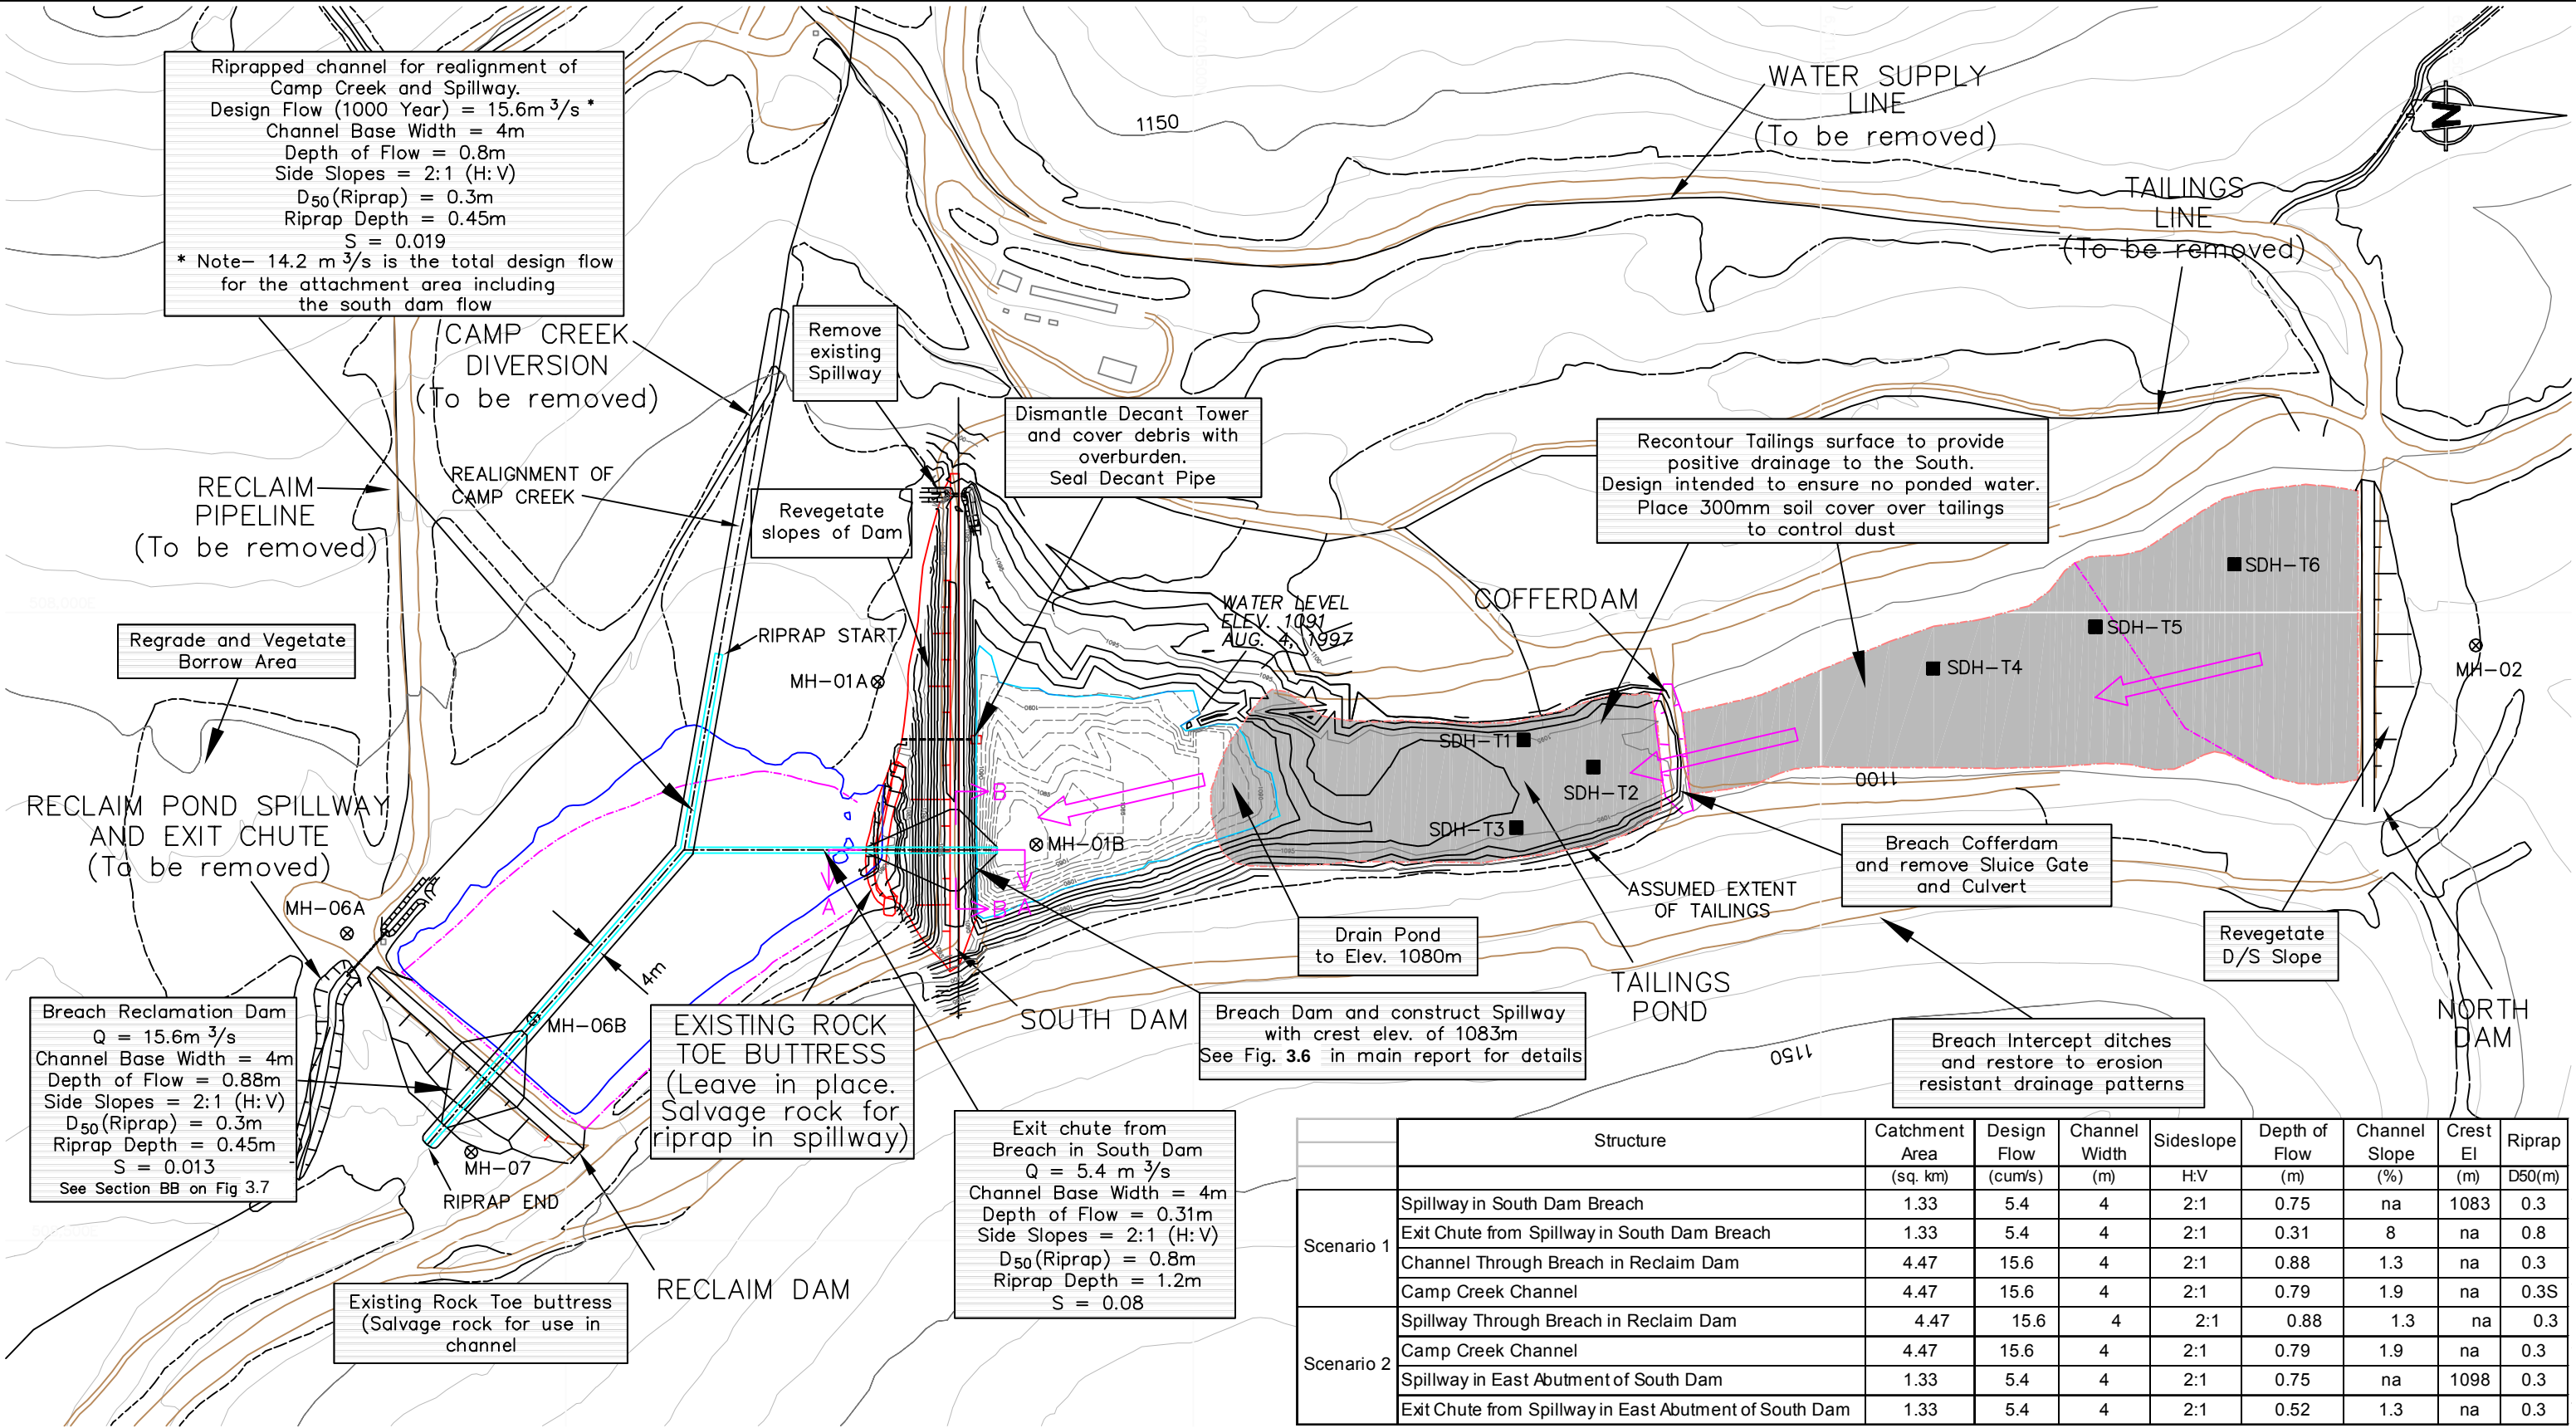
The first scenario addresses the option that the operation does not reopen the mine, and closure of the TMF would focus on the current conditions (see Figure 3-5).

General closure measures for the Tailings Management Facility are presented in Figure 3-5. The recent decision to enter into Permanent Closure at the site results in Scenario 1 – Mine Closure as being the only option.

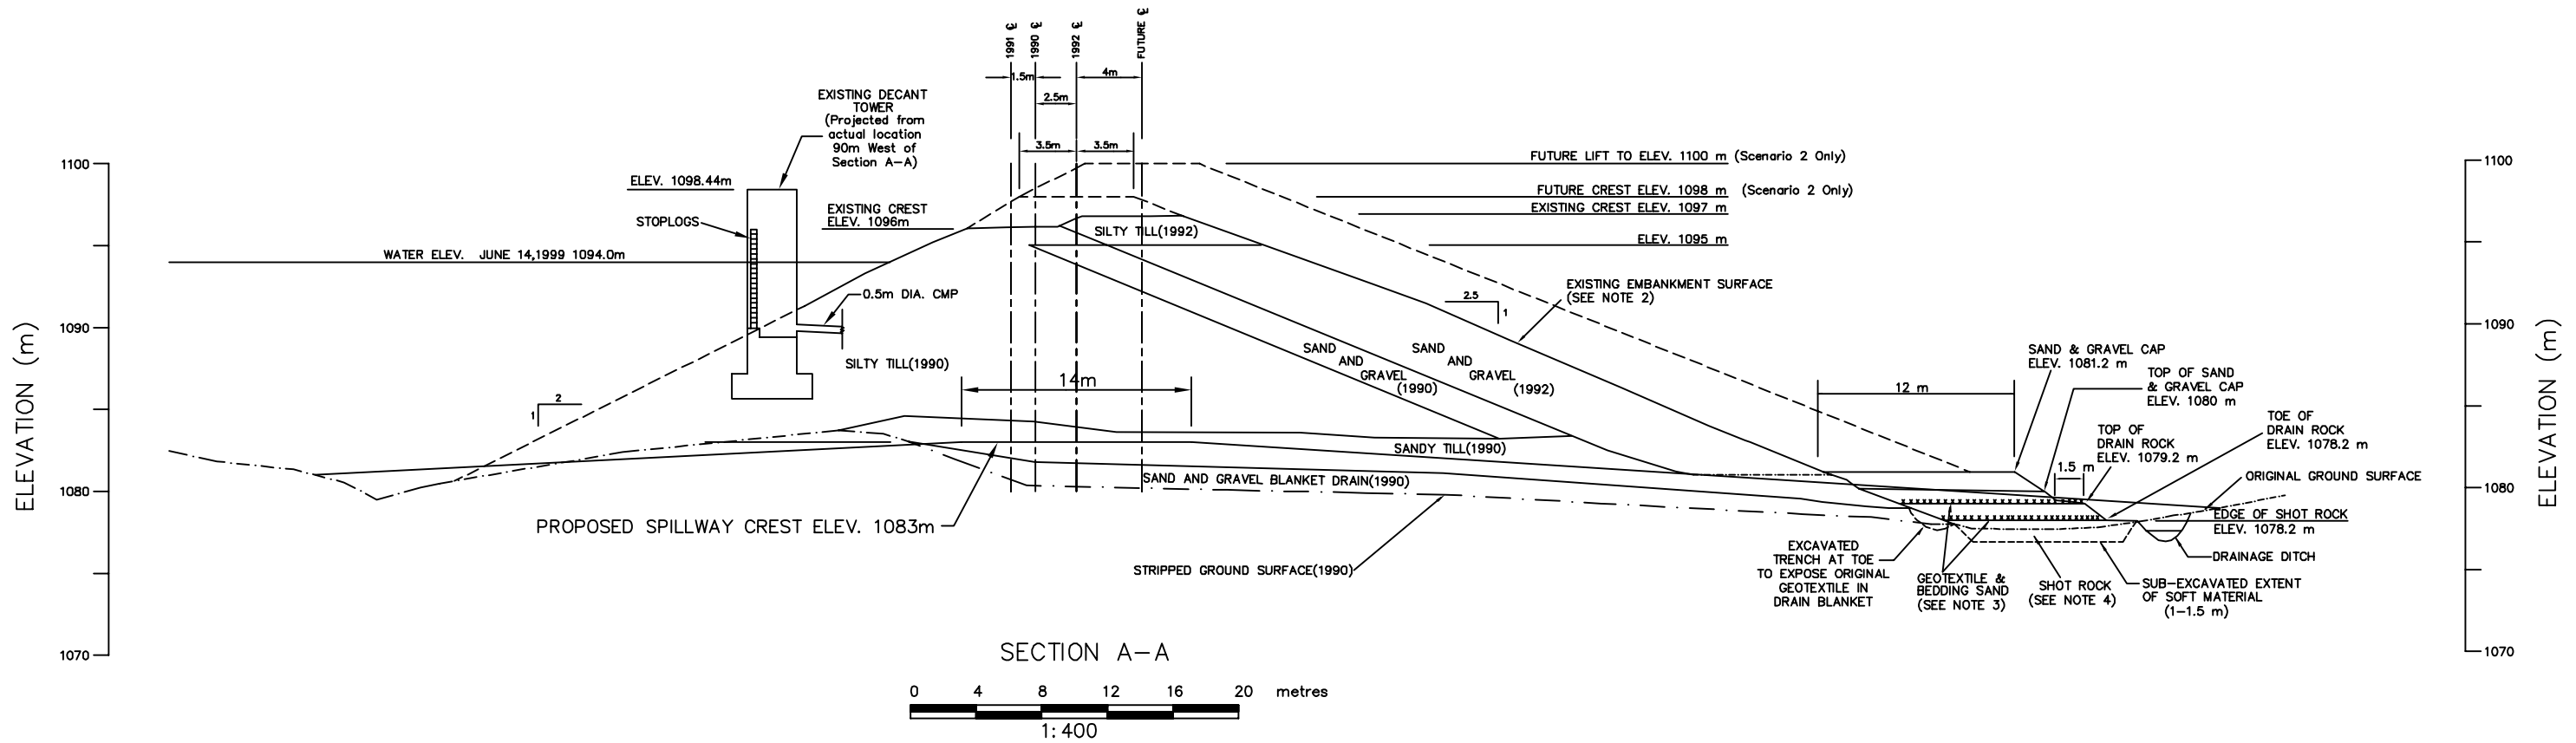
| DATE: January 2012 | PROJ. NO. 1CC005.05 | 3.5 | |

| | RECLAIM DAM<br>BREACH CHANNEL | SOUTH DAM<br>SPILLWAY |
| Q (m <sup>3</sup> /s) | 15.6 | 5.4 |
| Channel Slope | 0.013 | N/A |

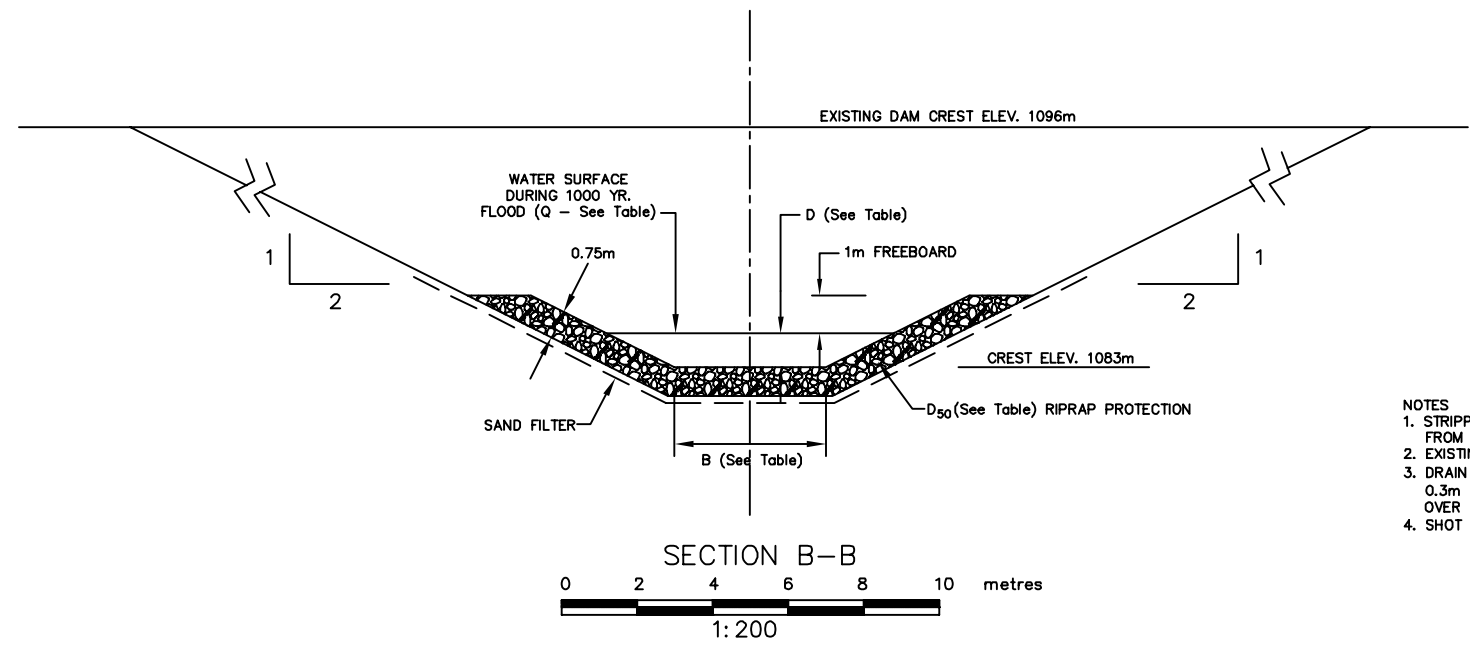
| DATE: | Dec. 2005 | PROJ. NO. | 1CC005.05 | 3-6 | |

- NOTES
1. STRIPPED GROUND SURFACE AND EXISTING DAM ZONES FROM Y.E.S. AS-BUILT DRAWINGS, JULY 1991.
  2. EXISTING DAM SURFACE FROM SURVEY COMPLETED AUGUST 1997.
  3. DRAIN ROCK FILTER CRITERIA -  $5\text{mm} \leq D_{15} \leq 25\text{mm}$   
0.3m THICK BEDDING LAYER OF PIT RUN SAND AND GRAVEL OVER SHOT ROCK PLATFORM.
  4. SHOT ROCK CONSISTS OF BLASTED LIMESTONE FROM JEWELBOX PIT.
