# **SÄ DENA HES OPERATING CORPORATION**

## **SÄ DENA HES MINE**

### **DETAILED DECOMMISSIONING & RECLAMATION PLAN**

### **JANUARY 2012 UPDATE**

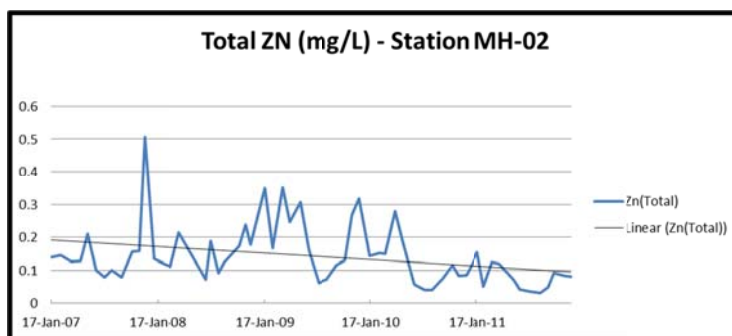
A short term increase in total Zinc levels noted at MH-02 in 2009 was noted in the 2010 update, however further data collected to the end of 2011 continues to show a decreasing trend. The following graph shows that zinc concentrations appear to increase over periods of low flows ie winter, however there is a definite downward trend still continuing. Significant higher total suspended solids readings associated with the elevated Zinc levels suggest that the high readings may be the result of sampling errors.

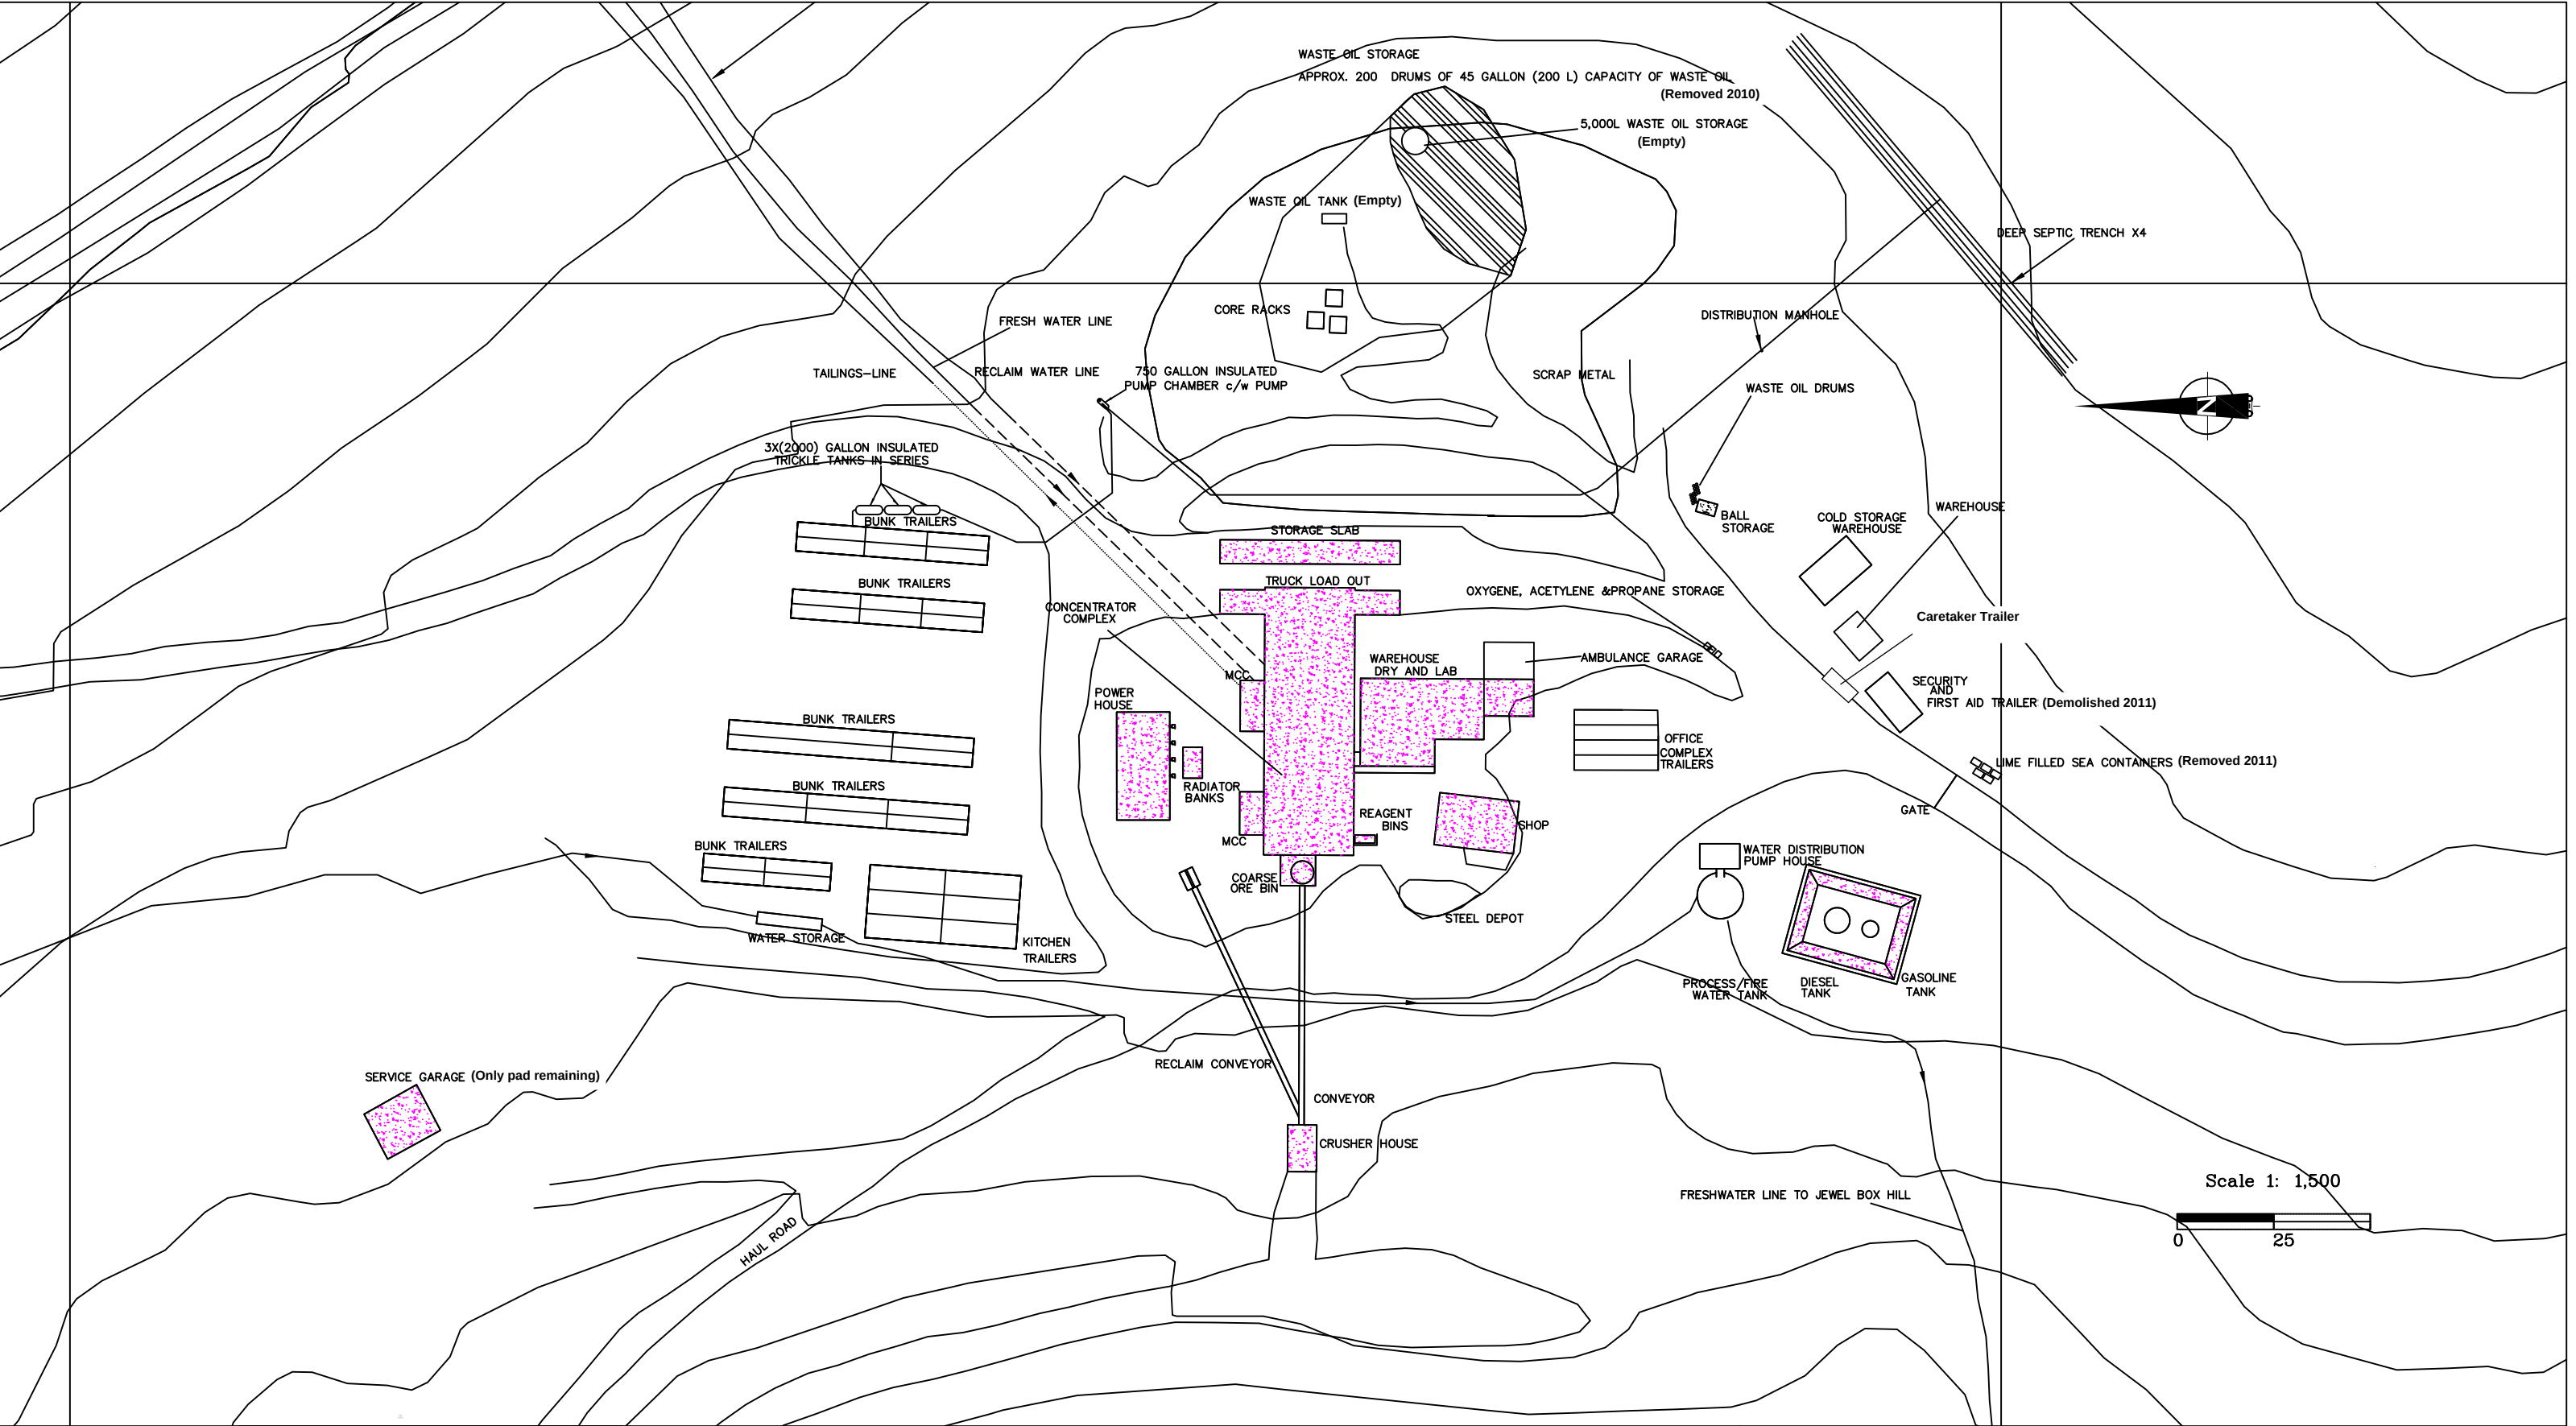
Table 3-1 provides a brief dimensional description of the various infrastructure components, and Figure 3-9 depicts the general arrangement of the central office, accommodation and mill site buildings and services. Over the past several years a number of buildings and structures have been removed as a result of old age and subsequent winter snow damage. These include all facilities previously located at the Jewel Box site, the shop at the Golden Hills site and the First Aid trailer located at the main gate. All waste generated from these demolitions have been disposed of in a permitted landfill site. Figure 3-10 depicts the generalized closure measures for this area.

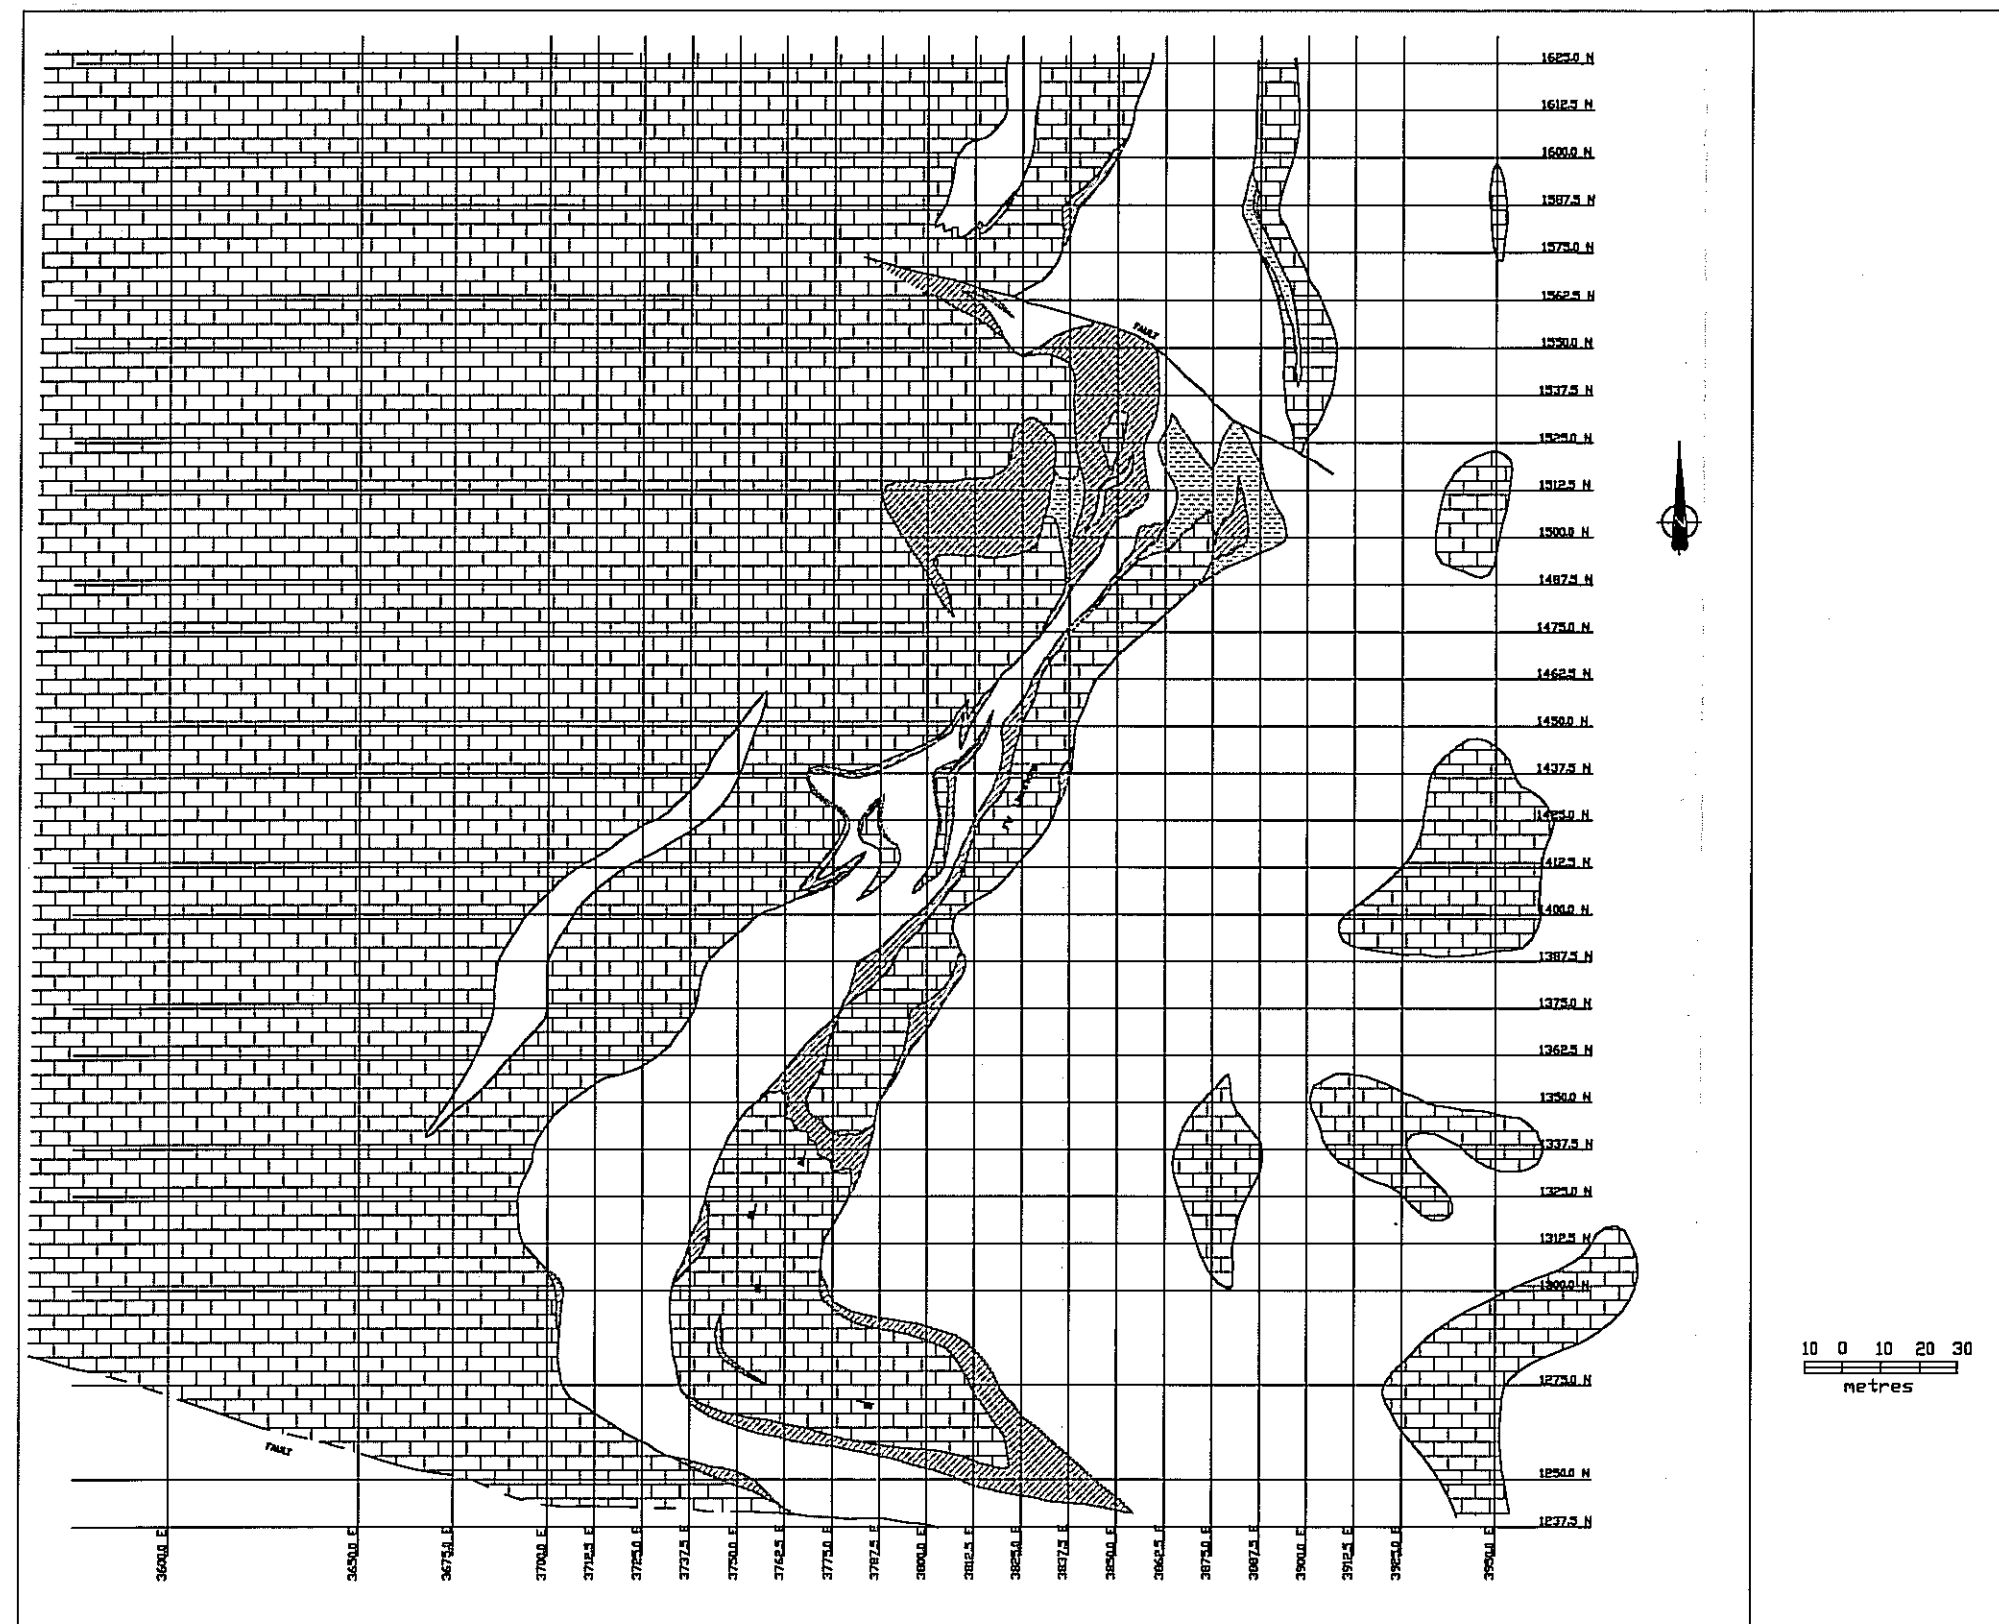
**Fig No. 1-1**

The Sä Dena Hes Property is underlain chiefly by lower Palaeozoic metasedimentary rocks, including both calcareous and non-calcareous pelitic phyllite and limestone. (Refer to Figure 1-1 “Typical Geology, Jewelbox Deposit”, and Figure 1-2 “Typical Geological Section, Burnick Deposit”, for a depiction of the typical geometry of the ore deposits and the associated rock types). Limestone comprises about five percent of the stratigraphic sequence and consists of discontinuous units which are up to 100 metres thick, and which typically pinch and swell over short distances. The thicker limestone units can be traced along strike for hundreds of metres. There is evidence locally that the limestone grades laterally into calcareous phyllite.

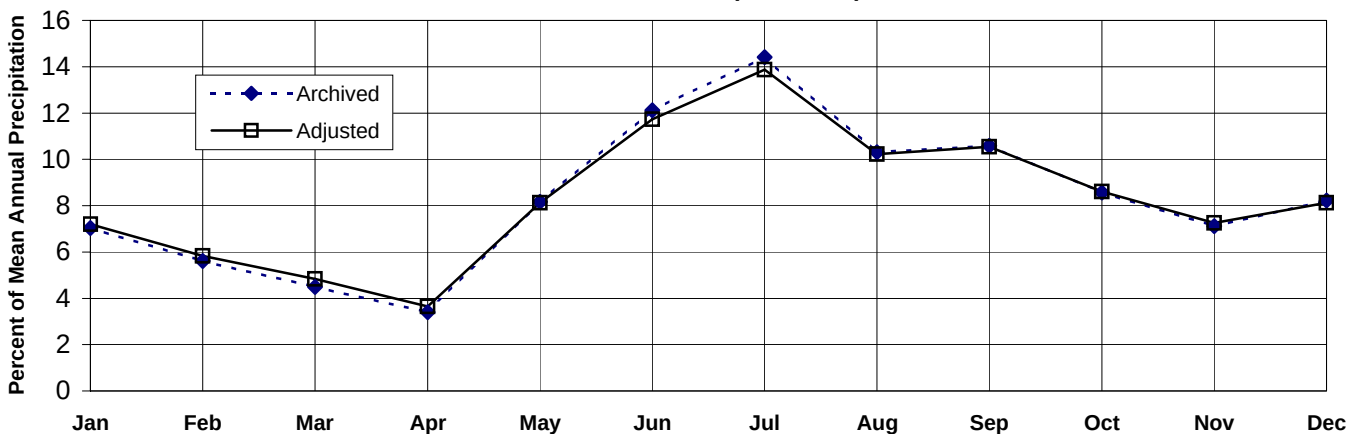
Comparison of Archived and Corrected Precipitation Records  
for Watson Lake A. - (1953-1993)

Therefore, the corrected MAP for Watson Lake of 490mm will be used in the analysis. The previous archived value from the 1961 – 1990 normals was 413 mm. For all other stations, the archived MAP value will be used. The correction of the archived records for these other stations is the focus of on-going research at the AES.

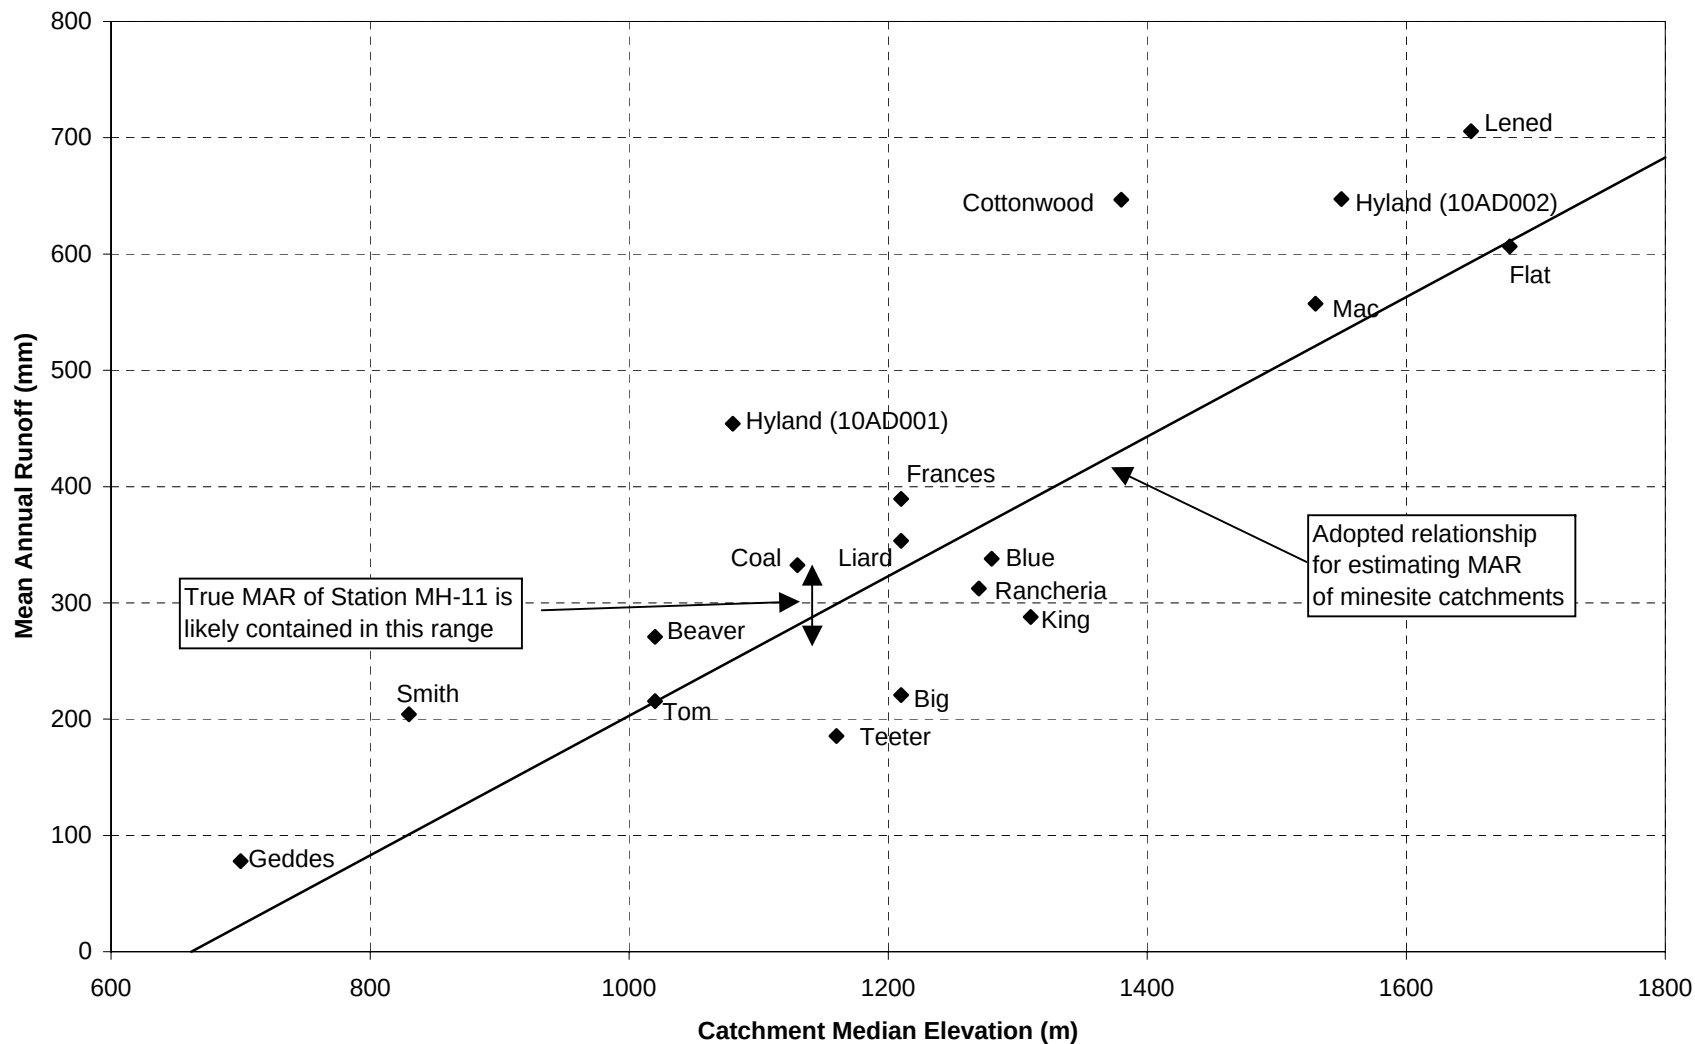
As indicated in Section 2.4 in Appendix B, elevation generally accounts for a large proportion of the variation in mean annual precipitation within a mountainous region. It follows, therefore, that mean annual runoff (MAR) would also be a function of elevation. Figure 3-3 shows how this observation was exploited to estimate the average flows of the minesite streams. The vertical axis of this figure displays values of MAR expressed as equivalent depths of water. The horizontal axis shows values of median elevation, which is the variable adopted to quantify the elevation characteristics of the regional and minesite catchments. The 18 pairs of MAR and median elevation values assembled in Table 3-2 for the WSC stations were plotted on this figure. These data demonstrate a reasonably strong relationship between the two variables.

$$\text{MAR} = 0.60 \text{ E} - 397$$

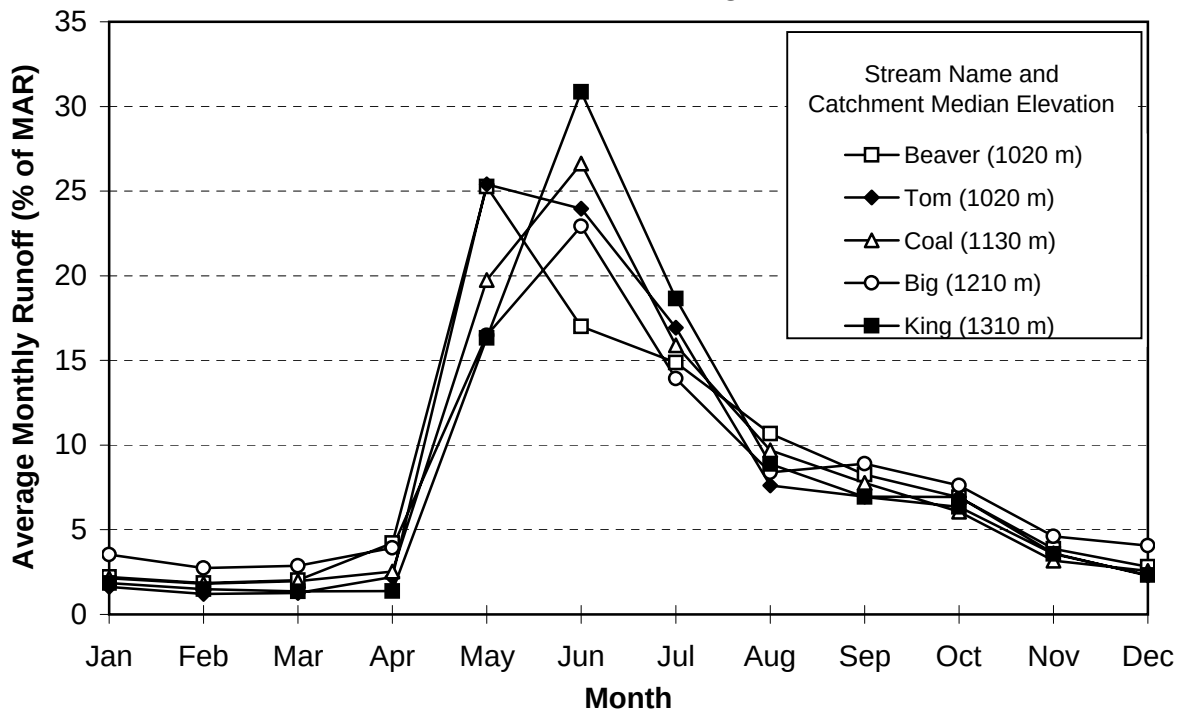
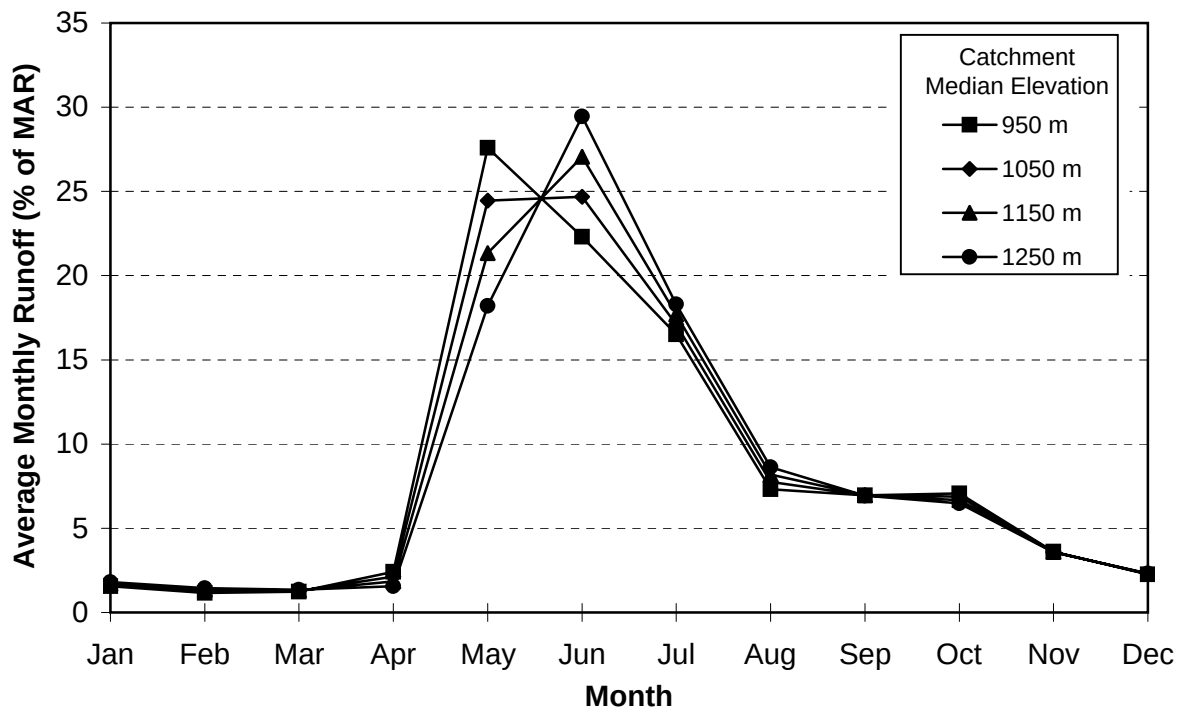
FIGURE  
**3-4**

**Observed Streamflow Distributions at Regional WSC Stations**

**Estimated Streamflow Distributions for Minesite Streams**

The distributions for the five selected stations are characterized by high spring flows during snowmelt and low winter flows during prolonged freezing conditions. All five distributions are remarkably similar over the period August to April, especially considering they represent runoff from significantly different catchment areas ranging from 13.7 km<sup>2</sup> to 9190 km<sup>2</sup>. The major difference that exists amongst the five distributions is the proportion of runoff that occurs during the months of May, June and July. Examination of these distributions and the characteristics of their associated catchments revealed that median elevation is a reasonably good predictor of the shape of the average monthly hydrograph. As expected, low-elevation catchments generally experience earlier peaks than high-elevation catchments. The median elevations for the catchments of the five stations are shown in the legend of the top plot.

The observed relationship between hydrograph shape and catchment median elevation was used to estimate the shape of the average monthly hydrograph at ungauged locations around the minesite. The bottom plot on Figure 3-5 shows how this was implemented. The normalized distributions for Tom Creek and King Creek were used to establish the hydrograph shape at median elevations of 1020 m and 1310 m, respectively. Interpolation between the shapes of these two hydrographs was used to estimate the distribution for intermediate median elevations. Figure 3-5 shows the estimated shapes of the hydrographs for four distinct elevations.

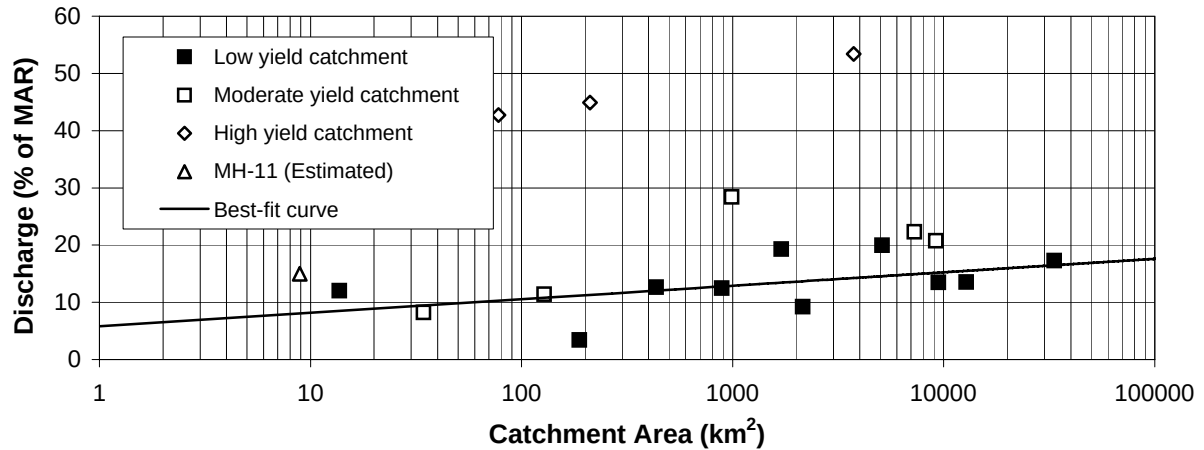
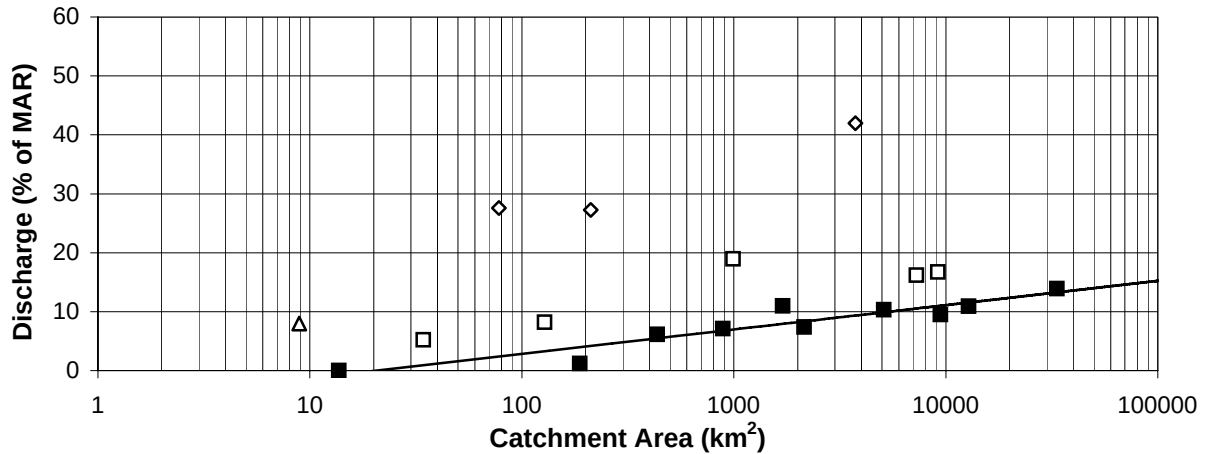
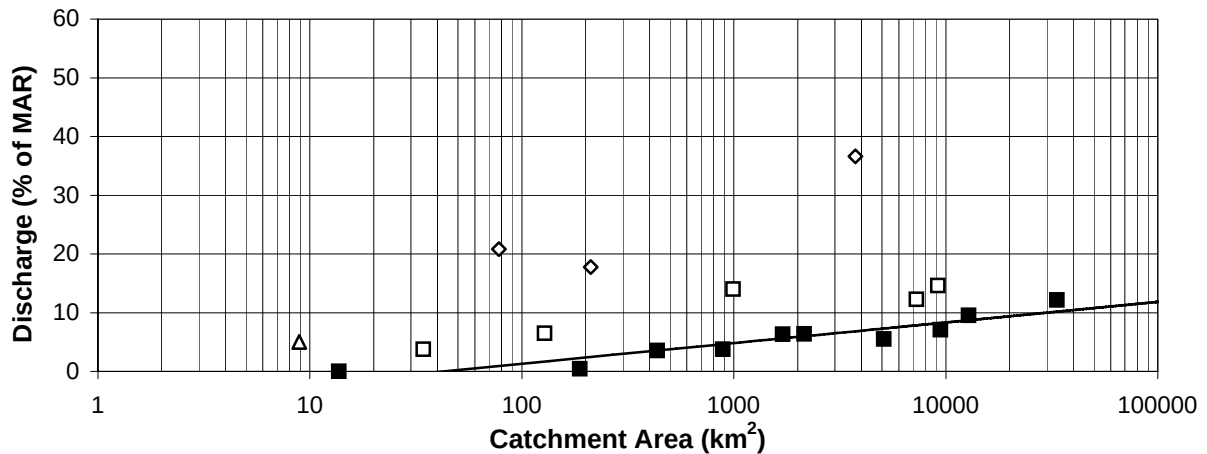
### 7-Day Low Flow with 2-Year Return Period

### 7-Day Low Flow with 10-Year Return Period

### 7-Day Low Flow with 50-Year Return Period

The magnitude of low flows at the minesite was estimated using Regional Analysis. To apply this technique, three steps were undertaken. Firstly, the annual series of 7-day low flows was extracted from each of the 18 WSC streamflow records assembled for this hydrology study. For the purpose of selecting the annual low-flow values, the year was defined as the period June 1 to May 31. Use of a calendar year was rejected for this purpose to avoid missing any low-flow periods that might span the period from late December to early January. It is interesting to note that the annual low flows for durations of 1, 3, 10 and 30 consecutive days have values very close to the 7-day low flow. This is a consequence of the low flows occurring in the winter rather than the late summer. The winter flows originate from storage releases (lake and groundwater) and, accordingly, vary only slightly over lengthy periods of time.

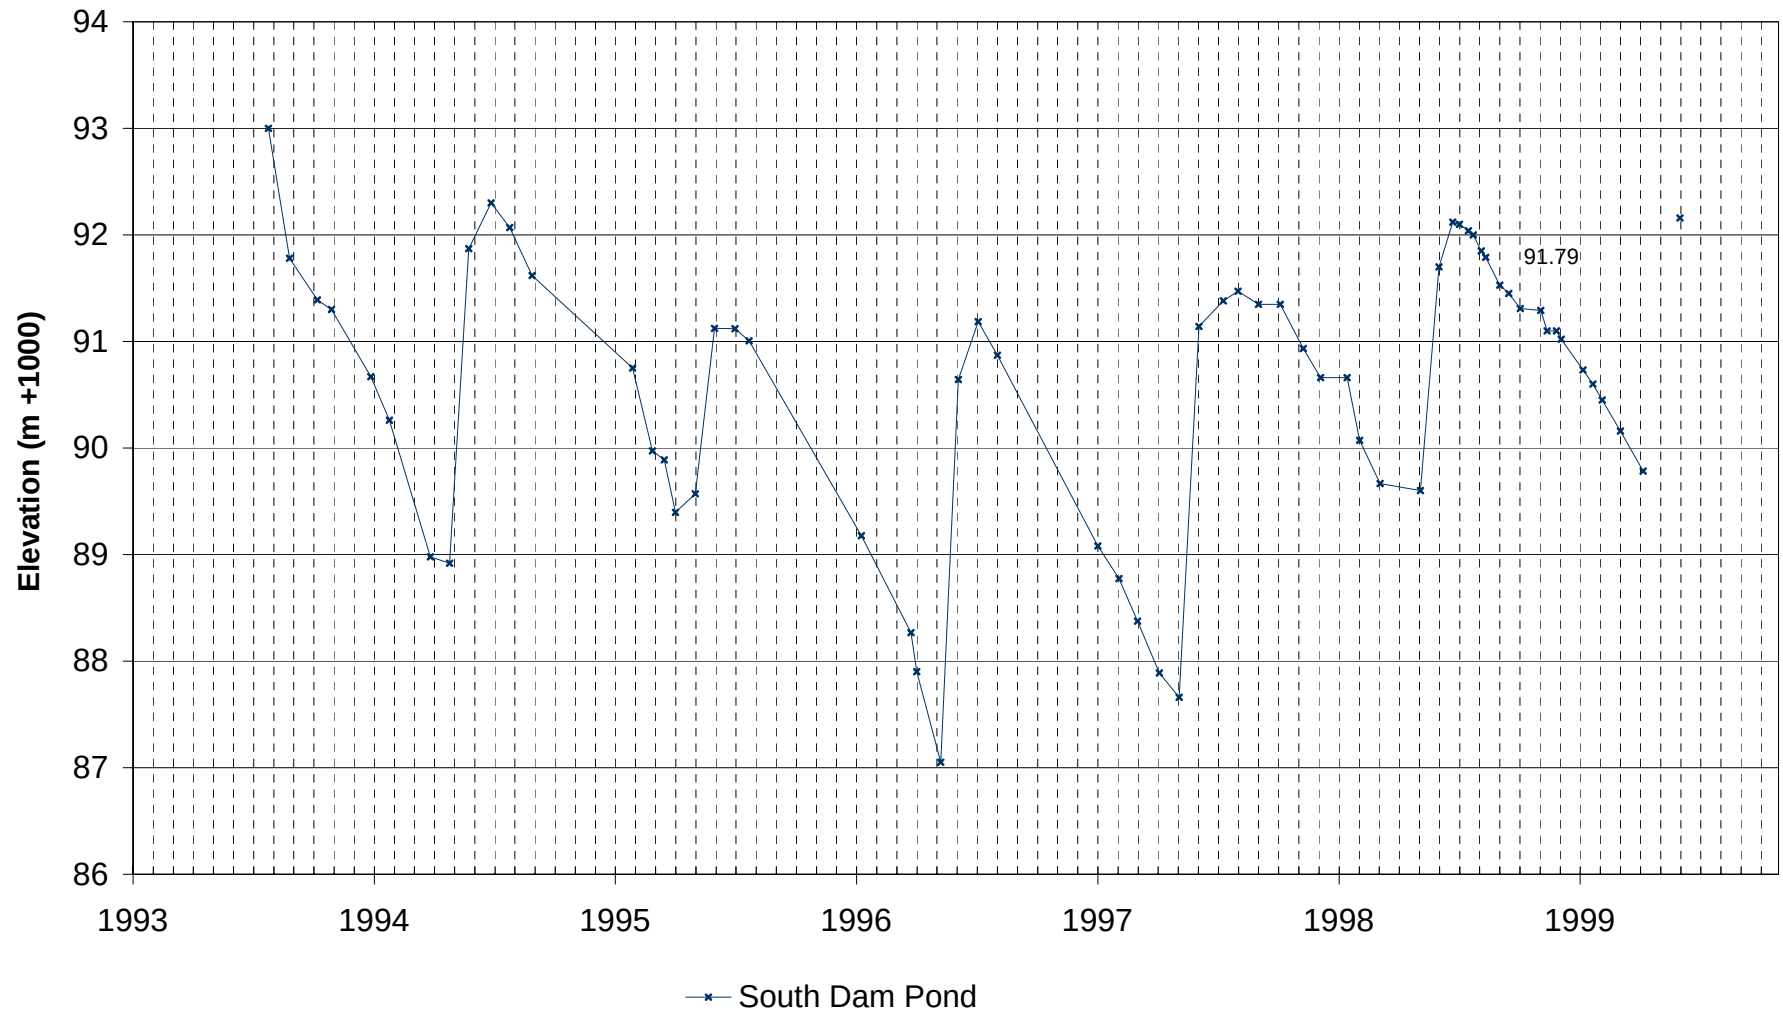
The graph shows a regular seasonal fluctuation in the pond level. The highest levels generally occur in late June or early July, corresponding to the end of the spring snowmelt. These levels steadily decrease to a minimum level in April or May of the following year. There are three possible mechanisms that could cause a drop in the pond level:

**South Dam Pond Levels**

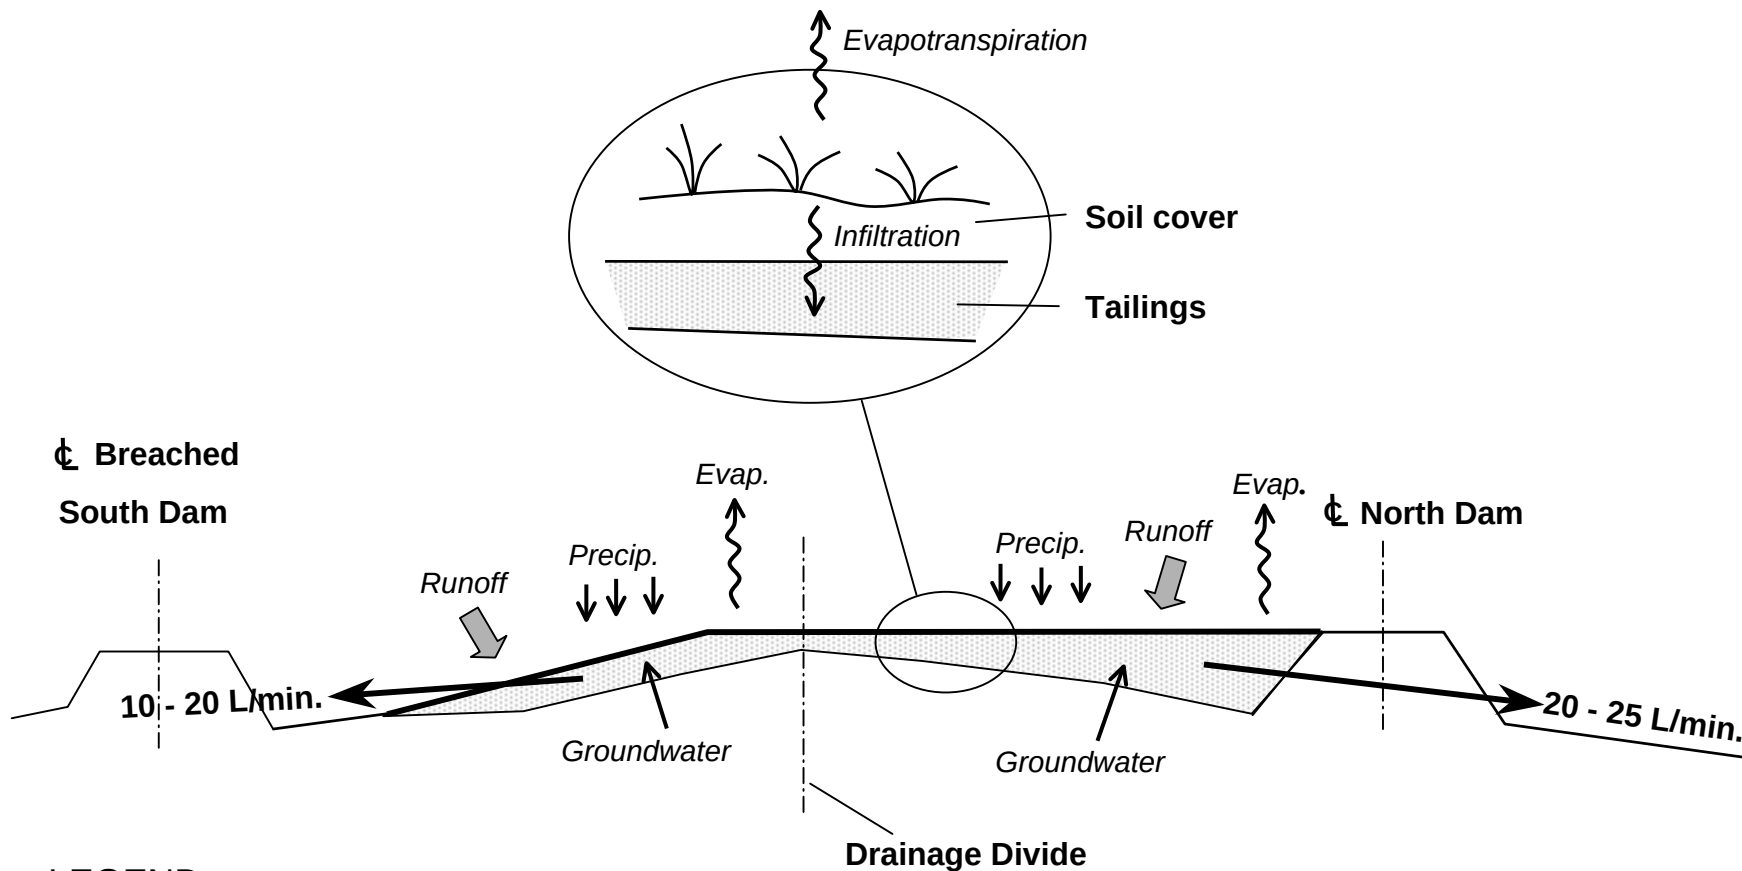
FIGURE:  
**3-9**

Seepage  
Flux through  
Tailings

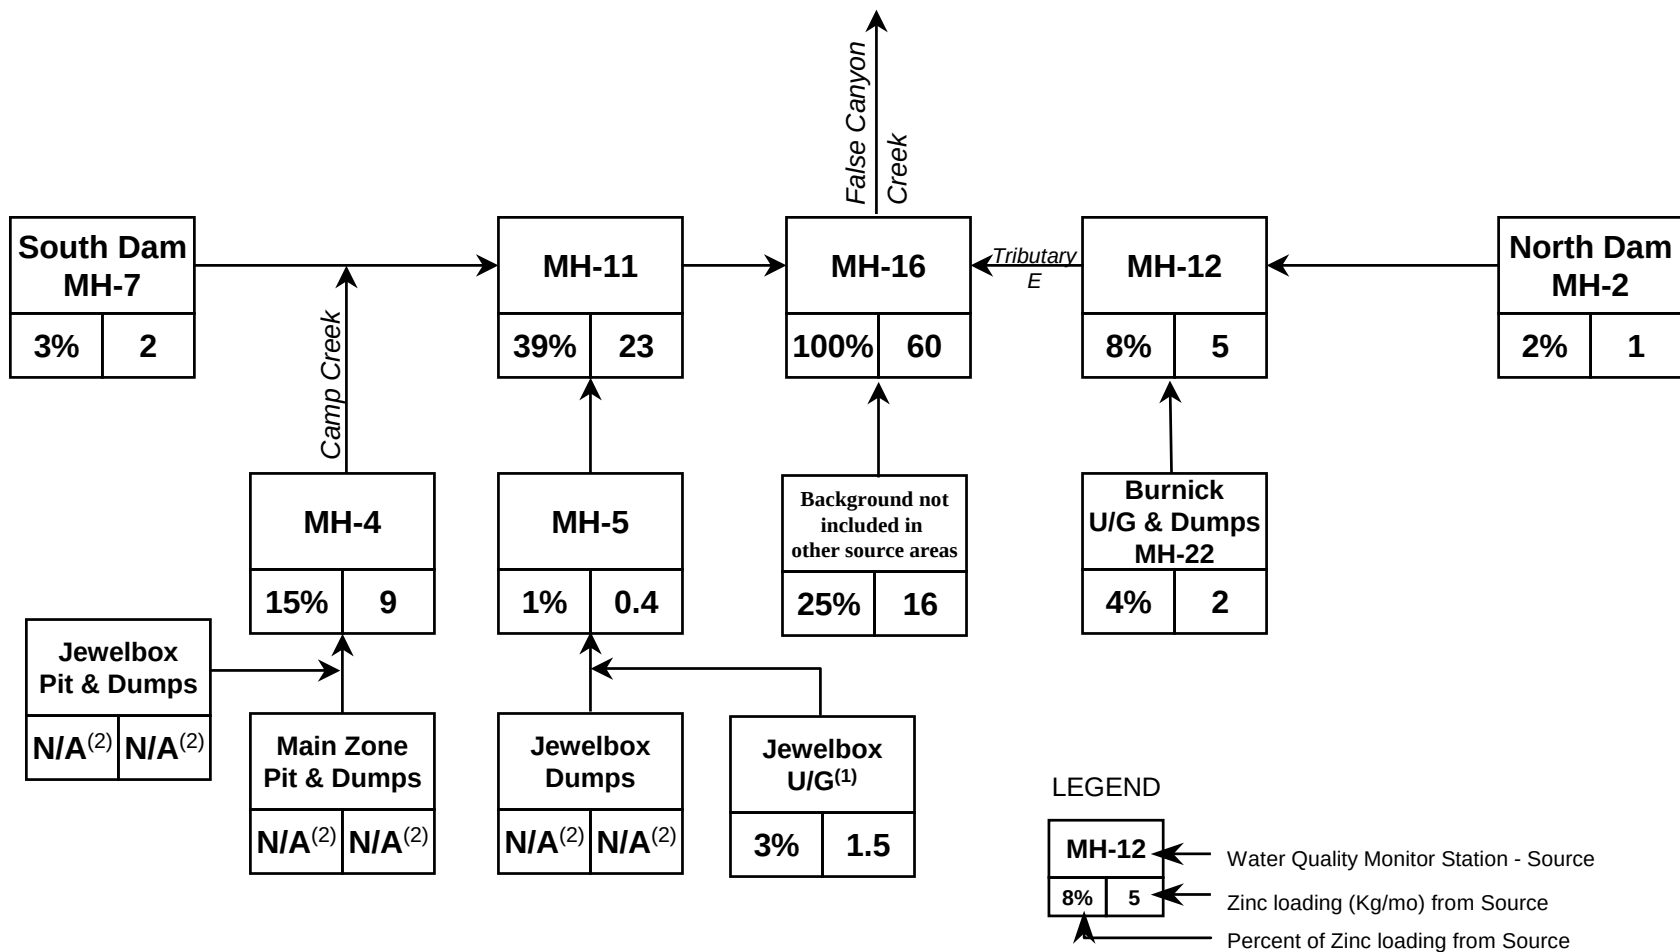
5. The proportion of load at each point as a proportion of the load in the basin (MH-16) was calculated to evaluate the contribution of each source to the total load in FCC (Table 4-8). This is graphically shown in Figure 4-1.

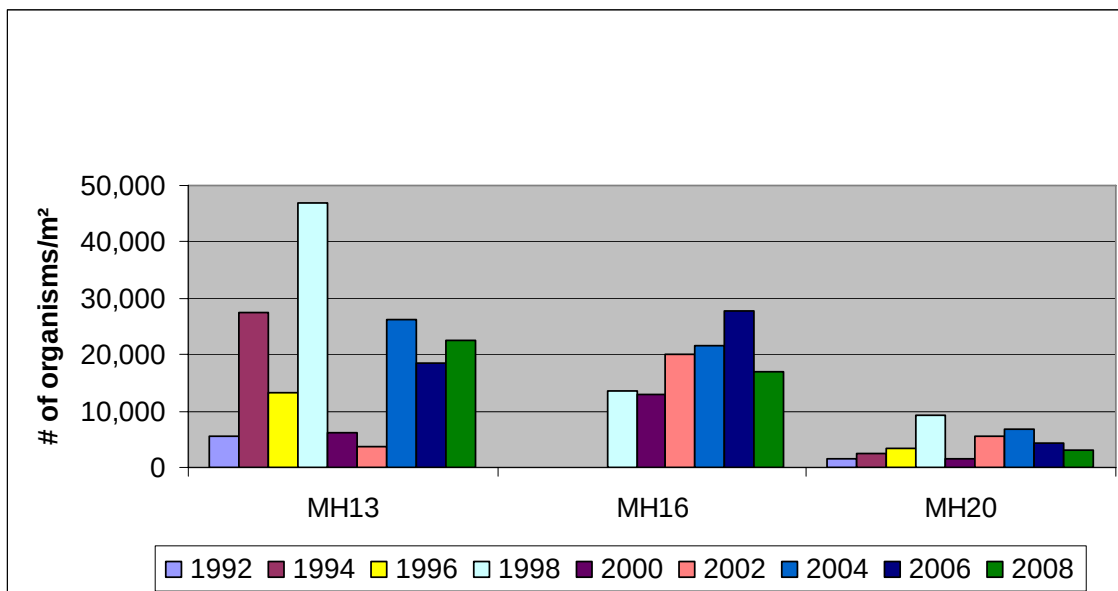
Data collected from False Canyon Creek since 1992 have been summarized and compiled in Table 6-2. Population densities were greatest in 1998 at MH13 and MH20, and in 2006 at MH16 (Figure 6-2). The population at MH13 has fluctuated considerably over time which probably reflects the instability of this site. Populations at MH16 and MH20 in 2008 decreased to their lowest levels since 2000.

**Figure 6-2 Community Density by Site Over Time**

The dominance of the respective communities has remained virtually unchanged over the study period. Diptera has been the dominant or co-dominant order at MH13 during every sampling period. Ephemeroptera and/or Diptera have been the dominant orders at MH16 and MH20 over time.

The temporal data generally indicates that the community at MH13 fluctuates depending on the changing habitat characteristics during the particular sampling period. The community at MH16 is stable in terms of numbers and composition, and the community at MH20 experiences some slight changes in numbers and composition.

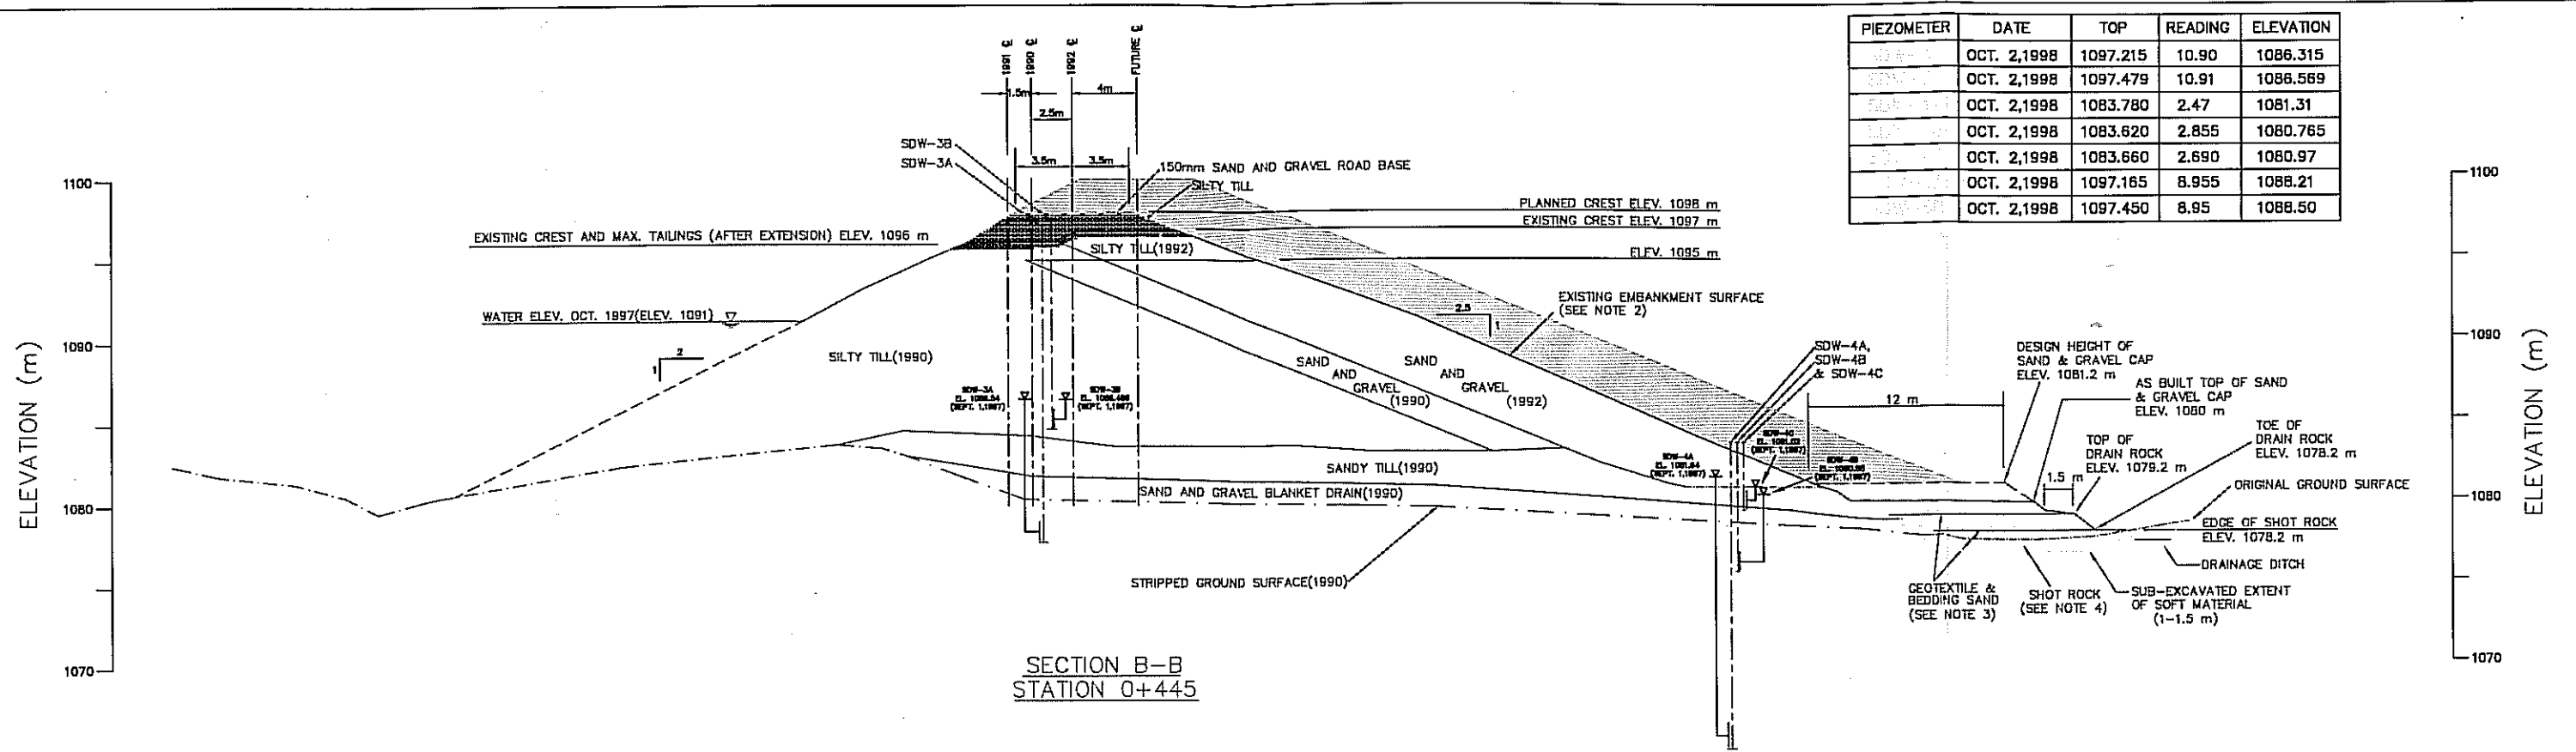
SECTION B-B  
STATION 0+445

The South Dam has a current crest elevation of 1096 to 1097 m, which corresponds to a dam height between 17 and 18 m (Figure 10-6 and Figure 10-7). Further operation would require the dam be raised to elevation 1100 m or a height of 21 m. Its configuration is similar to the North Dam, with a 2H:1V upstream slope, and a 2.5H:1V downstream slope. However, unlike the North Dam, a small stabilizing rock buttress is present at the toe of the South Dam. Two zones grading from upstream silty till through a downstream sandy till make up the dam section, along with a sandy gravel blanket drain. The buttress is comprised of a 1m thick layer of drainrock capped with 2 metres of sand and gravel.

Over the last five years, piezometric levels have been recorded in the South Dam at piezometers located both along the centreline of the dam and at the toe (Figure 10-6). The records indicate that although the levels in the dam fill are controlled reasonably well by the drainage blanket, elevated levels have been recorded in the piezometers at the toe of the dam (SDW-4A, 4B and 4C) and have demonstrated a sensitivity to water levels in the pond. The well tip of SDW-4A is located within deep gravel zones, which are believed to be hydraulically connected to the water stored in the pond upstream. Although piezometers SDW-4C and 4B are not as sensitive to the pond level as 4A, the levels indicated pore pressures in the drainage blanket and in the underlying shallow gravel zones.
