# **SÄ DENA HES OPERATING CORPORATION**

## **SÄ DENA HES MINE**

### **DETAILED DECOMMISSIONING & RECLAMATION PLAN**

### **JANUARY 2012 UPDATE**

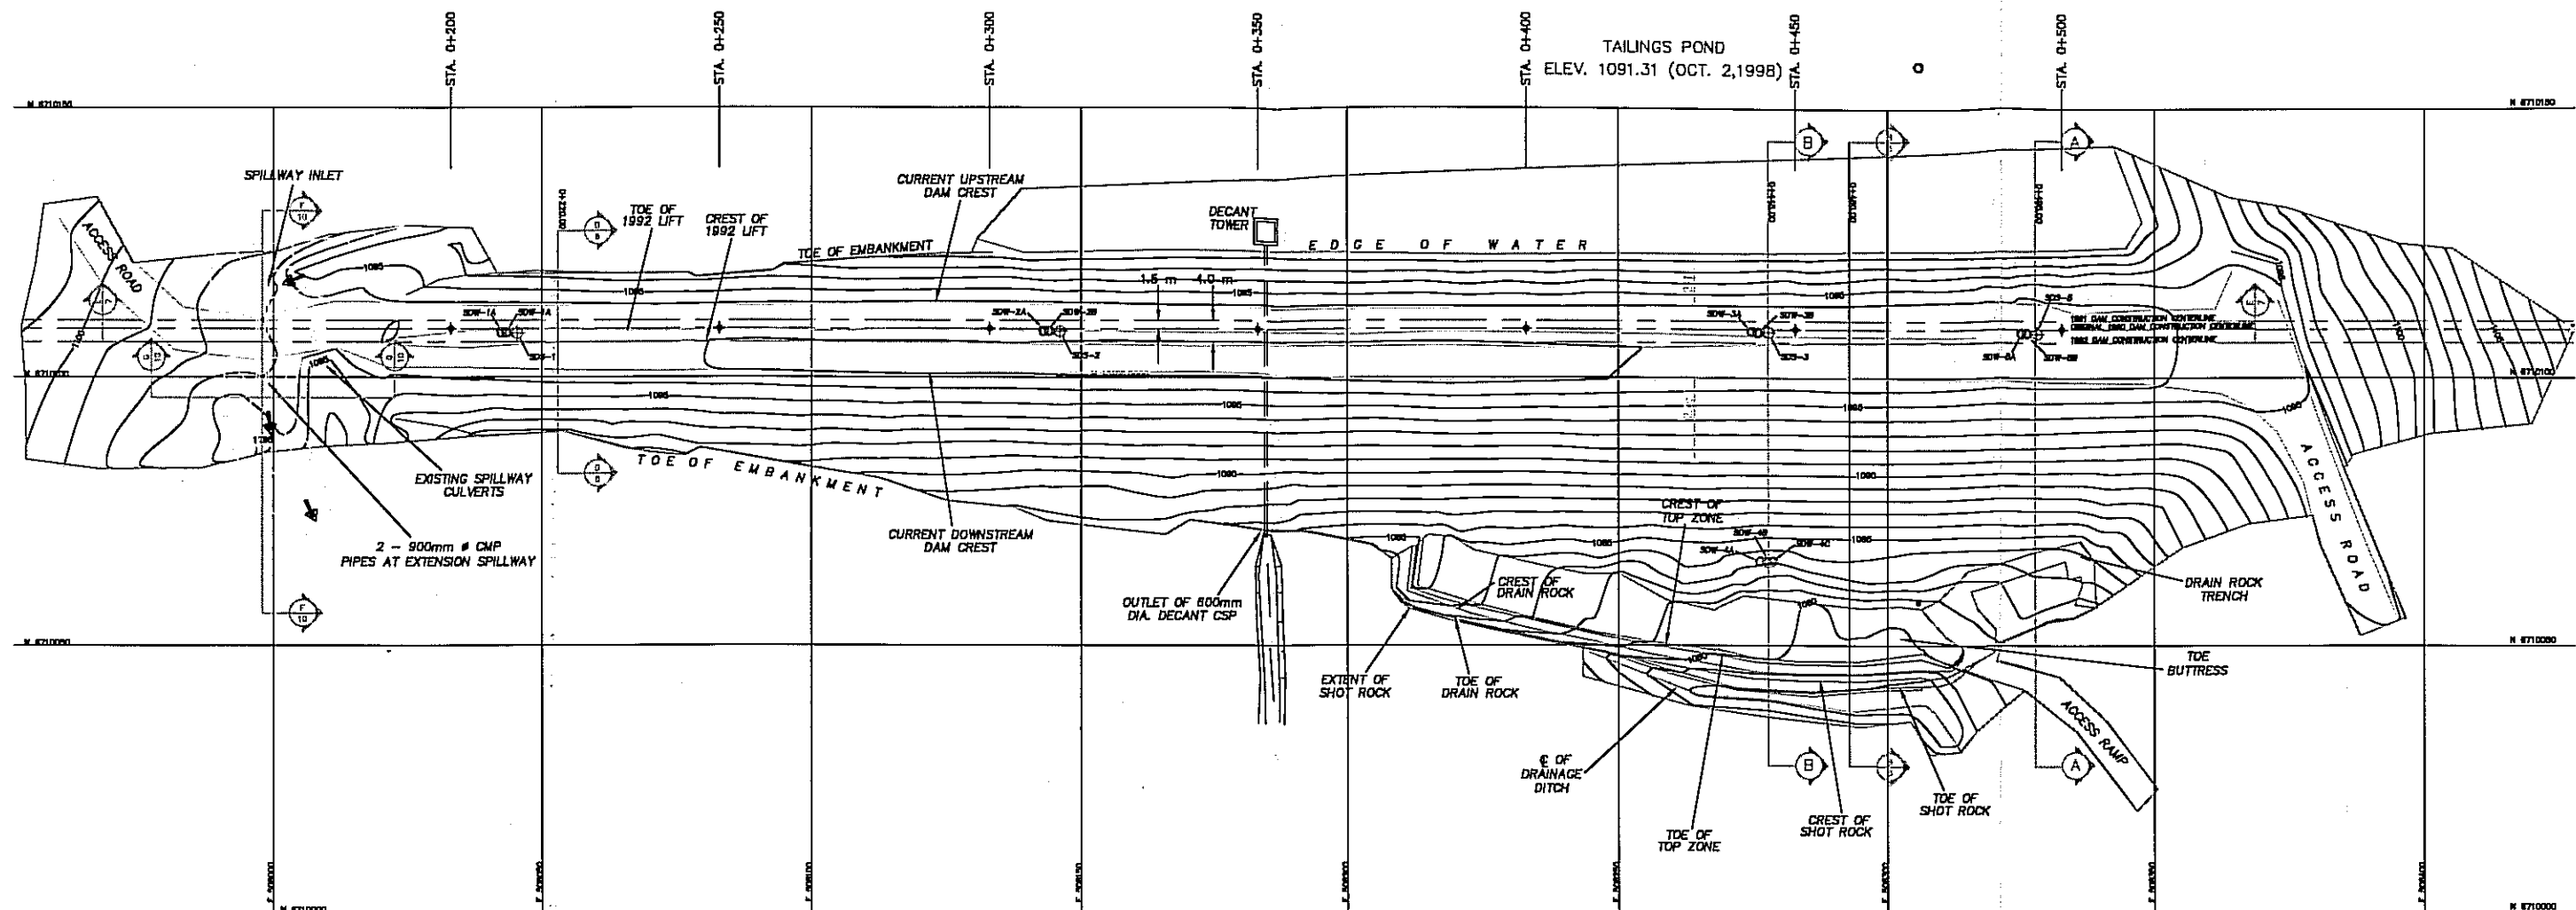
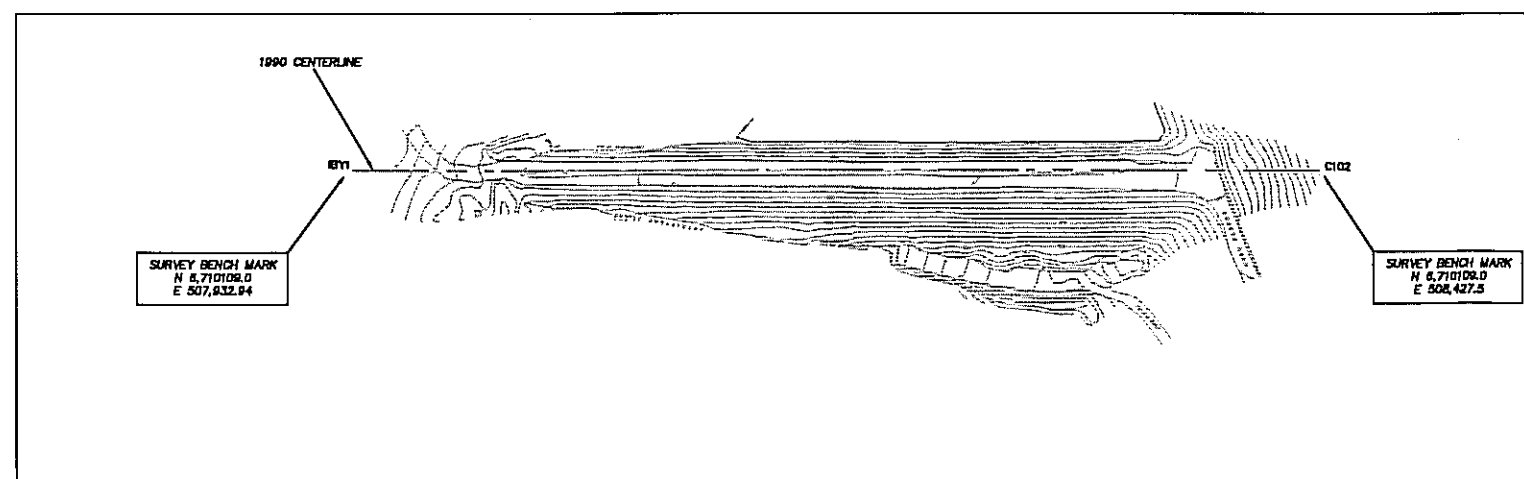
| DATE: | AUG. 6,1999 | PROJ. NO. | 1CC005.05 | 10-7 | |

RECLAIM POND  
ELEV. 1078.031 (OCT. 2,1998)  
MAX. ELEV. 1079.5

The South Dam has a current crest elevation of 1096 to 1097 m, which corresponds to a dam height between 17 and 18 m (Figure 10-6 and Figure 10-7). Further operation would require the dam be raised to elevation 1100 m or a height of 21 m. Its configuration is similar to the North Dam, with a 2H:1V upstream slope, and a 2.5H:1V downstream slope. However, unlike the North Dam, a small stabilizing rock buttress is present at the toe of the South Dam. Two zones grading from upstream silty till through a downstream sandy till make up the dam section, along with a sandy gravel blanket drain. The buttress is comprised of a 1m thick layer of drainrock capped with 2 metres of sand and gravel.

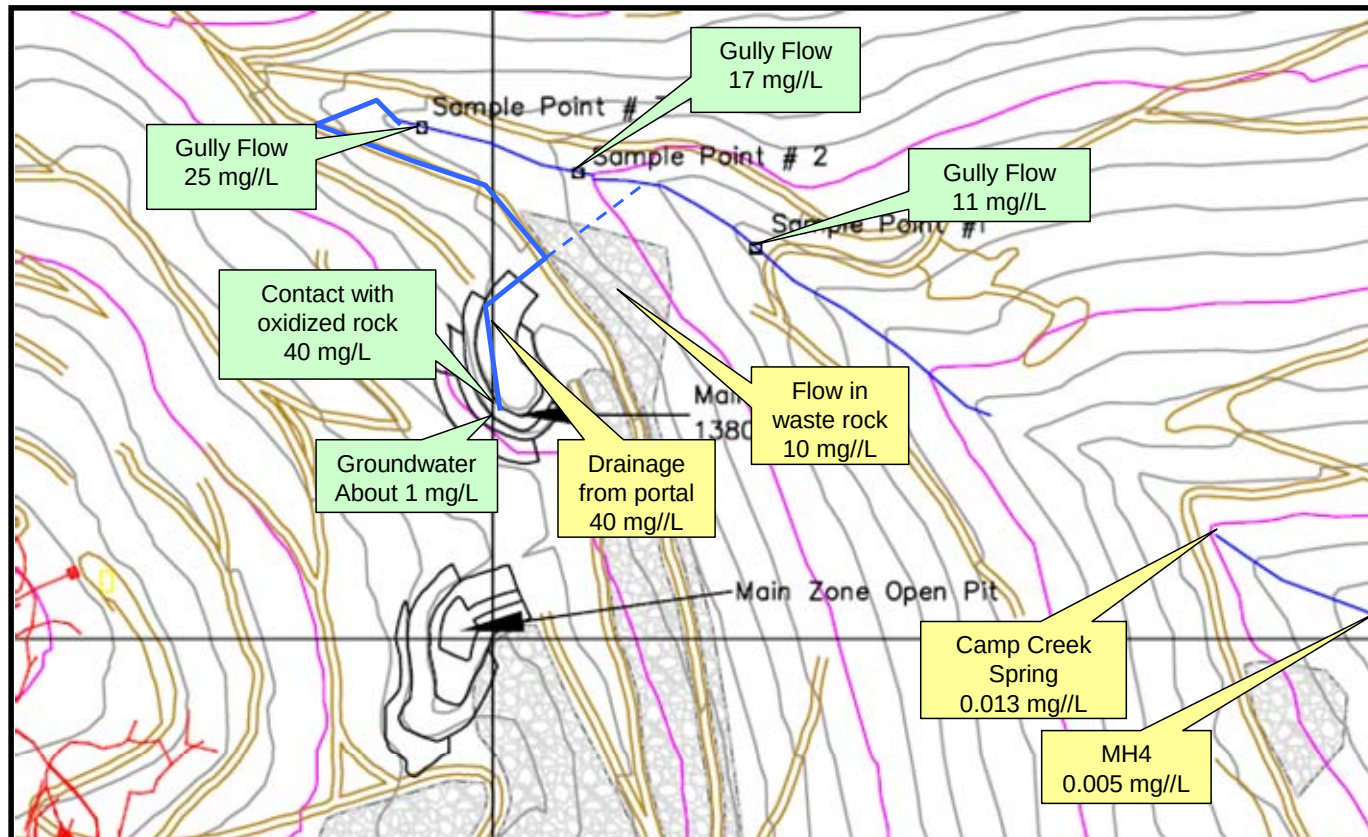
Figure 1: Compilation of Dissolved Zinc Concentrations as Determined by SRK (1999, 2000, 2002) (Yellow boxes) and Teck Cominco (2003) (Green boxes). Approximate flow paths between the portal and gully are shown.

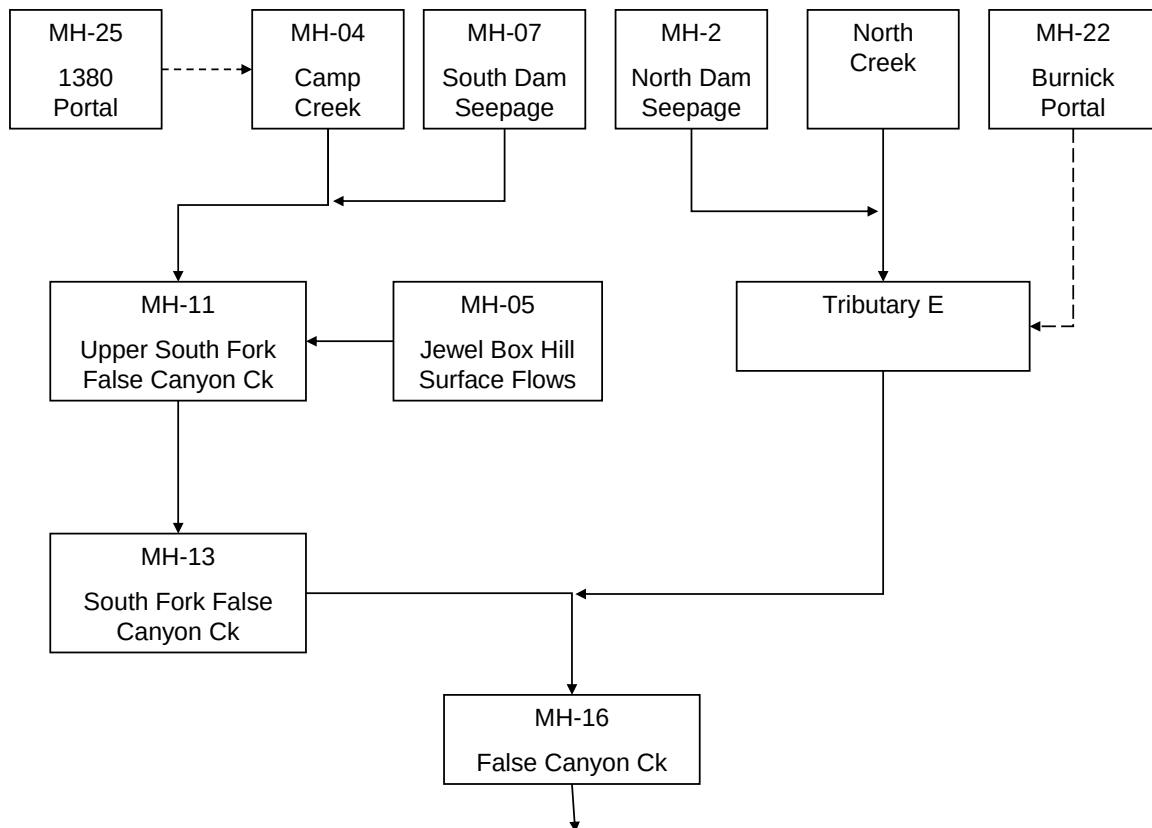
| Collect Date/Time | | 2006 | 2006 | 2006 | 2006 | 2006 | 2006 | 2007 | 2007 | 2007 | 2008 | 2008 | 2008 | 2008 | 2008 | 2009 | 2009 | 2009 | 2009 | 2009 |
|---|---|---|---|---|---|---|---|---|---|---|---|---|---|---|---|---|---|---|---|---|
| Silver - Total | mg/L | | <0.01 | <0.01 | | <0.01 | <0.01 | <0.01 | <0.01 | <0.00002 | <0.00002 | <0.00002 | | | <0.00002 | <0.00002 | <0.00002 | <0.00002 | | <0.00002 |

**Figure 1. Flow Network Used in Loading Calculations. Solid lines indicate surface flow connections. Dashed line indicates subsurface flow connection.**

The flow network used in the 2000 Detailed D&R Plan considered MH-22 (North Hill Settlement Basin) as a direct surface flow connection to Tributary E. Subsequent work reported by SRK Consulting (2003) has demonstrated that MH-22 does not have a surface connection to Tributary E and that soils in the slopes below MH-22 significantly attenuate zinc concentrations to low levels ( $<0.001$  mg/L). Sulphate is not attenuated and monitoring sulphate concentrations are used for calculation. The original loading balance has been re-calculated and the current loading balance calculated using attenuated zinc concentrations for MH-22 indicated by laboratory studies.

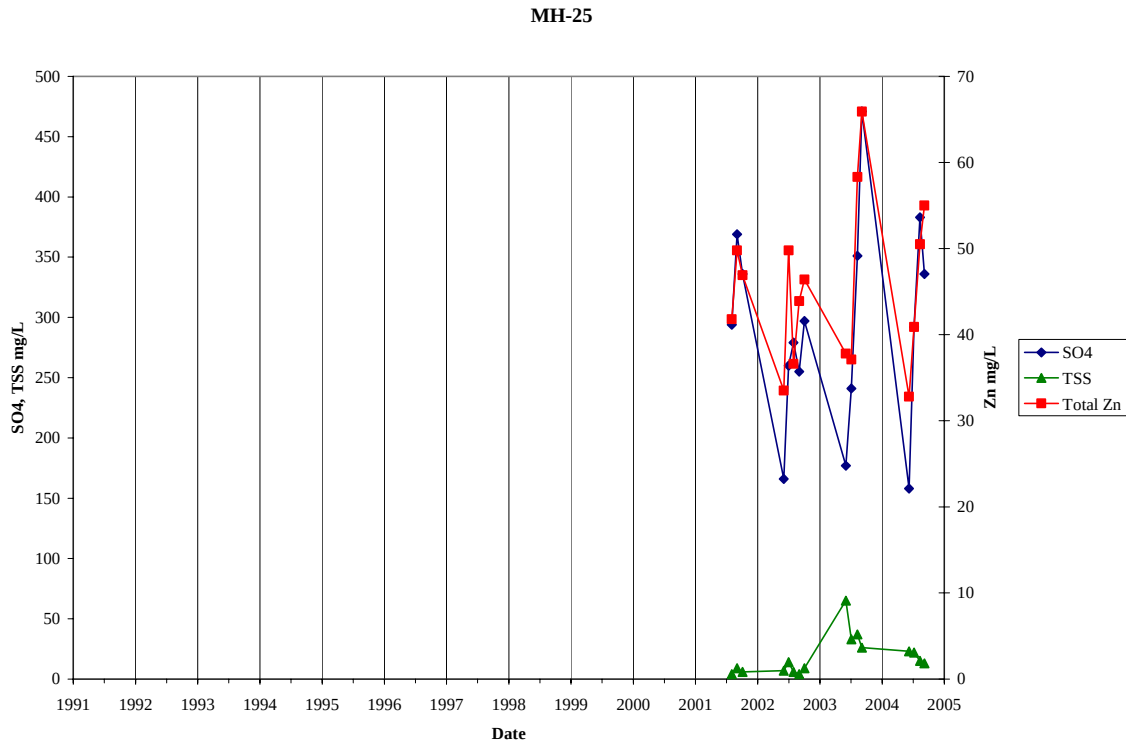
**Figure 2. Monitoring Results for 1380 Portal (MH-25).**

Camp Creek (MH-04) receives flow from the natural mineralized exposure on the north side of Jewelbox Hill as well as from the Main Zone Pit and 1380 Portal (MH-25) via subsurface flow. The 1380 Portal continues to be a source of elevated zinc concentrations and loads exceeding loads at MH-04 (Figure 2). Investigations subsequent to the 2000 Detailed D&R Plan (SRK Consulting 2003) indicated that this load reduction is probably occurring as a result of strong attenuation in waste rock and talus below the portal.

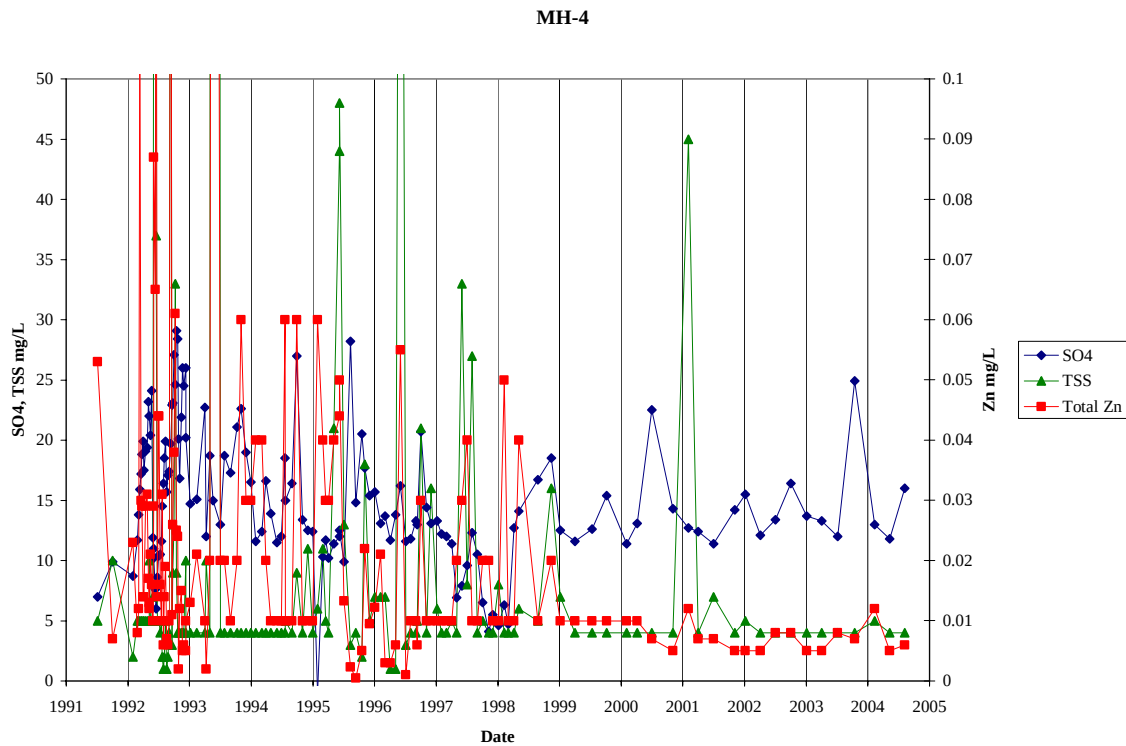
**Figure 3. Monitoring Results for Camp Creek at MH-4**

Monitoring results for MH-04 indicate that zinc concentrations have been low and decreasing slightly since 1998 (Figure 3). Sulphate concentrations have been relatively stable for at least ten years.

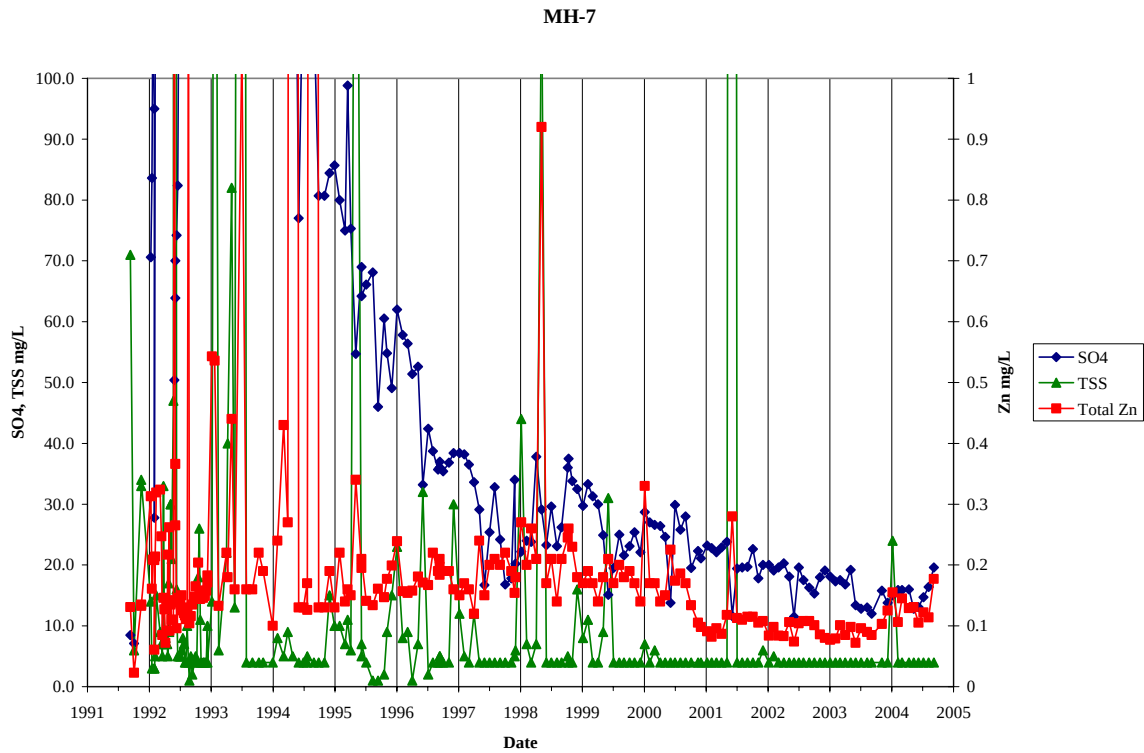
**Figure 4. Monitoring Results for South Dam Seepage (MH-07)**

Monitoring data for the South Dam seepage (MH-07) show a continuing long term decrease in sulphate concentrations which began when operations ceased. Zinc concentrations appeared to increase in the late 1990s reaching concentrations approaching 0.3 mg/L following a trend opposite to sulphate. Zinc concentrations decreased from 1998 to 2001. In 2003 and 2004, zinc concentrations increased from 0.07 mg/L to 0.18 mg/L (Figure 4).

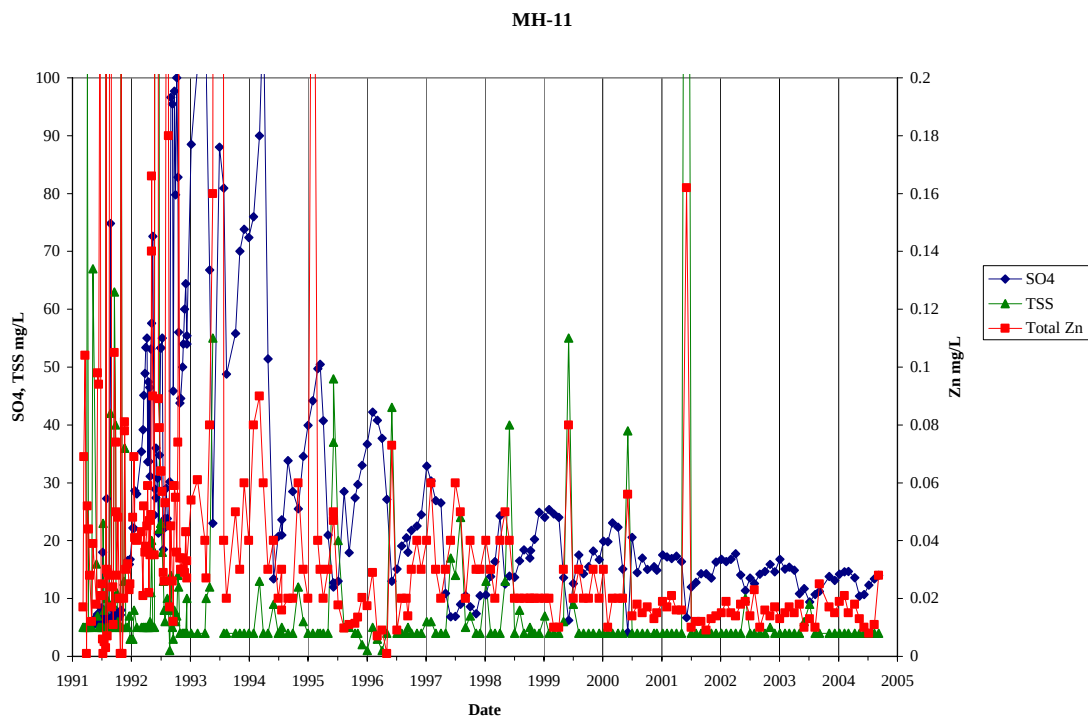
**Figure 5. Monitoring Results for MH-11**

MH-11 is roughly 3 km downstream of the South Dam. This site has shown a steady decrease in sulphate concentrations matching the decrease at MH-07 (Figure 5). Zinc has shown the same general trend though with a slight upward trend since 2001. The zinc concentration in September 2004 was 0.028 mg/L.

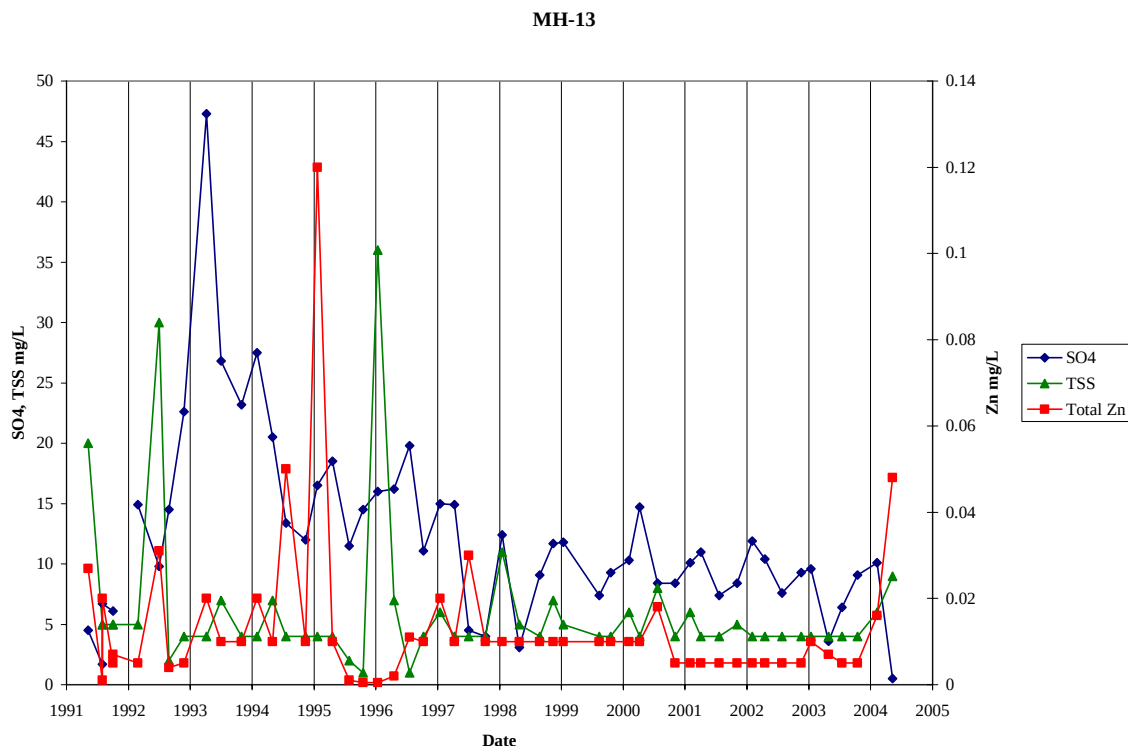
**Figure 6. Monitoring Results for MH-13.**

MH-13 is several kilometres downstream from MH-11 in False Canyon Creek. This site has also shown a steady decrease in sulphate concentrations. Zinc concentrations have remained low (Figure 6). The last two results in 2004 showed a slight increase to 0.048 mg/L, but this appears to be related to a corresponding increase in TSS to 9 mg/L.

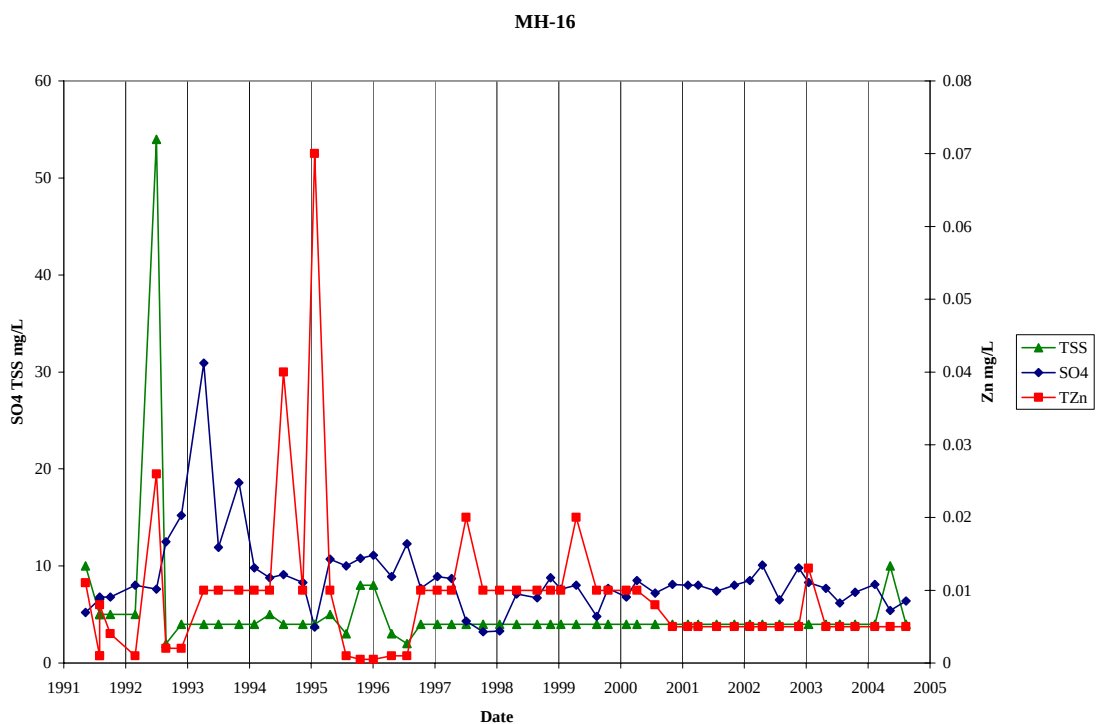
**Figure 9. Monitoring Results for False Canyon Creek Below Tributary E.**

MH-16 is in False Canyon Creek downstream of the confluence with Tributary E. Like MH-11 and MH-13, sulphate concentrations initially decreased but have remained stable since 1998 (Figure 9). Likewise, zinc concentrations have remained very low since 2001.
