# PERMAFROST INVESTIGATIONS IN BRITISH COLUMBIA AND YUKON TERRITORY

by R. J. E. Brown

December 1967

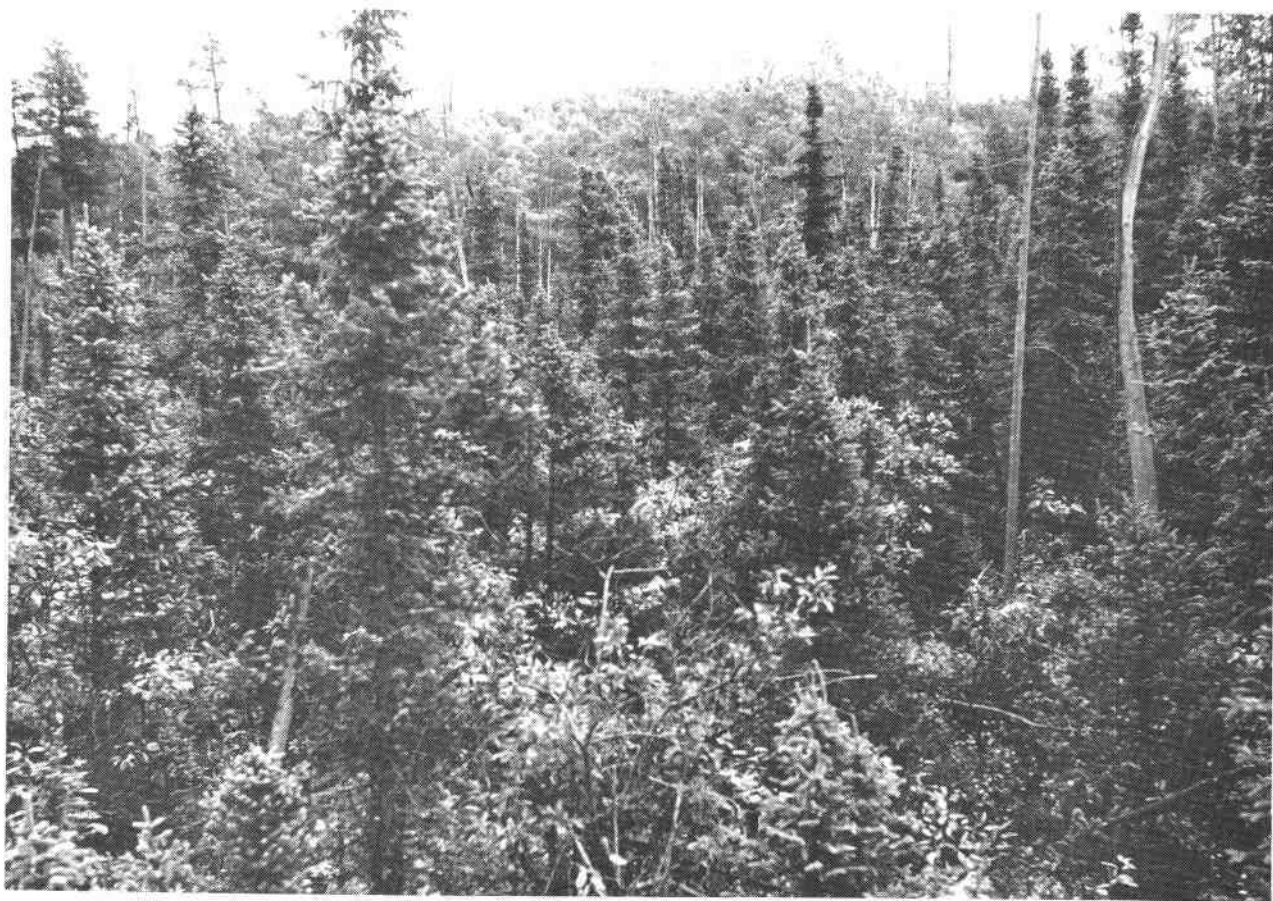
Figure 3      Location No. 5 - Mile 94.4 - Alaska Highway, B.C. This low area has tree growth of dense spruce up to 15 ft high with alder and willow. The ground vegetation is hummocky Sphagnum, feather moss, lichen and Labrador tea below which is peat to a depth of 3 ft 3 in. overlying silty clay. The permafrost table is at the 1 ft 9 in. depth (in the peat) and the permafrost is 5 ft 9 in. thick. September 9, 1964.

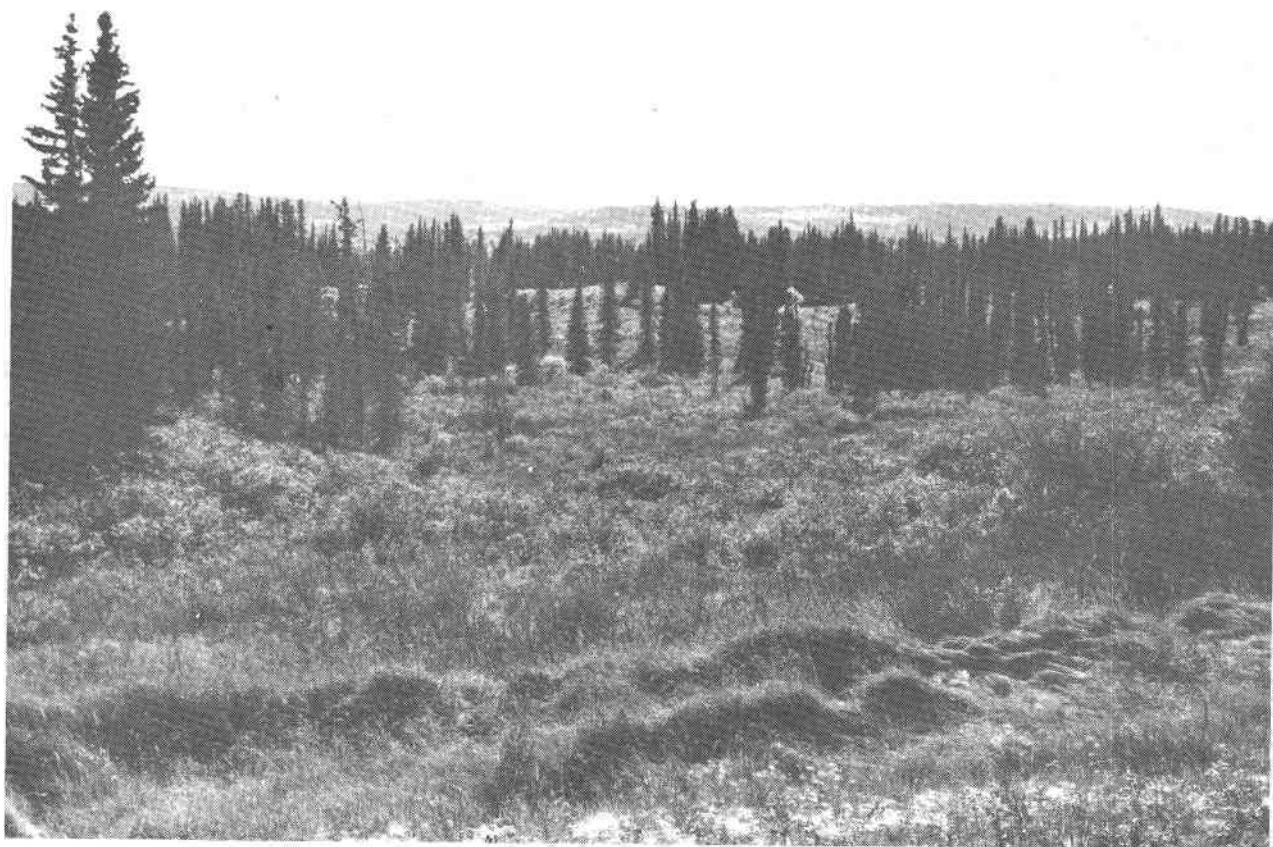
Figure 4 Location No. 9 - Mile 148.5 - Alaska Highway, B.C. This low area has tree growth of scattered spruce up to 30 ft high with ground vegetation of dense ground birch, hummocky feather moss, Labrador tea and scattered lichen below which is peat 0 ft 6 in. thick. No permafrost was encountered at this location. September 11, 1964.

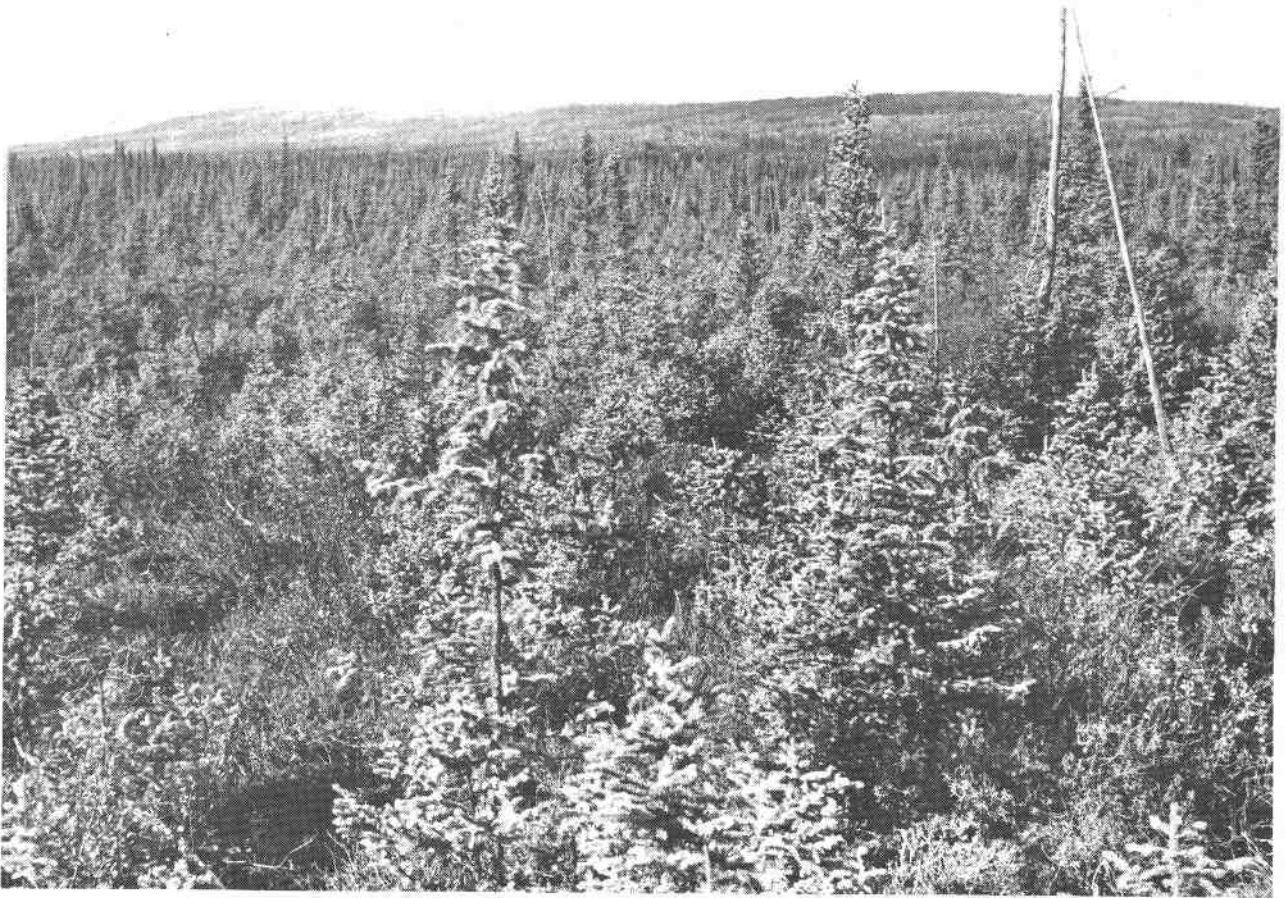
Figure 5      Location No. 28 - Mile 208.5 - Alaska Highway, B.C. This low area has tree growth of spruce up to 10 ft high with ground vegetation of hummocky Sphagnum, feather moss, lichen, and Labrador tea, below which is peat to a depth of 3 ft 4 in. overlying silty clay. The permafrost table is at the 1 ft 4 in. depth (in the peat) and extends into the mineral soil. September 12, 1964.

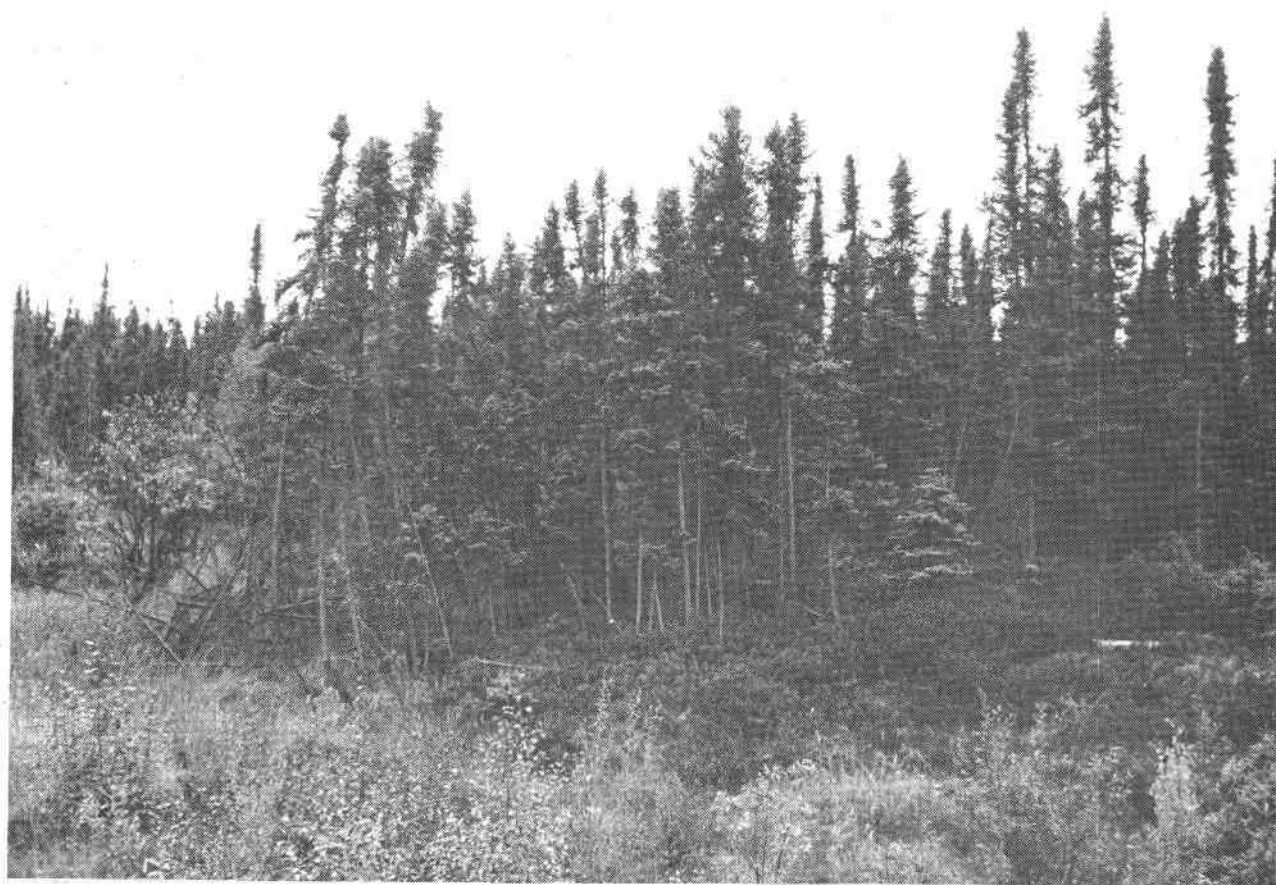
Figure 6      Location No. 36 - Mile 254.5 - Alaska Highway, B.C. This low area consists of peat plateaux interspersed with wet depressions. The tree growth on the peat plateau is dense spruce up to 30 ft high and tamarack with ground vegetation of feather moss, Sphagnum, lichen and Labrador tea below which is peat to a depth of 7 ft 6 in. overlying clay soil. The permafrost table is at the 3 ft 9 in. depth (in the peat) and the permafrost is 14 ft 3 in. thick. In the depressions the vegetation consists of ground birch and sedge, and the water table is at the ground surface. No permafrost was encountered in the depressions. September 13, 1964.

The following example illustrates the use of the symbols in Table I to describe the terrain and permafrost conditions (Figure 6). Location No. 36 (Column 1) is located 254.5 miles north of the southern terminus of the Alaska Highway in British Columbia. It is a low area located in a peat bog (Column 3 - L) in which there are depressions and peat plateaux. The background and right side in Figure 6 is a peat plateau supporting dense spruce up to 30 ft high and tamarack (Column 4 - S(30) T). The depression on the left side is treeless (Column 4 - No). The ground vegetation on the peat plateau (Column 5 - (p) ) consists of non-Sphagnum mosses, Sphagnum, lichen and Labrador tea (Column 5 - MSph Ln Lt). The depression is covered with sedge and ground birch, and the water table is at the ground surface (Column 5 - Se B (w) ). In the peat plateau, the peat is 7 ft 6 in. thick (Column 6: 7 ft 6 in.); its thickness was not measured in the depression. The mineral soil is clay (Column 8 - Yes) but not in the depression (Column 8 - No). The depth to the permafrost table in the peat plateau is 3 ft 9 in. (Column 9: 3 ft 9 in.) and the permafrost is 14 ft 3 in. thick (Column 10: 14 ft 9 in.)

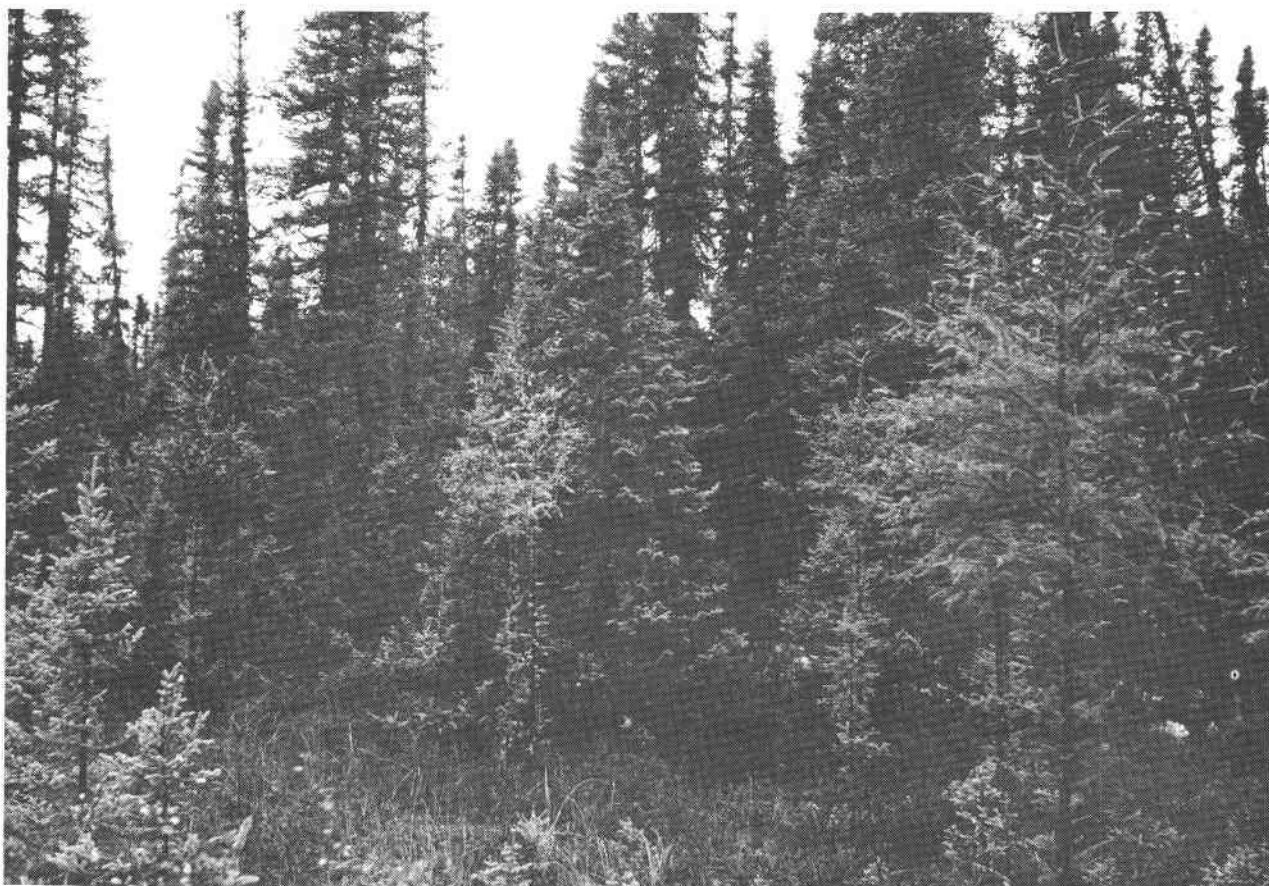
Figure 7      Location No. 38 - Mile 256.0 - Alaska Highway, B.C. This low area consists of peat plateaux interspersed with wet depressions. The tree growth on the peat plateau consists of spruce up to 25 ft and tamarack with ground vegetation of hummocky Sphagnum, feather moss, lichen and Labrador tea below which is peat exceeding 7 ft in thickness overlying clay soil. The depth to the permafrost table is 2 ft 0 in. and the permafrost is 3 ft 0 in. thick. In the depressions the vegetation consists of feather moss, Sphagnum, grass and sedge below which is peat 4 ft 0 in. thick overlying clay soil. No permafrost was encountered in this depression. September 13, 1964.

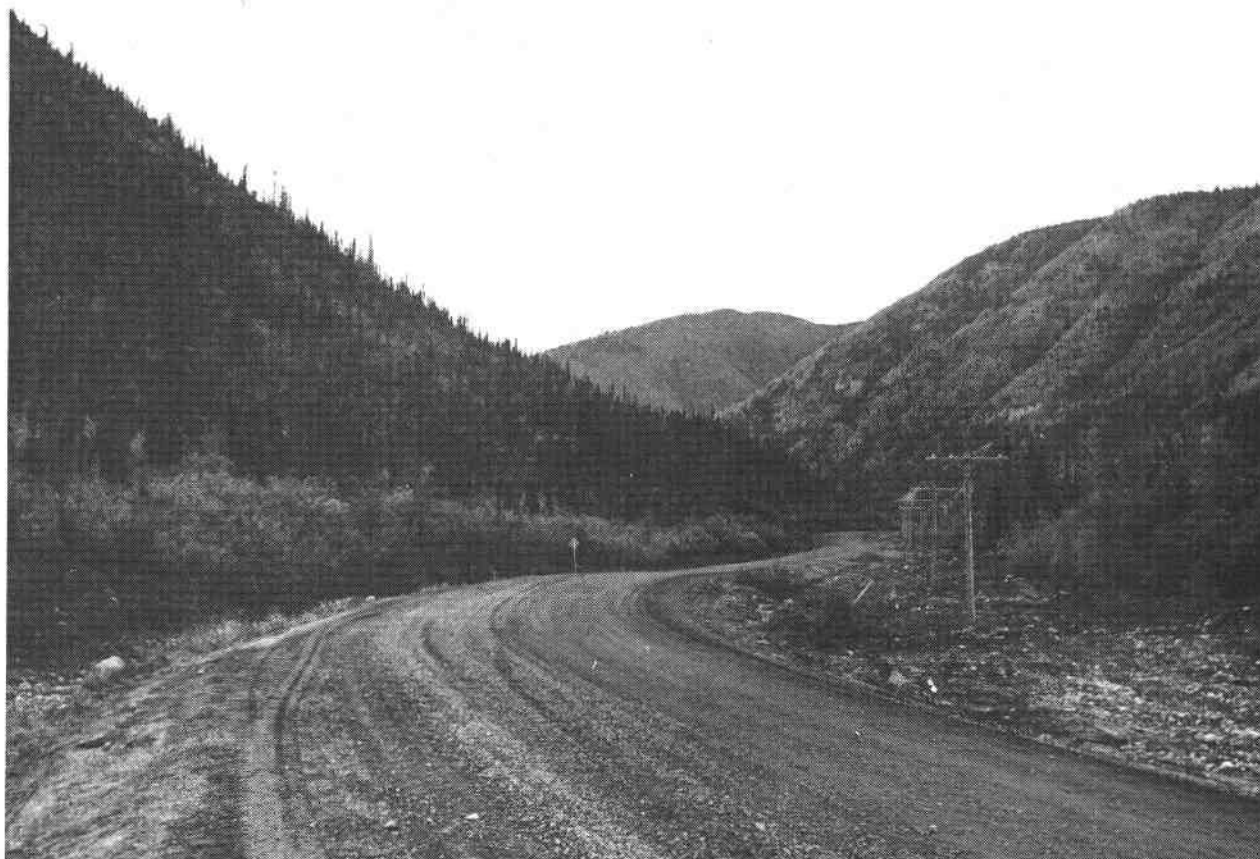
Figure 9      Location No. 58 - Mile 383.5 - Alaska Highway, B.C.  
 The slope on the left is north facing with tree growth of spruce up to 60 ft high and a few tamarack and stunted poplar with ground cover of ground birch, hummocky Sphagnum, feather moss, lichen, Labrador tea, grass and sedge below which is peat to a depth of 4 ft 6 in. overlying stony soil. The permafrost table is at the 1 ft 9 in. depth and the permafrost exceeds 3 ft 0 in. in thickness. The slope on the right is south facing with tree growth of poplar and scattered spruce and jackpine below which is a thin layer of forest litter overlying gravelly soil. No permafrost was encountered on this slope. September 14, 1964.

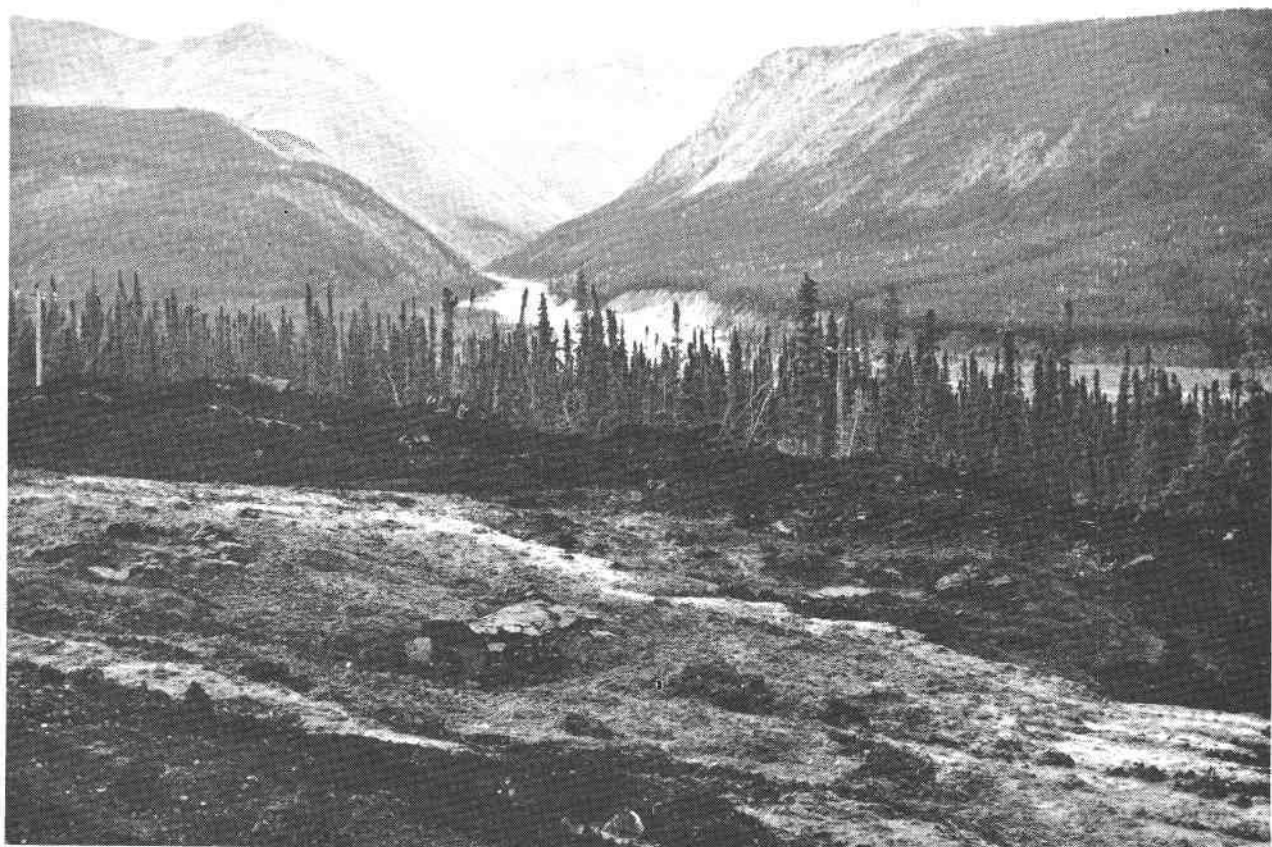
Figure 11 Location 60 - Mile 398.4 - Alaska Highway, B.C. This sloping area has tree growth of spruce up to 35 ft high with ground vegetation of hummocky Sphagnum, feather moss, lichen and Labrador tea below which is peat 2 ft 2 in. thick overlying sandy to clayey silt soil with small stones. The permafrost table is at the 2 ft 1 in. depth and the permafrost exceeds 5 ft 5 in. in thickness. Note area in foreground stripped of vegetation for road relocation. September 14, 1964.

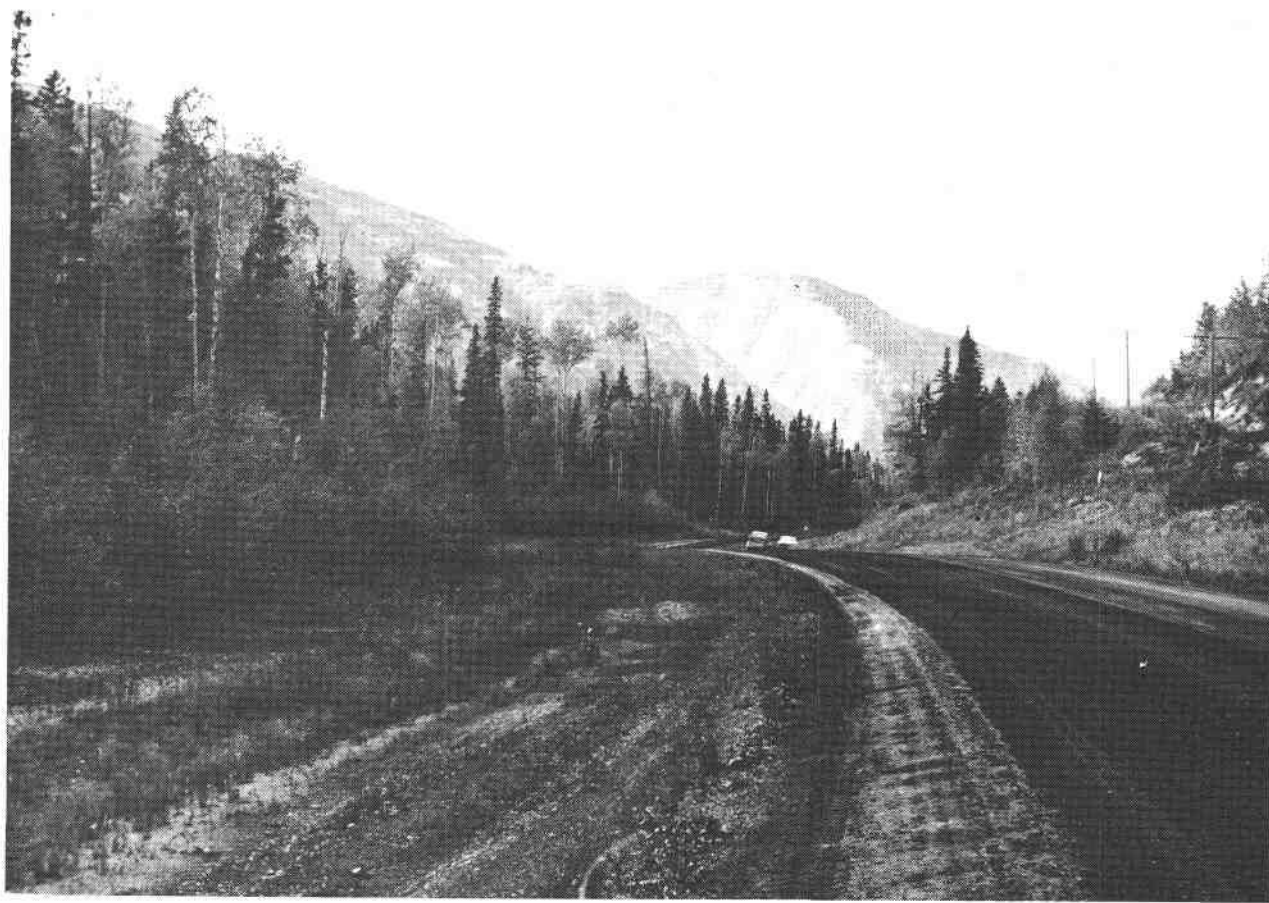
Figure 12 This high area located about Mile 500 on the Alaska Highway is typical of the high areas south of Whitehorse. The tree growth consists of tall spruce, jackpine and poplar. No permafrost was encountered in these locations. September 15, 1964.

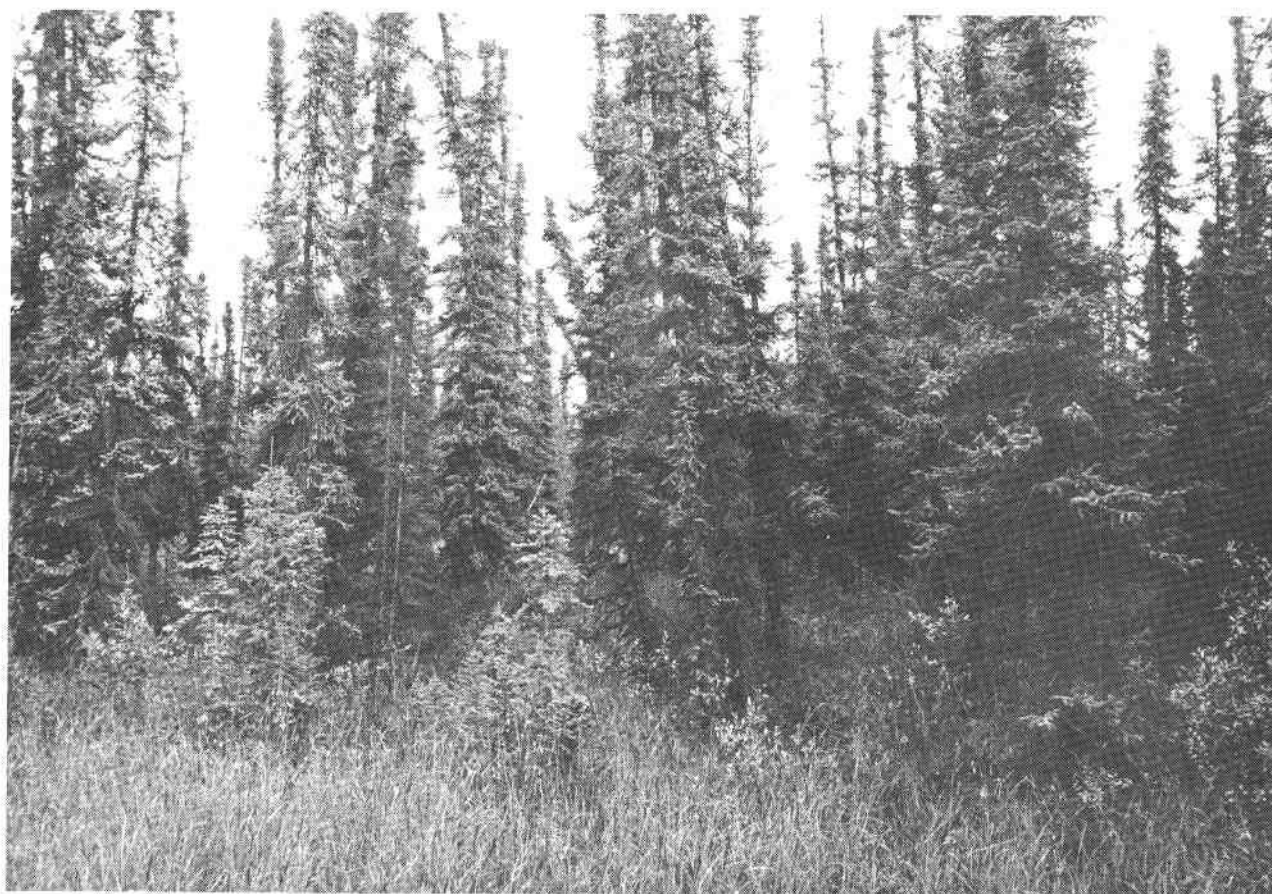
Figure 14 Location No. 93 - Mile 788.5 - Alaska Highway, B.C. This low area consists of peat plateaux interspersed with wet depressions. The tree growth on the peat plateaux consists of dense spruce up to 40 ft high with ground vegetation of very hummocky feather moss, Sphagnum, lichen and Labrador tea below which is peat exceeding 4 ft 6 in. in thickness overlying clayey silty soil. The permafrost table is at the 1 ft 6 in. depth and permafrost exceeds 3 ft 0 in. in thickness. In the depressions, the vegetation consists of sedge, grass, feather moss and Sphagnum and the water table is at the ground surface. The peat is 6 ft 9 in. thick overlying clayey silty soil. No permafrost was encountered in the depressions. September 19, 1964.

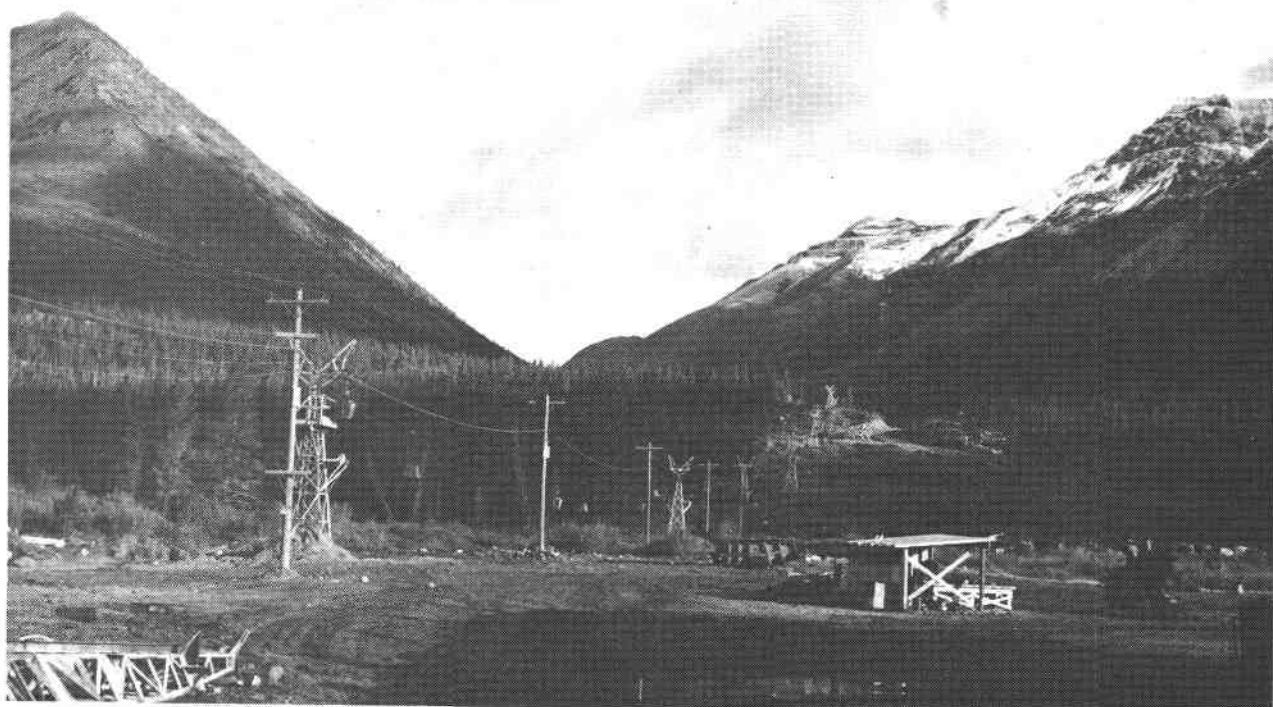
Figure 25      Tramline to asbestos mine at Cassiar, B.C. No permafrost occurs at townsite elevation of 3500 ft above sea level in foreground. Permafrost is widespread at top of tramline at asbestos mine at summit of mountain in centre background 6000 ft above sea level. September 17, 1964.

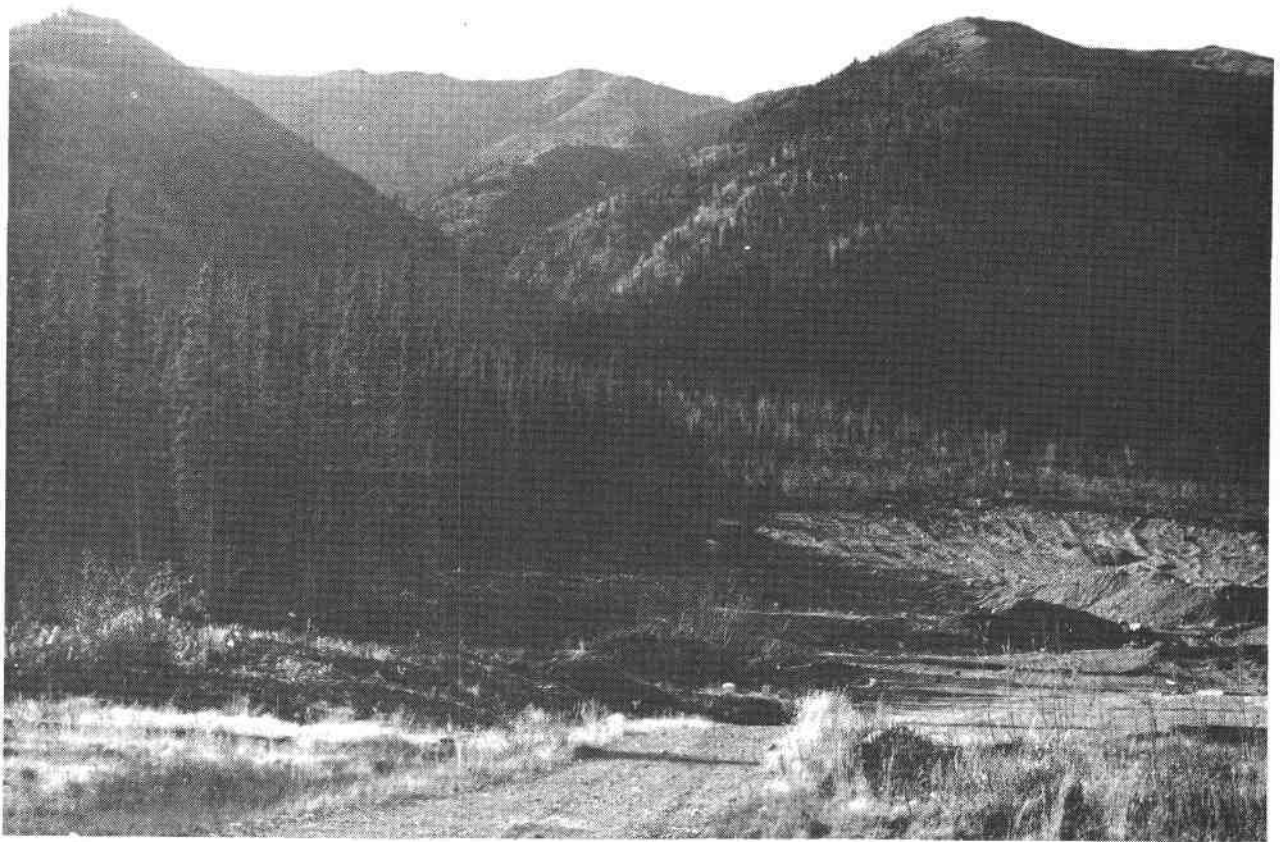
Figure 26      Permafrost is widespread in this gravel deposit at  
Mile 1170.7 - Alaska Highway, Y.T. September 27,  
1964.

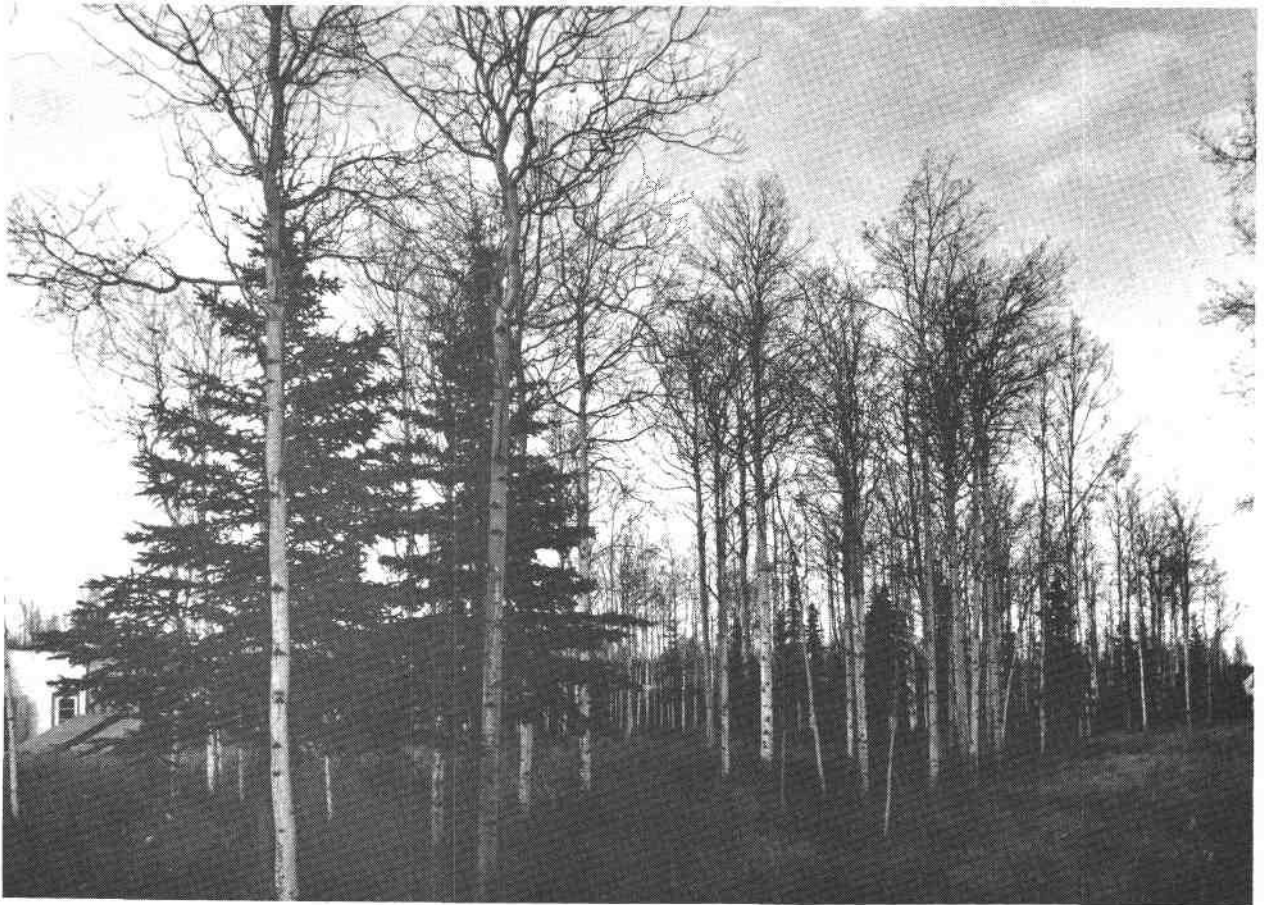
Figure 27      Location No. 115 - Mile 1202 - Alaska Highway, Y. T.  
No permafrost occurs in this gravel ridge supporting  
tree growth of spruce and poplar up to 50 ft high.  
September 27, 1964.

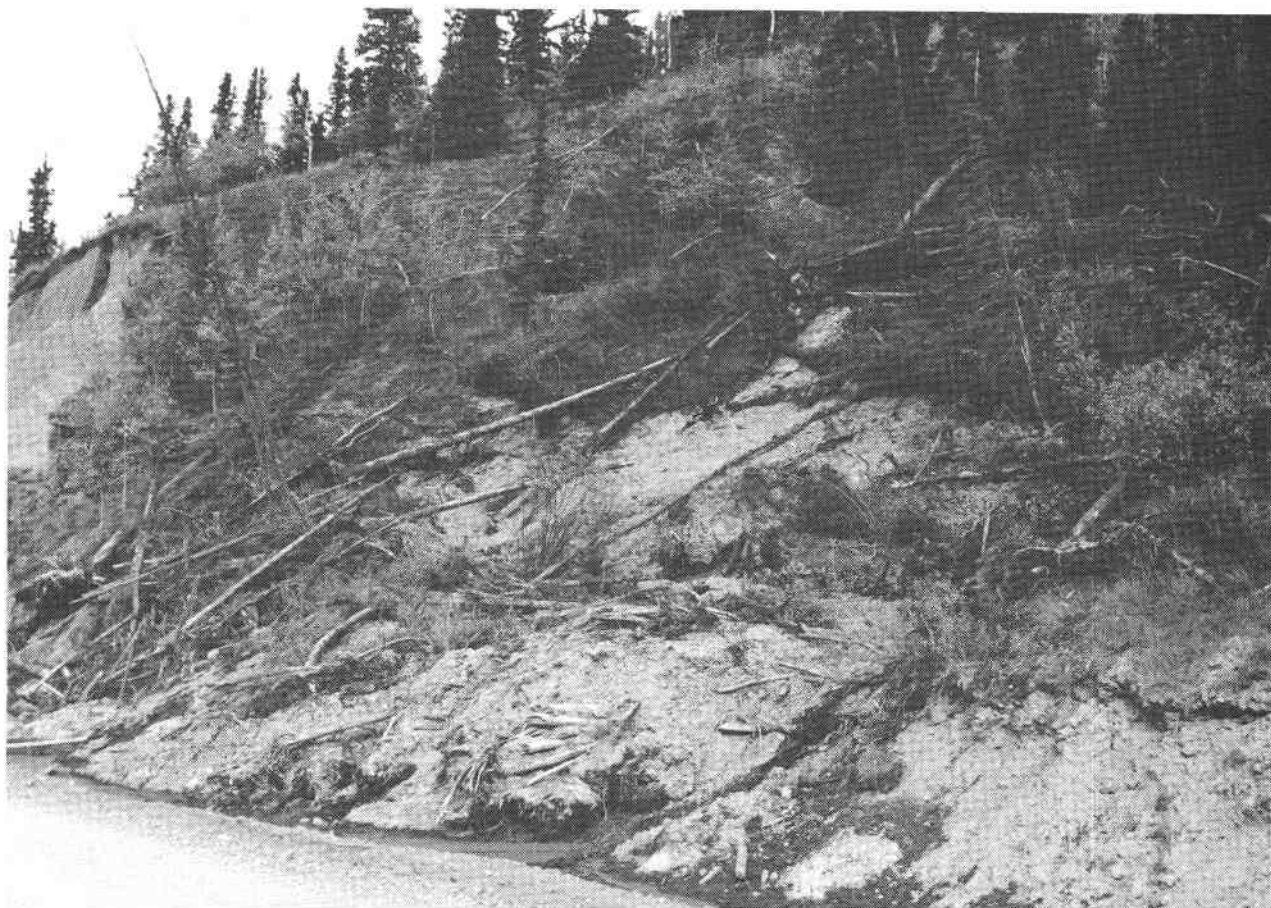
Figure 29      Location No. 127 - Mile 35.7 - Whitehorse-Mayo Highway, Y.T. This sloping area beside Fox Lake supports dense spruce up to 50 ft high and poplar with ground vegetation of moss below which is peat 1 ft 0 in. thick overlying fine-grained soil. Widening of the road in 1963 caused thawing of the widespread permafrost containing ice resulting in slumping and downslope movement of soil and vegetation. September 22, 1964.

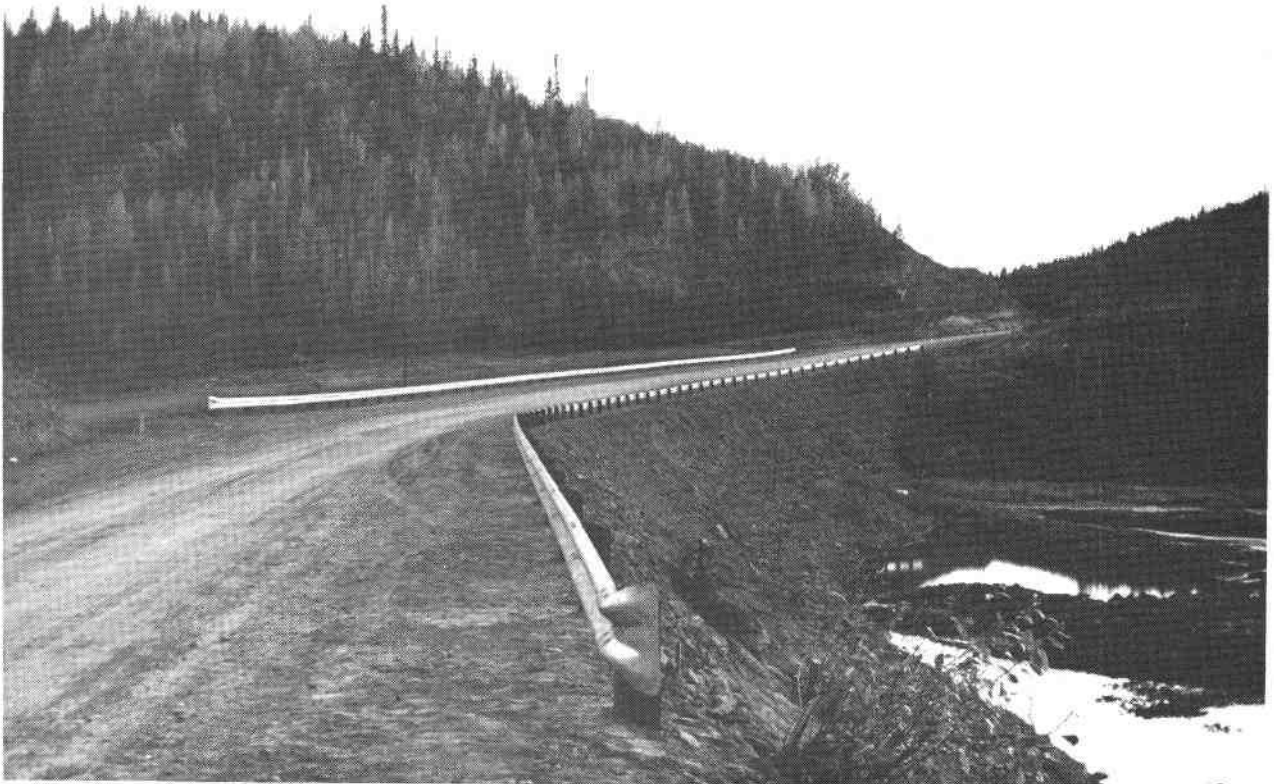
Figure 31      Location No. 131 - Mile 109 - Whitehorse-Mayo Highway, Y.T. This sloping area supports dense spruce up to 30 ft high with ground cover of feather moss, lichen and Labrador tea below which is peat 0 ft 9 in. thick overlying silty sand. The permafrost table is at the 2 ft 0 in. depth. September 22, 1964.

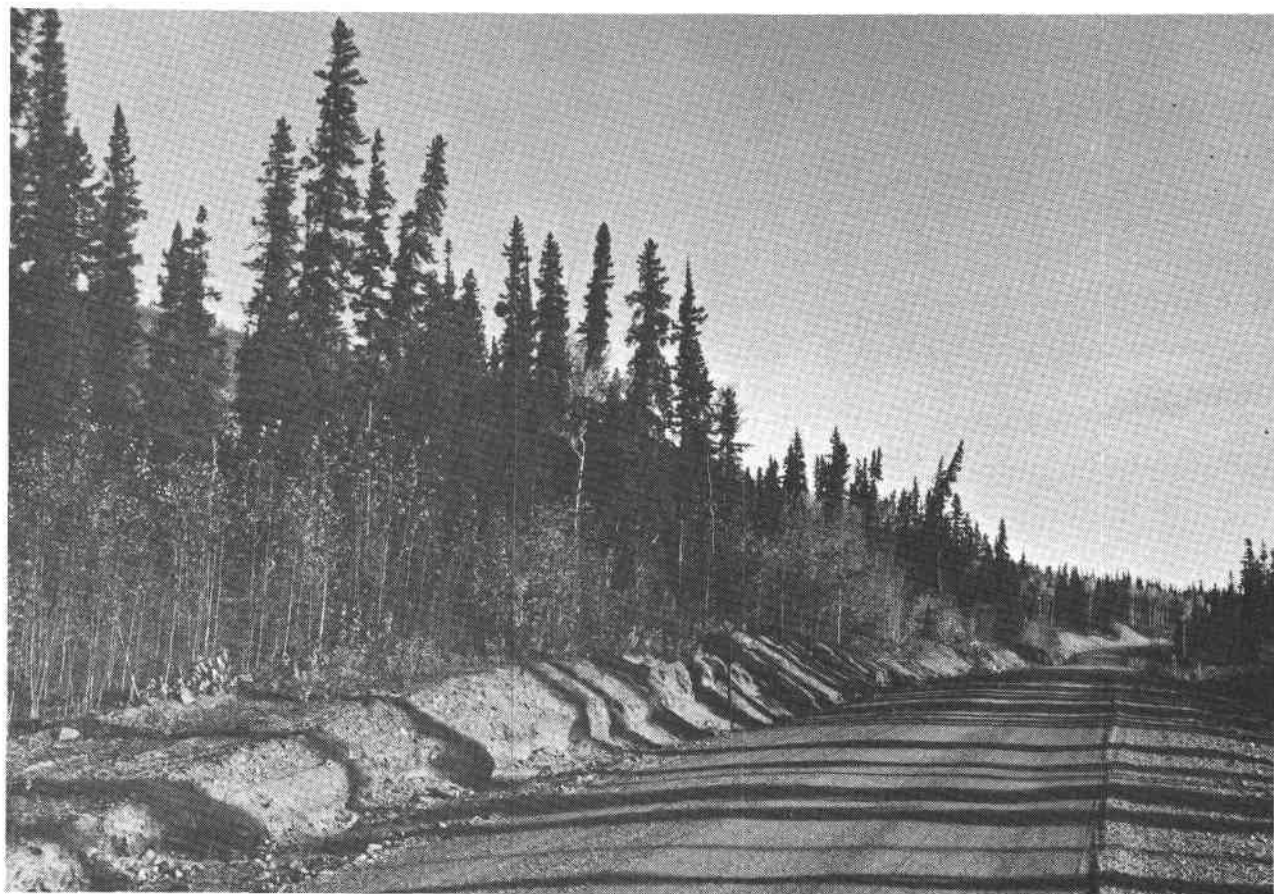
Figure 33      Location No. 137 - Mile 213 to 243 - Whitehorse-Mayo Highway, Y.T. This location is typical of the south facing slope of the Stewart River valley described in Figure 32. September 23, 1964.

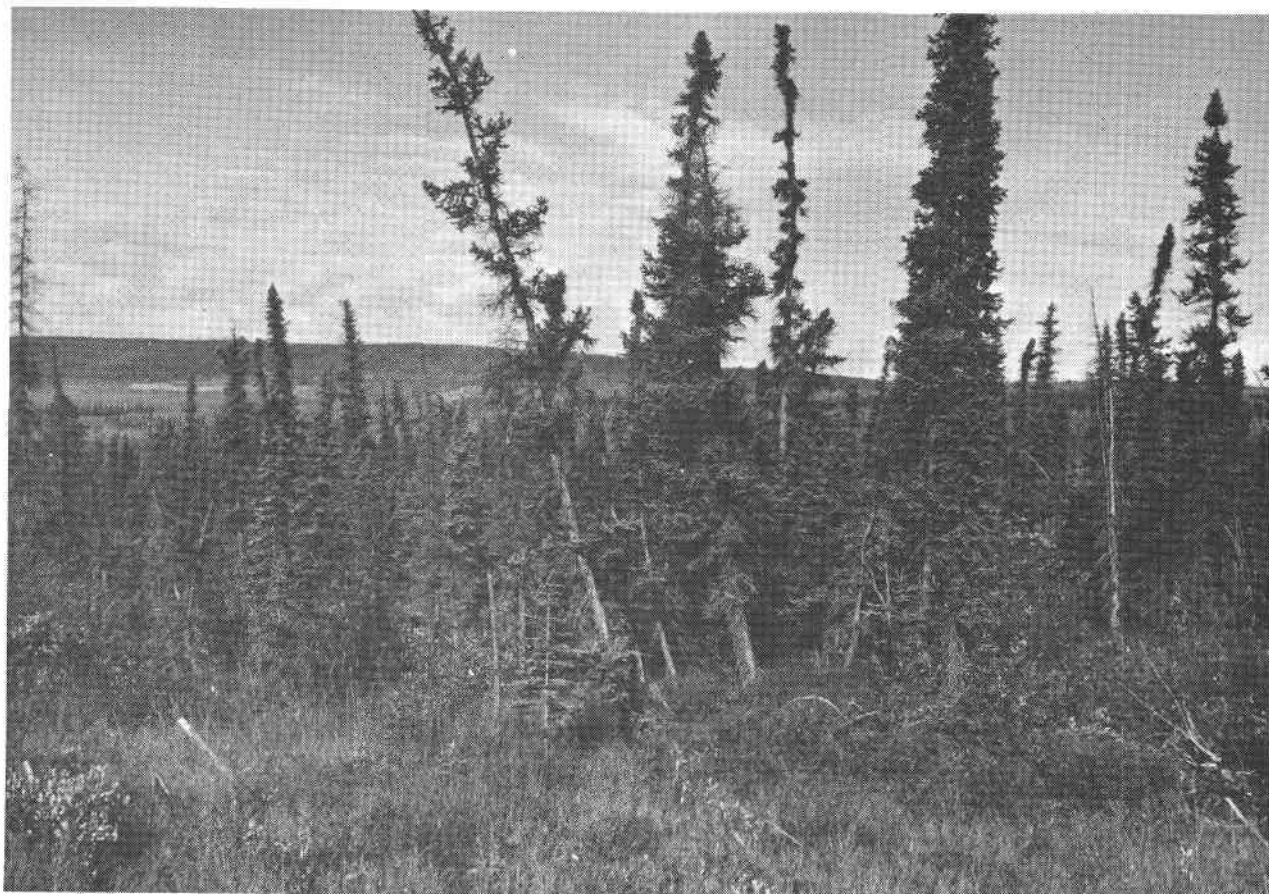
Figure 34      Location No. 138 - Mile 232.7 - Whitehorse-Mayo Highway, Y.T. This low area consists of peat plateaux interspersed with wet depressions. The tree growth on the peat plateaux consists of spruce up to 25 ft high with ground vegetation of hummocky Sphagnum, feather moss, lichen and Labrador tea below which is peat 5 ft 0 in. thick overlying medium sand with sands. The permafrost table is at the 1 ft 6 in. depth. In the depressions, the vegetation consists of feather moss, grass and sedge and the water table is at the ground surface. No permafrost was encountered in the depressions except in slightly higher patches where the moss surface was dry. In these areas the permafrost table was at the 5 ft 6 in. depth. September 23, 1964.

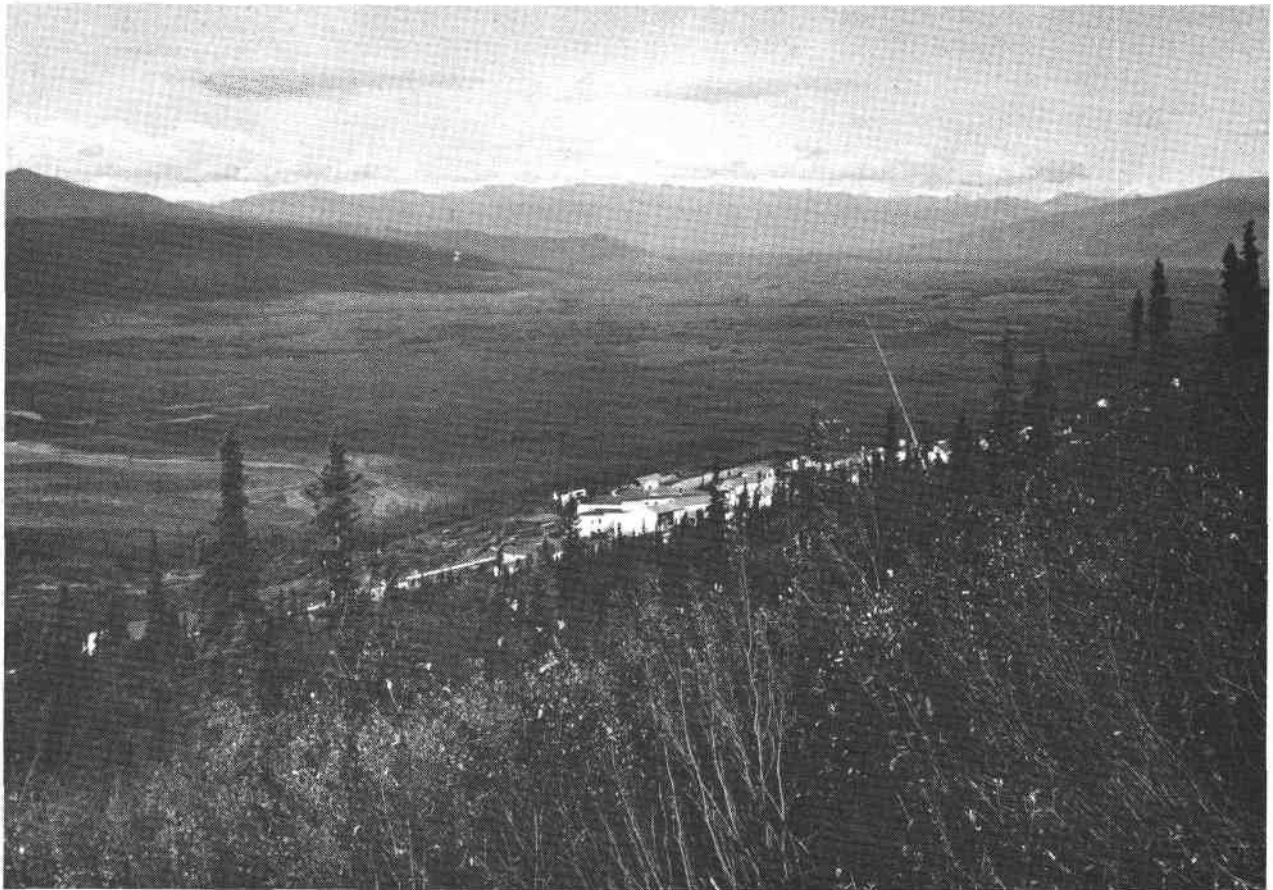
Figure 35      View northward up the South McQueston River valley  
at Elsa, Y.T. Permafrost is widespread in the valley  
bottom and slopes. September 23, 1964.

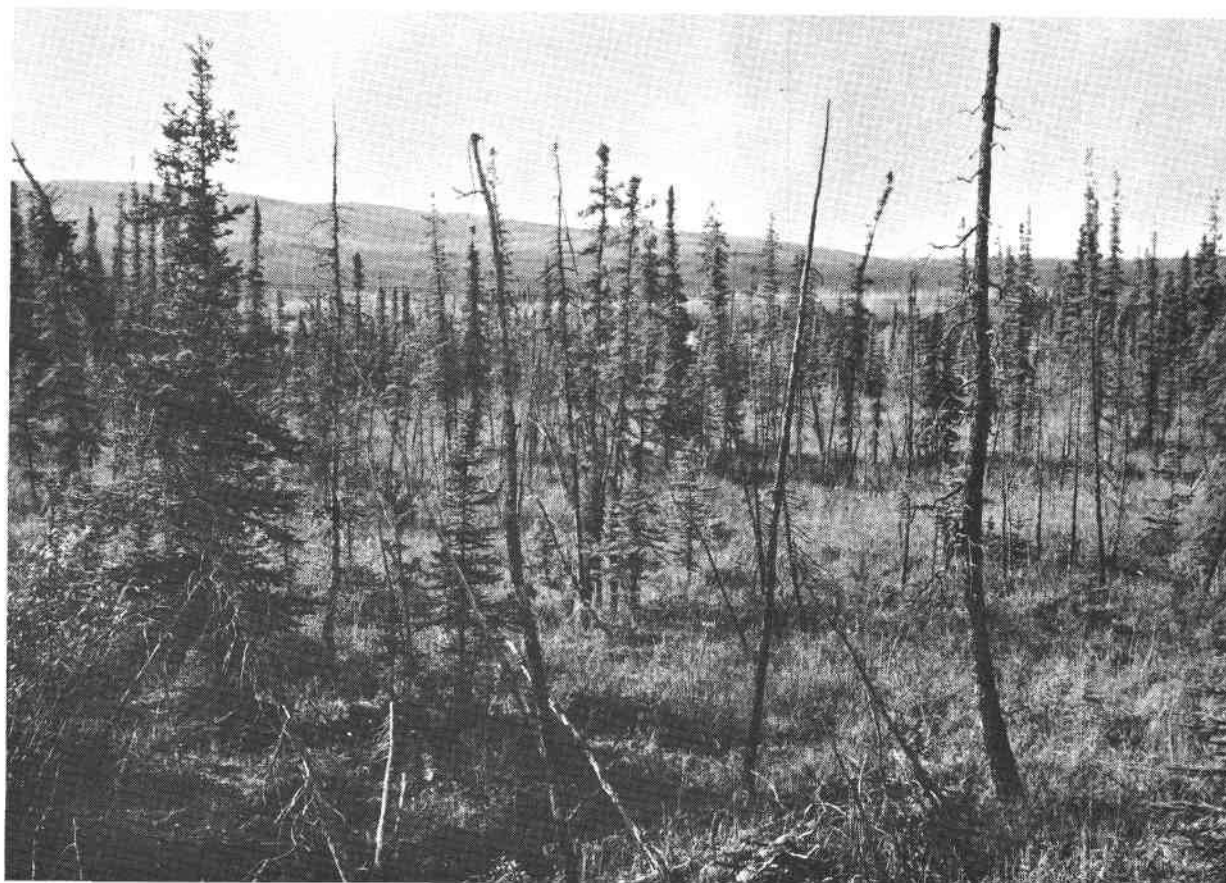
Figure 36      Location No. 141 - Mile 9 - Dawson Highway, Y.T. This low area has scattered spruce up to 30 ft high growing mostly on low peat plateaux about 1 ft high, with ground vegetation of hummocky Sphagnum, feather moss and Labrador tea below which is peat exceeding 3 ft 6 in. in thickness. The permafrost table is at the 1 ft 9 in. depth. The low wet depressions support scattered spruce up to 30 ft high with ground vegetation of feather moss, grass and sedge, and the water table is at the ground surface. The permafrost table is at the 2 ft 7 in. depth in these wet areas and at the 3 ft 6 in. depth beneath the surface of a pool of water 1 ft 3 in. deep. September 23, 1964.
