# PERMAFROST INVESTIGATIONS IN BRITISH COLUMBIA AND YUKON TERRITORY

by R. J. E. Brown

December 1967

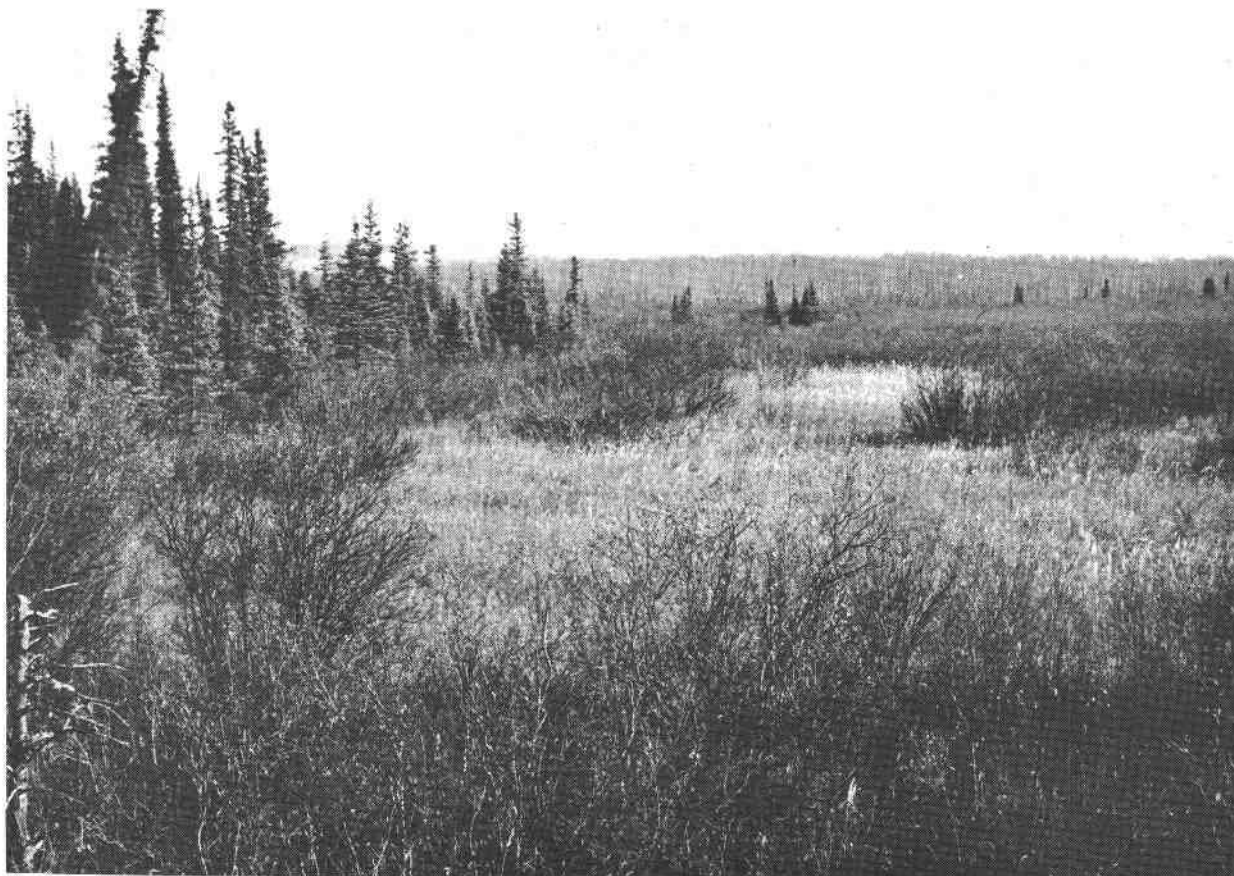
Figure 37      Location No. 143 - Mile 52.8 - Dawson Highway, Y.T.  
This wide shallow valley of Collins Creek supports scattered spruce up to 30 ft high and dense willow up to 5 ft high. Scattered depressions (foreground) support grass and sedge, and the water table is at the ground surface. The underlying soil is organic silt. Permafrost occurs throughout the area at a depth of 3 ft 6 in. September 23, 1964.

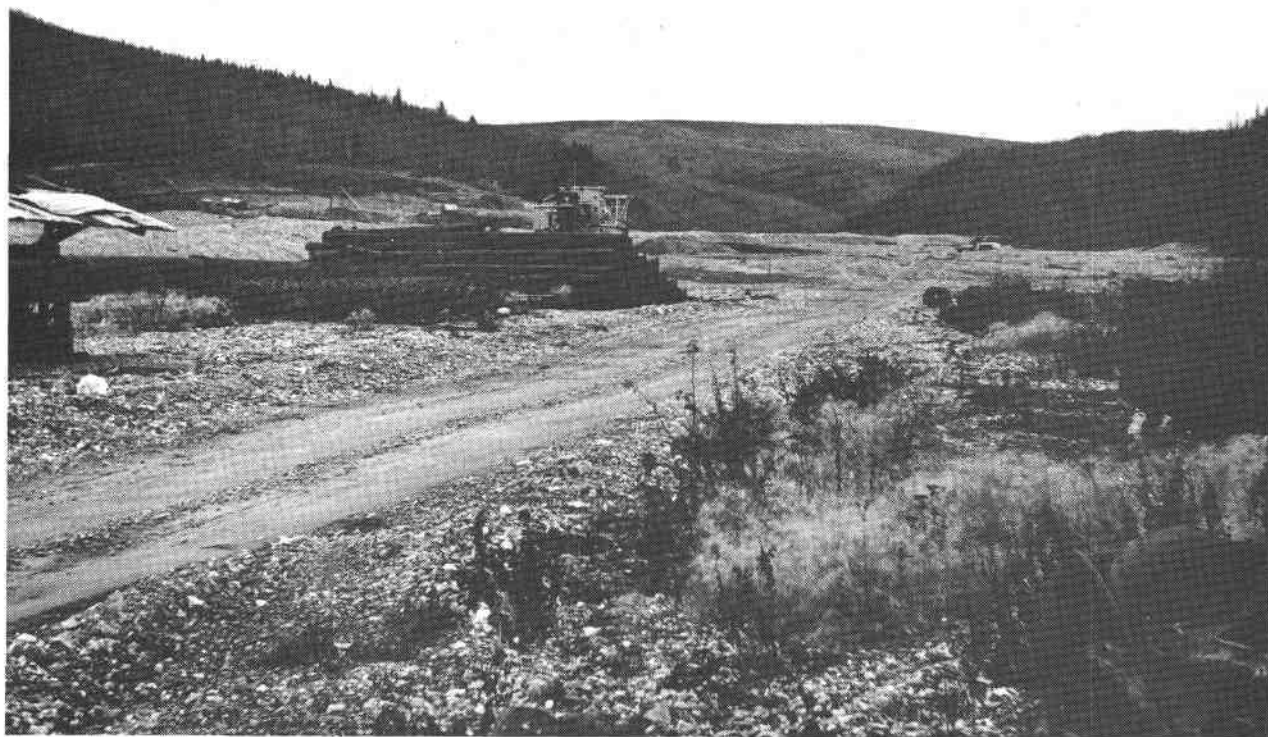
Figure 39      Placer gold mining operations in perennially frozen gravels in Bear Creek valley, a tributary of Klondike River near Dawson, Y.T. The stacks of pipe comprise the dismantled network through which cold water is circulated to thaw the frozen gravel. September 25, 1964.
