MERG Report 2002-3

**Monitoring of Low Permeability
Cover Performance
Arctic Gold and Silver Mine Site
Carcross, Yukon**

By EBA Engineering Consultants Ltd.

July 2002

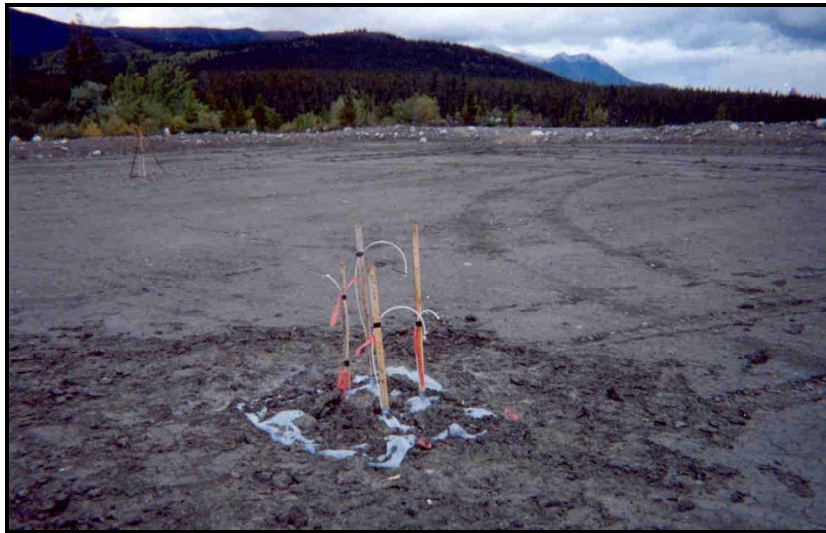
These vertical SGPs were installed by EBA within the reclaimed tailings pond at two locations; one at the center of each of the north and south halves of the impoundment that is separated by a drainage channel. SGPs were installed with a hollow tube hilti-hammer system to advance the screened tip and high-density polyethylene (HDPE) tube vertically into the ground with minimum annulus to limit short-circuiting of atmospheric oxygen down the annulus. At each location, probe tips and tubes were advanced to the following layers: one into the low conductivity cover, one in the coarse ramp material (capillary barrier), and two at progressively deeper depths within the tailings. Once the advancing rod was removed from the hole, the area around the HDPE tube was tamped to repack the annulus around the tube. A hydrated bentonite seal was placed from 0 to 0.3 m below grade to ensure a vapour seal around the annulus of each tube. As well, a polyethylene sheet was placed along ground surface to further inhibit short-circuiting of atmospheric oxygen into the SGPs (see Photograph 1). The polyethylene sheet was then covered with some of the clayey silt cover material.

Photograph 1: View of the completed soil gas vapour probe SGP1. (September 2000)

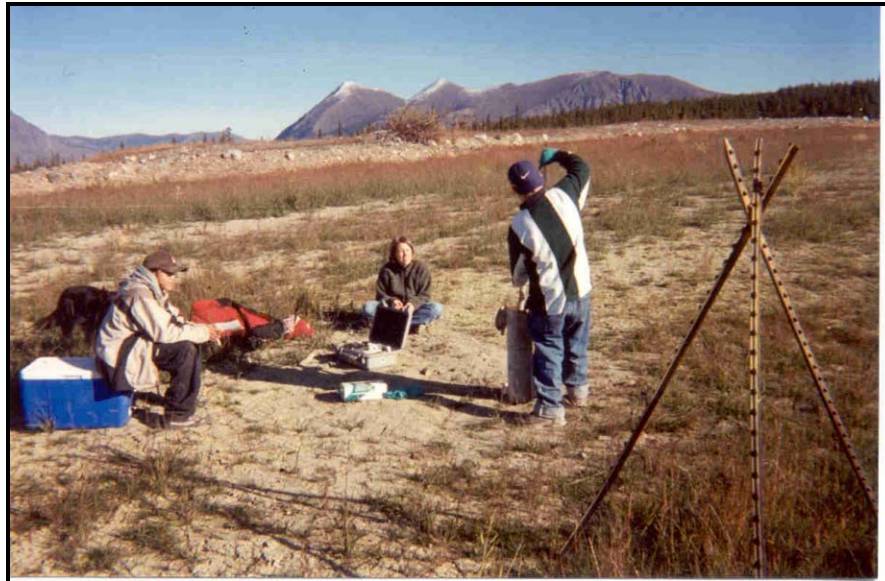
Photograph 2: Students of the Grade 7 Class of Carcross School assisting with the monitoring program. (October 2001)

EBA conducted sampling and monitoring during the two most recent events of the second phase of the study. The EBA representative, Mr. Ryan Martin was accompanied by the grade seven class of Carcross School (shown in Photograph 2) and their teacher, Leslie Doran, during the October 2001 monitoring event. During the March 2002 monitoring event Mr. Martin was accompanied by Mr. Jared Buchko and Mr. Michael Nahir of PWGSC and Mr. Werner Liebau of INAC.

As observed from the table and graphs presented above, the results of moisture content testing for Testpit 1 and 2 (TP1 and TP2) which were excavated during the first phase of the study were very similar. At these locations, the moisture contents started at approximately 23% at 0.001 m and increased to approximately 27 % (full saturation) at 0.20 m within the cover material. Within the sand and gravel ramp material below the cover, the moisture contents continued to decrease slowly. The hand-dug testpit at TP1 had refusal within the sand and gravel ramp material on a cobble, and hence was not advanced into the tailings. TP2, however, was advanced into the tailings, where the moisture content increased slightly. The moisture content results at TP1 and TP2 suggested that the cover material was working effectively to limit moisture migration into the tailings impoundment at the time of sampling. TP3 was excavated in the same area as TP1 in October 2001 (See Figure 2). Although the general trends observed for TP1 hold for TP3, there are some notable differences, these are: (1) the moisture content in the cover decreases slightly with depth in TP3 in contrast with TP1, (2) the moisture content near the interface between the sand and gravel layer and the cover is higher for TP3 than for TP1, (3) the moisture content in the tailings is higher in TP3 than in TP1, and (4) the moisture content with depth in the tailings increases much more dramatically for TP3 than for TP1. These differences are likely explained by the difference in climate between the summers of 2000 and 2001. In 2000, there was much more precipitation, which was sustained over the entire summer season, and in many places the ground was saturated. In 2001, there was above average precipitation in the period from April to June, which was then followed by hot dry conditions. As mentioned previously, Adorna Landscaping under a PWGSC contract revegetated the cover in October 2000. During the October 2001 sampling event some grass growth was obvious at various locations across the cover (see Photograph 2).

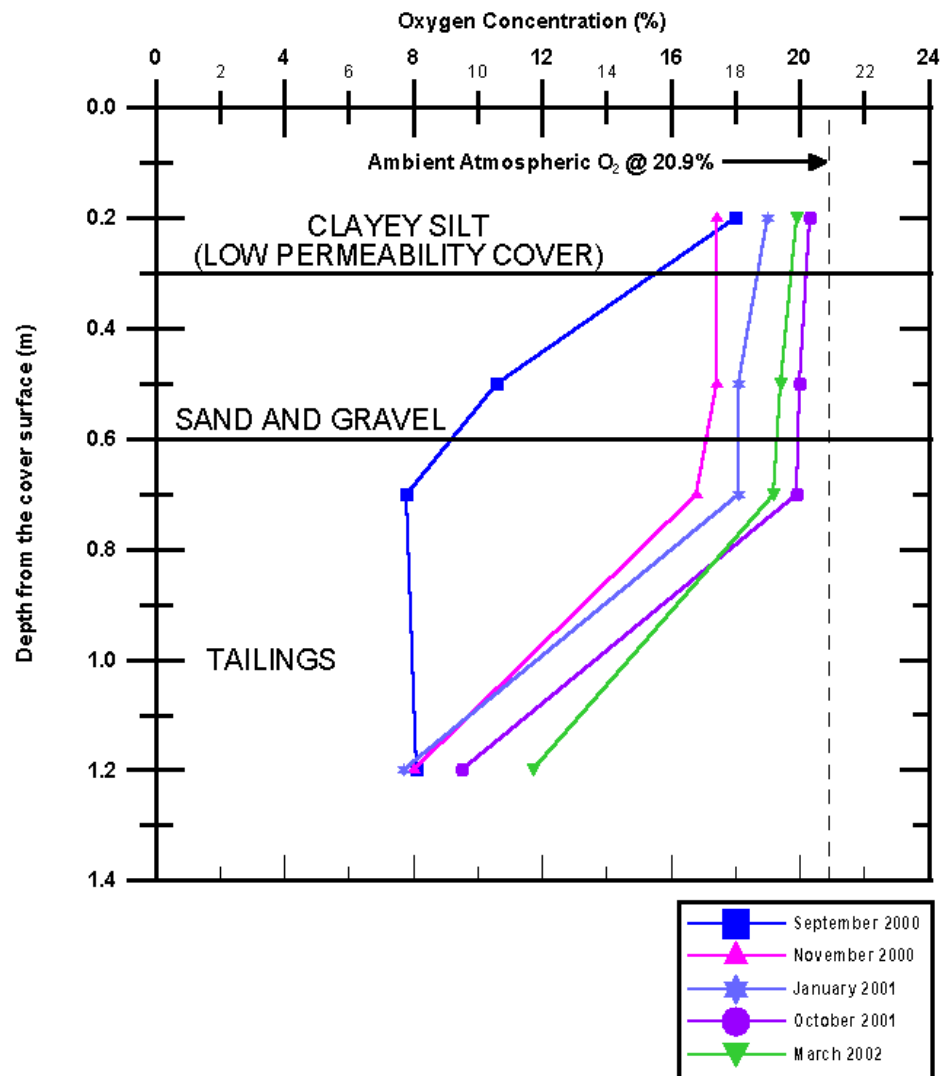
Figure 5.1.1: Oxygen Profiles for SGP 1

A graphical representation of this data is illustrated in Figure 5.1.1.

The trends that can be observed based on the oxygen profile graph are the following:

- During each monitoring event, there is less oxygen by % volume within the cover material than in ambient air. The clayey silt cover material has had on average over the five monitoring events approximately 18% by volume of oxygen at a depth of 0.2 m. This suggests that there is some limitation of oxygen flux between the atmosphere, and the tailings. Note that the oxygen concentrations within the cover, however, were highest during two most recent sampling events during this second phase of the study.
- During each monitoring event, there was a significant reduction in oxygen levels between the cover material and the tailings. The oxygen levels within the tailings ranged between 7.7% and 11.7 % by volume. Note that the concentrations observed within the tailings during the second phase of the study were higher than during the first phase.

At SGP 1 it has been observed that there is a notable oxygen reduction with depth into the tailings. This suggests that there is some oxidation and ARD occurring within the tailings, or that decomposition of the organic silts and peats that underlie the tailings is consuming oxygen. Given that higher concentrations of oxygen exist within the sand and gravel unit above the tailings, there is a concentration gradient between these two units, which would result in the driving force for diffusion. For a typical pyritic mine waste dump, the mass of oxygen required to oxidize all the pyritic material is about a thousand times greater than the oxygen initially available in the pore space of the pile (MEND Report 1.22.1a, 1993). Thus for complete oxidation of pyritic wastes, oxygen needs to flow from the surface of the wastes to oxidation sites within the wastes. The low permeability cover system is designed to restrict this oxygen flux leading to a low oxidation rate and hence a low rate of generation of contaminants within the wastes. At SGP2, however, it has been observed that a reduction in oxygen concentrations within the tailings is no longer being observed during the second and most recent phase of the study.

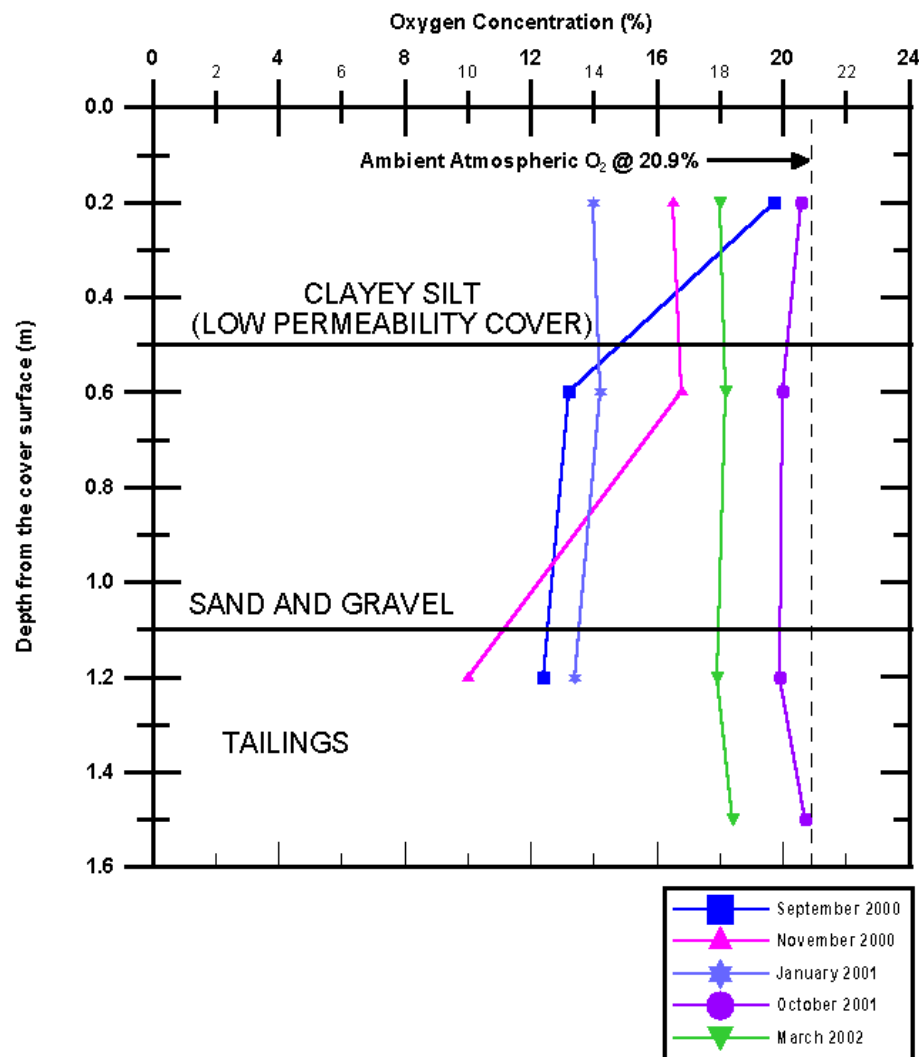
Figure 5.1.2: Oxygen Profiles for SGP 2

Observed oxygen readings for SGP 2 measured with the Minigas® during the three field monitoring events of phase 1 and two field monitoring events of phase 2 are shown in Table 5.1.2. and shown graphically in Figure 5.1.2.

Based on the oxygen profile graph, the following trends can be observed:

- There appear to be some temporal variations in the oxygen levels observed within the low permeability cover material at 0.2 m below grade over the monitoring period. Oxygen concentrations ranged from 14.0 % to 20.6 % by volume, consistently below the ambient oxygen concentrations (with the exception of SGP2 at 1.5 m in depth which had same as ambient concentrations during the October 2001 sampling event) suggesting that the cover material is limiting the flux of ambient air into the tailings impoundment.
- There was a noticeable reduction in O₂ concentrations between the clayey silt and the sand and gravel ramp material during the September 2000 monitoring event, yet there appears to be no significant reduction in O₂ during the subsequent sampling events. This may suggest

- Note that the general trend of a reduction of oxygen concentrations with depth as observed during the first phase monitoring events was not observed during the second phase sampling events. The elevated oxygen concentrations suggest that ARD is not occurring, or is only occurring at a nominal rate in the vicinity of SPG 2, because there are no significant drops in oxygen concentrations within the tailings. This is in contrast to SPG 1 where there is an obvious drop in the oxygen concentration concentrations within the tailings.

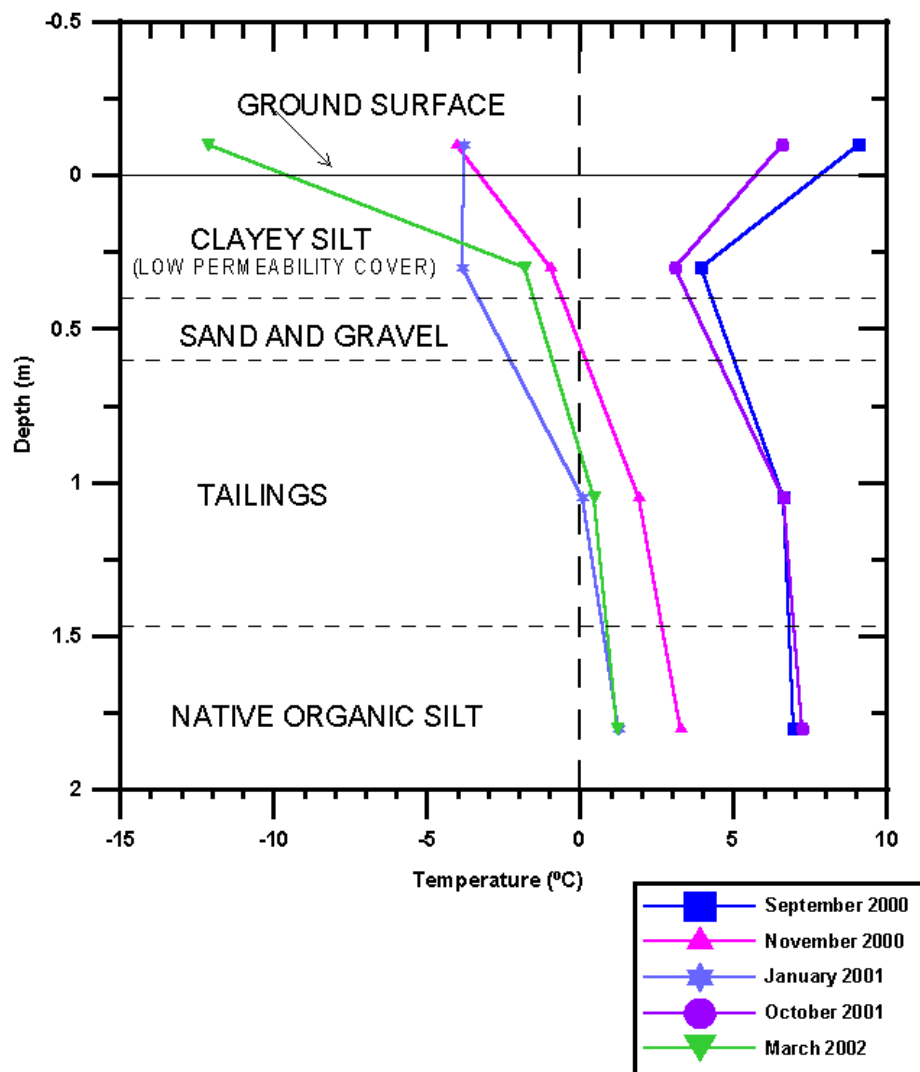
Figure 5.3.1: Temperature Profile

The following key observations are illustrated in Figure 5.3.1:

- The range of ground temperatures observed during each of the monitoring events did not fluctuate as much as did the ambient atmospheric temperatures, which suggests that the cover material has a moderating effect on the ground temperature within the tailings, resulting in cooler ground temperatures (in summer and fall) and hence less biological activity. This moderating effect is markedly apparent when looking at the temperature profile for March 2002. This is consistent with the results reported in other reports regarding low permeability covers.

- The tailings temperatures are very similar but always slightly colder than the underlying organic silt. Should ARD be occurring at this location, it would be expected that the temperature at 1.05 m within the tailings would be elevated with respect to that at 1.8 m within the underlying silt, due to the exothermic nature of pyritic redox reactions. It is noted that in September 2000 and October 2001, the two warmest ground monitoring events, the difference between the tailings temperature and organic silt temperature is negligible. This may be an indication that ARD is not occurring at this location, however, it should be noted that ARD is known to occur on a micro level and hence could be occurring at one location while it is not occurring at another location within the same deposit. Therefore, observing that ARD is not occurring at one location does not indicate that it is not occurring at other locations within a waste deposit.

- The temperature within the tailings at 1.05 m below did not drop below 0°C and reached a maximum of 7°C in September (it is expected that this would approach the maximum ground temperature at this depth). A linear interpolation of this graph suggests that seasonal frost extended to the surface of the tailings during the November monitoring event, and to approximately 1.0 m at the time of the January monitoring event.
