**ARCTIC GOLD AND SILVER MINE TAILINGS POND  
DISCHARGE EVALUATION  
FOR THE CARCROSS TAGISH FIRST NATION**

A Water Contaminants Evaluation under the Walk in Project

November 1997

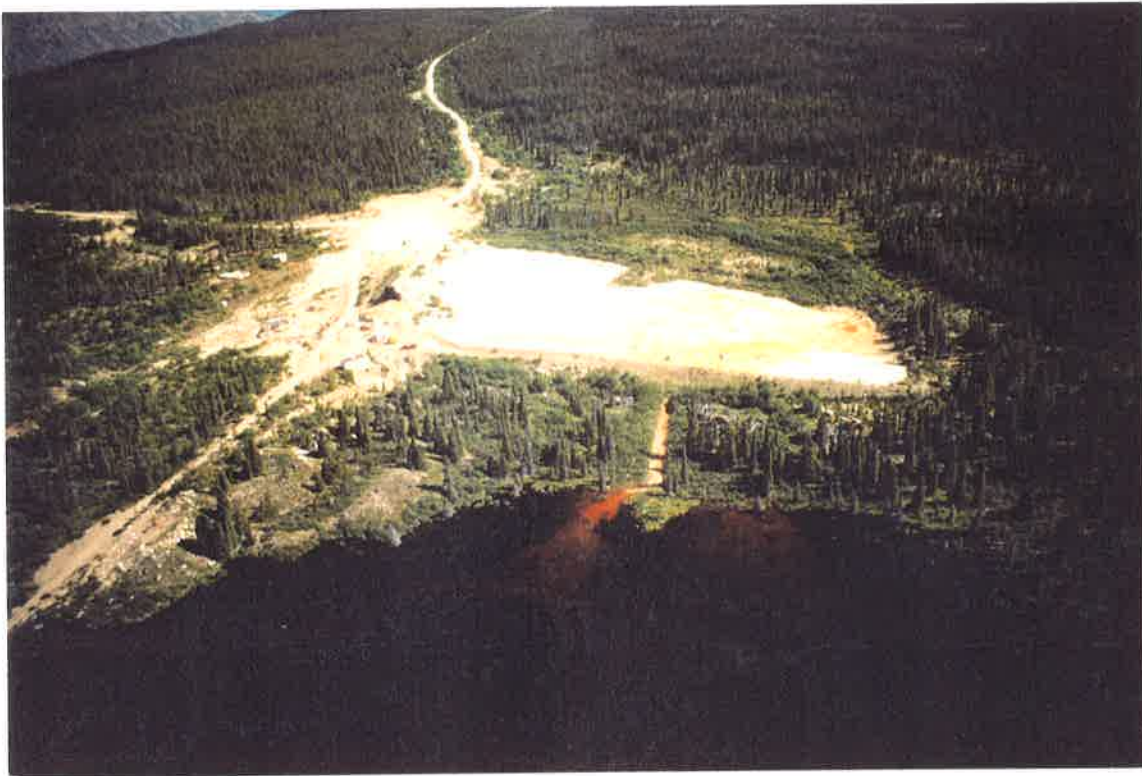
The AGS-US sample is from upstream of the tailings pond, in an area where water flows around the material pushed up to make part of the tailings dam. This is ground water that comes up near the road and then runs around the tailings area and into the beaver pond through the marsh on the pond's edge. In the photo, (page 4), it would run along the top of the tailings pond area where you see the strip of bright green vegetation. This water is of drinking water quality and none of the metals are above the aquatic life guidelines (Table 2.).

The AGS-BPD sample is from the beaver pond, above the old road down to the Lake. It is off the left side of the photo (page 4), in the middle of the beaver pond. This water is also of drinking water quality and again within the aquatic life guidelines (Table 2.). In the "total" metals analysis, Iron in the AGS-BPD sample, has a value of 0.476 and the guideline is 0.3. These values can be considered to be equal for water quality purposes.

**Arctic Gold and Silver Mill Site and Tailings Pond - August 1997**
