**SteveJan Consultants Inc.**  
405 – 9 Adams Rd.  
Campbell River, BC V9W 1R9  
Tel/Fax: 250-926-0285  
Cell: 250-850-9002

**Subject: Cost Estimate of Remaining Decommissioning and Reclamation Liabilities at Brewery Creek Mine as of September 30, 2007**

Photos From July 25, 2007 Site Inspection

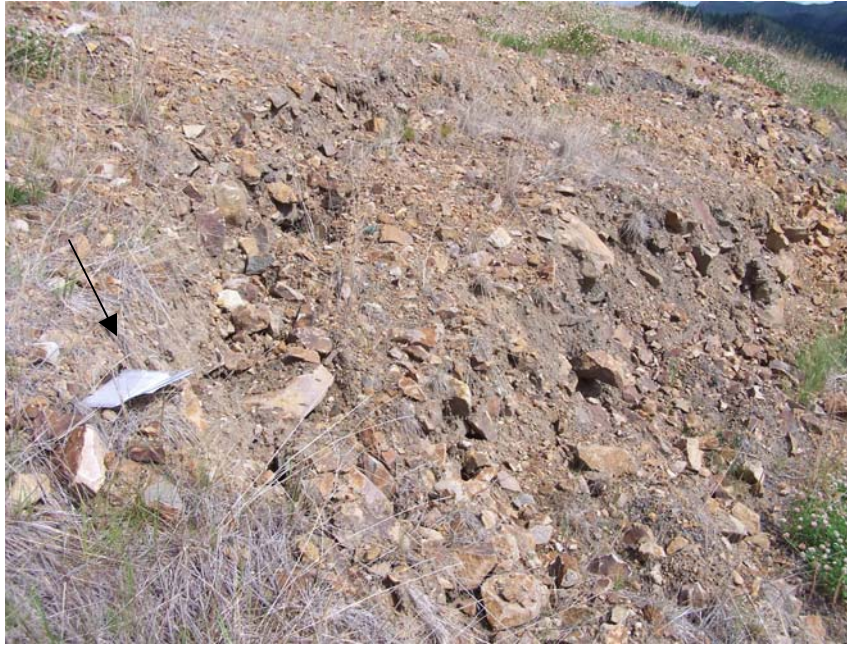
2. **Lucky Roadside Stabilization** – Two portions of the slope adjacent to the access road into the Lucky Pit area are showing instability. One of these was unloaded in 2004 and 2005 but continues to show weakness with slumping of surface material. A second area, further west along the slope is quite long and is showing multiple failures along the slope (see Plate 1). It is unlikely that the slumped material or any unraveled loose will travel to the low spot of the area which is some distance away but which has a small stream originating there. There is likely no easy solution for either of the two areas. They may require some unloading, patching or minor re-contouring and then re-seeding and fertilizing. Most likely the areas will continue to slump and erode but then self-armor and vegetation will slowly become established. Continued monitoring is required. The provision remains similar to what was in place last year.

Plate 1: Slumped bank in area of Lucky road (note: clipboard for scale)

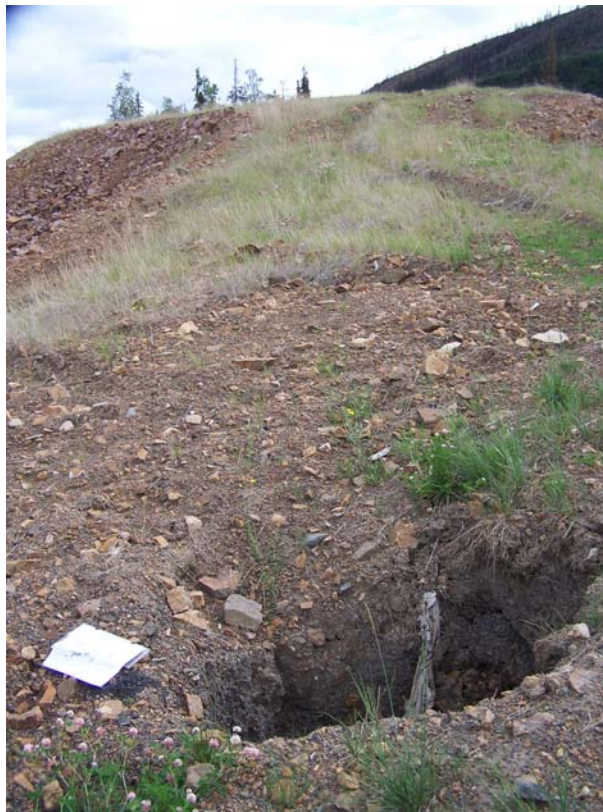
3. **Lucky Sinkhole** - An area of material subsidence continues to be apparent in the area of the open pit highwall in the form of vertical sinkholes. Two holes were noticed in the 2004 inspection, and these were found to be backfilled in the 2005 inspection. However, the latest inspection found a single hole (dimensions ~1.5m dia x 1.5m depth) in place again in a similar location (see Plate 2). A provision of \$5,000 has been included to continue to monitor this area, look for where the material may be emerging (unlikely) and to undertake any backfilling. The issue is not considered to be of a serious nature as it is likely due to a zone of voids in the backfilled area that is receiving finer materials from above.

Plate 2: Sinkhole atop Lucky open pit

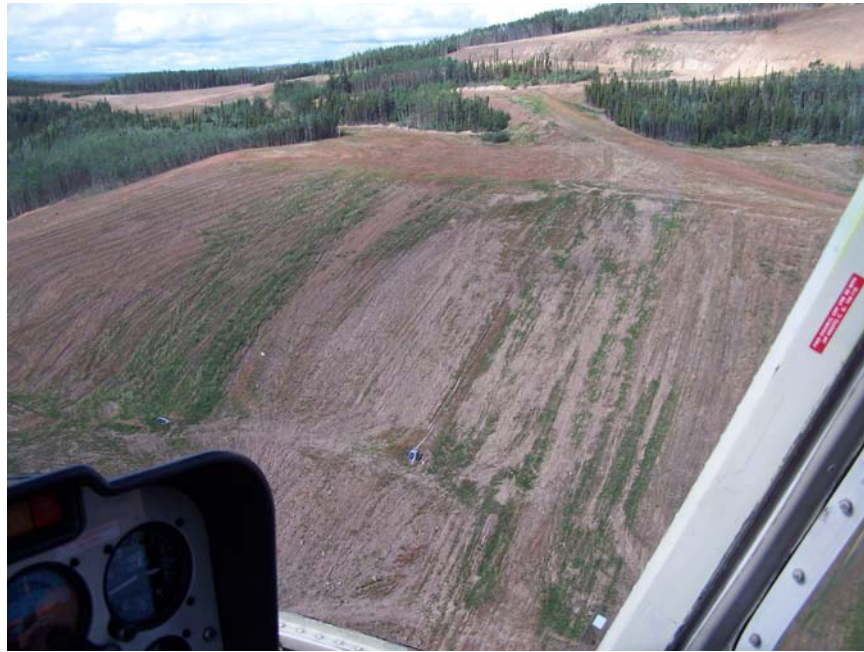
4. **BWRSa Seepage** - A risk provision of \$161,100 has been included as an additional mitigative contingency due to the uncertainty of the performance of the cover constructed over the Blue waste rock storage area, based on discussions with GY. A provision was originally recommended in the SJCI report of July 9, 2004. A provision should remain in place until satisfactory performance can be demonstrated. The current liability estimate is based on a residual risk factor of 15% of the \$1.074M estimated cost to implement a replacement cover over the dump as was costed by SRK (2003). A revised timeline for winding down the contingency was introduced in the previous liability cost estimate report (SJCI 2006) and consists of:

Plate 3: Surface of Blue WRSA from helicopter

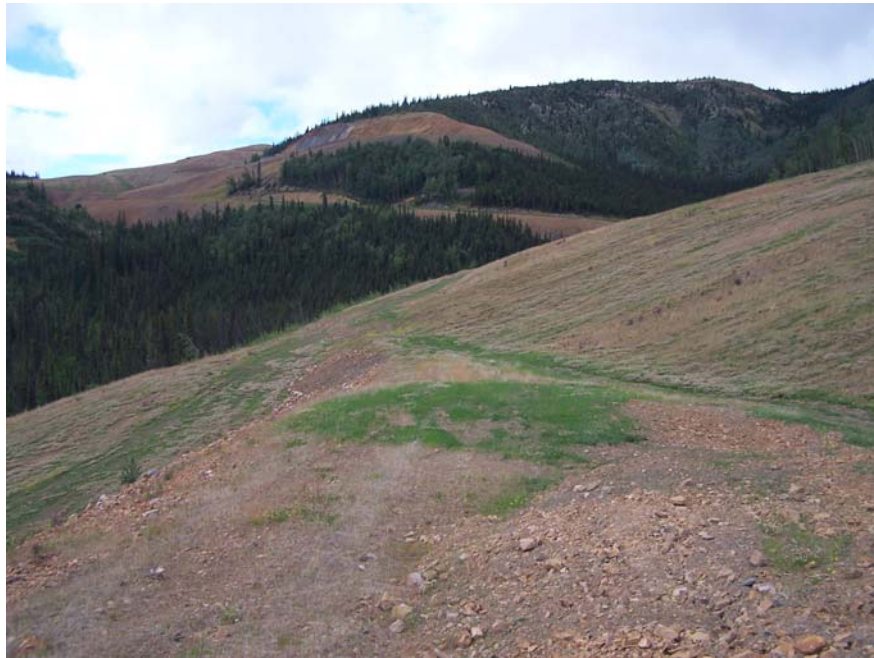
Plate 4: Western end of Lucky & view back toward North Golden
