ISSUED FOR USE
EBA FILE: W14101068.037

Subject: Ice Rich Overburden Dump – 2011 Annual Review, Minto Mine, YT

As requested, this letter presents a report by EBA Engineering Consultants Ltd. (EBA) resulting from a site visit completed to examine the current condition of the Ice-Rich Overburden Dump (IROD) at Minto Mine, YT. The intent of the site visit was to provide a geotechnical engineering report on the condition of the dump, in partial fulfillment of the requirements of the existing Quartz Mining Licence QML-0001.

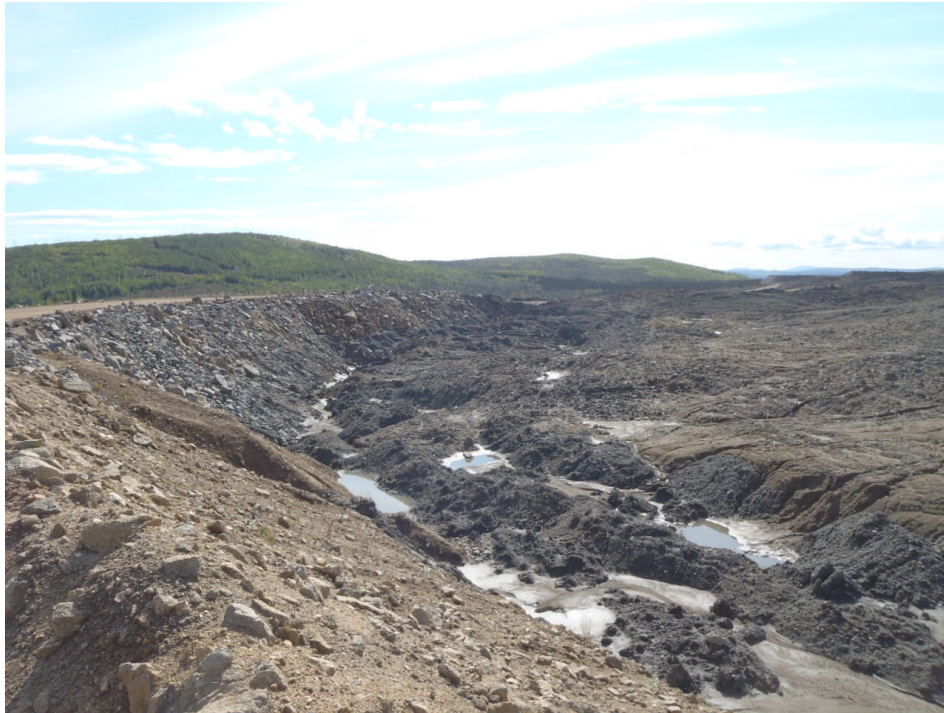
Photo 1

- Overburden covered the base of the containment area. The interior of the dump is shown in Photos 1 and 2. Small areas of ponded water are noted in Photo 2.
- Slopes of the containment berm appear consistent with original placement with no signs of slumping or bulging noted. Safety berms were present along the containment berm crest of the slopes.
- No erosion was noted along the interior or exterior slopes of the structure.

Looking south at inside of IROD containment structure. (August 25, 2011)

It is recommended that the area of ponded water be regraded to ensure water can not ponded within the facility. The remaining interior base area should be graded to allow any water to drain through the containment berm and out of the facility.

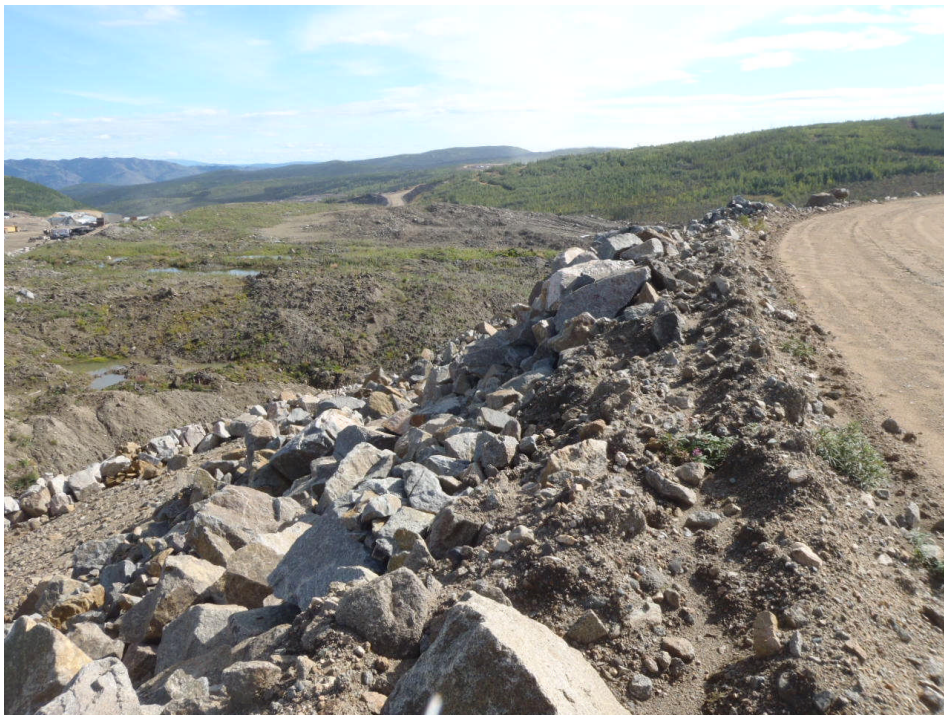
Photo 2

Looking south at exterior slope of IROD containment structure. (August 25, 2011)
