8 Waste Rock Management

This section provides as-constructed details pertaining to the construction of the temporary waste rock and ore storage facility (the pad) for the Wolverine Project. The pad has been approved under Mining Land Use Approval LQ00140. Table 8-1 provides a summary of the reviewer comments and the location of the response.

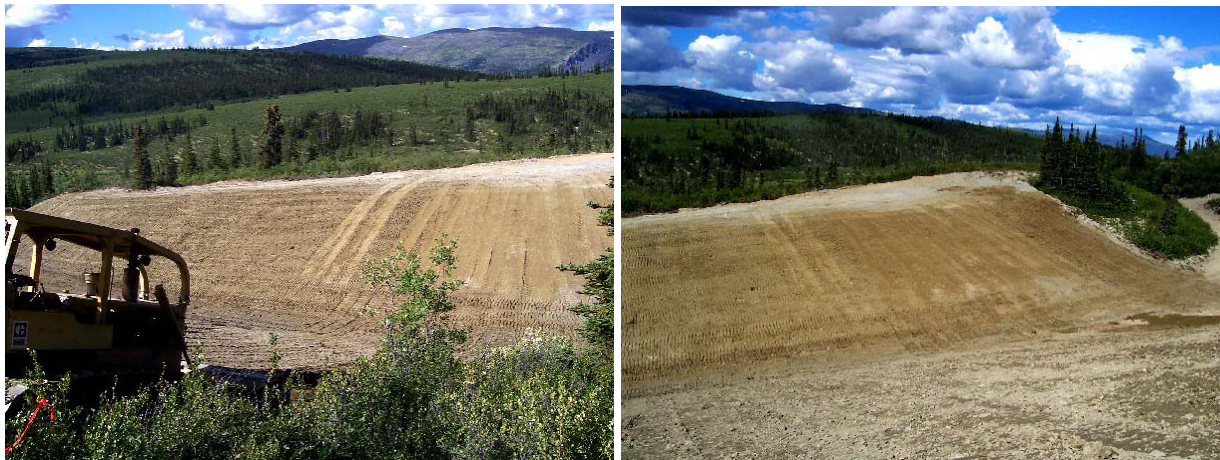
Picture 8-1 Grading, Contouring and Proof-Rolling the Till-Like Surface

In order to provide a base for the waste rock pad, the existing organic and topsoil layer was stripped to expose the underlying low permeability till-like layer and stockpiled for future reclamation activities. The exposed till-like surface was then graded, contoured and proof-rolled to facilitate the collection of water from the pad to the south end (Picture 8-1).

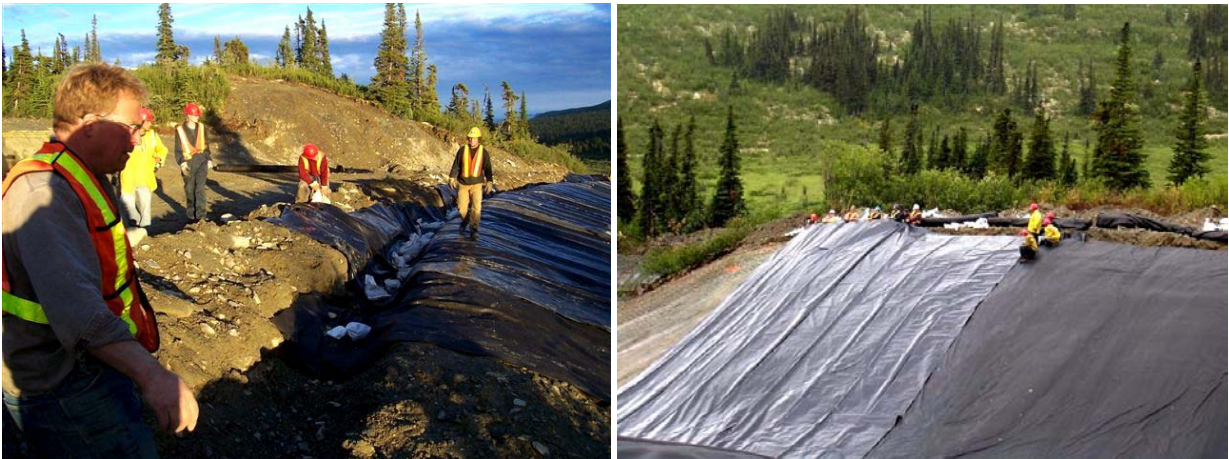
Picture 8-2 Installation of the Geotextile Layer and Enviro Liner®

The liner was supplied, placed and anchored by a specialist contractor in compliance with its quality control and assurance programs (Picture 8-2 and Picture 8-3). The preparation and excavation of the site was inspected and approved by a professional engineer licensed to practice in the Yukon and by the supplier before and after liner installation. To protect the installed liner from potential damage due to the waste rock placement, a layer of geotextile fabric and a 0.5 m thick protective layer of clay material were placed over the Enviro Liner®.

As site permeability with the clay layer could not achieve 10^{-6} cm/s, an area slightly larger than the footprint of the pad was lined with an impervious 30 mil Enviro Liner® encased in geotextile cloth for additional protection. The liner will minimize infiltration of water into the foundation subsoil. The Enviro Liner® is a proprietary polyolefin material designed by Layfield Environmental Systems Ltd. (Layfield) for outstanding durability, chemical resistance, and flexibility. The Enviro Liner® formulation includes a proprietary UV inhibitor/antioxidant additive that makes it the most durable thin film

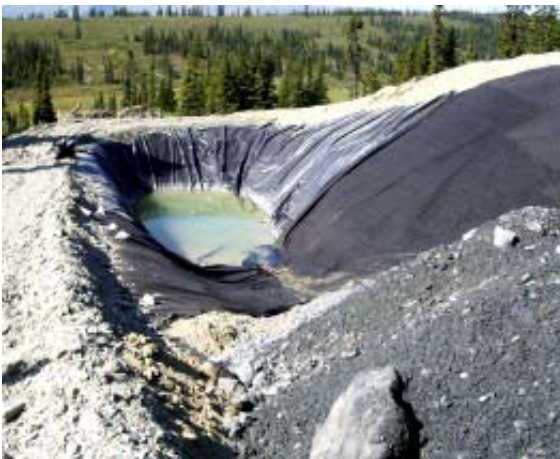
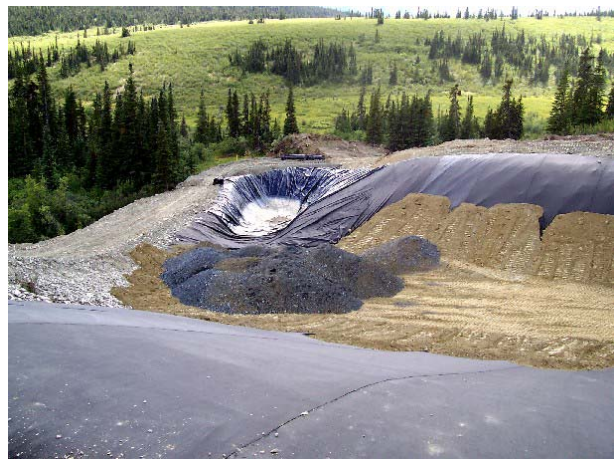
Picture 8-4 Water Collection Sump at the Southeast Corner of the Waste Rock Pad

The collection sump is located at the southern downslope end of the pad (Picture 8.4). All runoff from the waste rock pad is collected in the collection sump where it is treated. Once the water meets the applicable criteria to allow for discharge, it is discharged downslope to a vegetated area that eventually drains into Go Creek. The collection sump was constructed from compacted till and lined with a 40-mil Enviro Liner®. A second sump will be constructed in spring 2006 if the project moves towards production

The sump, with a capacity of 221 m³, has been increased from the original proposed volume of 24 m³. The sump volume is the capable of retaining water from a 24-hour rain event with additional melt waters.

Limited volumes of sediment have reached the collection sump. Based on the results of the 2005 monitoring program, the total suspended solids (TSS) within the sump water are low (Table 8-3). Sediment-laden road runoff has been diverted from entering the waste rock pad using ditches and berms and the waste rock on the pad acts as a filter. TSS was initially high immediately following liner installation and the initial rain event.

The water in the sump is regularly tested as per the requirements of the Type B Water License. Once the water reaches discharge limits, the sump will be emptied by pumping the treated water directly from the sump into the headwaters of the Go Creek drainage.

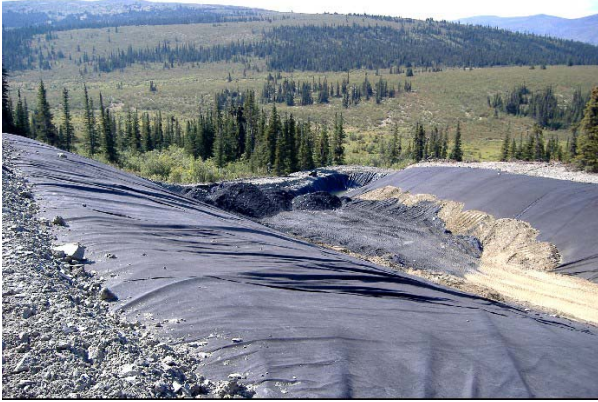
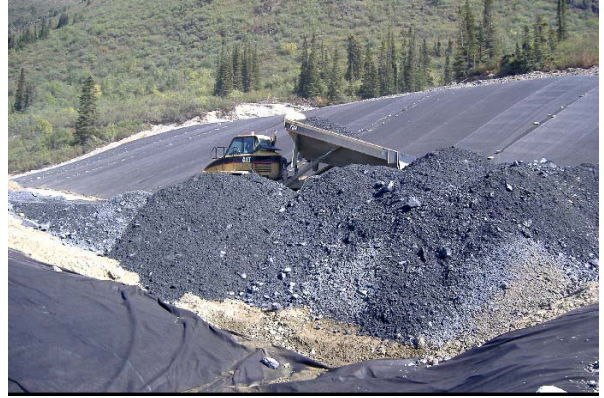
Picture 8-5 Haulage of Waste Rock on to the Waste Rock Pad

Waste rock and ore will continue to be hauled from the portal area to the waste rock pad at the onset of 2006 activities. Material hauled from the portal to the waste rock pad and dumped at the southeast end as shown in Picture 8-5 to Picture 8-7.
