Fish Habitat Management System for Yukon Placer Mining

Appendix B – Aquatic Health Monitoring Program 2018 Report

Aquatic Health Monitoring Program 2018 Report

May 16 2019

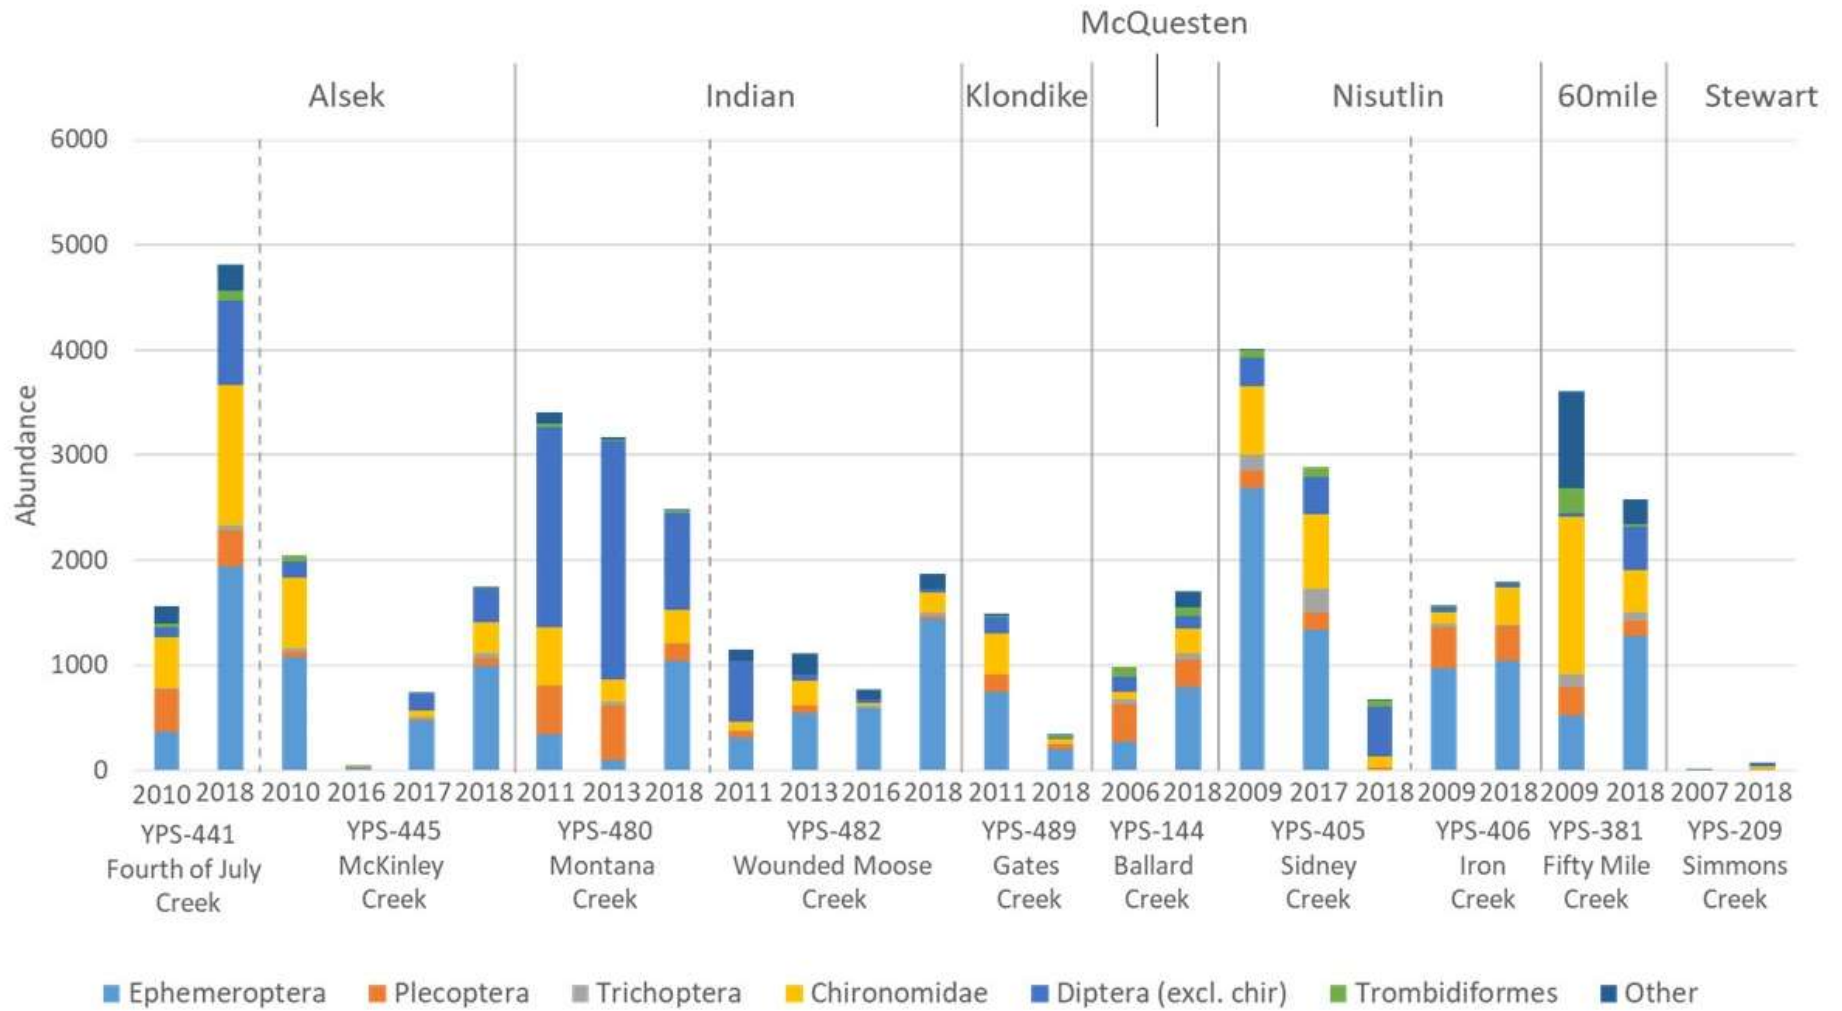
Figure 2. Relative Abundance of Major Taxonomic Groups Identified at Reference Sites Sampled from 2006 to 2018.

Abundance and richness were observed to be highly variable at reference sites. Abundance ranged from 15 to 4,814 individuals with a mean value of 1,808. Three sites with less than 100 individuals (McKinley Creek: YPS-445 in 2016, Simmons Creek: YPS-209 in 2007 and YPS-209 in 2018) were notably lower in abundance compared to other locations. Low richness was also observed at these sites. Simmons Creek was observed to have silt/sand as the dominant substrate type indicating that habitat differences may help to explain the different invertebrate community at this site.

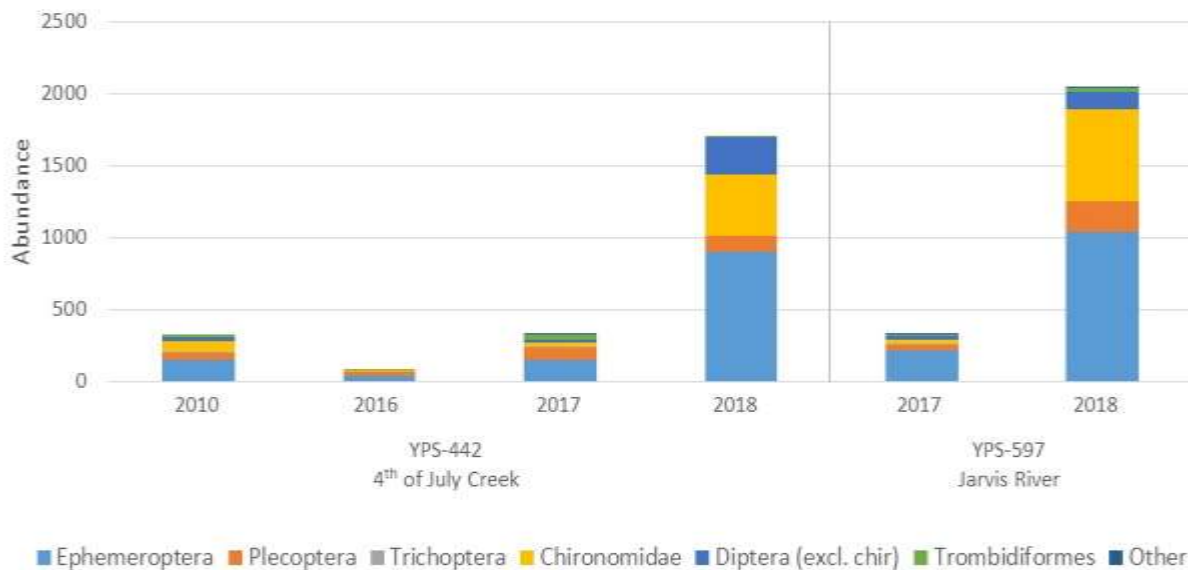
Figure 3 Relative Abundance of Major Taxonomic Groups Identified at Sites in the Alsek River Watershed

This site is located on the main channel of Fourth of July Creek approximately two kilometres upstream of the confluence with the Jarvis River. Abundance and richness were higher in 2018 compared to previous years. The majority of the community was made up of Ephemeroptera and Chironomidae and overall community composition is typical of what is observed in other locations including nearby reference sites.

This site is located on the Jarvis River approximately 700 meters downstream of the mouth of Fourth of July Creek and well downstream of placer activity. Abundance was higher in 2018 compared to 2017. Richness was lower than 2017 although still within the range of normal variability observed at reference sites. The majority of the community was made up of Ephemeroptera and Chironomidae and overall community composition is typical of what is observed in other locations including nearby reference sites.

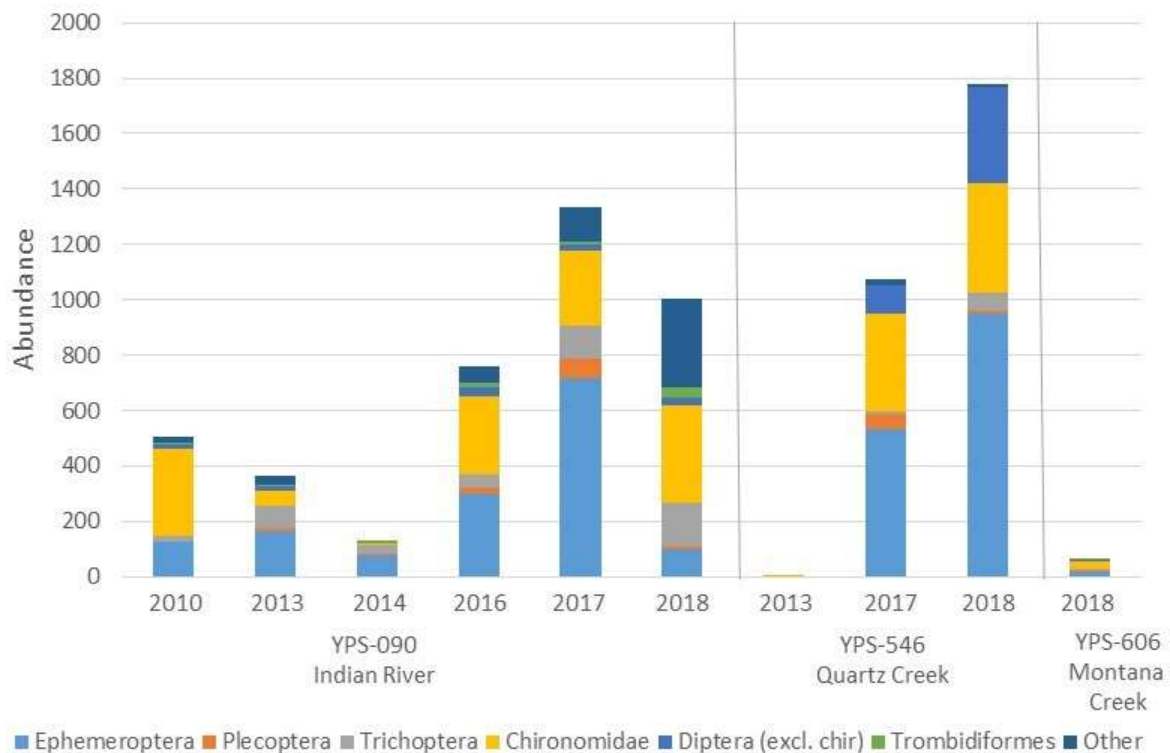
Figure 4. Relative Abundance of Major Taxonomic Groups Identified at Sites in the Indian River Watershed

This moderate-moderate suitability site is located approximately 10 km upstream of the mouth of the Indian River and 9 km downstream of active placer mining. Some variability in abundance has been observed over the six years of sampling. No consistent upwards or downwards trends were noted. In 2018, a decrease in relative abundance of Ephemeroptera was noted. High abundance of Tubificidae were identified at YPS-090 in 2018 compared to previous years.

This site is located near the mouth of Quartz Creek in low suitability habitat and immediately downstream of active placer mining. Abundance in 2018 is higher compared to past year and suggests an increasing trend. Abundance in 2013 was extremely low with only two individuals collected. Richness in 2018 (9 families) was lower than the reference mean (14 families) but was within the range of variability observed at reference sites. Community composition is typical of what is observed in other locations with the majority of individuals from the Order Ephemeroptera and the family Chironomidae. In 2018, a large number of individuals from the family Simuliidae (black flies) were identified.

Given the high degree of placer mining development upstream of this site, additional sampling at this location is recommended to build on the long term data set for this creek.
