TECHNICAL REPORT

BULK SAMPLING OF THE FIFTY MILE PLACER PROPERTIES, CHERYL CREEK AND RALPH CREEK, FIFTY MILE RIVER AREA, YUKON TERRITORY

YMIP 04-002
~~**YMIP 04-067**~~

Date: January 11, 2005

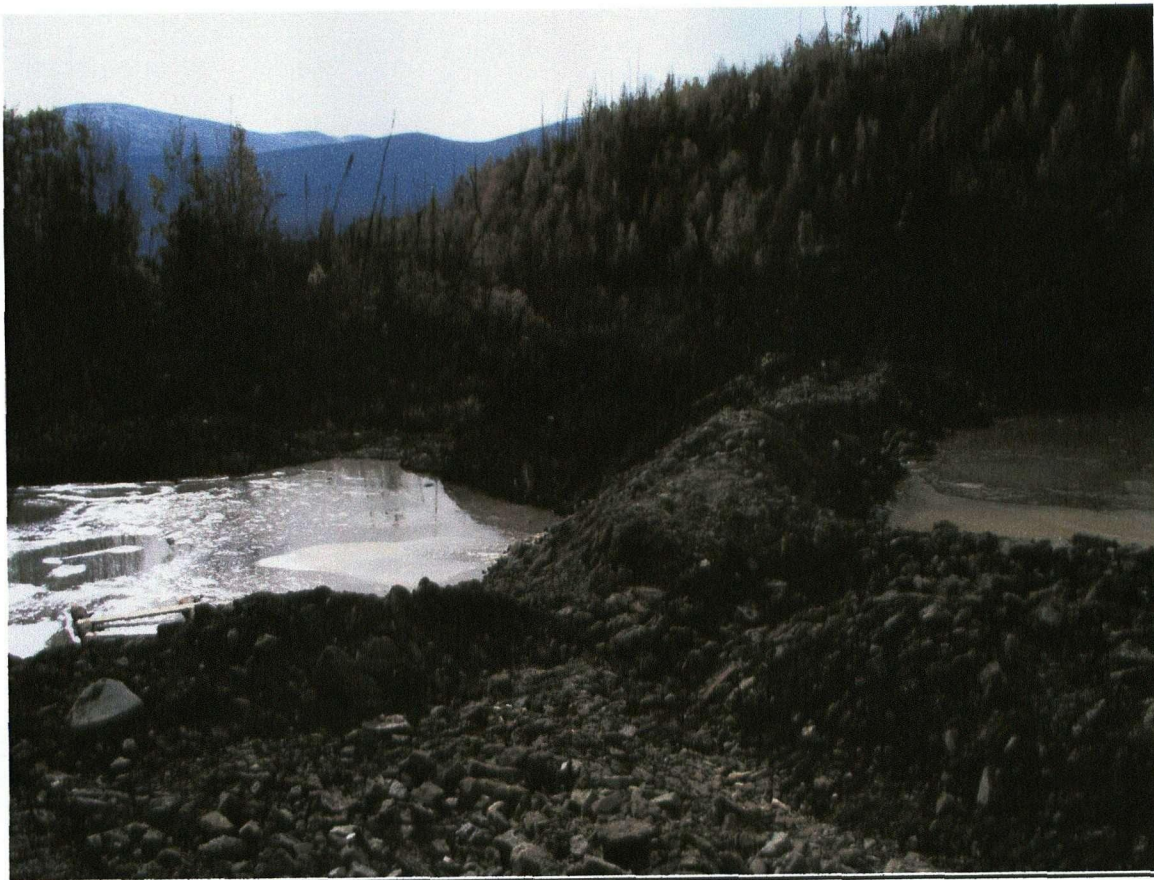
Attachment 2. c04pit1 recirculation

- Recirculation system: All pits and sampling were out of stream. 100% recirculation was used with water from the creeks taken only for initial reservoir charging and make-up water. A two settling pond/recirculation system was used for Cheryl Creek, while Ralph Creek was limited to a single recirculation pond. Yukon Client Services monitored all work and were satisfied with it and the way it was done. Attachment 2 in the enclosed photo section shows the Cheryl Creek recirculation system.

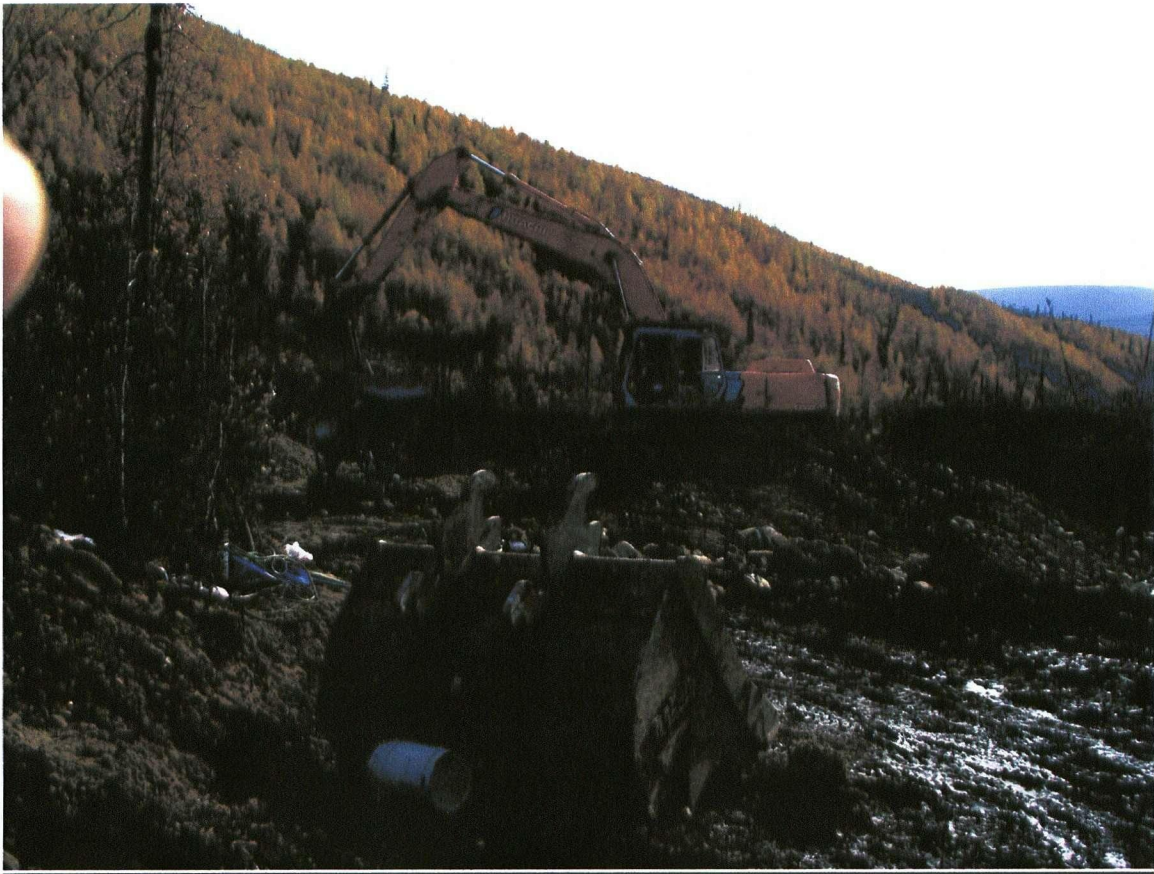
Attachment 3: Loading pay into test trommel at c04pit1

- Key Equipment utilized included a Hitachi EX300 excavator, a D8H CAT, a 25 yards per hour test trommel with hydraulic riffles over NOMAD matting, and a 2'X4' U-Tech vibrating table.

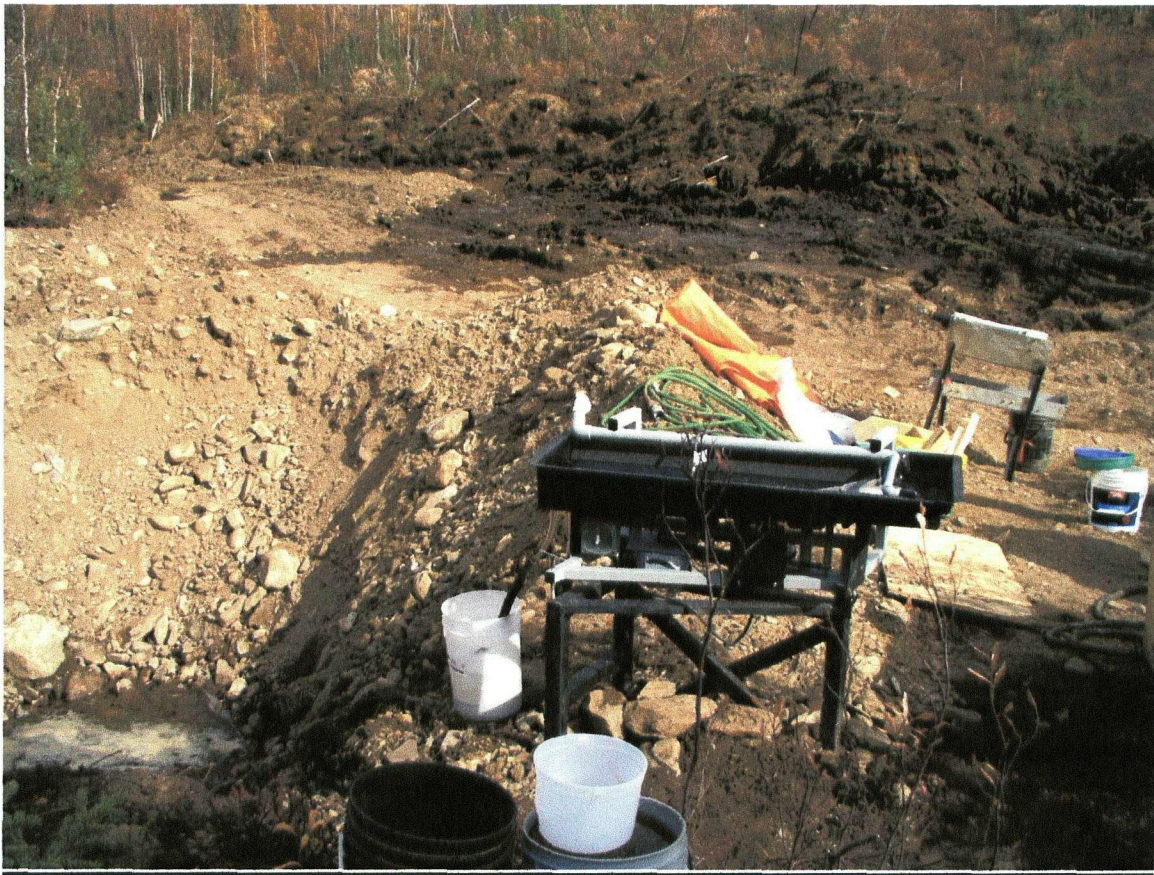
Attachment 5: c04pit2 also showing part of stripped area

- *Cheryl Creek Sample Pit c04pit2:* 250 feet by 250 feet was stripped on the East side of Cheryl Creek in a zone directly across the creek from c04pit1. Of this only a

40' buffer zone close to the creek was unthawed. A 10' X 15' test pit was dug to bedrock in the thawed area. Pit GPS location is 07525708E, 7079918N. Depth of gravel to bedrock averages about 5.5 feet. An average of 1.5 feet of muck overlies the gravel. Below the muck there is 1.5 feet of cobbles and pebbles in a sandy matrix, over 1.5 feet of sand consisting of decomposed schist, over 2 feet of well layered but poorly sorted cobbles and pebbles that are elongated by stream wear, over 1 foot of very poorly sorted boulders, cobbles and pebbles over bedrock. The boulders are up to 20". Bedrock lenses up and down. It is different from the blocky gneiss in c04pit1. It consists of highly fractured layered micaceous schist reposing perpendicular to stream flow at a dip of 15 degrees. It holds this structure for about 3.5' to the bottom of the pit where it continues down. It is judged to form a very good gold trap. A one bucket sample was taken from two feet above and down to bedrock. It was run over a long tom, was weighed, and showed a value of over \$16 per yard for \$500 CN gold. Photos of the stripped area, the pit, and the gravel column are given in the photo section. The unthawed balance of the stripped area did not thaw sufficiently in the time available to allow its testing.

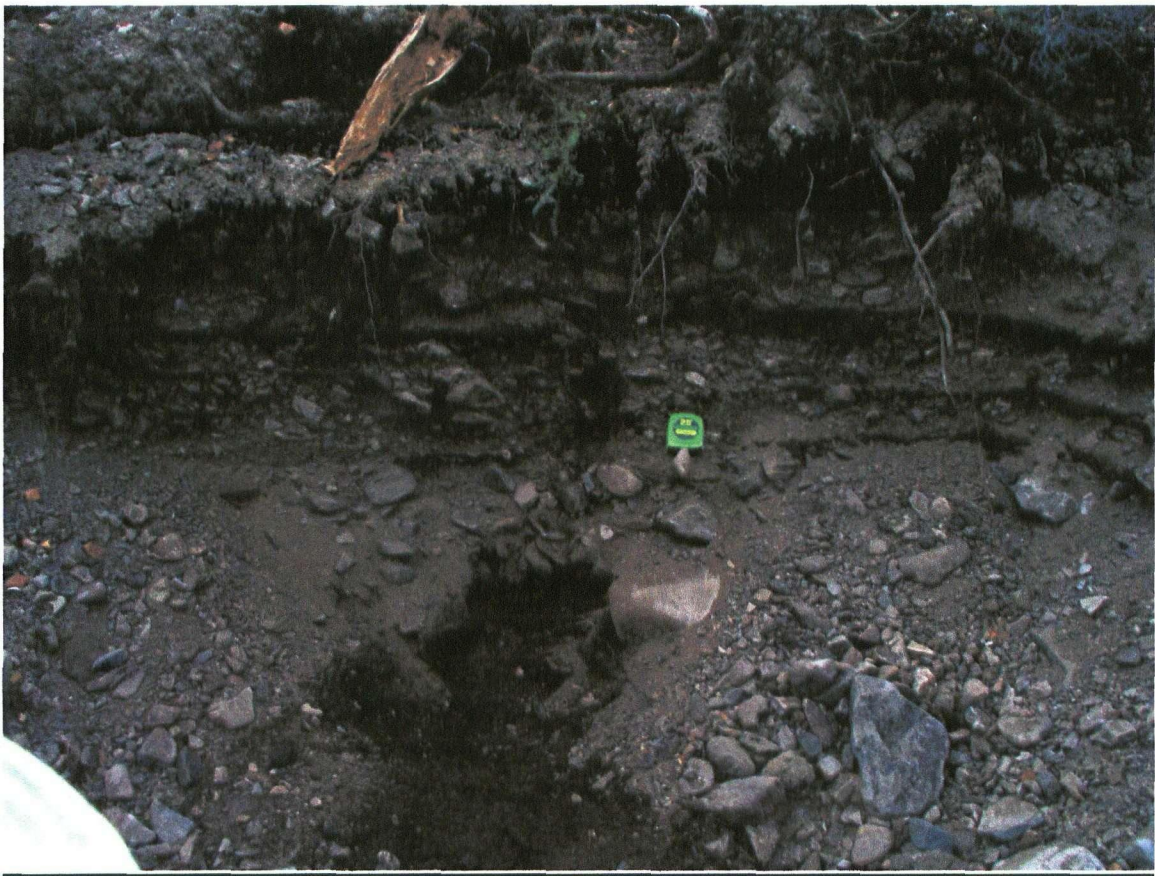
Attachment 7: c04pit3 gravel column

- *Cheryl Creek Sample Pit c04pit3*: This test pit was dug in a thawed East/West trending reef 150 feet directly North of c04pit2 at GPS location 07525714E; 7079952N. The reef is 15' higher than the adjoining valley floor, and thus represents an earlier deposition than c04pit1 and c04pit2. A similar parallel reef is located 100 feet to the South (downstream), and there may be a possible enrichment zone between the two. Both reefs are about 20' wide. Pebble orientation shows stream flow to come from 350 degrees true. 4 feet of gravel is exposed down to a frozen base of gravel. Depth to bedrock is unknown. Coverage is a light moss and no muck. The pit floor at four feet is a cobble, pebble, and boulder base and the depth to bedrock is not known. The top 1 foot of column is of poorly sorted cobbles up to 6"; over 3" of sandy material; over 6" of poorly sorted cobbles up to 3"; over 1" of sand; over 2" of sand and smaller pebbles; over 1 foot of cobbles to 6" and pebbles; on top of the frozen floor of sand, pebbles, cobbles, and boulders to 18". A one bucket representative sample was run over a long tom. Gold recovered was weighed and represents \$16 per yard at \$500CN. The gravel column is shown in the photo section.

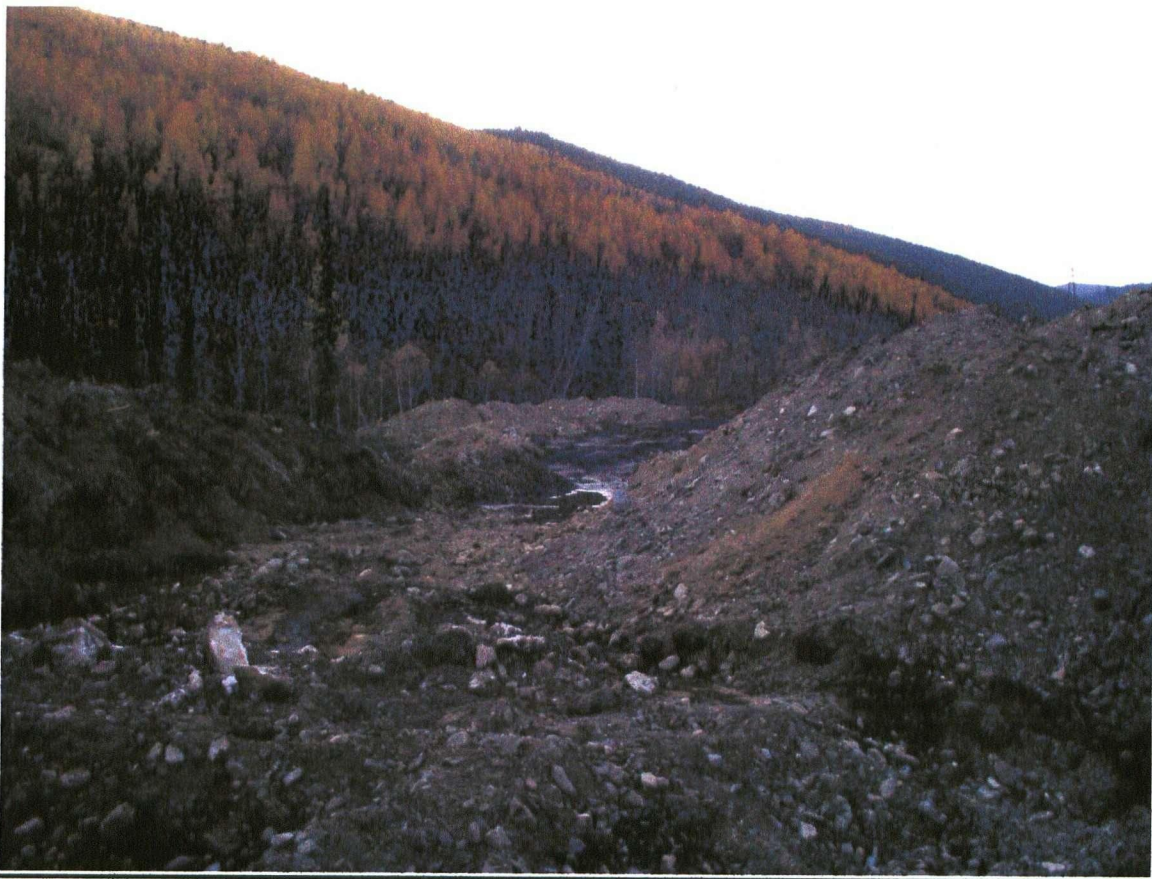
Attachment 8: r04pit1 stripped area

- Ralph Creek Pit Descriptions:
- *Ralph Creek Main Pit (r04pit1)*: 1,000' by 50' was stripped on the East bench running NW along the bench and parallel to the Ralph Creek canyon. No thawed areas were uncovered. The area was left to thaw while operations were switched to Cheryl Creek. The Southern limit of the cut was at GPS 07522271E; 7080100N. Where exposed 100' North from the above Southern most point, the gravel column shows 2.5 feet of muck; over one foot of brown sand; over 4 feet of a very poorly sorted mix of pebbles and cobbles; over 2 feet of a pebble,

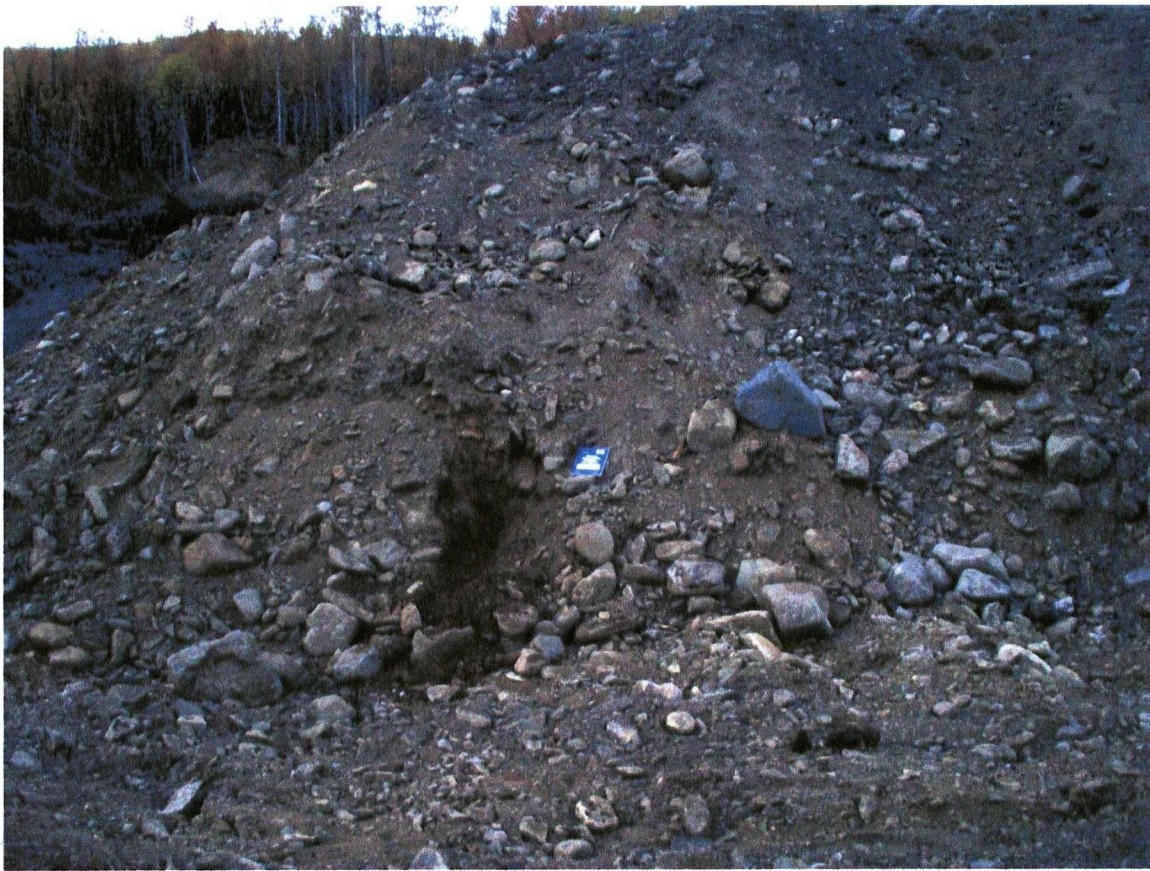
Attachment 9: r04pit1 exposed gravel column

cobble, boulder mix; over bedrock. The column is hard to read due to slide material up slope covering and infiltrating the cut. Where exposed, bedrock is highly fractured quartz schist grading to gneiss. It is well positioned to trap gold. When operations shifted back to Ralph Creek only a limited area 100' North of the cuts Southern limit was thawed sufficiently to permit sluicing. Several pan samples at bedrock showed a visually estimated \$9 per yard (\$500 CN gold). 363 yards were sluiced. Pictures of the stripped area, the gravel column, and gold recovered are given in the photo section.

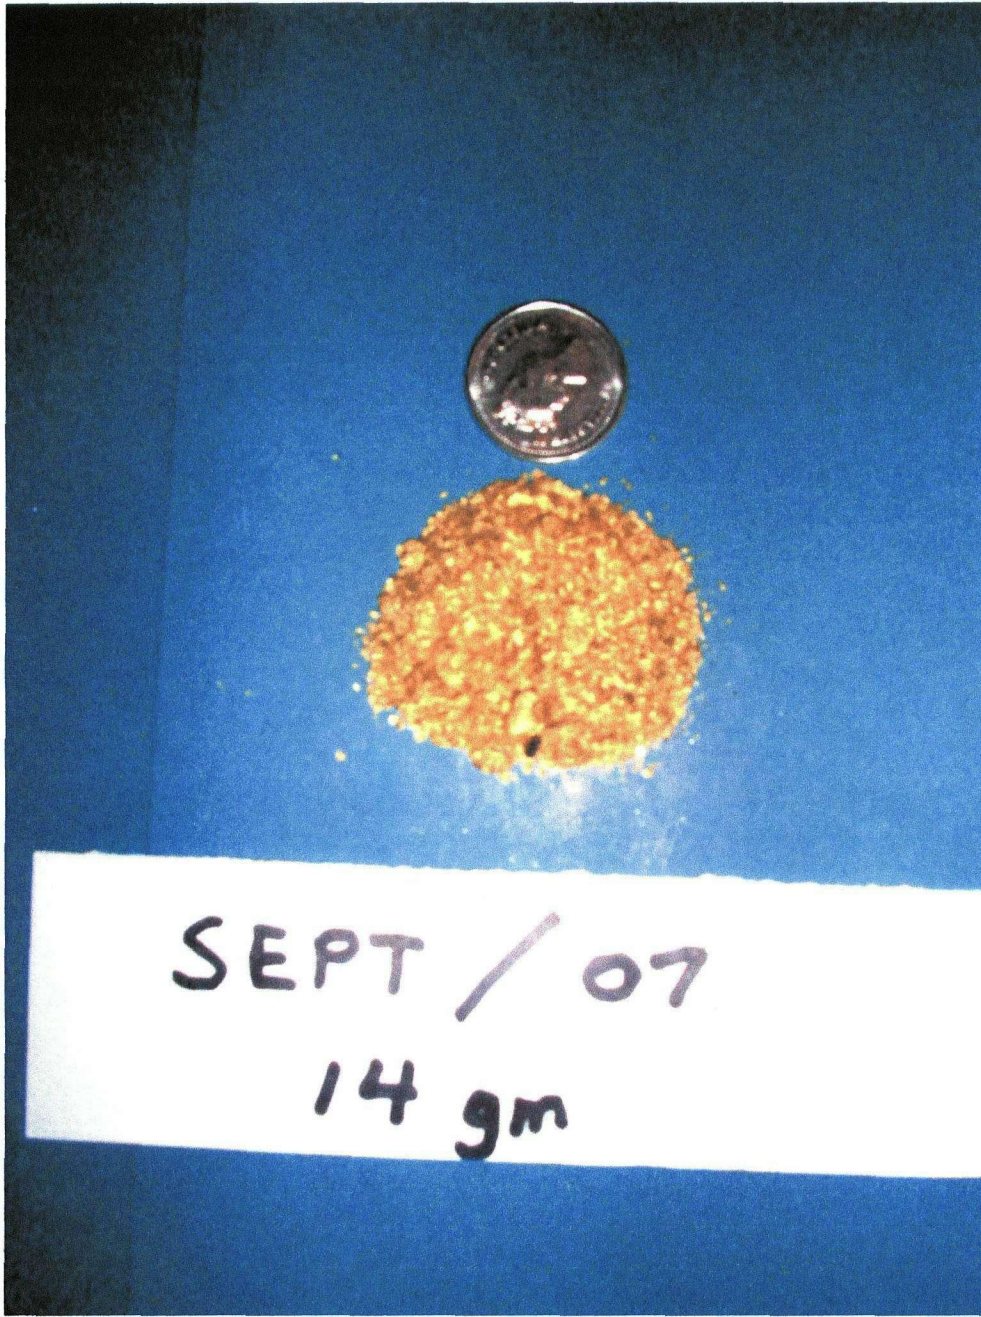
Attachment 12: Au Sept 7

SEPT / 07

14 gm

Date	Cu. Yards	Au	Au/Yd.	Material Run
Sept. 7	45.0	14.0 grams	.3111 grams	1.5' BR+1.5' Grv
Sept. 8	22.5	13.0 grams	.5778 grams	1.5' BR+1.5' Grv
Sept. 9	112.0	50.9 grams	.4545 grams	1.5' BR+1.5' Grv
Sept. 10	49.0	14.0 grams	.2857 grams	top to btm+BR
Sept. 11	150.0	37.0 grams	.2467 grams	top to btm+BR
Sept. 12	54.0	11.0 grams	.2037 grams	top to btm+BR
Sept. 13	81.0	14.0 grams	.1728 grams	top to btm+BR

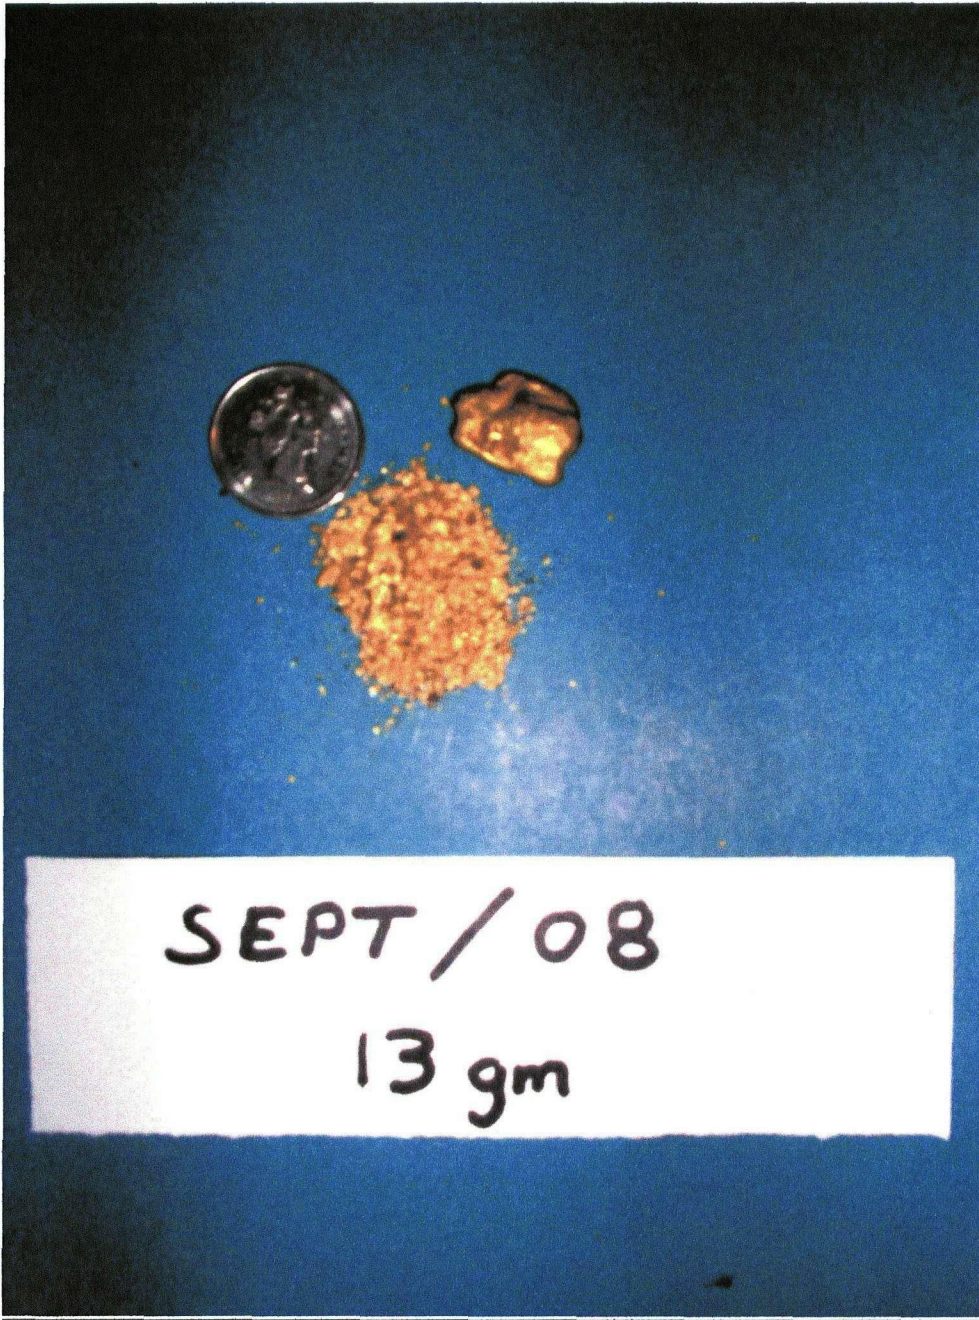
Attachment 13: Au Sept 8

SEPT / 08

13 gm

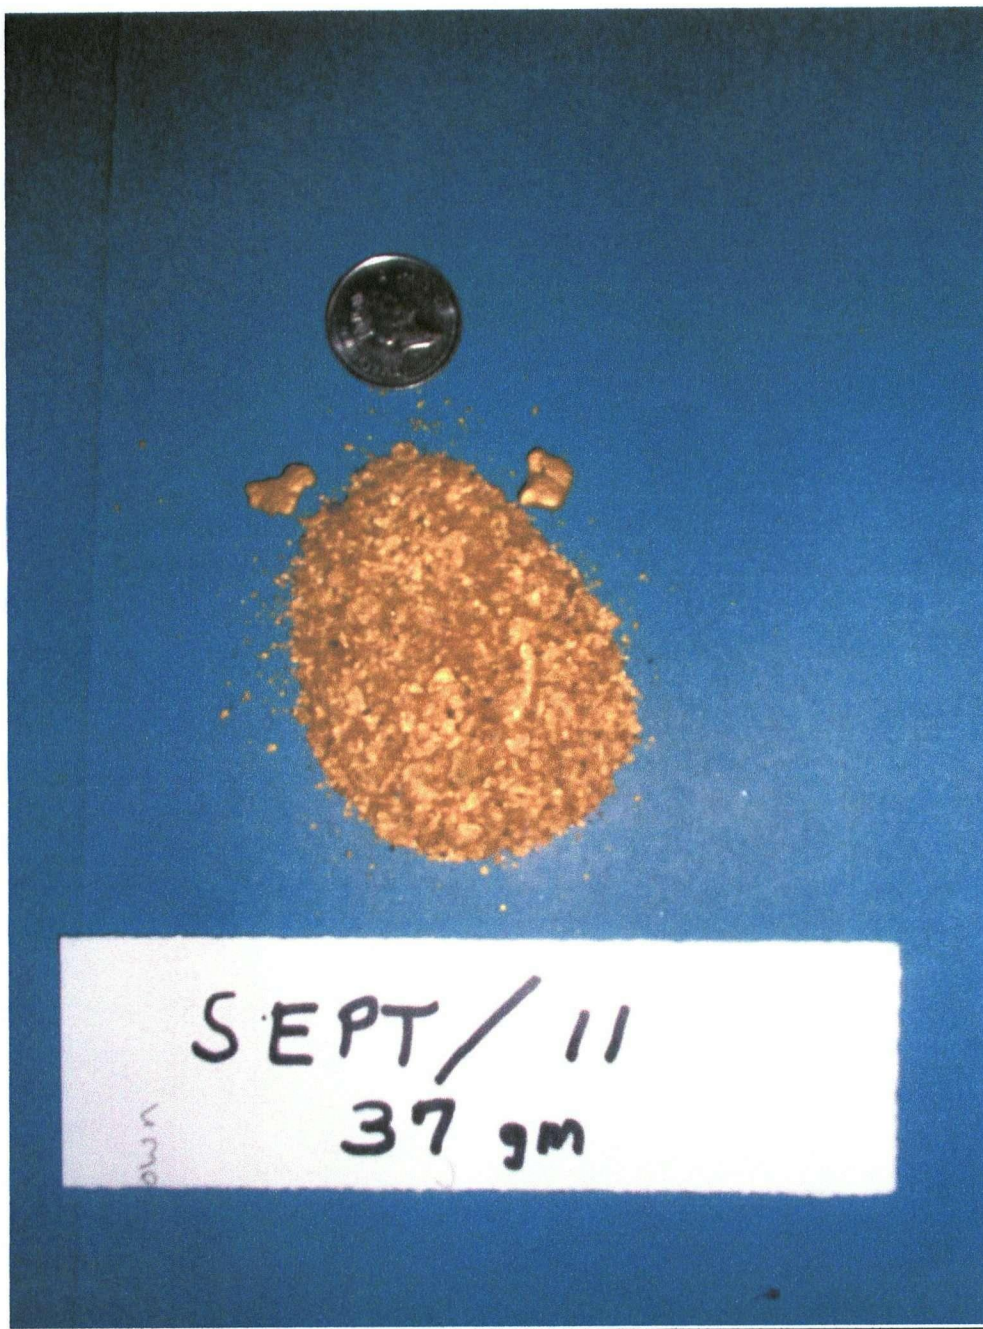
Attachment 16: Au Sept 11

SEPT / 11
37 gm

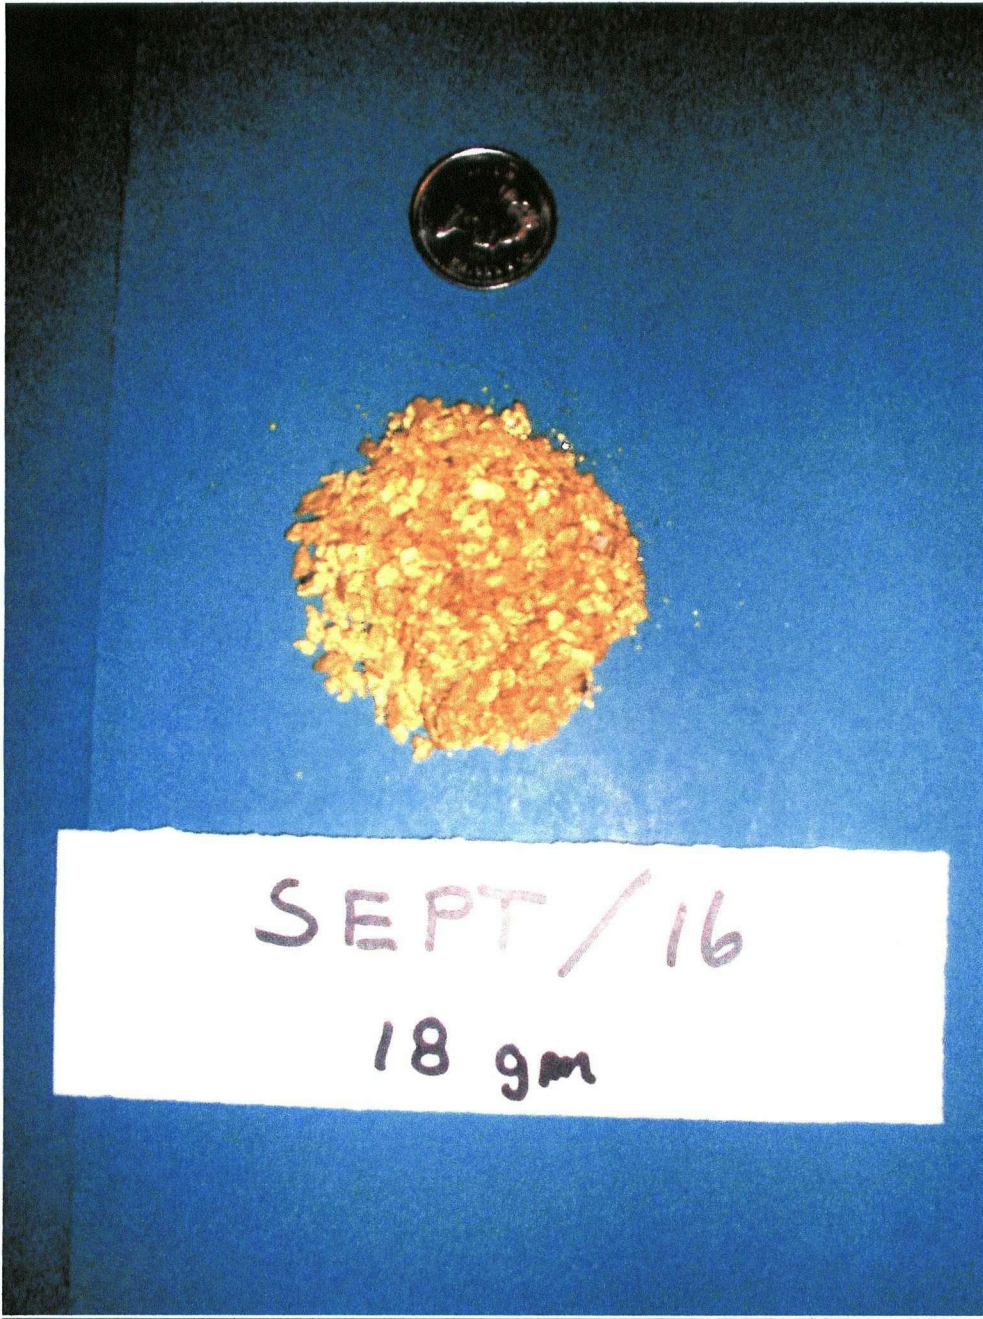
Attachment 20: Au Sept 16

SEPT / 16

18 gm

Date	Cu. Yards	Au	Au/Yd.	Material Run
Sept. 15	96.0	08.0 grams	.0833	top to btm
Sept. 16	200.0	18.0 grams	.0900	top to btm
Sept. 17	67.0	13.0 grams	.1940	top to btm
