Canaan Gold Resources Inc.

KLAZA RIVER PLACER GOLD PROPERTY

Mount Nansen Gold District, Yukon

An Exploration Summary Report (YMEP2017-010)

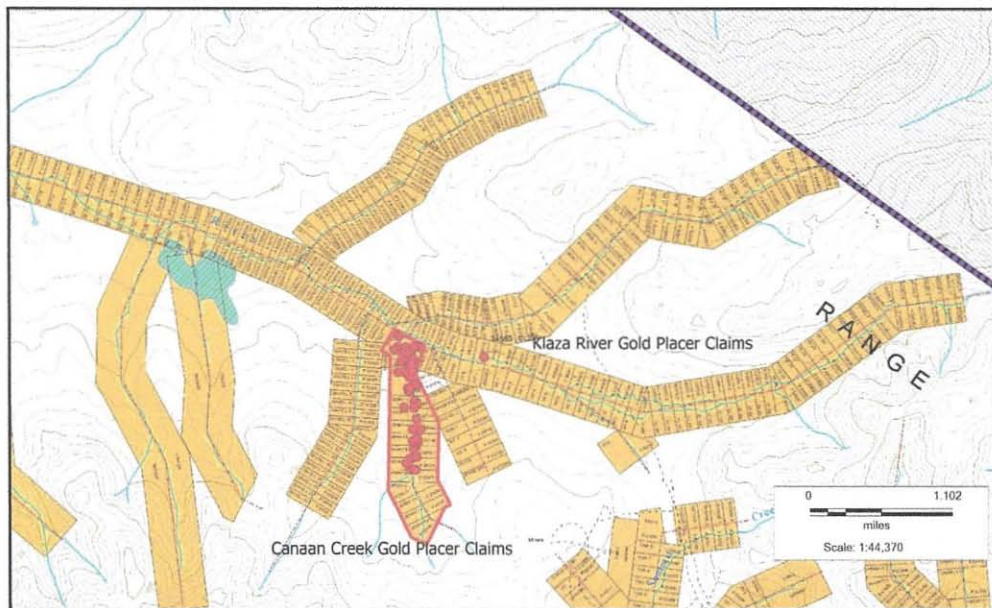
Figure 2. Placer Claims Owned by Canaan from Yukon Mining Viewer, Claims outline is Canaan Creek and Klaza River Placer Gold Property (After Dr. Y.T. Guo, P.Geo., 2016)

Canaan Gold Resources Inc. and its owner, Dr. Kehong (Kevin) Wu, CEO (hereafter “Canaan”) owns 100% of the Canaan Creek and Klaza Placer Gold (Figure 1.2) and two Placer Land Approvals with Water Usage Licences (Table 1.1), which are valid until 2019 and 2021, respectively. The operation is currently permitted to use 4000m³ fresh water per day per water permit, and there is no process amount limitation on gold - bearing sediments per permit as long as there is water to use for the washing plants. The placer claims with a water usage permit and a placer land approval are considered as constituting a full permit to operate a placer mine in YT, Canada.

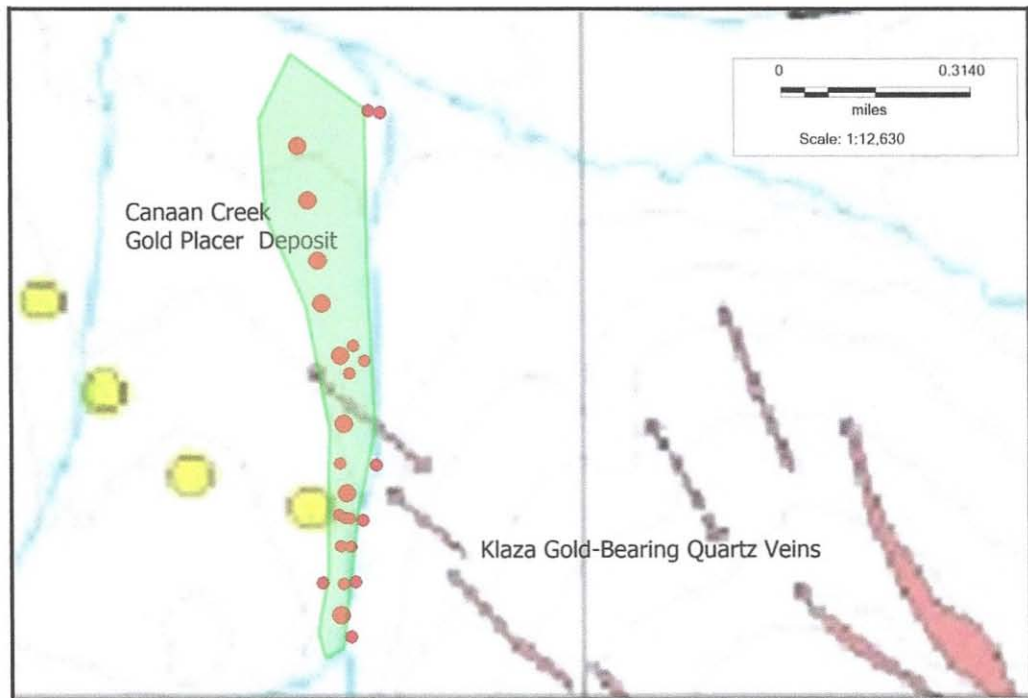
Figure 3 Canaan Creek Gold Placer Deposit and the Adjacent Klaza Gold-Bearing Quartz Veins (After Dr. Y.T. Guo, P.Geo., 2016)

The irregular rough morphology gold particle seems from nearby local fluvial and alluvial environments, in which some of them even occur together with quartz vein. The rough morphology of gold grains or nuggets from the Canaan Creek and Klaza River Gold Placer Claims indicates very limited fluvial transporting features and proximity to the source. The fact is that the Canaan Creek and Klaza River Gold Placer site is right adjacent to the Klaza gold vein system (Figure 1.3).

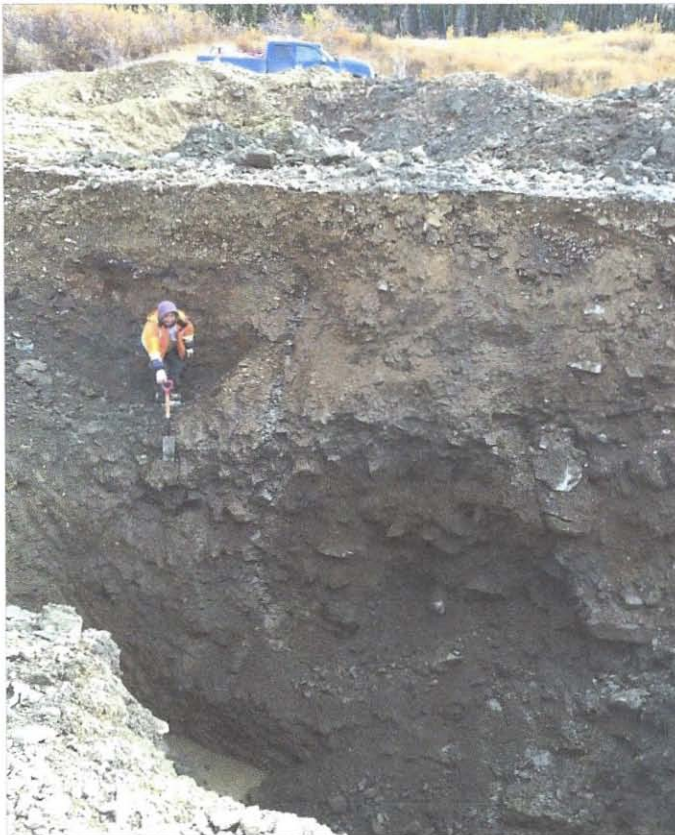
Figure 4 The Test Pit, Showing the Auriferous Glacial Till Sediments (After Dr. Y.T. Guo, P.Geo., 2016)

The lithology of sediments (Figure 1.4) in the Canaan Creek Gold Placer Property consists of diamicton, unsorted glacial deposits and contains particles ranging in size from clay to boulders, and alluvial/fluvial sand, mud and gravel from local streams and rivers

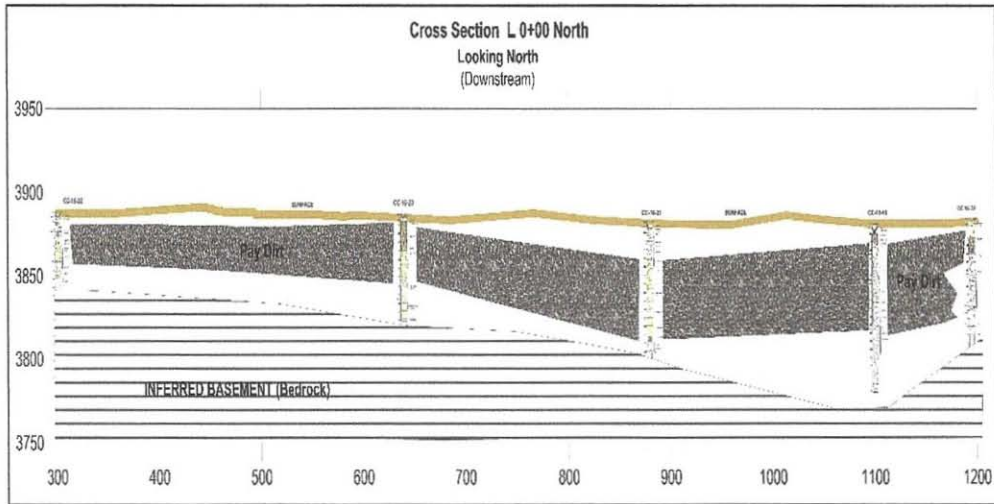
Figure 5. Cross Section Line 0 Based on Auger Drilling Holes in the Downstream of Canaan Creek, showing the Pay Dirt Layer Thickness Up to 30m (After Dr. Y.T. Guo, P.Geo., 2016)

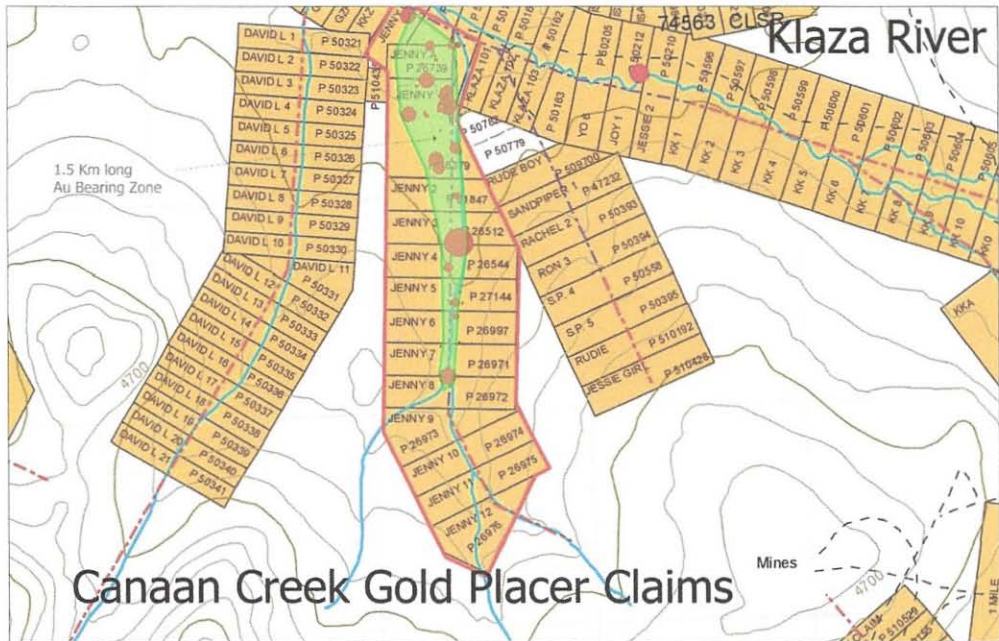
Figure 6. Auriferous Zone (Green Color) defined by Auger Drill Holes and Test Pits in the Canaan Creek Gold Placer Property (After Dr. Y.T. Guo, P.Geo., 2016)

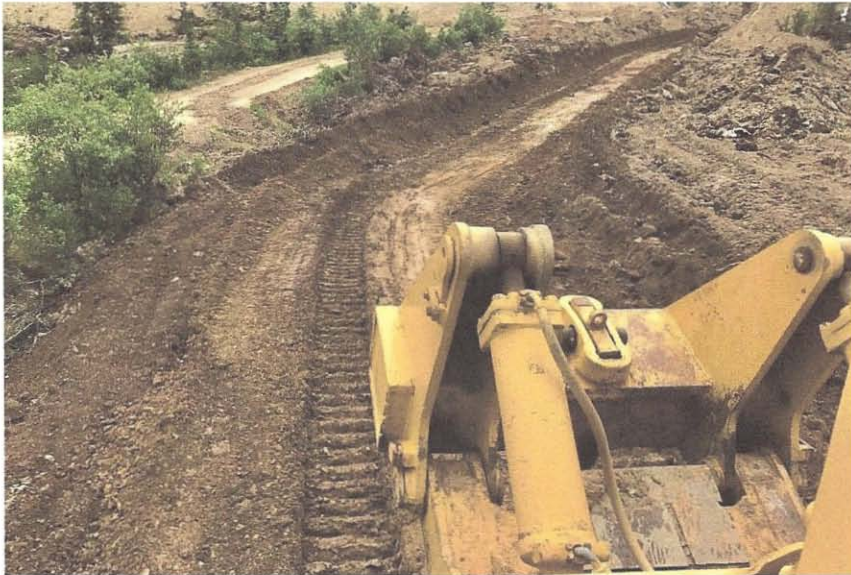
Site Photo#4. Trench Stripping on site

Total 40 testing pits including 400m trenches had been carried out on the Klaza River Placer Property during June to August 2017. The trenches are varied from 5-6m wide and 50-80m long stripping by a D9Cat dozer and further excavated with a KOMATSU PC-240 excavator, and the depth of each test pit varied 3-5m below the ground surface. Some pits are benched large enough for the excavator to sit at lower levels to reach depths up to 7m (Refer to Appendix I, Site Photos1-4). A total of 5 testing holes had been drilled utilizing a portable the reverse circulation percussion drill (RC). The drill string was made up of standard 6-foot long with a 8-inch inside diameter. The sediments and bedrock chips were pumped and recovered by a compressor unit. All sediments and bedrock chips were collected and examined on each 2.0m (6-foot) long sections. When the driller note a change in lithology, due to behavior of the drill, it will be noted in the logs(Refer to Appendix I, Site Photos1-6).

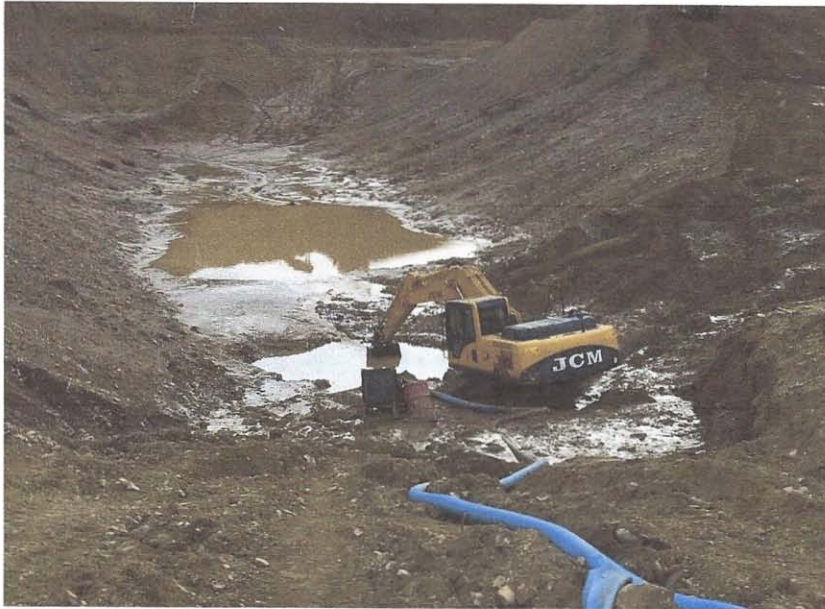
Site Photo#5. Sampling inside the Open-pit by an Excavator

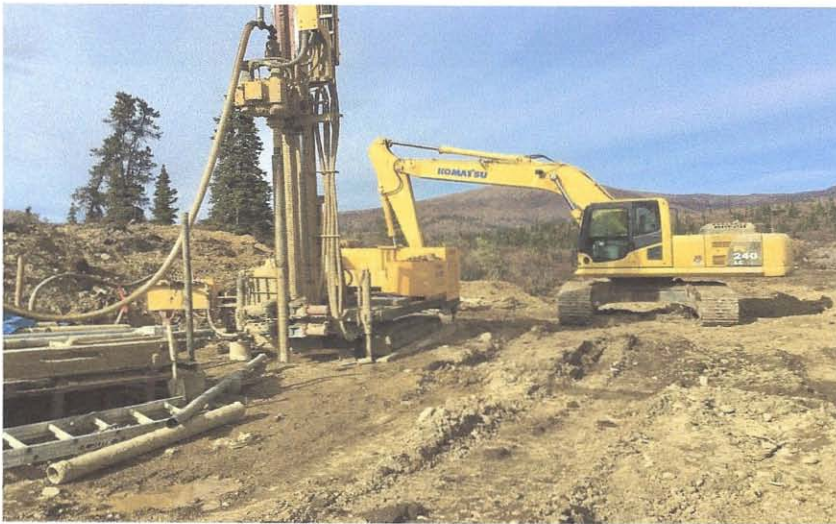
Site Photo#6. A RC Drill working on Site

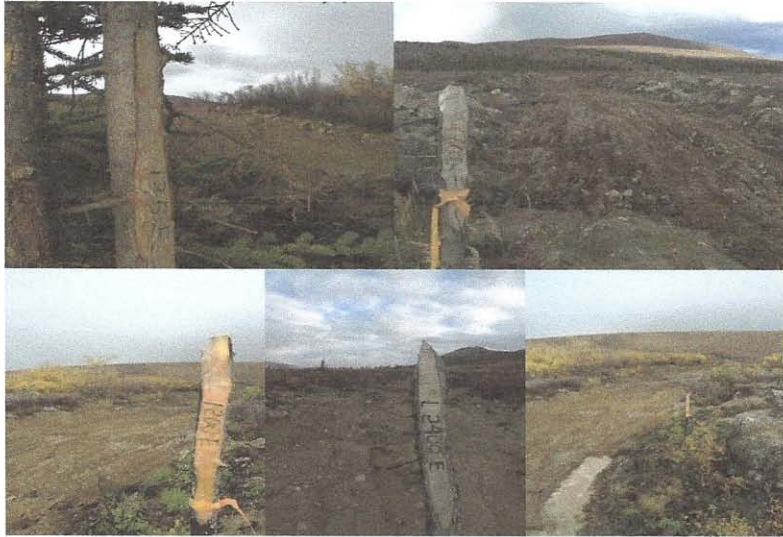
Site Photo#7. Trenches and Testing Pits (1)

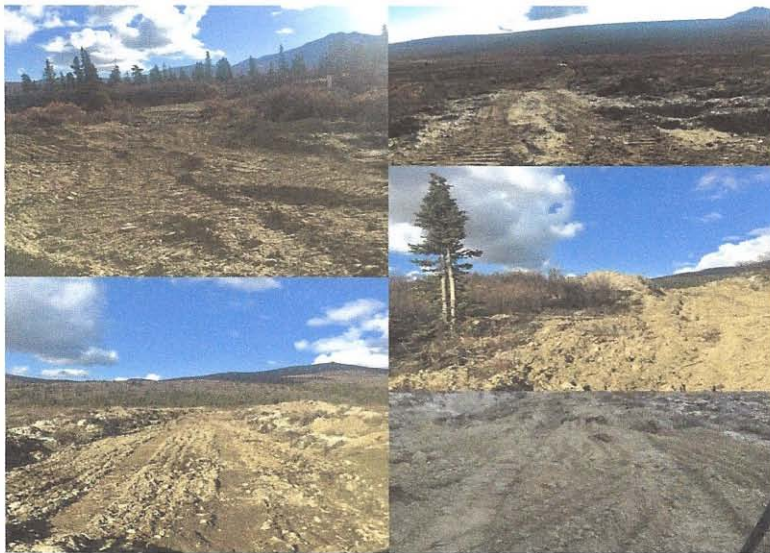
Site Photo#8. Trenches and Testing Pits (2)

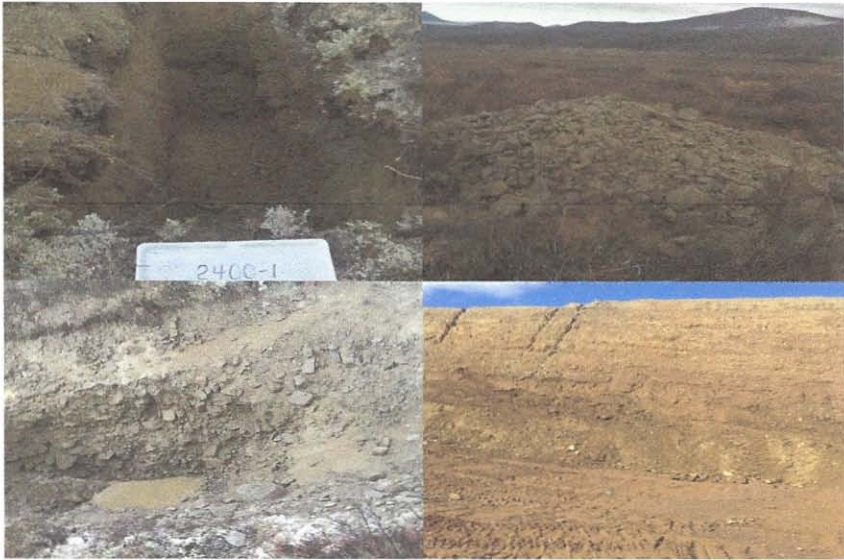
Site Photo#9. Sampling from Testing Pits

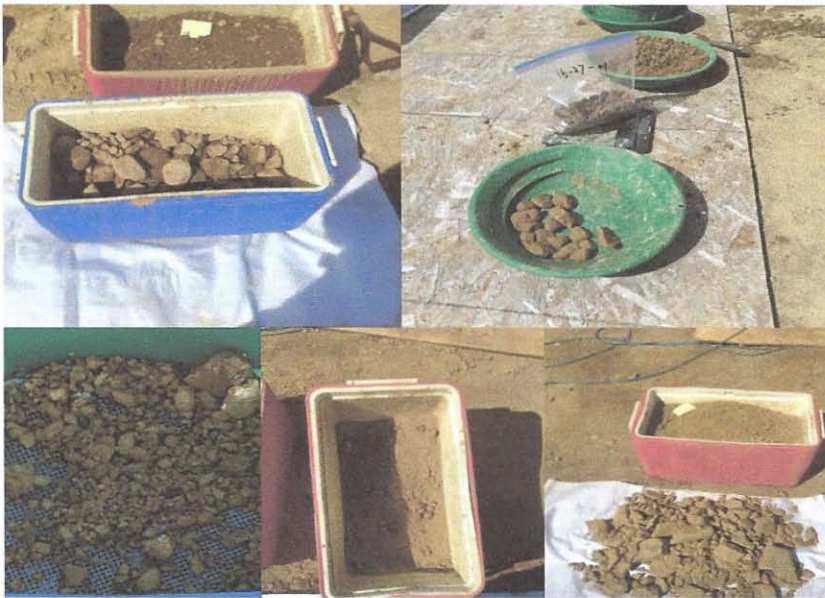
Site Photo#10. Samples and Treatments

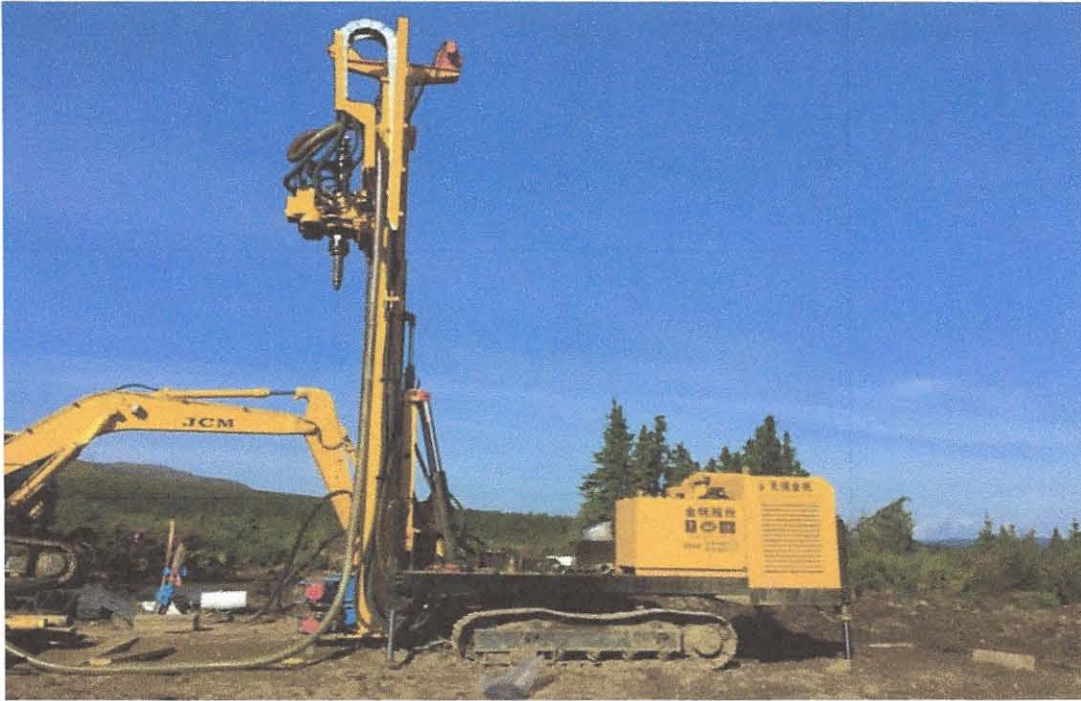
App.IV-2 RC Drilling on Site

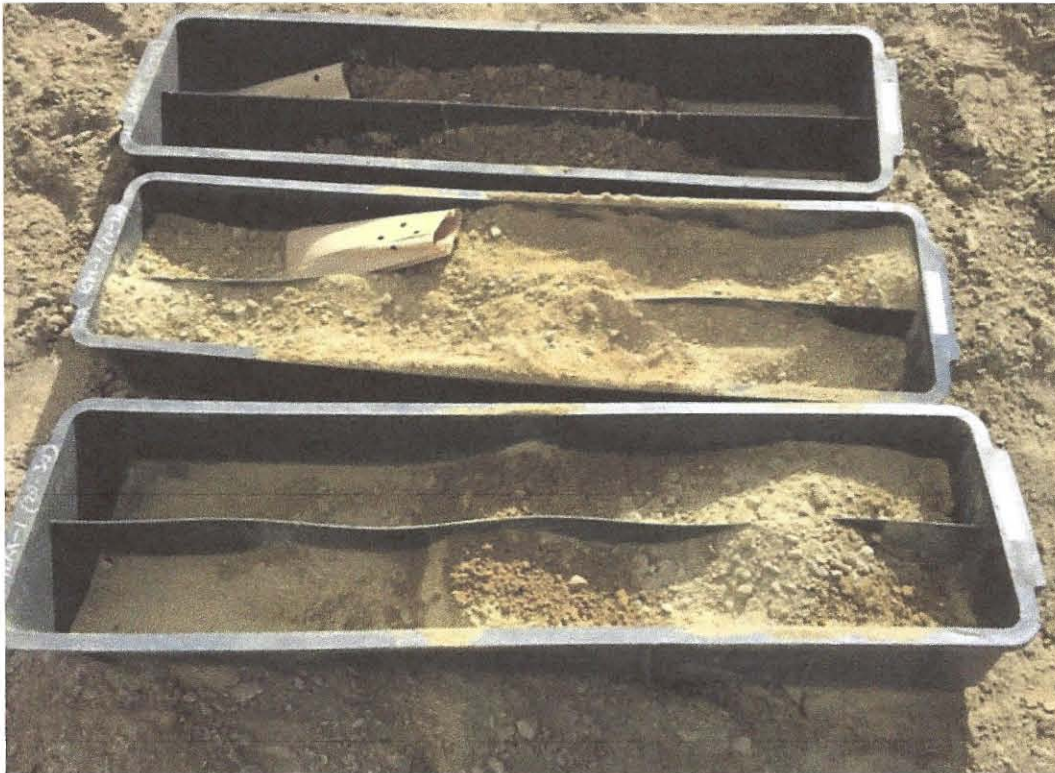
App. IV-3 Soil/Sandy Gravels chips sampled by RC Drilling

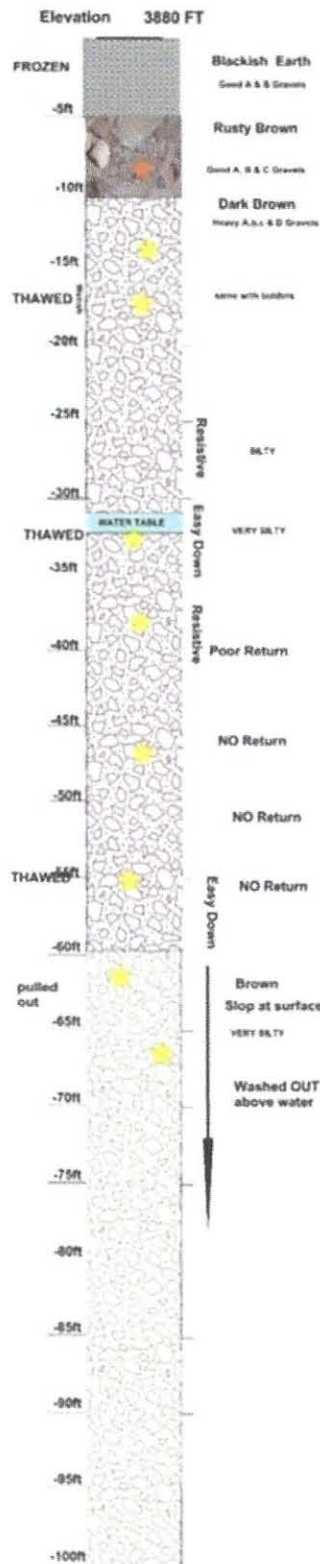
- COLOR
- specs ★
 - Tweezers ★
 - Nuggets ★
- Gravels
 (classification)
- 0 to 3MM= fines
 - 0 to 1CM= "A"
 - 1 to 3CM= "B"
 - 3 to 8CM= "C"
 - 8 to 15CM= "D"
 - > 15CM= boulders

Poor to no recovery
 Bottom Half
 Major Water
