GEOPROCESS FILE - SUMMARY REPORT DEZADEASH MAP AREA - NTS 115A

MOUNT ST ELIAS DEZADEASH

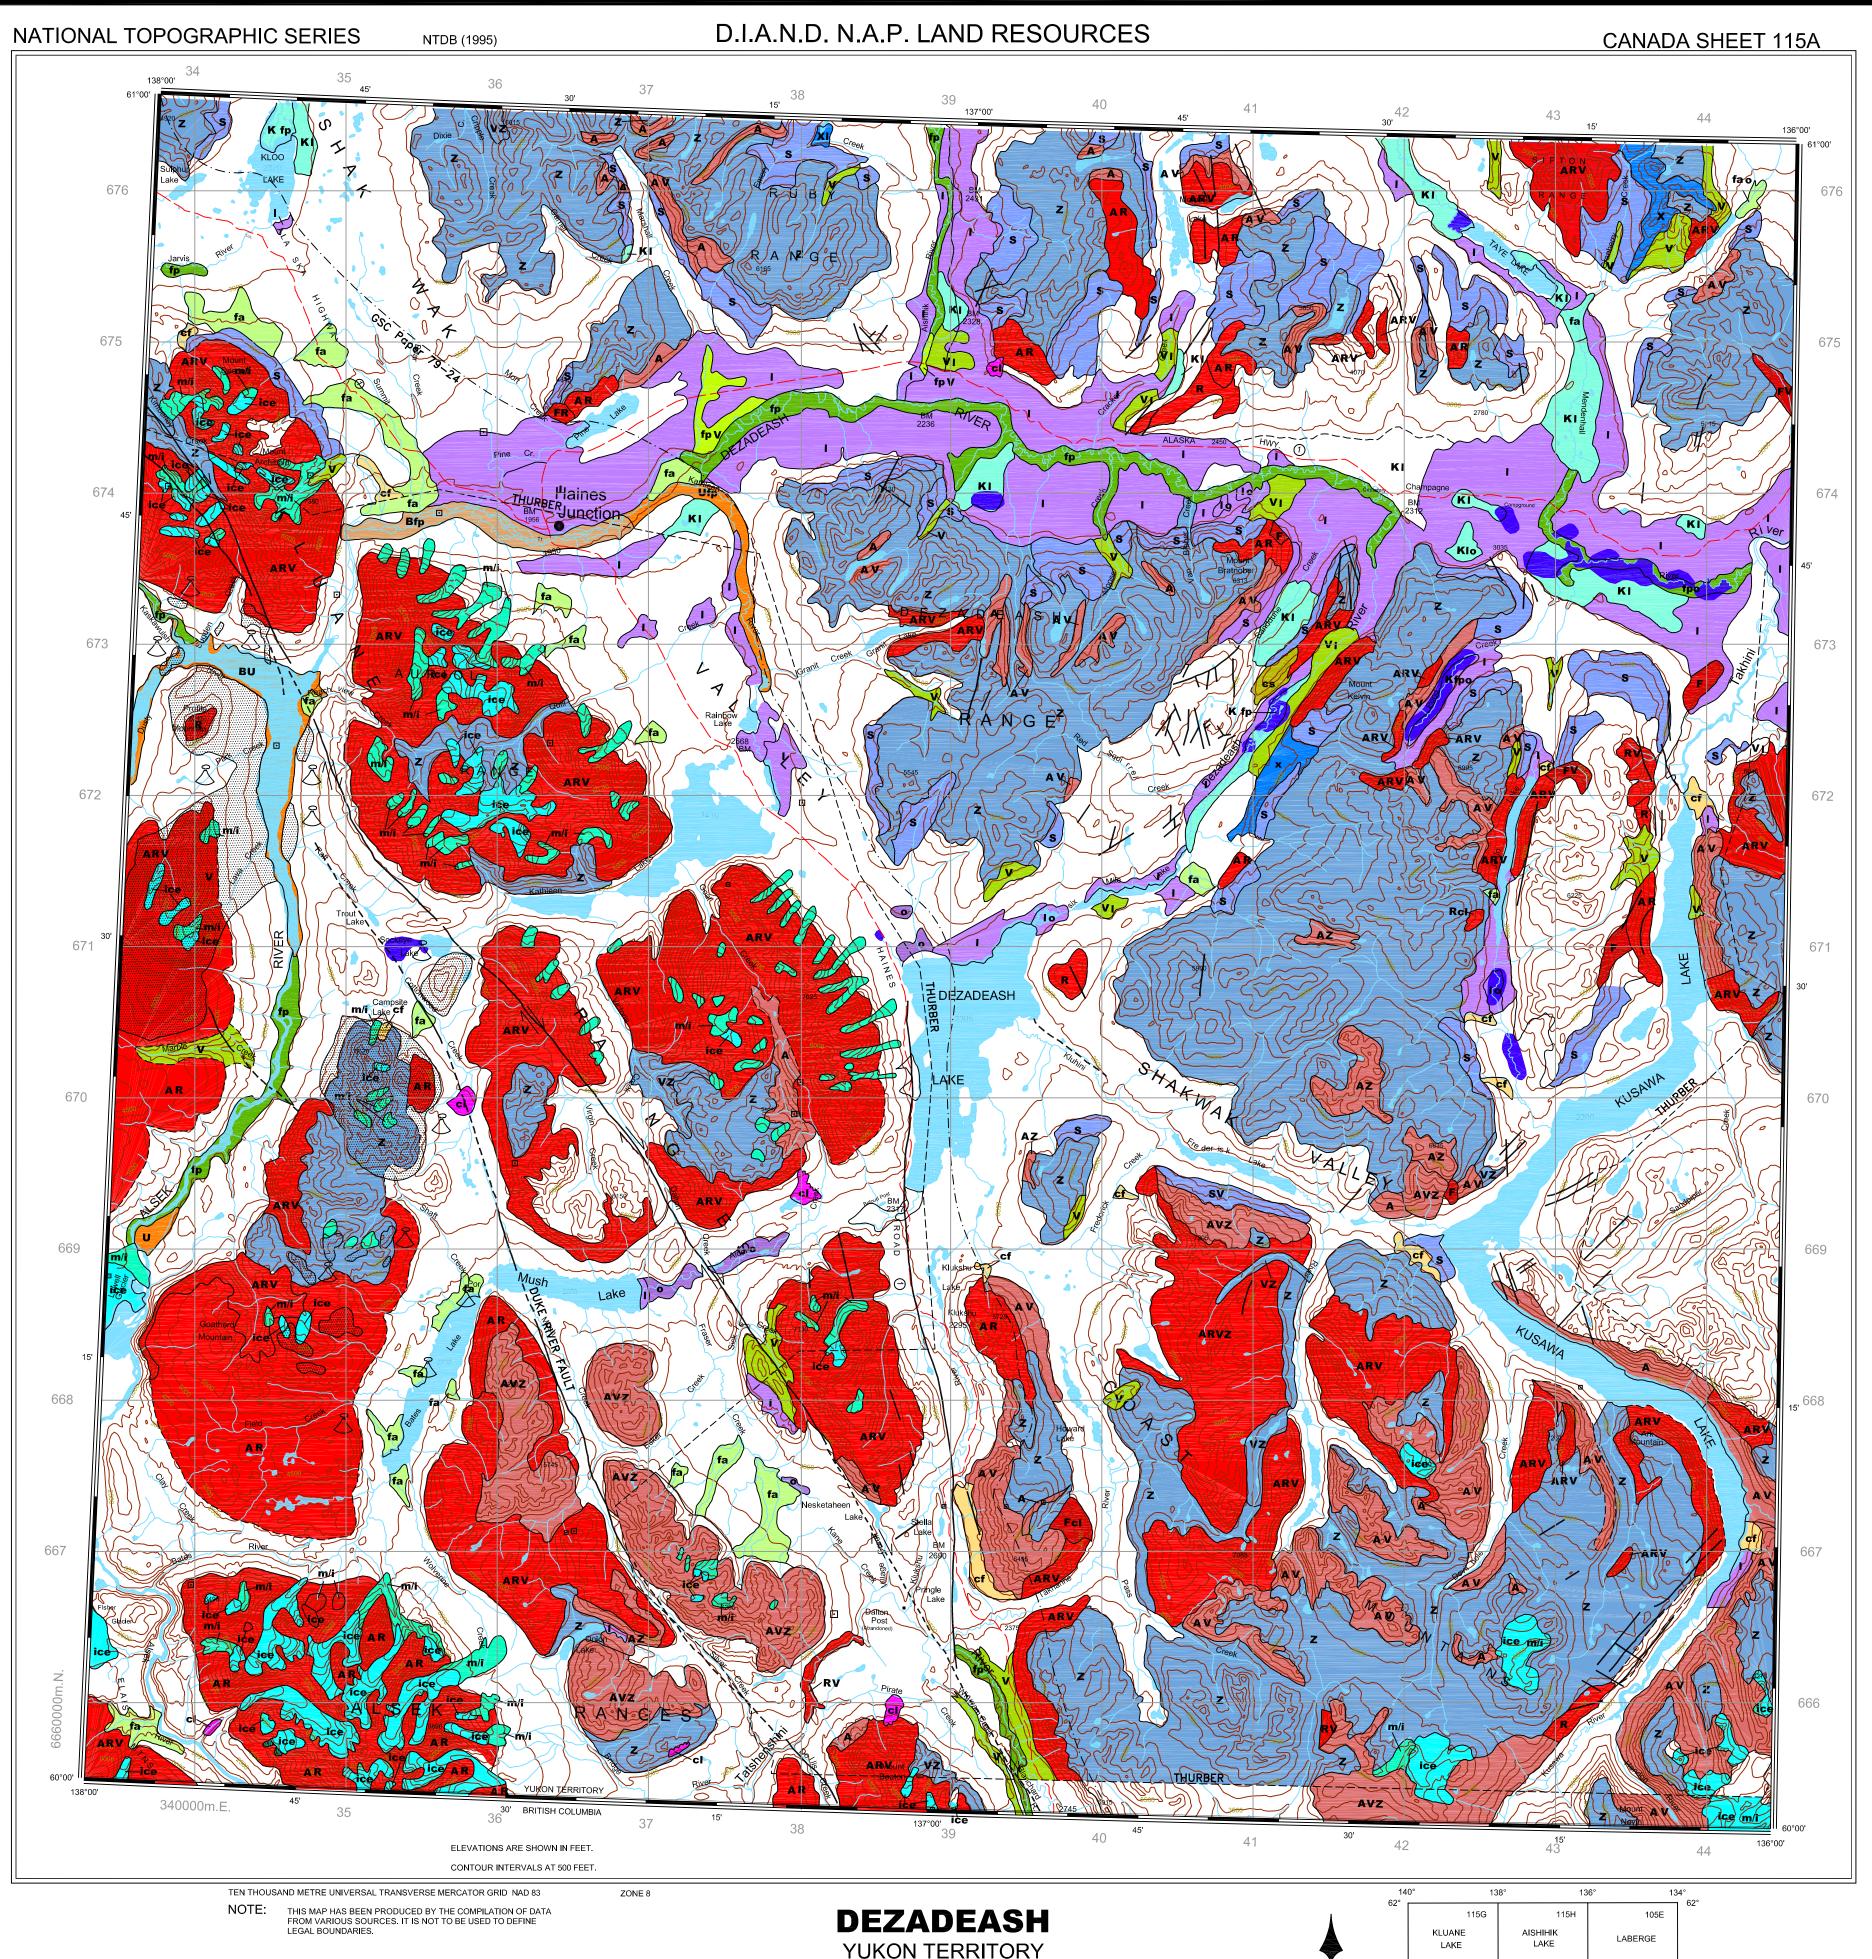
hazards for this NTS map area, and a list of references. Geological Processes and Terrain Hazard Compilation Maps

The GEOPROCESS File map units were drafted on the 1:250 000 topographic base maps through interpretation from bedrock geology maps, surficial geology maps and in some cases terrain hazard maps at various scales. The compilation maps have a confidence level reflecting the original source material. All materials used to produce the maps are listed in the references on each map. A file containing the documentation used to construct these maps is available at the Indian and Northern Affairs library in Whitehorse, Yukon. Areas for which no surficial geology or terrain hazard information is published were left blank. Summary reports on surficial geology and terrain hazards for these map sheets were written by extrapolating the data from adjacent map sheets or smaller scale maps. Information from small scale (e.g., 1:1 000 000) maps was used for the summary reports, but not redrafted onto the 1:250 000 GEOPROCESS

The GEOPROCESS File compilation maps are intended as a first cut planning tool; the legend on the maps describes the general aspects of terrain hazards (also see below) and associated geological processes. These maps should never replace individual site investigations for planning of site specific features, such as buildings, roads, pits, etc. Bedrock Geology Summaries
