# Draft Baseline Environmental Report United Keno Hill Mines Property

Project Reference Number SRK 1CA009.000

January 2007

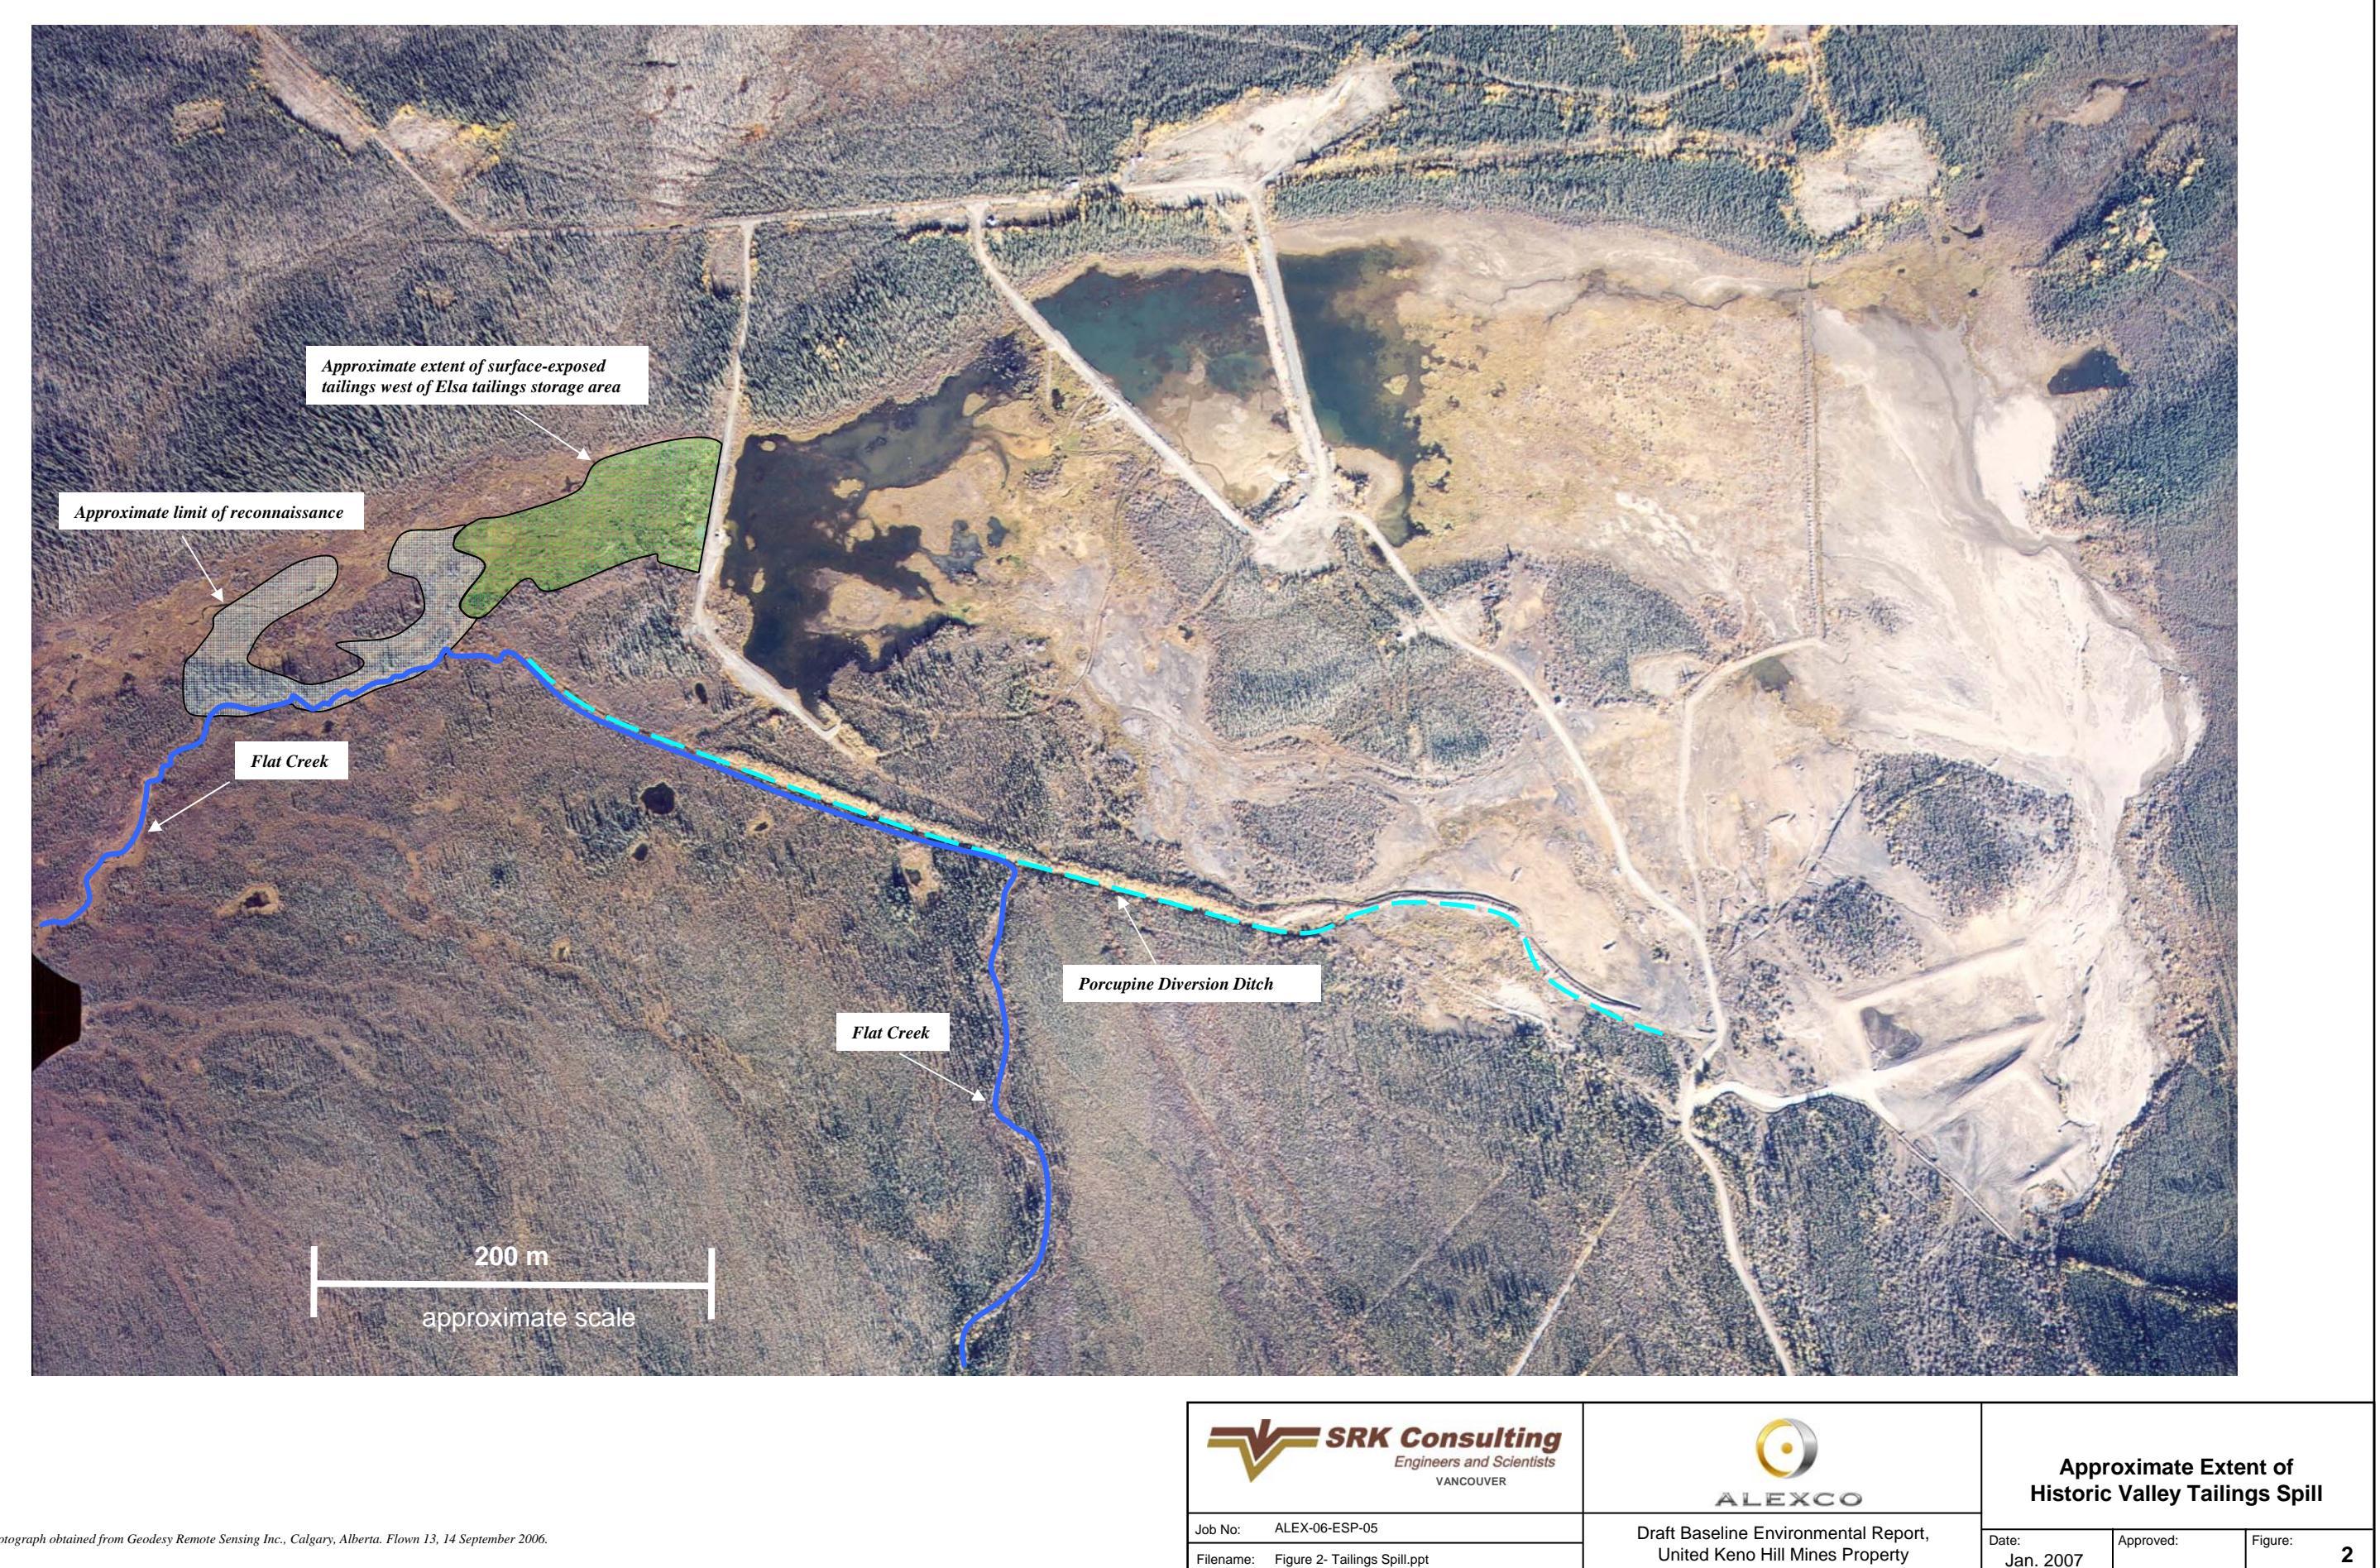
2

Historic release of tailings has resulted in a shallow deposit of tailings outside of the Valley Tailings Facility to the west. To assess the extent of tailings dispersion, field reconnaissance was carried out over an area extending approximately 300 m west of Dam 3, as shown in Figure 2.

The approximate area covered by spilled tailings is outlined in Figure 2. The tailings deposit appears to be up to a meter thick, judging from the topography of adjacent natural ground. The margins of the deposit are colonized by a variety of vegetation which forms a continuous organic layer at the surface. In these areas, the upper 0.3 m of soil consists of mottled light tan to orange tailings with abundant roots and occasional black staining along macropores formed by plant roots. The vegetated margins grade laterally from 100% vegetation coverage to fully exposed fine-to-medium tailings sand in the central portion of the deposit. The surface tailings in the central exposed area were orange in colour, with mottled tan and orange tailings at depth.

The investigation extended west beyond the limits of the contiguous mass of surface tailings, as shown in Figure 2. While the large volume of water released during the 1978 spill (11.8 million gallons released over approximately one hour, as recorded in court documents) likely dispersed tailings solids further downstream, the surface extent of the bulk of the tailings solids released during the 1978 spill appears to be constrained to the mapped area.

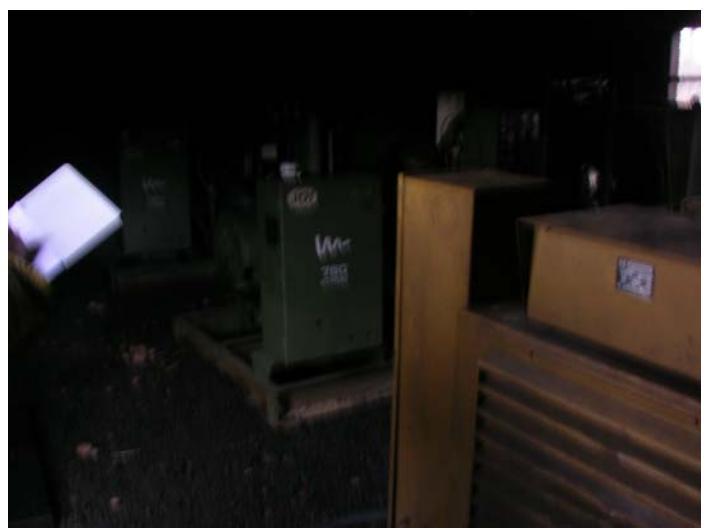
#18 Building 1C accessible to public, contains 3 generators/compressors, hydrocarbon staining on crushed gravel floor inside

Photo 1.2\_Silver\_King\_ Inside compressor house

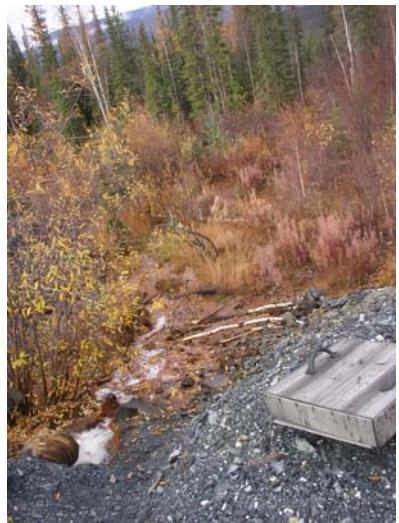
#16 Orange precipitate marks bed of flow below settling pond outfall; unclear whether this is sludge escaping (short residence time), or continued Fe oxidation. Quality of precipitate decreases with distance along stream. Flow forms gently inclined wetlands in

Photo 1.3\_Silver\_King\_Discharge from treatment ponds

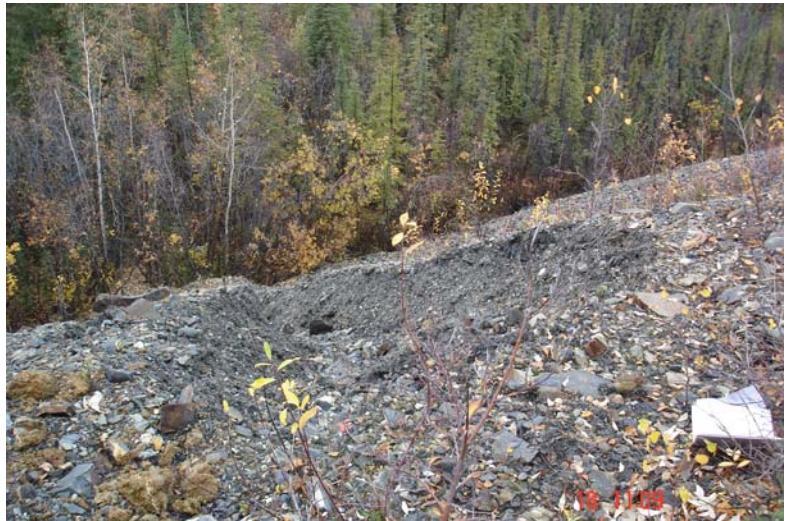
Photo 1.7\_Pt1\_SK\_Drainage channel erroded in dump

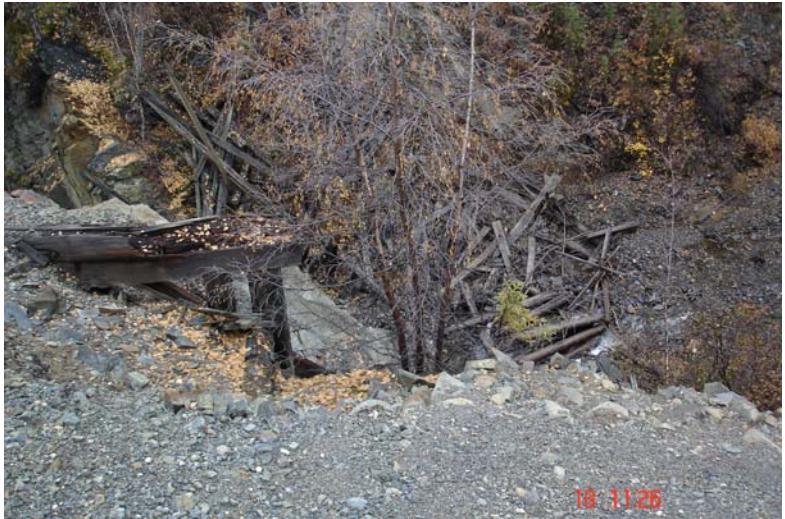
Photos 1.10\_Pt2\_SK\_Waste dump above Galena Creek- note timber

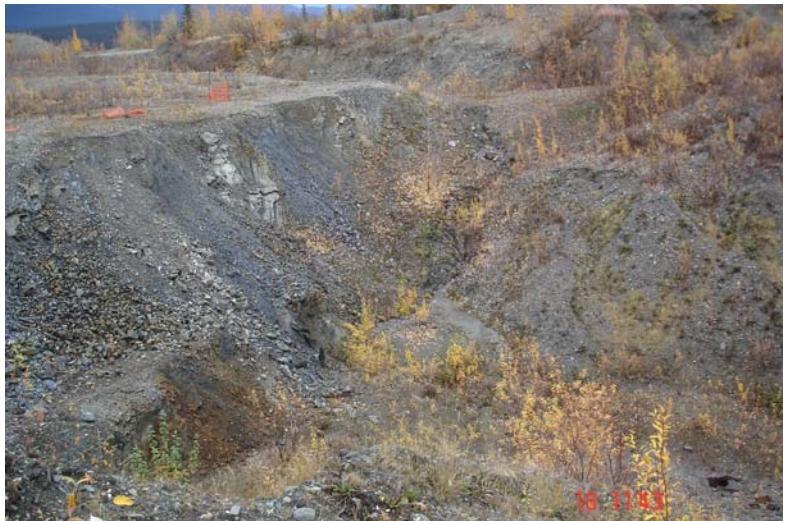
Photos 1.15\_Pt5\_SK\_Runoff gulley

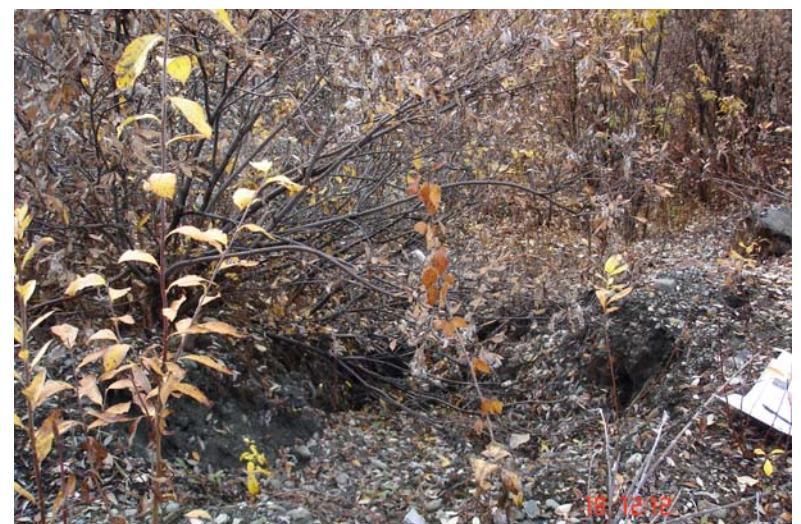
Photos 1.16\_Pt6\_SK\_Sinkhole in area of excavation on SE side of site

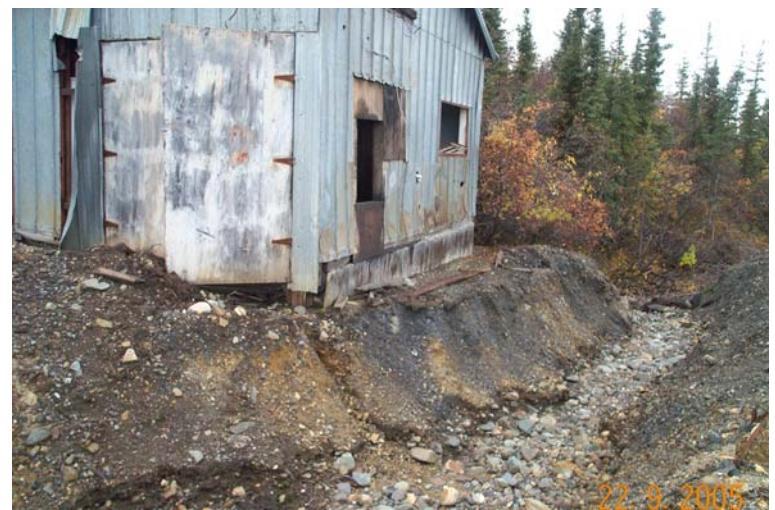
Photo\_4.1\_Dixie\_Recent ditchwork near building

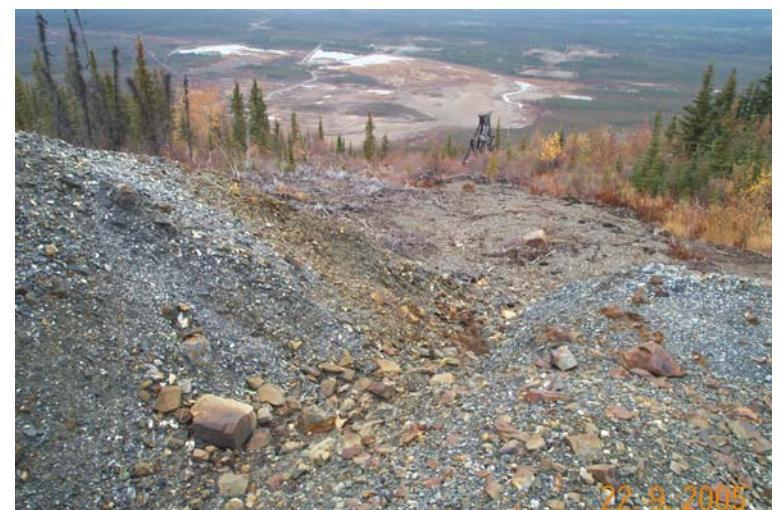
Photo\_4.2\_Dixie\_Waste rock deposited below gully in dump face

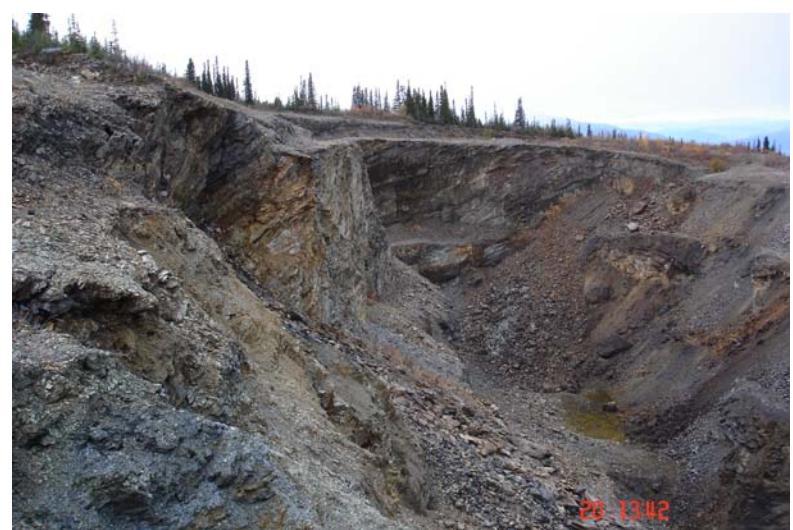
Photo 6.3\_Pt.1\_Bermingham\_Pit\_SW viewpoint- unravelling on SE wall

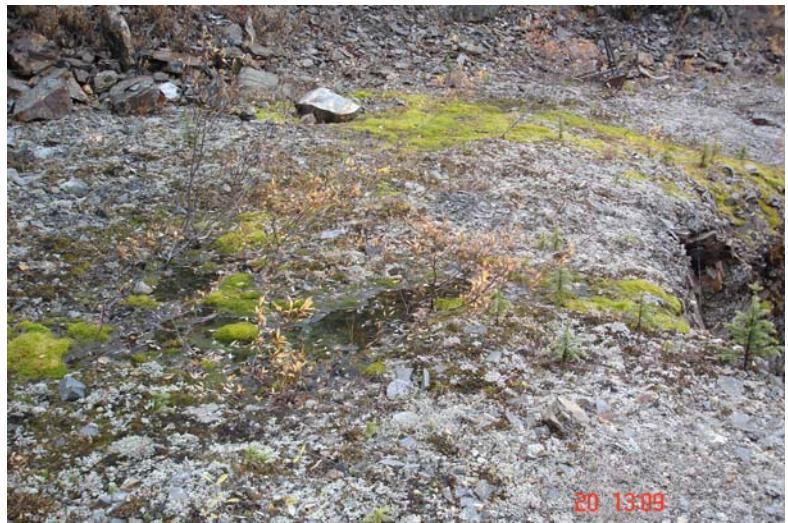
Photo 6.5\_Pt.2\_Bermingham\_Pit\_South corner- water

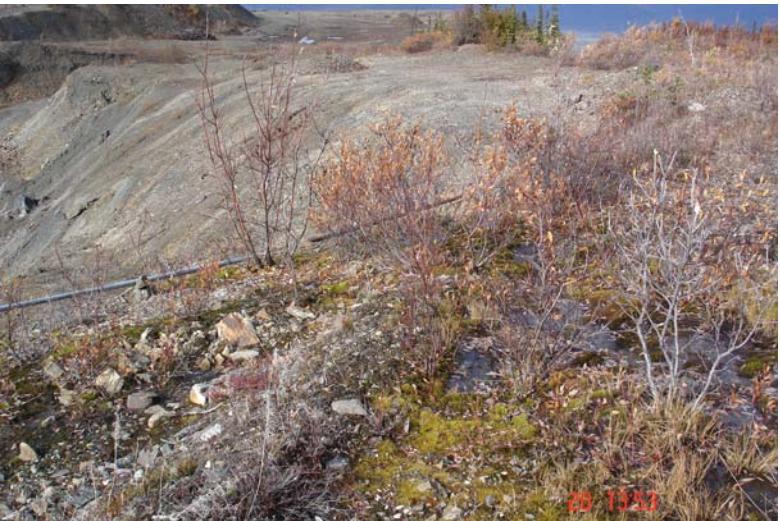
Photos 6.13\_Pt.7\_Bermingham\_Pit\_Small creek draining into pit

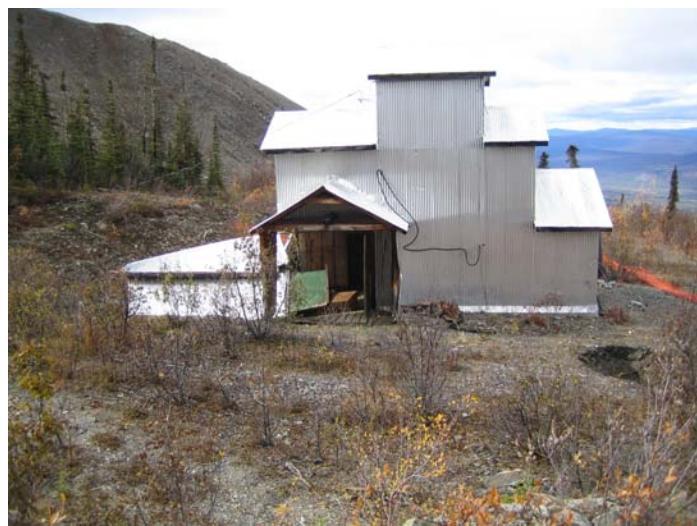
Photos 6.18\_Ruby\_Shaft\_ Raise hole and shaft buildings

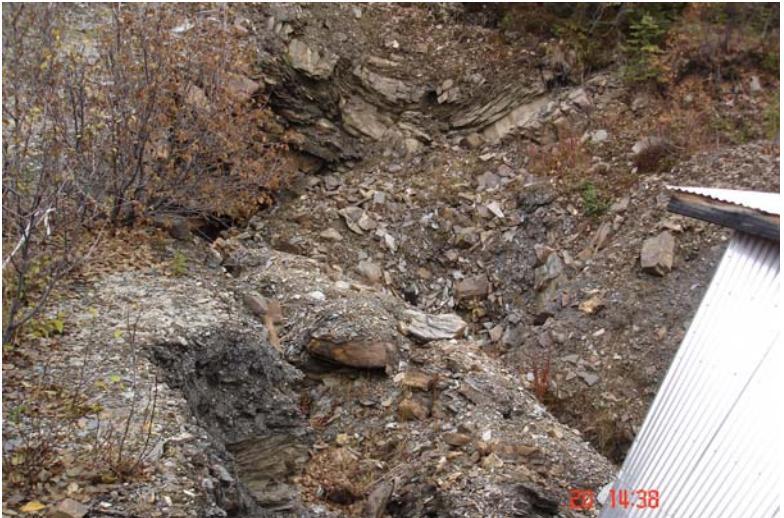
Photos 6.19\_Ruby\_Shaft\_Collapsed excavation south of shaft

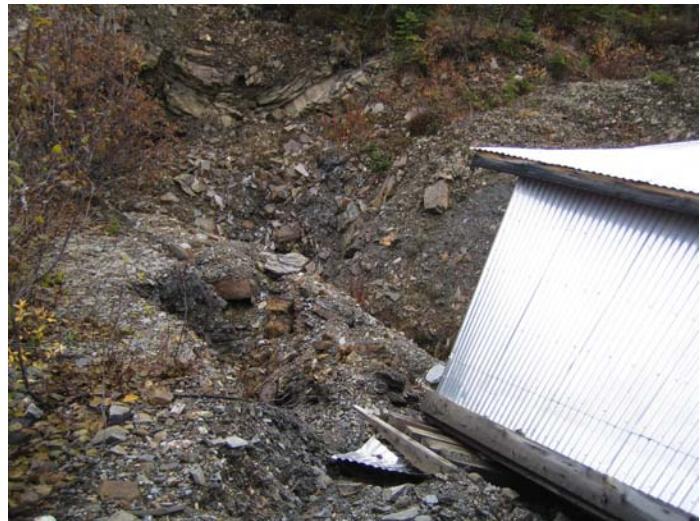
Photos 6.20\_Ruby\_Shaft\_Collapsed excavation south of shaft

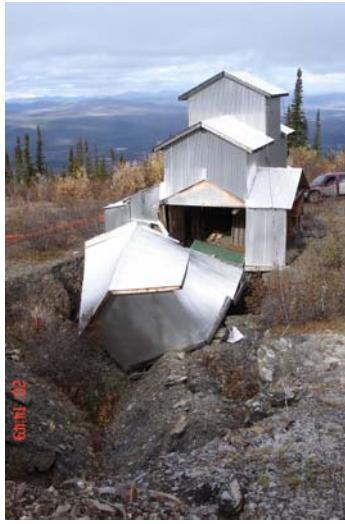
Photos 6.21\_Ruby\_Shaft\_Collapsed front section of shaft house

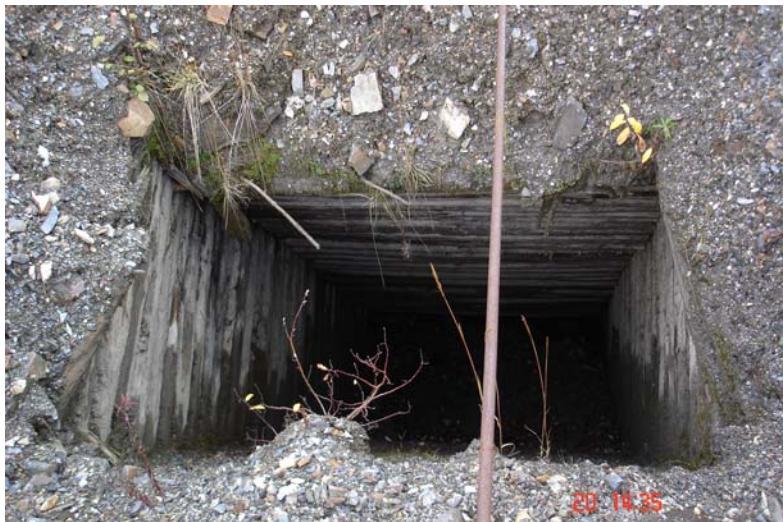
Photos 6.22\_Ruby\_Shaft\_Detail- open raise hole

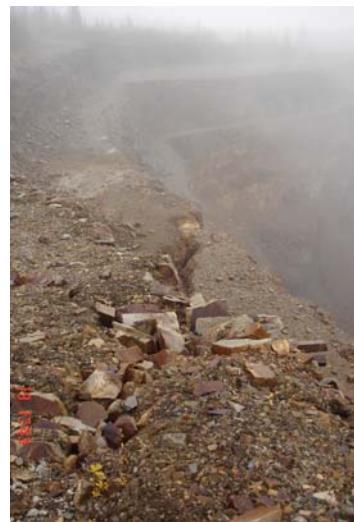
Photo 9.2\_Pt2\_Calumet\_East\_Wall\_Tension\_Crack

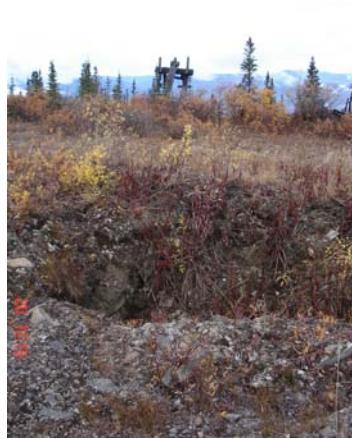
- #4 A new sinkhole has formed since the previous review. The dimensions are 4 m x 3 m and 2 to 3 m deep.
- #5 Upper sides are steep, these are slabbing and unravelling. This is expected to break back on the order of 10-15° - no water was noted at the bottom of the pit - no large failures are anticipated

Photo 9.5\_Pt4\_Calumet\_Sinkhole\_Formed\_Since\_Last\_Review

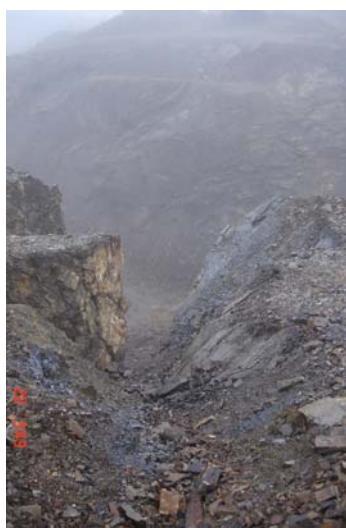
Photo 9.6\_Pt5\_Hector\_Pit\_Down Trenching\_to\_NW\_Wall

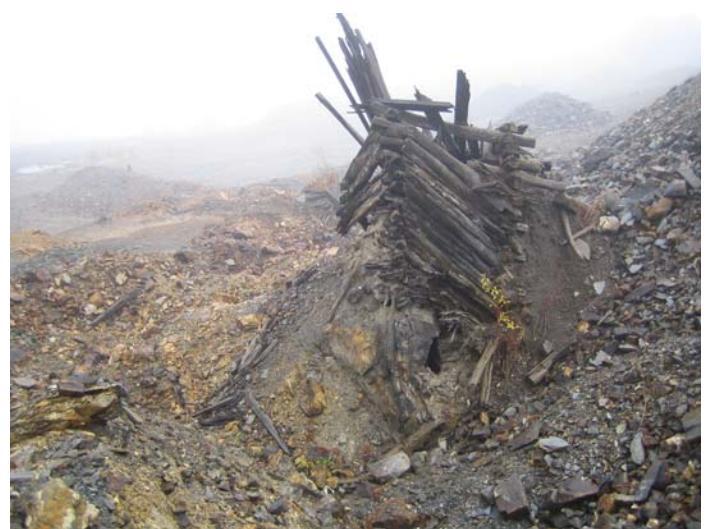
Photo 9.7\_Pt6\_Hector\_Pit\_Possible Surface\_Raise

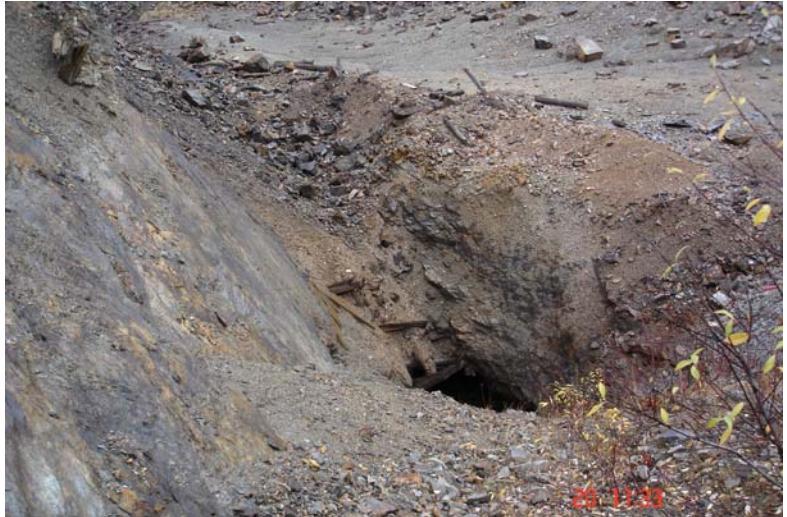
Photo 9.9\_Pt6\_Hector\_Underground\_Opening\_West Corner

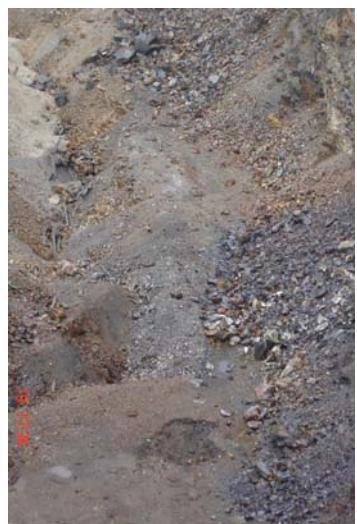
Photos 9.12\_Pt\_2\_Calumet\_SE\_Pit\_Bottom\_Subsidence

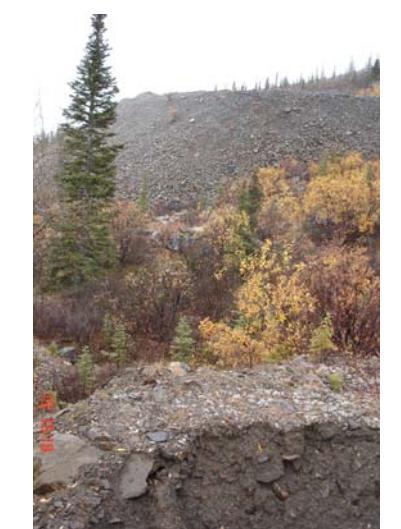
#1 - Subsidence/Sinkhole, no timber was noted within the hole. This is a previously-unidentified hole, with 2 – 3m of fill over the area

Photo 11.1\_Pt1\_Sinkhole below (E) of Sime #4 pit

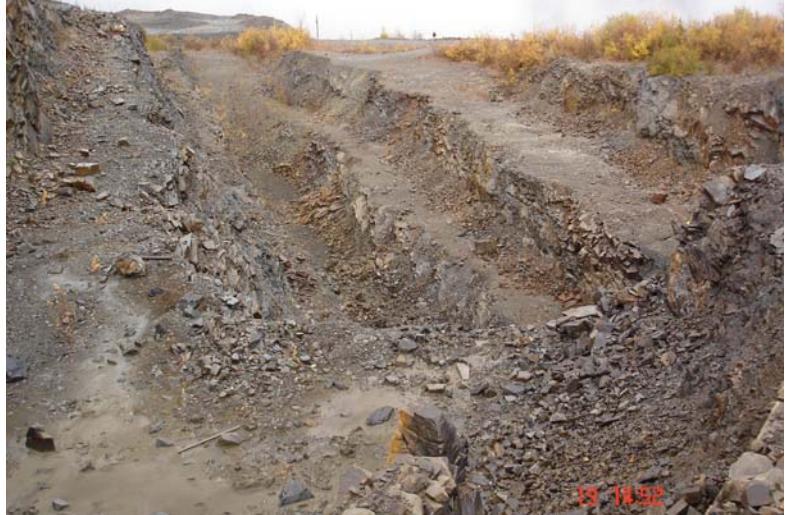
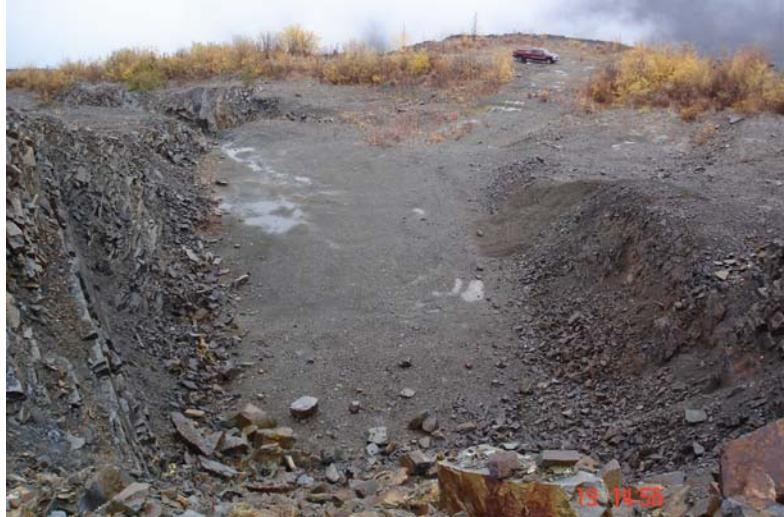
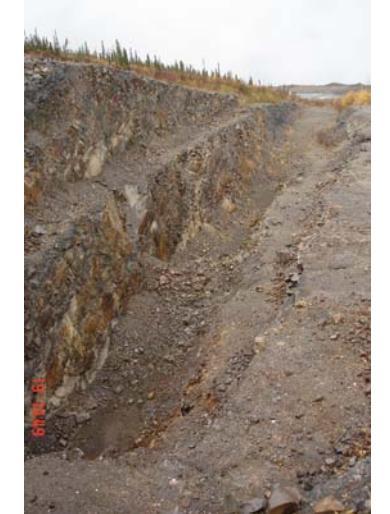
#2 - The #35 Vein pits are stable with no tension cracks observed around the pit perimeter. - Some unravelling of the slope face is occurring, but this is to be expected. - No water observed at the bottom of either pits.

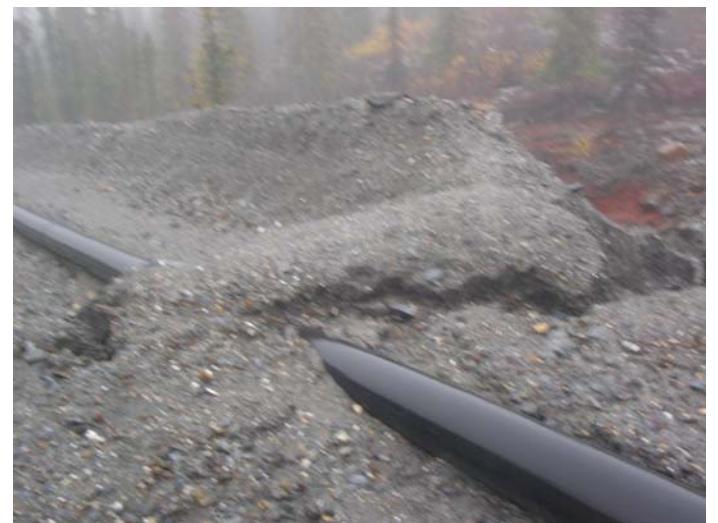
Photo\_11.15\_Discharge channel erosion

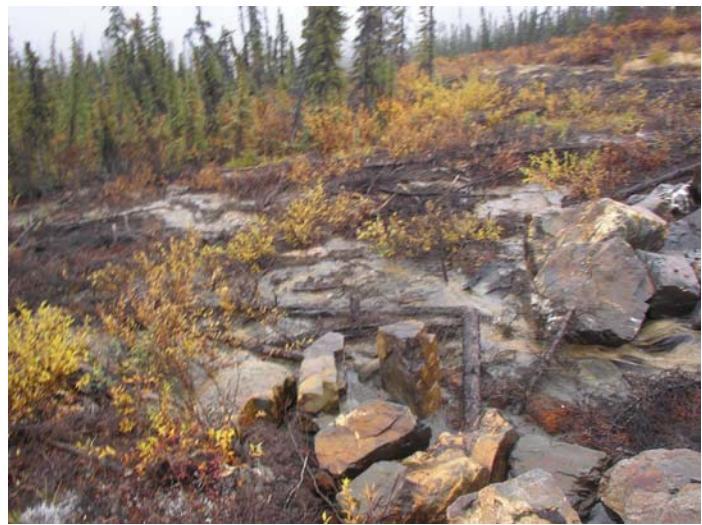
Photo\_11.17\_Discharge flow in braided channels over organic soils

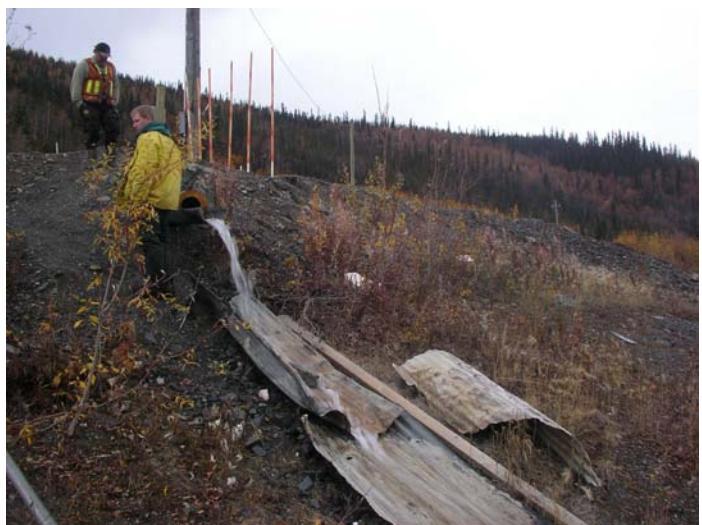
- #1 Discharge from pipe into unbraced corrugated sections (Photo3)
- #2 Corrugated sections are twisted and flow escapes over side (Photo 4) and under lower sections
- #3 Discharge path shows whitish precipitates, heavy iron-staining and permafrost thaw features (Photo 5)
- #4 Permafrost degradation and erosion along former discharge channel
- #5 Settling Pond #2 decommissioned and recontoured

Photo\_12.3\_ Discharge pipe and flume

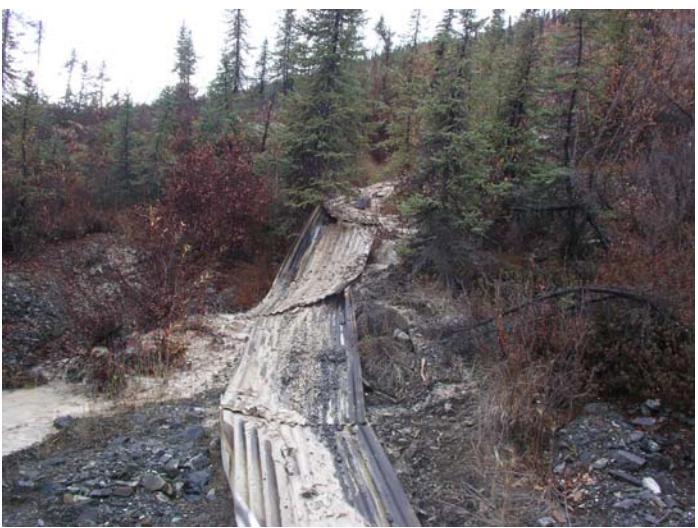
Photo\_12.4\_Damaged flume

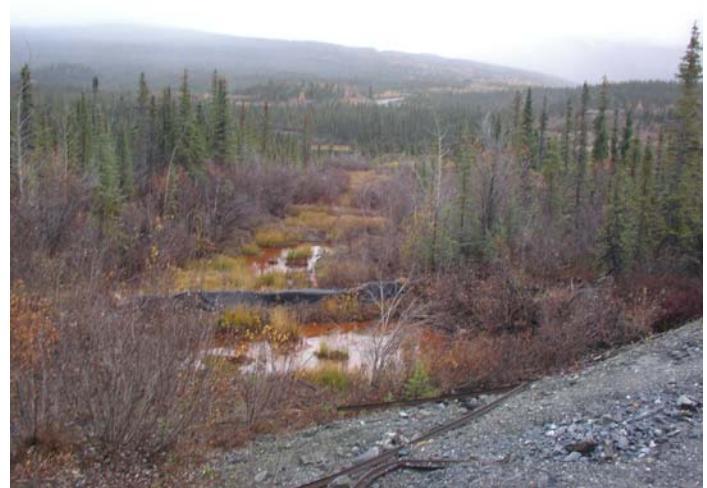
Photo\_12.5\_Outflow area

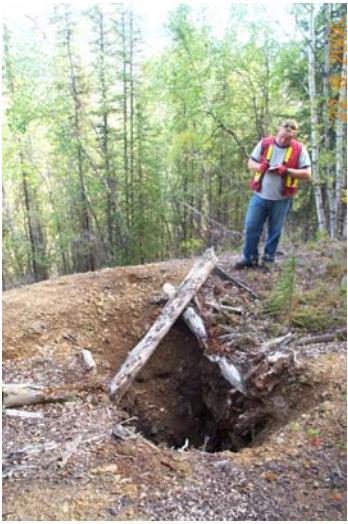
- Shaft #4: NAD 83 483522 E, 7088649 N. 1.5 m x 1.5 m timber lined shaft, open to depth of 2.5 m, minor subsidence around shaft collar (up to 1 m, extending up to 2 m away from shaft collar). - Waste pile at Shaft #4 forms a flat 7 m wide bench across hillside at elevation of collar. Pile extends downslope for 6 m. Margins of exposed pile are composed of greenstone, with surface of central portion of pile extending from shaft to toe composed of orange-stained greenstone with purplish-black stained clasts and minor limonite. -Orange staining extends to depth of 0.3 m. Rinse pH of sample of near-surface fines was 6.2, with a rinse conductivity of 0.9 mS/cm. - Unoxidized greenstone observed below veneer of oxidized waste in shallow test pit.

Photo 15-2\_TinCan\_Shaft 4

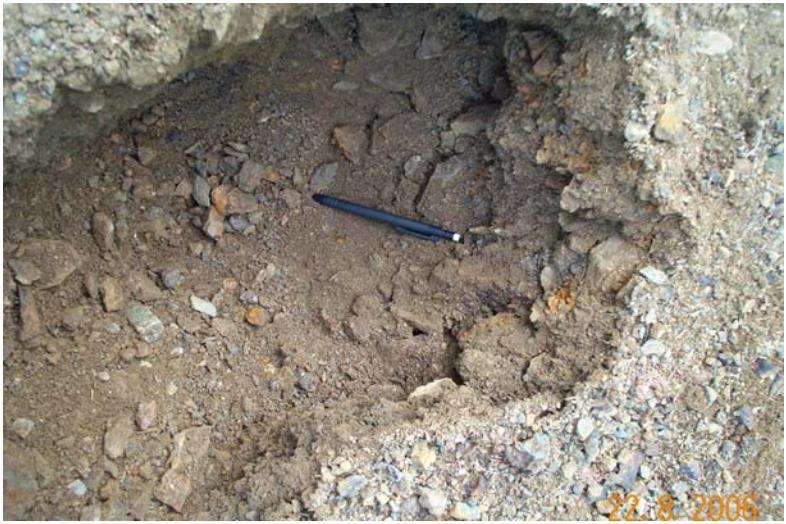
Photo 15-5\_TinCan\_Oxidation in surface waste rock at Shaft 4

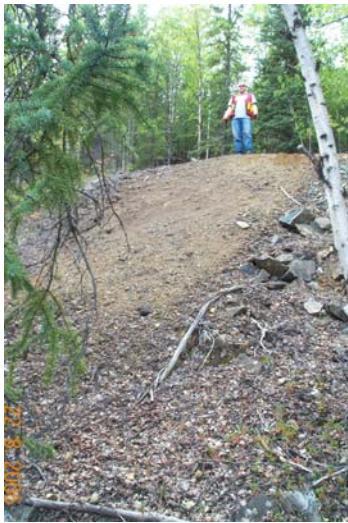
Photo 15-6\_TinCan\_Collapsed cabin west of Shaft 4

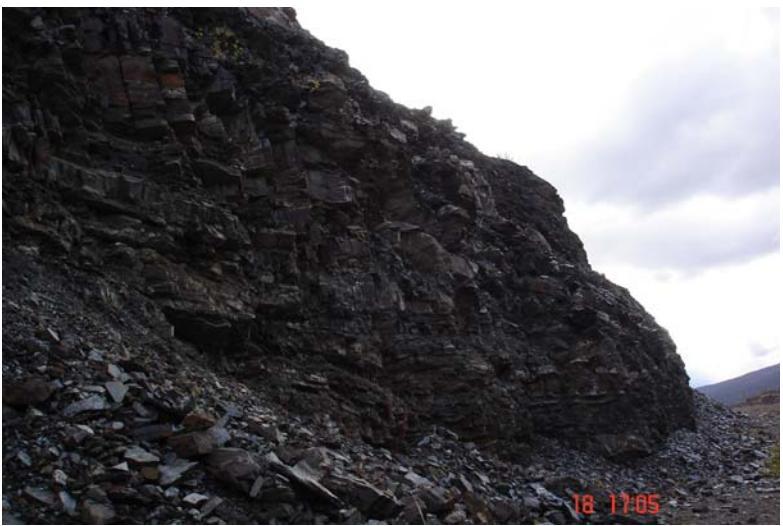
Photo 19.1\_Blocky rockmass SE slope, west side

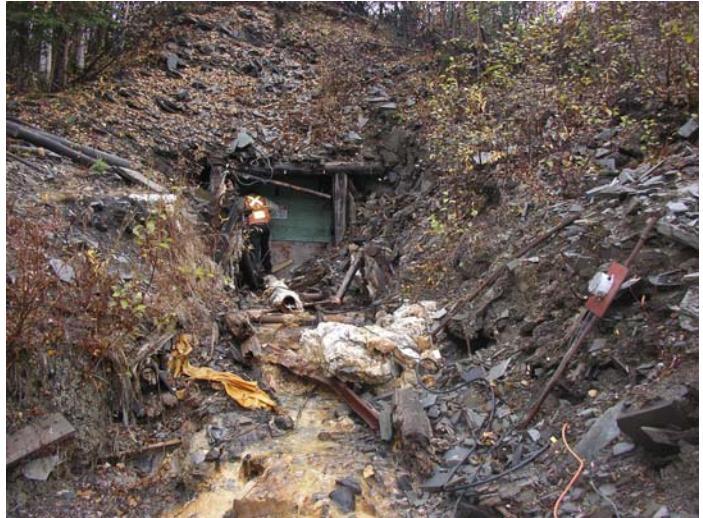
- #2 Drainage from portal flows along ditch (Photos 19.7 and 19.8) and infiltrates about 10 m above culvert. Does not re-emerge downstream of road.
- #3 No changes to buildings, debris, or rock pad since PWGSC (2000).

Photo 19.7\_Onek\_Adit\_1

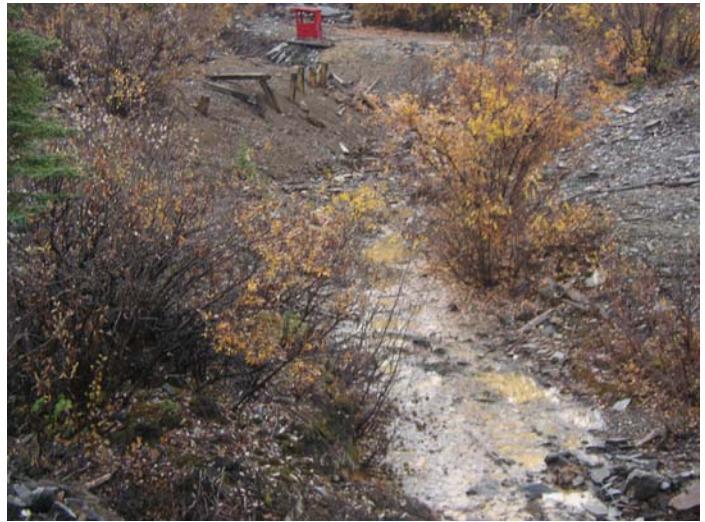
Photo 19.8\_Onek\_Adit\_9 Discharge

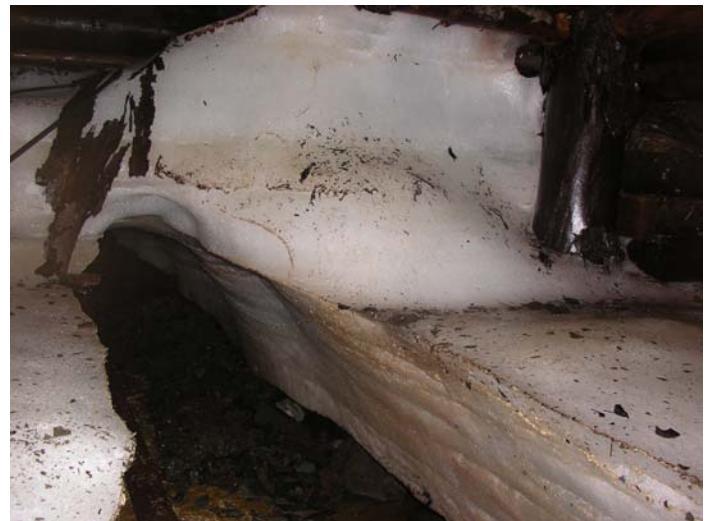
Photo 19.9\_Onek\_Adit\_5

#1 Ice blockage in portal. Outflow is not in discharge pipe, but flows along base (Photo 19.9). Timber bracing in poor condition (Photo 19.10).

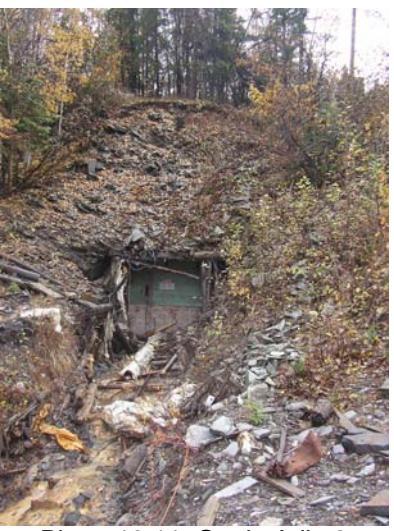
Photo 19.11\_Onek\_Adit\_8

New heat trace in place to maintain open flowpath through ice (Photo 19.11).

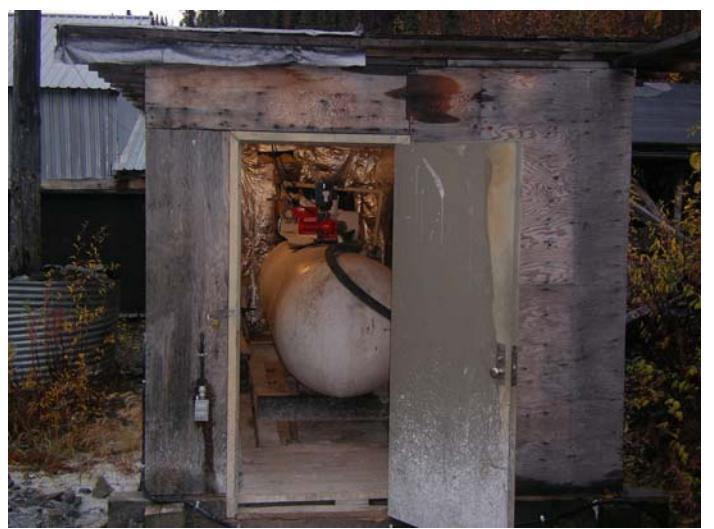
Photo 22.2\_Bellekeno lime tank and pumps

#3 Lime addition system in Bellekeno 625 adit shack - lime slurry storage tank with single mixer - slurry drips into adit outflow in half-round 16" corrugated pipe - system is connected to grid power (Photos 22.1, 22.2, 22.3, 22.4)

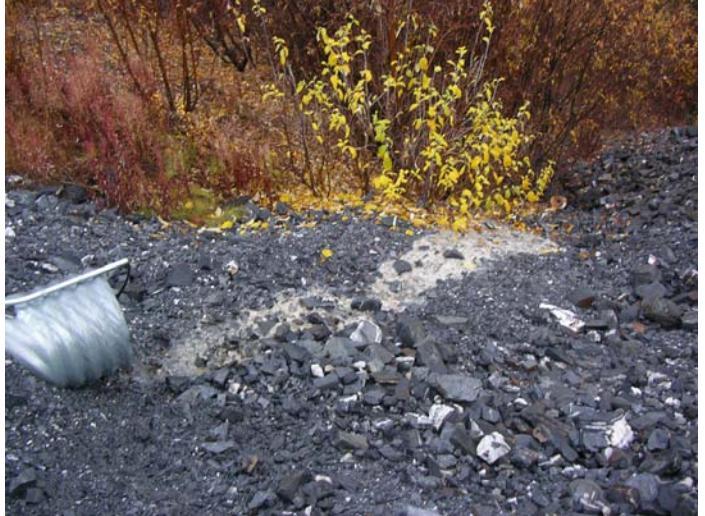
Photo 22.9b\_Bellekeno discharge

#5 Pond discharge via 16" corrugated pipe over edge of waste rock pile (Photos 22.9 and 22.9a)

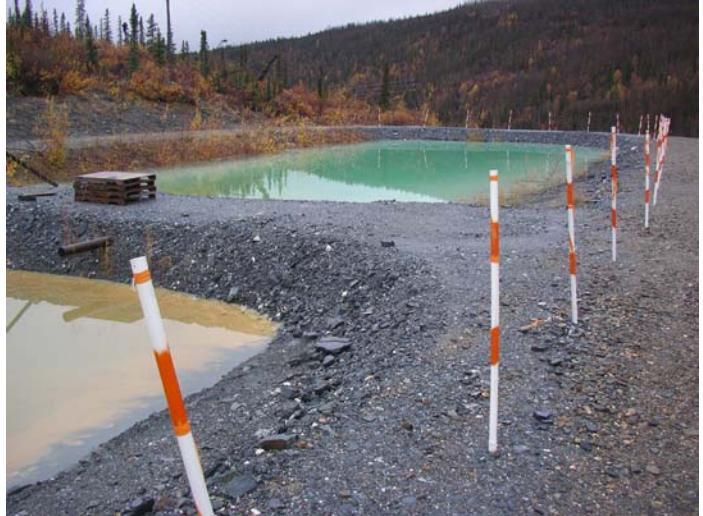
Photos 22.11\_Bellekeno outflow from adit

General Notes - September 20, 2005 - inflow to ponds ~5L/s (Photo 22.11) - outflow via discharge pipe ~ 0.4 L/s (Photo 22.9a) - remainder lost to seepage

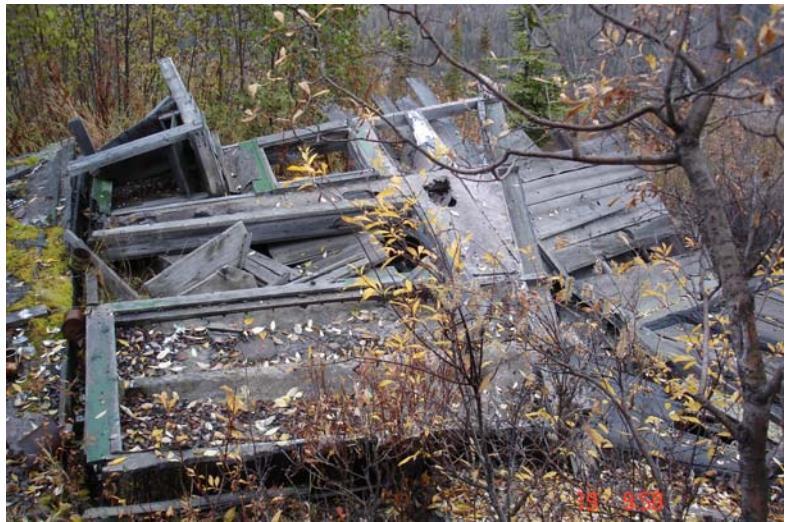
Photo 22.15\_Shaft at 100 Level with collapsed structure

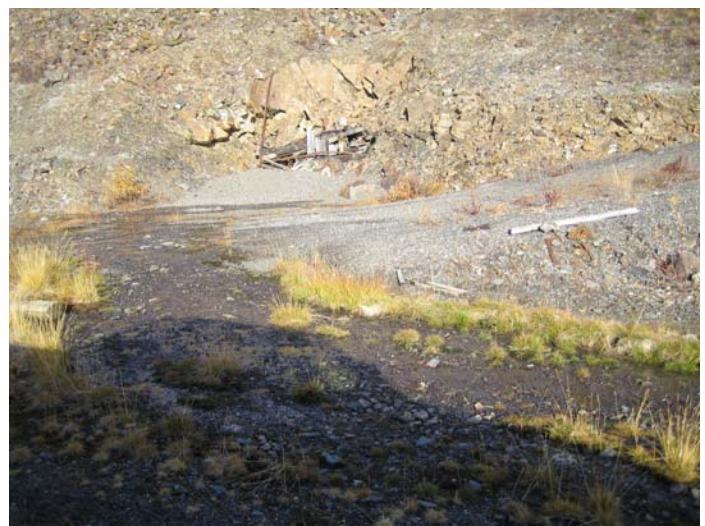
Photo 25.2\_Black\_Cap\_Collapsed\_Adit\_Water\_Flow

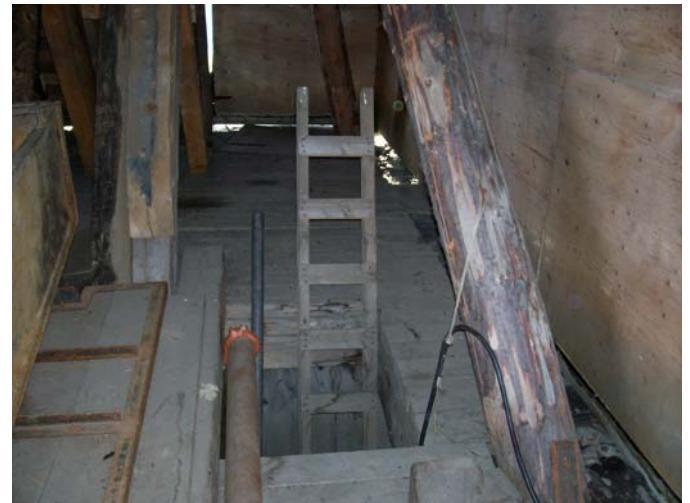
Photo 26.2\_Open manway in shaft house at Lucky Queen

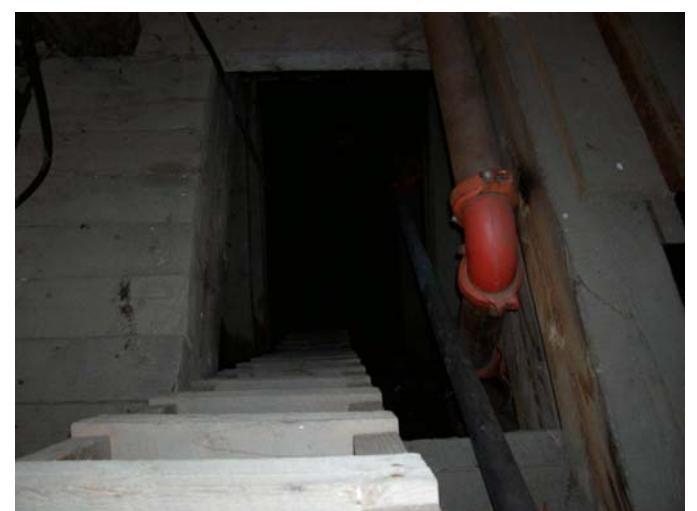
Photo 26.3\_Open manway in shaft house at Lucky Queen

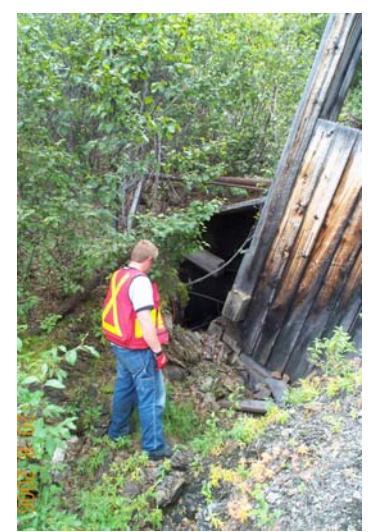
#1 - Hanging wall to shaft has collapsed, and there appears to be an open void. Risk of inadvertent access was low at the time of inspection; however, wood structure that formed a roof over the opening was observed to be actively deteriorating, and may lead to the development of an open hole in the future. May be exacerbated

Photo 27.1\_Failed hanging wall immediately E of shaft

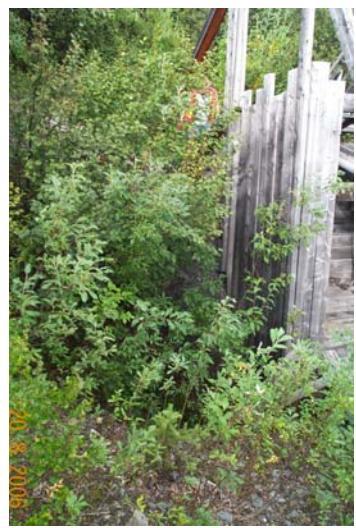
Photo 27.3\_Subsidence immediately W of shaft

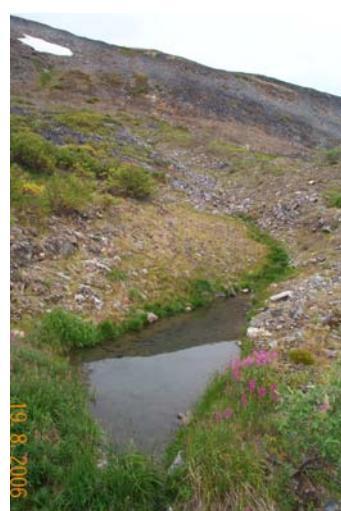
- #2 Ponded water in trench upslope of Upper Faro Gulch Trail (0.5 m deep x 2 m wide x 7 m long). Water was clear, with grasses growing around edges of pond (Photo 30-5). Trickling flow observed from spill point onto trail, then flow infiltrated into surface of trail.

Photo 30.05\_Ponded water in trench above Upper Faro Gulch Trail

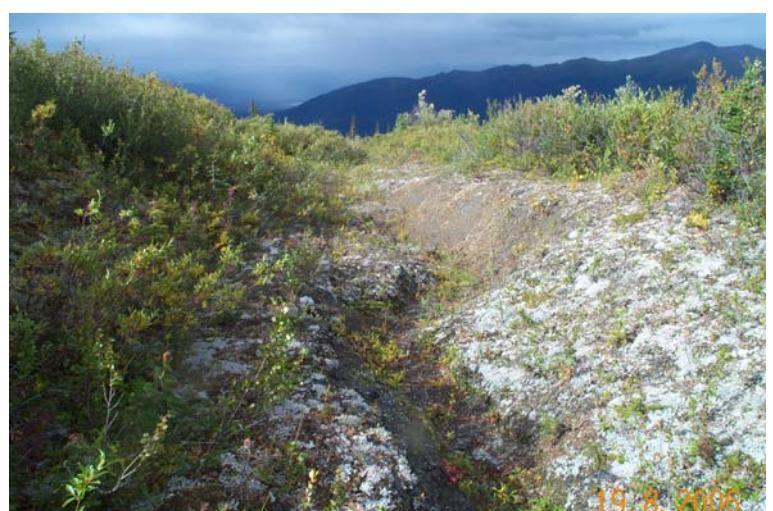
- #3 Trench #1 appears to collect and channel water during freshet; a 0.3 m deep incised channel (Photo 30-6) was observed in the base of the trench at the northwest end over a length of 10 m. This incised channel contains a 5 m long zone bearing intermittent orange staining on exposed phyllite surfaces. - Trench #1 is similar to the many other trenches shown. Revegetation of trench base and walls is occurring by willows, grasses, moss, and lichens (Photo 30-7). - Trench location is NAD 83 488824 E, 7092324 N

Photo 30.06\_Incised channel in Trench #1

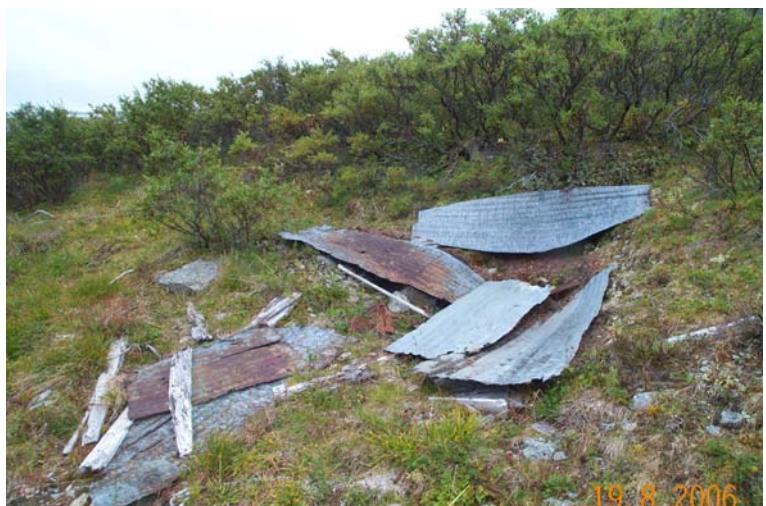
- #4 A collapsed adit into a shallow hillside was identified at this location. The site is marked by a broken wheelbarrow with an iron wheel, and several panels of galvanized sheet roofing material, and miscellaneous debris (Photo 30-8). The adit is not accessible.

Photo 30.08\_Collapsed adit south of Cub Pit
