# Draft Baseline Environmental Report United Keno Hill Mines Property

Project Reference Number SRK 1CA009.000

January 2007

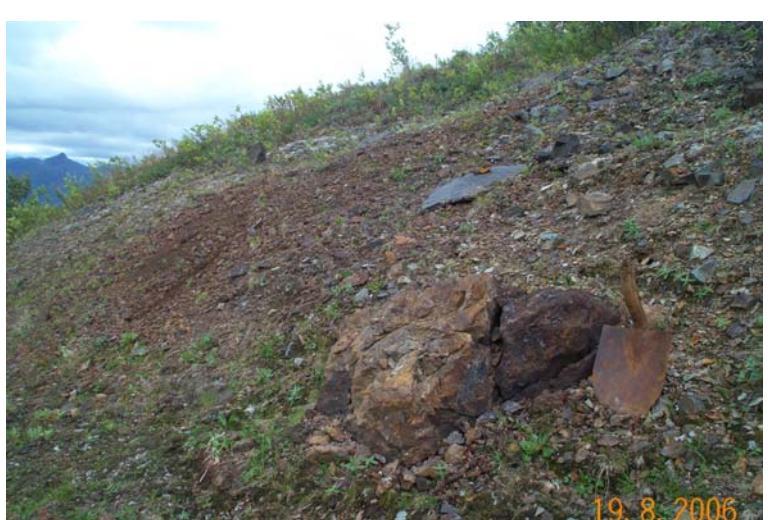
- #5 Orange to dark brown to purplish stained vein material exposed in east wall of pit (Photo 30-9).
  - Solifluction is causing fine grained soils at south end of pit to flow into excavation (Photo 30-10).

Photo 30.09\_Vein material exposed in of Cub Pit

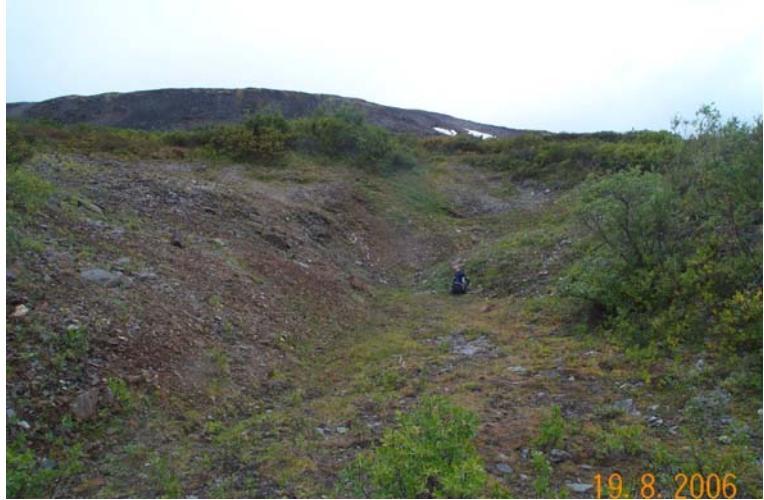
Photo 30.10\_Solifluction at south end of Cub Pit

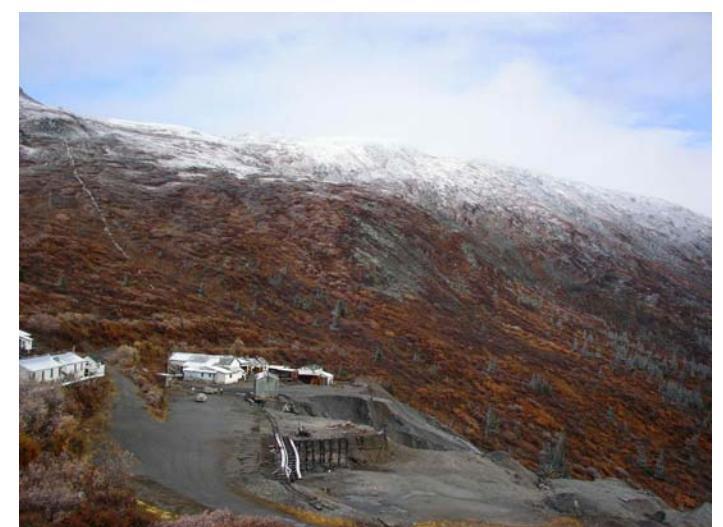
#1 Waste dumps are actively failing and waste material is being dispersed down Hope Gulch. Waste that forms foundation of Garage is at risk of failure in the short term. Timber cribbing is deteriorating and releasing retained waste material.

Photo 32.1\_Keno 700\_Overview showing eroding dumps and unstable building

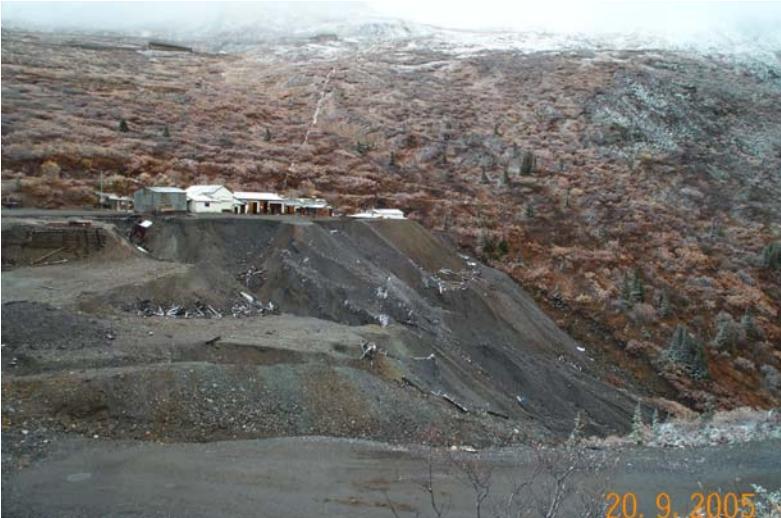
Photo 32.2\_Keno 700\_Actively eroding dump faces

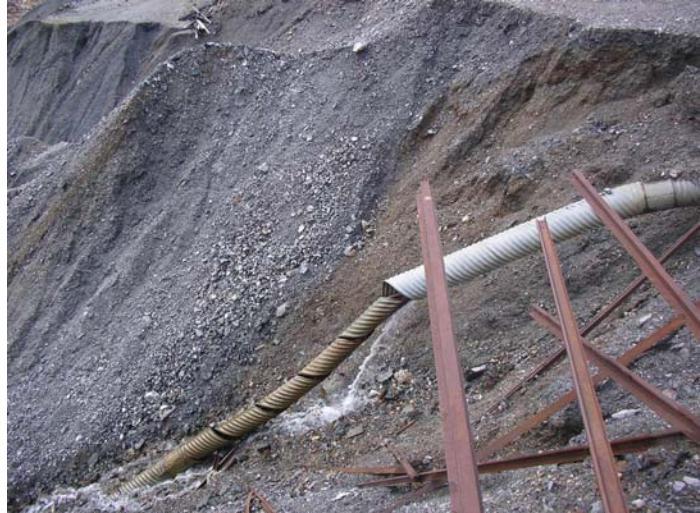
- #2 16" corrugated outflow pipe has unwound at crest of slope. Significant gully below unwound section of
- #3 Intake point for underground culvert is outside of adit and could easily be blocked by ice
- #4 Adit has ice with flow emerging from underneath
- #5 Buildings are in various states of disrepair. It appears as though scavenging of lumber from building frames
- #6 Access road has blocked culvert at first gulch back

Photo 32.3\_Keno 700\_Keno\_700\_Adit discharge culvert showing progress of dump erosion

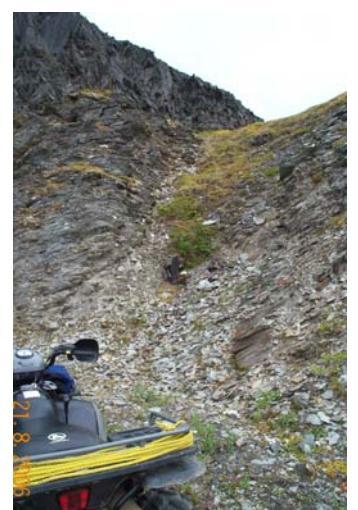
Photo 47-1\_Collapsed Monument and Ladue Fraction adit

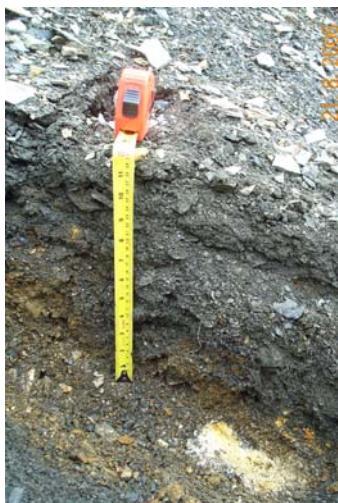
Photo 47-3\_Evidence of acid weathering in waste pile

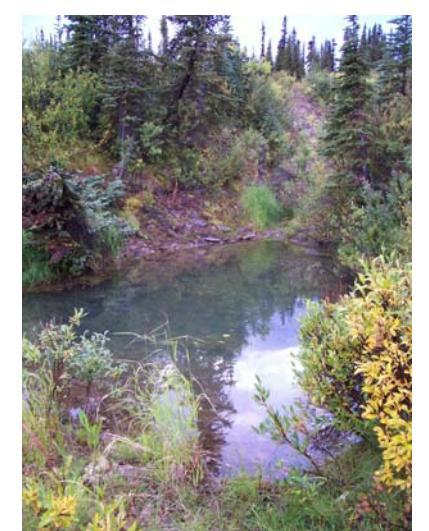
- #1 Permanent pond at upper limit of trench (Photo 59-1). Water is dammed behind material pushed into trench to form roadway. Fill is low, broad, and appears stable. - Water trickles from pond spill point into trench below. Trench bottom has welldeveloped mini-wetland community of horsetails, willows and algal mats; extends entire length of trench (Photos 59-2, 59-3). - Sides of trench range from bare to partially-vegetated.

Photo 59.01\_Pond at upper end of Eagle trench

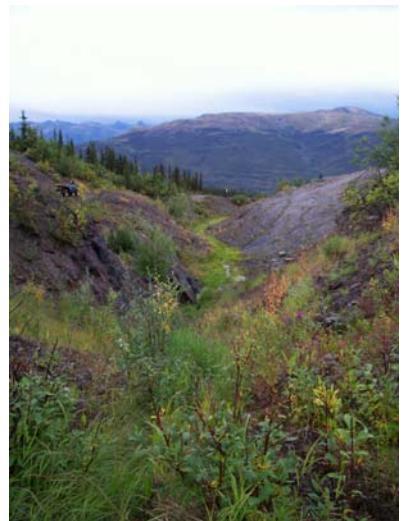
Photo 59.02\_Revegetation of base of Eagle trench, looking E from pond

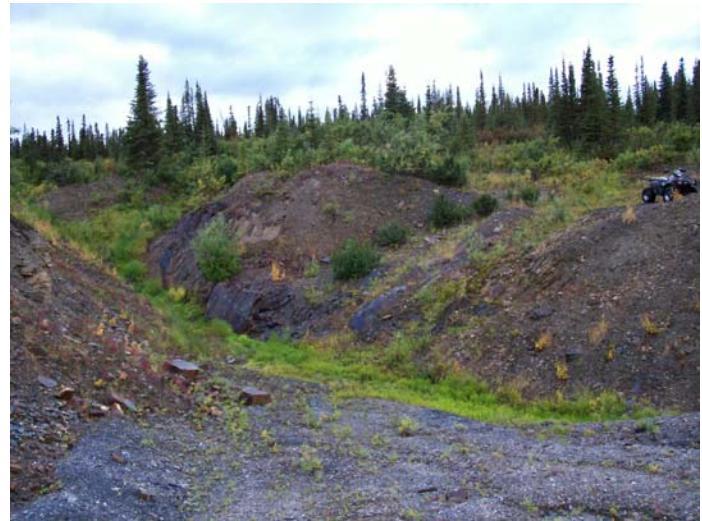
Photo 59.03\_Revegetation of Eagle trench base and walls, looking NW

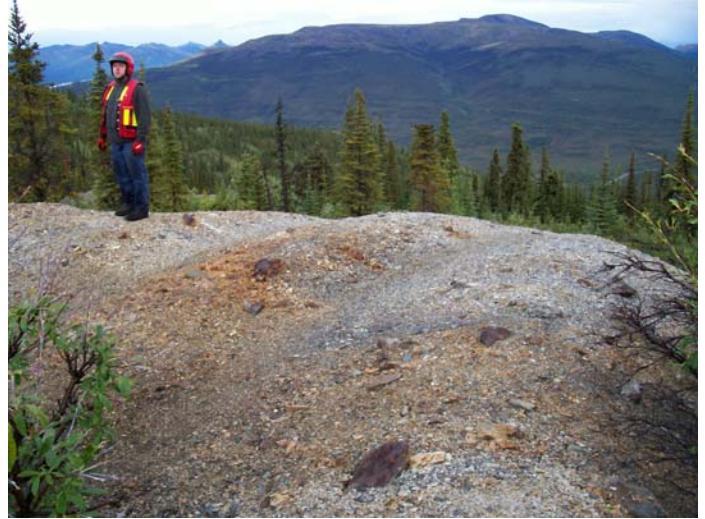
- #2 Dump composed of acid-generating waste- dark grey schist, quartz vein material and rare quartzite- with rinse pH of 2.6 from the <2mm fraction of a single sample. Light orange staining is common, with less frequent bleached regions (Photos 59-4, 59-5). Keno Hill Quartzite clasts in bleached areas have no stain near contact with underlying material, but have dark purplish brown staining on the tops of the clasts, away from contact with the substrate. Minor limonite observed.

Photo 59.04\_Bleached waste rock

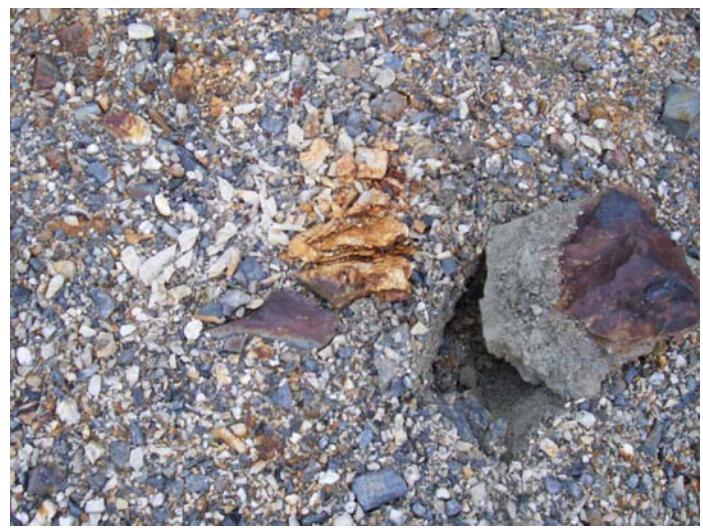
Photo 59.05\_Bleached waste rock and purplish-brown stained clast

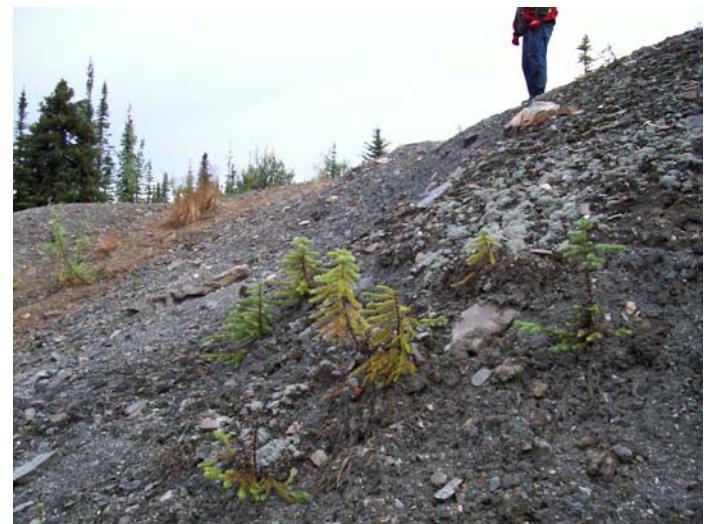
- #3 Flow lobes observed on downhill face of waste pile (Photo 59-7), over area approximately 15 m wide x 30 m long x 4 m high. Minor cracking at crest of pile indicates minor instability; minor erosion channel down dump face and sediment fan extending from toe indicates that waste is transported during runoff events (Photo 59-8). Dump toe is oversteepened. Minor revegetation of dump face- spruce seedlings up to 1 m, grasses, willows.

Photo 59.07\_Active waste pile slope

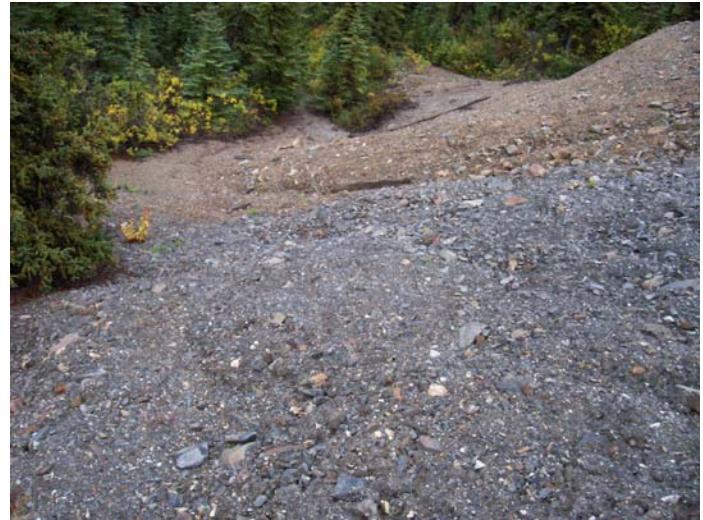
Photo 59.08\_Erosion gully and sediment deposited at base of gully

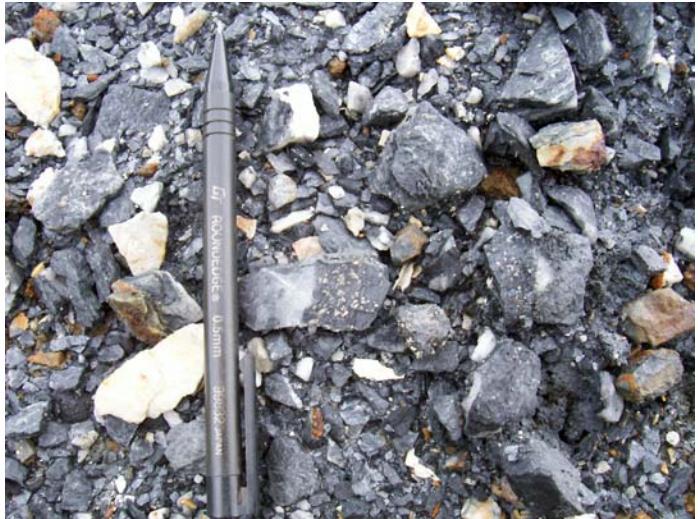
- #4 Abundant medium-grained pyrite observed in waste rock (Photos 59-9, 59-10). Staining varied from no staining to light orange to rusty black (Photo 59-11). Revegetation of waste rock piles is generally limited to isolated plants- overall coverage is poor.

Photo 59.09\_Pyrite in Keno Hill Quartzite from waste pile

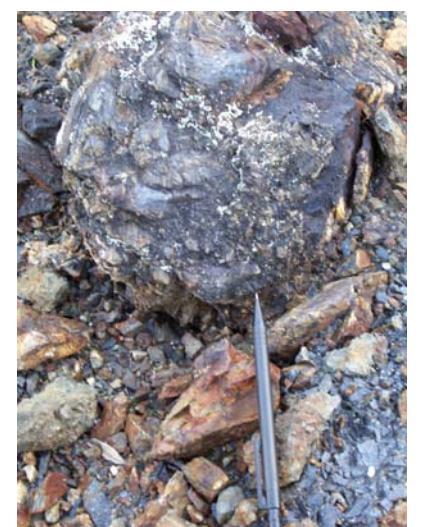
Photo 59.10\_Pyrite and staining on rock from waste pile

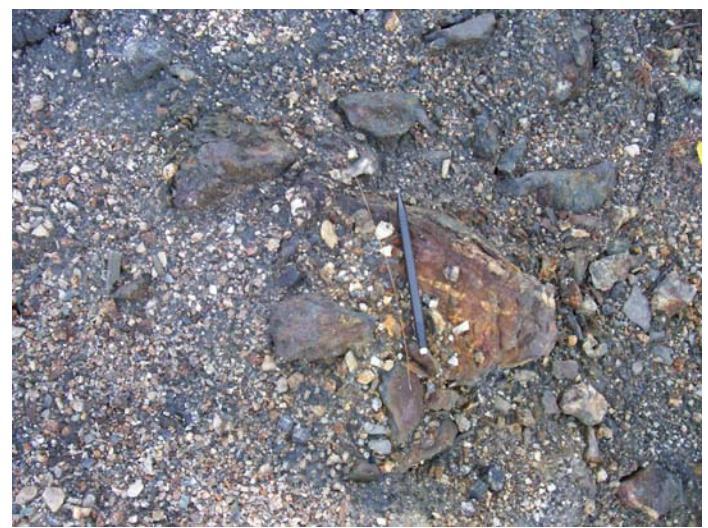
Photo 59.11\_Yellowish and orange staining on surface of waste pile

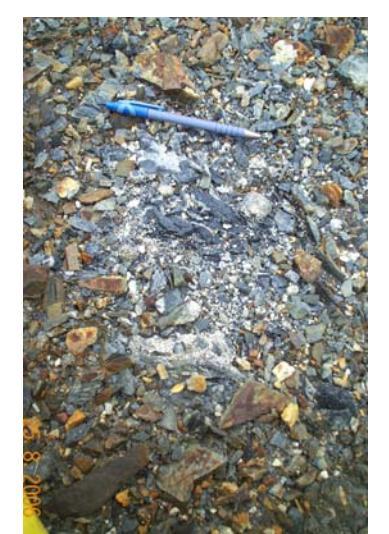
#1 - Waste rock pile at northwest end of Trench #1 has widespread staining (yellowish, yellowish-brown, and rusty orange to rusty brown), as well as areas that appear to be leached (Photos 63-1, 63-3). Abundant medium- to coarse-grained pyrite (up to 5% locally) noted as massive pods and veinlets, as well as disseminated in waste rock.
- Grain relief within clasts and fresh, untarnished appearance of pyrite suggests galvanic protection of pyrite and selective weathering of other sulphides.

Photo 63-1\_Fresh pyrite surrounded by leached area and staining

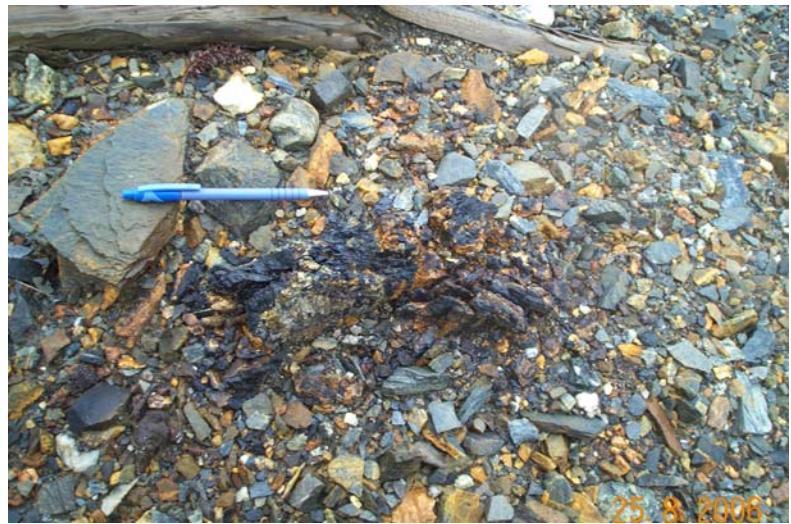
Photo 63-2\_Fresh pyrite in vein material

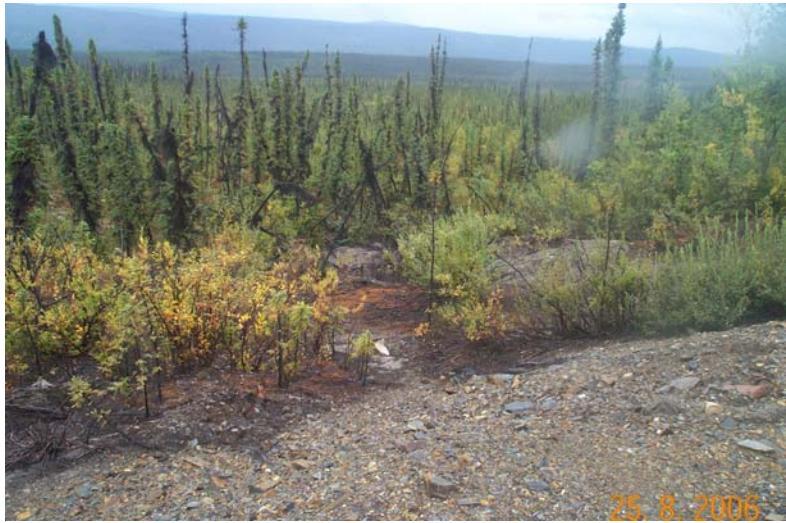
- An area of heavily stressed vegetation (2 m wide) was noted north of waste rock pile toe (Photo 63-3).

Photo 63-3\_Stressed vegetation at toe of waste pile

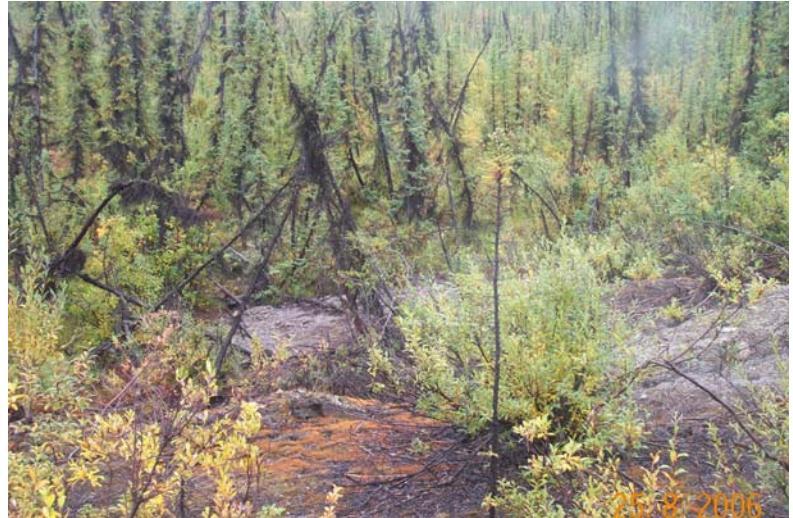
- Two flow lobes were observed, and an unvegetated flow deposit of waste rock extended to north from toe of pile (Photo 63-4). Small headwall in source region indicates that instability is ongoing (Photo 63-5). Dump height approximately 2 m.

Photo 63-4\_Flow of waste rock away from waste pile

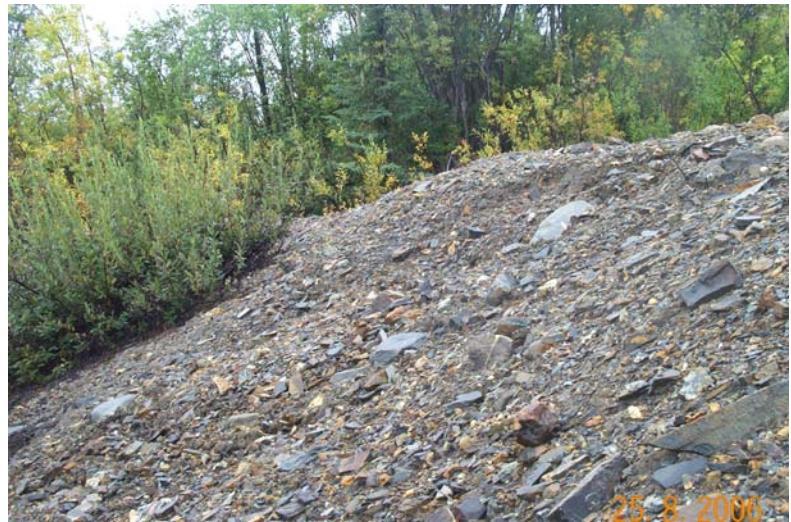
Photo 63-5\_Source zone with active headwall

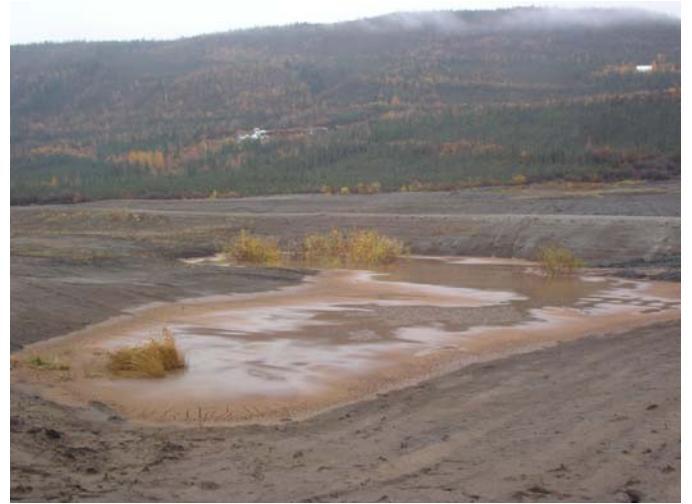
- #1 Approx. location of sludge disposal cells (Photo 79.1) Tension cracks in berm at the NE corner.
- #2 Tailings extensively re-graded in this area (Photos 79.2, 79.3).
- #3 Vegetation kills above former tailings discharge points
- #4 Diversion ditch in tailings. No flow observed (Photo 79.4) Oxidized tailings in upper 20 cm (Photos 79.5, 79.6)
- #5 Tailings present much further upslope than indicated on PWGSC 2000 maps

Photo 79.1\_24\_Elsa\_Tailings\_24 Sludge pond

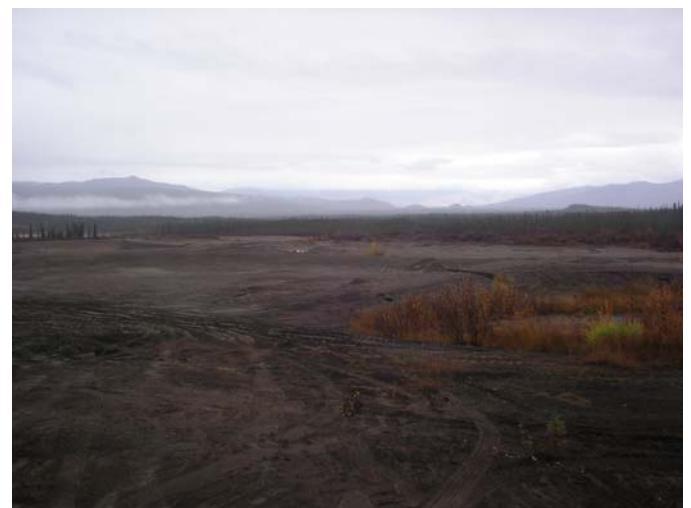
Photo 79.2\_26a\_Elsa\_Tailings\_26a Re-worked upland tailings

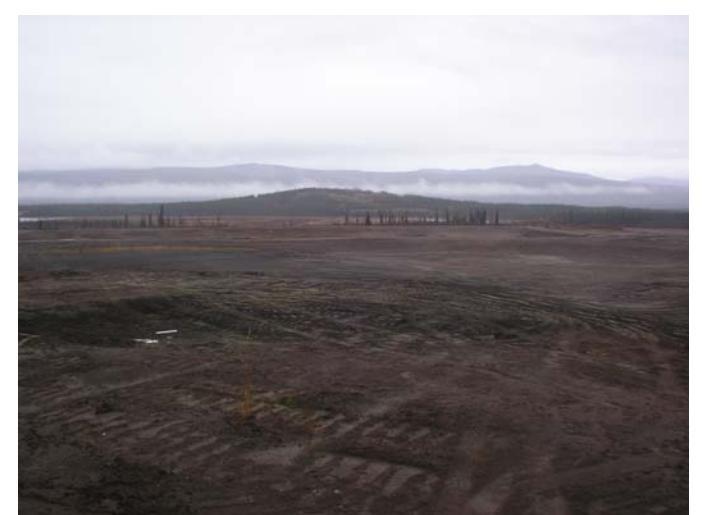
Photo 79.3\_26b\_Elsa-Tailings\_26b Re-worked upland tailings

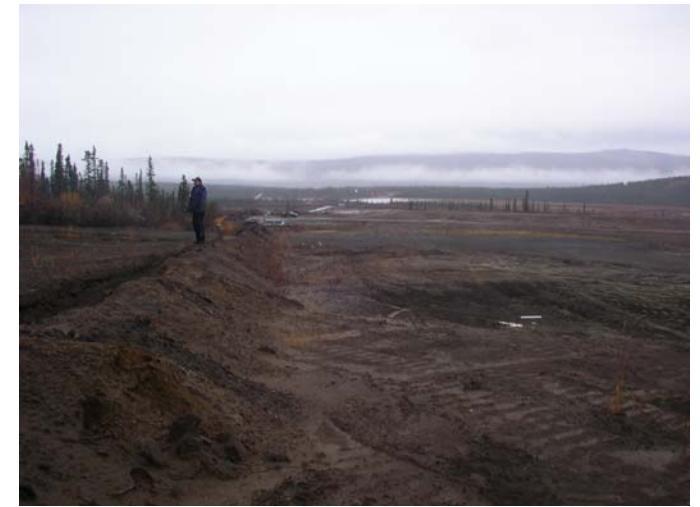
Photo 79.4\_27\_Elsa\_Tailings\_27 Ditch in upland tailings

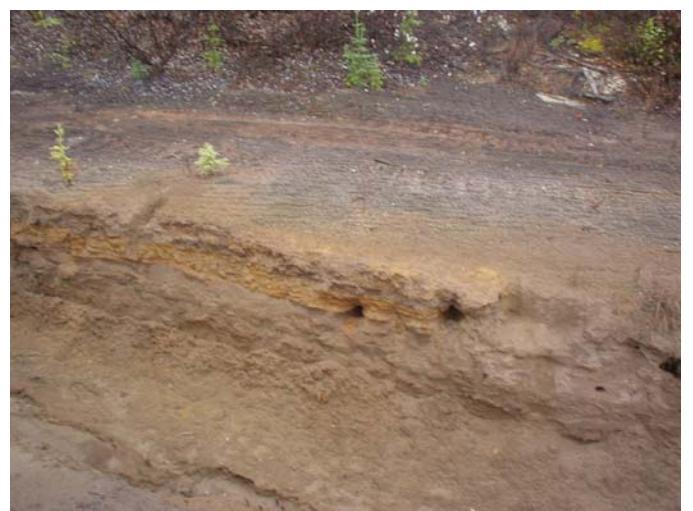
Photo 79.5\_ 28\_Elsa\_Tailings\_28 Ditch close-up

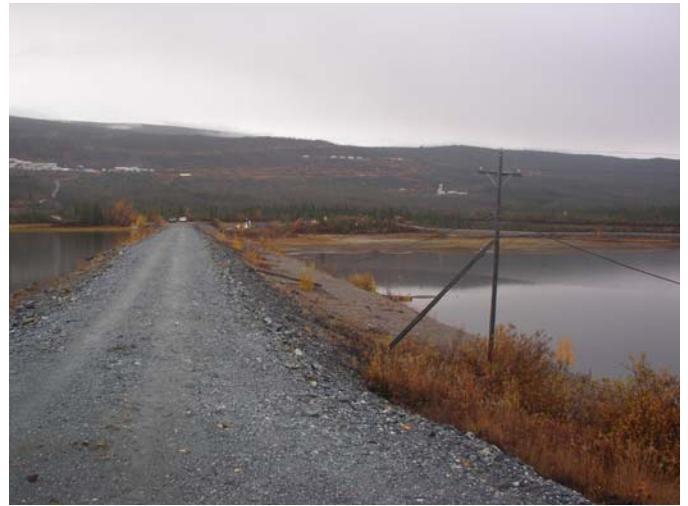
- #1 Dam 1 recently re-surfaced (Photos 79.7, 79.8)
- #2 Upstream crest shows tension cracks

Photo 79.07\_5\_Elsa\_Tailings\_5 Dam 1 looking SW

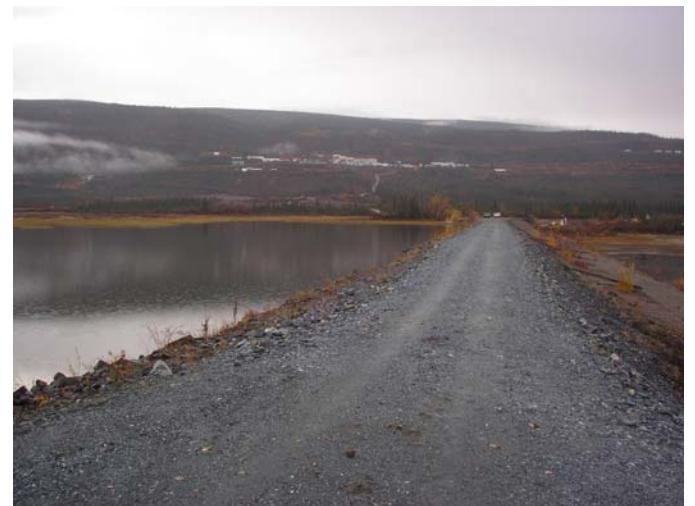
Photo 79.08\_6\_Elsa\_Tailings\_6 Dam 1 looking S

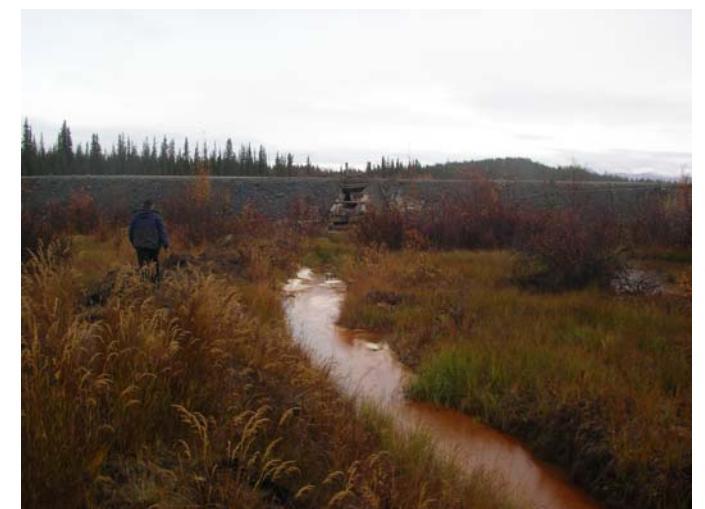
- #10 Extensive tension (Photos 79.9, 79.10) cracking on upstream face approx. 200 m south of decant (Photo 79.14)
- #11 Treated water drains to Dam 3 pond. Unreacted lime present.

Photo 79.09\_11\_Elsa\_Tailings\_11 Dam 2 decant and outflow

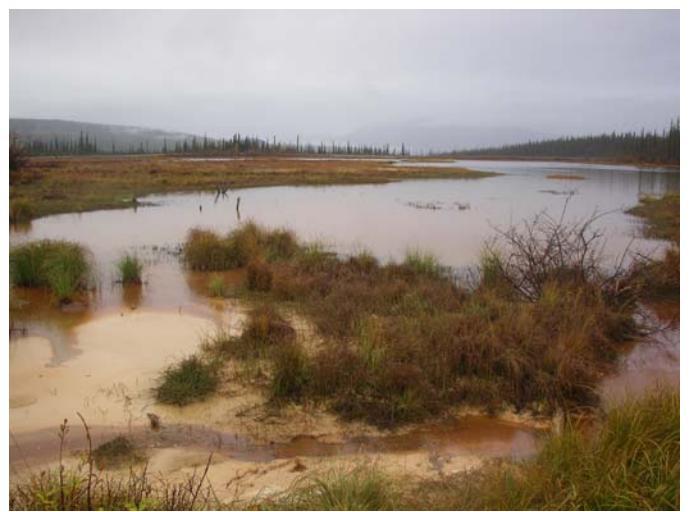
Photo 79.10\_13\_Elsa\_Tailings\_13 decant outflow area

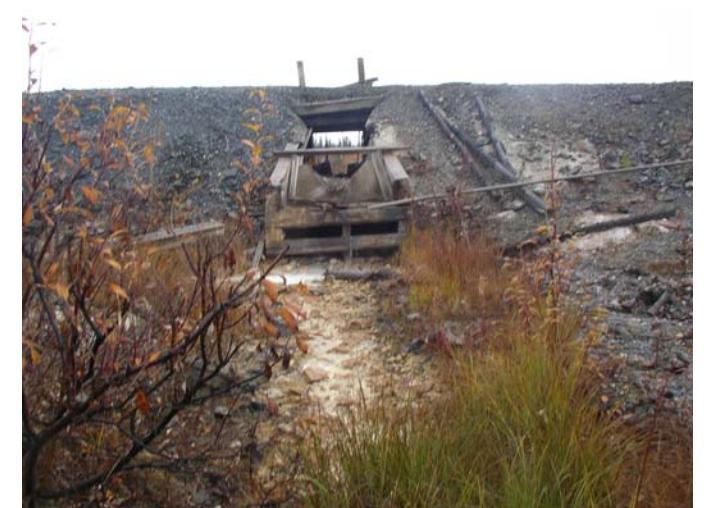
- #12 Dam 2 lime addition system
  lime slurry tank
  pump feeds lime slurry into decant outlet
- #13 Decant constructed from lumber and plywood. V-notch weir at outlet has leakage along toe. (Photos 79.11, 79.12, 79.13)

Photo 79.11\_14\_Elsa\_Tailings\_14 Dam 2 decant close-up 1

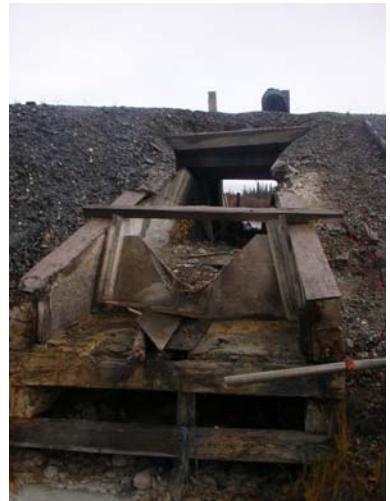
Photo 79.12\_15\_Elsa\_Tailings\_15 Dam 2 decant closeup 2

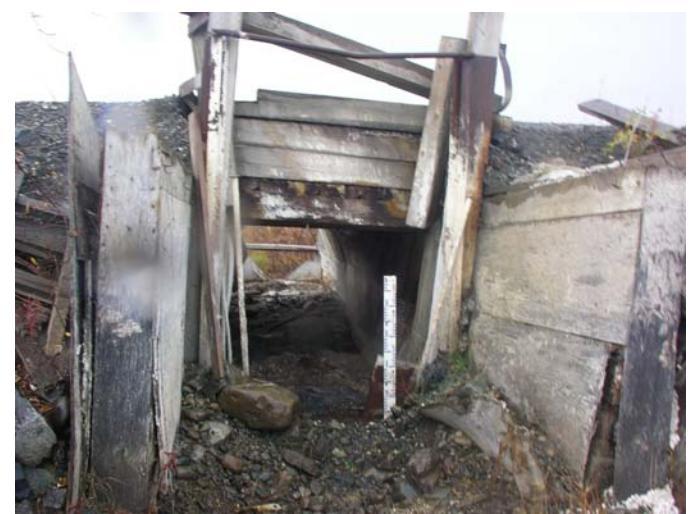
Photo 79.13\_16\_Elsa\_Tailings\_16 Dam 2 decant upstream end

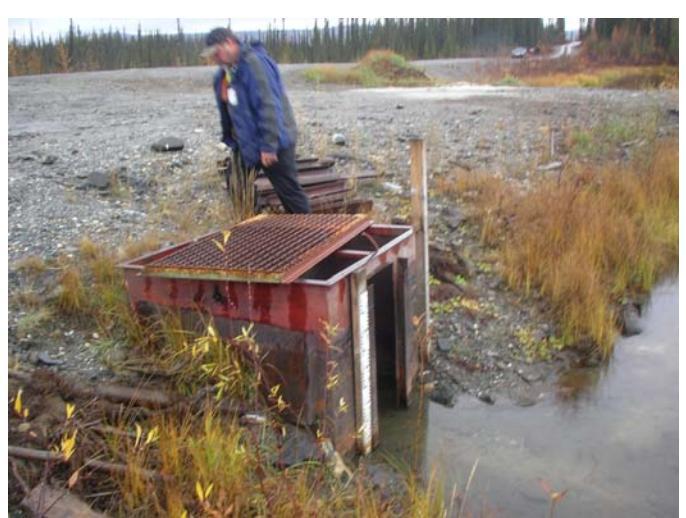
Photo 79.15\_19\_Elsa\_Tailings\_19 Dam 3 discharge point

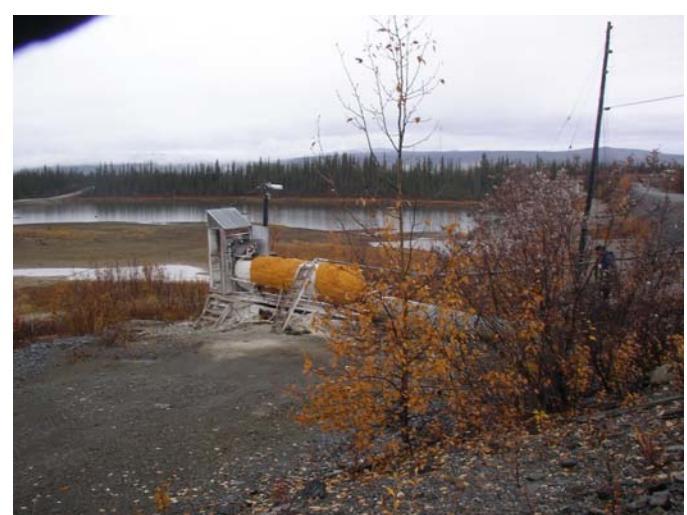
- #5 Decant intake B a steel box with stop-log slots. Good condition
- #6 Dam 1 lime addition system (Photo 79.17)
  - lime slurry tank - mixer
  - lime slurry drips into mixing box at outlet of decant pipe

Photo 79.17\_20b\_Elsa\_Tailings\_20b Dam 1 treatment system and spilled tailings

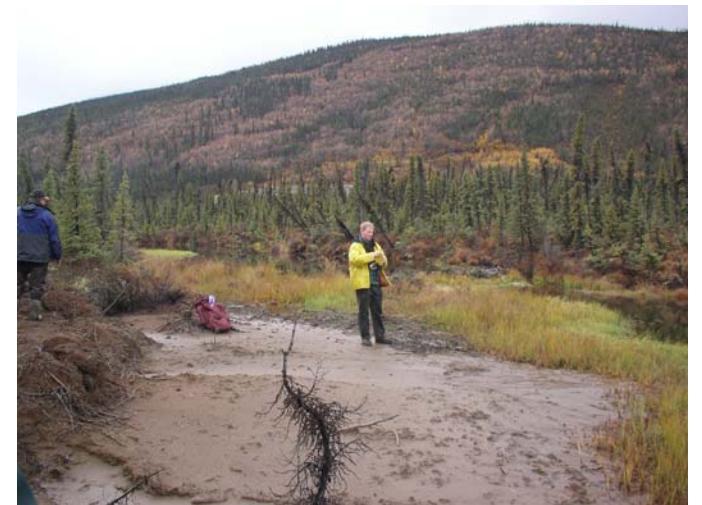
Photo 81.01\_Tailings deposit along creek

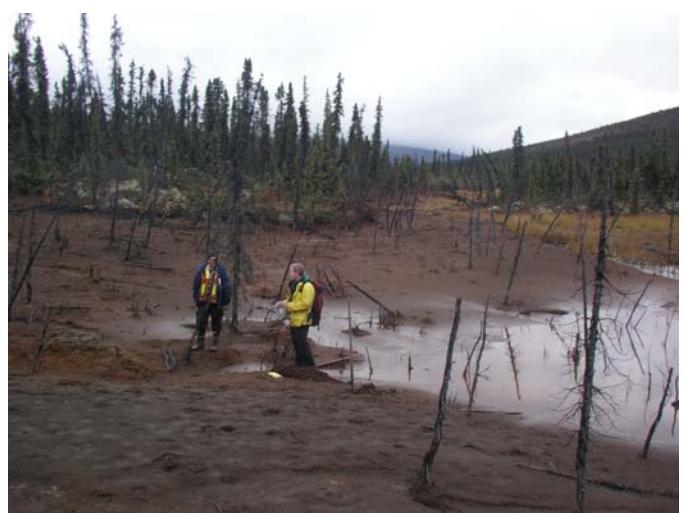
Photo 81.02\_Tailings deposit along lakeshore

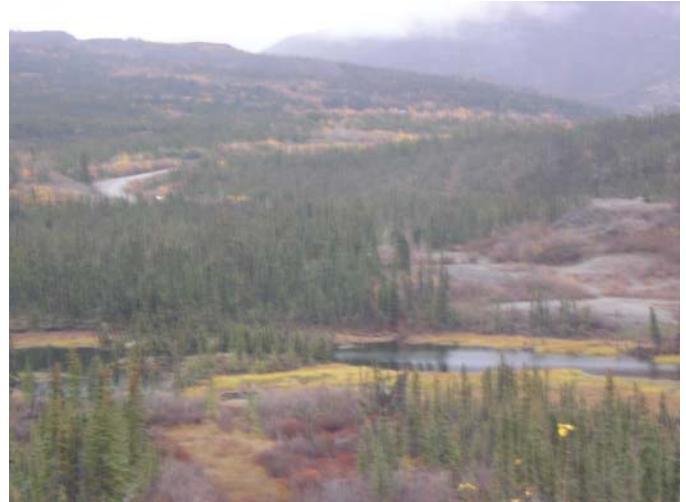
Photo 81.03b\_Christal Lake outflow from Galkeno 900

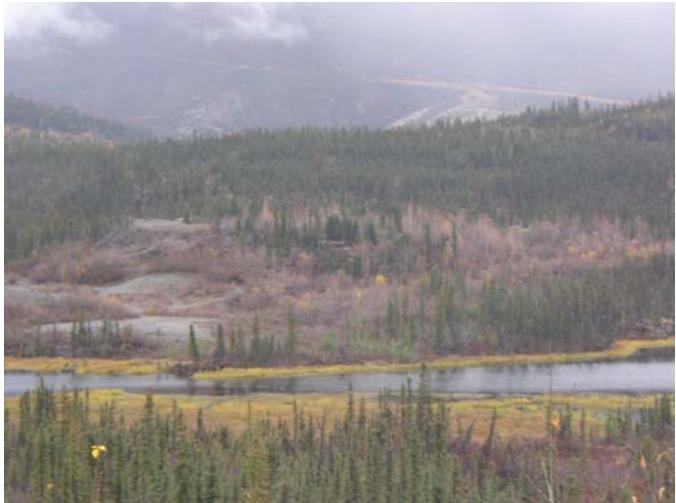
Photo 81.03c\_Christal Lake outflow from Galkeno 900

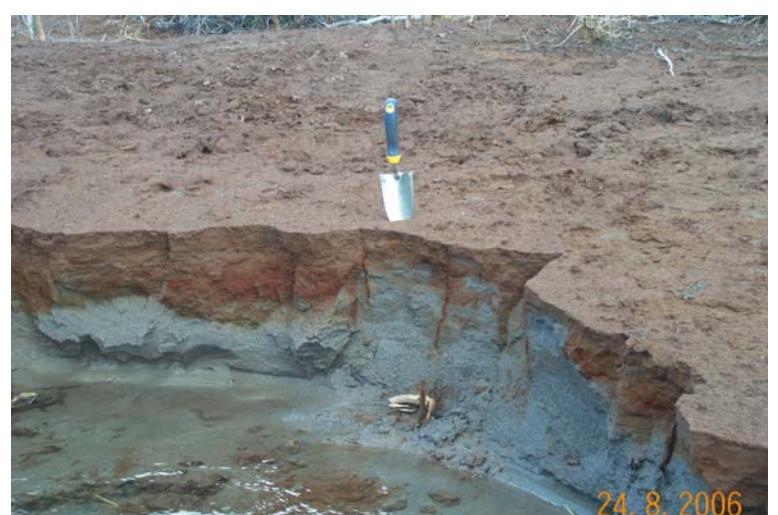
Photo 81.04\_Active erosion of tailings by Christal Lake outflow

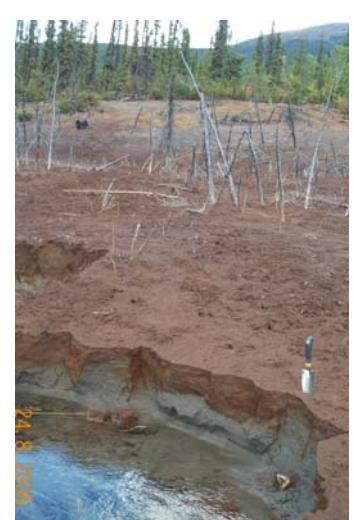
Photo 81.05\_Fresh and weathered tailings in active erosion face, with weathered tailings surface in background

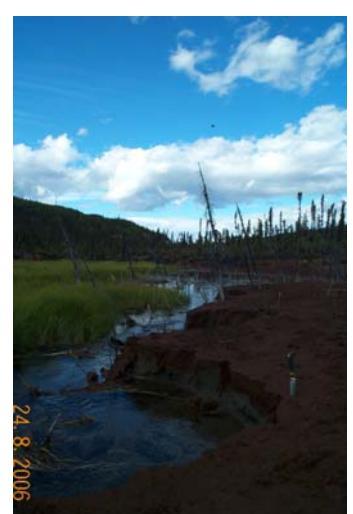
Photo 81.06\_Looking downstream at Christal Creek cutting into tailings

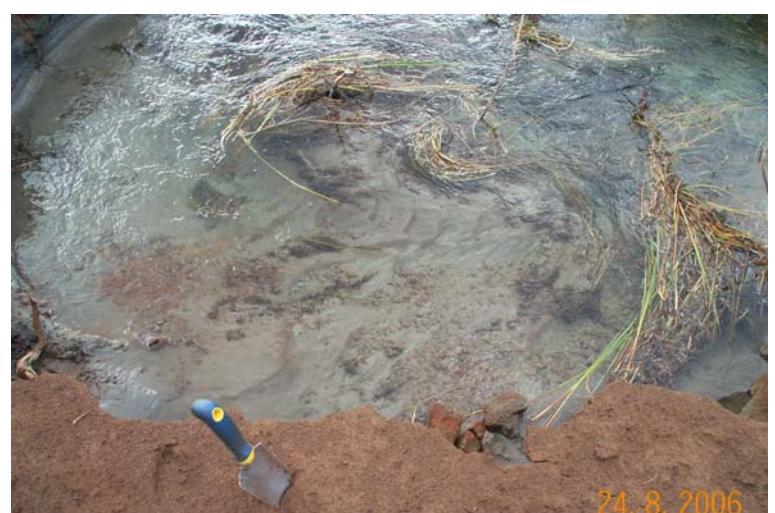
Photo 81.07\_Fresh tailings on bed of Christal Creek adjacent to in-situ tailings

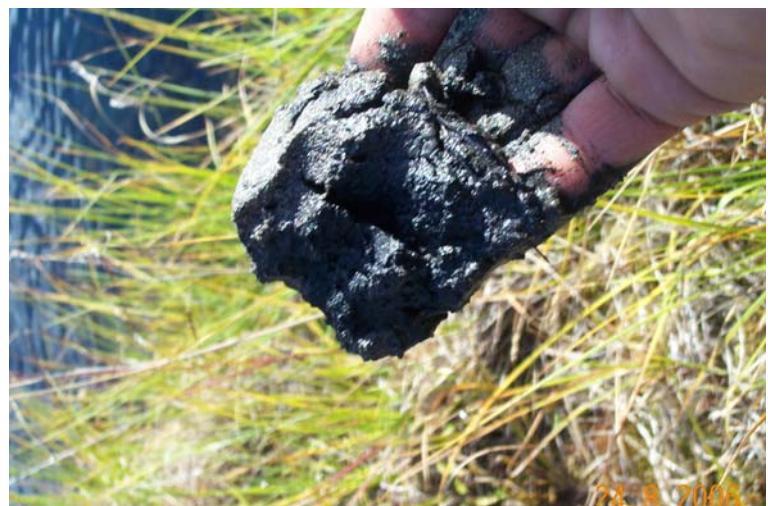
Photo 81.09\_Fresh pyrite in sediment from bed of Christal Creek downstream of Mackeno

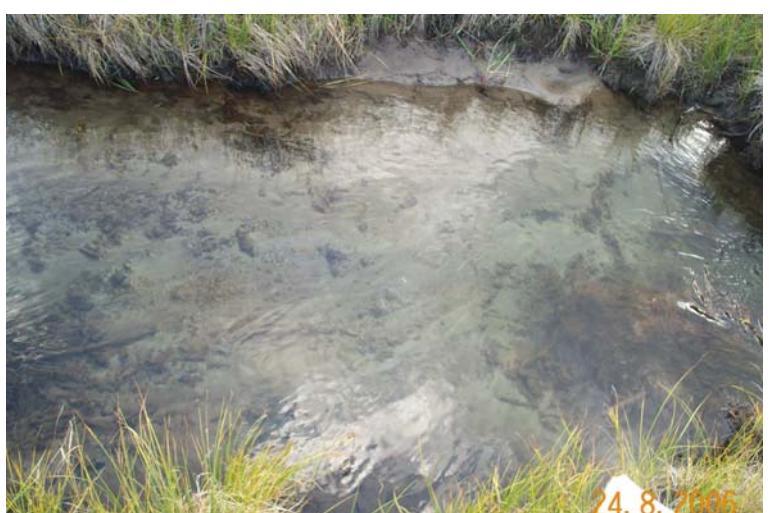
Photo 81.10\_Fresh pyrite in sediment on bed of Christal Creek downstream of Mackeno

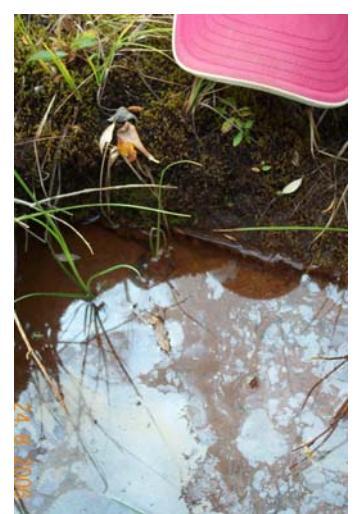
Photo 81.11\_Orange staining and shiny surface particulate in standing water adjacent to Christal Creek

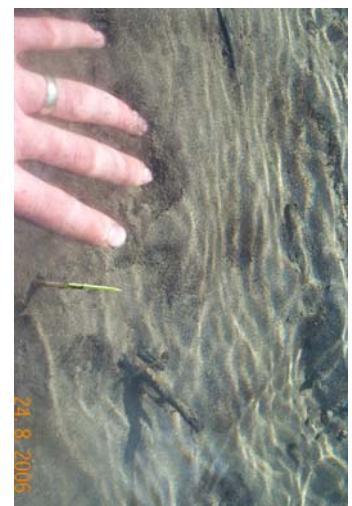
Photo 81.12\_Fresh pyrite in sediment on bed of Christal Creek downstream of Mackeno

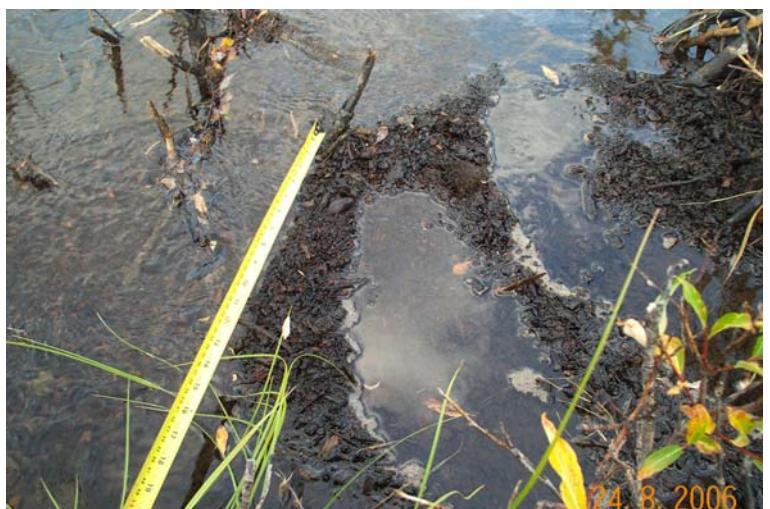
Photo 81.13\_Black coatings on gravel in Christal Creek doiwnstream of Mackeno

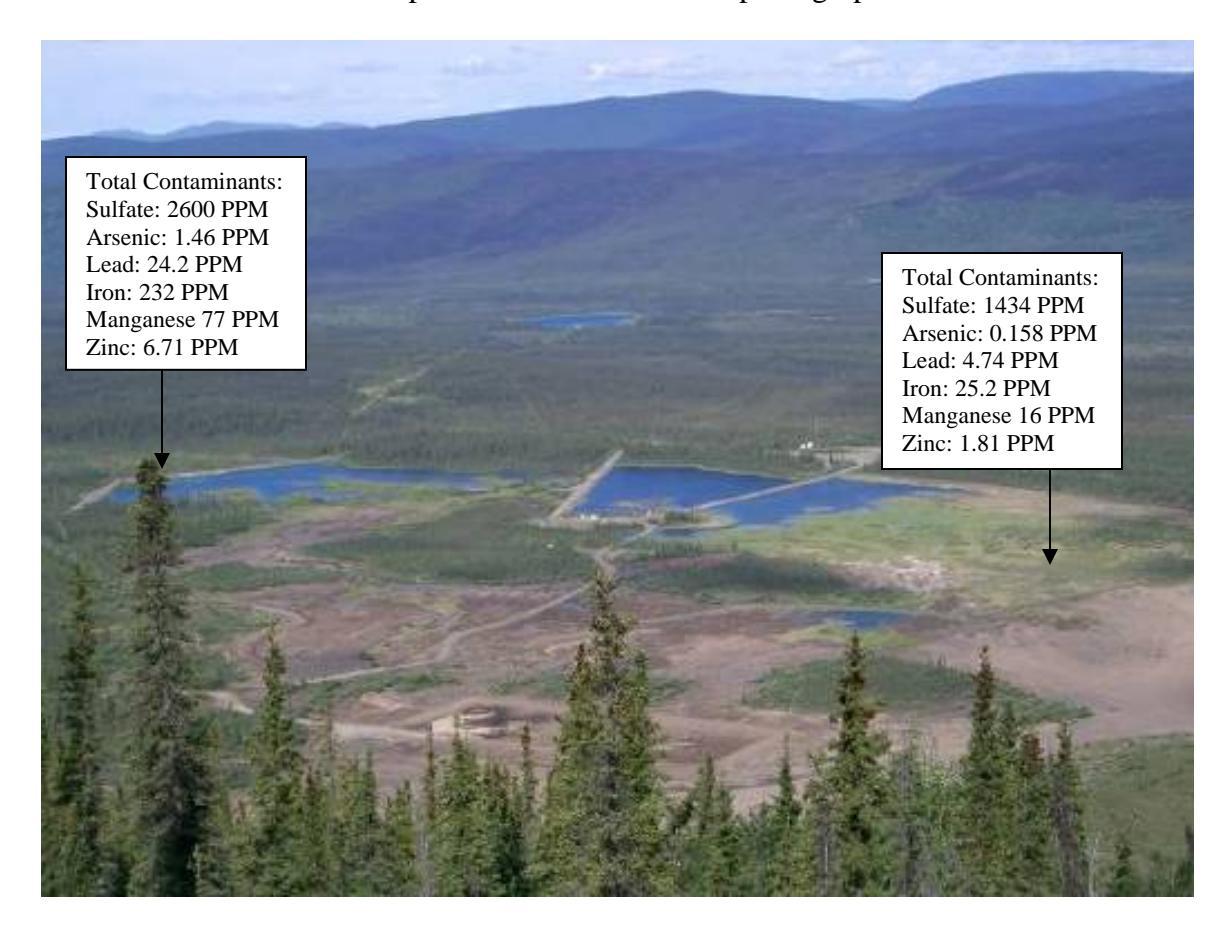
Temporary drive point piezometers were installed and sampled at several locations to assess the level of contamination in shallow flows transmitted at the interface between the Valley Tailings and the subsurface soils. A trend of increasing contamination with gradient was observed in these flows by selecting the maximum level of total contaminants from each sampled area as shown in the photograph below:

The above data suggests that contaminants are accumulating at the interface beneath the Valley Tailings and are likely to pose a source of loading to Flat Creek and the South McQuesten.

It should be noted that the sample data for total levels of contaminants reported 1,000x higher levels, but in the author's judgment the reported levels likely reflected an improper conversion to PPM rather than PPB. For example, the analysis of the whole collected sample indicated 4,740 PPM lead, rather than as shown above at 4.74 PPM.

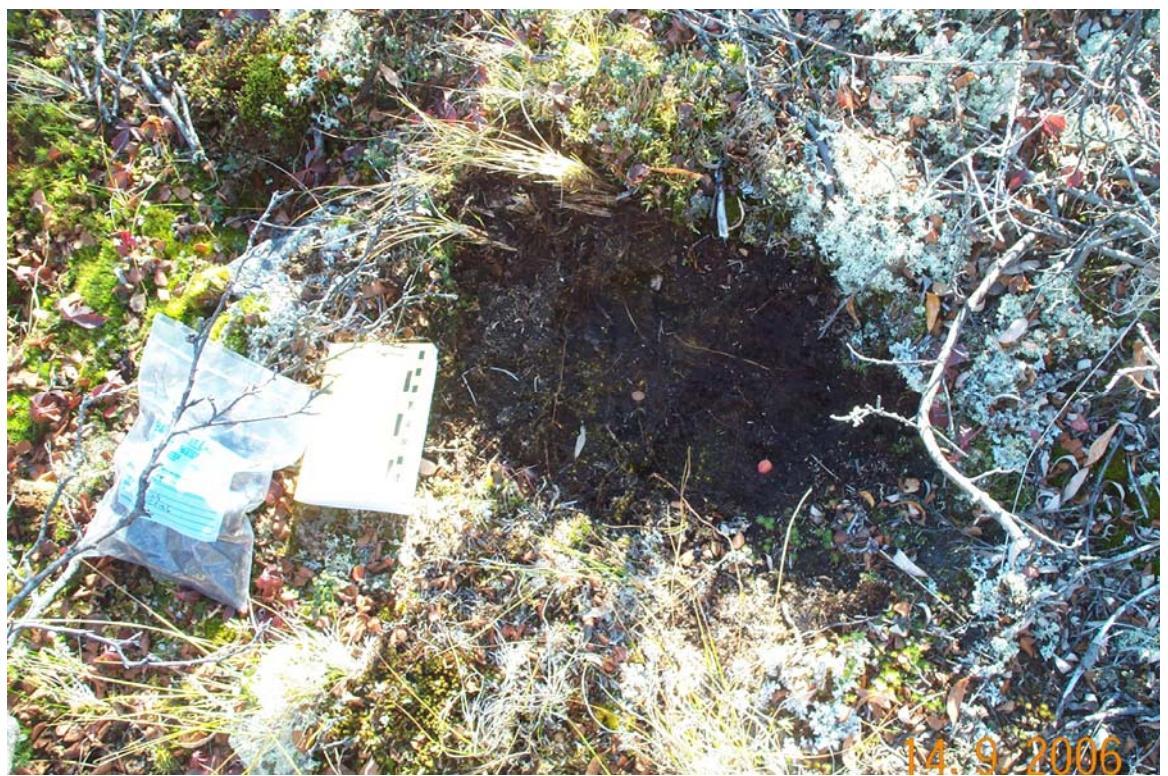
Initial lab results indicate highest metal concentrations (principally zinc, lead and manganese) on Transect 4, Calumet Drive near Dixie adit. Provisional laboratory results have been summarized in the UKHM Haulage Route Sampling Table.

Soil sample location near Keno Hill.

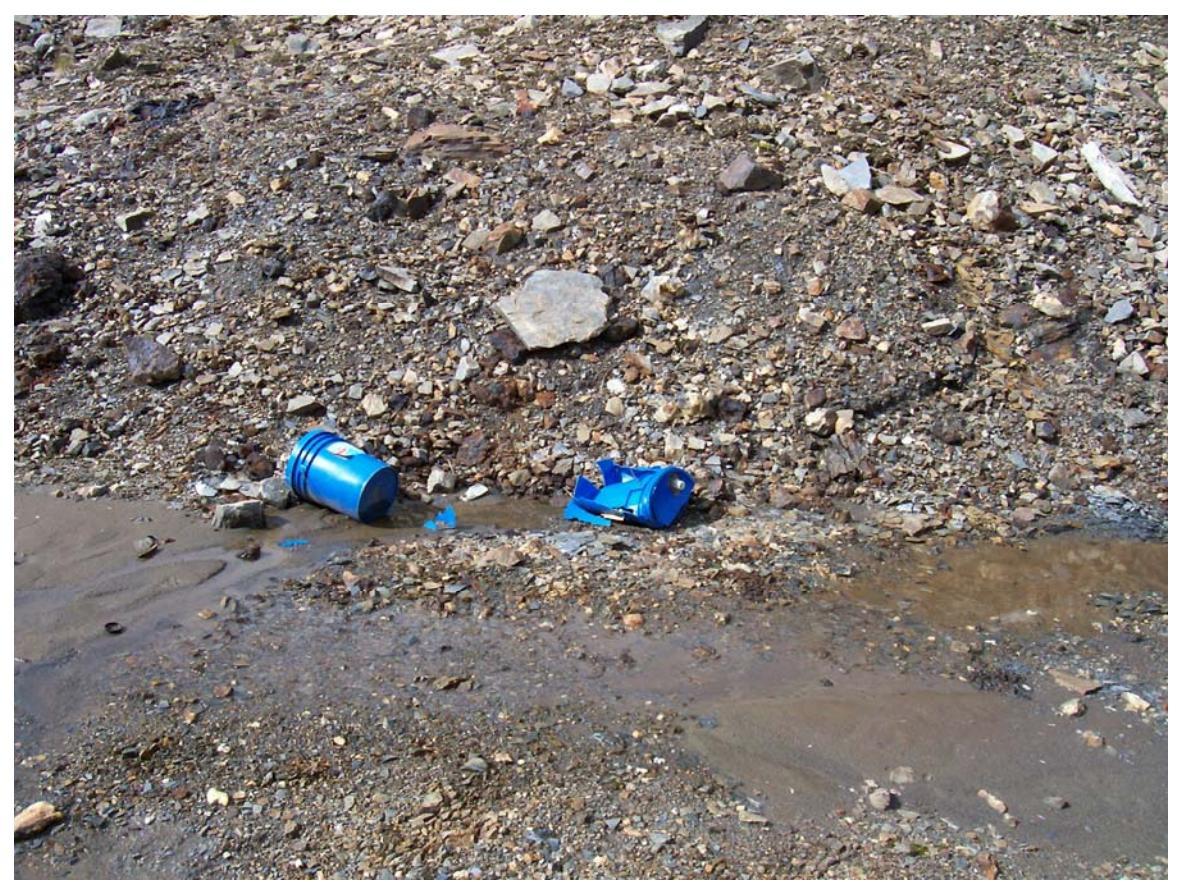
Evidence of hydrocarbon contamination at Caribou (Segsworth) site (later research determined that this site was not on UKHM claim package).

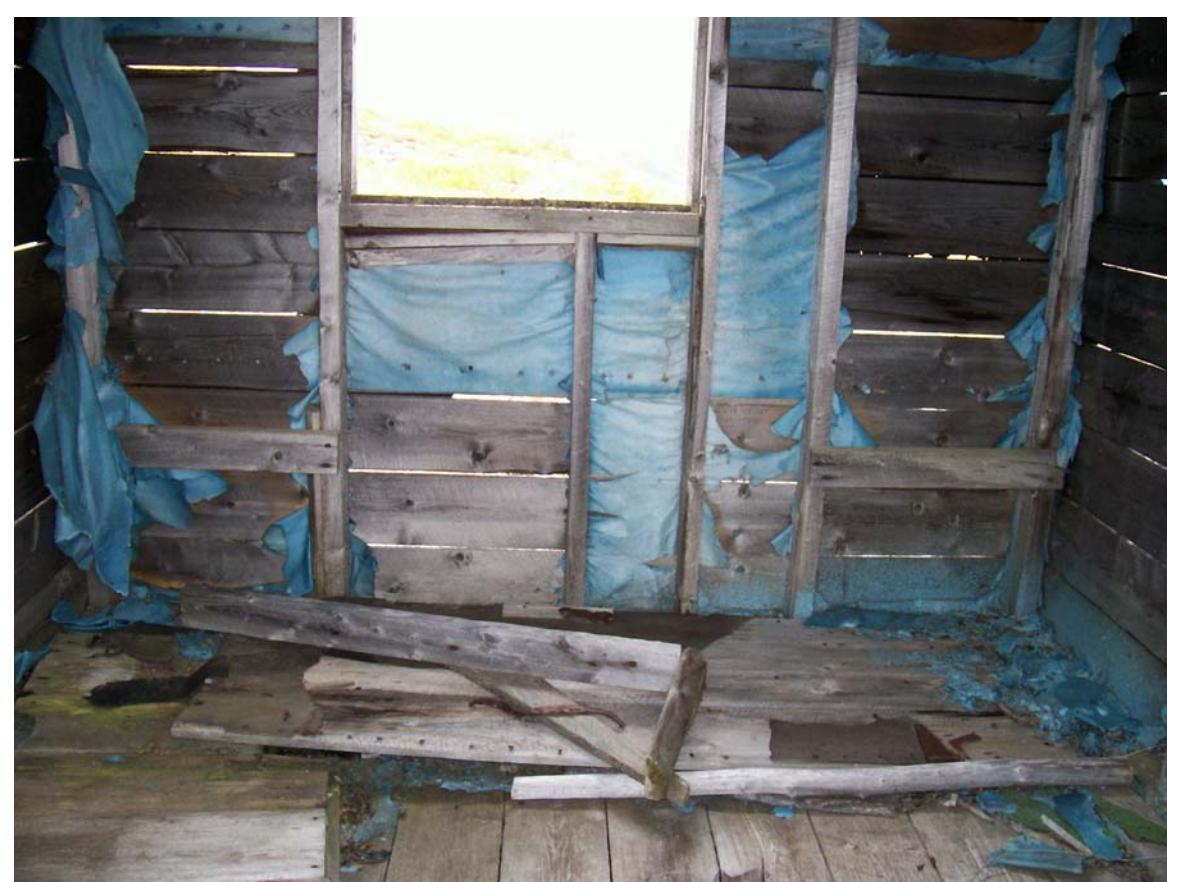
Possible building contamination at Main Fault & Nabob site.
