## Anvil Range Mining Complex: Results from Trial Covers at Rose Creek Tailings Impoundment

2005/06 Task 22b

**DELOITTE & TOUCHE INC.**

**FARO MINE CLOSURE PLANNING OFFICE**

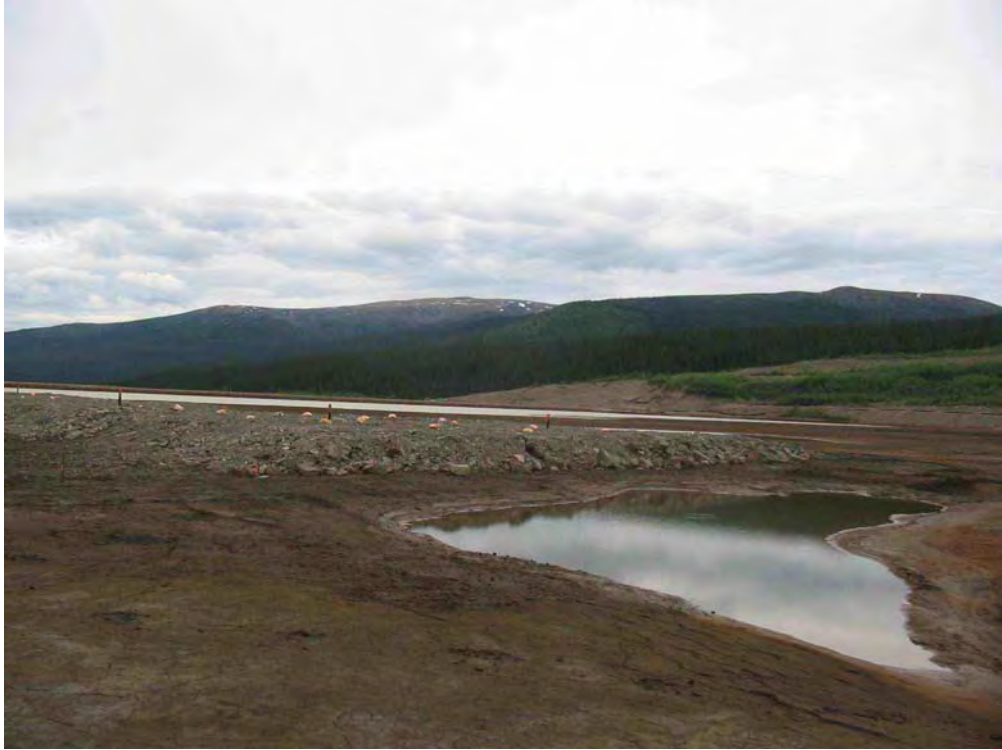
Figure 3. East test cover: Eastern edge, showing NE surface and marker stones.

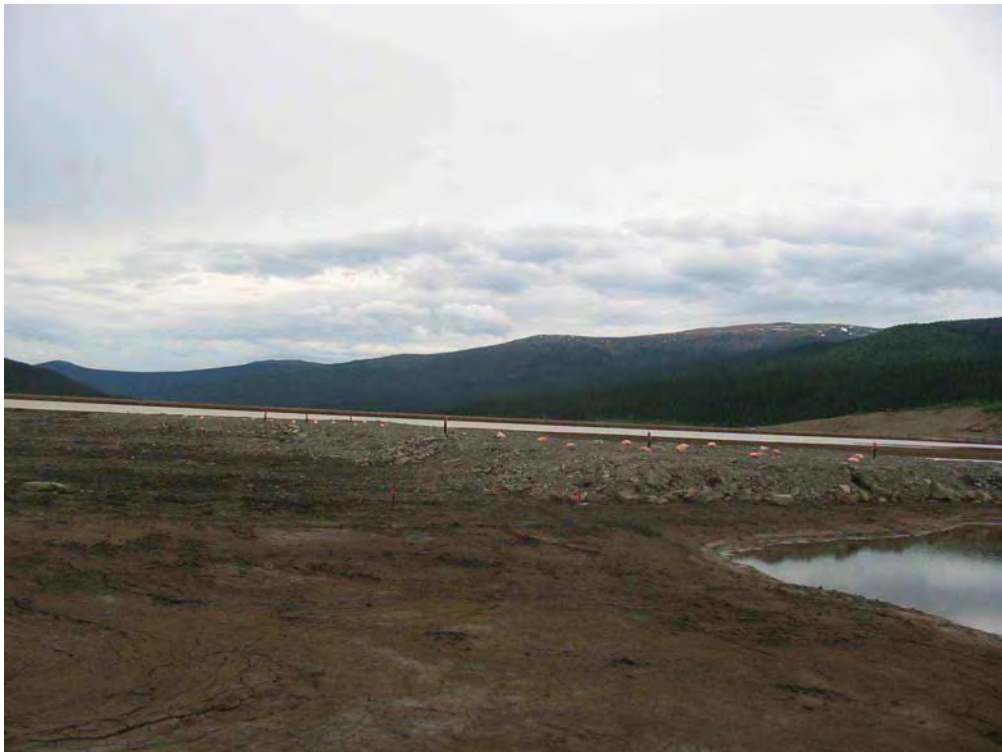
Figure 4. East test cover: Eastern edge, showing SW surface and marker stones.

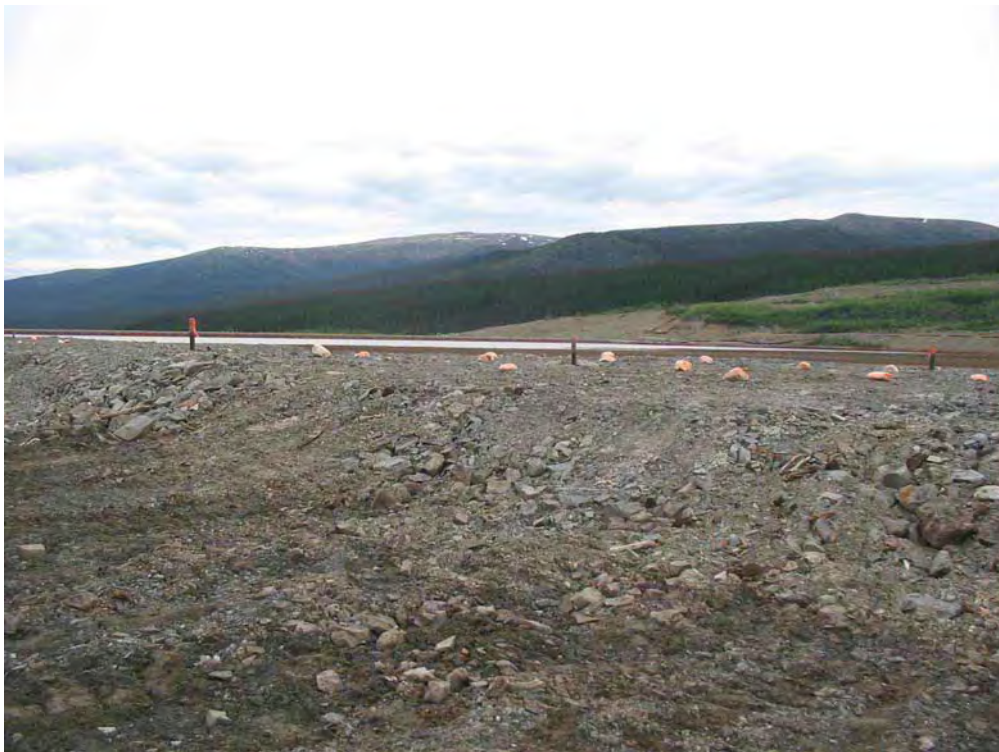
Figure 6. East test cover: Eastern edge, showing equipment access point and steel columns.

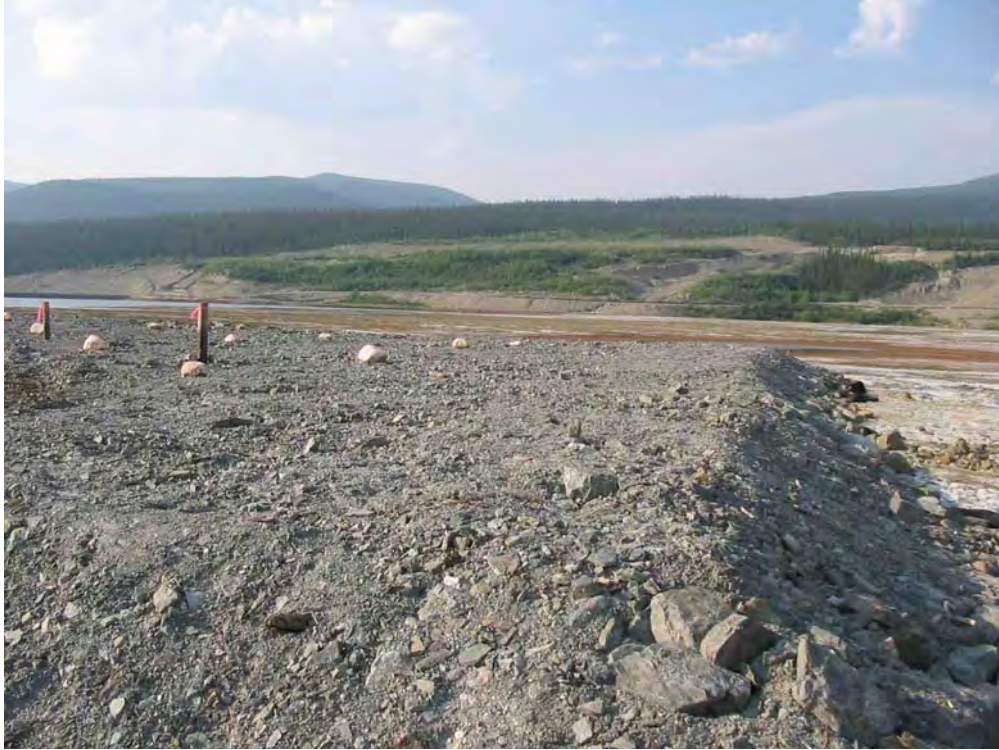
Figure 25. West test cover: Eastern edge, showing undisturbed NE surface and marker stones.

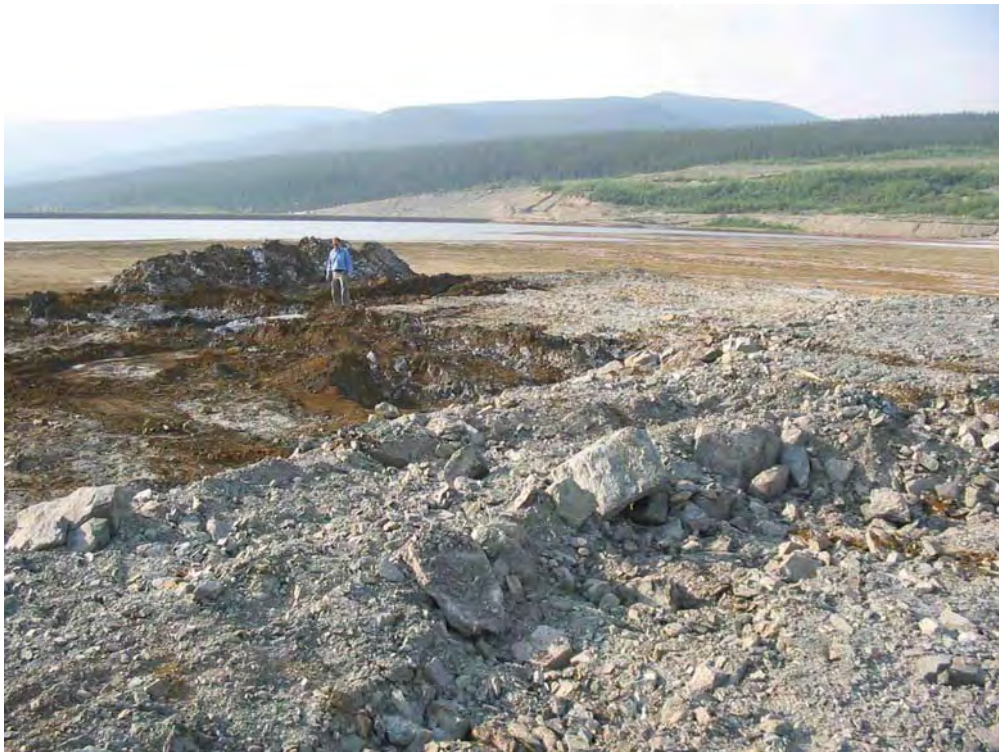
Figure 26. West test cover: Western edge and adjacent disturbed tailings.

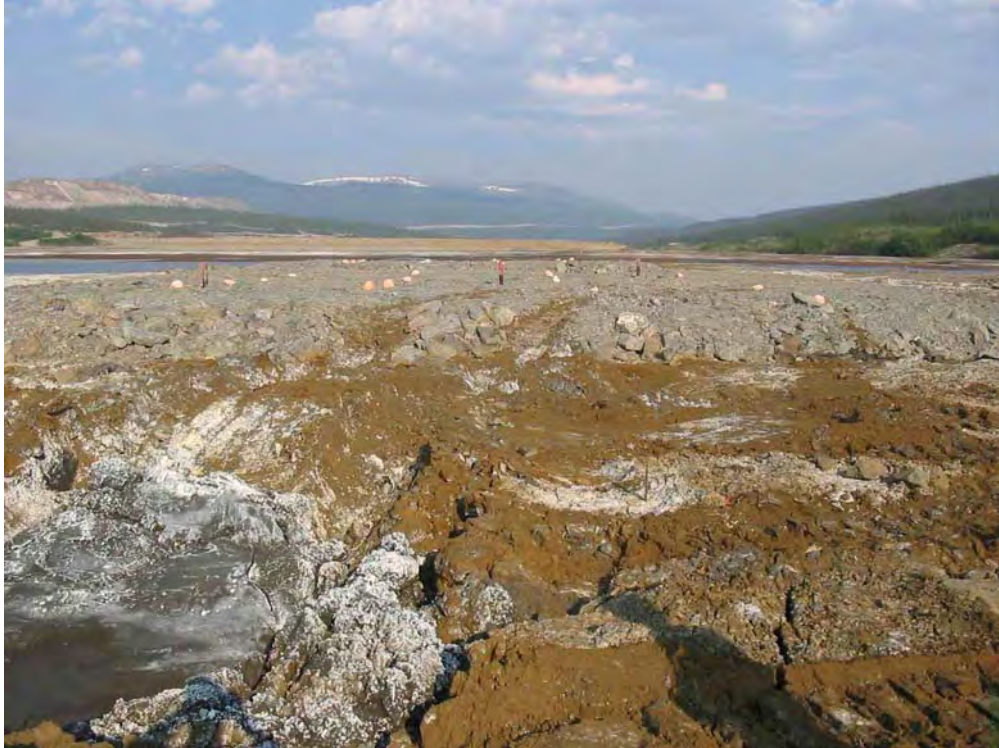
Figure 29. Looking from tailings at western edge of west test cover.

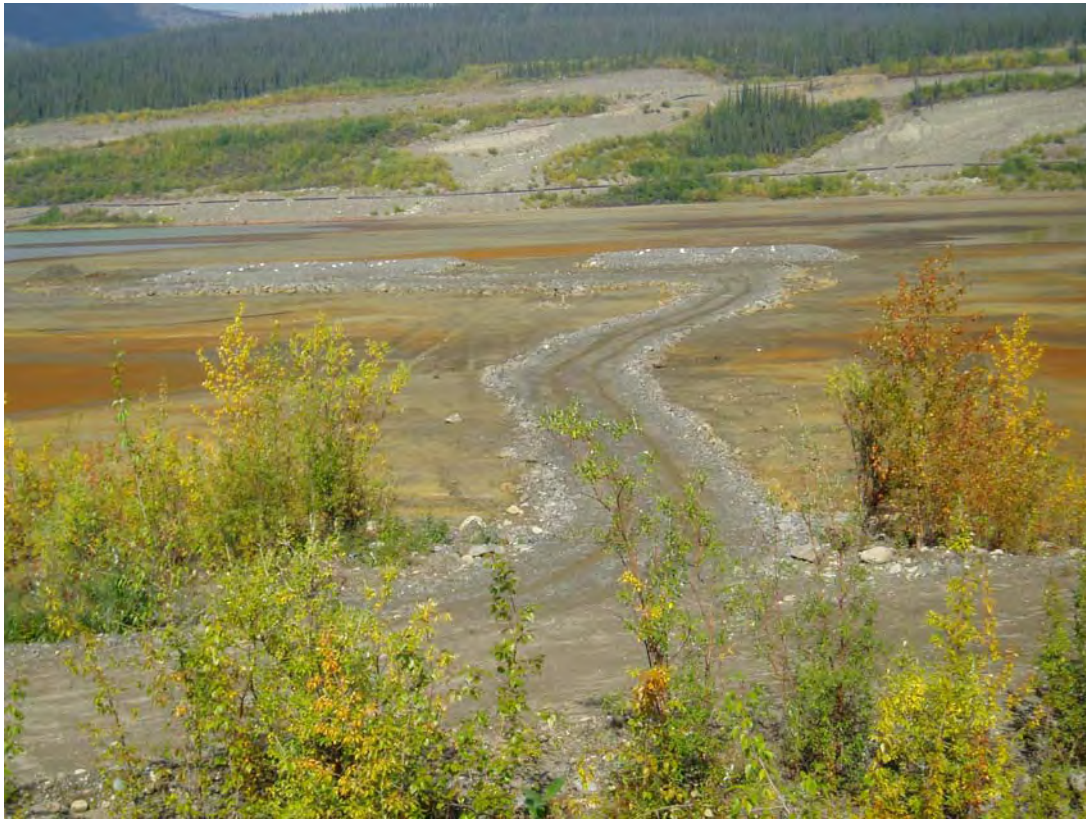
Photo 1: View of tailings trial cover areas from the Rose Creek diversion. The West Pad (including geotextile) is to the left and the East Pad is to the right.

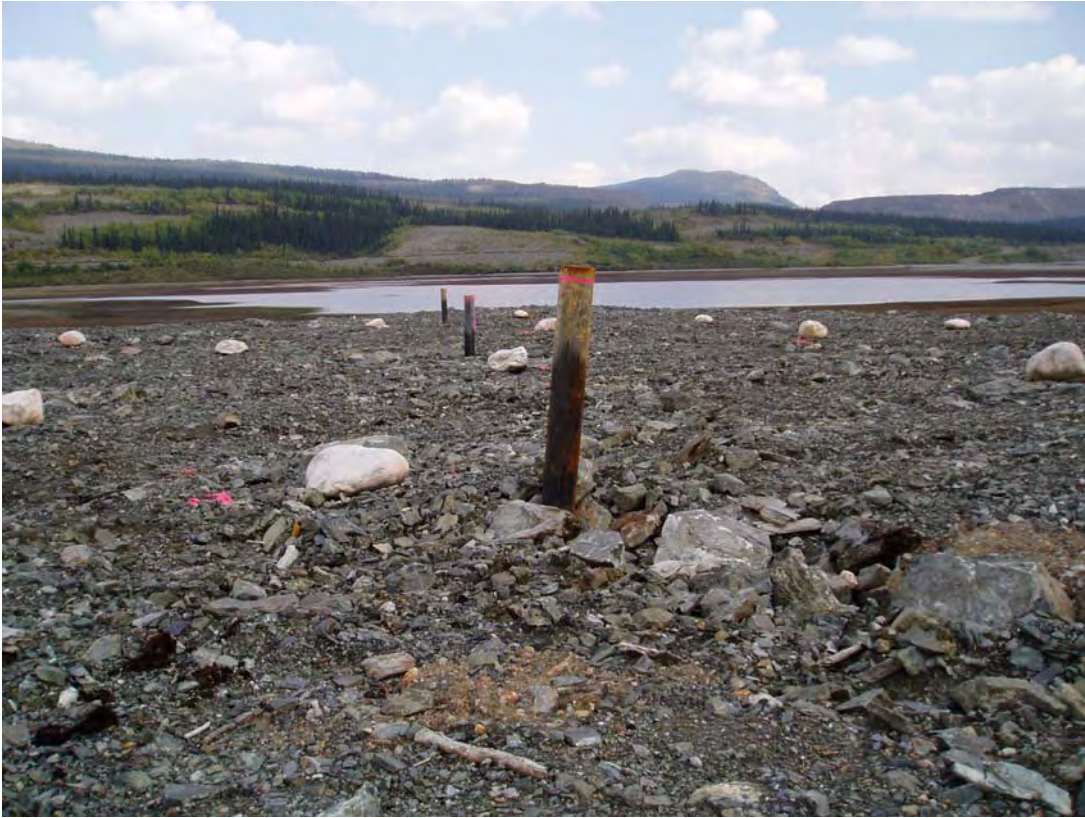
Photo 6: Looking north-east along the primary survey beacons of the East Pad.

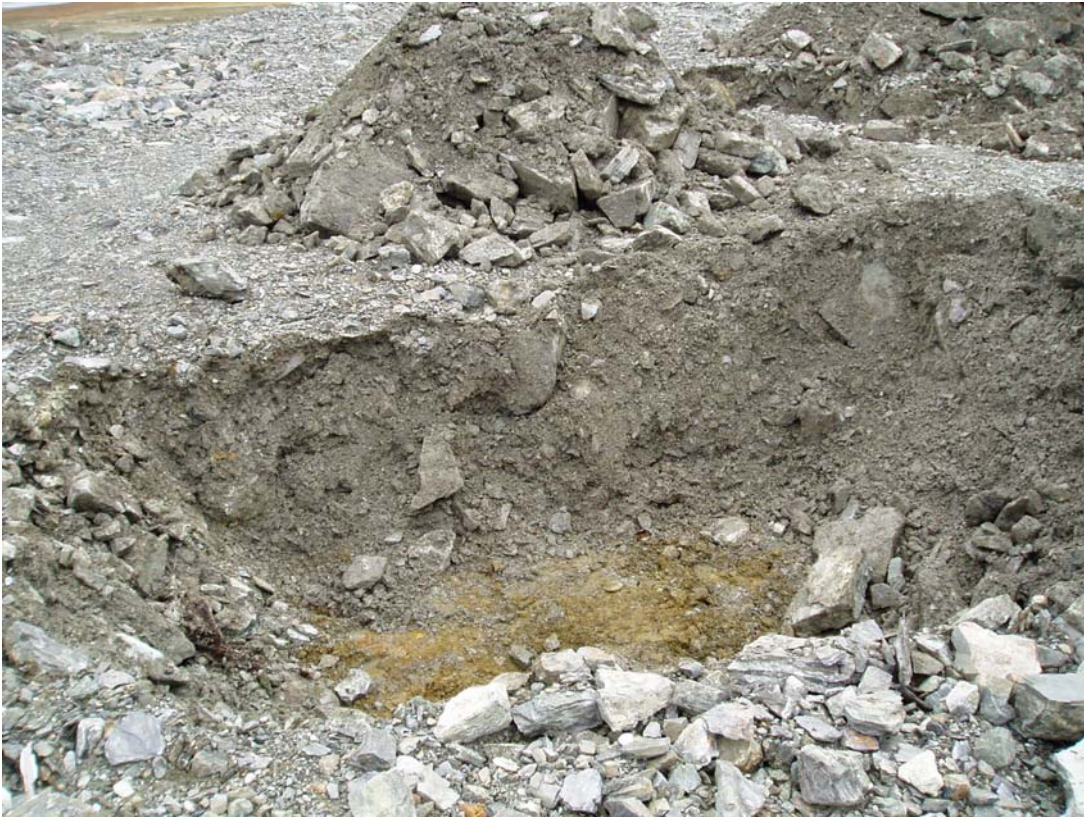
Photo 10: TP-TTC-04-03 Profile showing the range of particle sizes in the cover material.

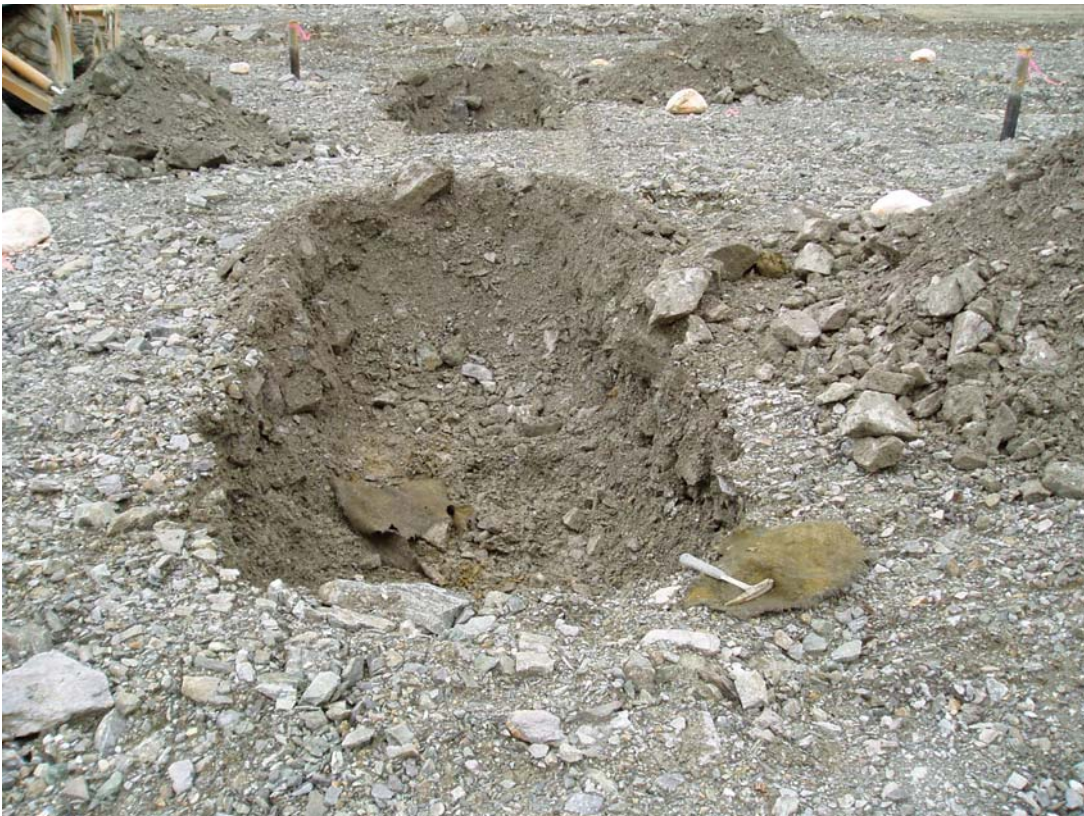
Photo 14: TP-TTC-04-04 Complete view of test pit showing the gradation of the cover material.

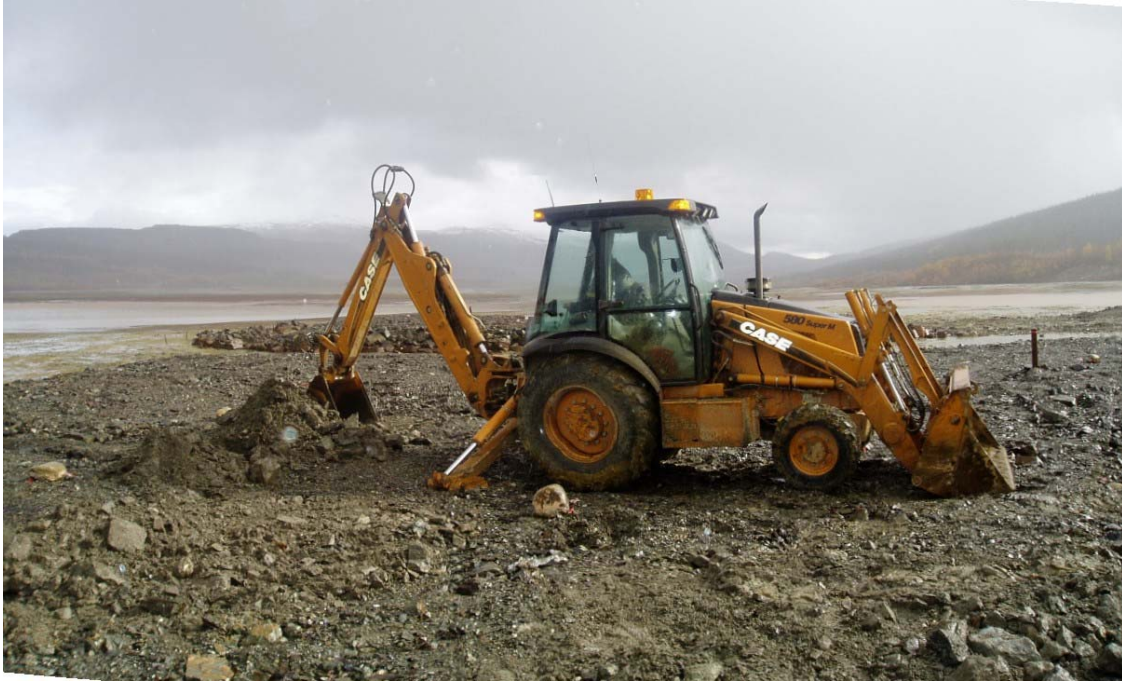
Photo 1: Case 580 Super-M backhoe used for test pit excavations.

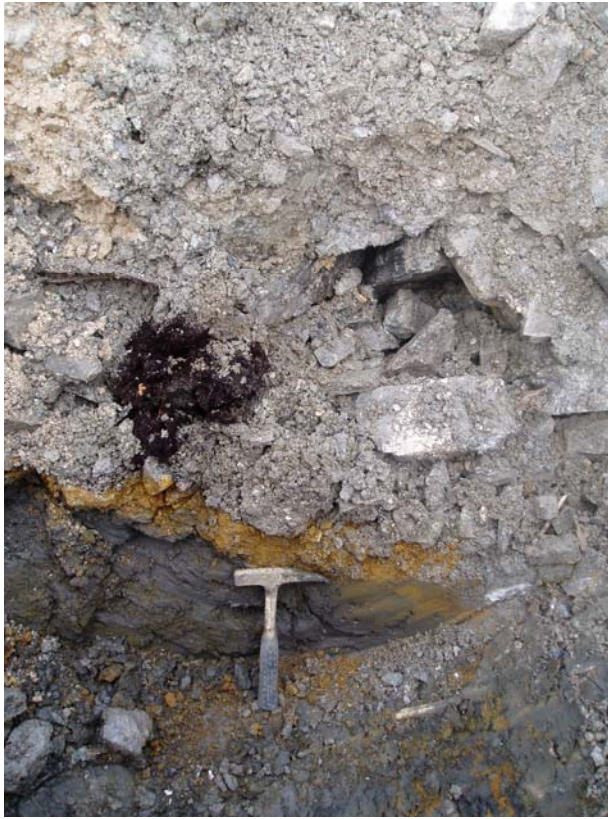
Photo 3: TP-TTC-05-01 Smaller scale view of the transition zone between tailings and the waste rock cover.

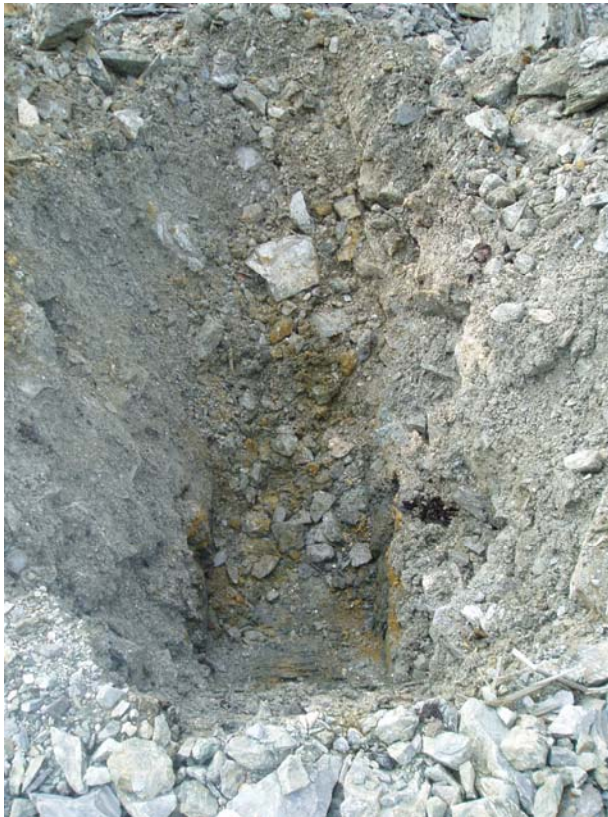
Photo 4: TP-TTC-05-01 View of complete test pit showing range in grain size from fines to boulders measuring 50 cm in diameter.

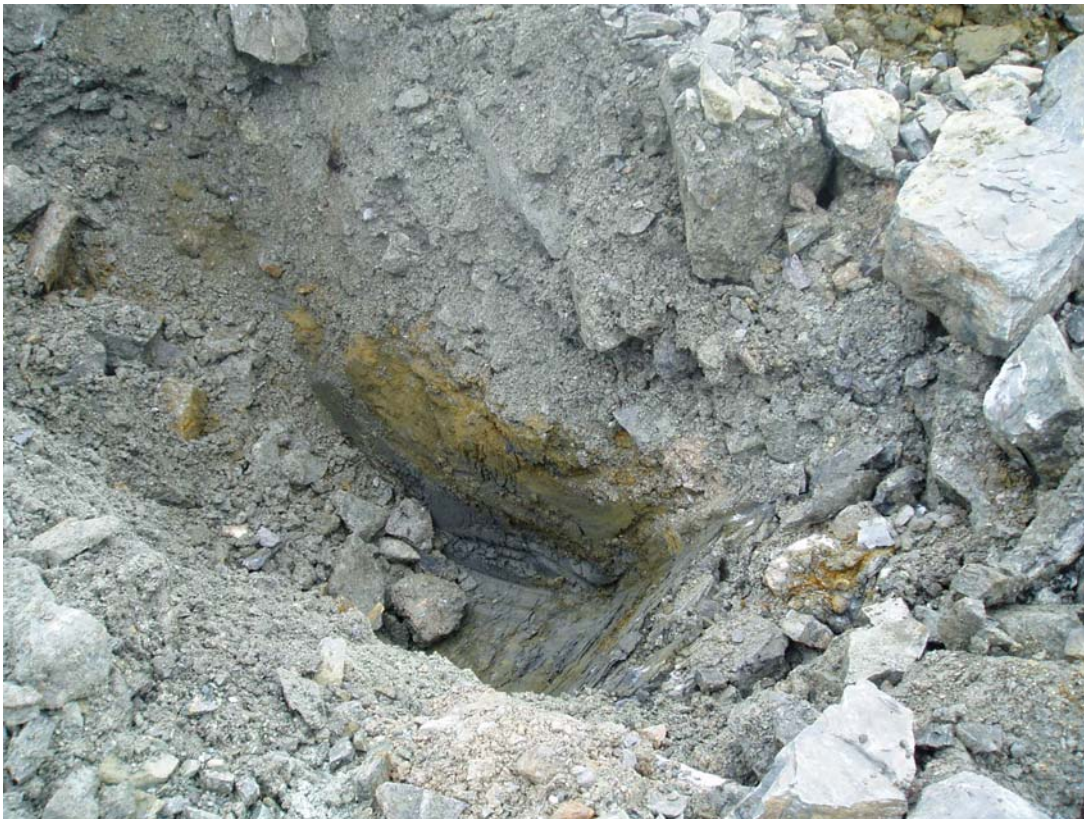
Photo 5: TP-TTC-05-02 Profile of test pit showing range of particle sizes in cover material.

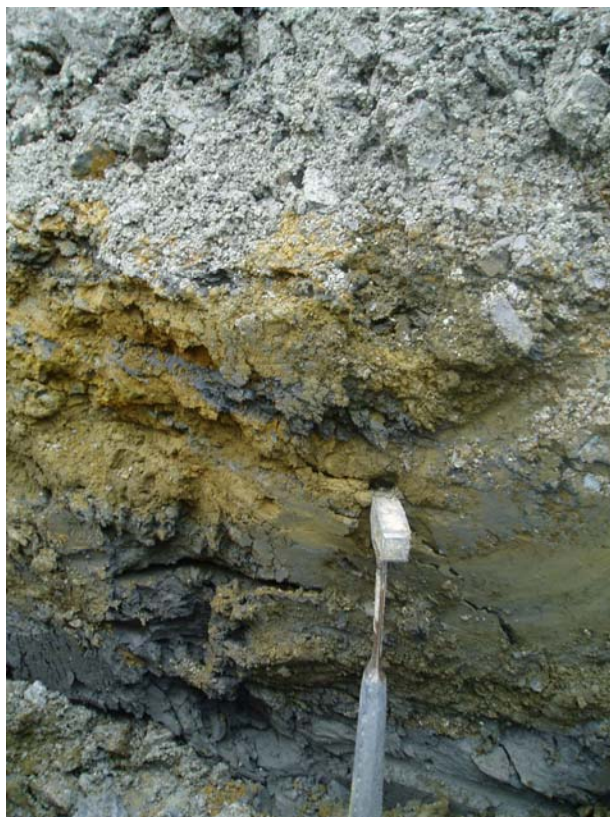
Photo 6: TP-TTC-05-02 View of the interface between the tailings and the waste rock cover.

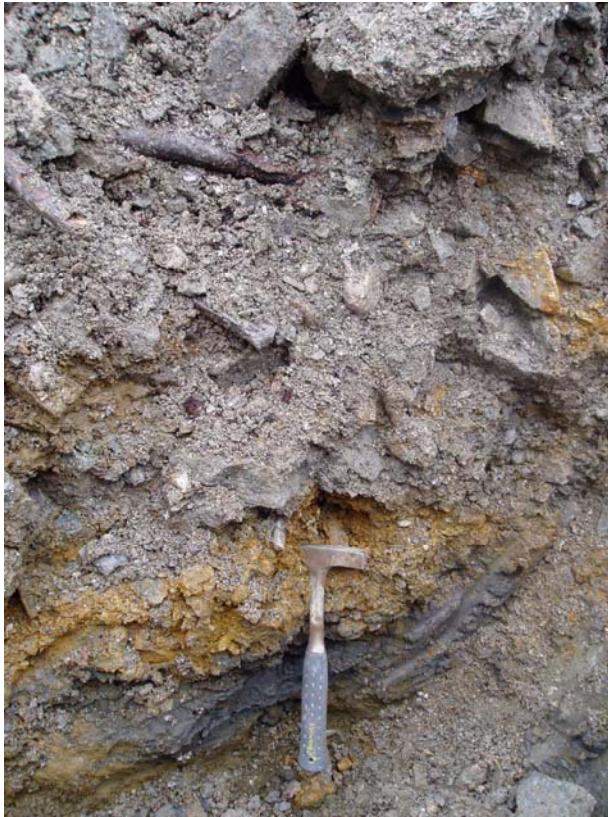
Photo 7: TP-TTC-05-03 profile of the test pit showing the interface between the tailings and the waste rock cover.

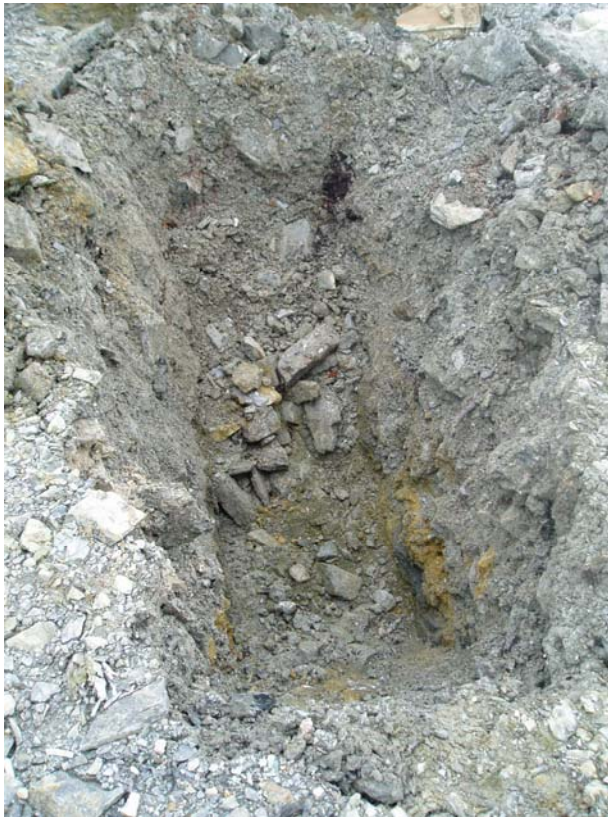
Photo 8: TP-TTC-05-03 View of complete test pit showing range in grain size from fines to boulders measuring 50 cm in diameter.

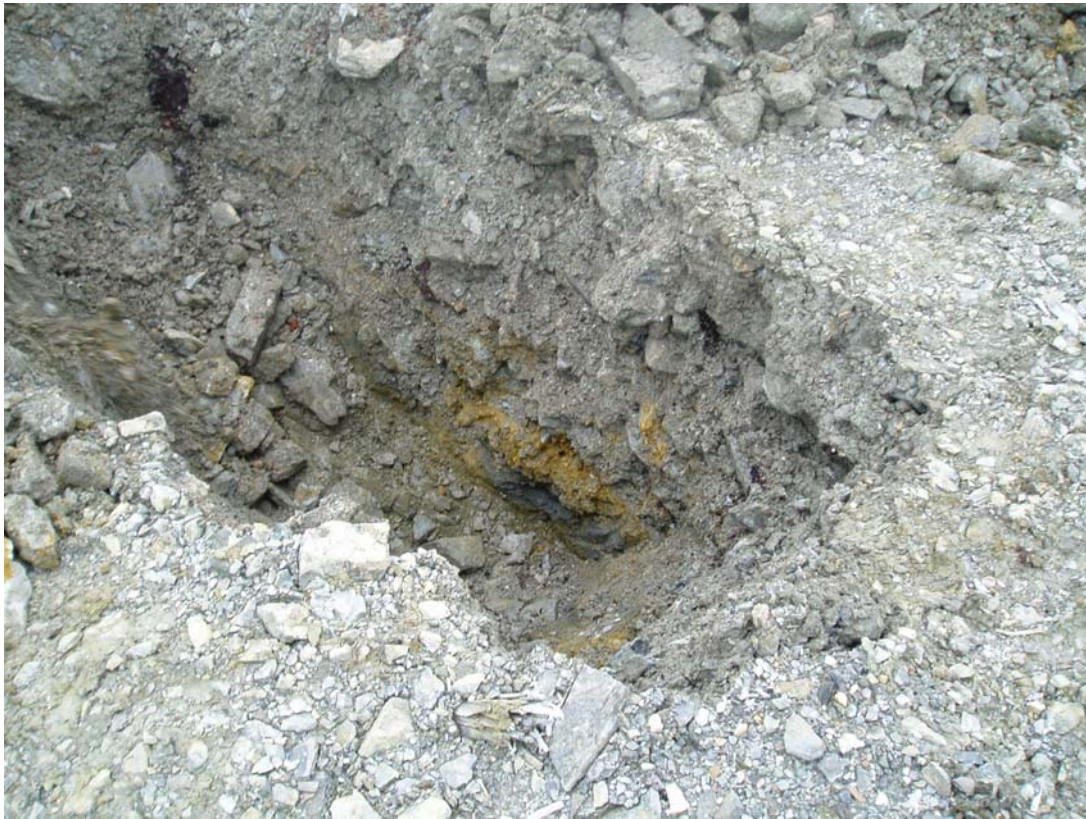
Photo 9: TP-TTC-05-03 Profile showing the range of particle sizes in the cover material.

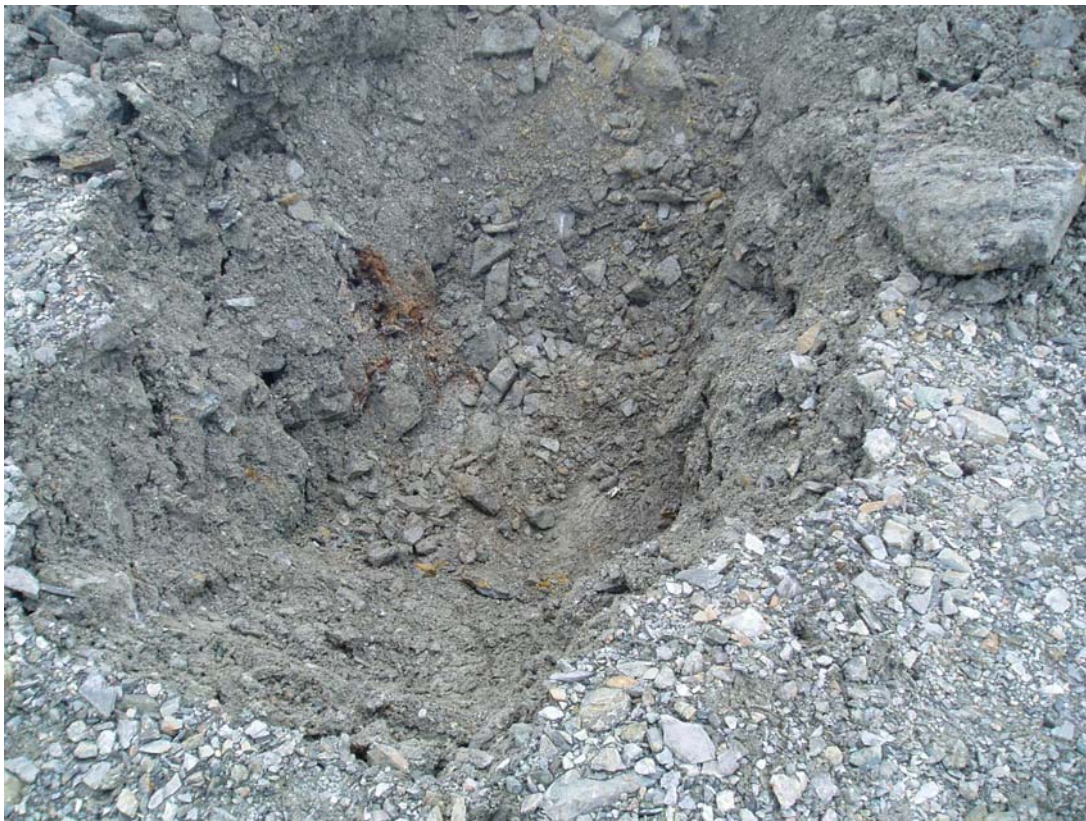
Photo 13: TP-TTC-05-05 Complete view of test pit showing the gradation of the cover material.
