Anvil Range Mining Complex: Results from Trial Covers at Rose Creek Tailings Impoundment

2006/07 Task 17b

DELOITTE & TOUCHE INC.

FARO MINE CLOSURE PLANNING OFFICE

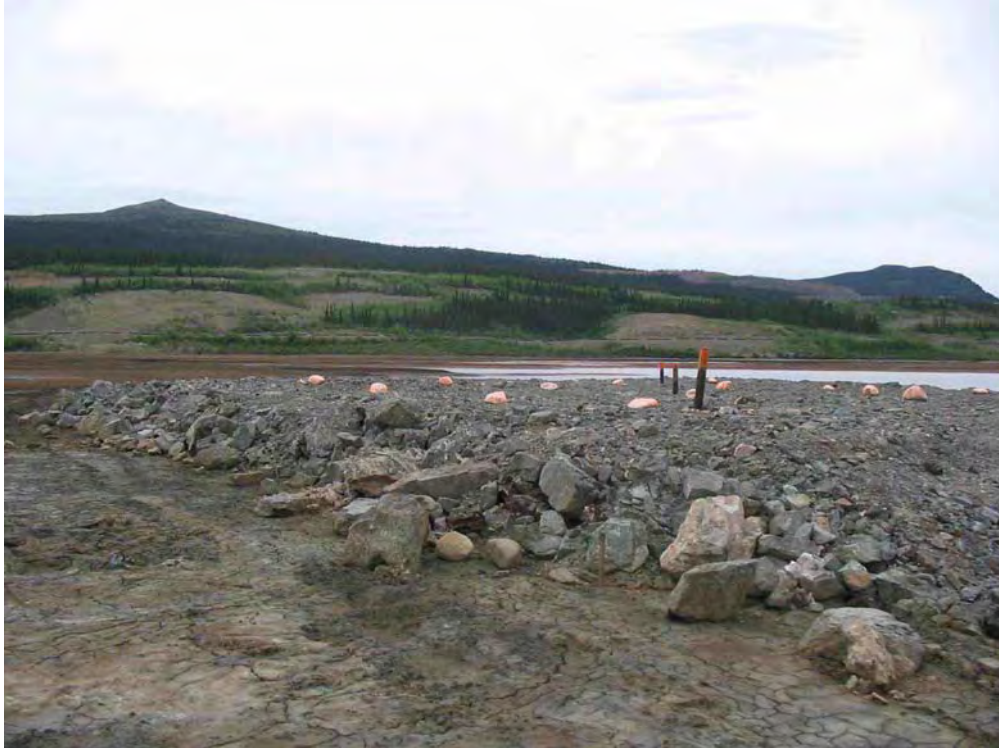
Figure 9. East test cover: Western edge, showing NW surface, steel columns, and marker stones.

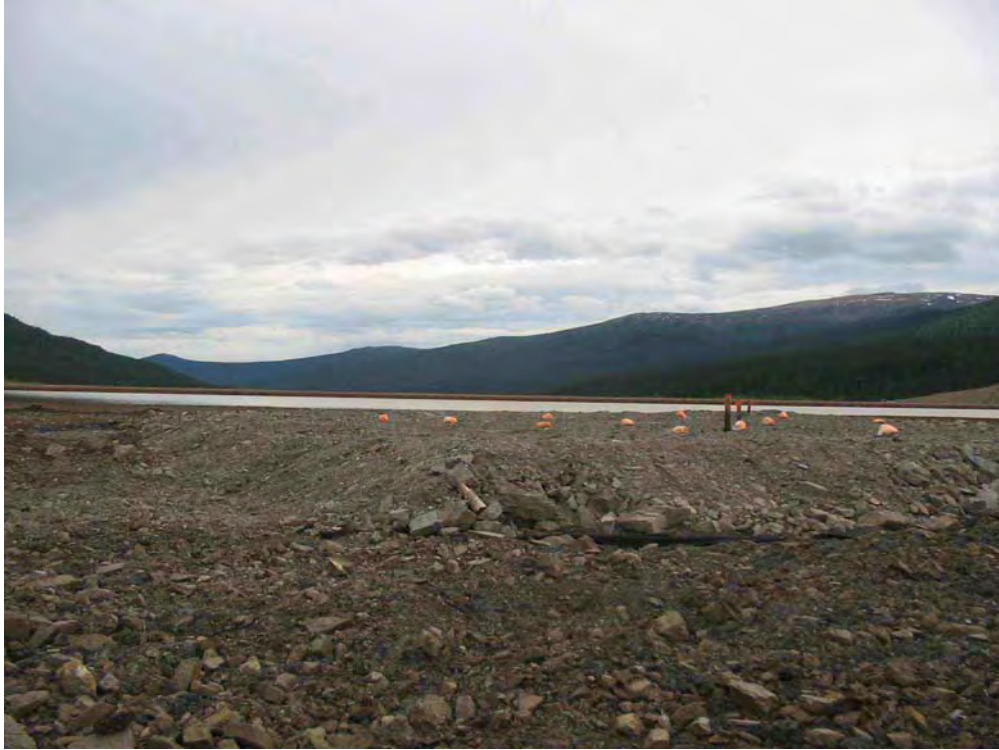
Figure 11. West test cover: Southeastern corner, showing SW surface, marker stones and steel columns.

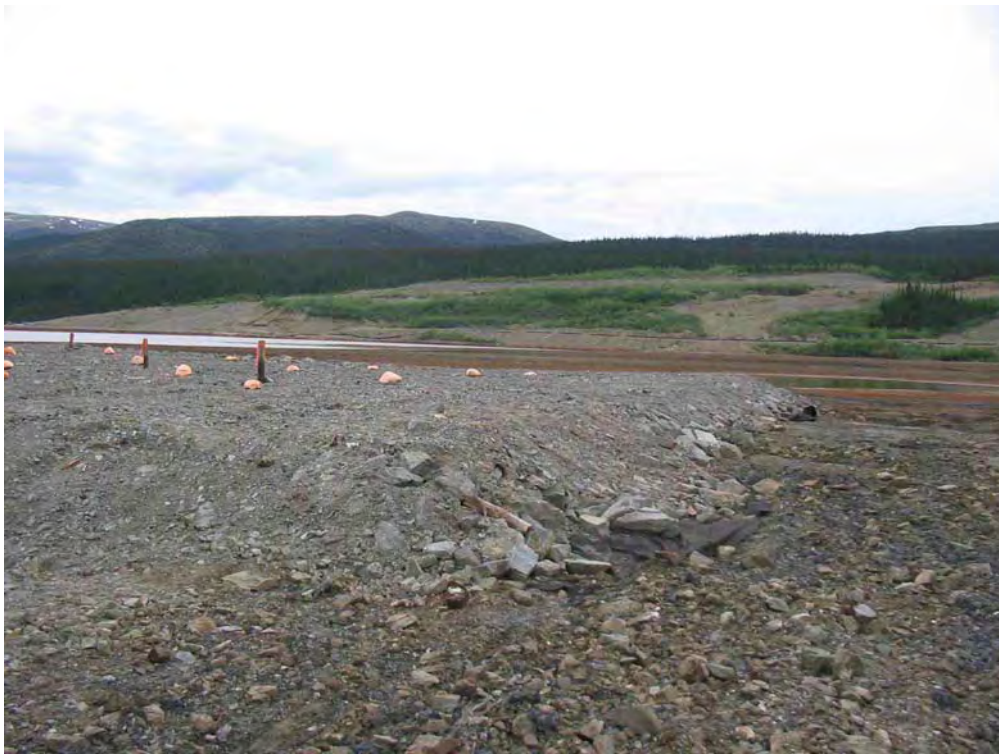
Figure 12. West test cover: Eastern edge, showing NE surface and marker stones.

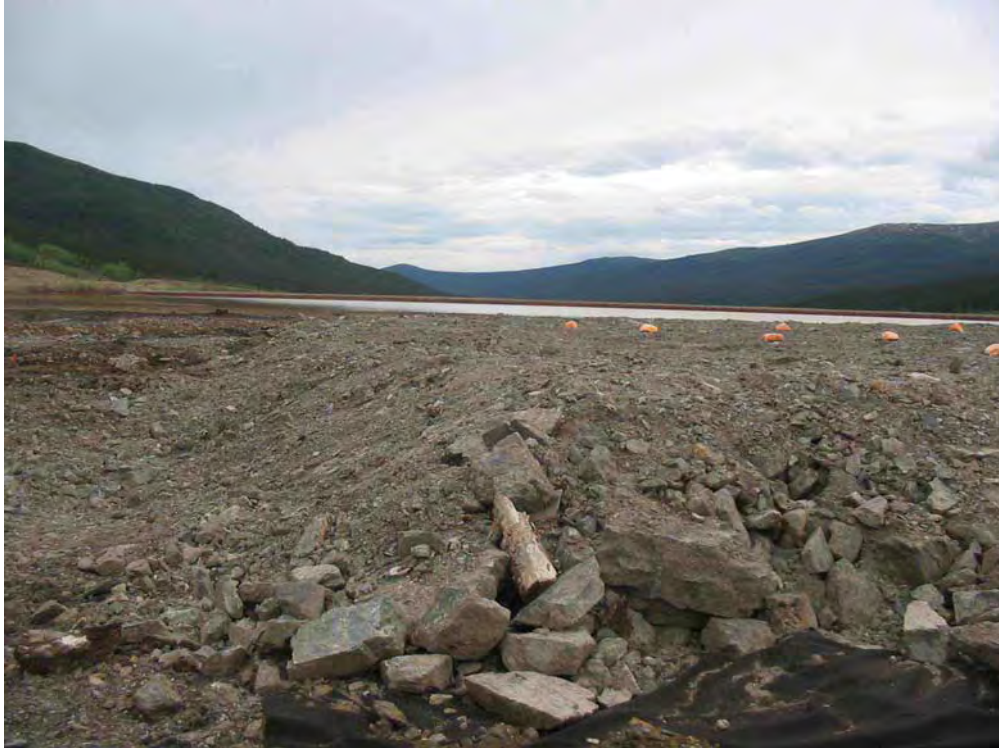
Figure 13. West test cover: Southern edge, showing SW surface and marker stones.

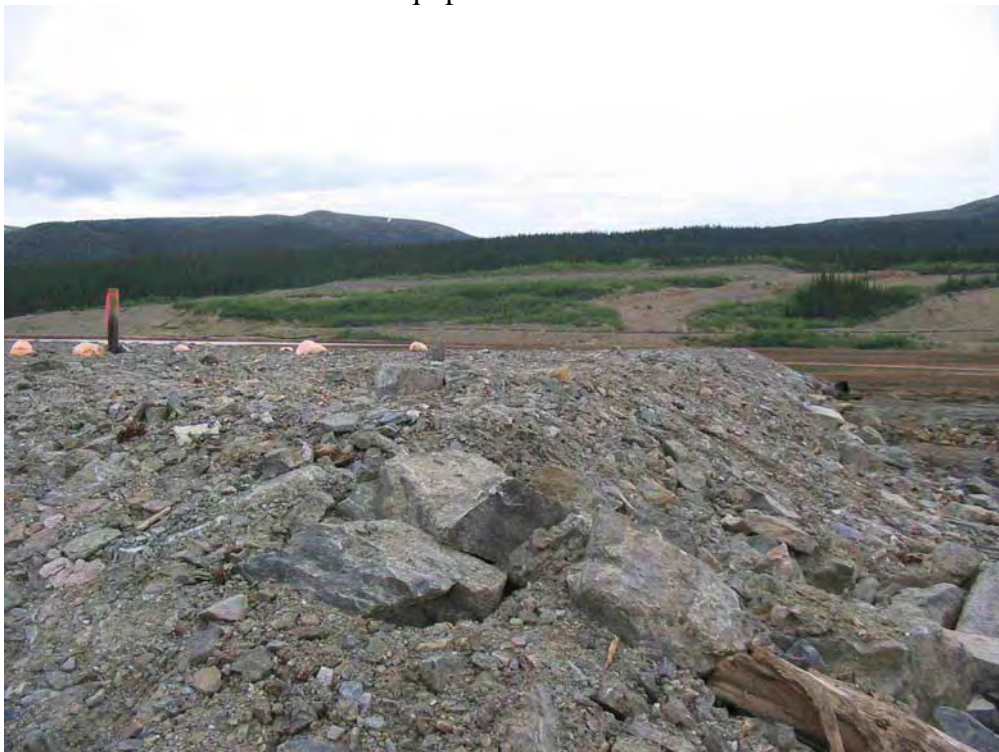
Figure 18. West test cover: Eastern edge from SE corner, showing regular profile.

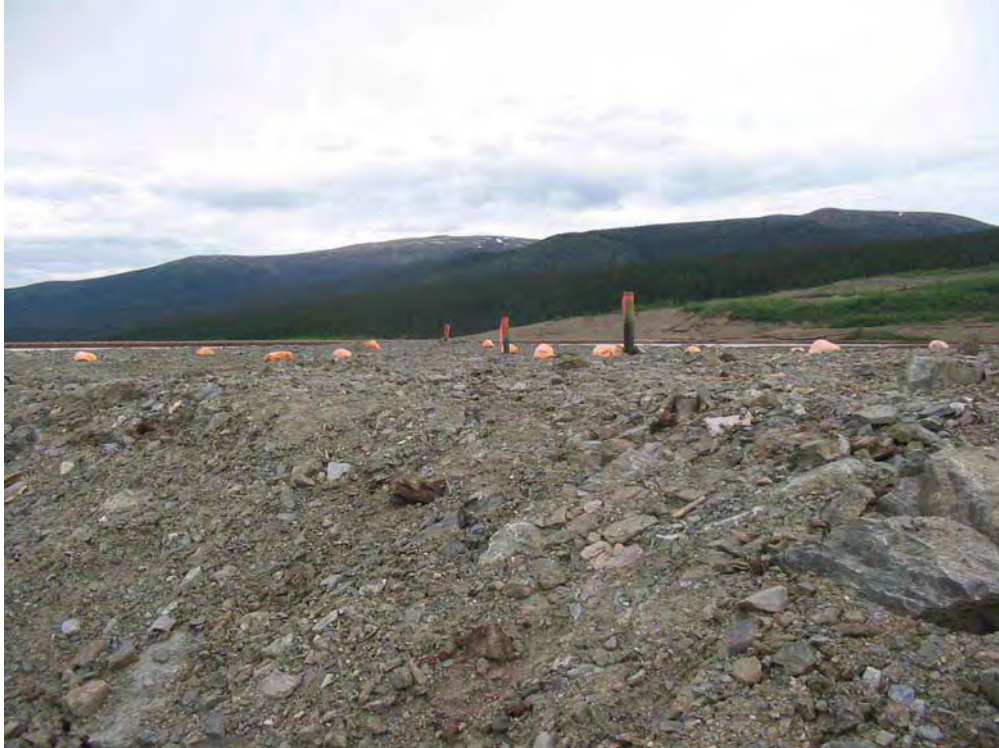
Figure 19. West test cover: Looking NW from SE corner at vertical steel columns.

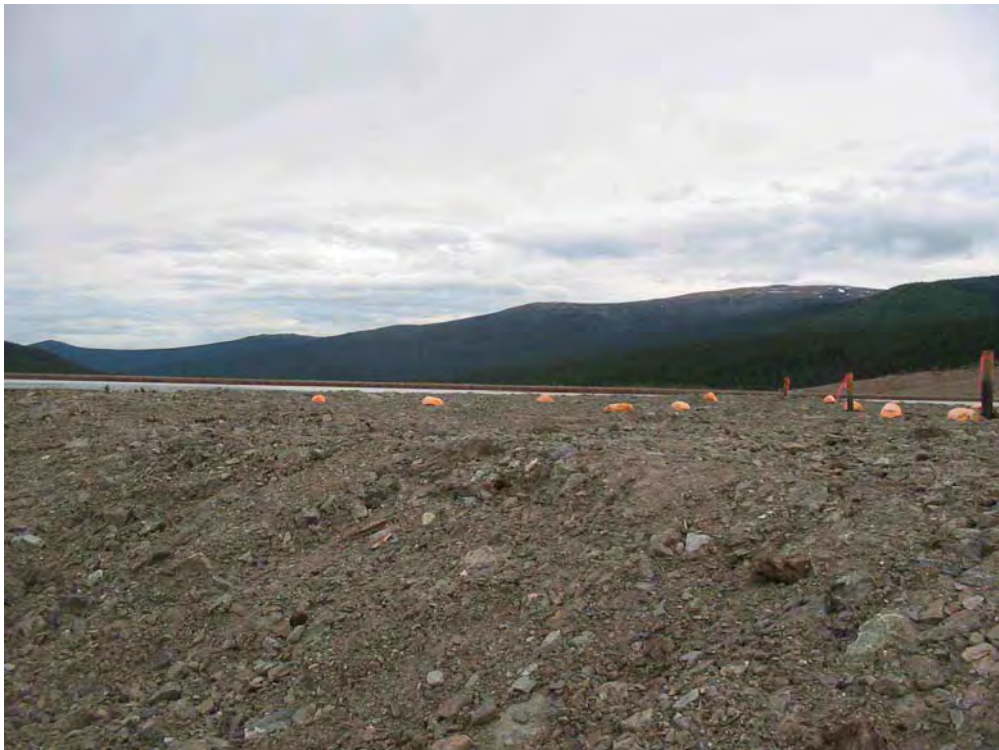
Figure 20. West test cover: Looking west from SE corner across surface of test cover.

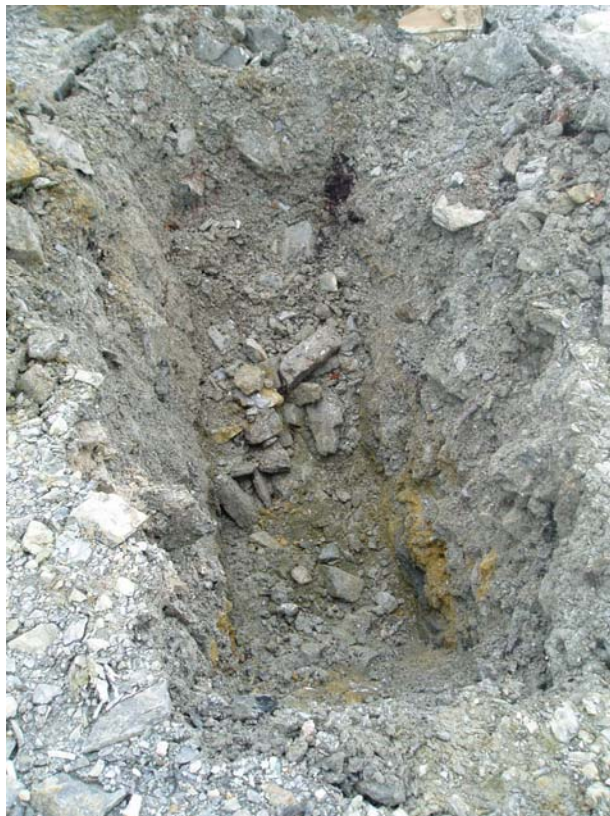
Photo 8: TP-TTC-05-03 View of complete test pit showing range in grain size from fines to boulders measuring 50 cm in diameter.
