Anvil Range Mining Complex Results from Trial covers at Rose Creek Tailings Impoundment: 2007 Data Summary

2007 Task 18b - FINAL

Deloitte and Touche Inc.

May 2008

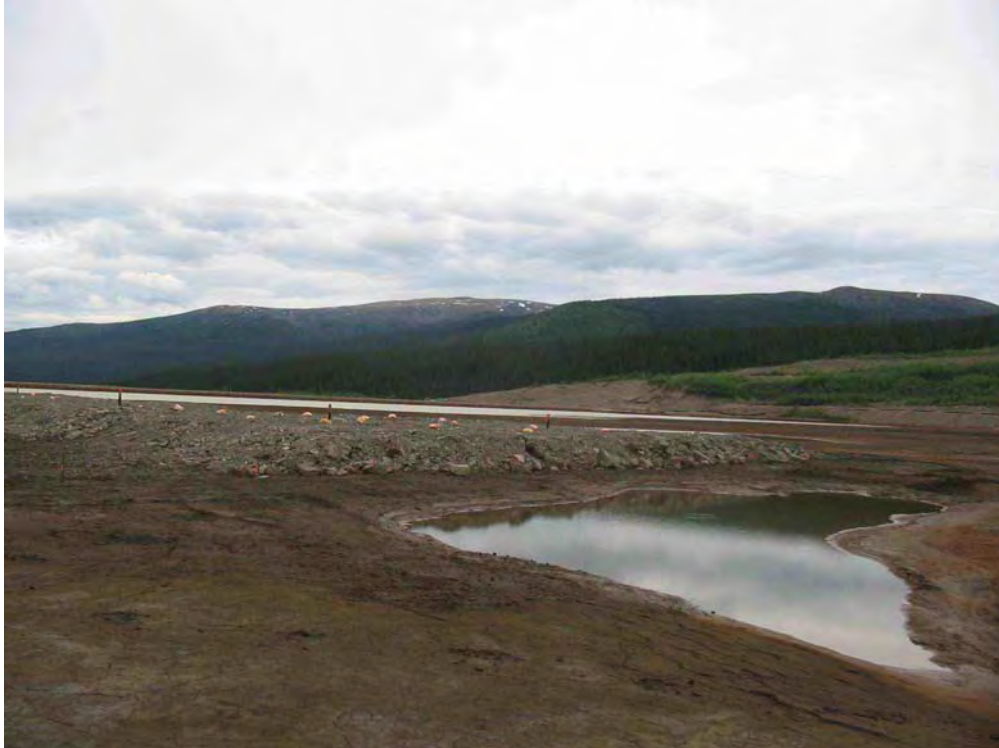
Figure 3. East test cover: Eastern edge, showing NE surface and marker stones.

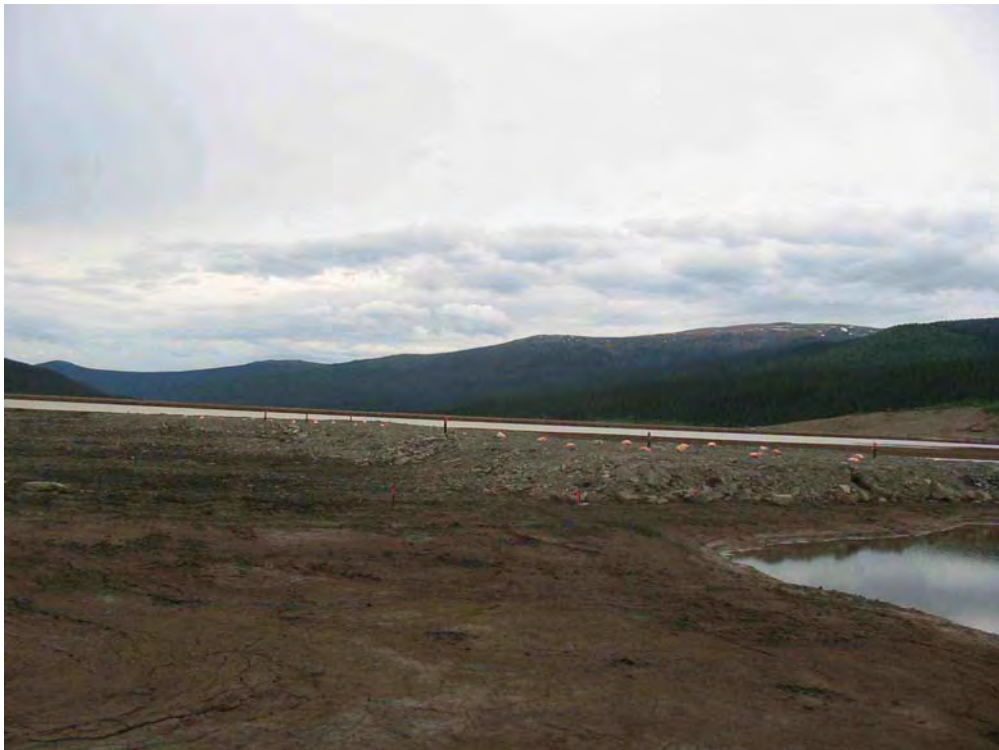
Figure 4. East test cover: Eastern edge, showing SW surface and marker stones.

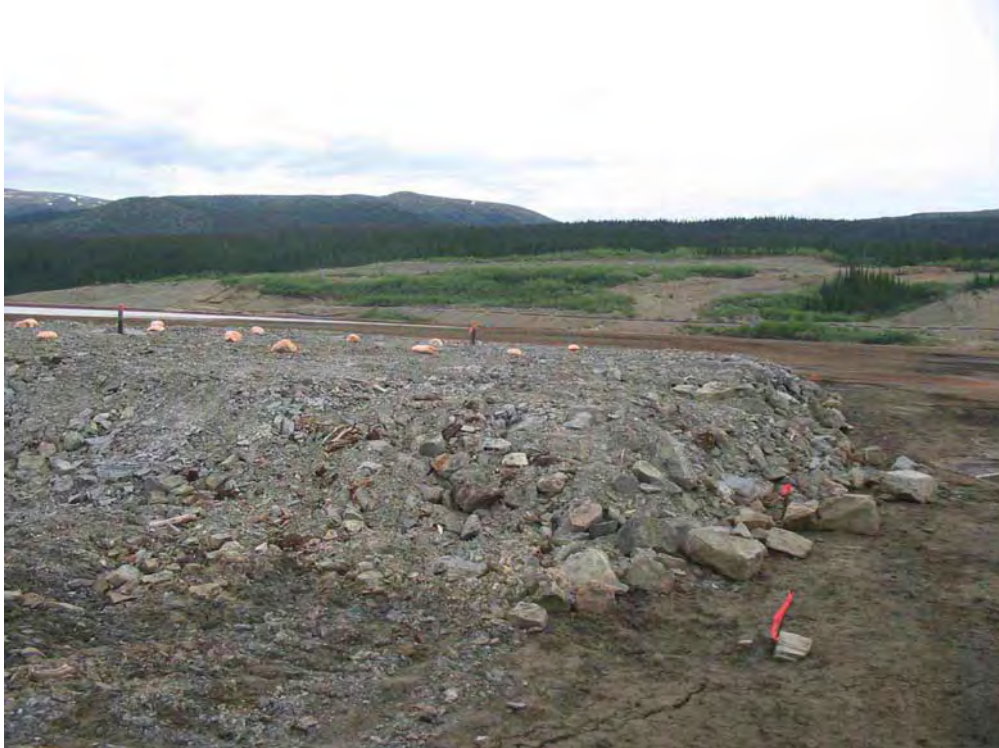
Figure 5. East test cover: Eastern edge, showing slightly undulating surface.

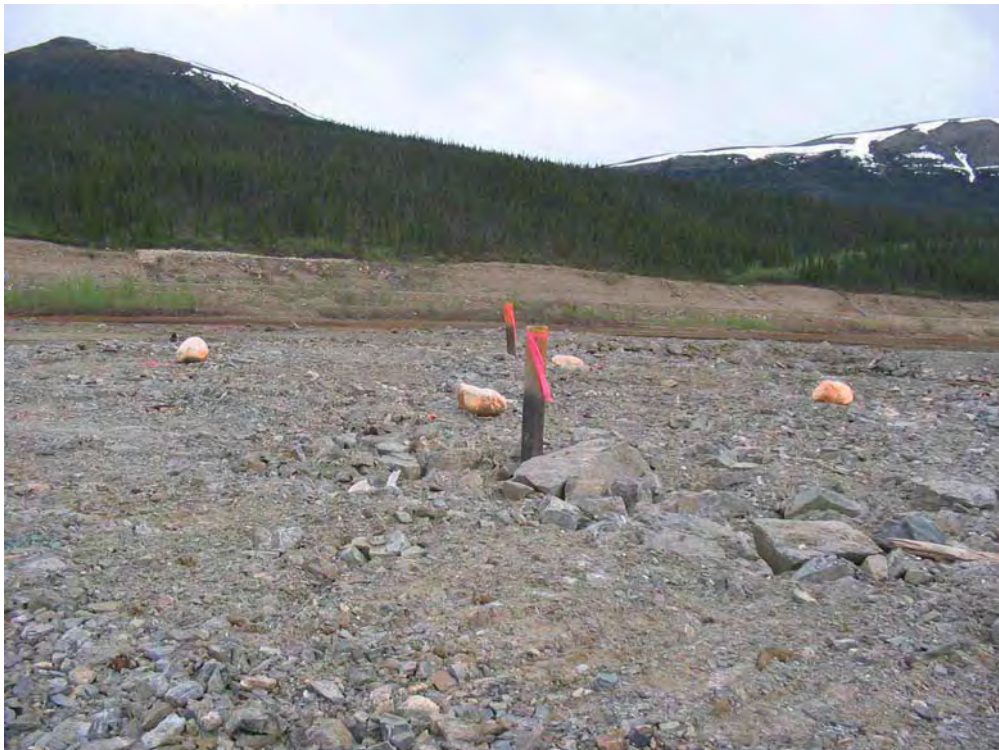
Figure 8. East test cover: Looking SW at steel columns.

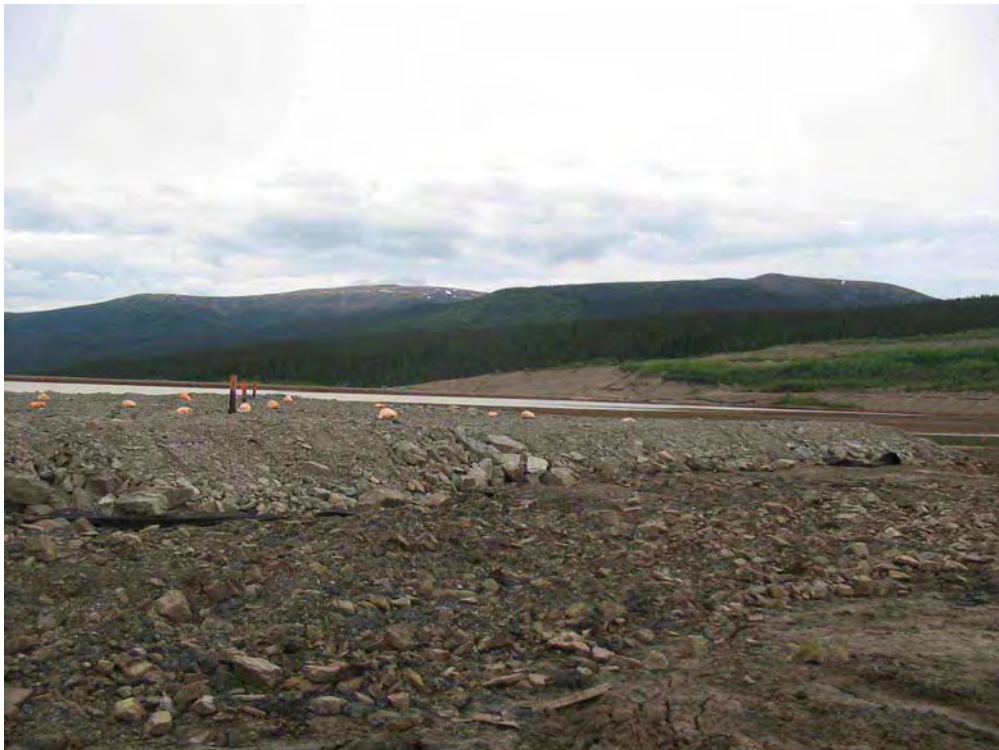
Figure 10. West test cover: Eastern edge, showing NE surface and marker stones.

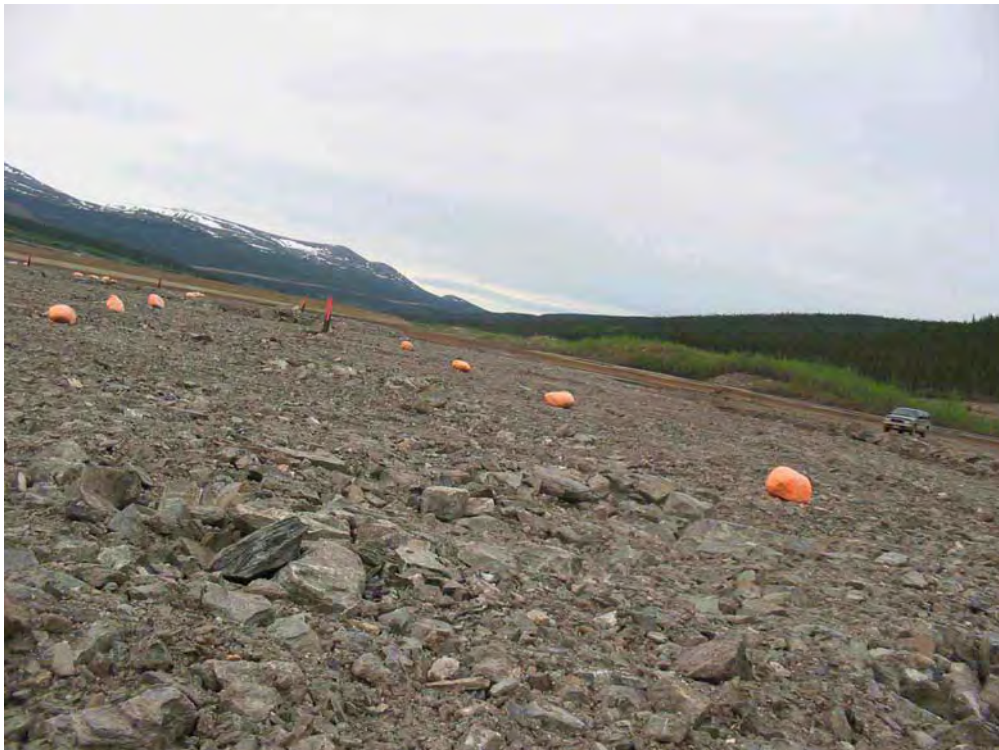
Figure 16. West test cover: Looking southeast at traffic surface of test cover.

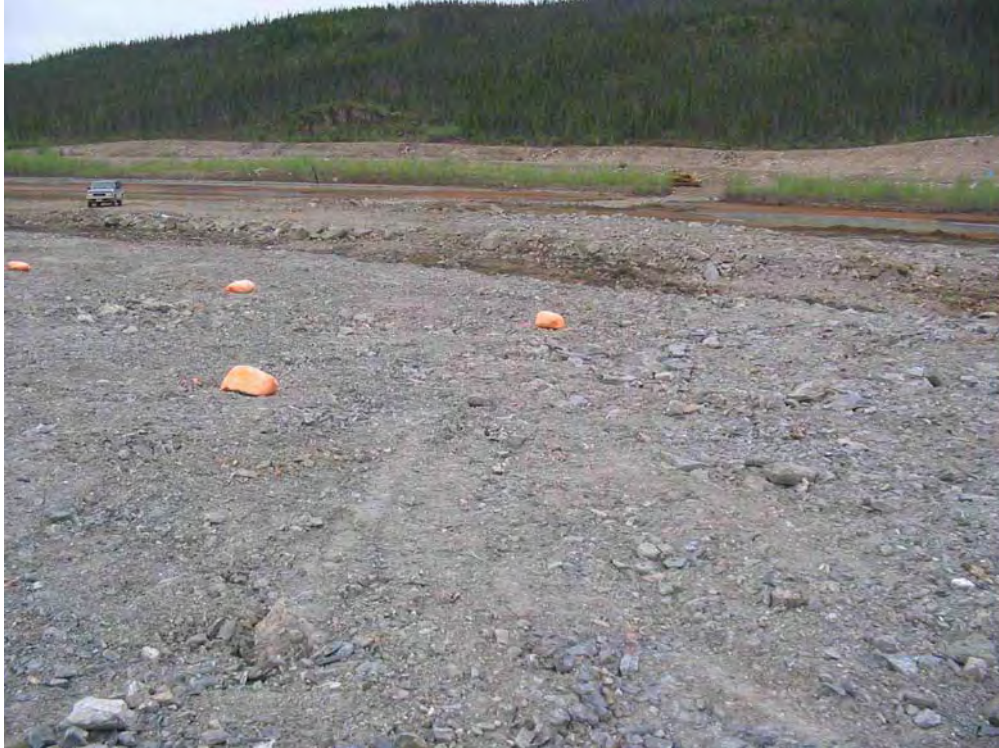
Figure 17. West test cover: Southern edge, from center of cover, showing minor equipment tracks.

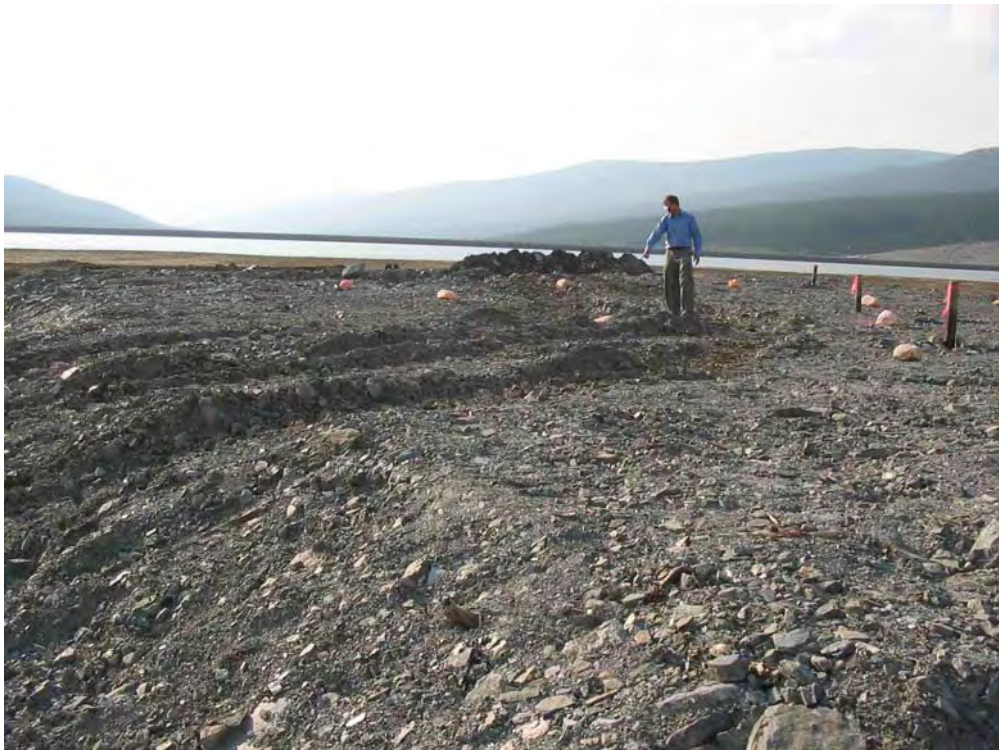
Figure 22. West test cover: Southern edge, showing equipment egress point.

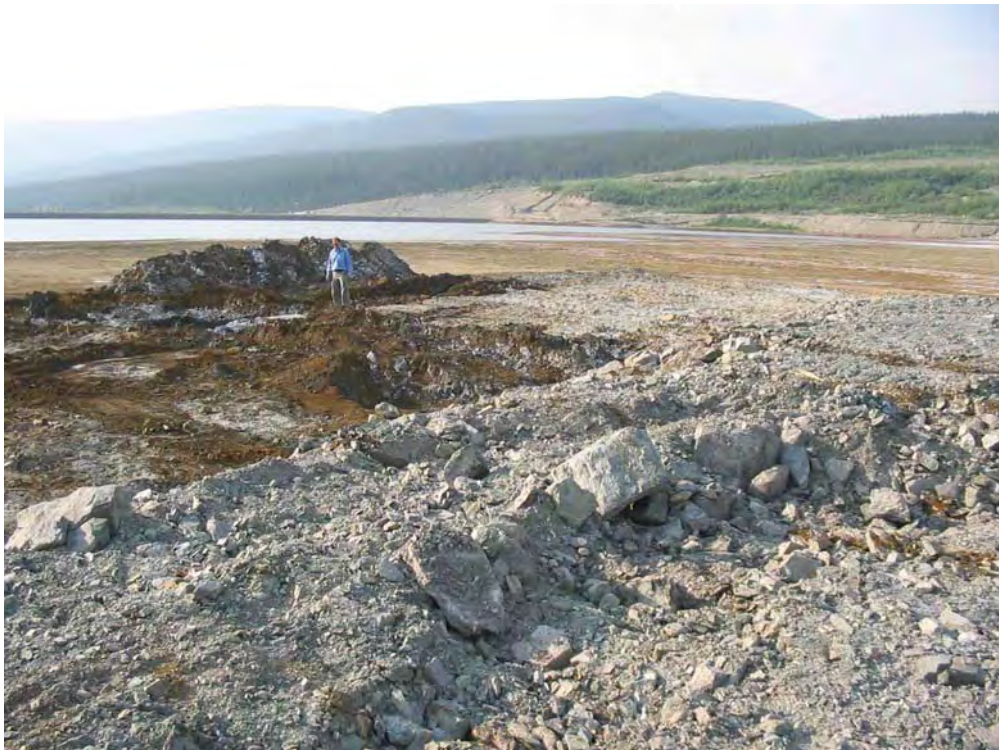
Figure 26. West test cover: Western edge and adjacent disturbed tailings.

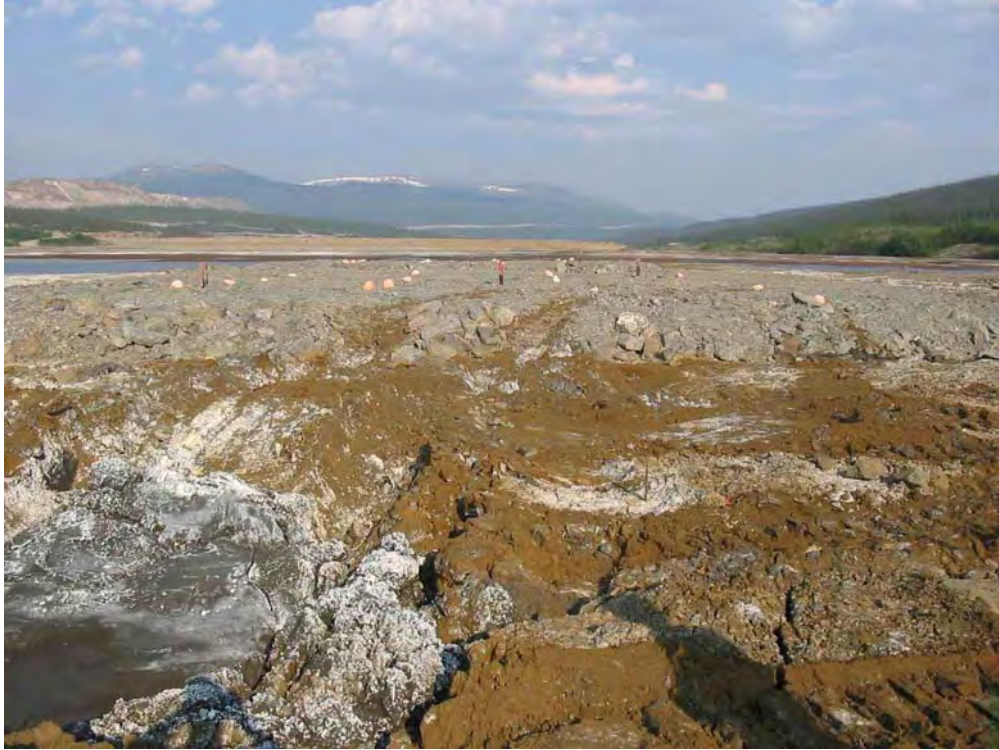
Figure 29. Looking from tailings at western edge of west test cover.

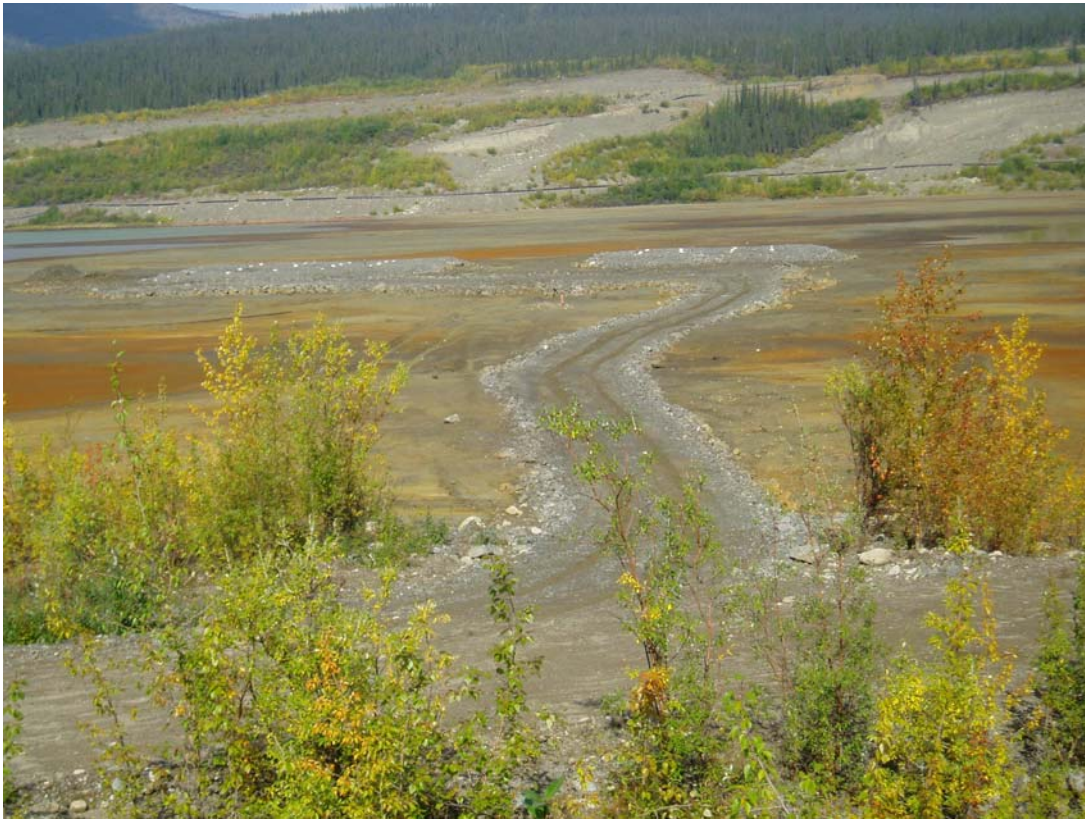
Photo 1: View of tailings trial cover areas from the Rose Creek diversion. The West Pad (including geotextile) is to the left and the East Pad is to the right.

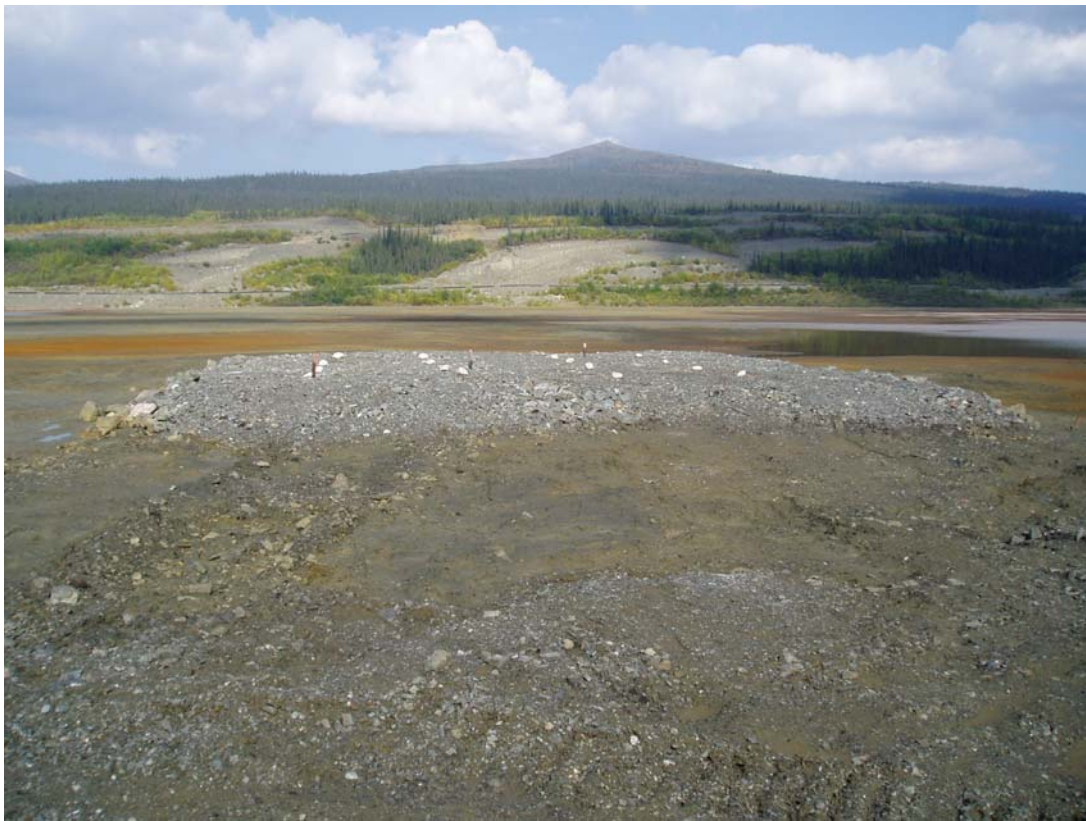
Photo 3: Looking north towards the East Pad. Note the standing water in the background.

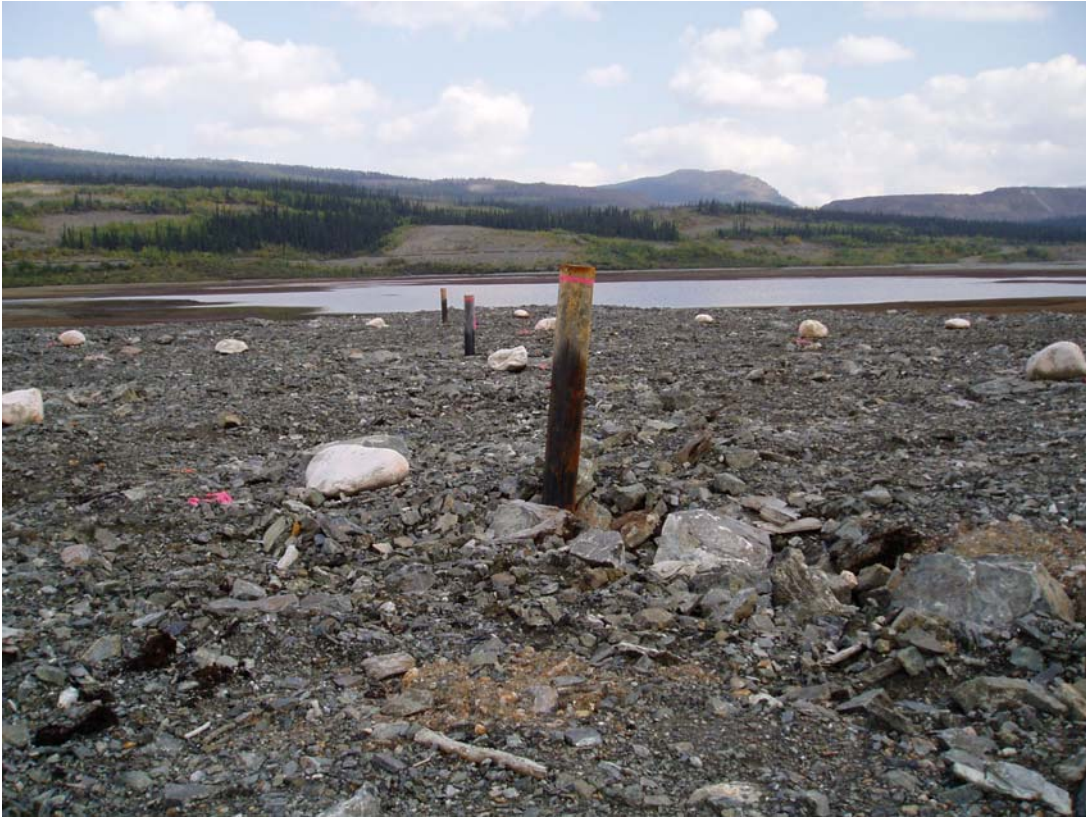
Photo 6: Looking north-east along the primary survey beacons of the East Pad.

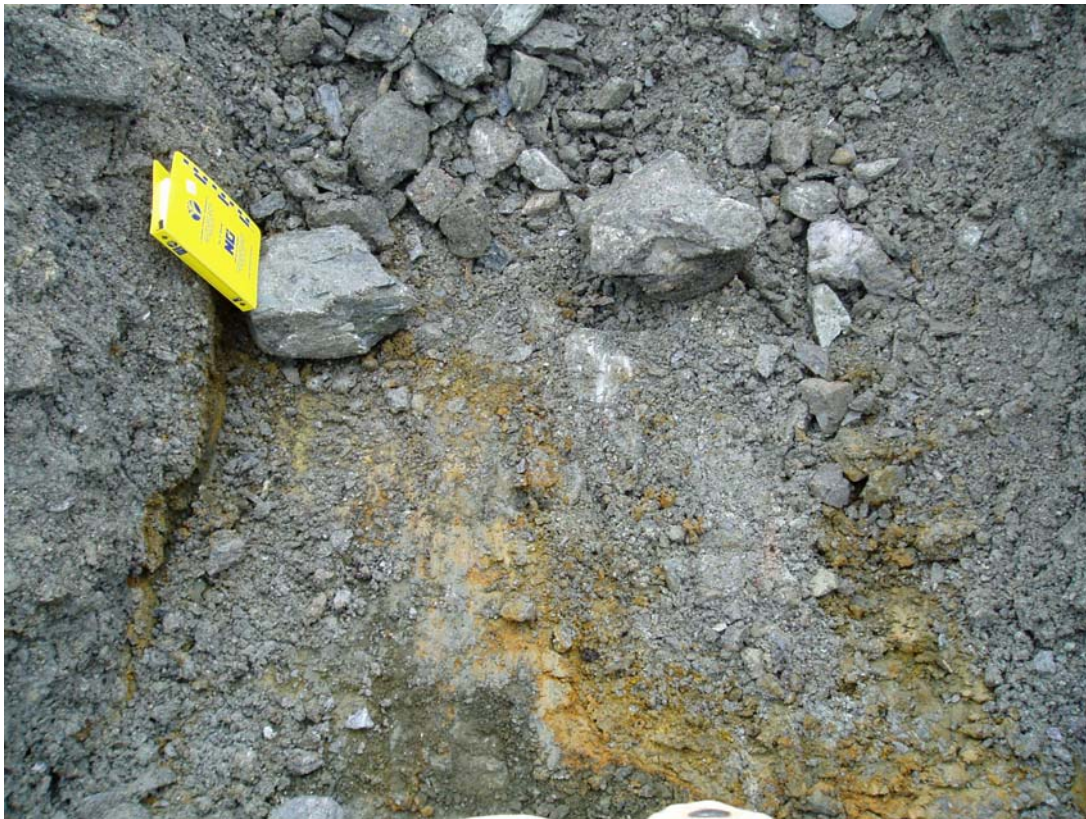
Photo 2: TP-TTC-04-01 Base of test pit excavation into tailings.

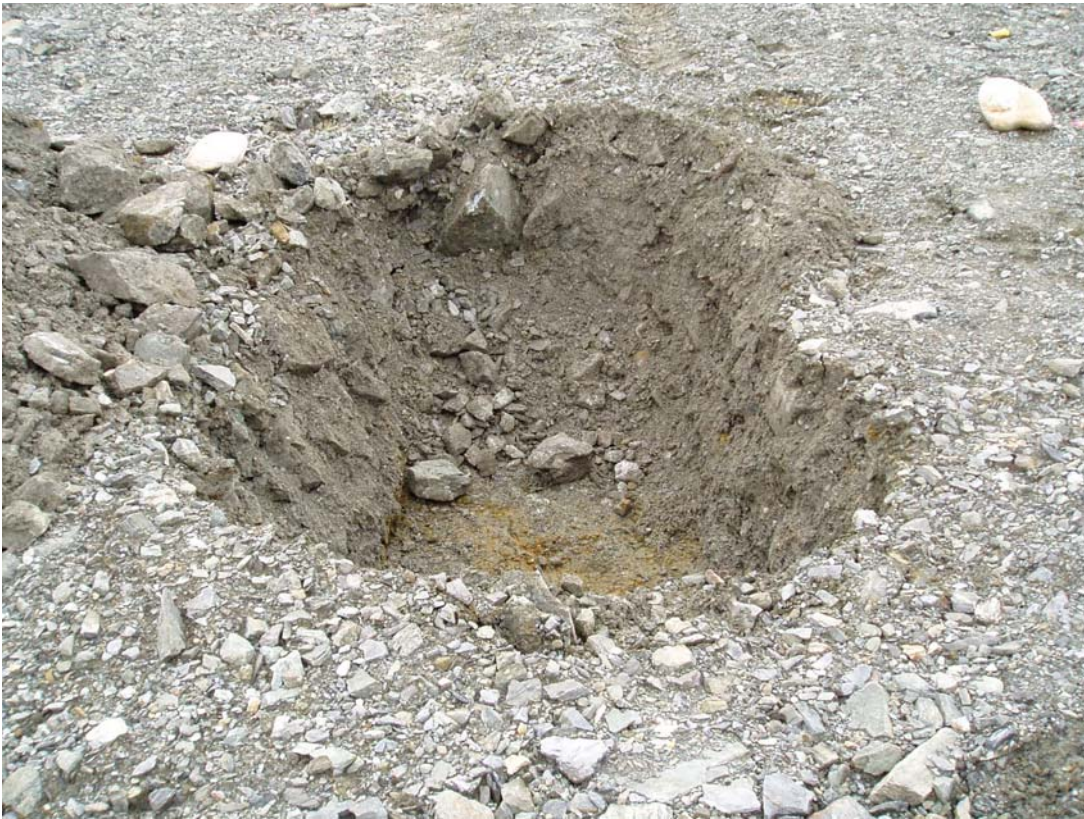
Photo 3: TP-TTC-04-01 View of complete test pit showing the range amount of fines present in the cover material.

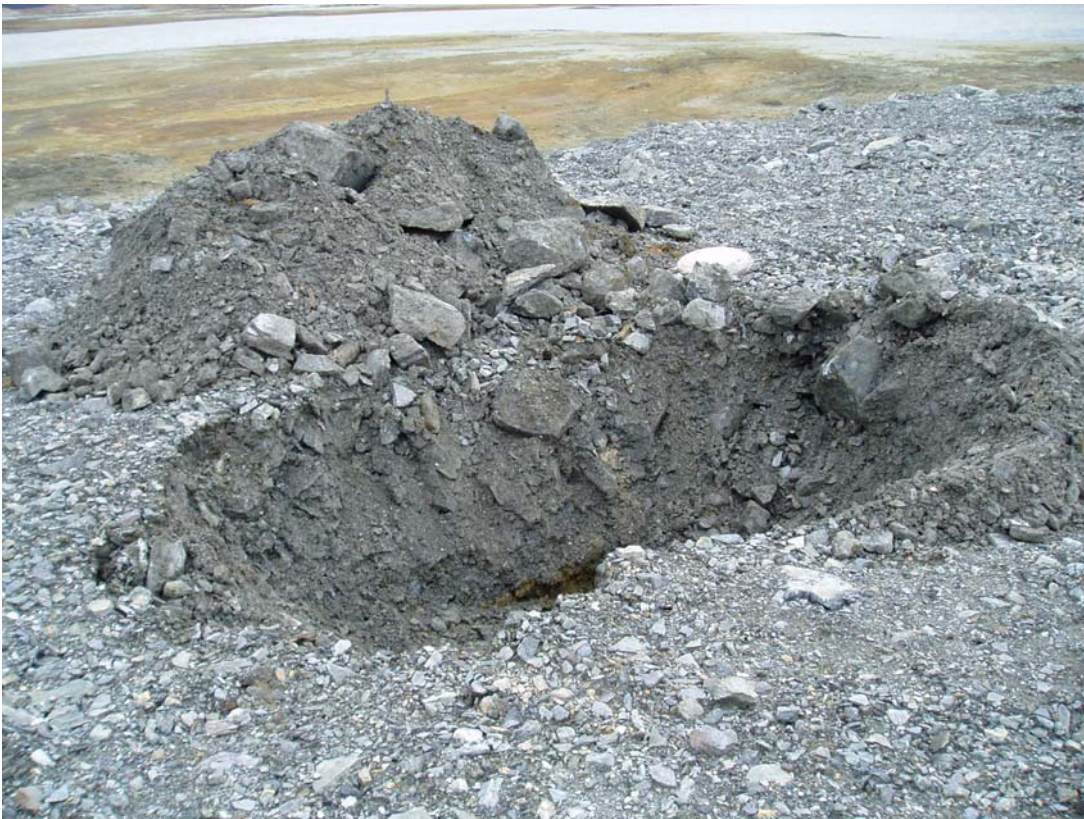
Photo 4: TP-TTC-04-01 View of complete test pit showing range in grain size from fines to boulders measuring 50 cm in diameter.

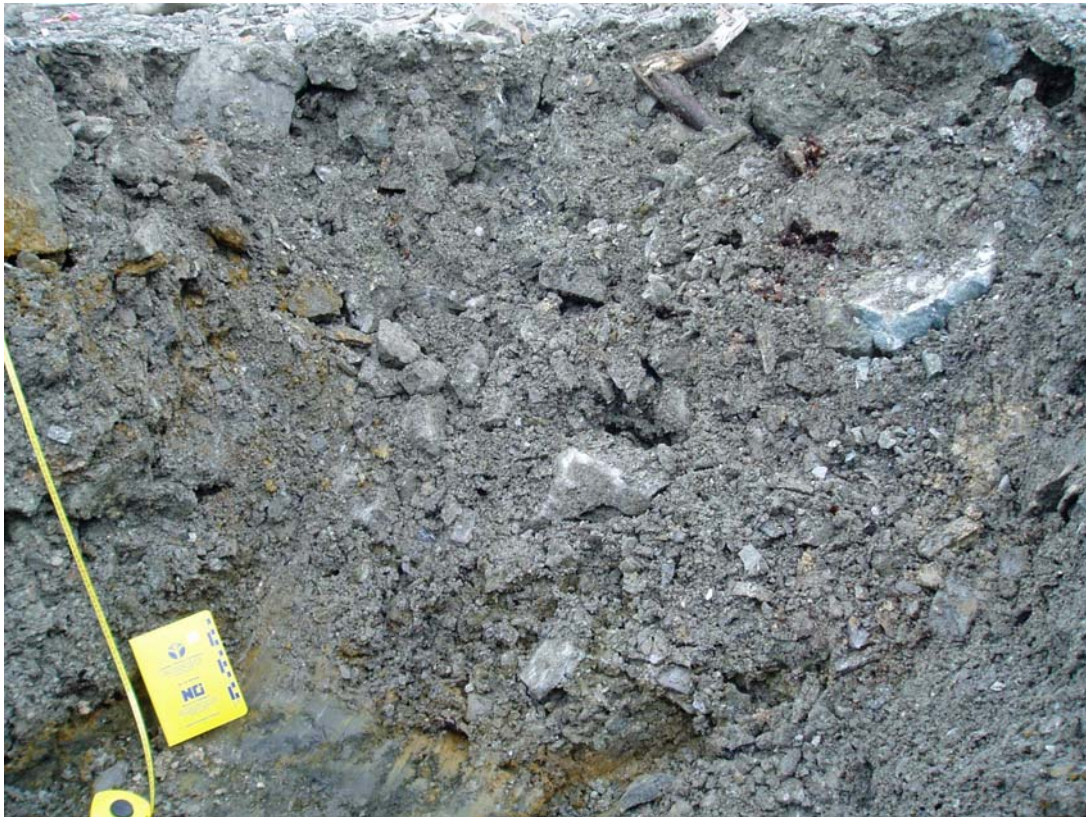
Photo 6: TP-TTC-04-02 Profile of test pit showing range of article sizes in cover material.

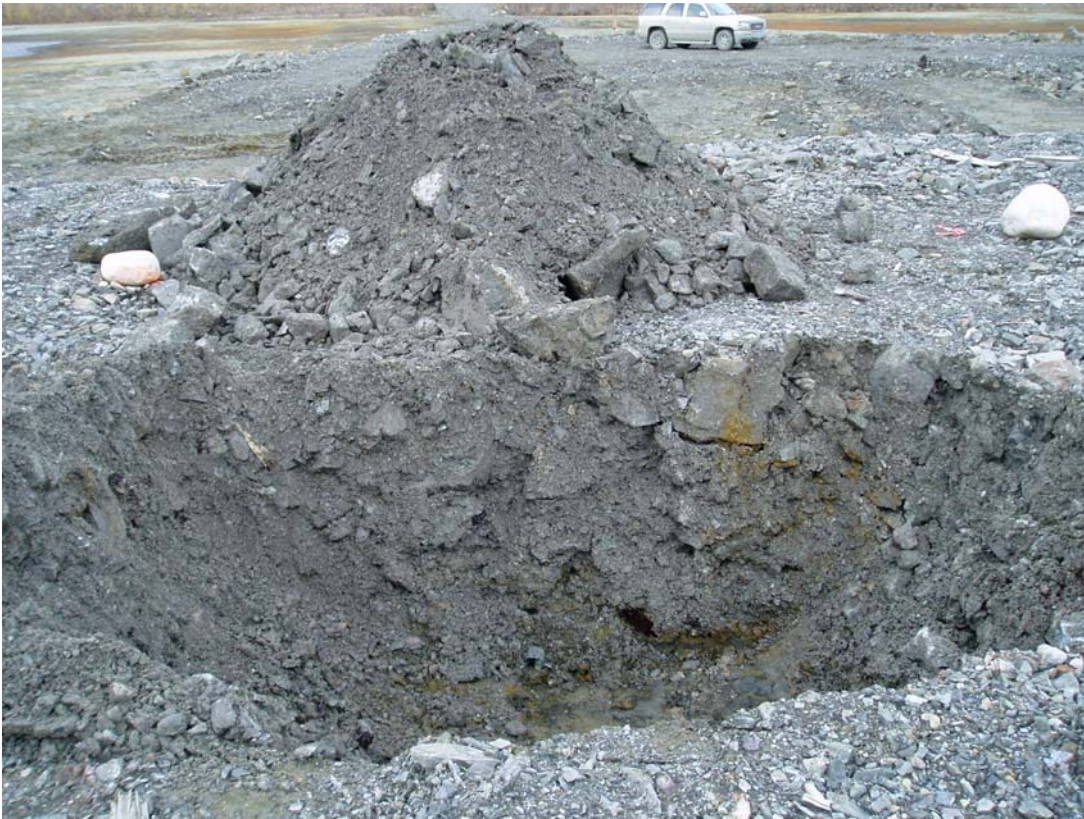
Photo 7: TP-TTC-04-02 Overall view of test pit showing range in grain size distribution of cover material.

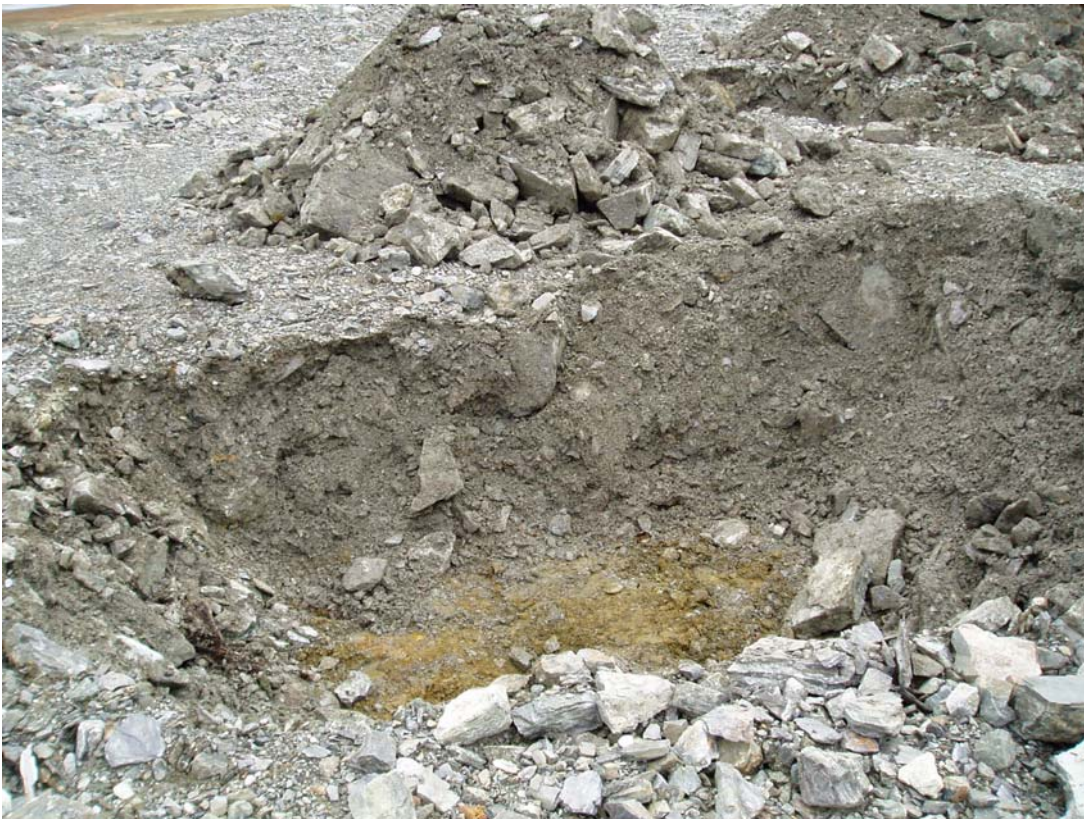
Photo 10: TP-TTC-04-03 Profile showing the range of particle sizes in the cover material.

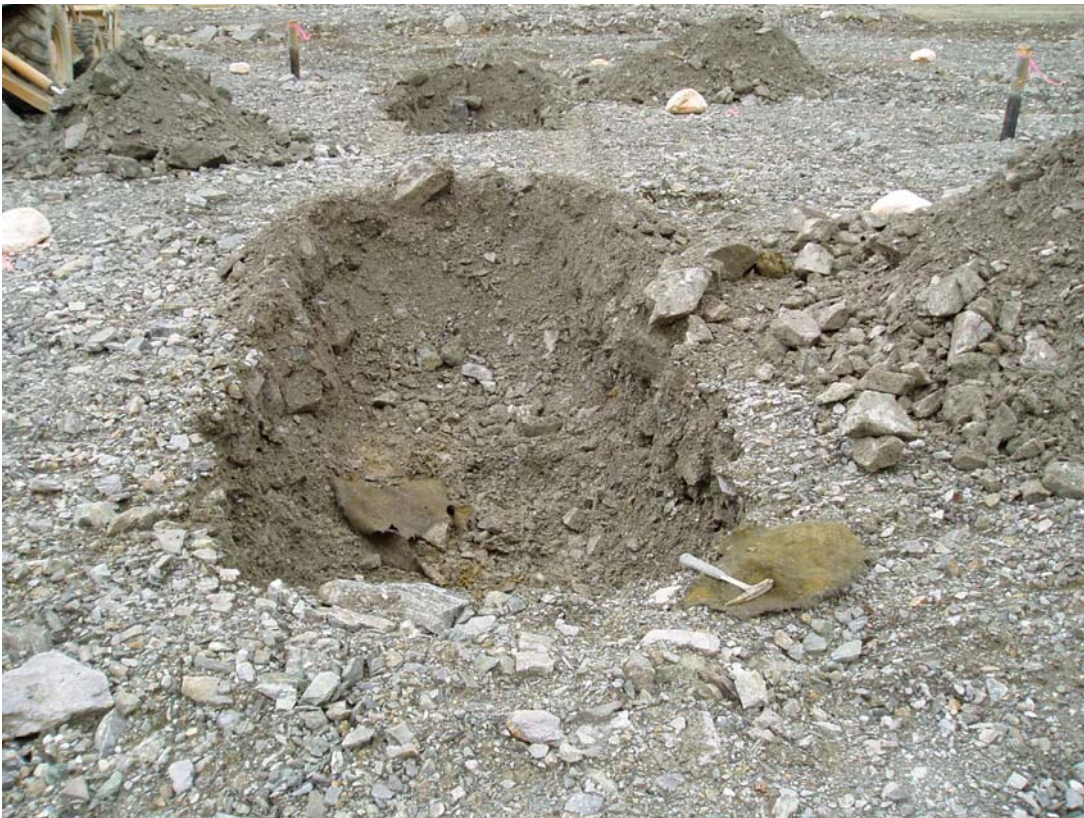
Photo 14: TP-TTC-04-04 Complete view of test pit showing the gradation of the cover material.

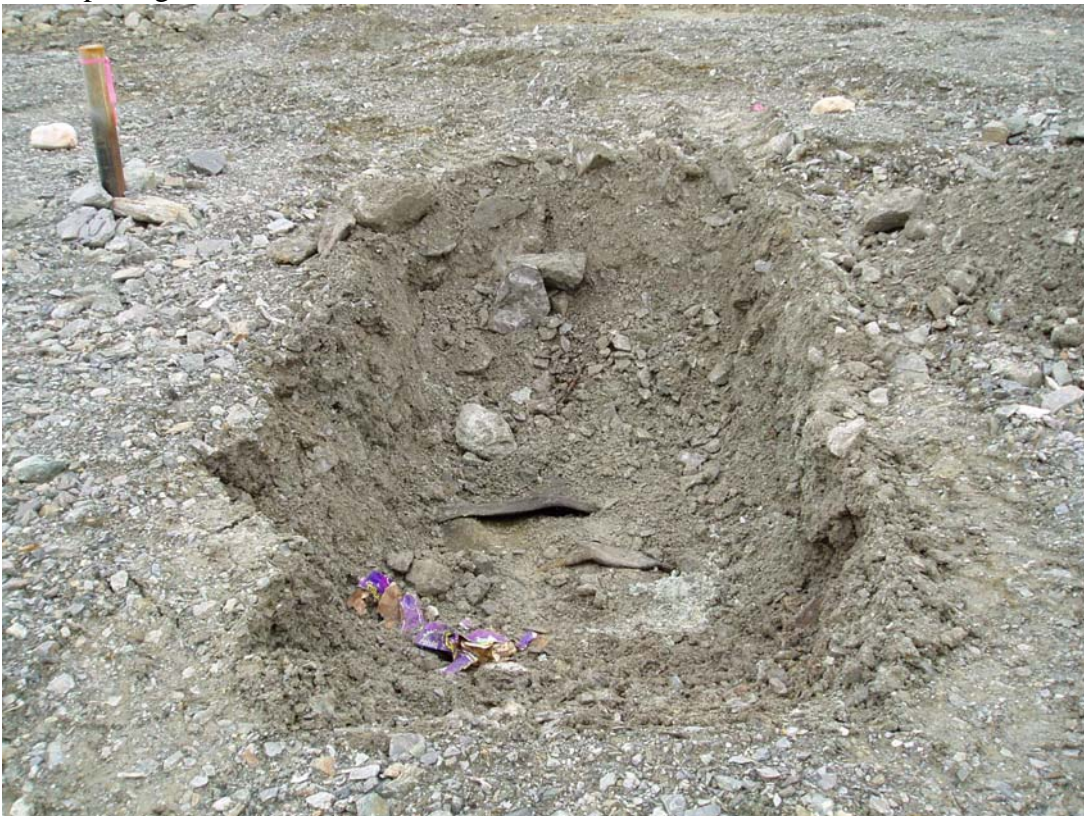
Photo 16: TP-TTC-04-05 Complete view of test pit showing gradation of the cover material.

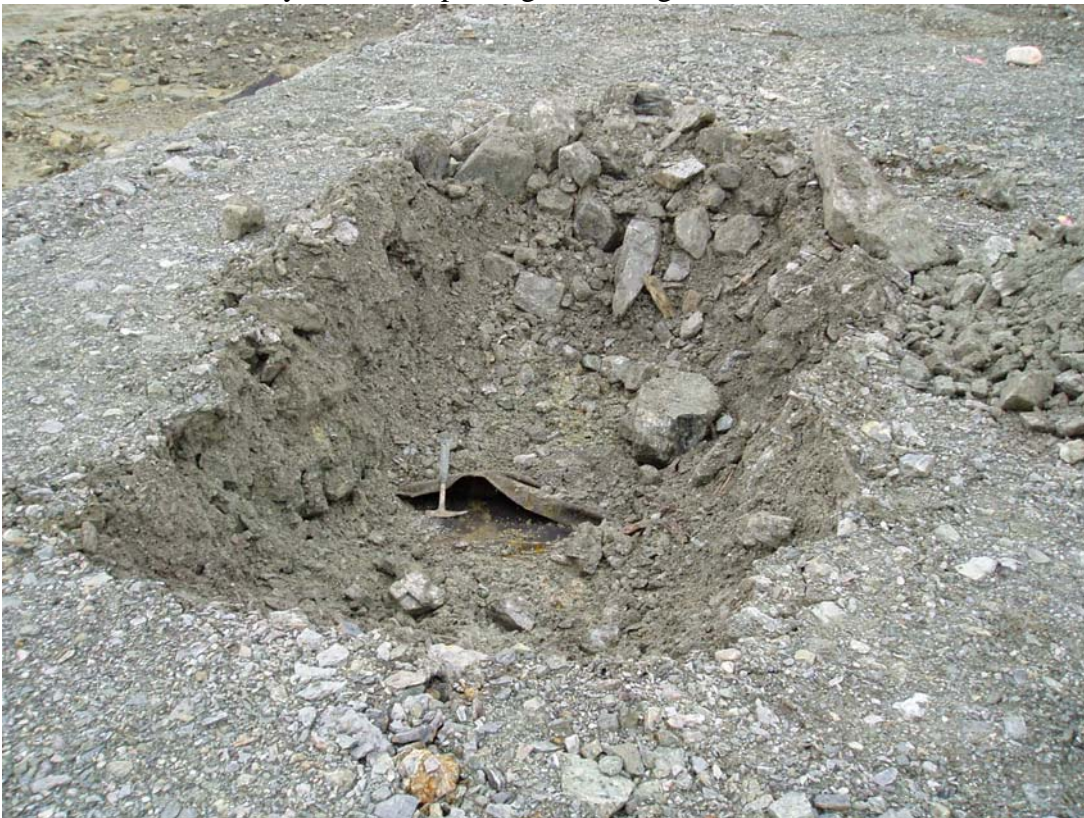
Photo 18: TP-TTC-04-06 Complete view of test pit showing range in gradation of cover material.

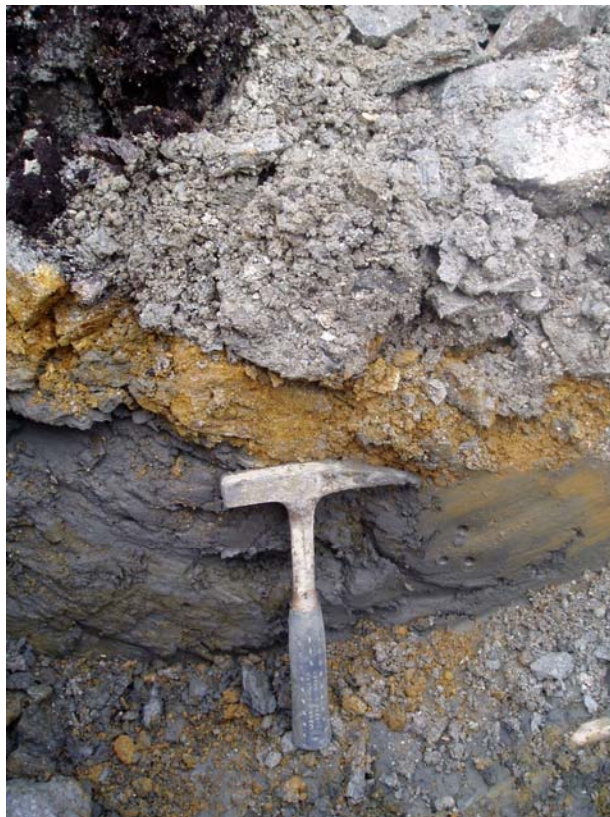
Photo 2: TP-TTC-05-01 Base of test pit excavation showing the interface between the tailings and waste rock cover. Note layer of oxidized tailings.

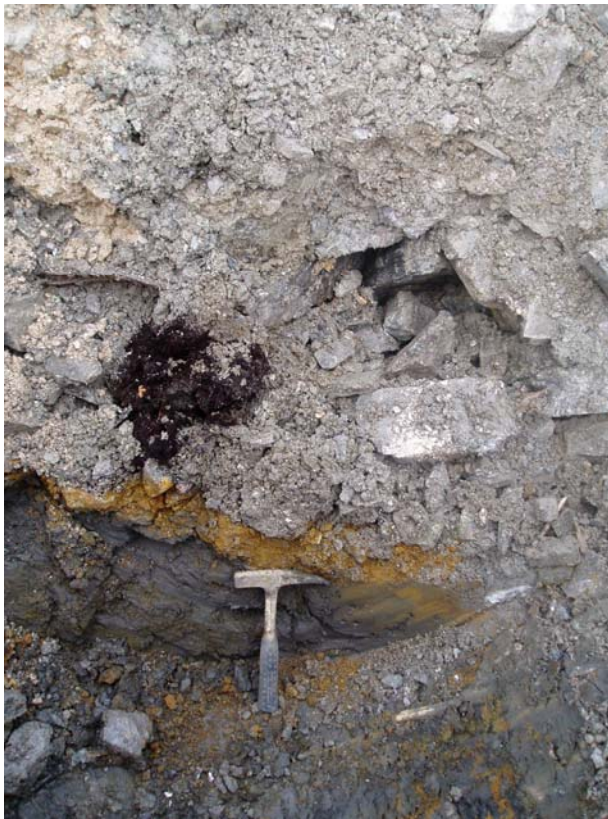
Photo 3: TP-TTC-05-01 Smaller scale view of the transition zone between tailings and the waste rock cover.

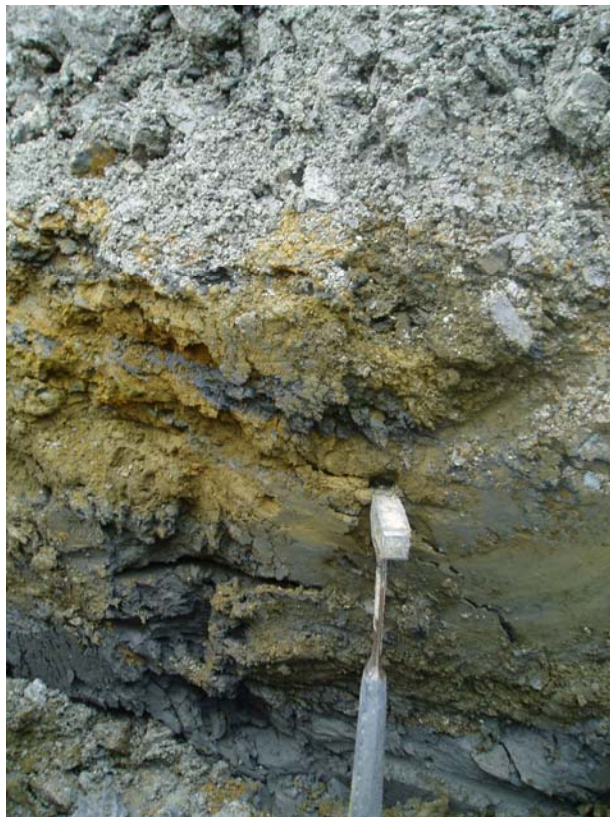
Photo 6: TP-TTC-05-02 View of the interface between the tailings and the waste rock cover.

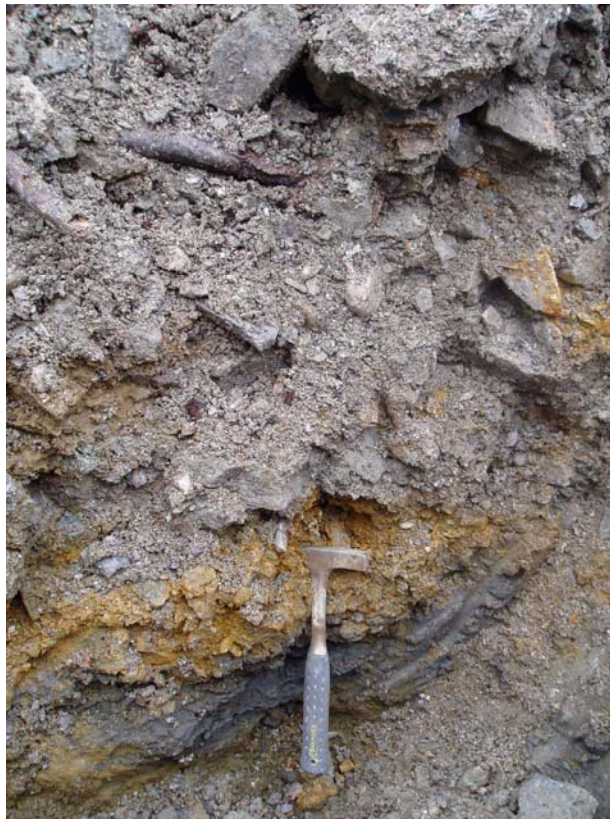
Photo 7: TP-TTC-05-03 profile of the test pit showing the interface between the tailings and the waste rock cover.

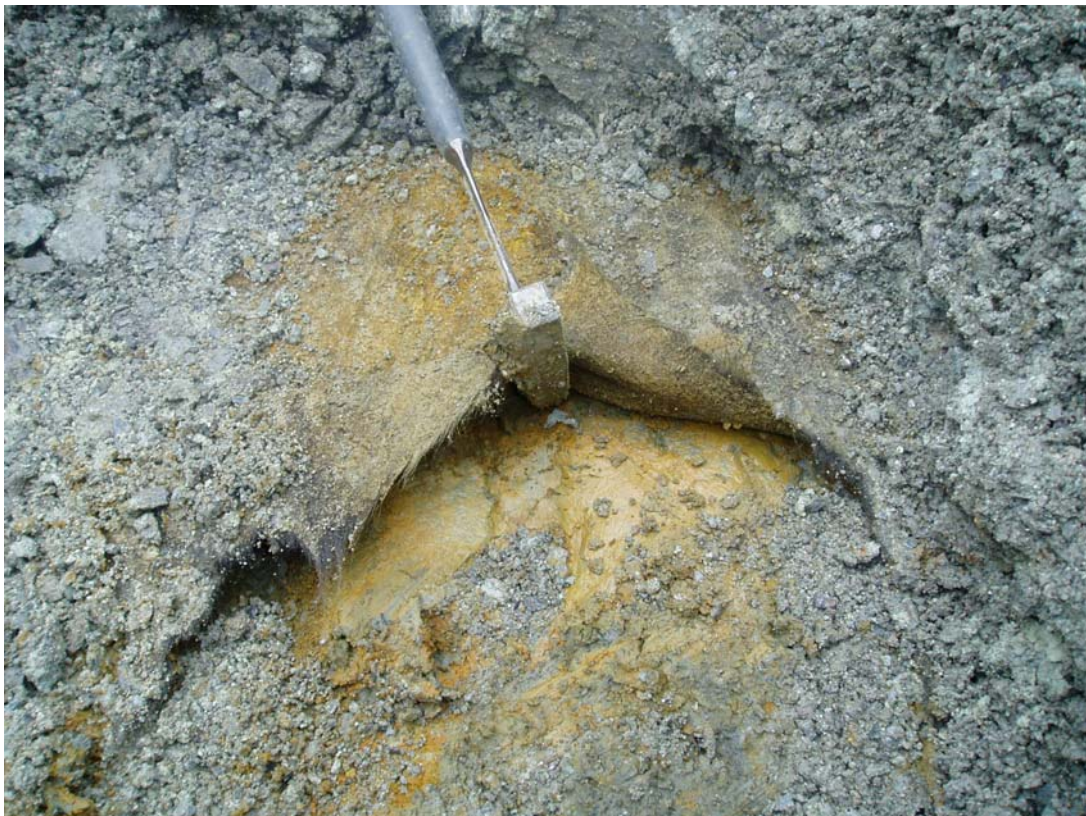
Photo 10: TP-TTC-05-04 Contact between cover material and tailings.

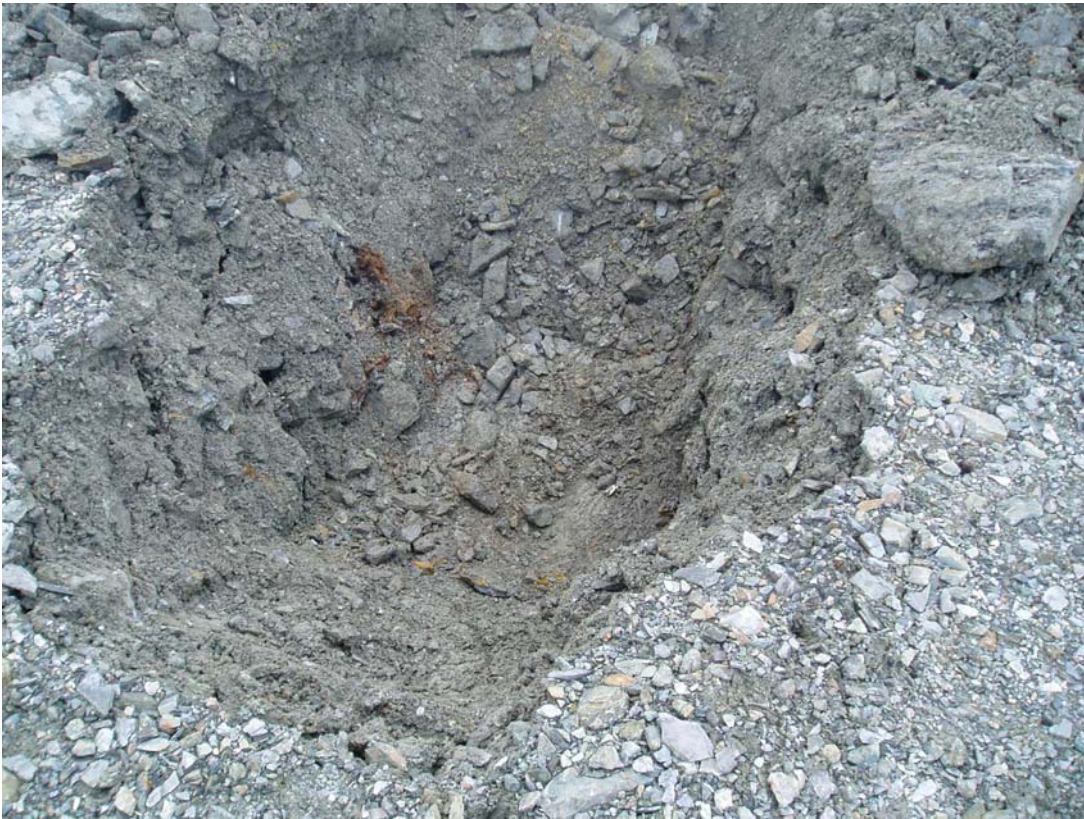
Photo 13: TP-TTC-05-05 Complete view of test pit showing the gradation of the cover material.
