Anvil Range Mining Complex Results from Trial covers at Rose Creek Tailings Impoundment: 2007 Data Summary

2007 Task 18b - FINAL

Deloitte and Touche Inc.

May 2008

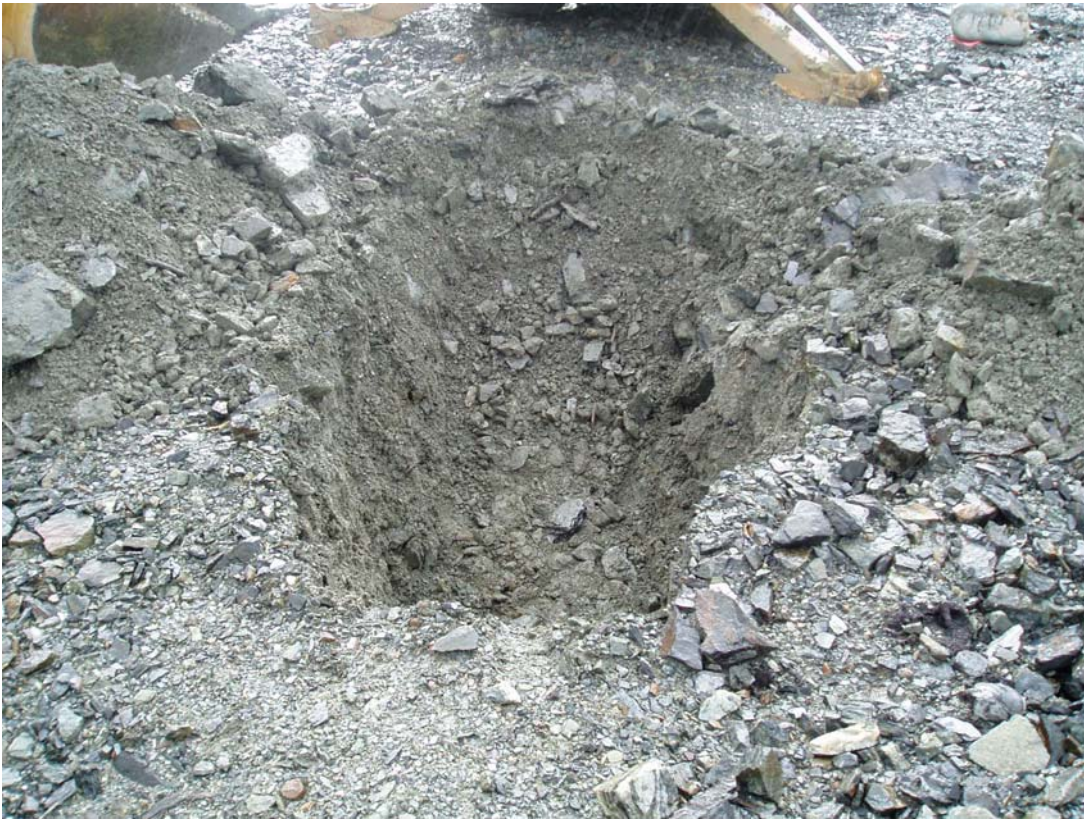
Photo 15: TP-TTC-05-06 Complete view of test pit showing gradation of the cover material.
