June 15, 2012

Yukon Government
Faro Mine Remediation Project
Suite 2C-4114-4th Ave
PO Box 2703 (K-149)
Whitehorse, Yukon Territory
Y1A 2C6

Faro Mine Complex
2011 Annual Geotechnical Review

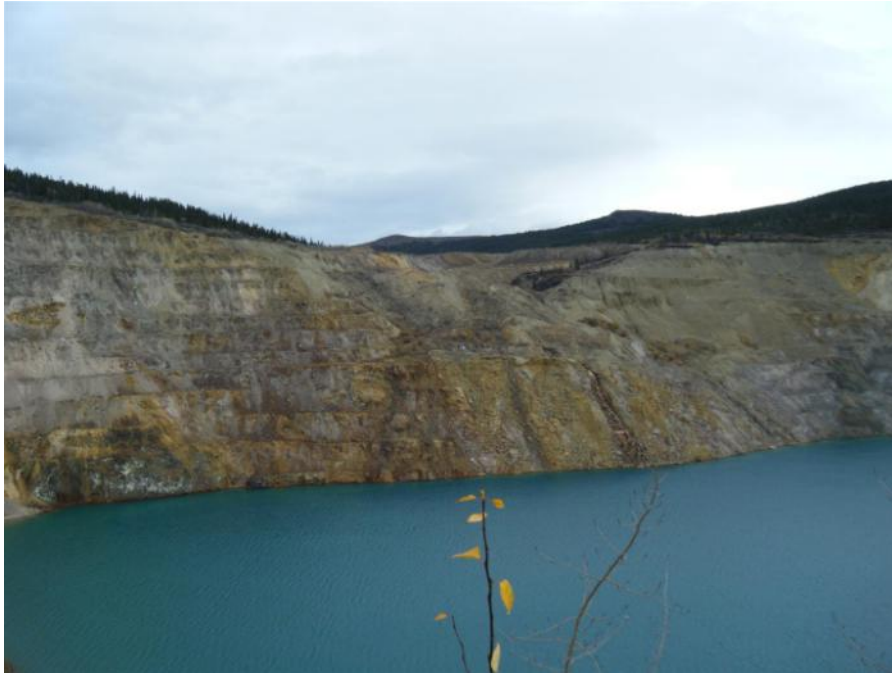
Photo 1 Faro Pit east wall as seen from “eye-in-the-sky” (September 20, 2011)

- Continue visual monitoring of pit wall conditions with photos taken at same vantage points.
- Continue monitoring distances between the pit brim and reference bars installed in the North and South Instability Zone as a means to monitor the safety of the Faro Creek Diversion Channel at these strategic locations.

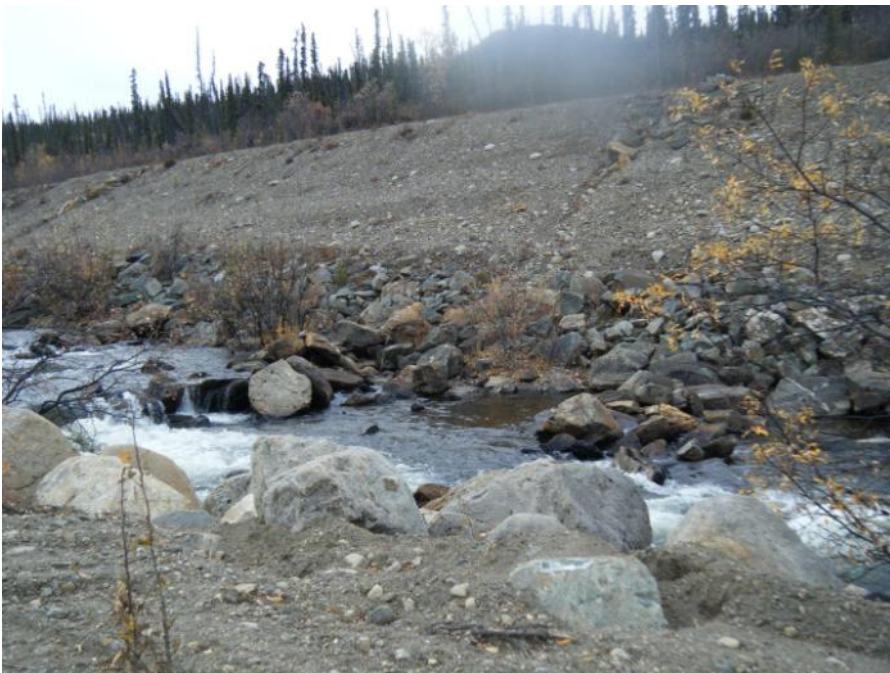
Photo 14 **Rose Creek Diversion Channel downstream of Cross Valley Dam
(September 21, 2011)**

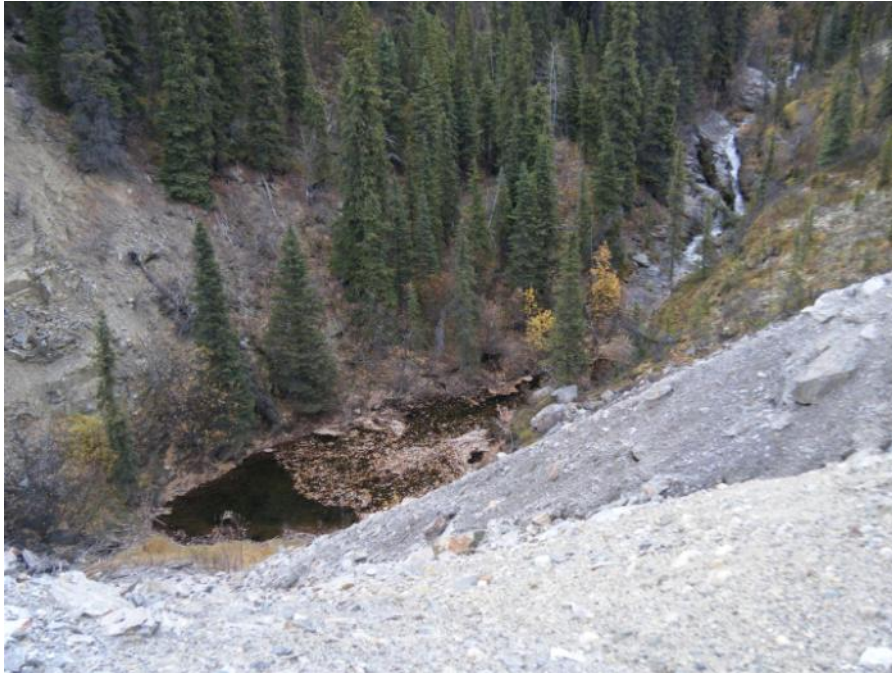
Photo 19 K8 Creek upstream pool (September 20, 2011)

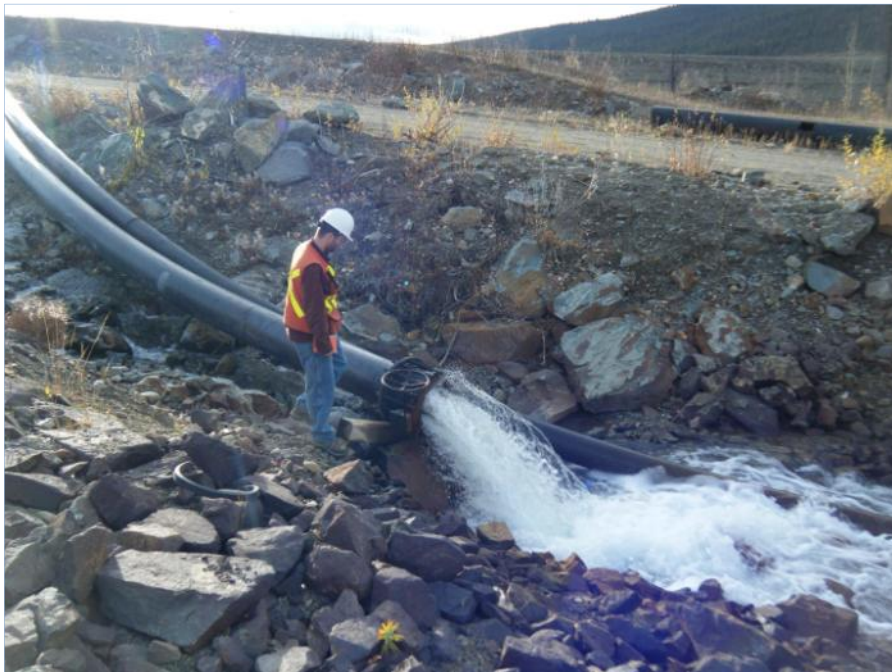
Photo 42 Cross Valley Pond siphon outlet discharge (September 20, 2011)

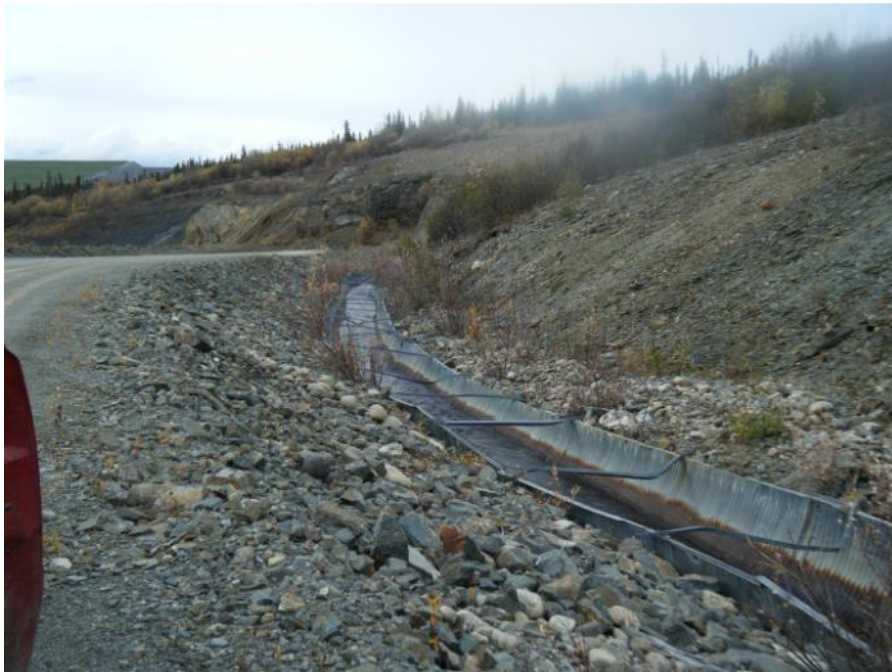
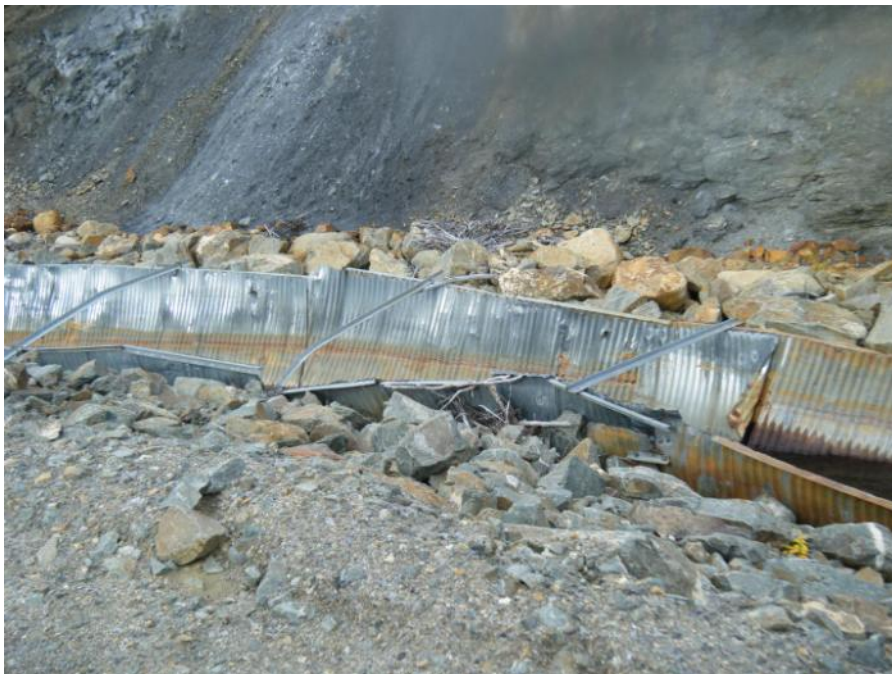
- The flume is damaged, mainly from ice removal activities during the winter (The half section of CSP was dented with holes, and the pipe bracings were bent or broken, see Photos 81 and 82). We understand that no ice removal has taken place in recent years.

Photo 81 Vangorda Flume (September 20, 2011)

Photo 82 Vangorda Flume (September 20, 2011)

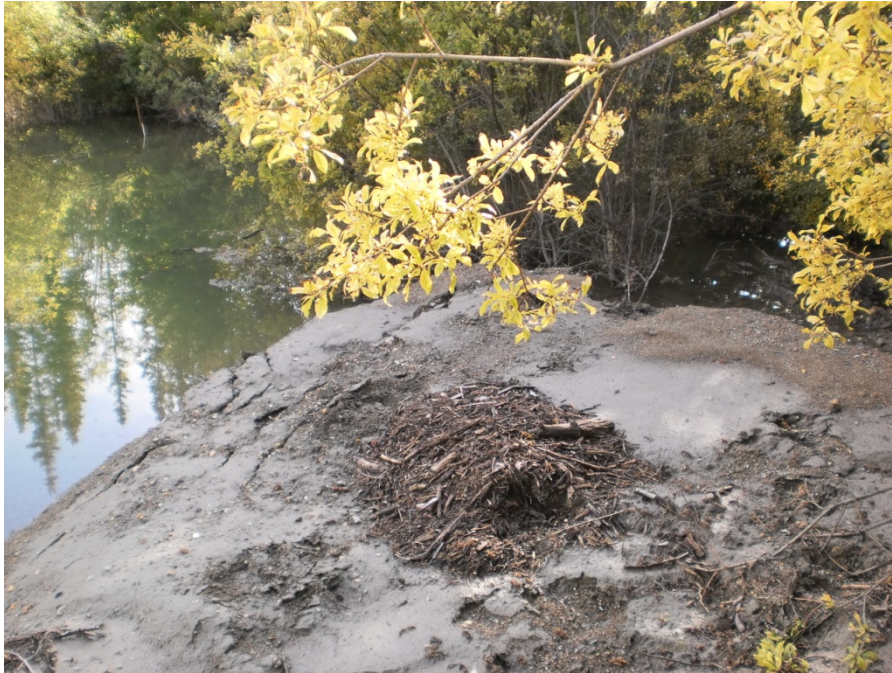
- Excess water from runoff over newly constructed Grum Dump cover was allowed to enter into the Moose Pond in the spring of 2011.
- Significant erosion and slumping of the sides of the V-15 seep ditch was observed at the location where the ditch entered into a steep reach before entering the Moose Pond (see Photos 108).
- Sedimentation caused by excess inflow sealed off the Moose Pond bottom (see Photo 110), and raised the pond level and caused excess seepage through a retaining esker (see Photos 112), and slumping of esker downstream slope (see Photos 113 to 115).
- Cessation of inflow to Moose Pond resulted in drop of pond level to the current level, which is probably higher than previous pond levels.
- Exfiltration from Moose Pond has probably changed from the pond bottom to the bank slope at higher elevations.

Photo 110 Moose Pond with new sediments deposited during 2011 spring excess runoff (August 23, 2011)

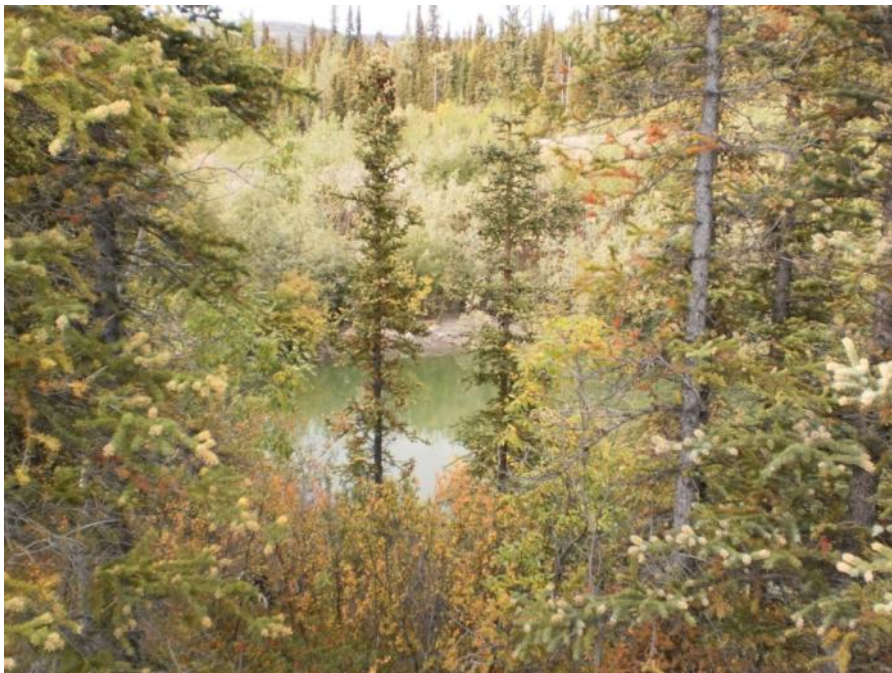
Photo 111 Moose Pond seen from downstream esker ridge top (August 23, 2011)

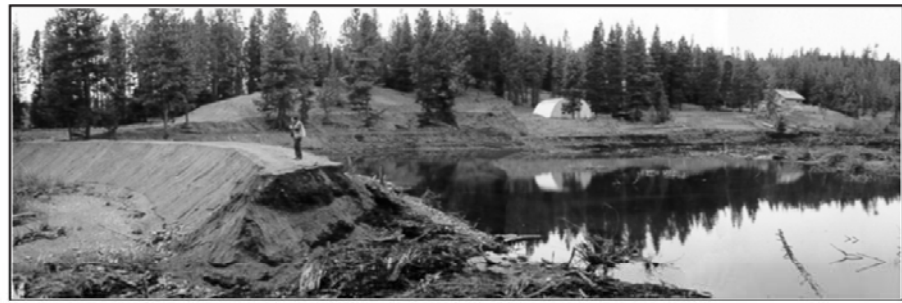
Figure 4 – Dam Breach caused by Slope Instability

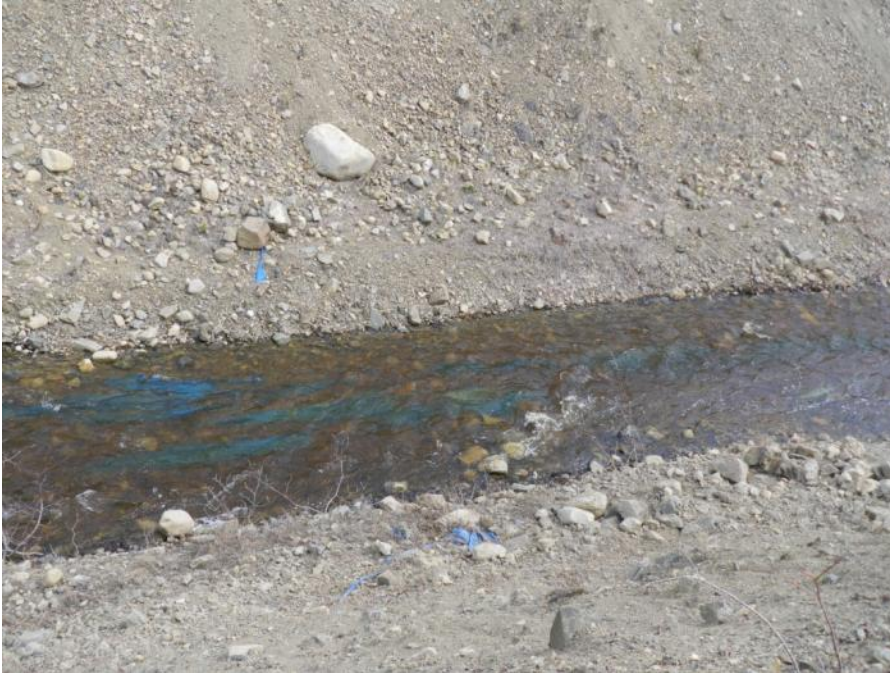
Photo 5 Close up of channel bottom and bank slopes (May 29, 2012)

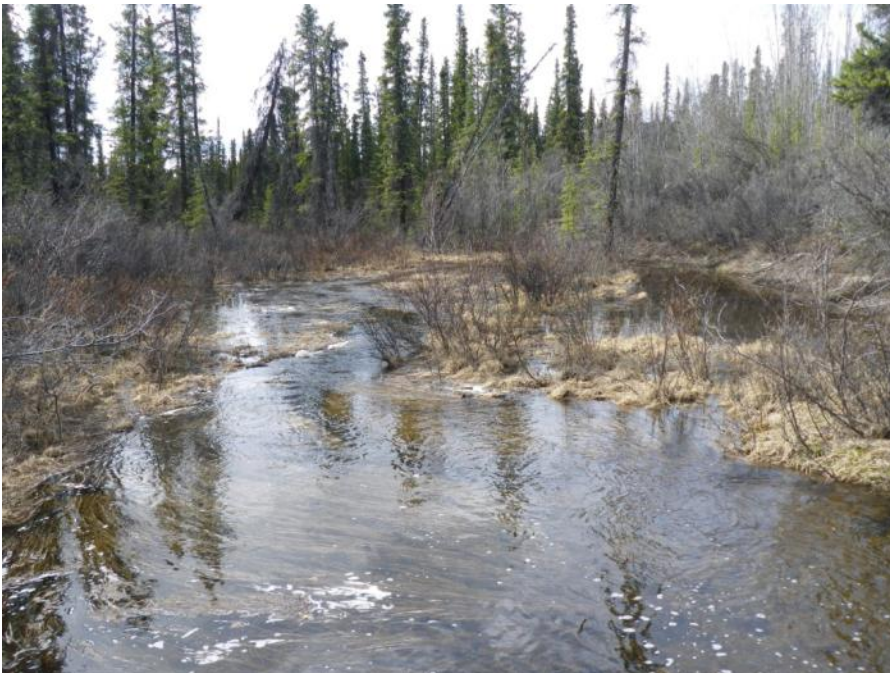
Photo 10 End of upper reach of man-made Interceptor Ditch (May 30, 2012)

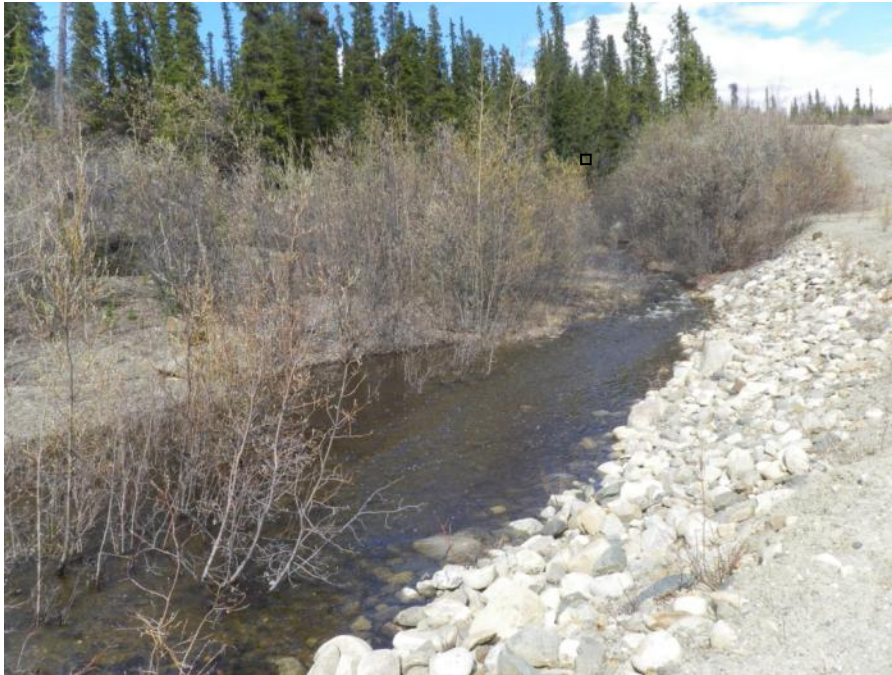
Photo 11 Beginning of middle reach of man-made Interceptor Ditch
(May 30, 2012)

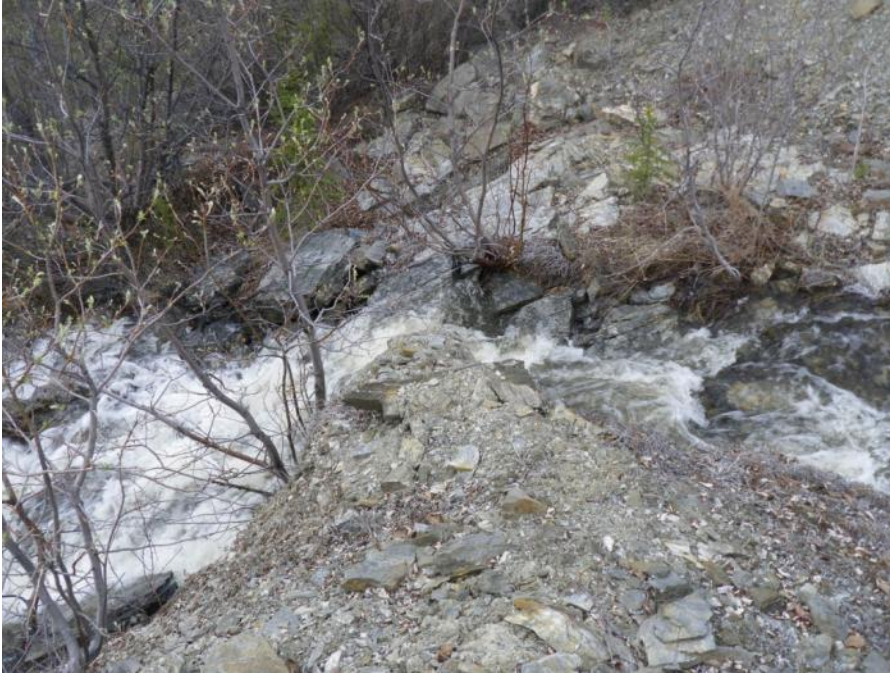
Photo 13 End of middle reach of man-made Interceptor Ditch (May 30, 2012)

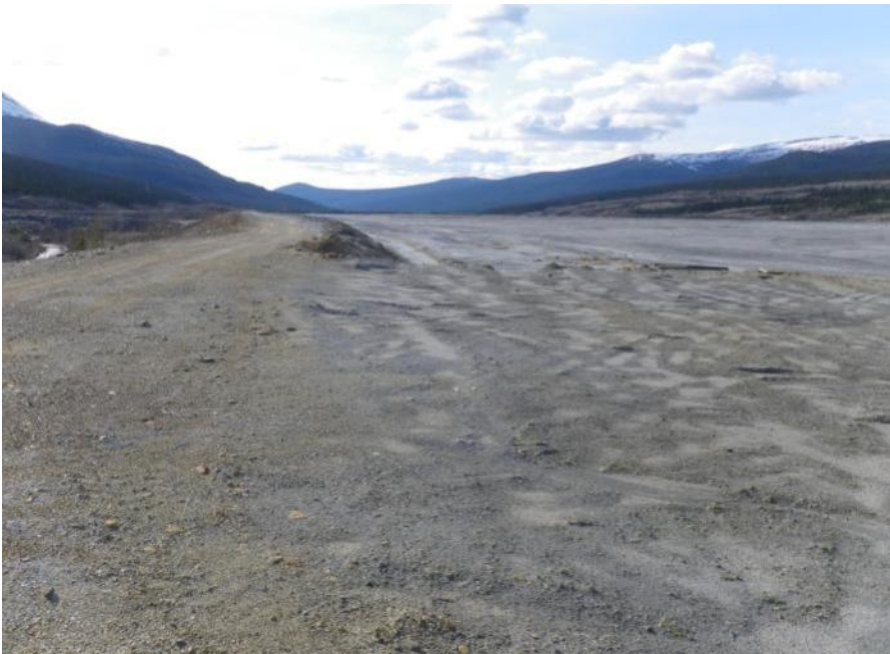
Photo 28 Secondary Tailings Dam and beach downstream of fuse plug (May 29, 2012).

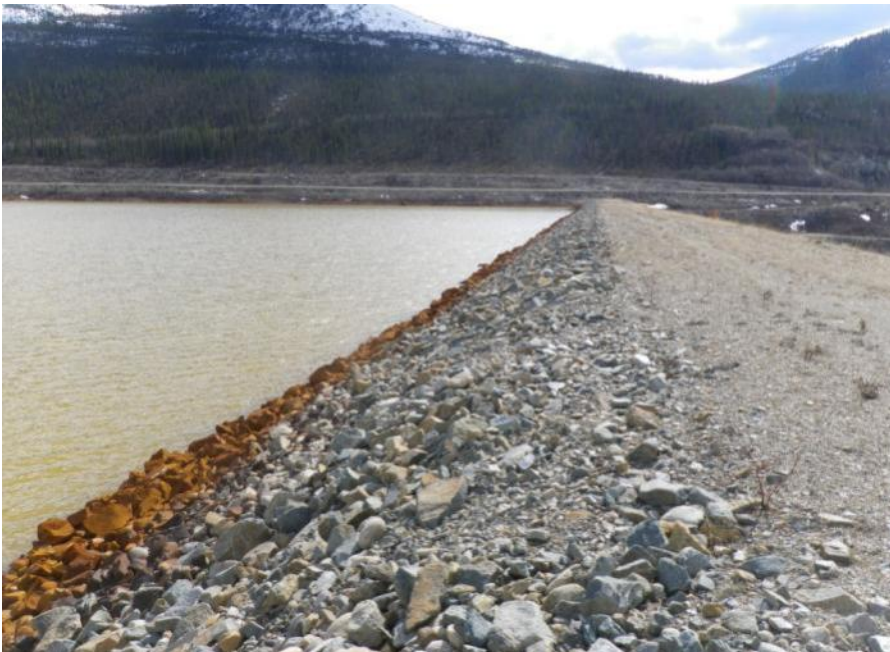
Photo 30 Intermediate Dam upstream slope – looking southwest (May 29, 2012)

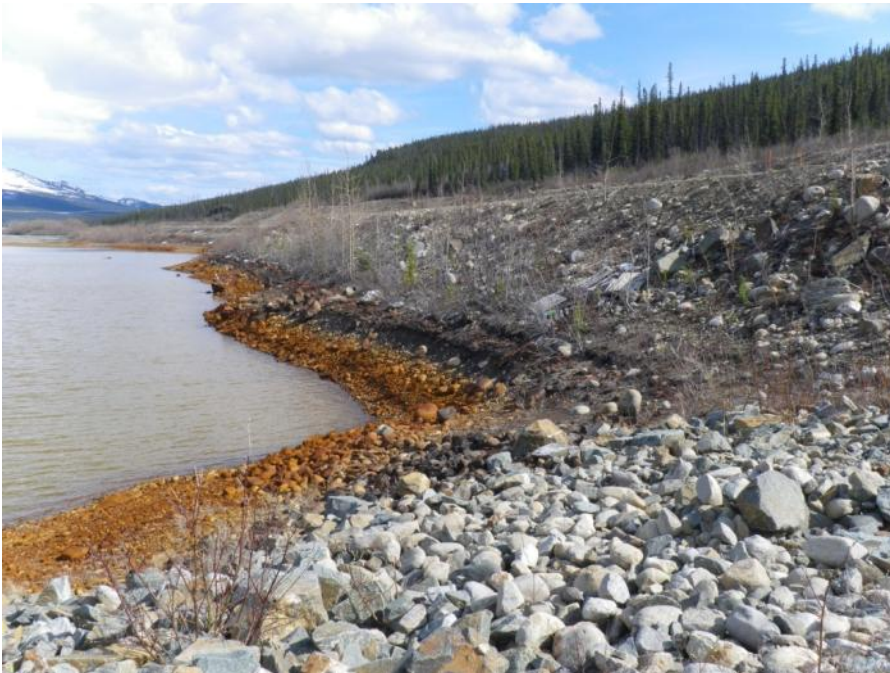
Photo 32 Canal Dyke slope upstream of Intermediate Dam (May 29, 2012)

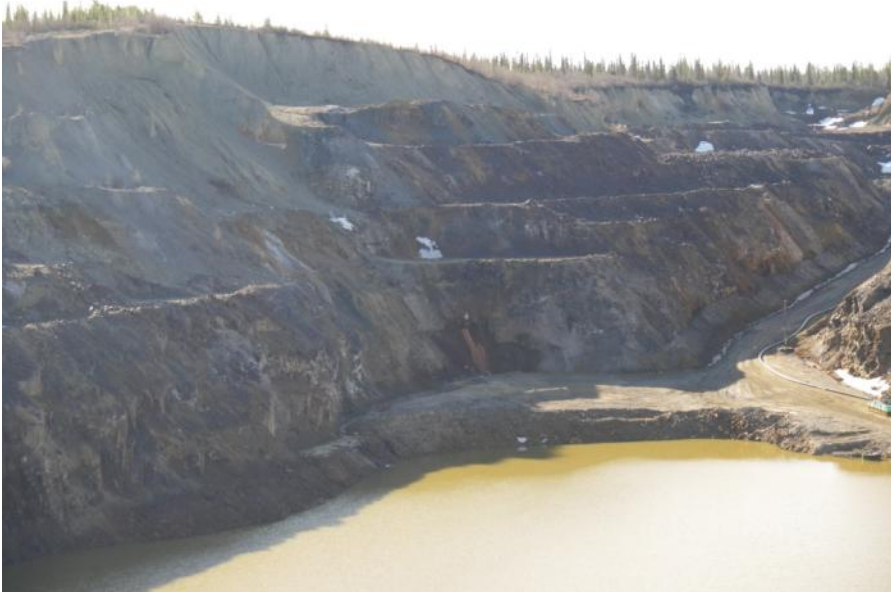
Photo 45 Vangorda Pit southeast wall as seen from northwest wall
(May 30, 2012)

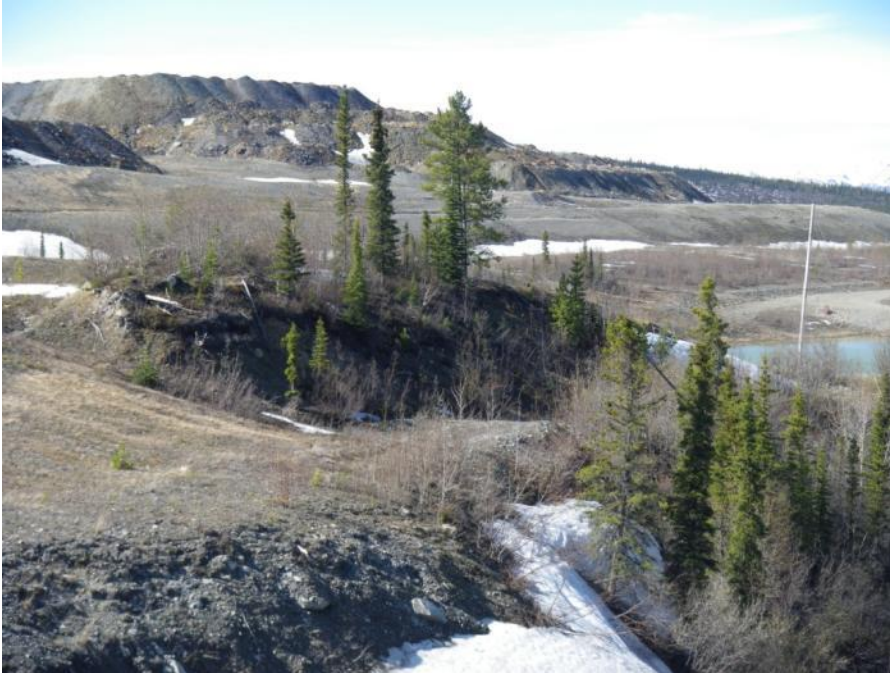
Photo 51 Vangorda Waste Dump at distance - looking from north
(May 30, 2012)

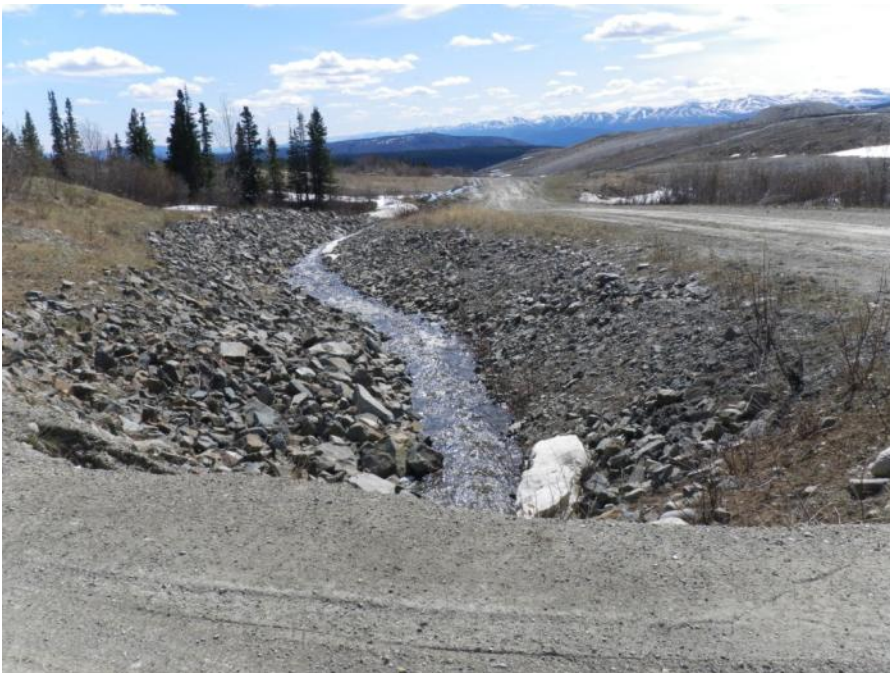
Photo 60 Ditch along Grum Overburden Dump (May 30, 2012)

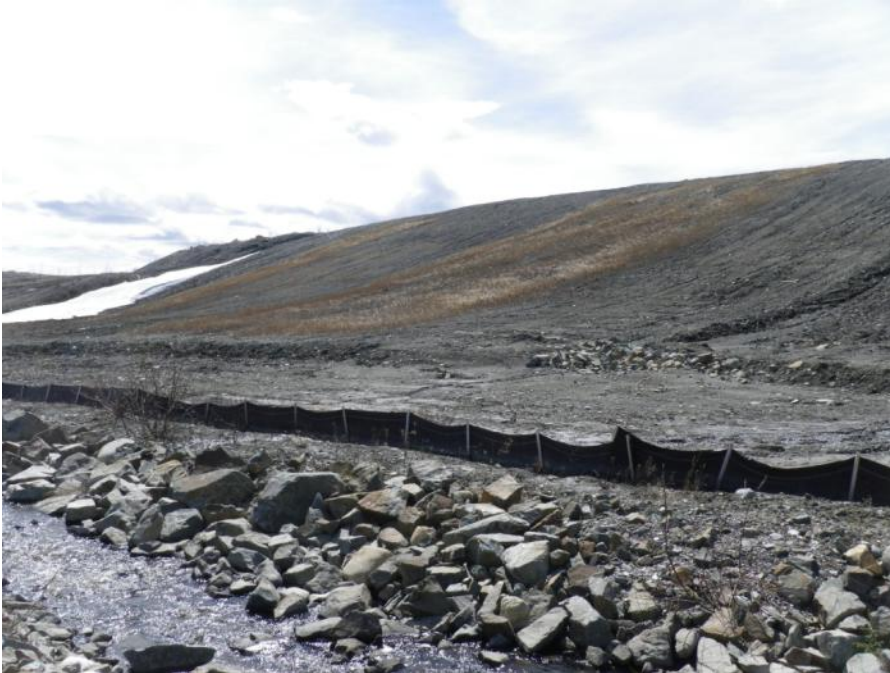
Photo 61 Grum Interceptor Ditch – Grum Overburden Dump test plot in background (May 30, 2012)

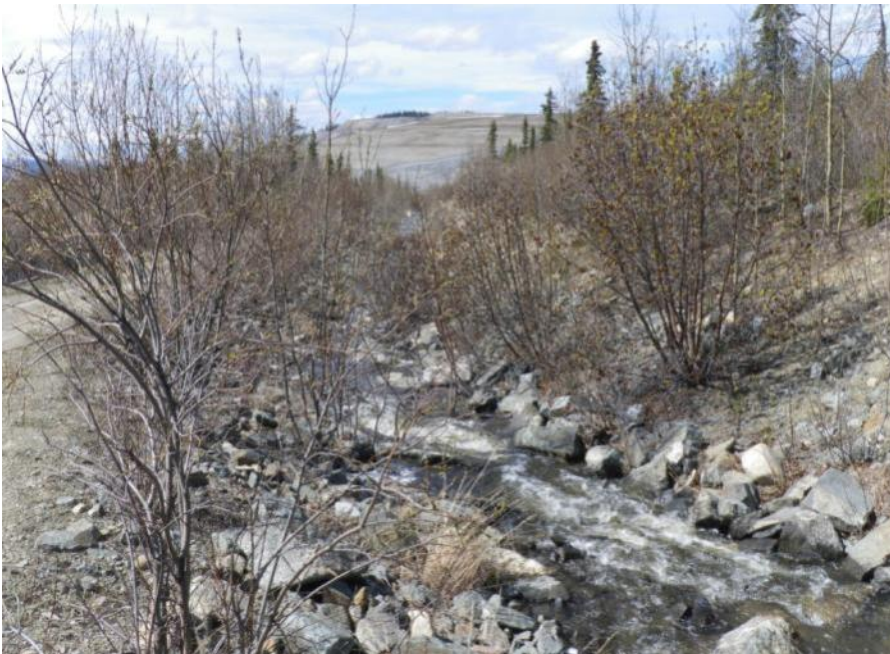
Photo 62 Interceptor Ditch flowing towards Sheep Pad Sediment Ponds (May 30, 2012).

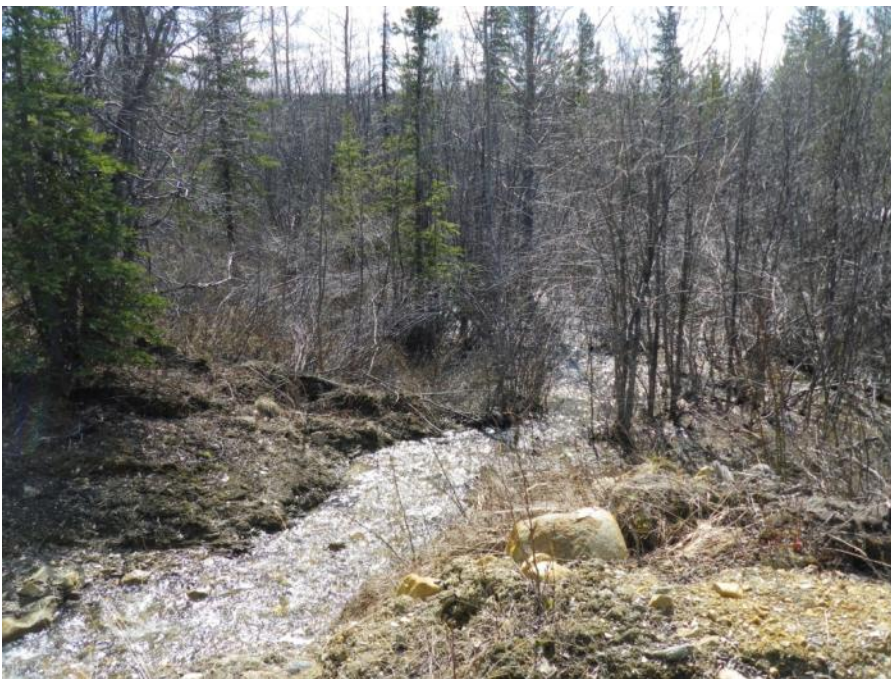
Photo 68 Ditch flow discharging into natural stream (May 30, 2012)

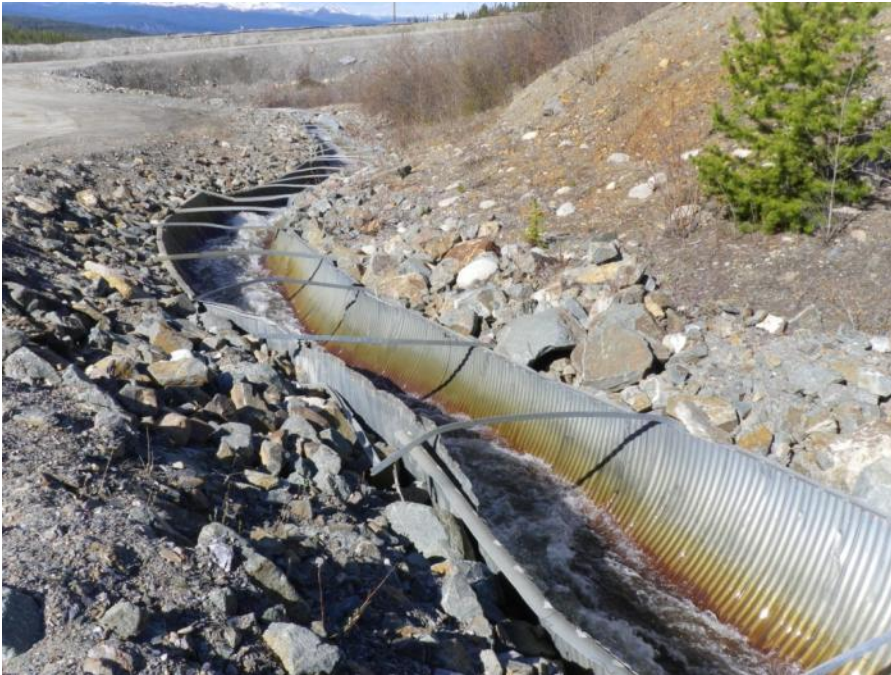
Photo 77 End reach of Vangorda Flume (May 30, 2012)

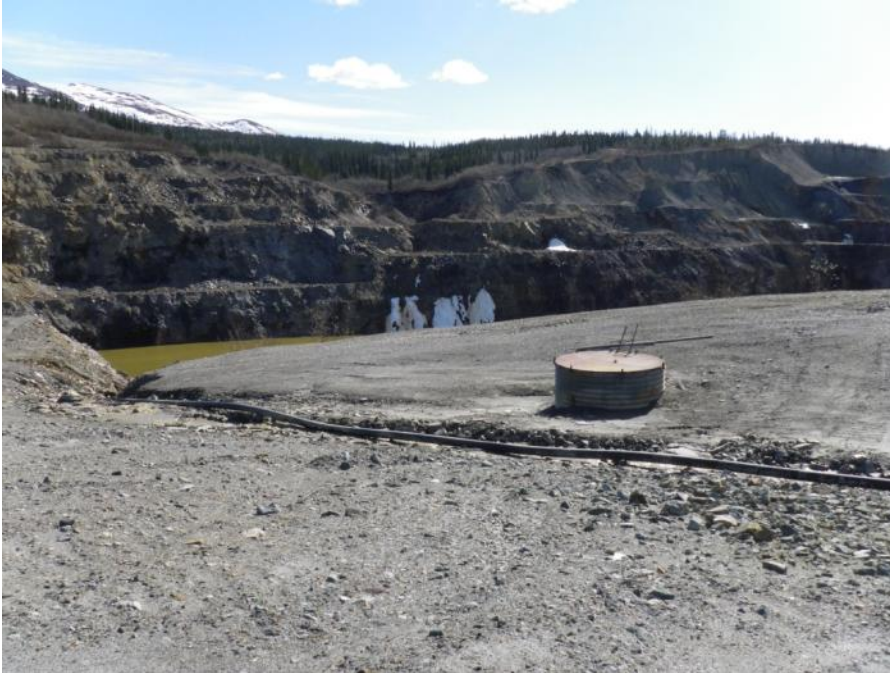
Photo 79 Vangorda Flume drop box (May 30, 2012)

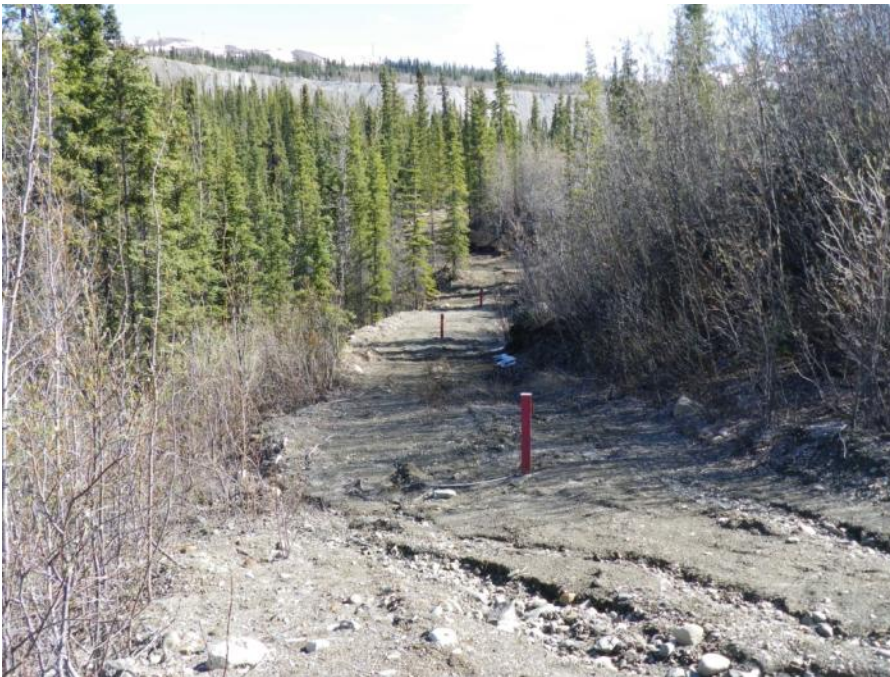
Photo 86 Downstream piezometers (May 30, 2012)

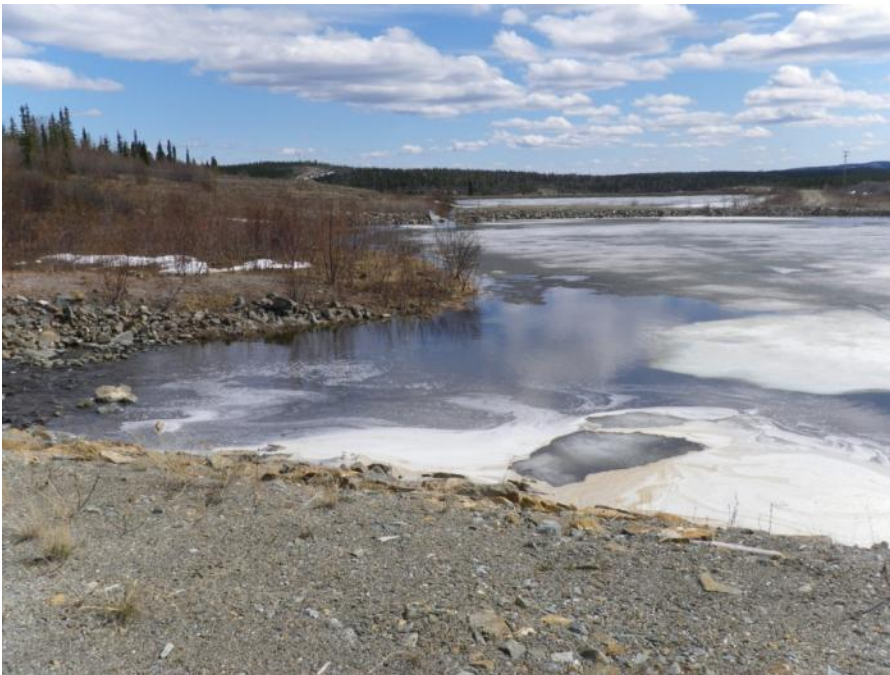
Photo 88 Upper (foreground) and Lower (background) Sheep Pad Ponds (May 30, 2012)

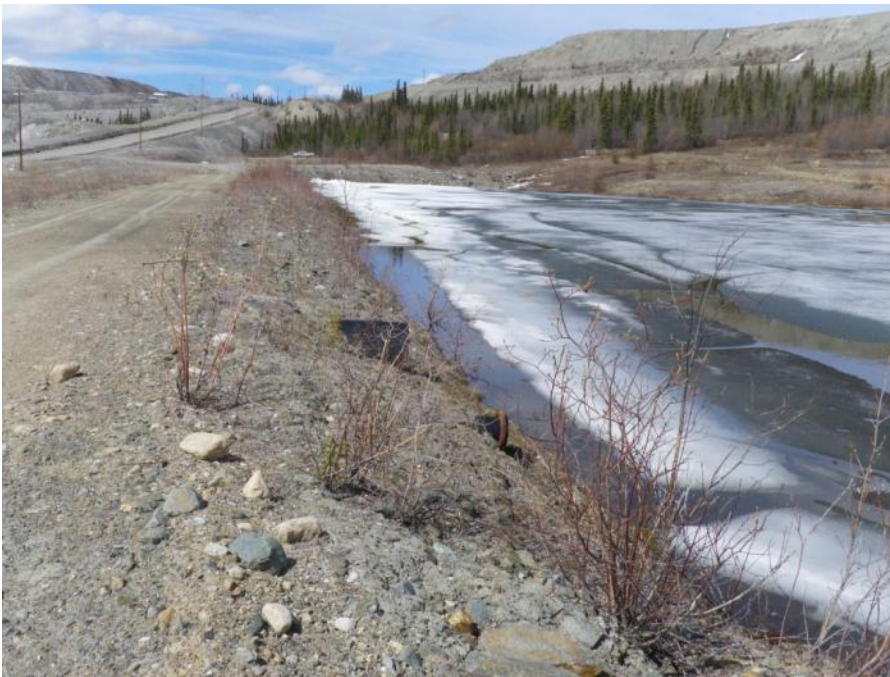
Photo 90 Lower Sheep Pad Pond (May 30, 2012)

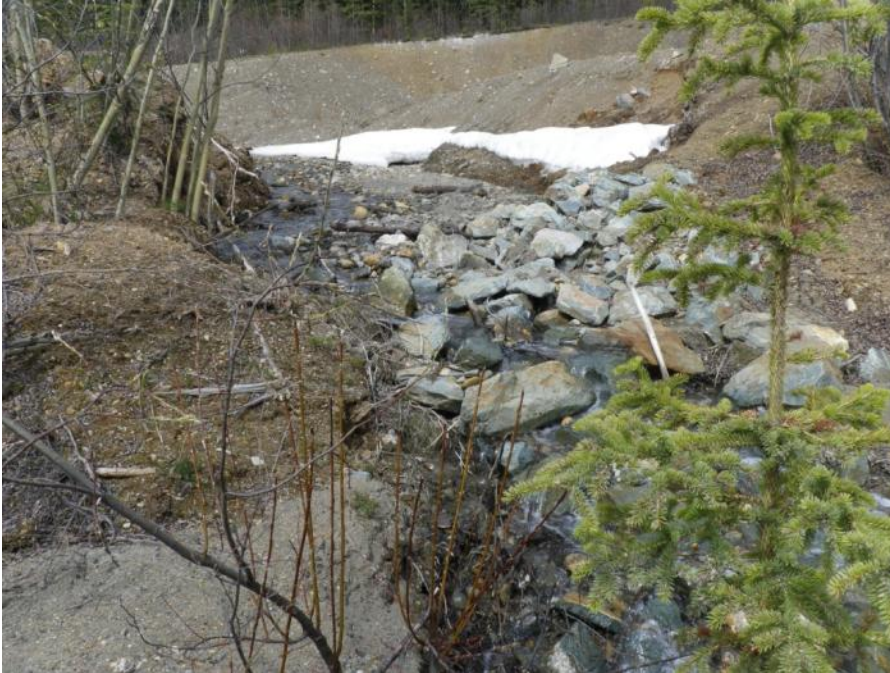
Photo 95 Water flow from diversion ditch down slope towards Moose Pond
(May 30, 2012)

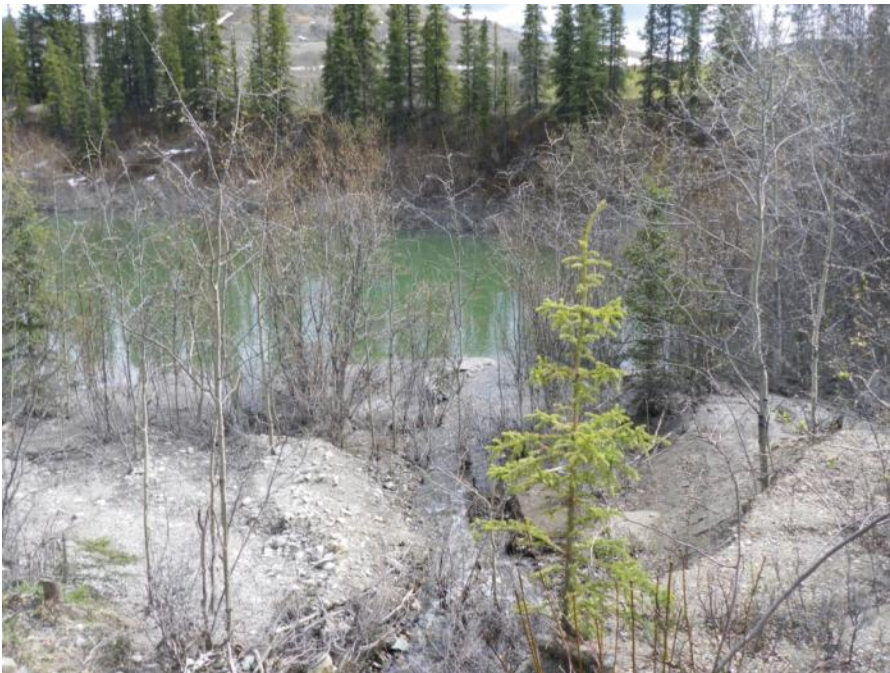
Photo 96 Sediment deposits at entrance to Moose Pond (May 30, 2012)

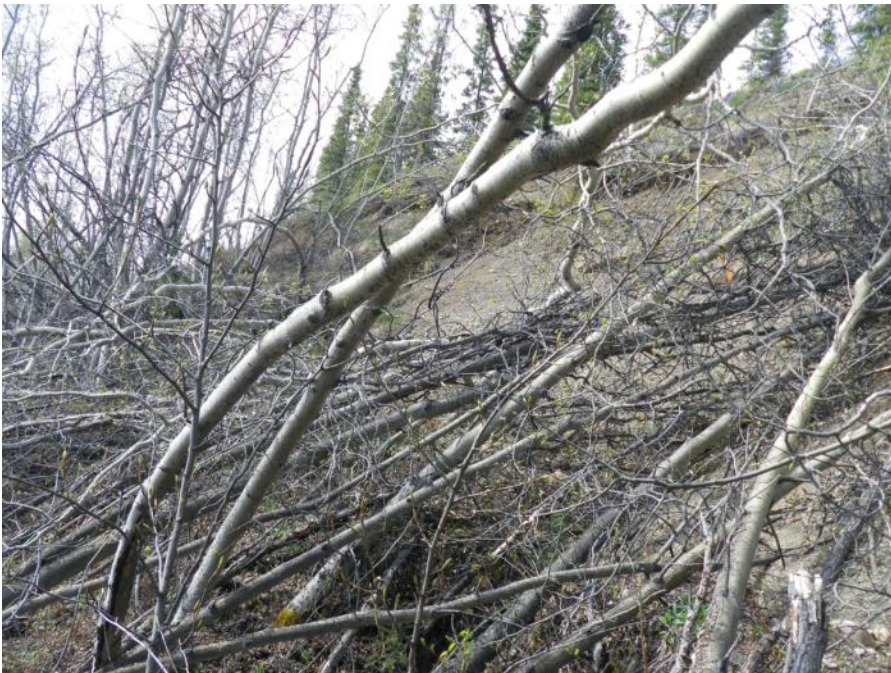
Photo 100 Disturbed esker slope and vegetation (May 29, 2012)
