2006 ANNUAL REPORT

FRESH WATER SUPPLY DAM BREACH PROJECT FARO MINE, YUKON

PROJECT NO.: 0257-040-01
DATE: JANUARY 26, 2007

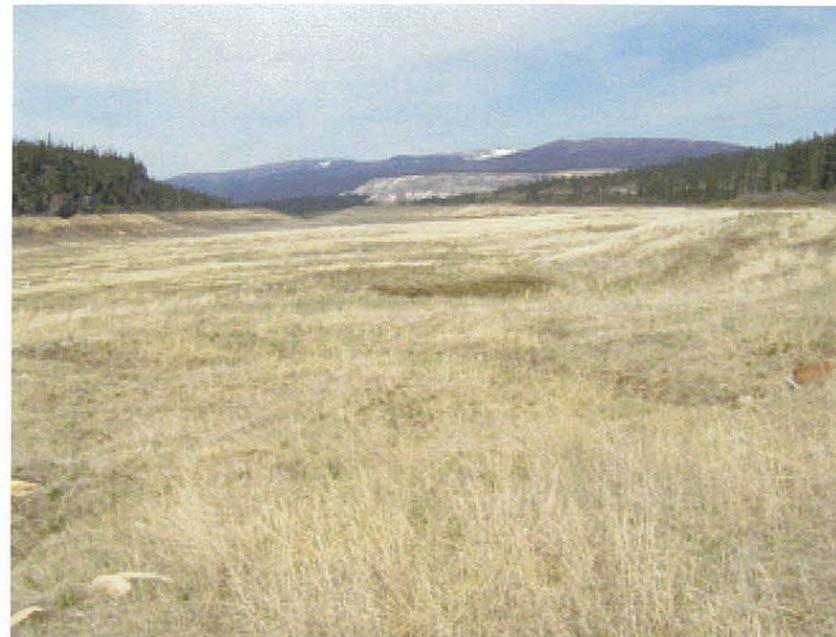
June: View of vegetation in the former reservoir looking towards the breach in the background.

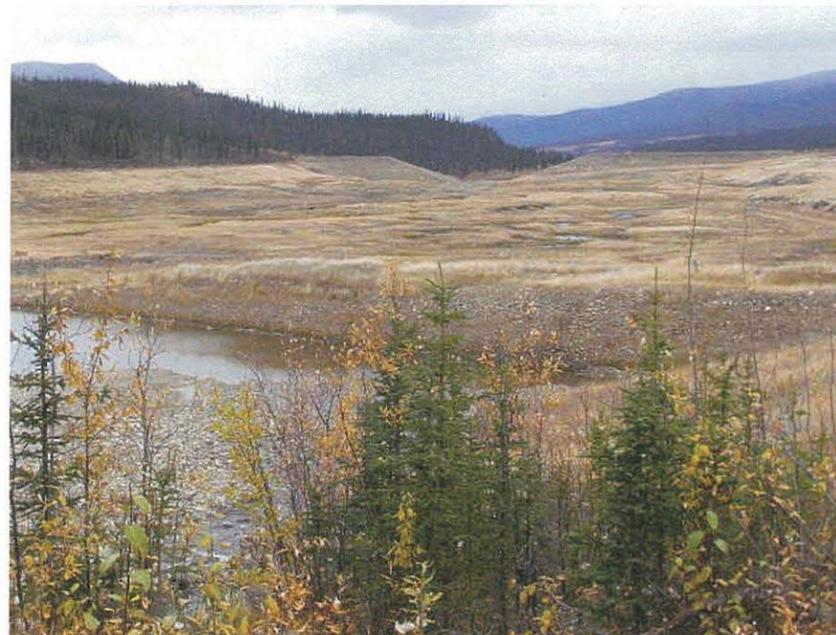
September: A general view of the former reservoir bottom and the upstream side of the Fresh Water Supply Dam Breach.

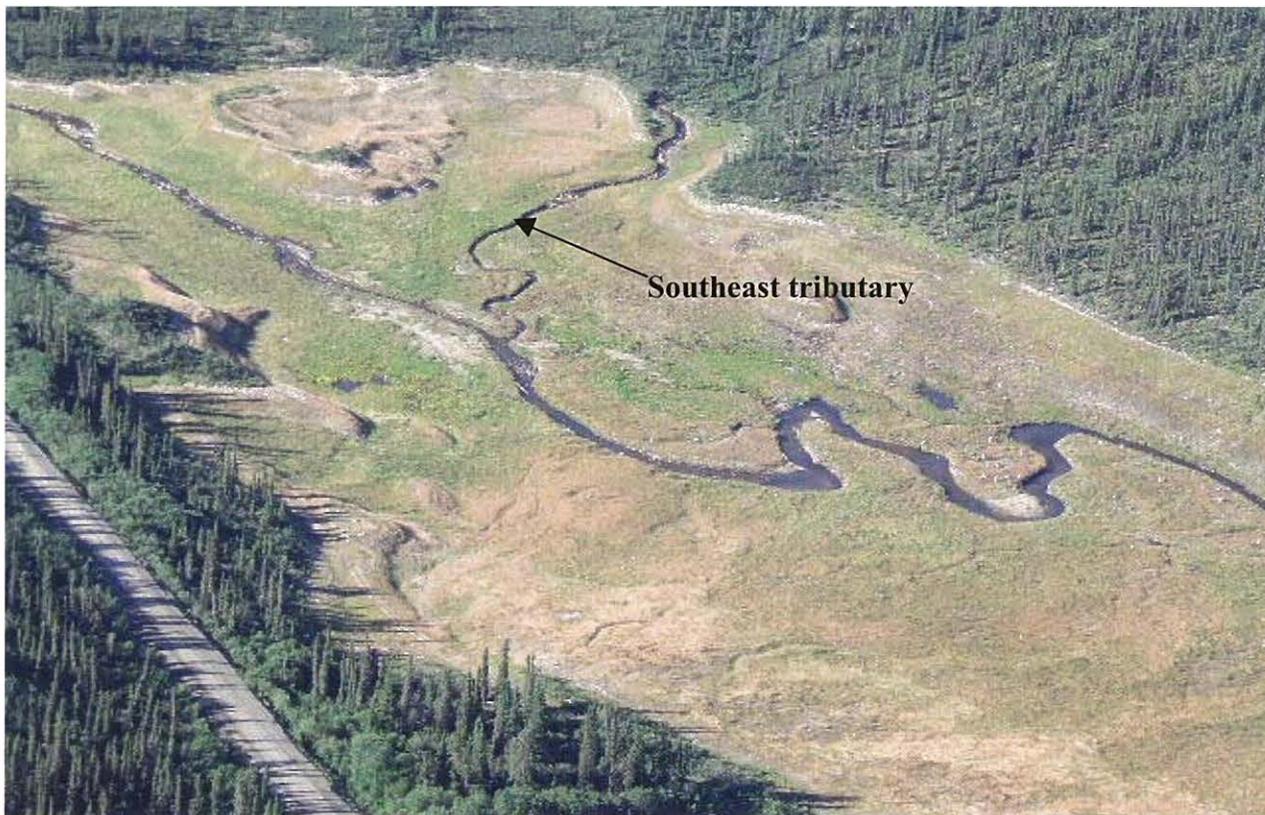
Overall view of the southwest section of the dewatered reservoir, July 2006.

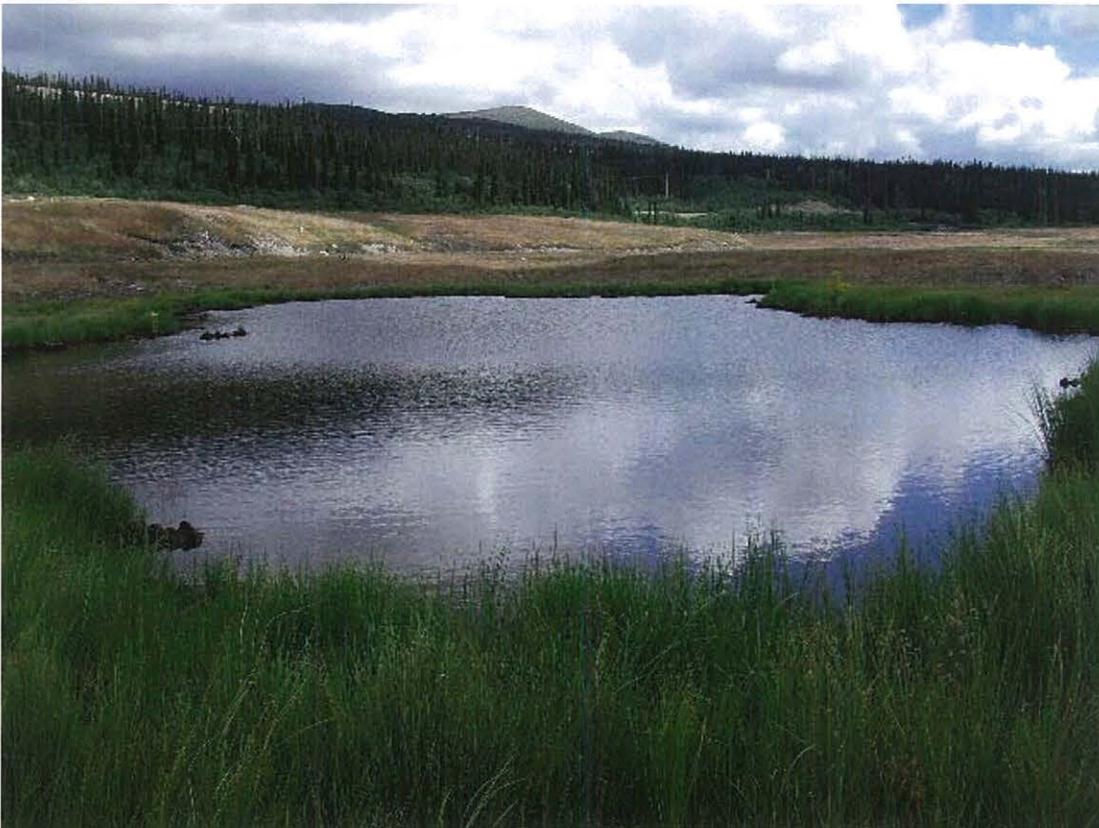
Lush growth of sedges around a wetland area of the valley floor, July 2006.

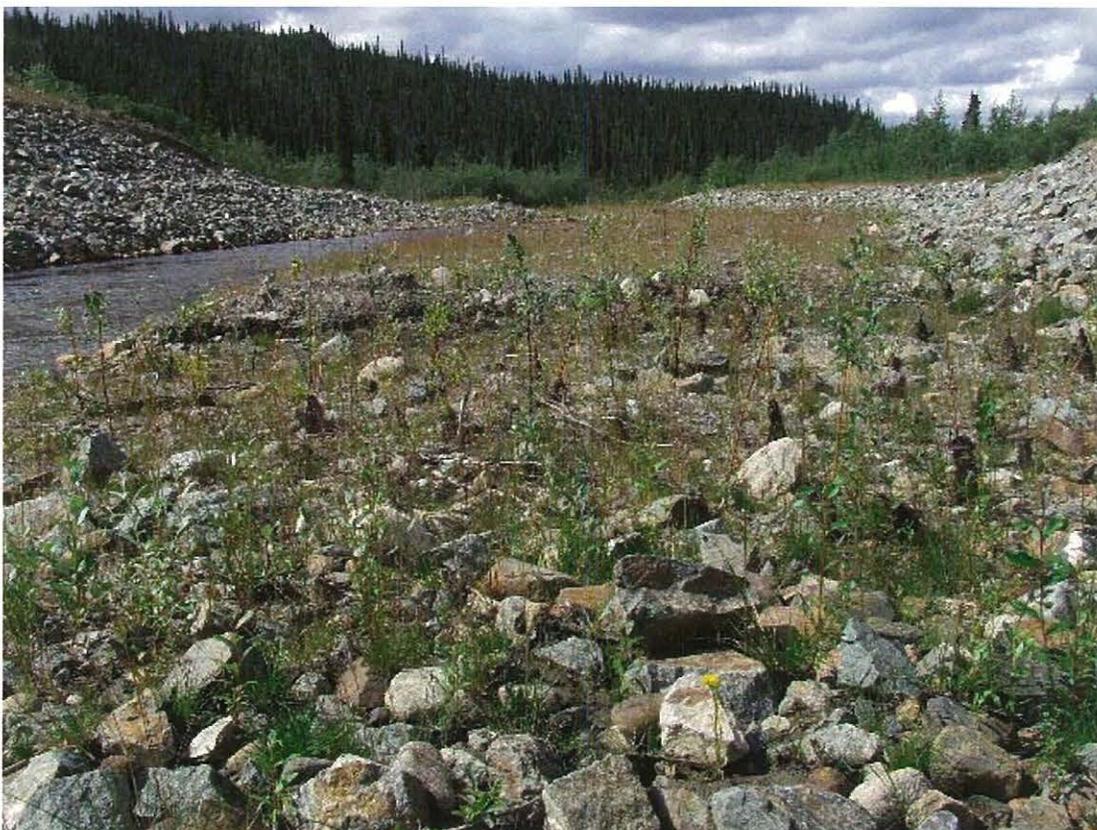
Good growth of transplanted willows and seeded grasses in the flood plain of the breach.

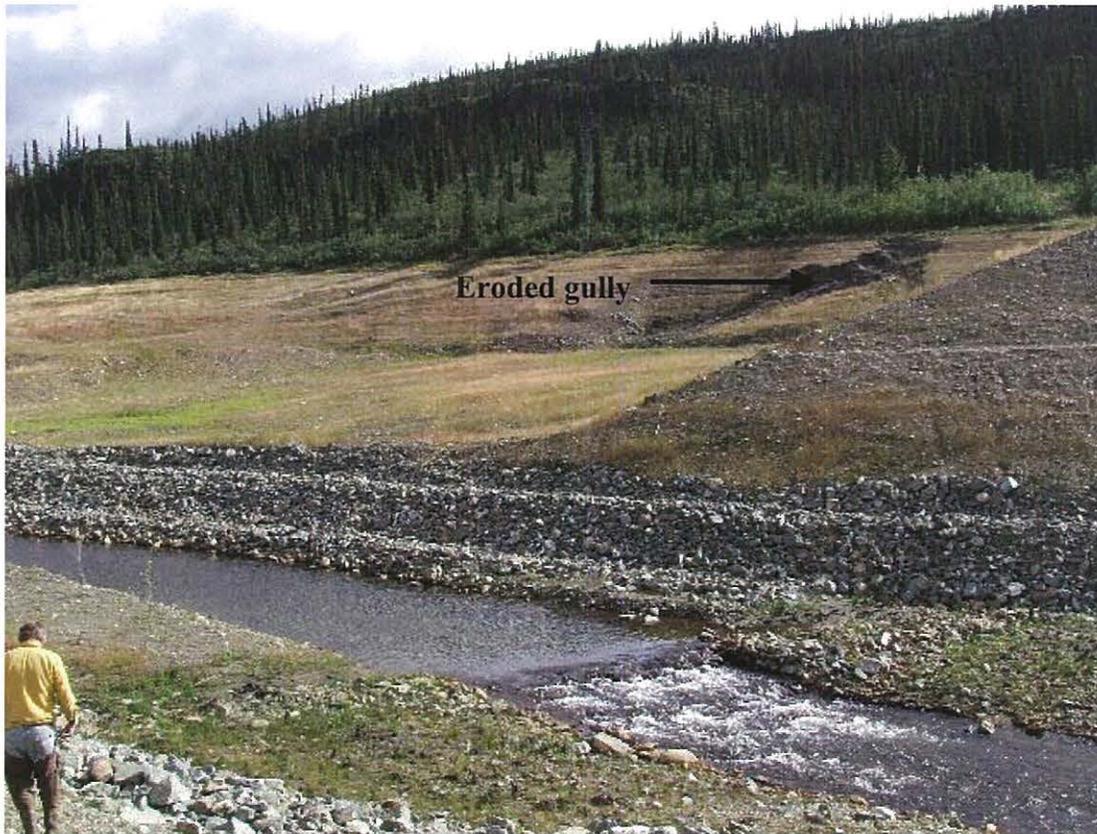
The breached section. The eroded gully in the background. July 2006.

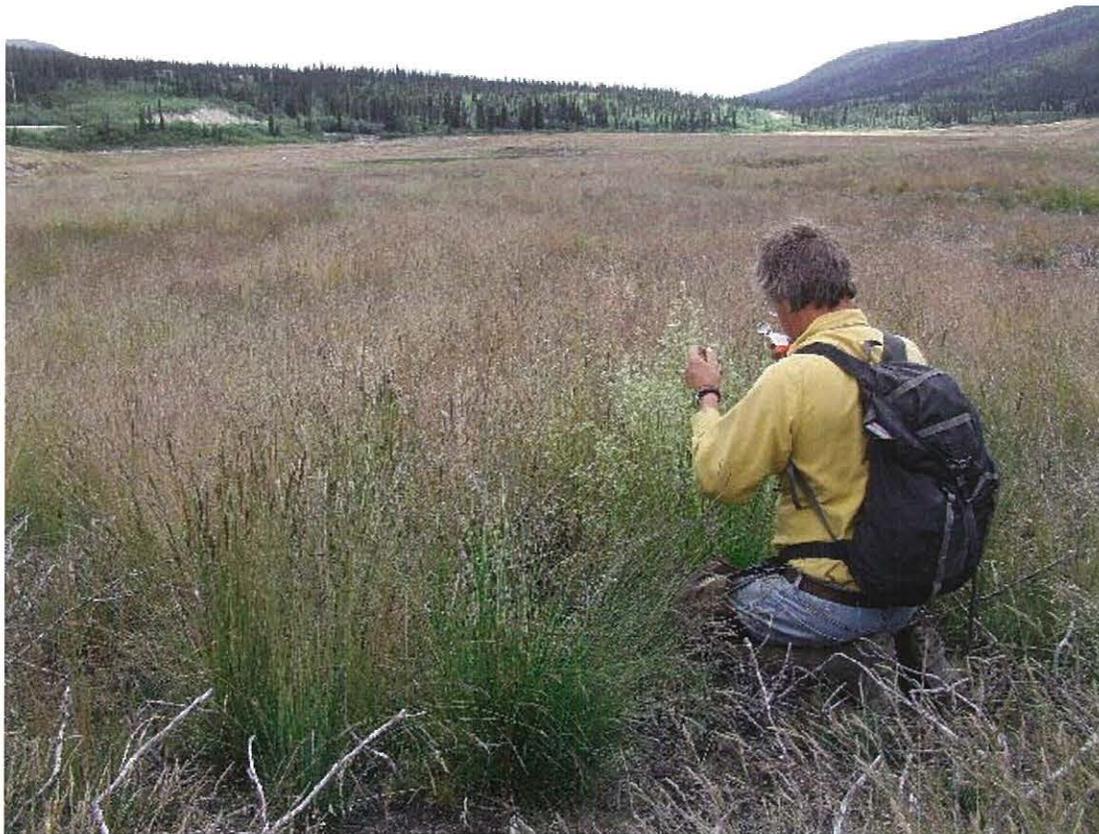
Stu Withers identifying a clump of Tufted Hairgrass. Grasses now cover 80 to 100% of the valley floor, looking southwest.

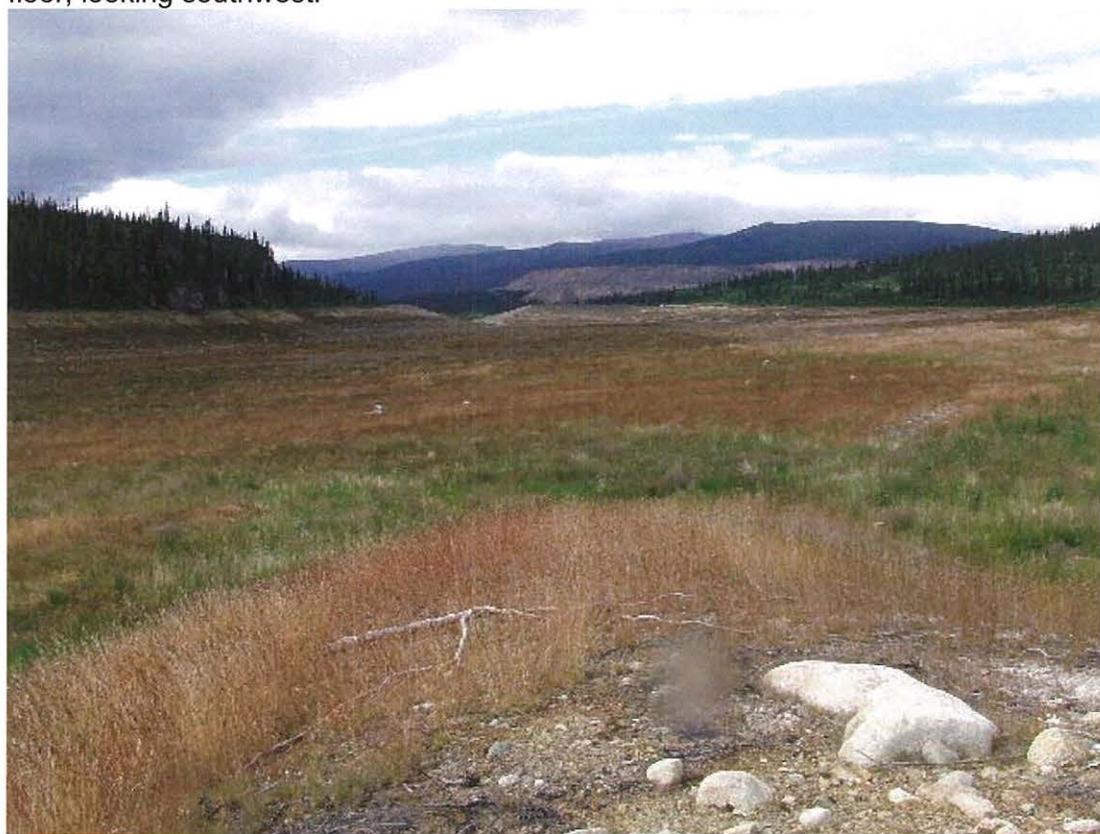
Good grass growth on the valley floor, looking northeast towards the breach. July 2006.

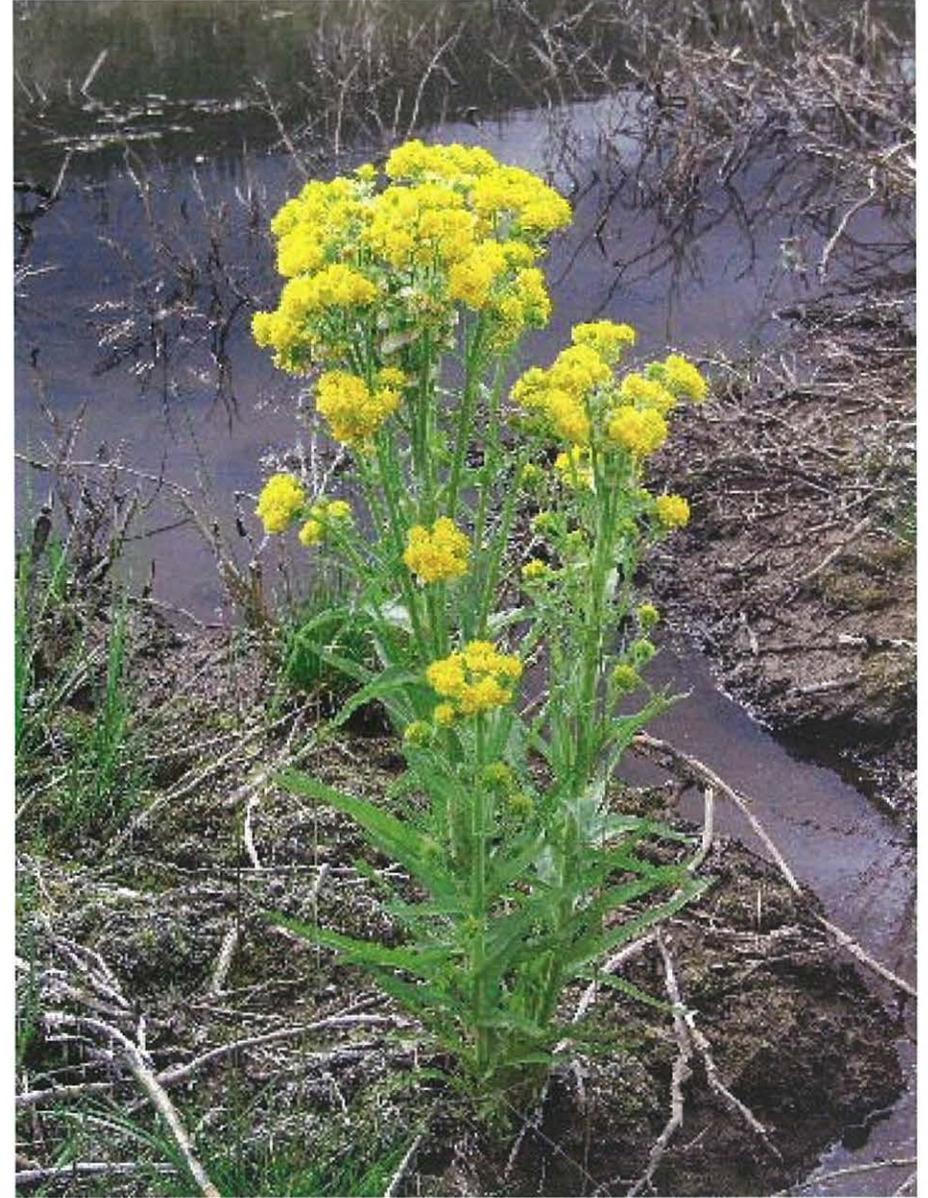
Mastodon Flower was prolific in the wetter areas of the valley floor.

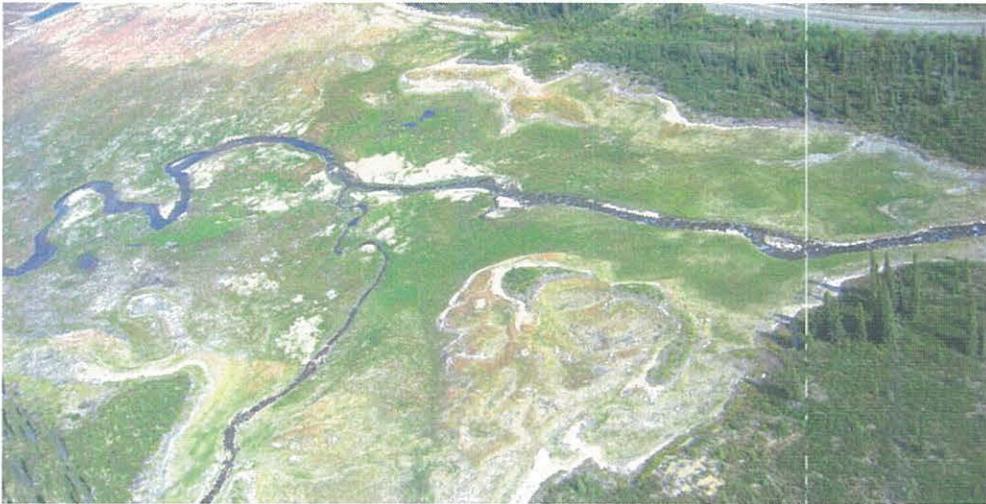
Photo #1: Reach 1 entering the dewatered Reservoir basin from the right. The South East Tributary enters Rose Creek from the bottom, August, 2005.

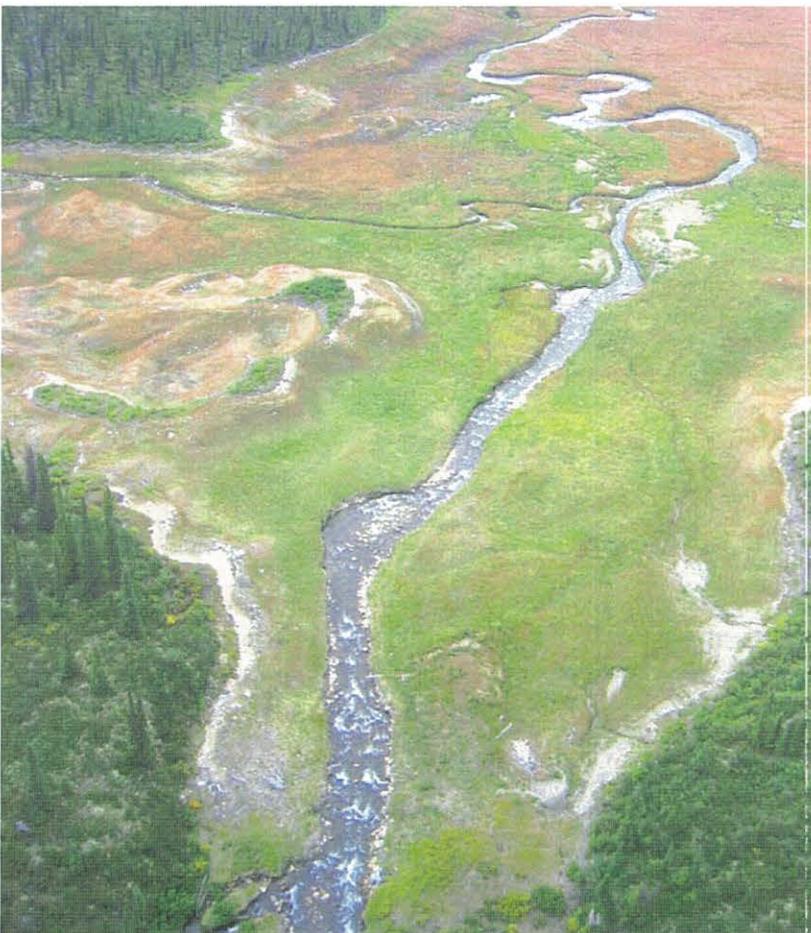
Photo #2: Rose Creek entering the reservoir basin 2006.

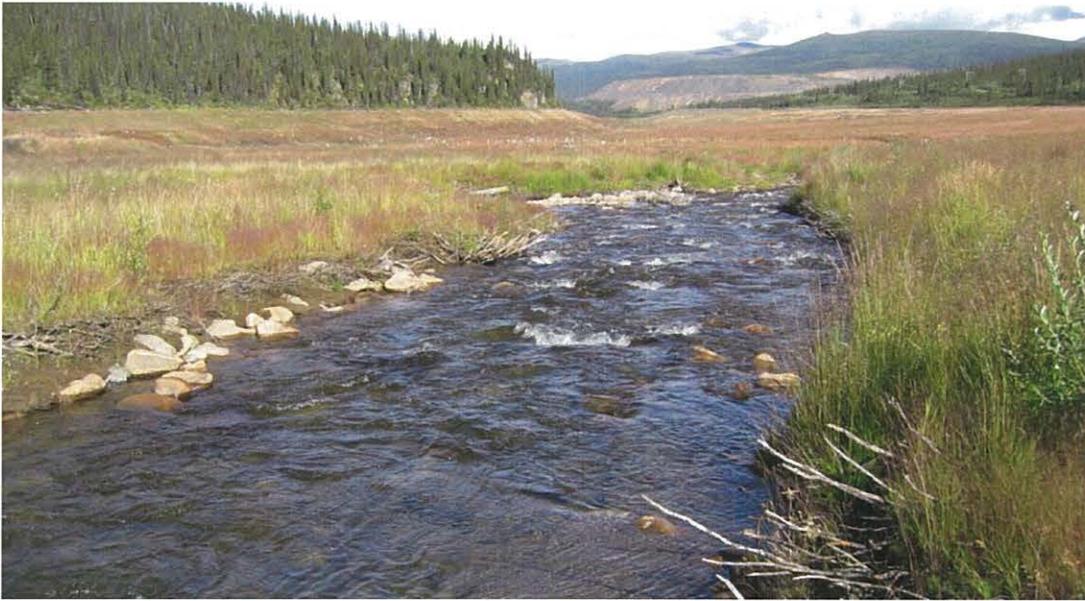
Photo #3: Reach 1, 2006 looking downstream at deflection point mid way in reach.

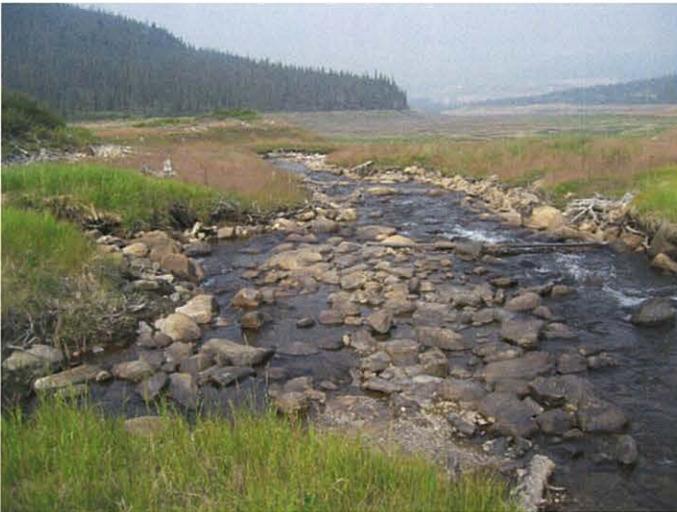
Photo #4: Reach 1 entering the basin in 2004.

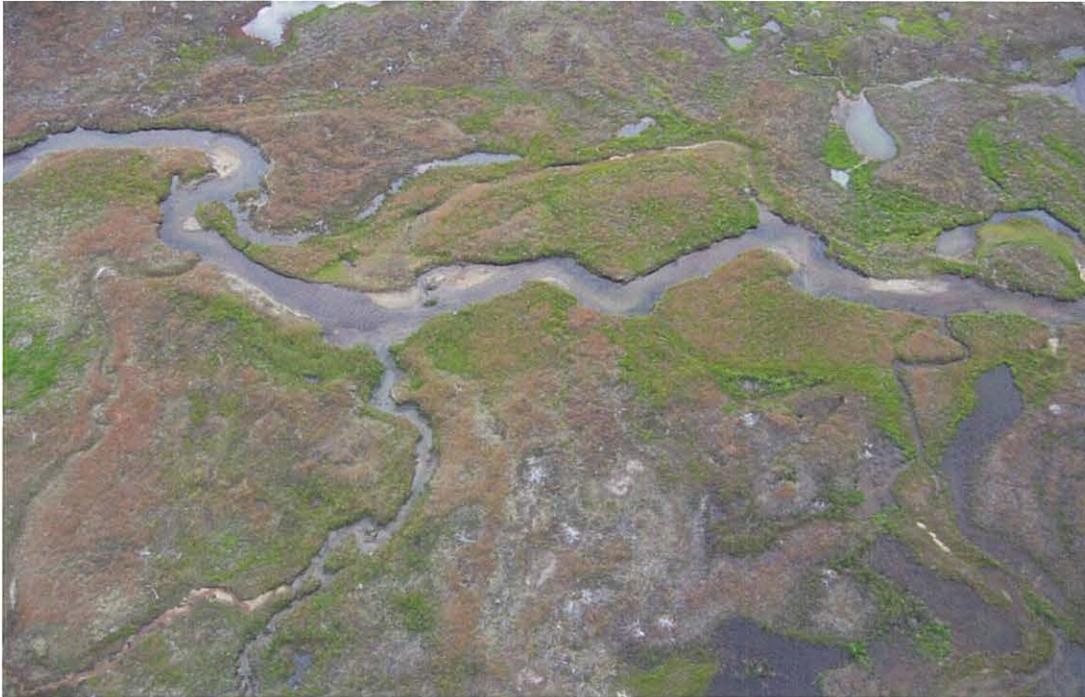
Photo #11: Channel development of the North Tributary entering Rose Creek, 2006.

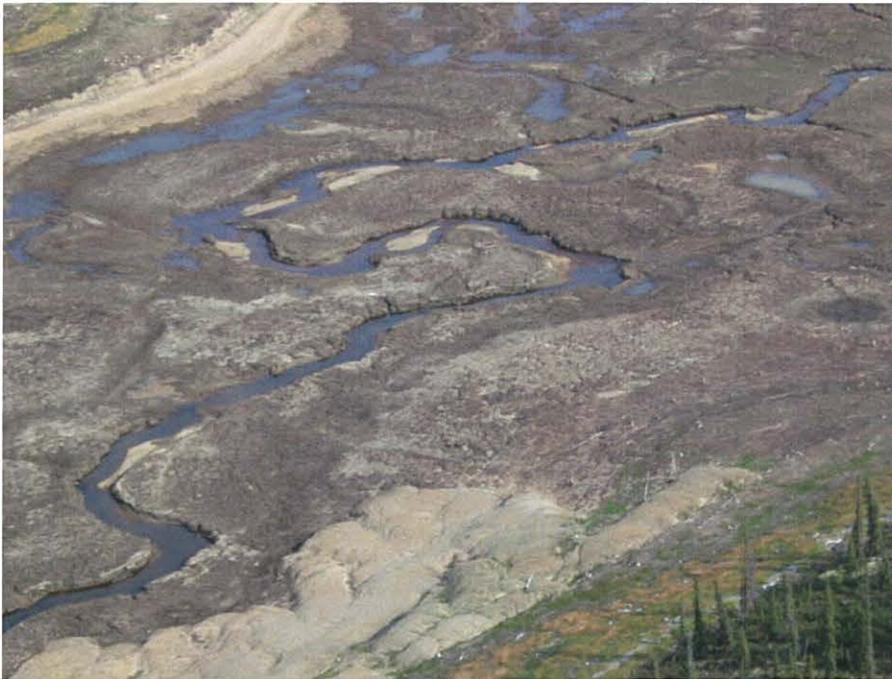
Photo #13: Aerial view for comparison to photo # 14 of lower section of Reach #3 showing deposition areas and extent of gravel bar formation during 2004.

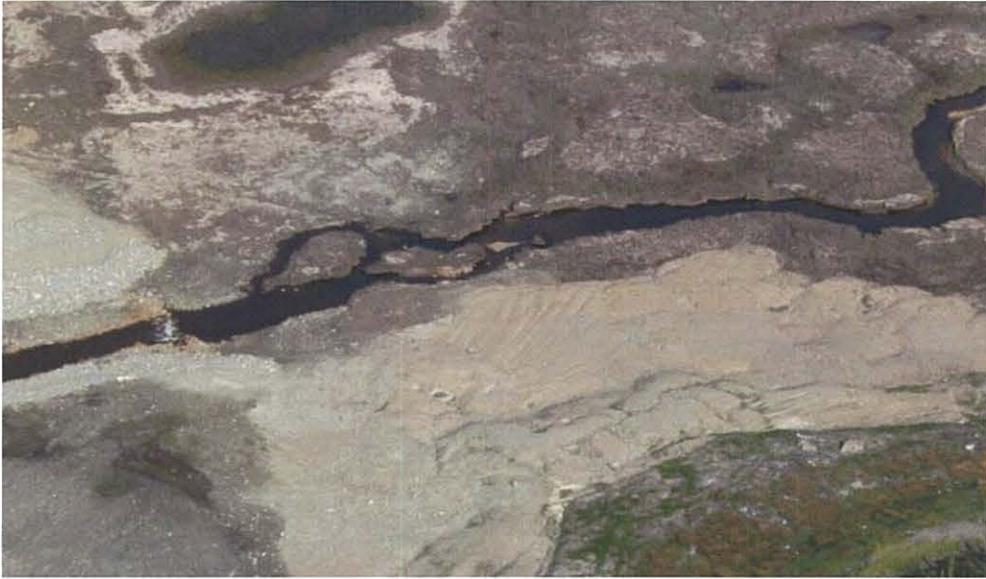
Photo # 15: Aerial view of the downstream end of Reach #3 in 2004 for comparison of island formation above the old coffer dam site.

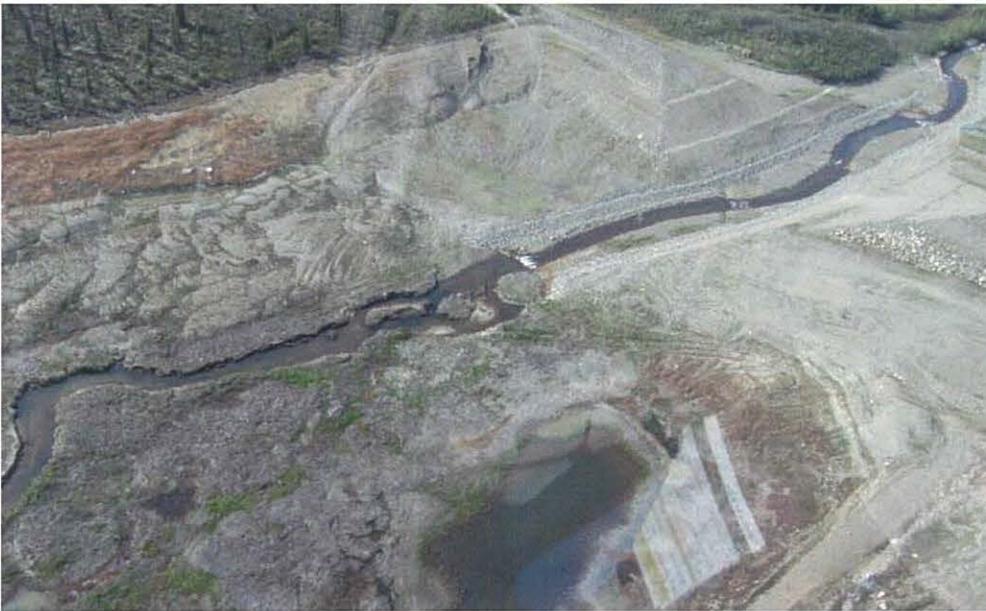
Photo #16: Rose Creek entering the breach, August, 2005. Note channel development outside of islands in comparison to photos # 15 and 17 from.

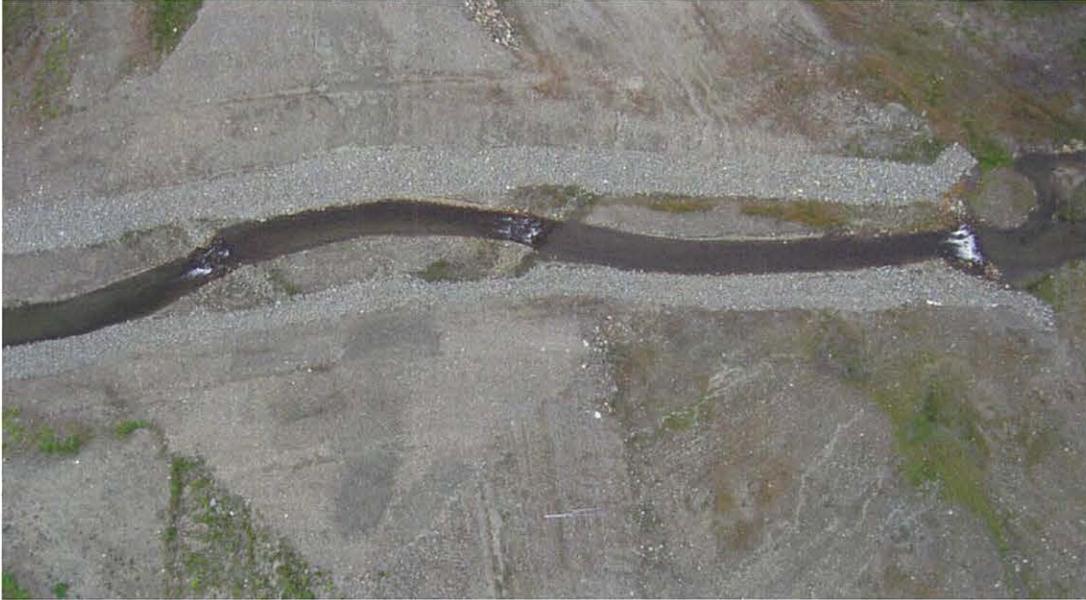
The newly constructed channel has very stable banks and channel features. Sediment infilling of the new rip rap in low flow areas continues and the constructed riffles have maintained their shape through high flow events. Some movement of native materials used in reconstruction of the riffles occurred in 2004 and has now stabilized. Low velocity areas had light silt coverings over boulders and cobbles in 2004, all above surface fines were absent during the 2005 and 2006 investigations. In general the newly created channel provides good fish habitats. Fish cover amongst the cobbles and boulders is enhanced by depth and by the adjacent riffles. Deep spacing between the rip-rap has filled substantially with fines since construction (see photos 19 & 20).

Photo #19: Flows through the breach, 2006.

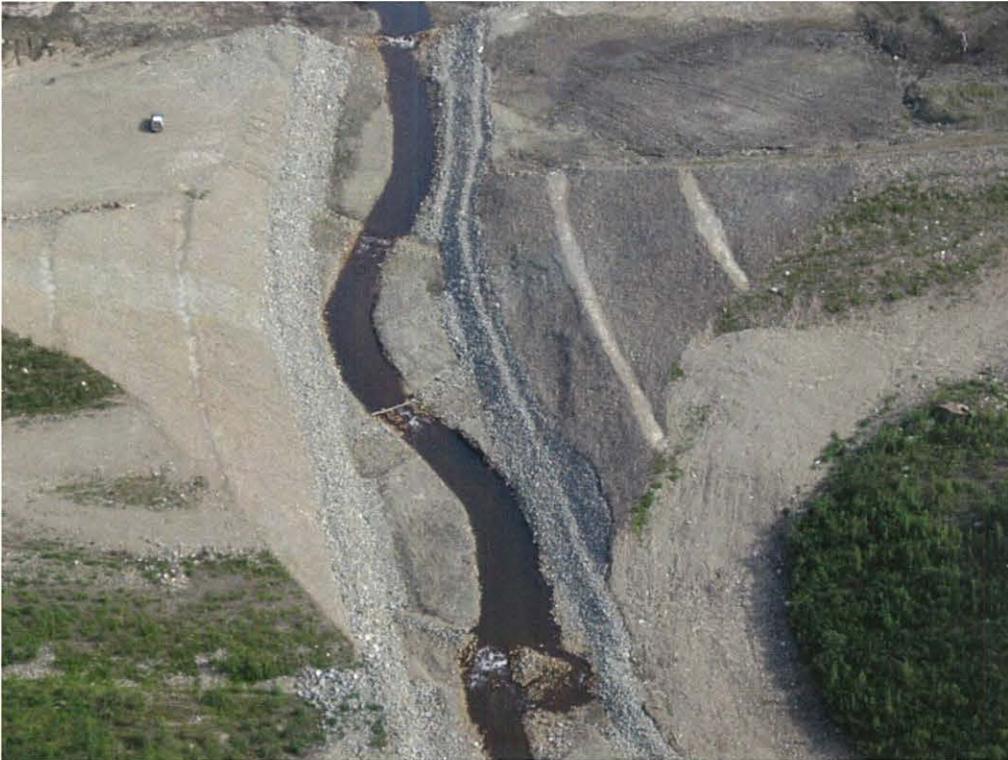
Photo #20: Aerial view for comparison from 2004 of the constructed channel within the breach.

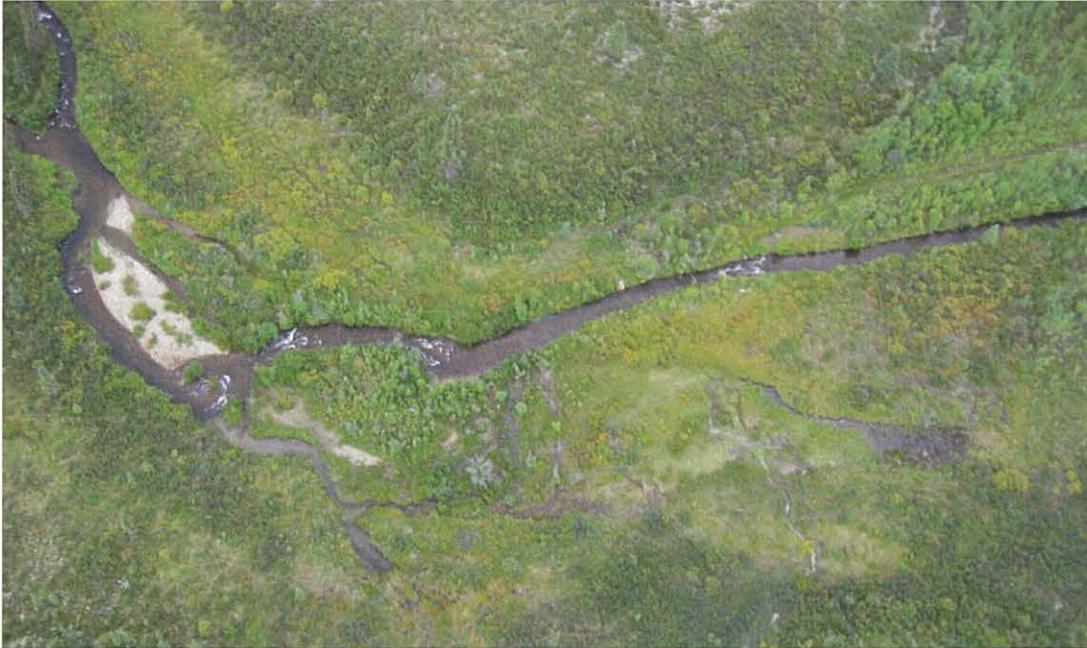
Reach 5b is the section of Rose Creek below the constructed channel. The native channel in this reach has become a deposition point for gravels washed from the reservoir basin (see photos 21 & 22).

Photo #21: The transition between reaches 5a and 5b. The gravel deposition areas are reach 5b, the straight channel on the right of the photo is reach 5a, 2006.

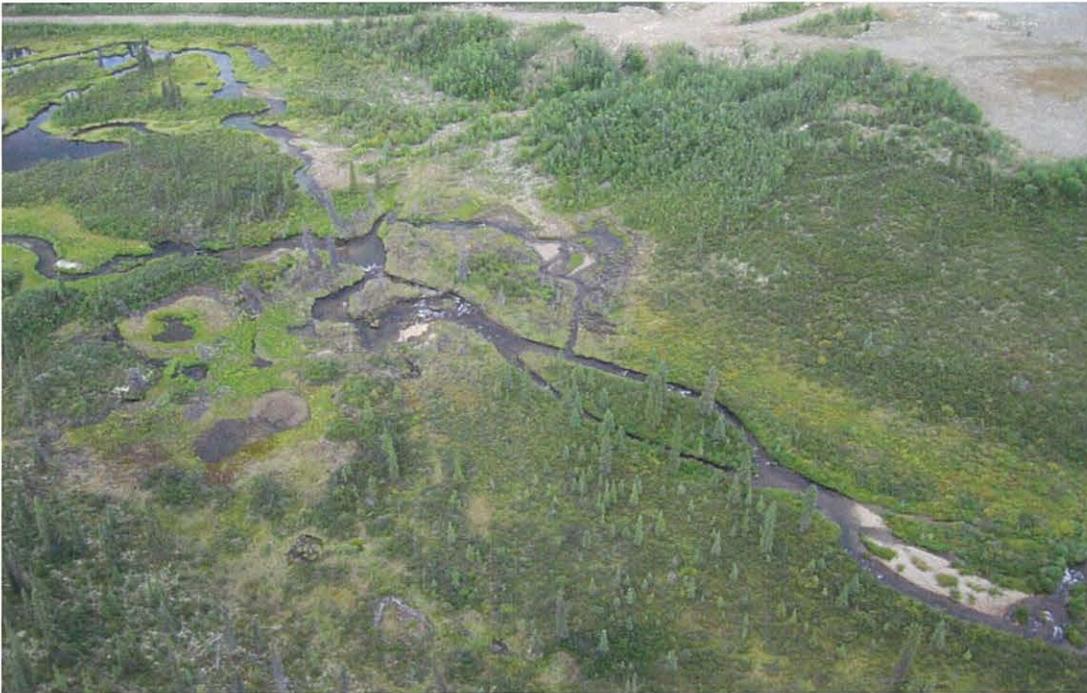
Photo #22: Rose Creek downstream of the breach (and photo 21) showing gravel deposition areas and natural channel formations, 2006.
