2021 Annual Report Long-Term Performance Monitoring Program Clinton Creek Mine, Yukon

PRESENTED TO
**Government of Yukon
Department of Energy, Mines and Resources
Assessment and Abandoned Mines Branch**

JANUARY 11, 2022
ISSUED FOR REVIEW
FILE: 704-ENG.WARC03956-03

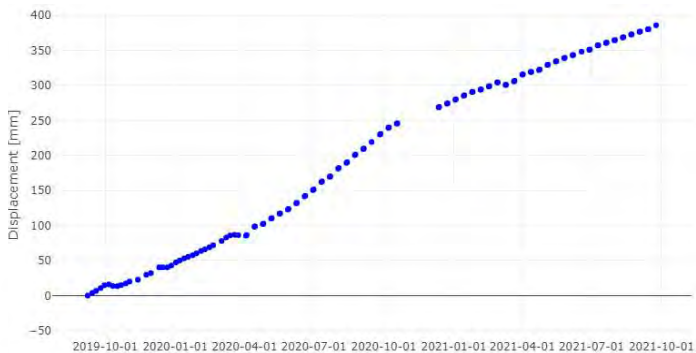
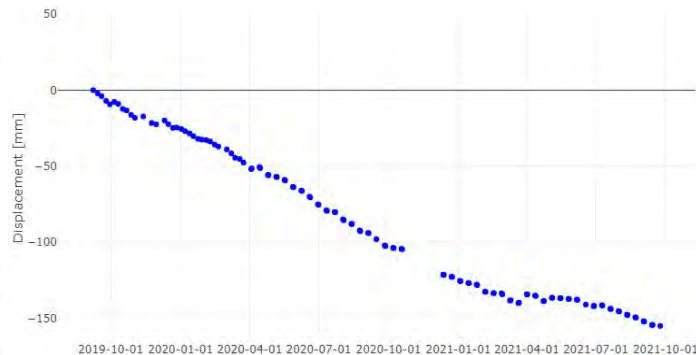
FIGURE 32

Figure 32 shows displacement detected by InSAR near the eastern toe of the Porcupine Creek waste rock dump. Horizontal displacement to the east is steady at about 5 cm/yr over the two-year monitoring period. Vertical settlement was approximately 6 cm/yr in 2020, decelerating to about 4 cm/yr in 2021.

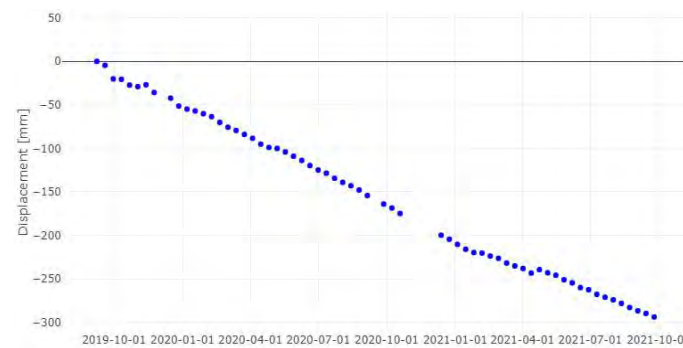
FIGURE 34

The southeast wall of the Porcupine Pit has a localized zone of movement in the central portion of the wall, which is shown in Figure 34. The area shown in the figure may correspond to an old, relatively large landslide that originated from near the pit rim, where a possible headscarp has been observed during site inspections. InSAR detected about 12 cm of westward movement and 4 cm of downward movement of the landslide over the monitoring period. Movement of the surrounding areas of the pit wall was less than approximately 2 cm over the same period. This is illustrated by the movement profiles shown on Figure 34, where localized movement is observed at about 200 m distance along the surface profile. InSAR coverage in the top of the landslide area near the pit rim is poor, possibly due to a lack of coherent reflectors detected from the descending orbit; however, LoS results from the ascending orbit indicates low to moderate movement away from the satellite, which would be consistent with downslope movement on the steep headscarp near the pit rim.

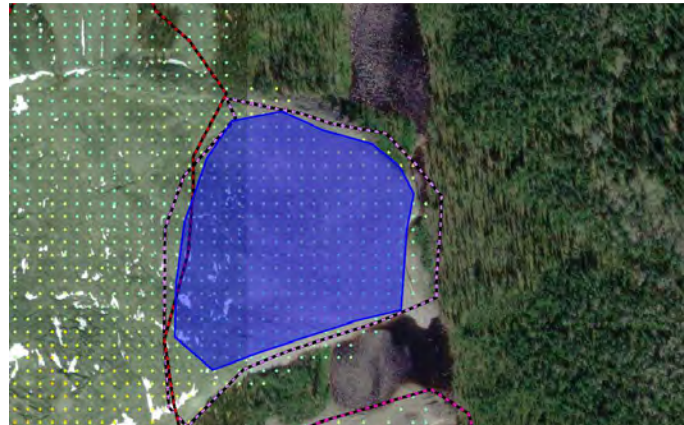
FIGURE 35

- The lower slope of the South Lobe, shown on Figure 35, shows approximately 15 cm/yr of eastward movement and 5 cm/yr of vertical settlement. The movement rate is nominally constant throughout the InSAR monitoring period.

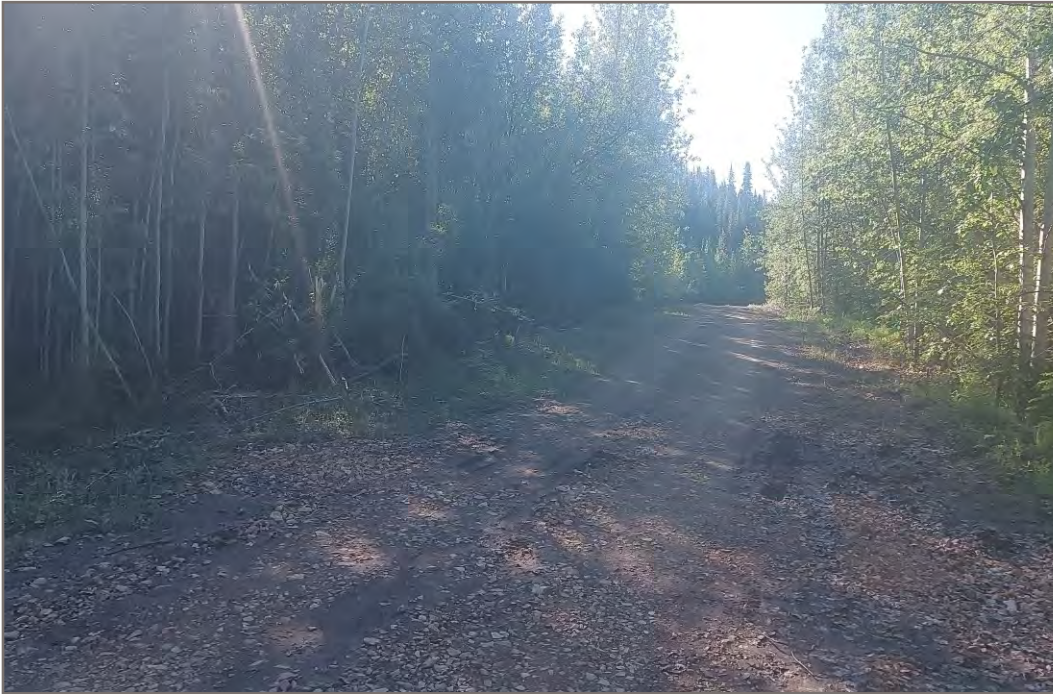
Typical road conditions in this section are shown in Photos 1 to 4. An aerial view of the landslide at about km 36.0 is shown in Photo 5.

Photo 1: Typical Access Road condition from Forty Mile Bridge to Site Access Gate.
Clinton Creek Road km 33.2, facing southeast.
Photo taken by Shawn Matthies, June 16, 2021.

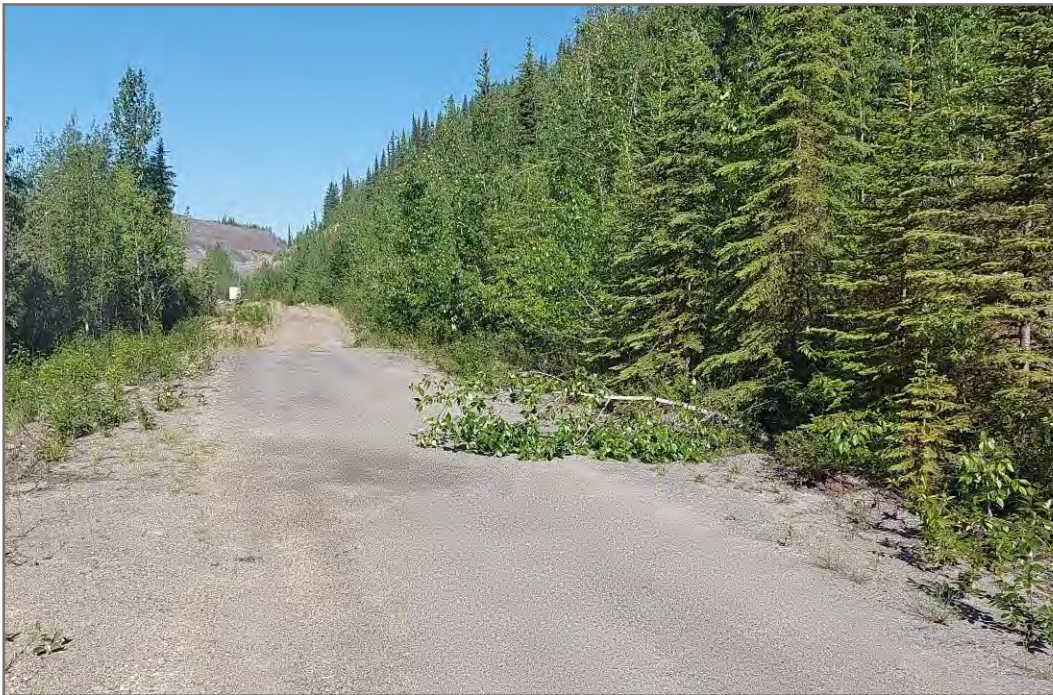
Photo 4: Small tree fallen on road.
Clinton Creek Road km 39.0, facing west.
Photo taken by Shawn Matthies, June 16, 2021.

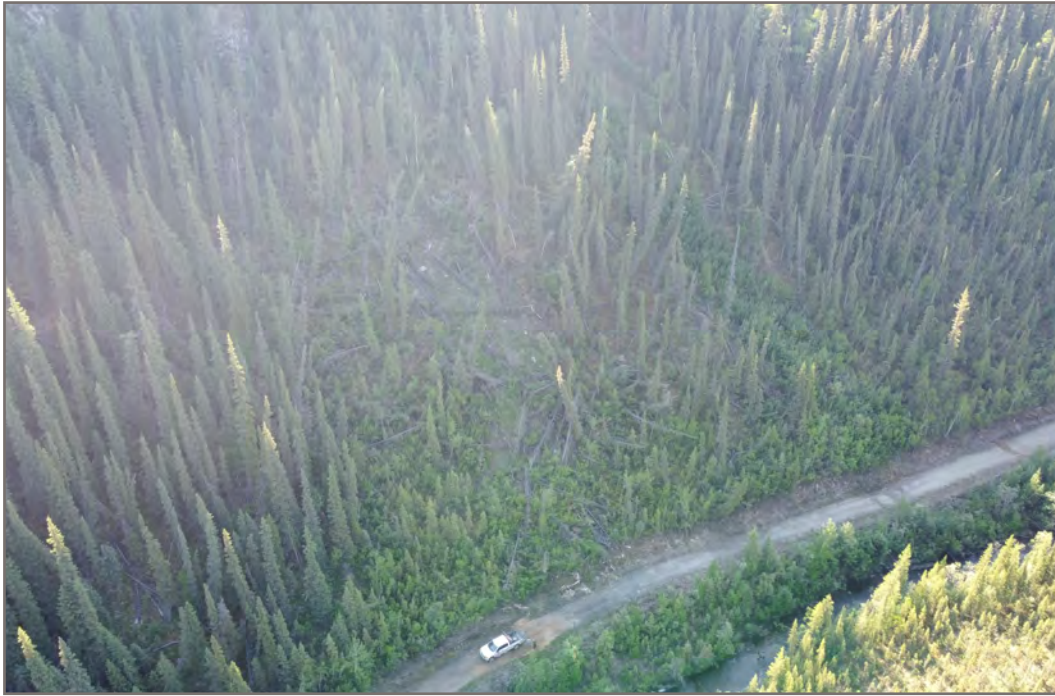
Photo 5: Active landslide along Access Road.
Clinton Creek Road km 36.0.
Photo taken by Shawn Matthies, June 16, 2021.

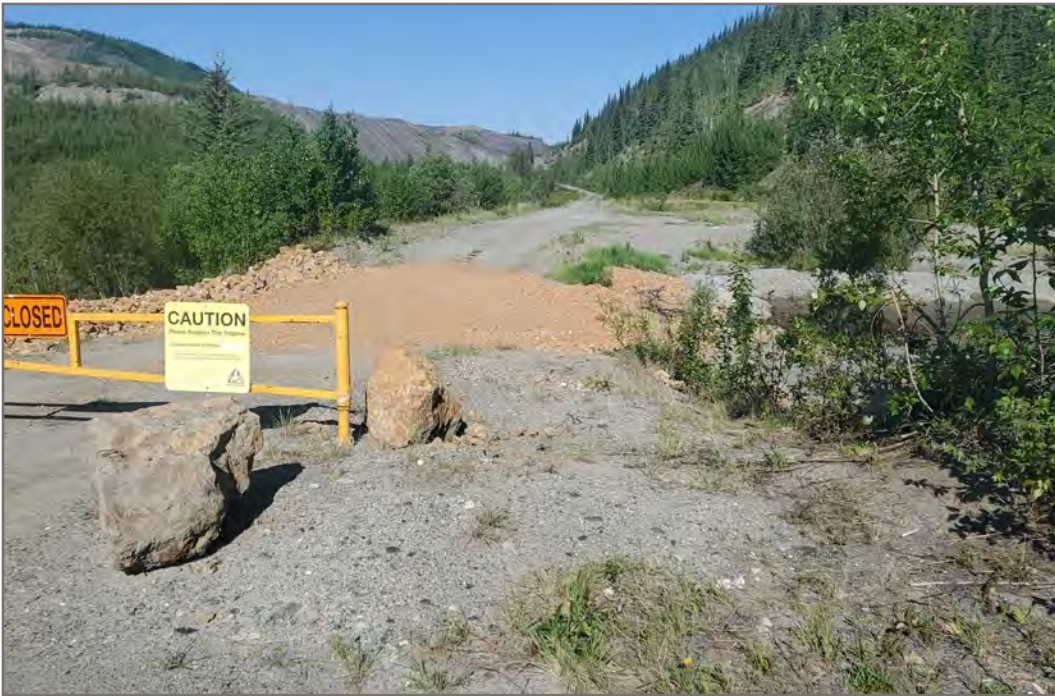
The site access gate is intact and in good condition. Several boulders on the north side of the access gate have been moved to allow vehicles to bypass the gate and obtain unauthorized site access (see Photo 6). Tire tracks were visible on the ground around the gate. One boulder was moved directly in front of the Wolverine Creek overflow culvert inlet. A spare gate key that is normally hidden near the gate was missing, however we understand that the lock on the gate was replaced in Fall 2020. The Wolverine Creek road crossing, which was washed out during the spring 2020 freshet, is in good condition and there is no sign that water overtopped the road during the 2021 freshet (shown in Photo 7). Rutting increases somewhat upon entrance to the mine site however the road is still easily passable to light vehicles.

Photo 6: Boulders on north side of site access gate moved, facing west.
Photo taken by Adam Wallace, June 15, 2021.

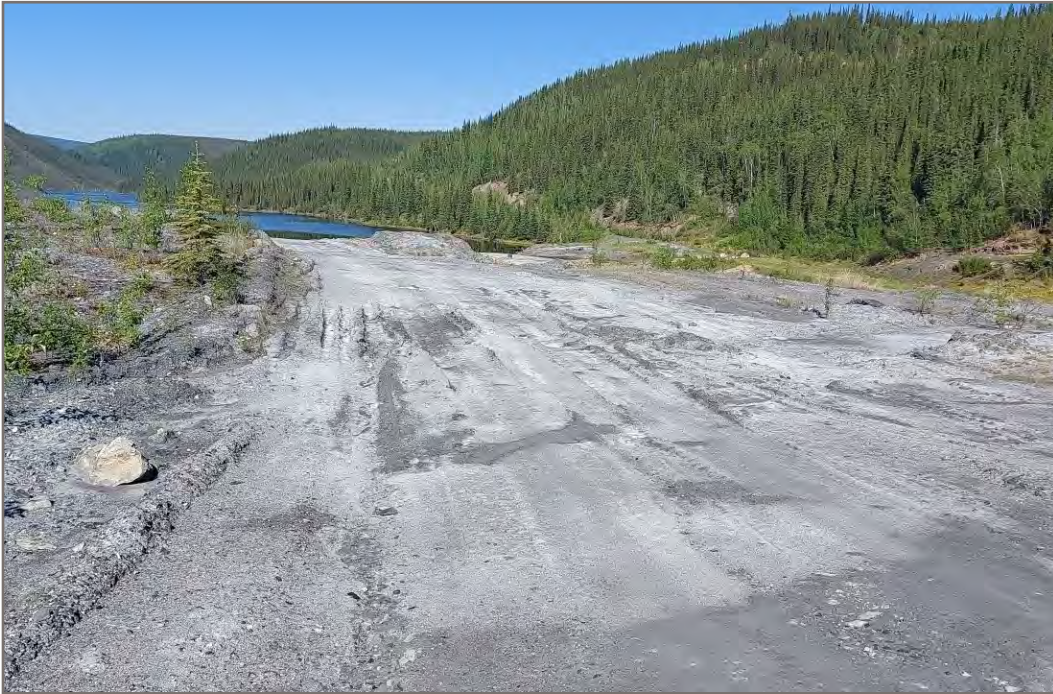
Some moderate surface erosion and rutting is present along the portion of the access road that traverses the waste rock dump, where surface water flows down the waste rock slopes and onto the road surface (see Photos 8 and 9). This erosion has created a number of small gullies on the waste rock slopes and the road surface (see Photos 10 and 11). There are also small erosion gullies along the Clinton Creek channel where water flows off of the road and spills into the creek channel (see Photo 12); this erosion is ongoing and will eventually impact the road alignment.

Several gullies on the slope to the south of Ford Crossing No. 1 have continued to develop (examples visible in Photos 9 and 49). In one of these gullies, a section of culvert has become dislodged (see Photo 49). An additional length of culvert is protruding slightly from the back of the eroded gully. The location of the culvert inlet and the area that the culvert is intended to drain is unknown. The outlet of the culvert was dry at the time of the inspection.

Photo 9: Rutting on road surface.
Access Road km 40.6, facing west.
Photo taken by Shawn Matthies, June 16, 2021.

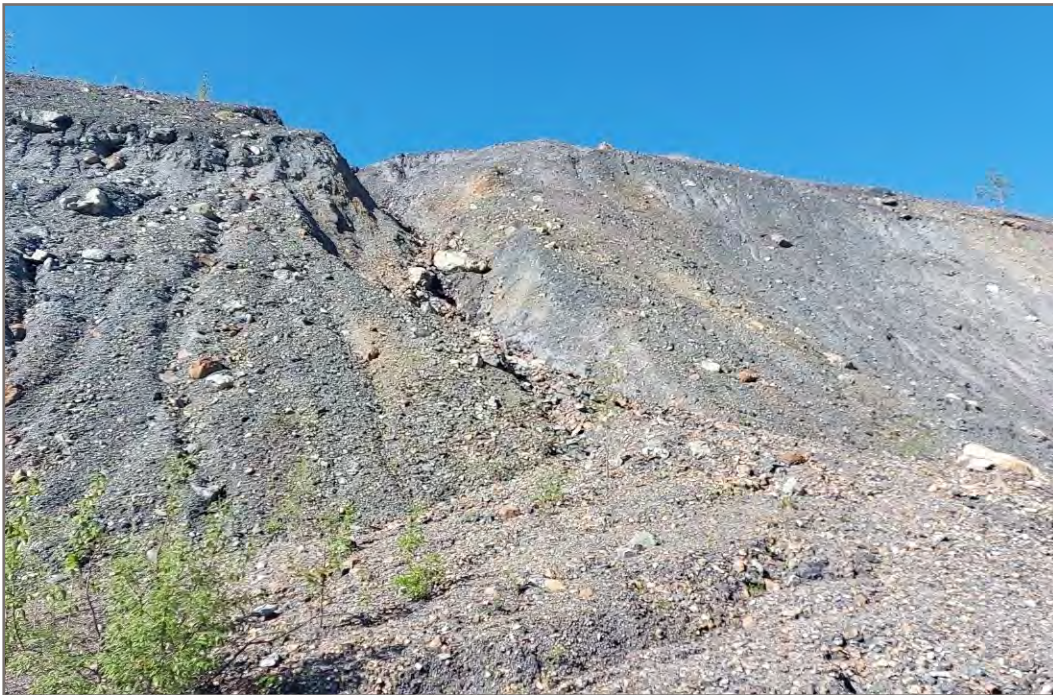
Photo 10: Erosion gully above road.
Access Road km 39.5, facing southwest.
Photo taken by Shawn Matthies, June 16, 2021.

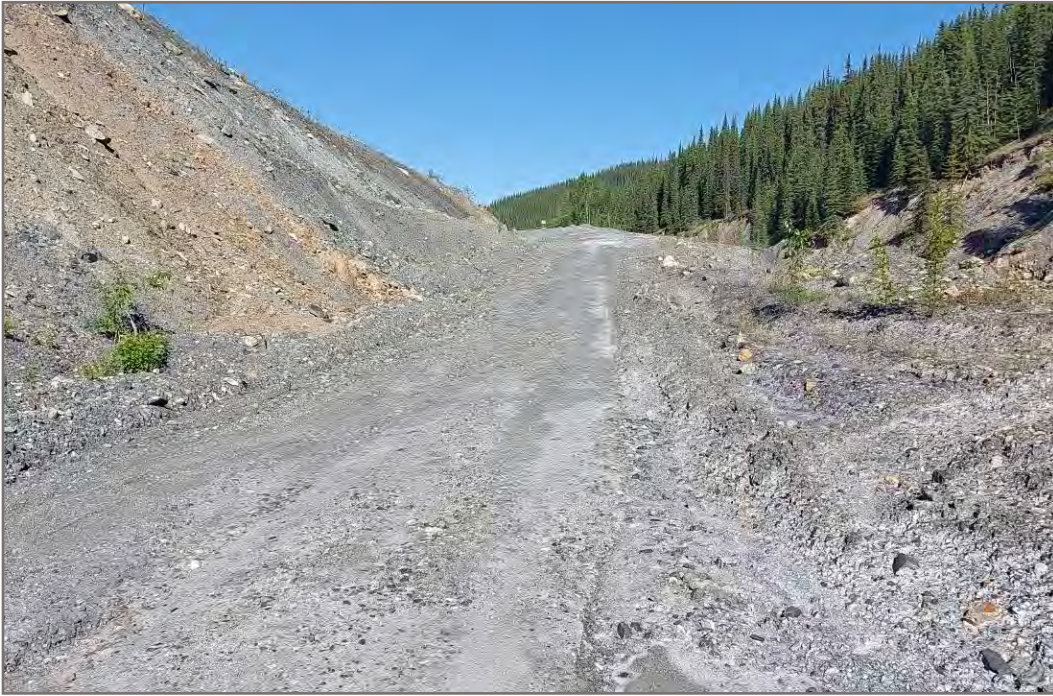
Photo 11: Erosion gullies on road surface.
Access Road km 39.6, facing west.
Photo taken by Shawn Matthies, June 16, 2021.

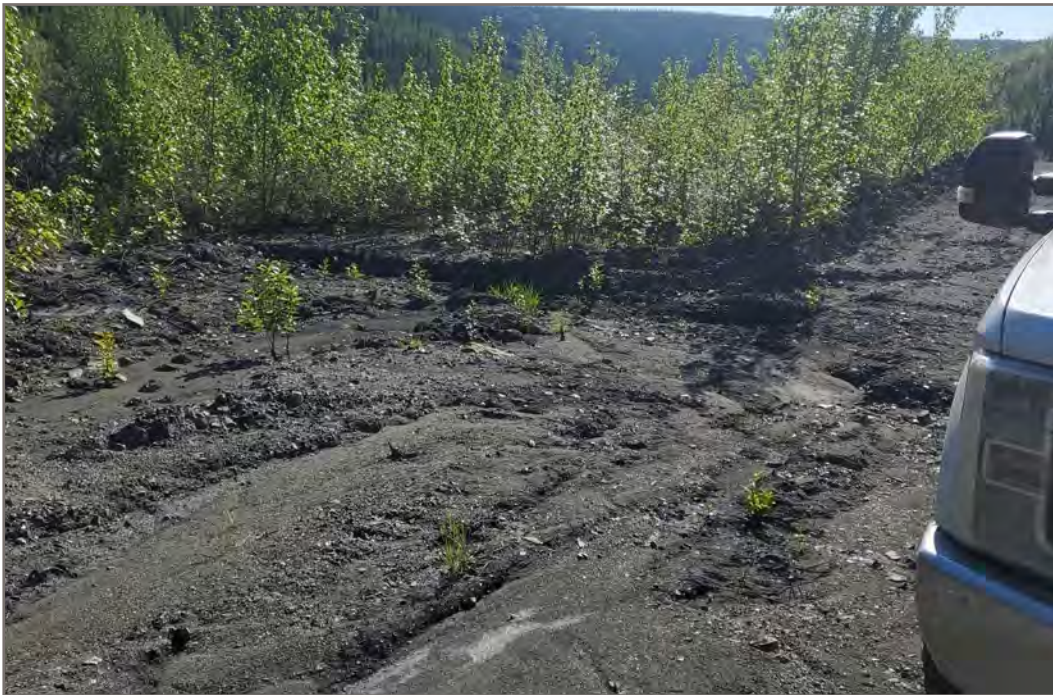
Photo 12: Erosion gully leading to Clinton Creek channel.
Access Road km 39.5, facing east.
Photo taken by Adam Wallace, June 16, 2021.

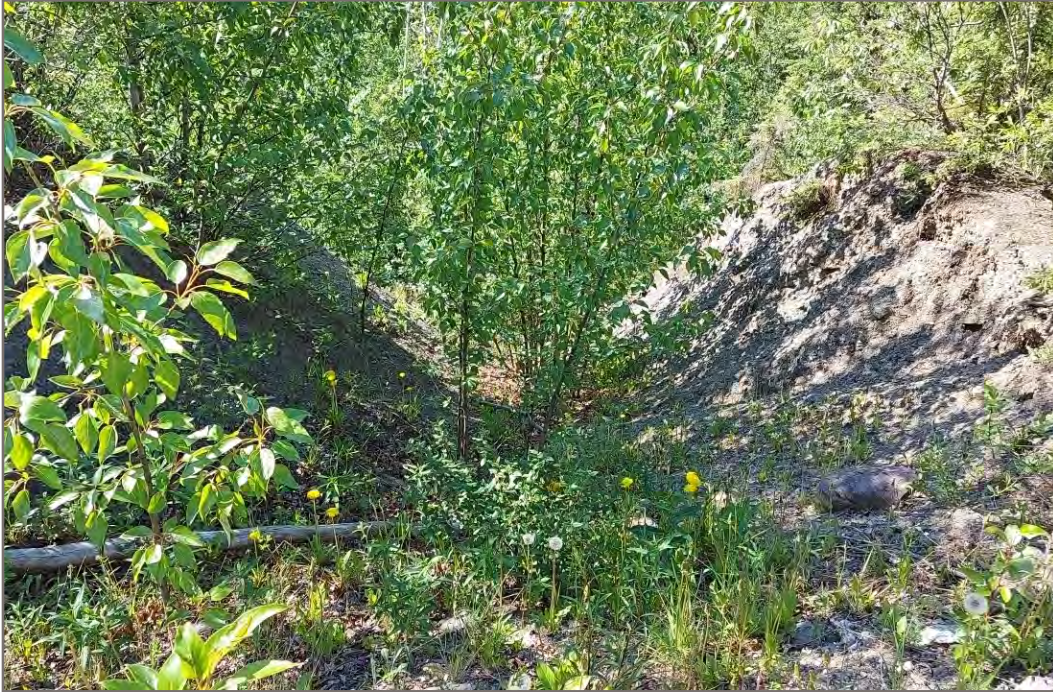
Photo 15: Gully on downslope side of road.
Access Road km 41.8 facing south.
Photo taken by Shawn Matthies, June 16, 2021.

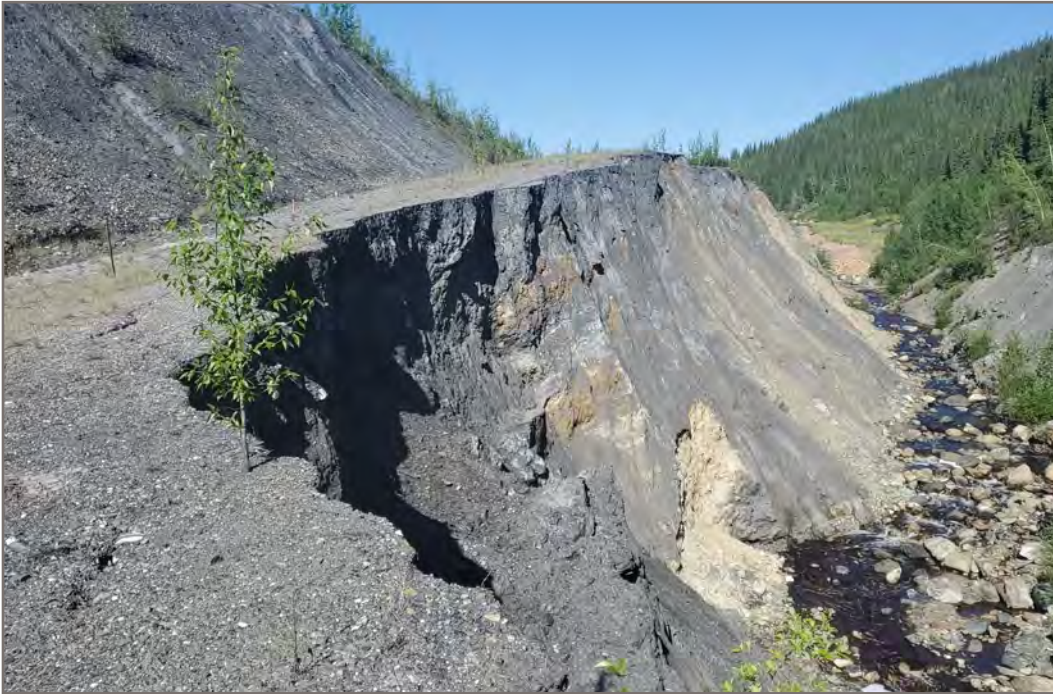
The closed section of the site access road experienced major erosion and embankment loss during the spring freshet in 2020. Comparatively little new movement was observed during this year's site inspection (see Photo 17), and no additional survey pins were lost from the monitoring baseline (four pins fell into the Clinton Creek channel due to erosion in 2020). Some minor new tension cracking was observed (see Photos 18 and 19). A shallow erosion gully on the upslope side of the road continues to function as a ditch to collect and divert surface water to the east, onto the active access road (visible in Photos 18 and 20); tension cracks are spreading and may eventually intersect this gully, which would result in increased surface water flow and erosion over the edge of the embankment.

Photo 17: Closed section of access road, facing west.
Photo taken by Adam Wallace, June 16, 2021.

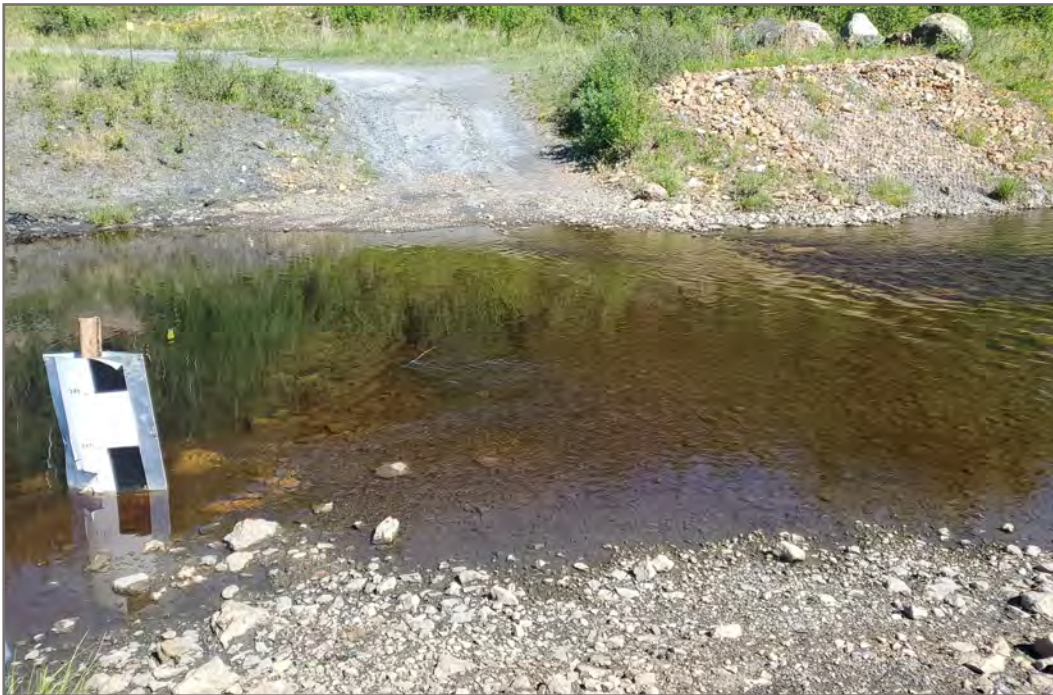
The ford crossings are in very good condition compared to previous years (see Photos 21 and 22). Both crossings were easily passable in a vehicle with moderate clearance, such as a light pickup truck. Ford crossing approaches were previously very steep, however repairs completed in 2020 have established a gentler grade and are holding up well. Staff gauges indicated a water depth of approximately 1 ft (0.3 m) at both crossings.

Photo 22: Ford Crossing No. 2, facing north toward Clinton Creek natural slope.
Photo taken by Adam Wallace, June 15, 2021.

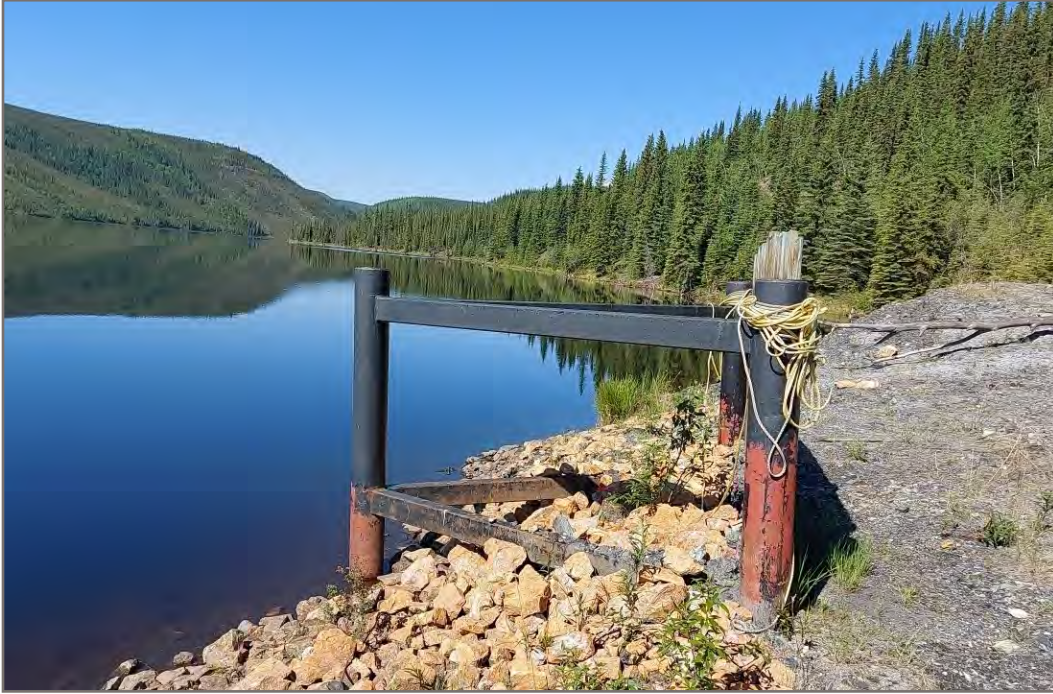
Photo 23: North log boom abutment, facing west.
The frame tilts approximately 3° toward Hudgeon Lake.
Photo taken by Shawn Matthies, June 16, 2021.

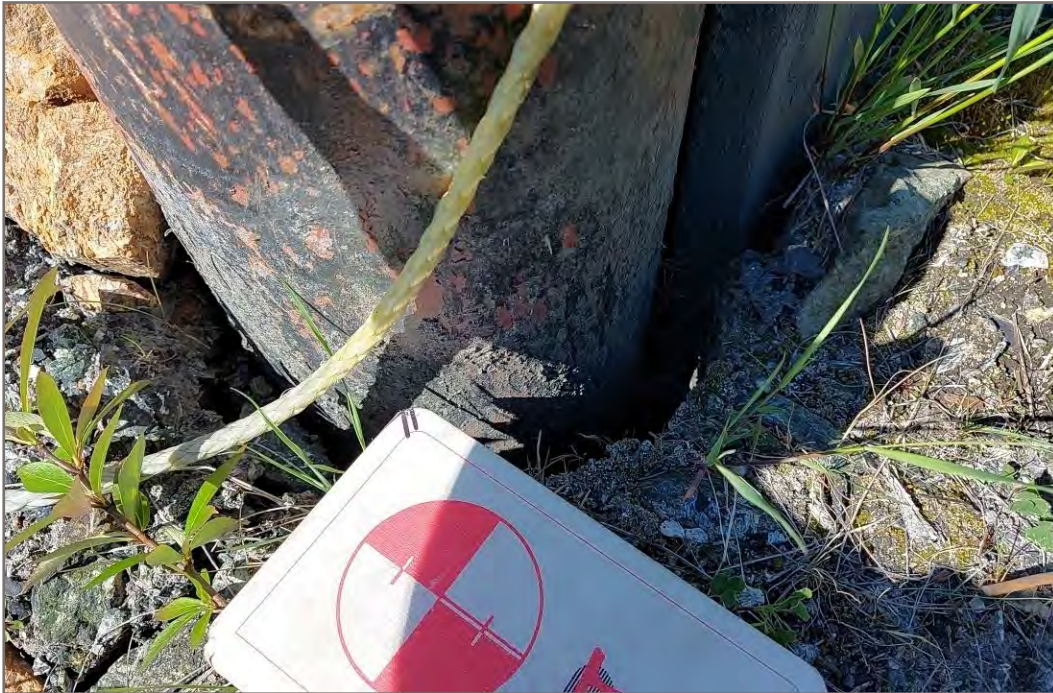
Photo 24: Open space around steel post on the north log boom abutment.
Photo taken by Shawn Matthies, June 16, 2021.

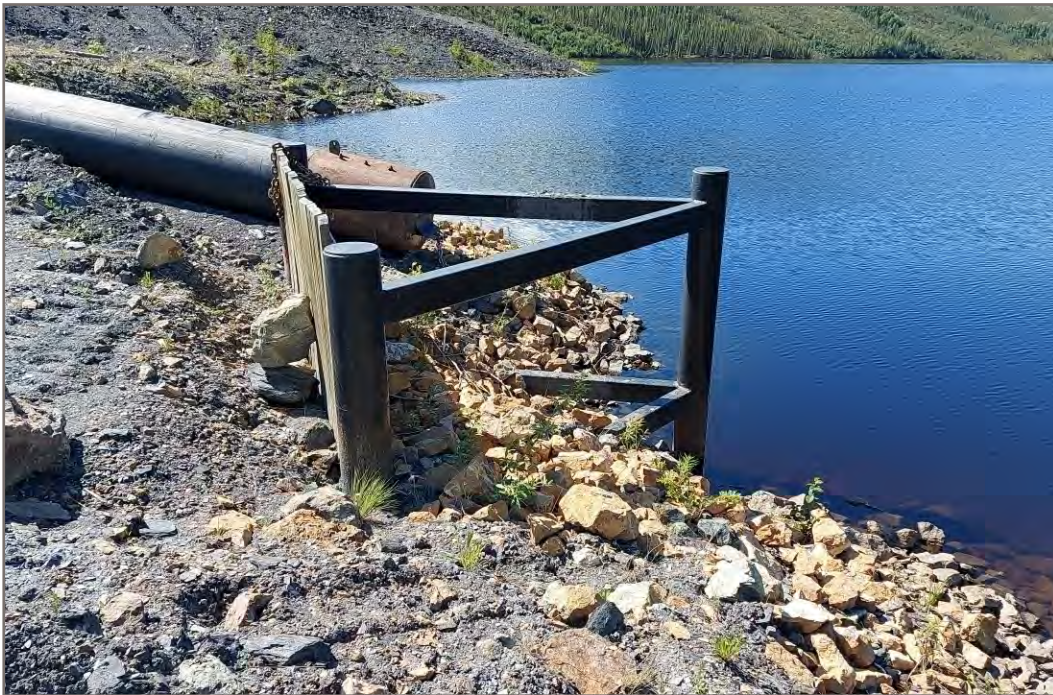
Photo 26: South log boom abutment, facing southwest.
Photo taken by Shawn Matthies, June 16, 2021.

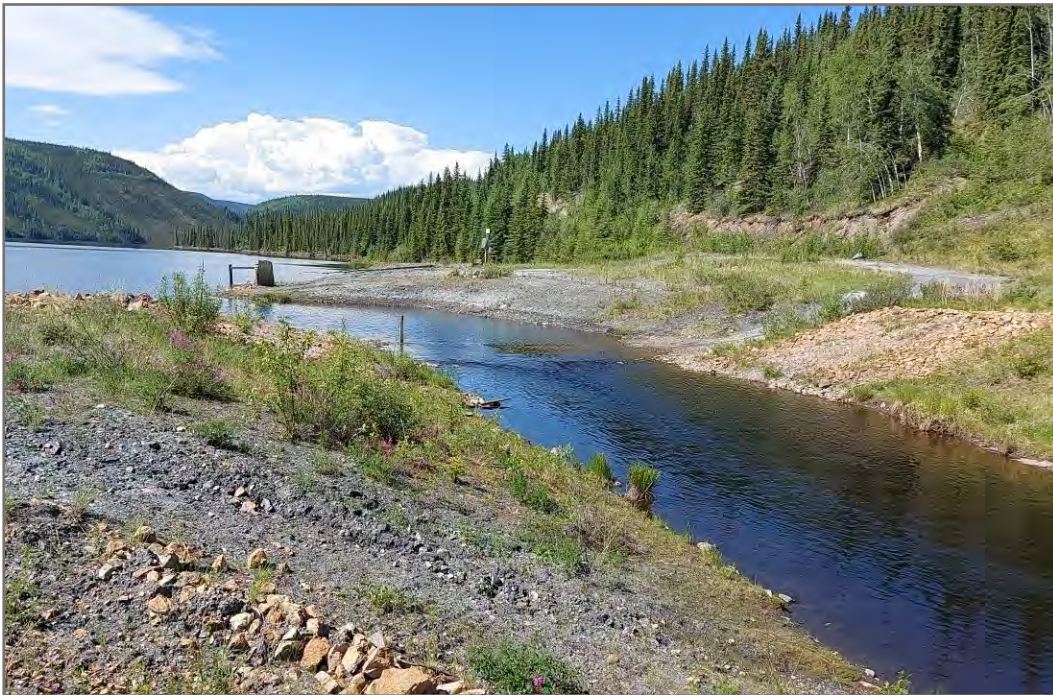
Photo 28: Hudgeon Lake outlet, facing east.
Photo taken by Shawn Matthies, June 16, 2021.

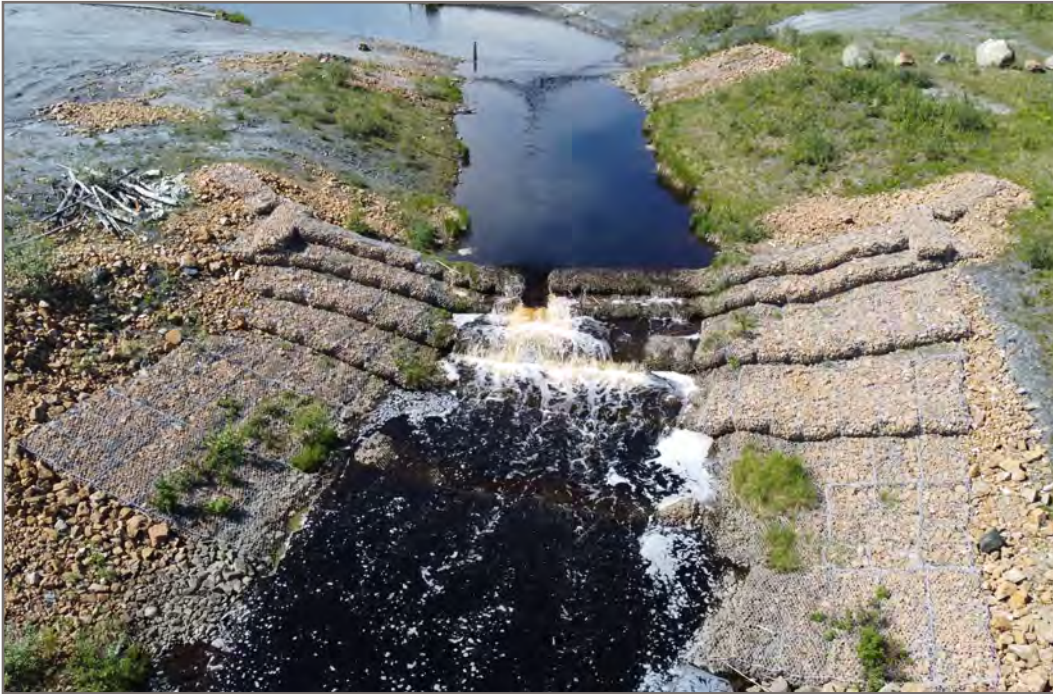
Photo 29: Drop Structure 1, facing west.
Photo taken by Adam Wallace, June 16, 2021.

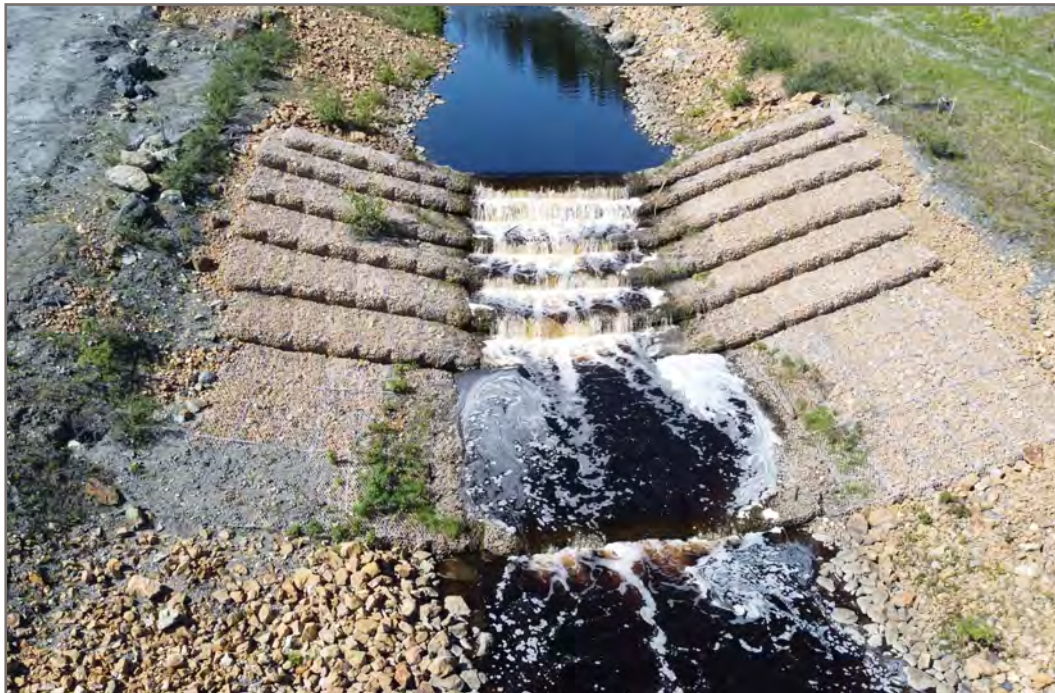
Photo 30: Drop Structure 2, facing west.
Photo taken by Adam Wallace, June 16, 2021.

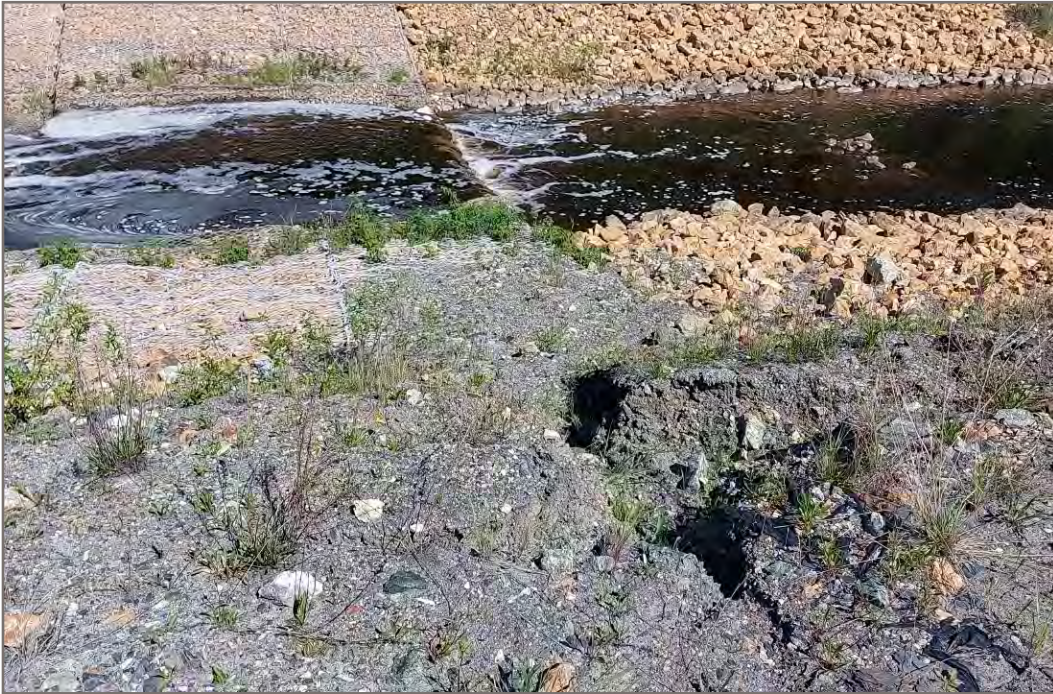
Photo 31: Erosion on south bank of DS2, facing north.
Photo taken by Shawn Matthies, June 16, 2021.

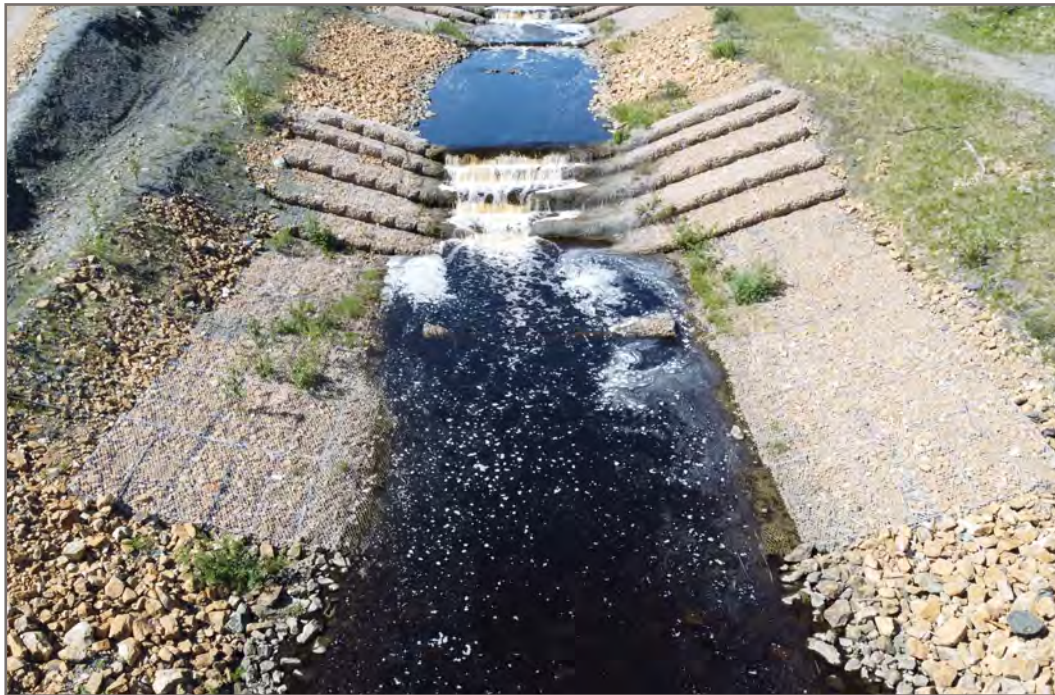
Photo 32: Drop Structure 3, facing west.
Photo taken by Adam Wallace, June 16, 2021.

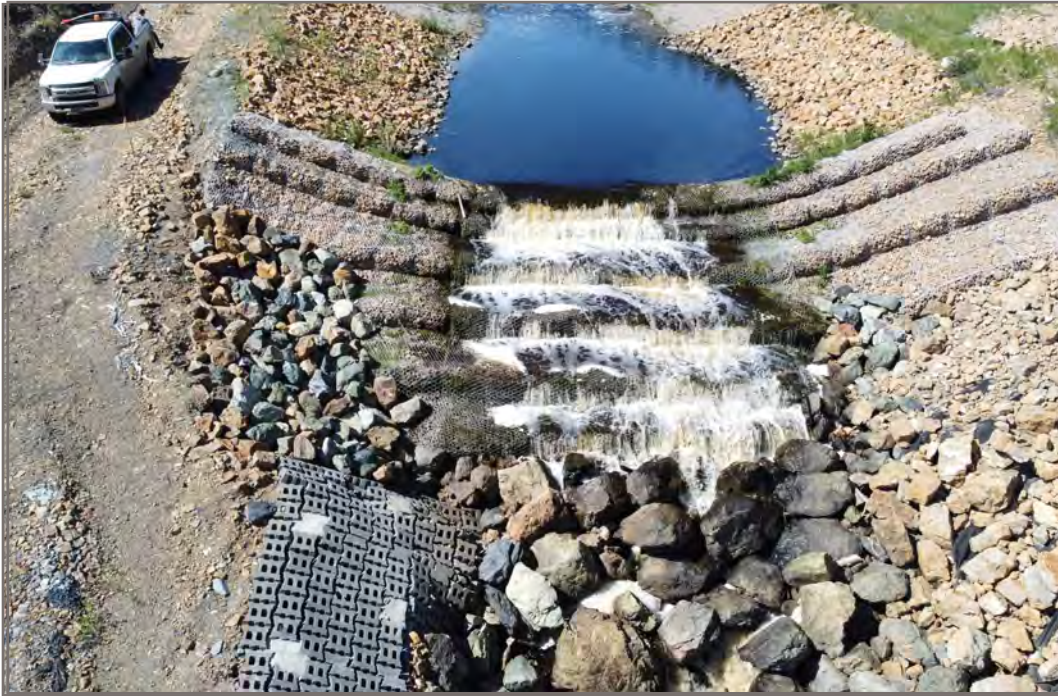
Photo 35: Drop Structure 4, facing west.
Photo taken by Adam Wallace, June 16, 2021.

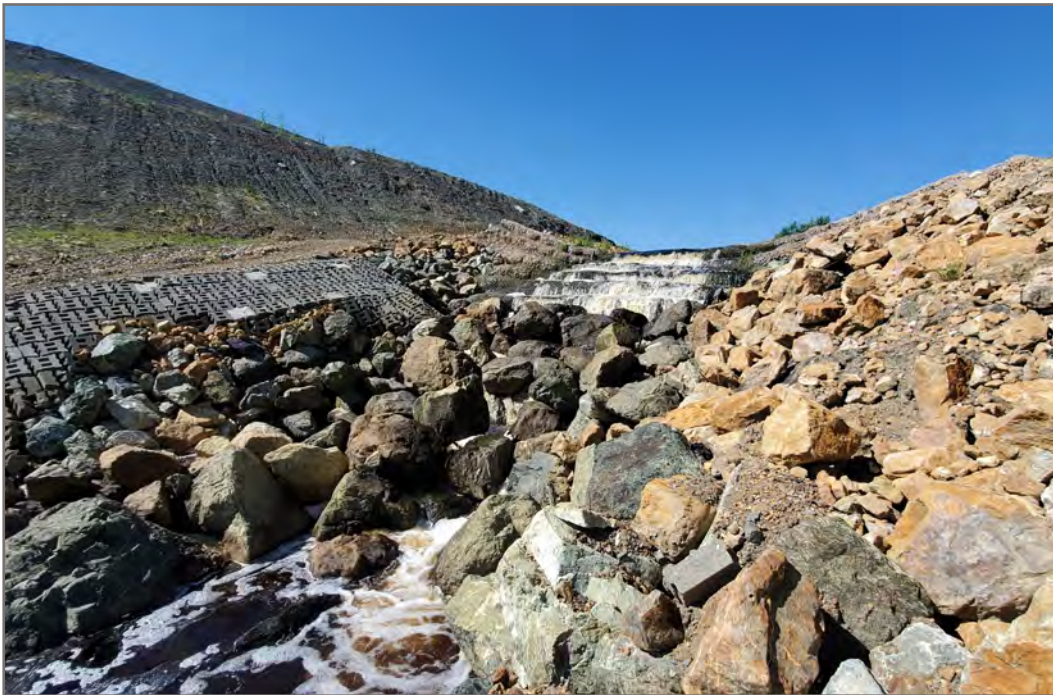
Photo 36: Drop Structure 4, facing southwest.
Photo taken by Adam Wallace, June 16, 2021.

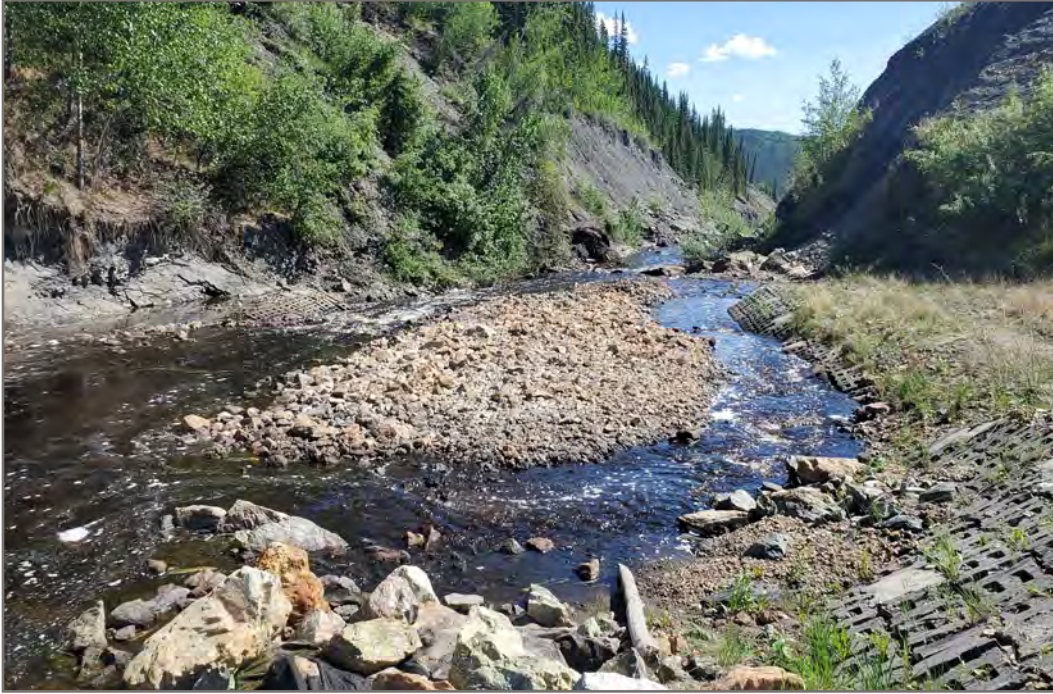
Photo 37: Eroded fill material deposited in stilling basin at DS4, facing east.
Photo taken by Adam Wallace, June 16, 2021.

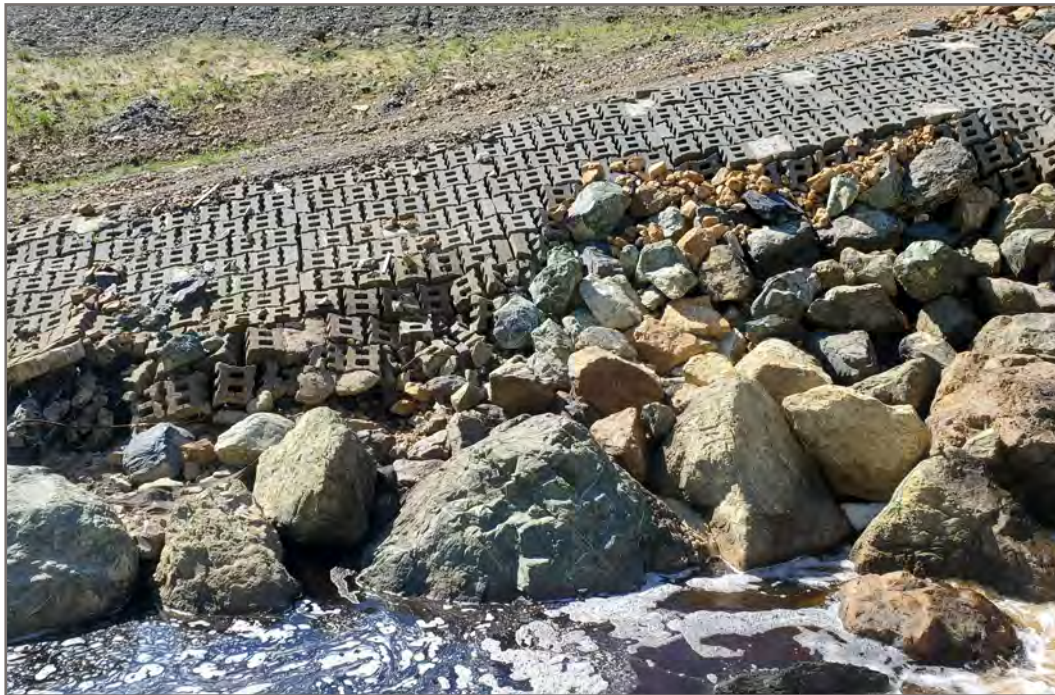
Photo 38: Remaining ACB mats at DS4, facing south.
Photo taken by Adam Wallace, June 16, 2021.

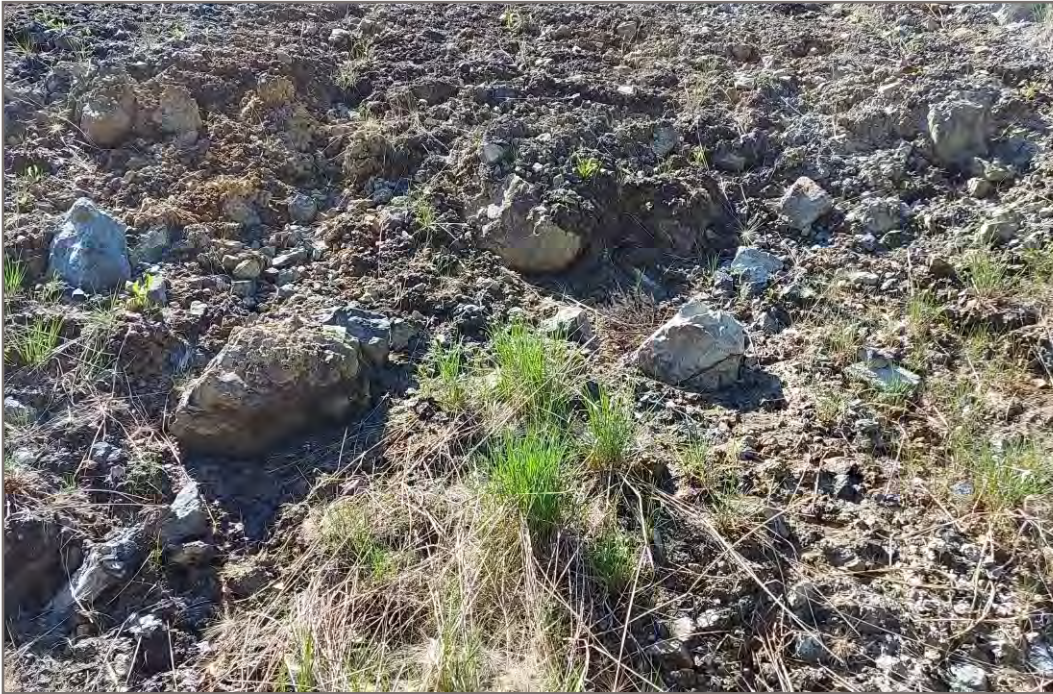
Photo 39: Seepage area from toe of waste rock at DS4, facing south.
Photo taken by Shawn Matthies, June 16, 2021.

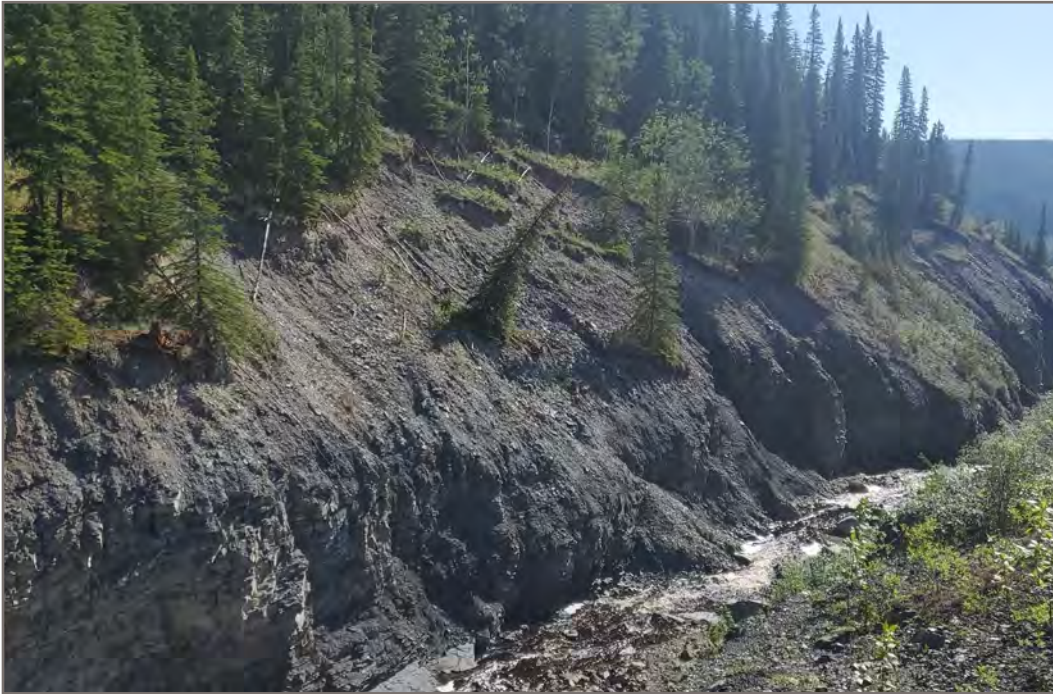
Photo 41: Clinton Creek north bank, facing northeast.
Sloughing and shallow slope movement on the natural slope and erosion in the creek channel is ongoing.
Photo taken by Adam Wallace, June 16, 2021.

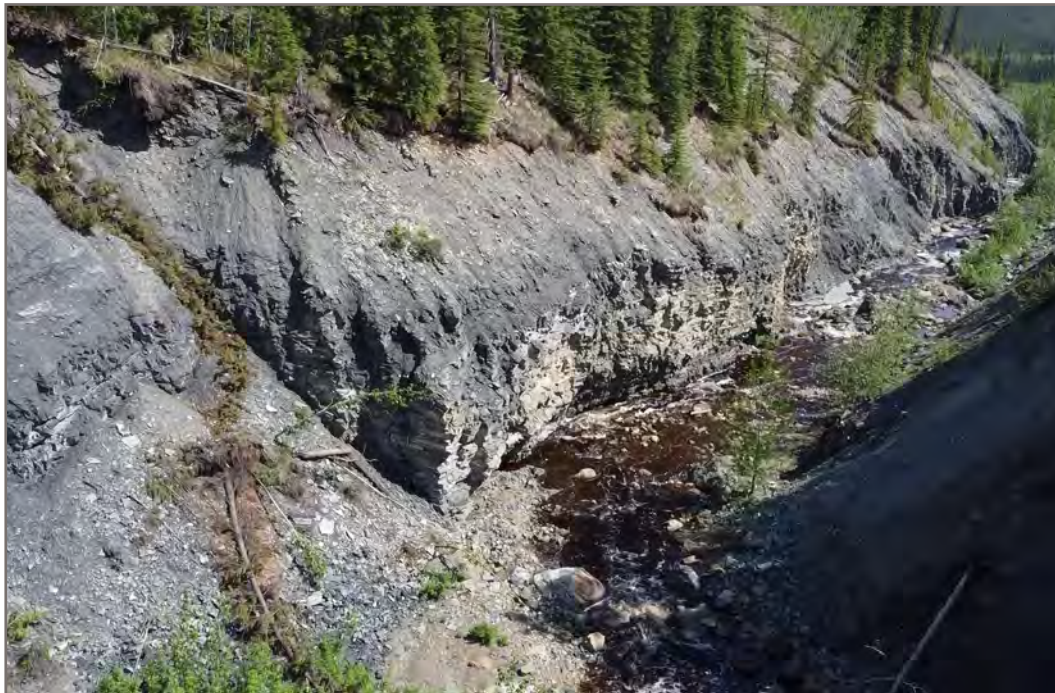
Photo 42: Clinton Creek north bank, facing northeast.
The creek is cutting into bedrock, toppling of small blocks of rock is ongoing.
Photo taken by Adam Wallace, June 16, 2021.

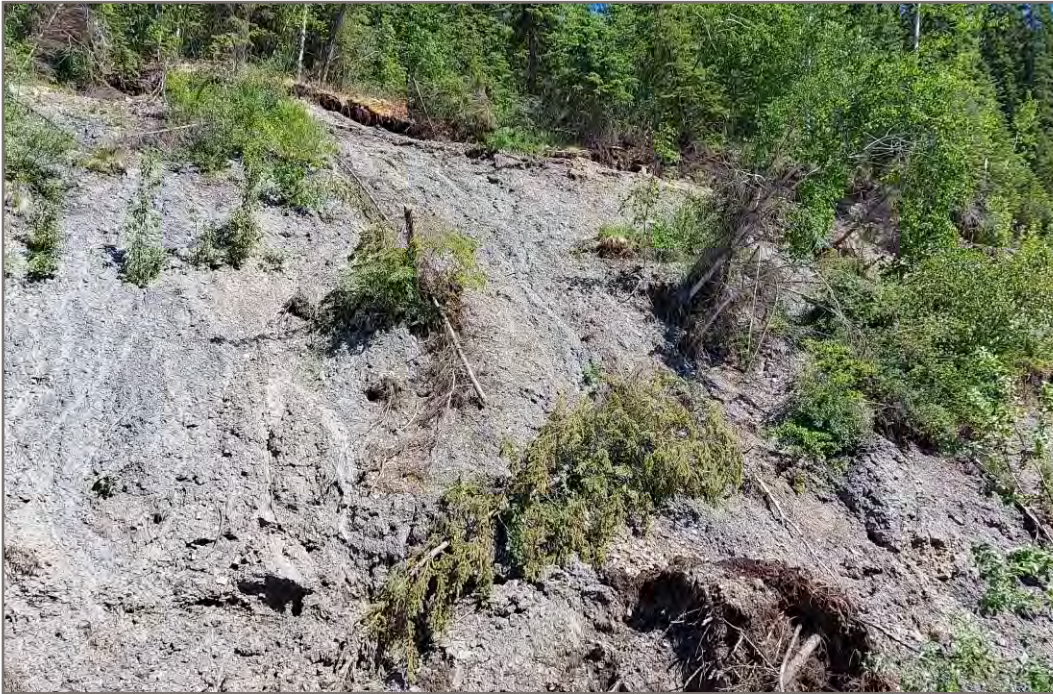
Photo 43: Vegetation rafts on Clinton Creek north slope, facing north.
Photo taken by Shawn Matthies, June 16, 2021.
