2021 Annual Report Long-Term Performance Monitoring Program Clinton Creek Mine, Yukon

PRESENTED TO
**Government of Yukon
Department of Energy, Mines and Resources
Assessment and Abandoned Mines Branch**

JANUARY 11, 2022
ISSUED FOR REVIEW
FILE: 704-ENG.WARC03956-03

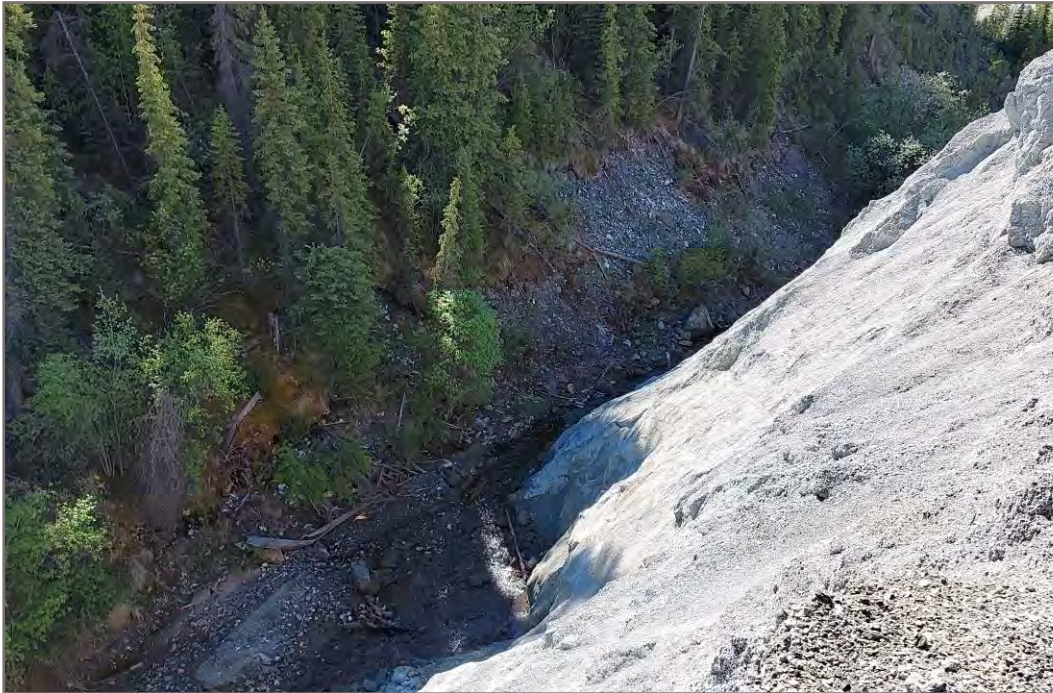
Photo 57: Debris in Wolverine Creek channel, downstream of south pond, facing southwest.
Photo taken by Shawn Matthies, June 15, 2021.

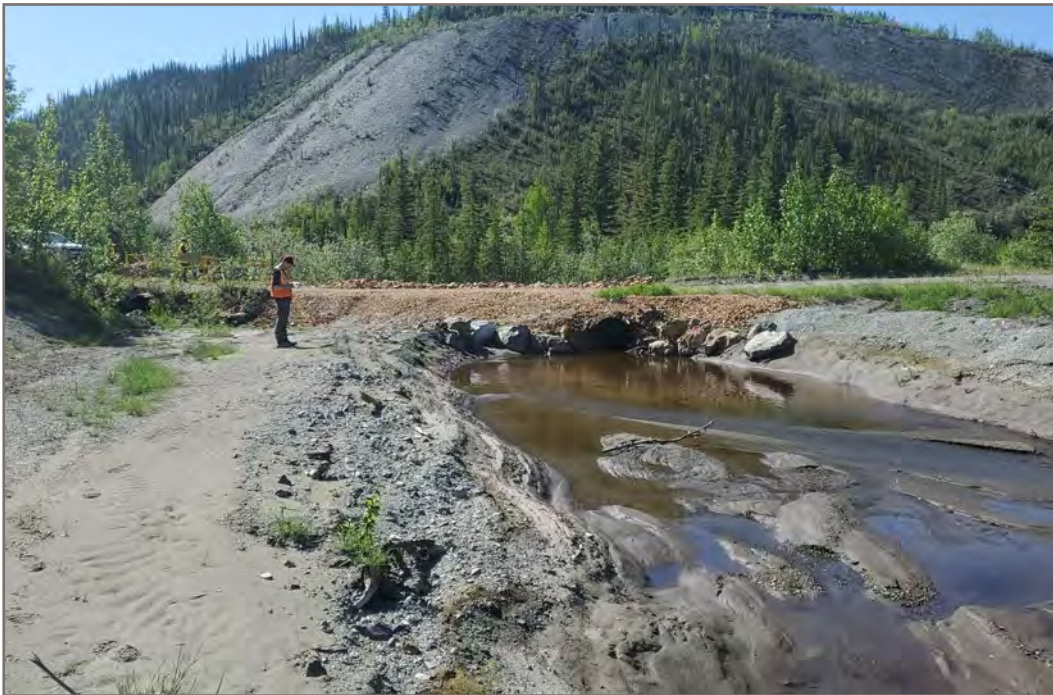
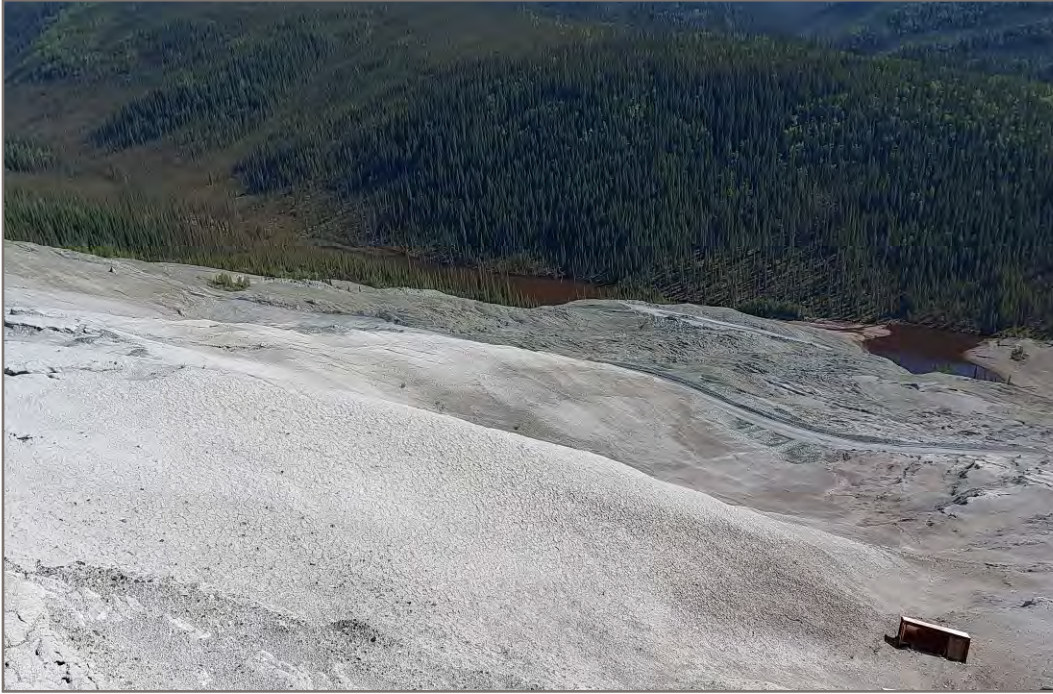
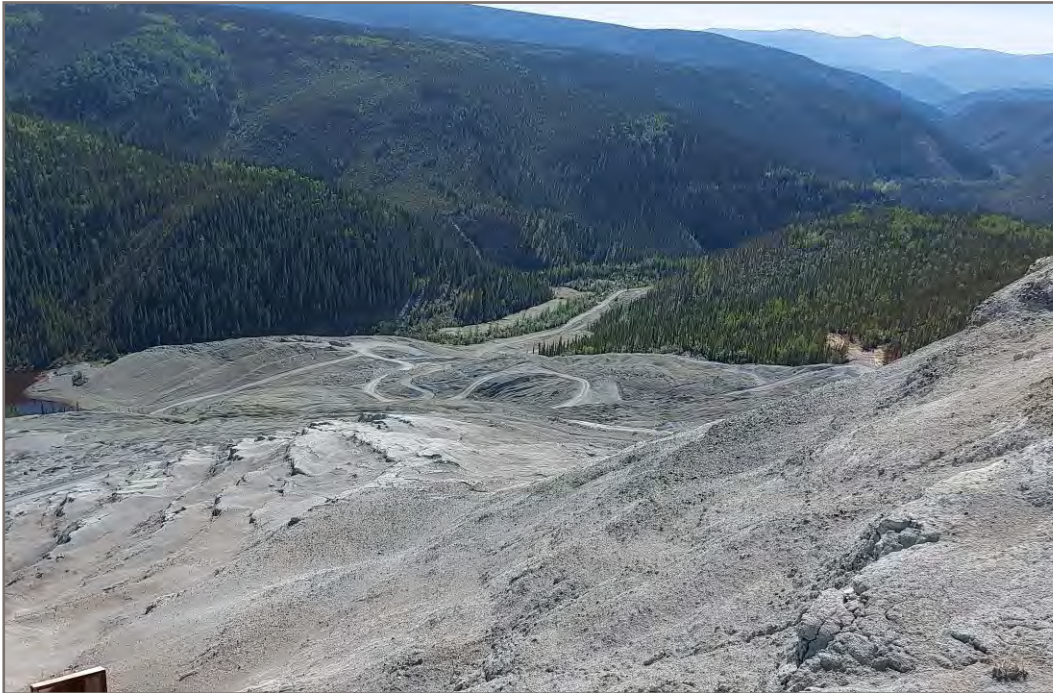
The Wolverine Creek tailings piles show signs of ongoing creep, erosion, and gullyng. Changes since the 2020 inspection are minor, and no significant new slope movement was observed. The typical condition of the tailings piles is illustrated in Photos 61 to 64.

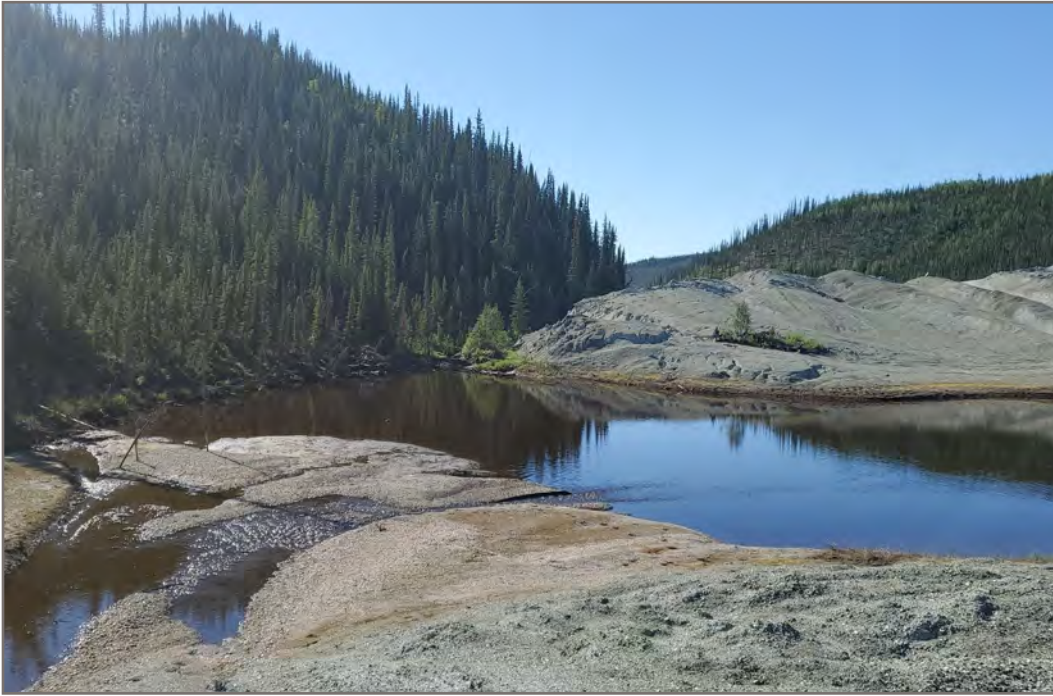
The water level in the south pond appeared to be similar to previous years (see Photo 65), and the water level in the north pond was slightly higher than typical (see Photo 66).

Photo 66: Wolverine Creek north pond, facing north.
Photo taken by Adam Wallace, June 15, 2021.

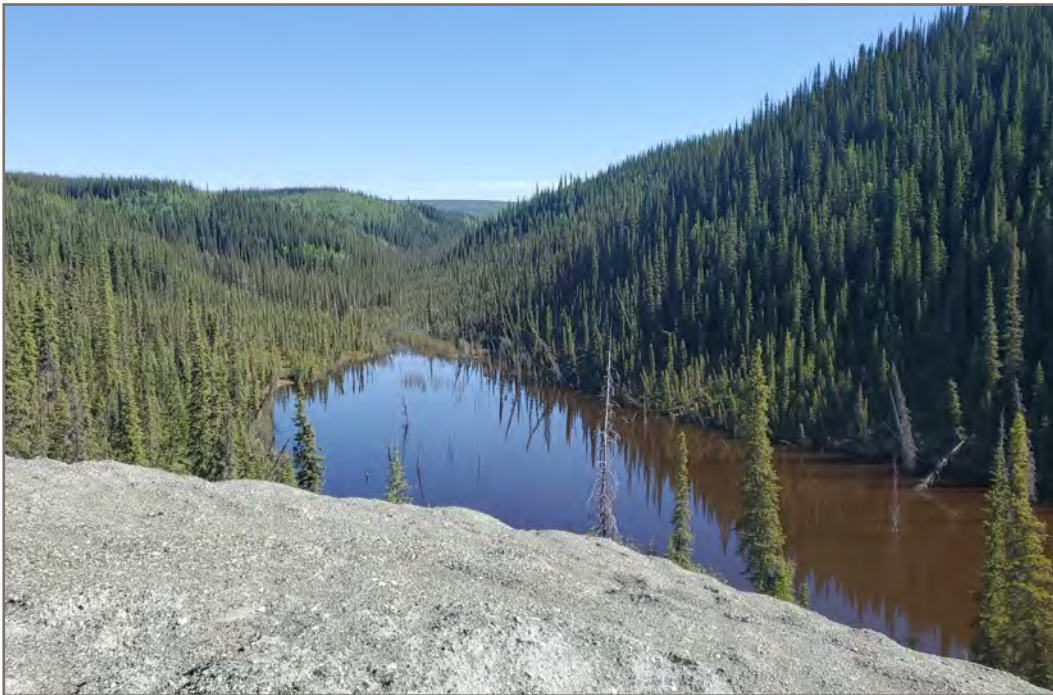
Several new beaver dams were observed around the Wolverine Creek ponds. There is a significant dam (approx. 1 m high above downstream water level) at the outlet of the north pond (see Photo 67), which has resulted in the elevated water level in the pond, and a second, smaller dam approximately midway between the north and south ponds (see Photo 68). A third, partially breached dam is present at the outlet of the south pond (see Photo 69), which is partially obstructing flow at the outlet but does not appear to be affecting the water level in the pond.

Photo 67: Beaver dam at outlet of north pond, facing north.
Photo taken by Adam Wallace, June 15, 2021.

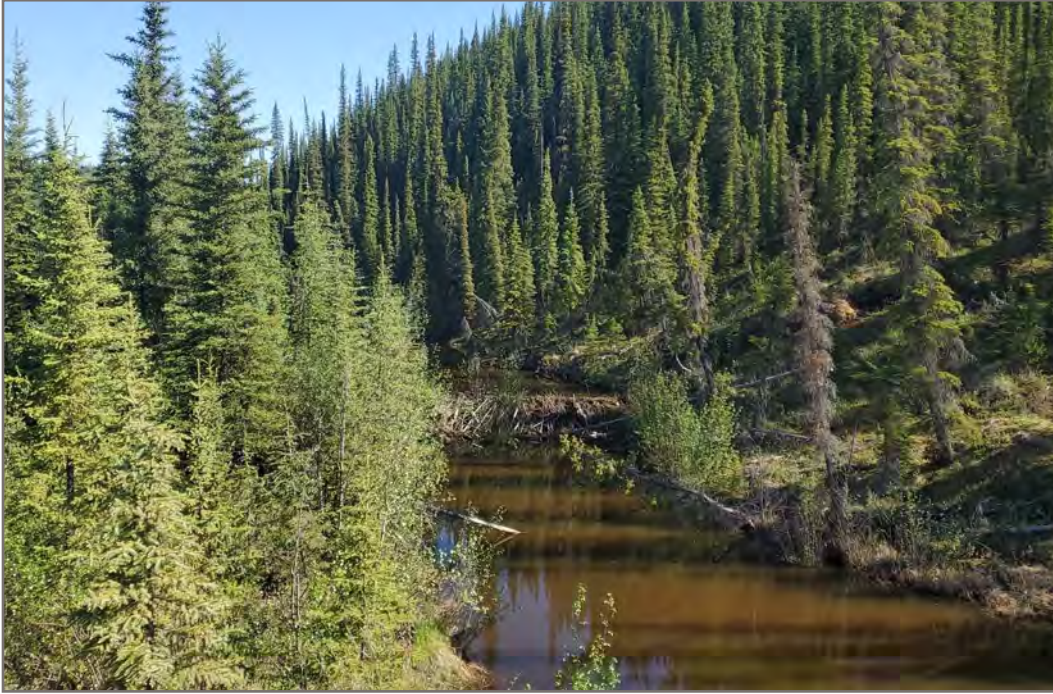
Photo 68: Small beaver dam between Wolverine Creek north and south ponds, facing east.
Photo taken by Adam Wallace, June 15, 2021.

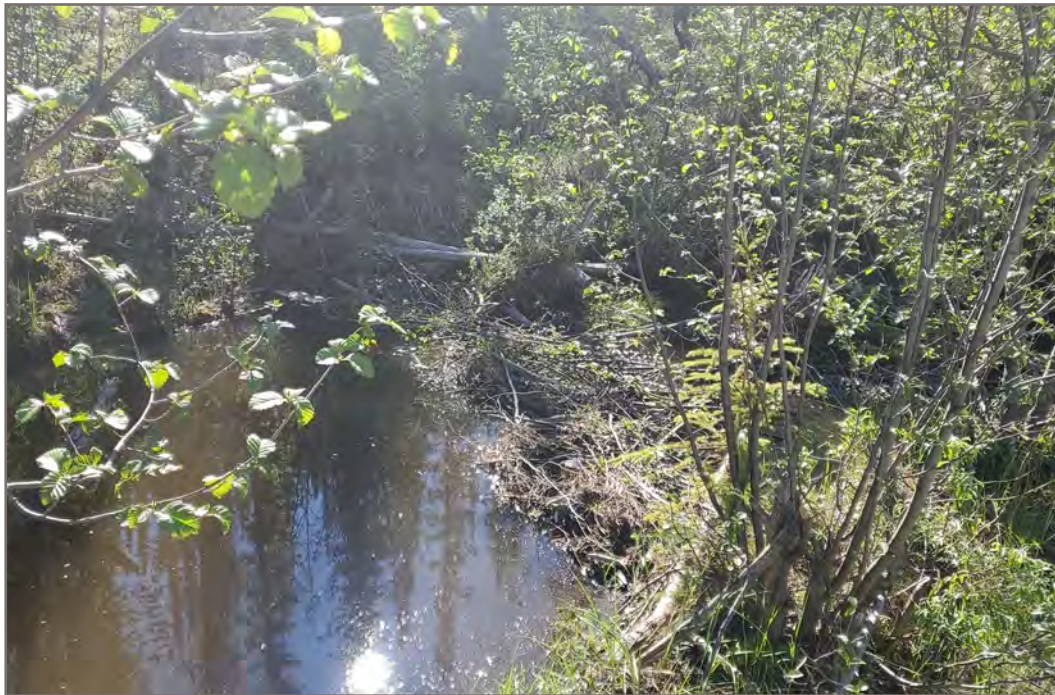
Photo 69: Partially breached beaver dam at outlet of Wolverine Creek south pond, facing south, Photo taken by Shawn Matthies, June 15, 2021.

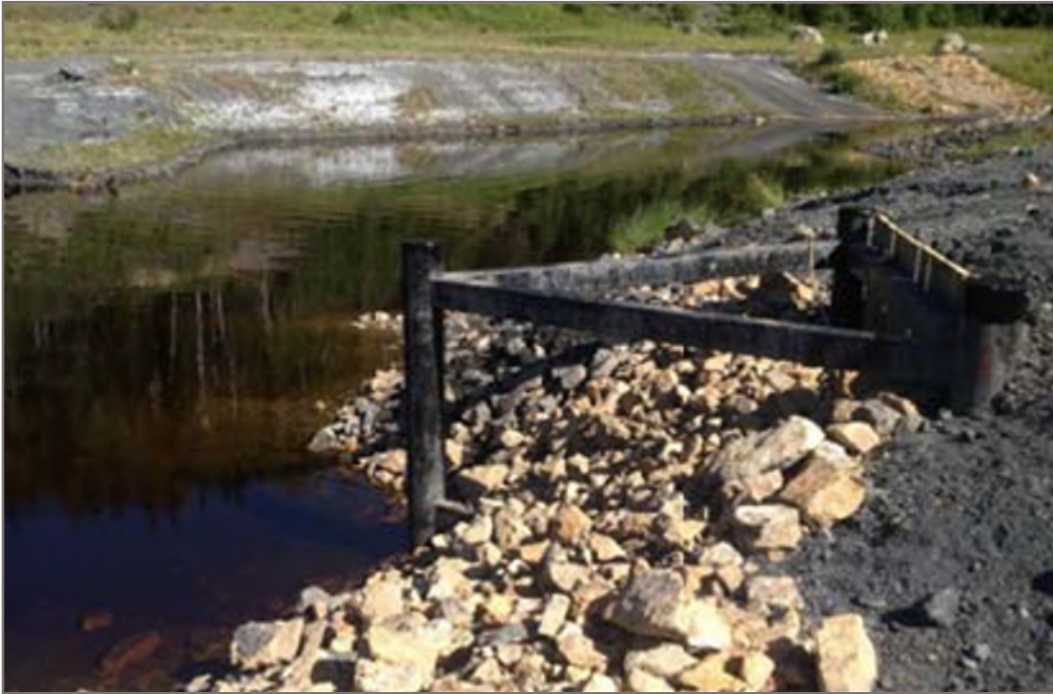
Photo 1: South Log Boom Abutment showing the as-built condition in 2013, facing east.
Photo taken by Boreal Engineering Ltd.

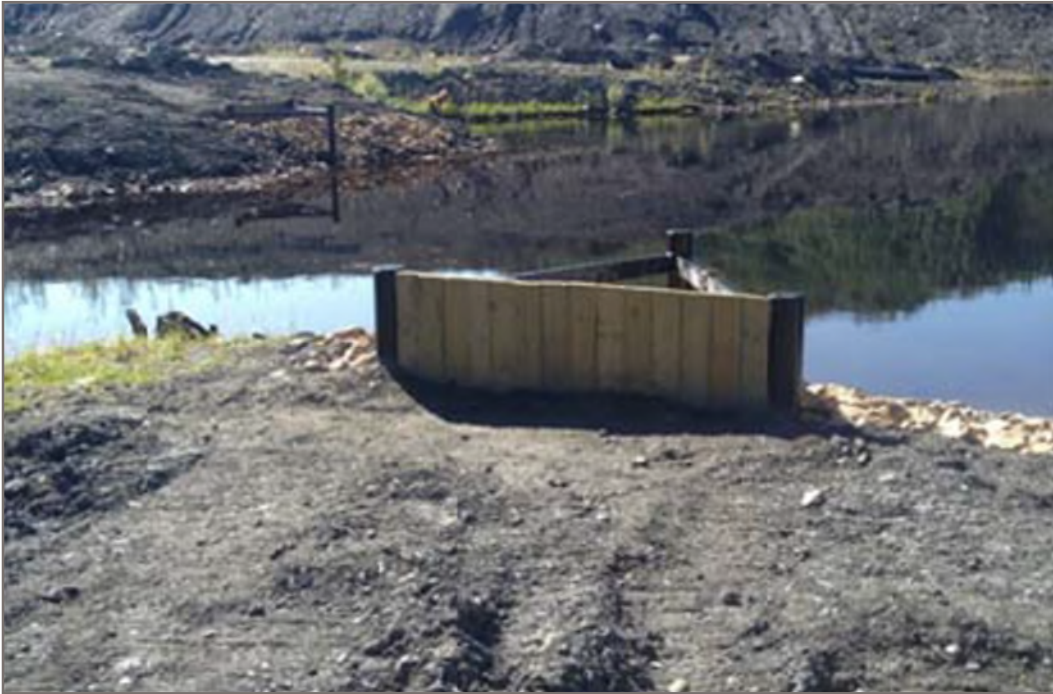
Photo 3: North Log Boom Abutment showing the as-built condition in 2013, facing south.
Photo taken by Boreal Engineering Ltd.

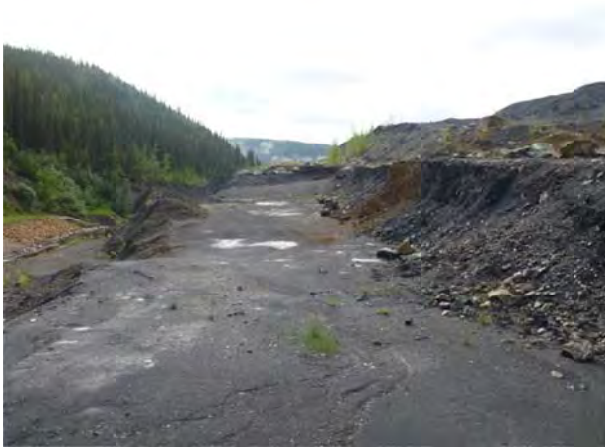
Photo 5 – Road blocked at the gabion baskets to prevent access along creek

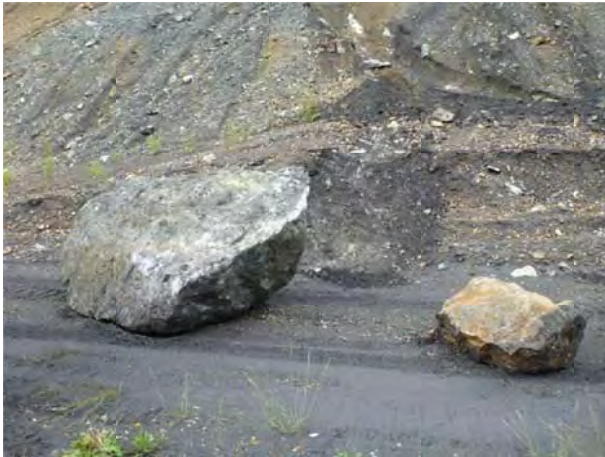
Photo 6 – Road blockage along creek near gabion baskets

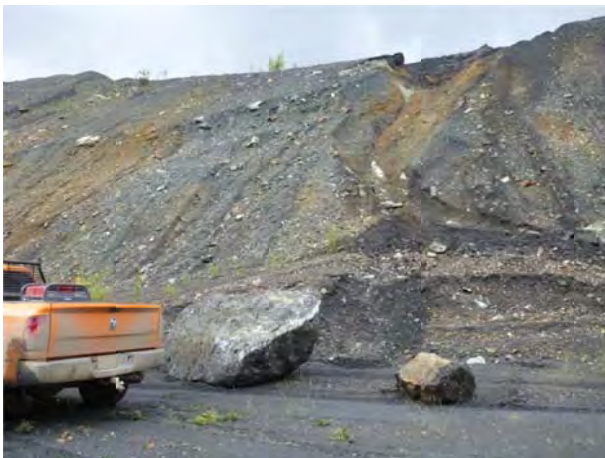
Photo 7 – Rock removed from slope above road

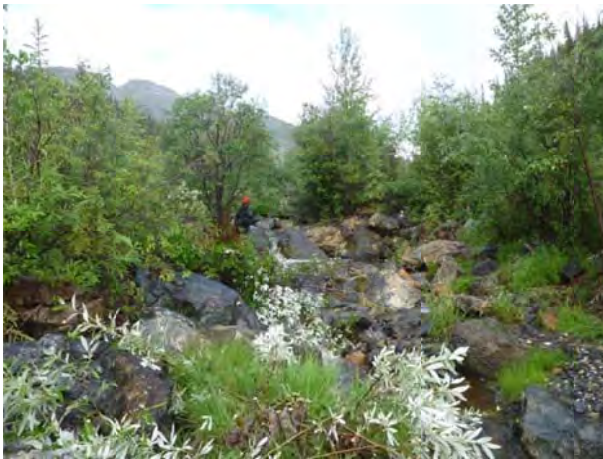
Photo 10 - Brushing in Wolverine Creek

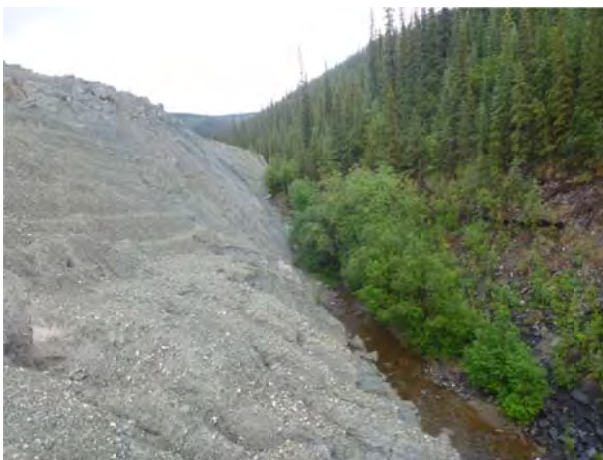
Photo 11 - Tailings at Wolverine Creek

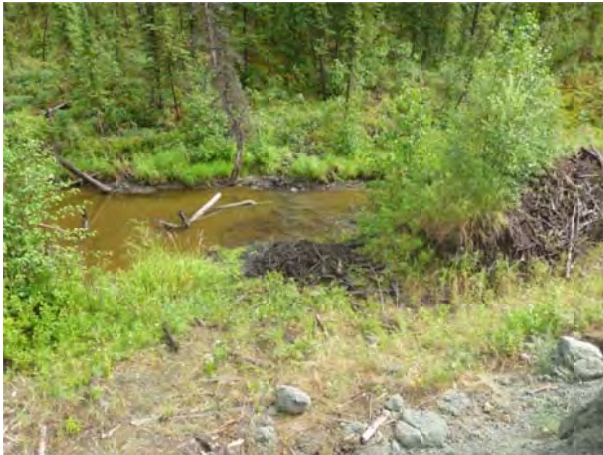
Photo 12 – Lower Beaver Dam Removed

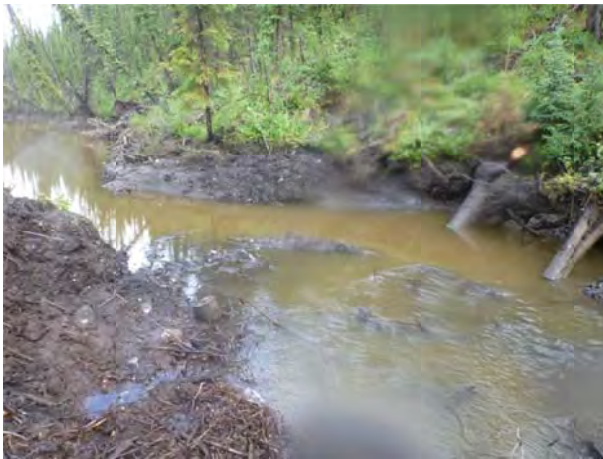
Photo 13 - Upper Beaver Dam Removed

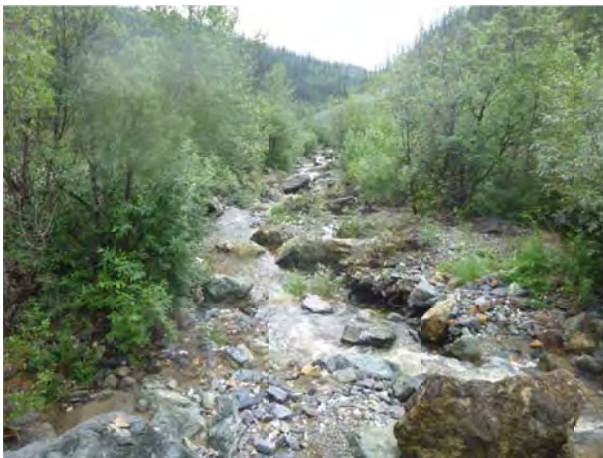
Photo 14 - Brush removed from Wolverine Creek

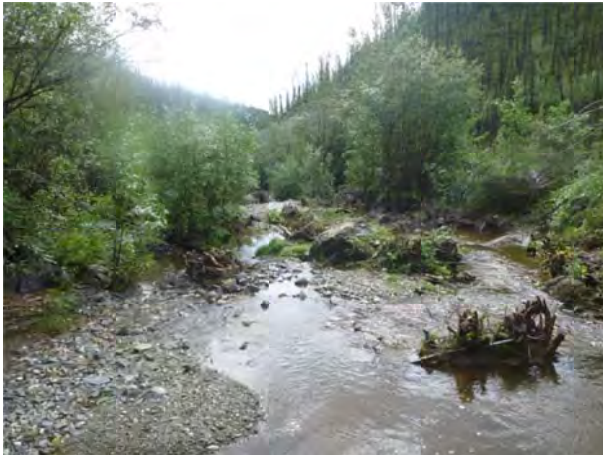
Photo 15 - Brush removed from Wolverine Creek

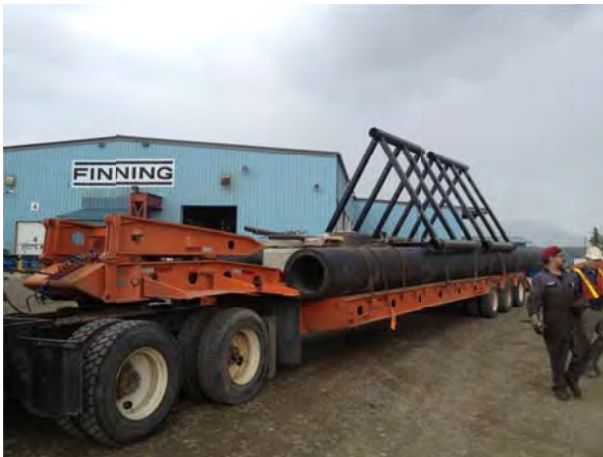
Photo 16 - Delivery of pipes and abutment structures to site

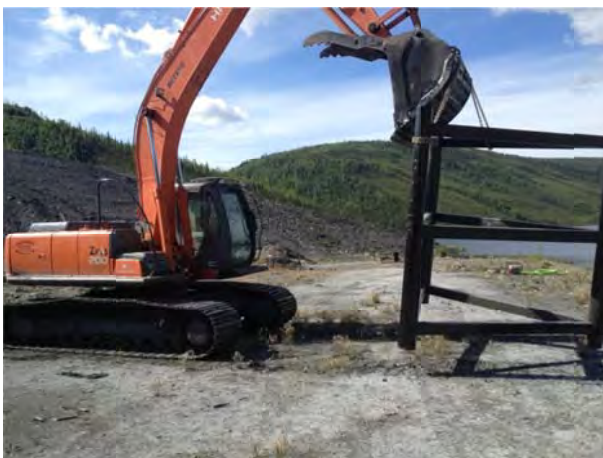
Photo 17 - Unload abutment structure from truck

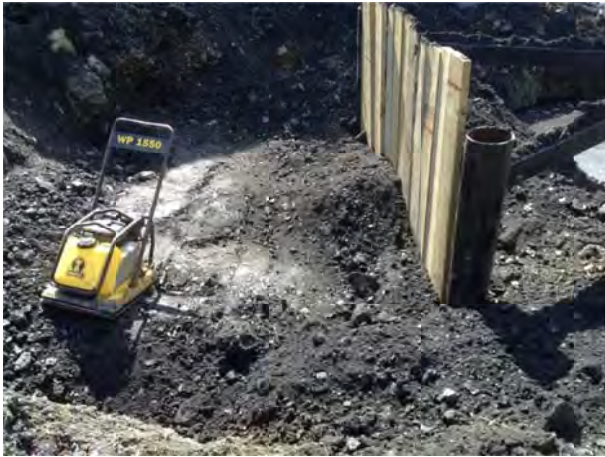
Photo 18 - Installing abutment structure and compacting backfill

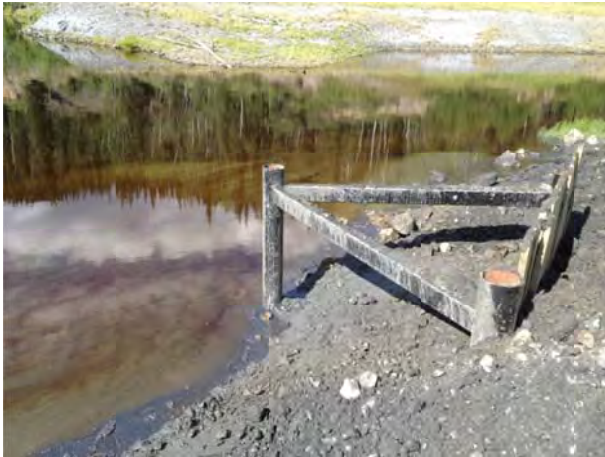
Photo 19 – Installed south abutment

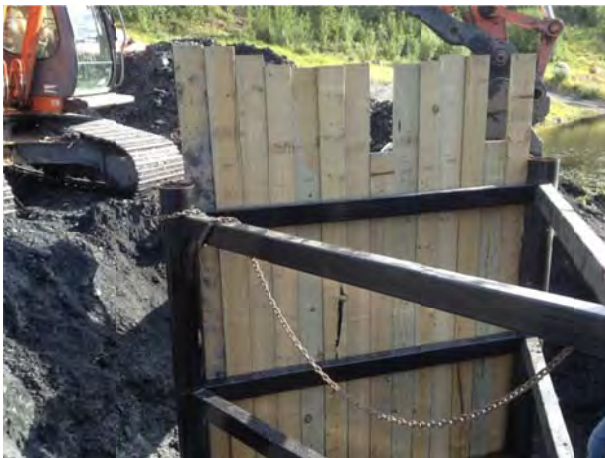
Photo 20 - Installing north abutment

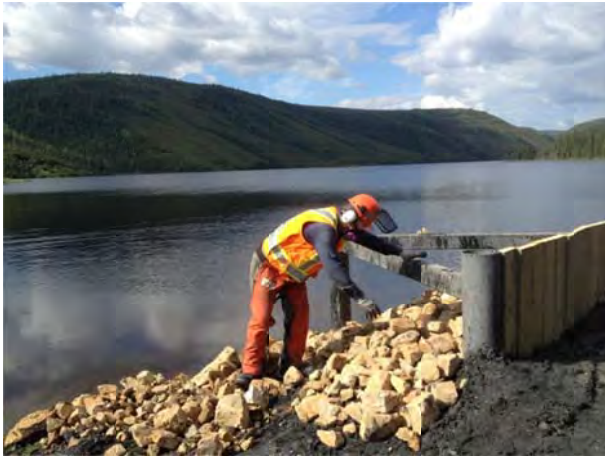
Photo 21 Placing rip rap around north abutment

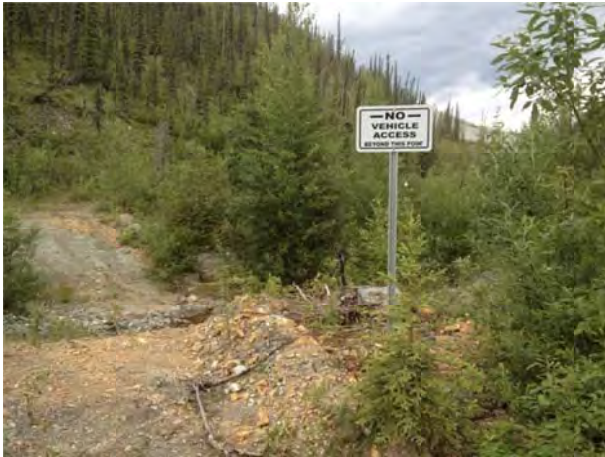
Photo 22 - Signage at Wolverine Creek crossing

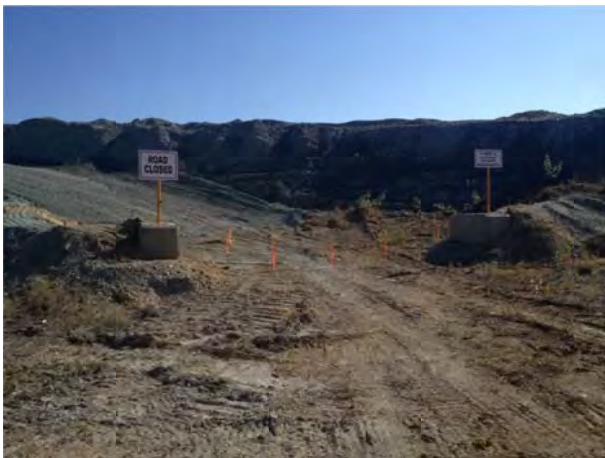
Photo 23 - Signage and gate at top of tailings pile

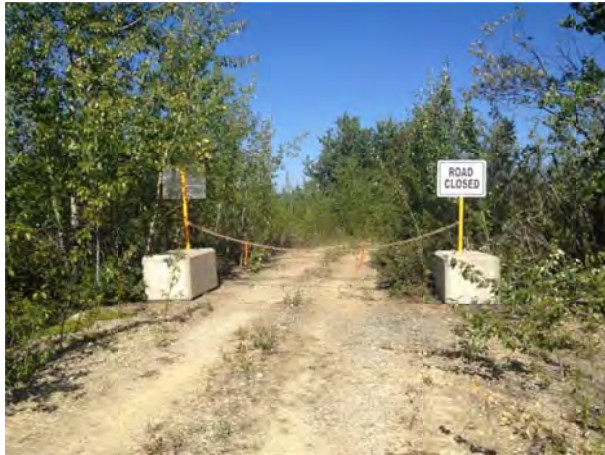
Photo 24 - Signage and gate at airport access road

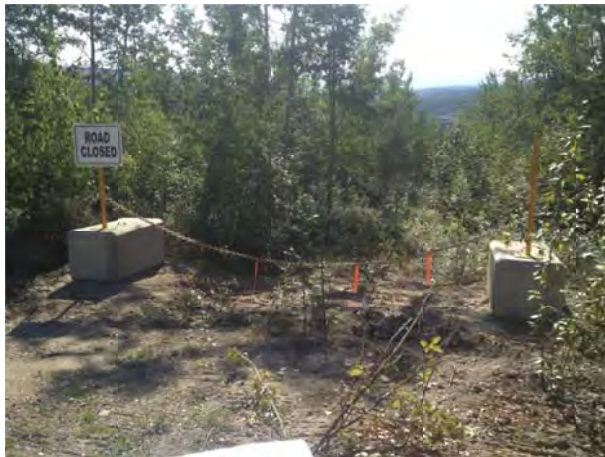
Photo 25 - Signage and gate at trail off mill site access road

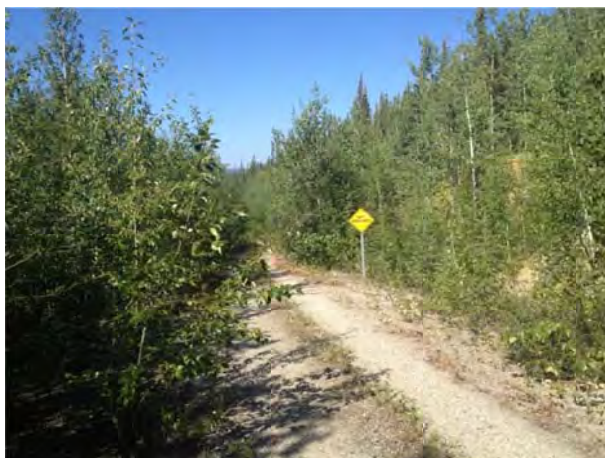
Photo 26 - Soft shoulder sign on mill site access road

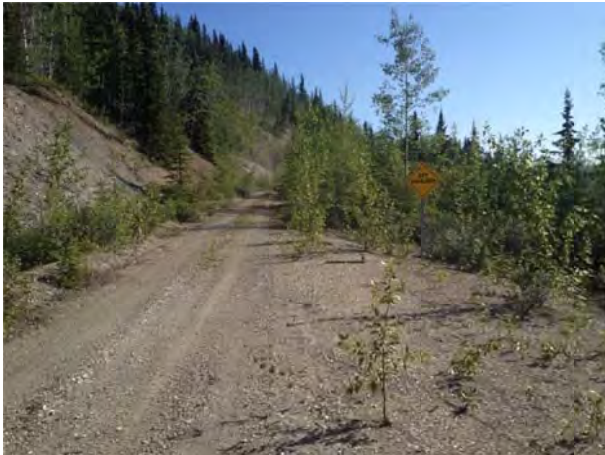
Photo 27 - Signage on mill site access road

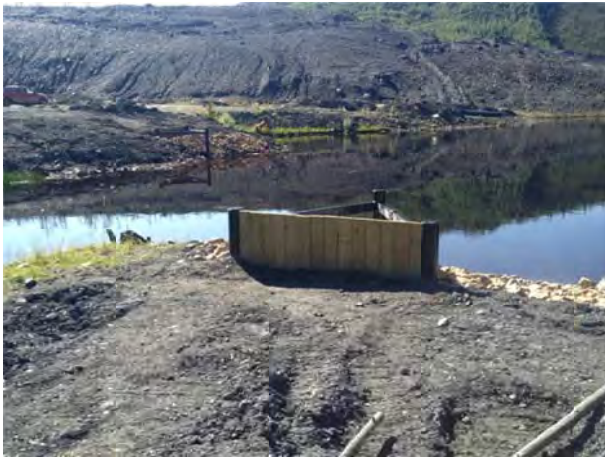
Photo 28 - Installed north abutment

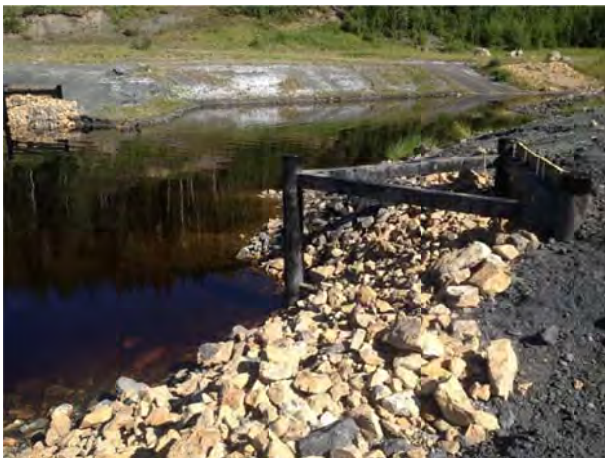
Photo 29 - Installed south abutment

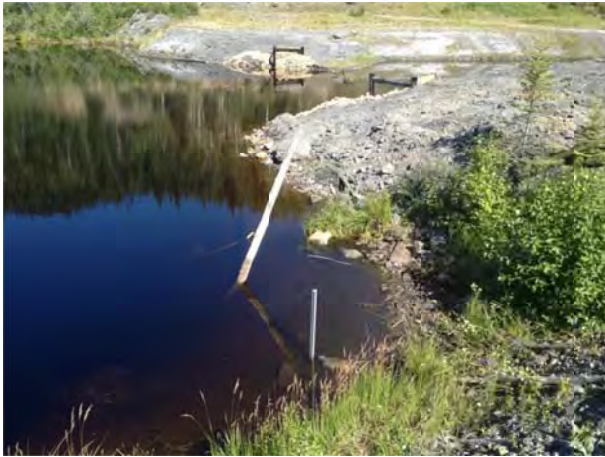
Photo 30 - Post for staff gauge

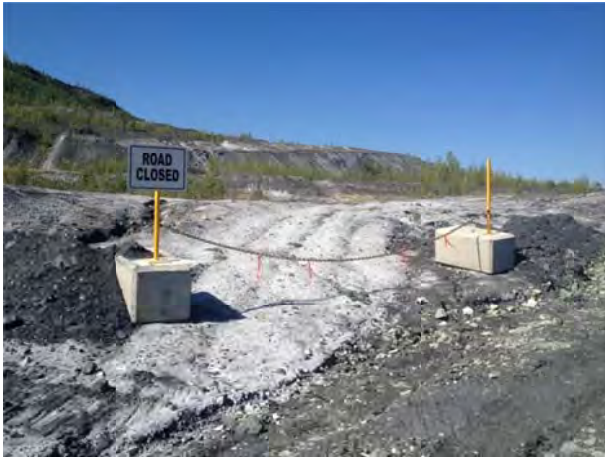
Photo 31 - Gate and sign at trail on waste rock pile

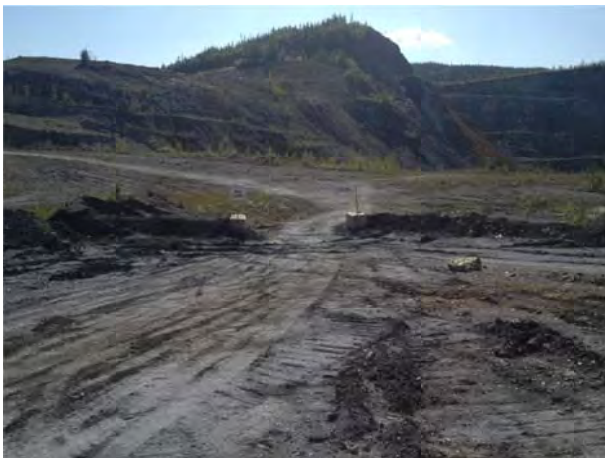
Photo 32 - Gate and sign at trail on waste rock pile

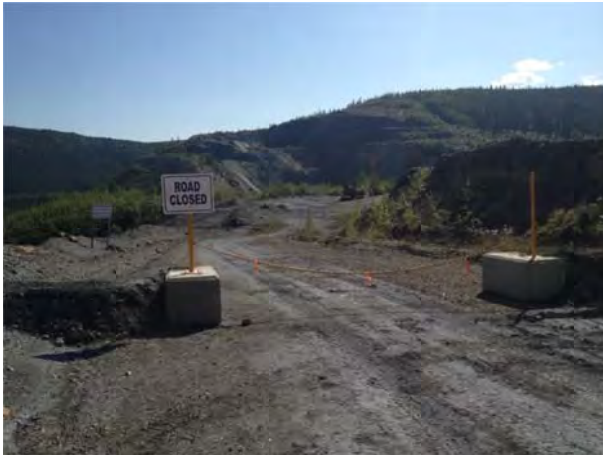
Photo 33 - Gate and sign at access road to abandoned shovel and drill

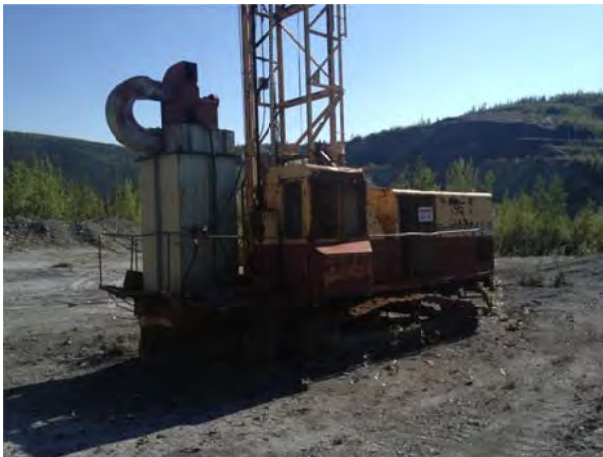
Photo 34 - Sign and evidence of ladder removed from abandoned drill

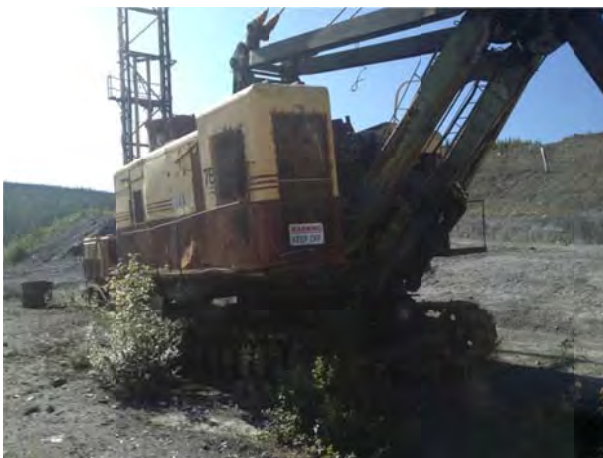
Photo 35 - Sign on abandoned shovel

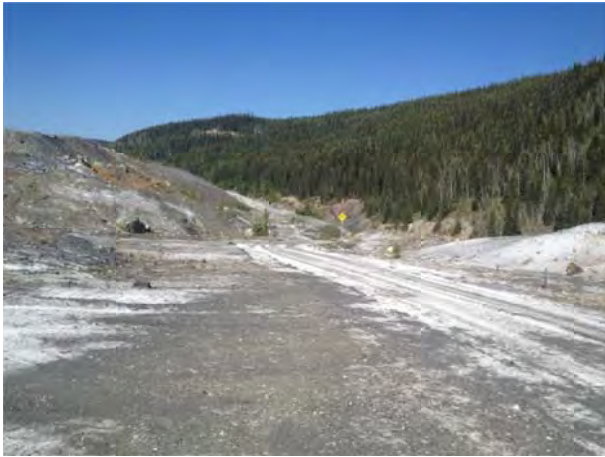
Photo 36 - Soft Shoulder sign on road along waste rock pile

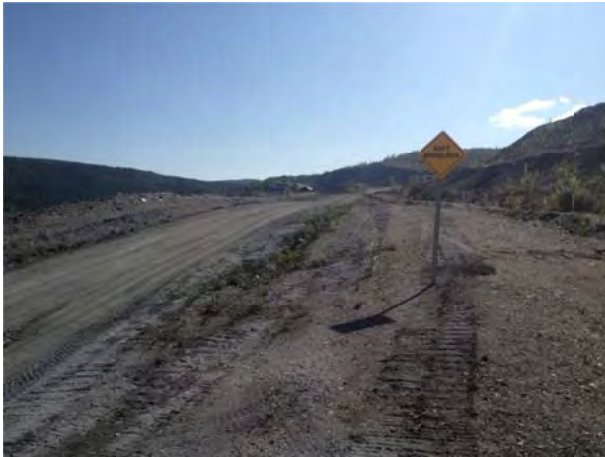
Photo 37 -- Sign along road on waste rock pile

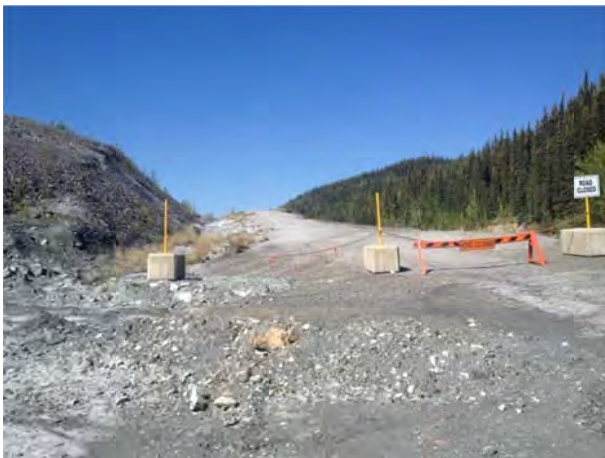
Photo 38 Gate and sign at abandoned section of road on waste rock pile

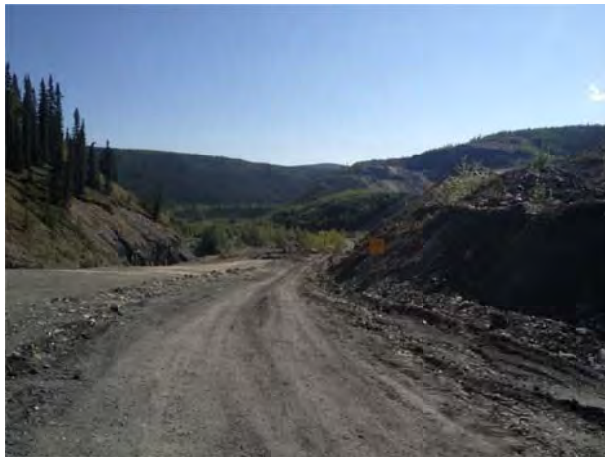
Photo 39 - Sign along road on waste rock pile

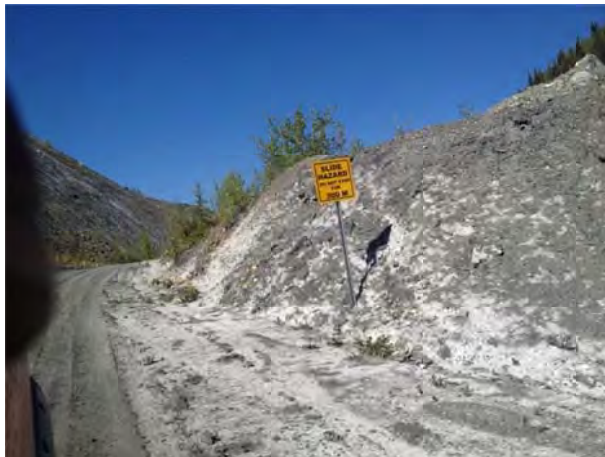
Photo 40 - Sign on waste rock pile near Clinton Creek

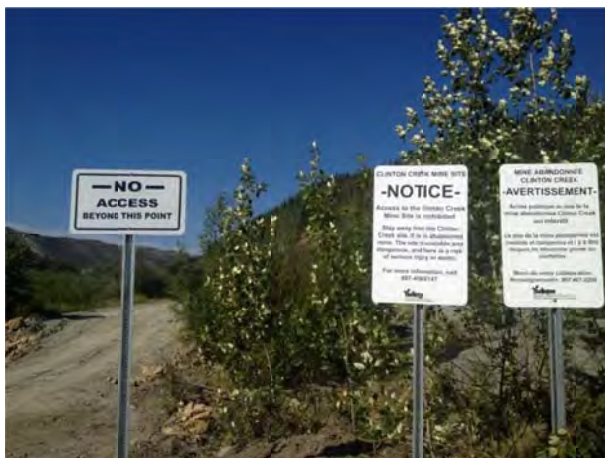
Photo 41 - Signage at site access

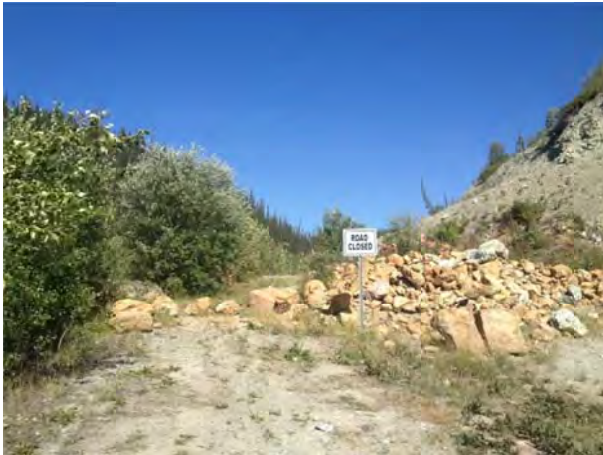
Photo 42 - Sign and rock blockage at Wolverine Creek access

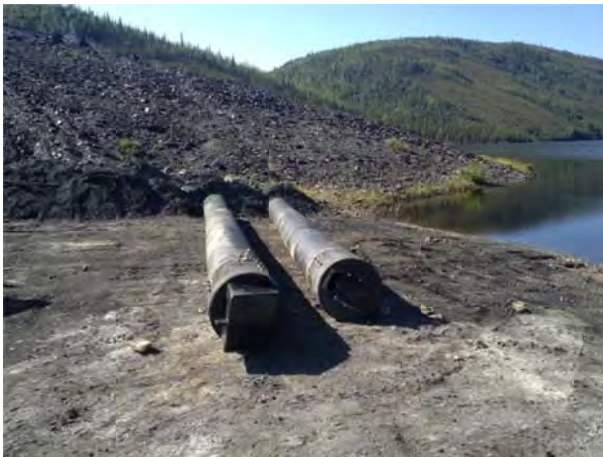
Photo 43 - Log-booms on shore after removal from water

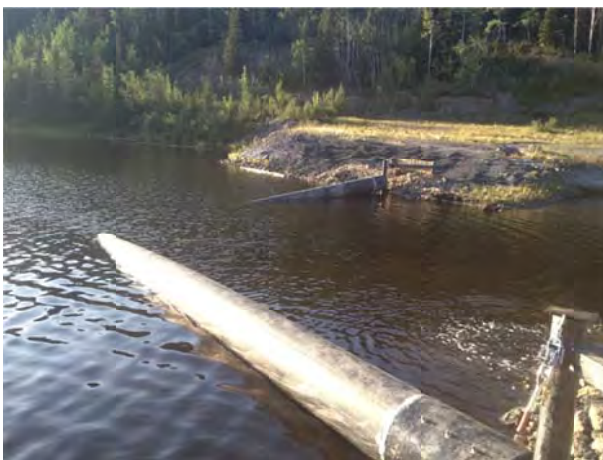
Photo 44 - Log-booms in place showing settlement in the water

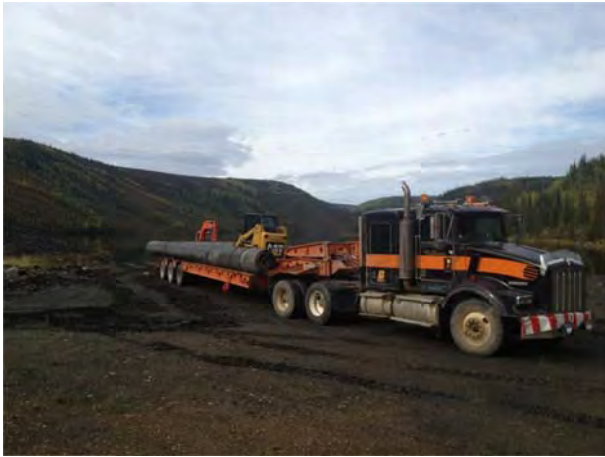
Photo 45 - Log-booms loaded for transport to Whitehorse

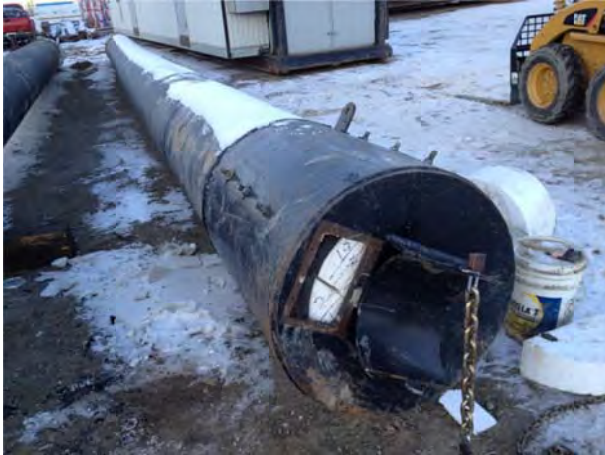
Photo 46 – Flotation foam installed in pipes

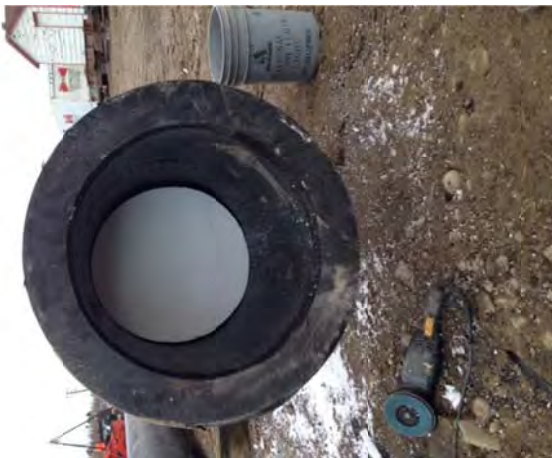
Photo 47 - Foam inserted into pipe.

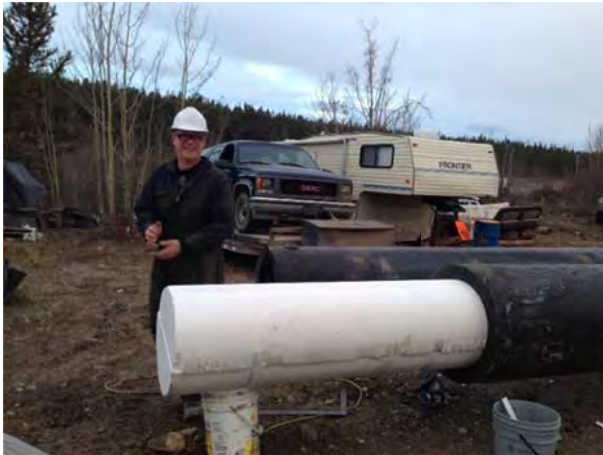
Photo 48 - Foam being placed in pipe

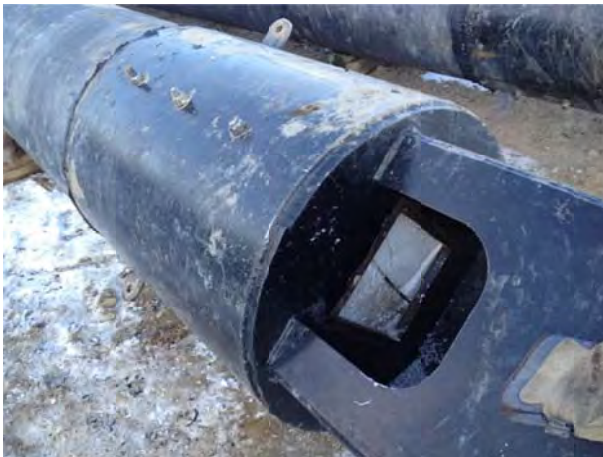
Photo 49 - Foam installed in pipe and end cap installed

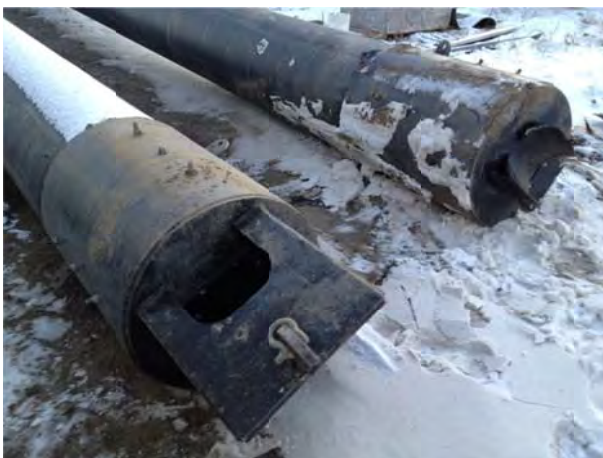
Photo 50 - Foam installation complete with inspection covers installed

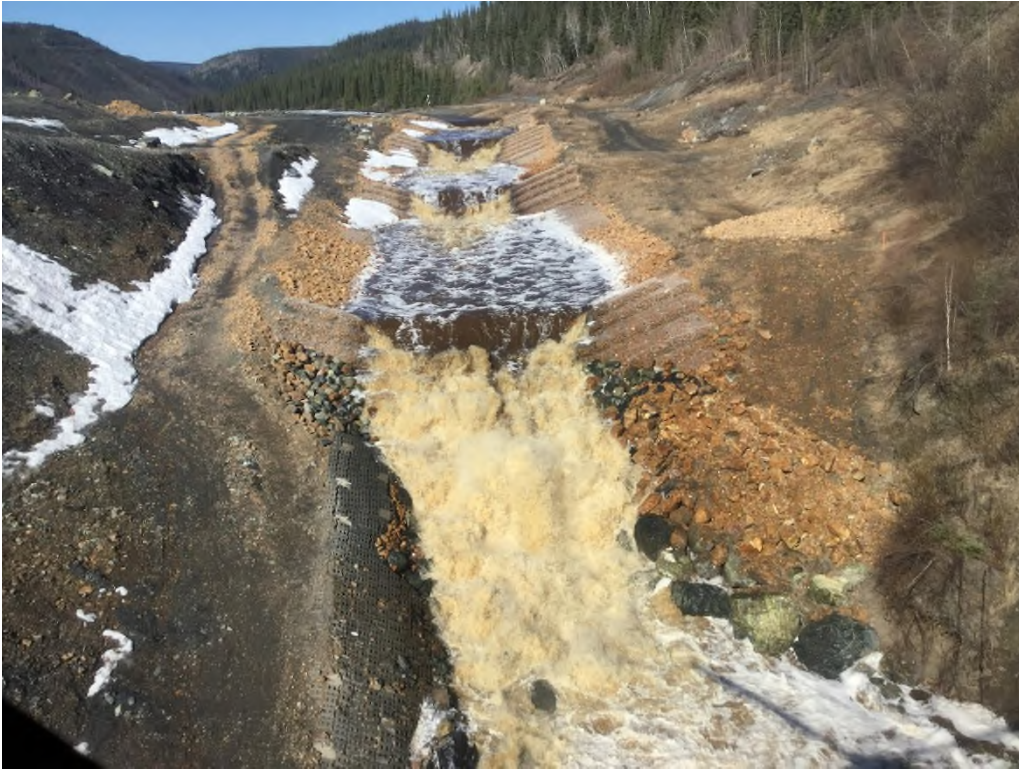
Figure 6: 2020 Freshet – May 11 Flow Over DS4

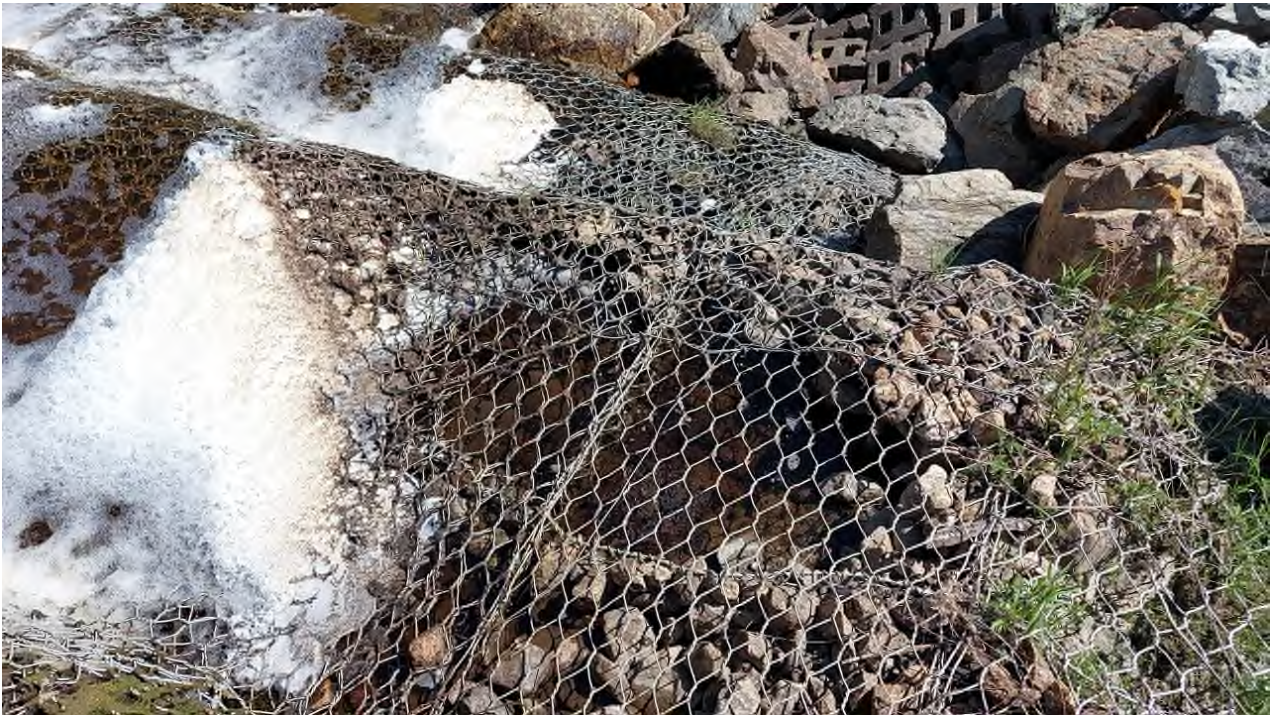
As detailed in Figure 5, it appears that DS4 has retained its structural integrity and has survived the intense flow rates of 2020 (See Figure 6) and the (relatively lighter) freshet in 2021. Similar to DS3, some of the gabions at DS4 have lost some of the rocks needed to maintain the structural integrity of the gabion baskets (See Figure 7). It appears that the temporary works completed in 2019 remain intact including the bank stabilization works and the large energy dissipation boulders placed just downstream from the gabions.

Figure 7: Voids in DS4 Gabions – June 2021

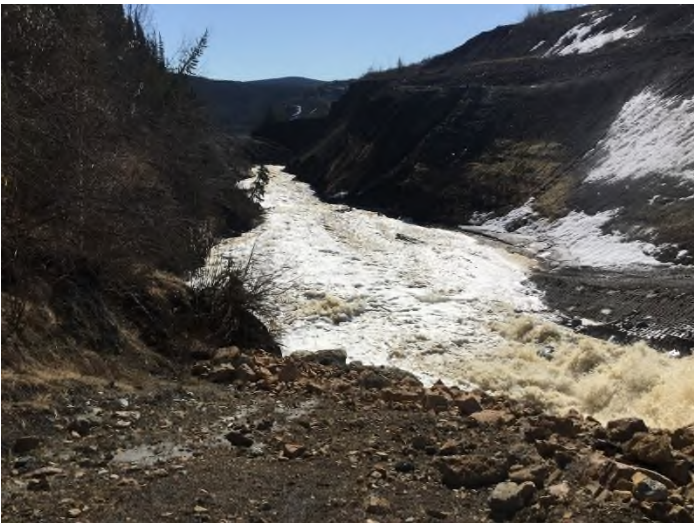
As detailed in Figure 8, the plunge pool downstream of DS4 witnessed significant flows during the 2020 freshet. In 2019, a rock weir was constructed to backup water and promote the formation of a deeper pool at the base of DS4. A check dam at the downstream end of the pool was also constructed for the same purpose. Based on the photographic record (See Figure 9), it appears that both structures have partly survived the recent freshets. Some of the smaller rocks were likely washed away. Portions of the south bank remain unprotected, and sections of the filter fabric remain exposed. As previously recommended, the south bank should be reconstructed and the existing Articulated Concrete Blocks (ACB) system should be removed and replaced with larger rocks, similar to the work completed along the north bank (See Figure 10).

Figure 8: Plunge Pool – May 2020
