2021 Annual Report Long-Term Performance Monitoring Program Clinton Creek Mine, Yukon

PRESENTED TO
**Government of Yukon
Department of Energy, Mines and Resources
Assessment and Abandoned Mines Branch**

JANUARY 11, 2022
ISSUED FOR REVIEW
FILE: 704-ENG.WARC03956-03

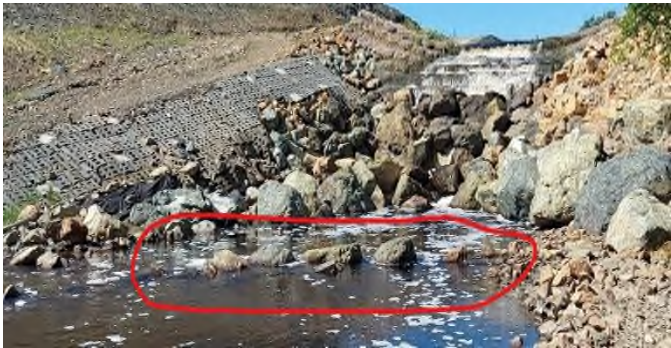
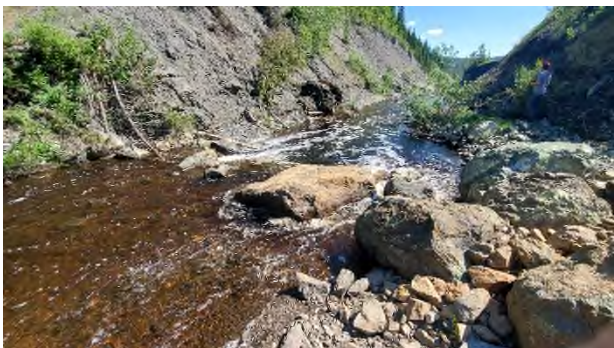
Rock Weir	Check Dam
Figure 9: Plunge Pool Weir and Check Dam (2021)

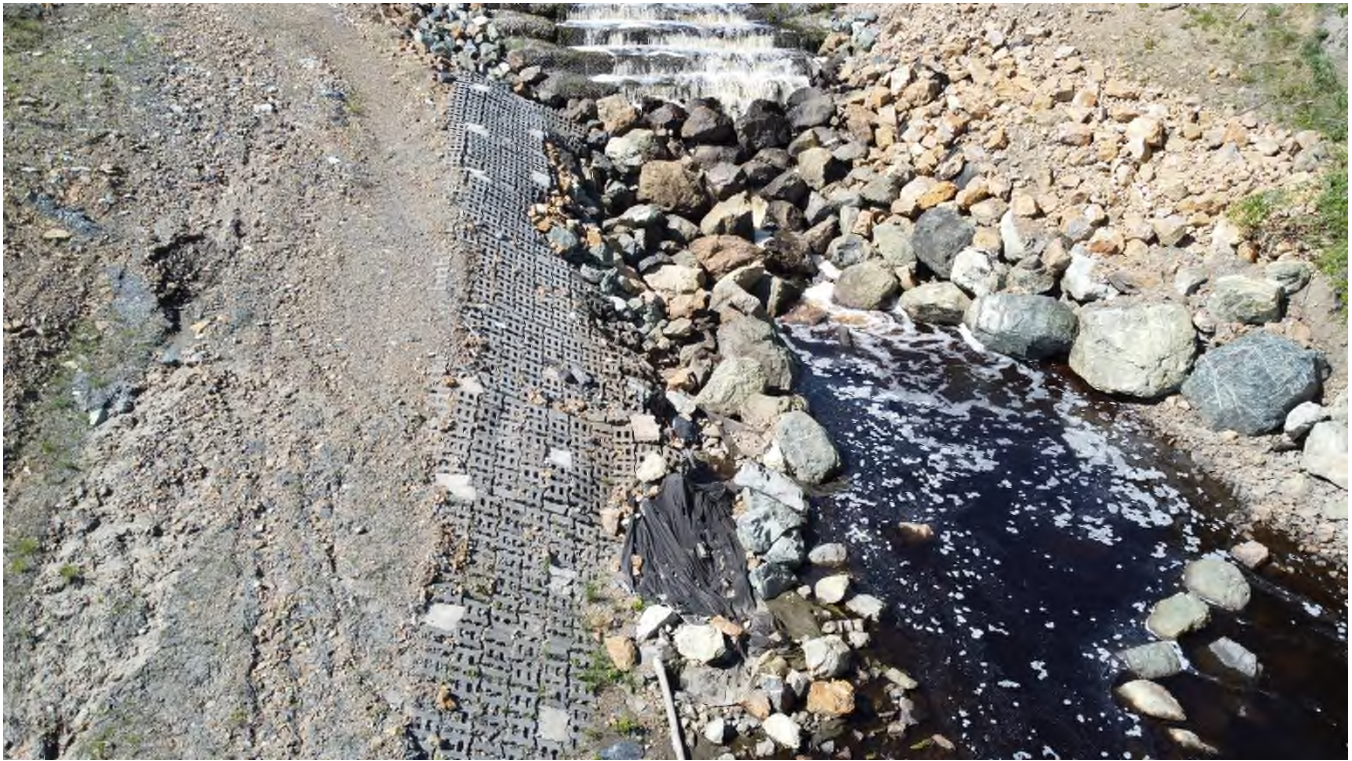
As detailed in Figure 8, the plunge pool downstream of DS4 witnessed significant flows during the 2020 freshet. In 2019, a rock weir was constructed to backup water and promote the formation of a deeper pool at the base of DS4. A check dam at the downstream end of the pool was also constructed for the same purpose. Based on the photographic record (See Figure 9), it appears that both structures have partly survived the recent freshets. Some of the smaller rocks were likely washed away. Portions of the south bank remain unprotected, and sections of the filter fabric remain exposed. As previously recommended, the south bank should be reconstructed and the existing Articulated Concrete Blocks (ACB) system should be removed and replaced with larger rocks, similar to the work completed along the north bank (See Figure 10).

Figure 10: Exposed Filter Fabric along the South Bank

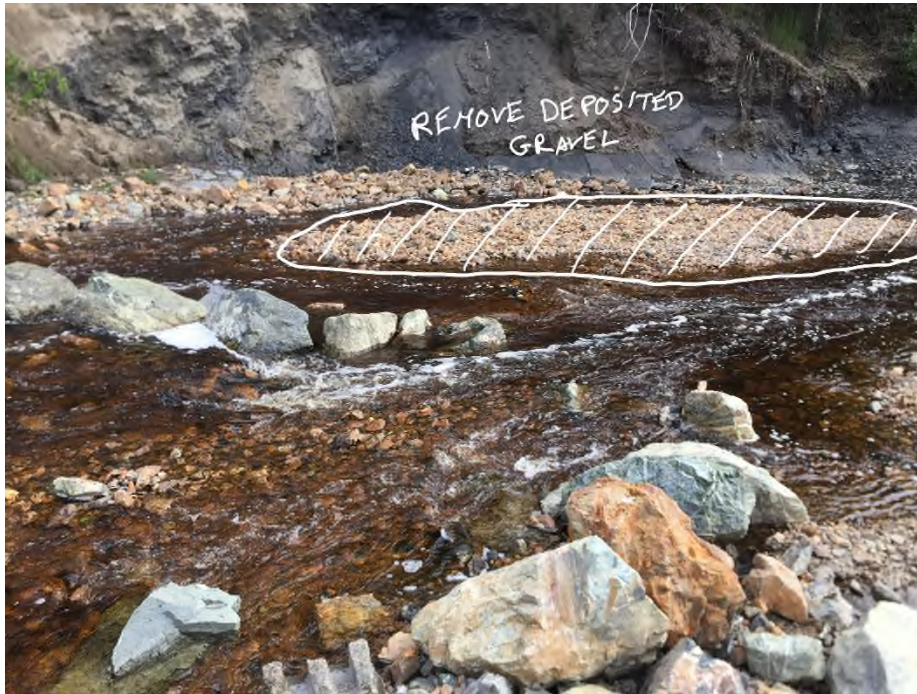
The plunge pool is again full of gravel material. In 2019 we had recommended to remove the gravels/sediments (Figure 14). As Parsons is currently working on the final upgrade plans, we don't feel this should be included in the list of critical upgrades for this summer.

Figure 14: Original Recommendations Provided in 2019 (Plunge Pool Gravel Removal)

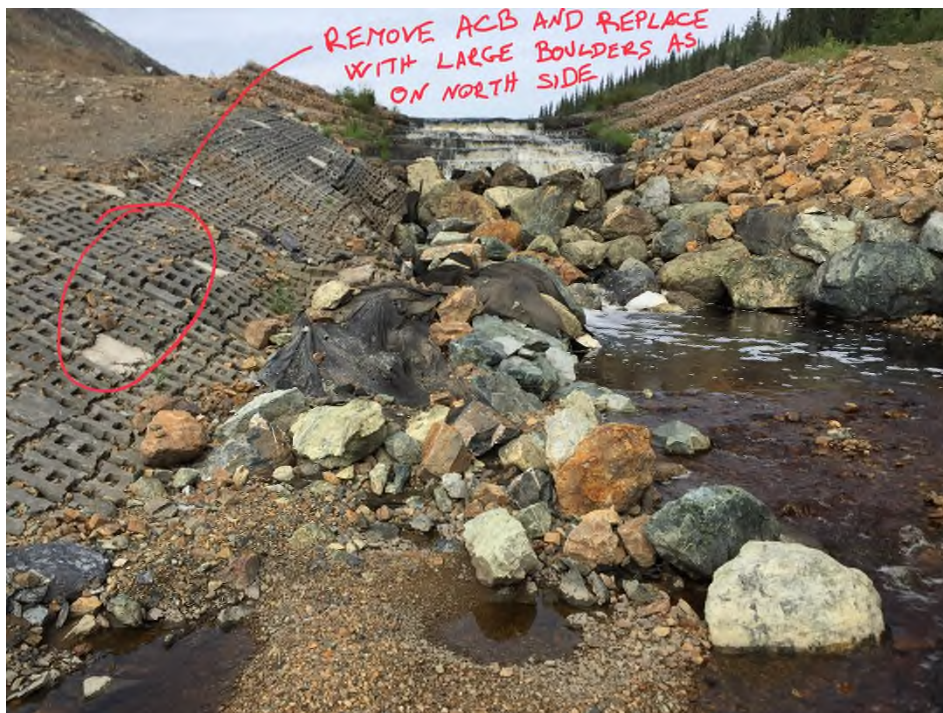
Figure 16: Proposed Upgrades along South Toe of Slope

As for the south bank, we had proposed that the remaining ACB mats be removed completely and that the exposed south bank be stabilized with the same treatment as the north bank, using large rocks (See Figure 16). Flows appear to find a way to undermine the existing ACB system and destabilize the embankment. We do believe this to remain a critical item and if possible, it should be advanced this summer.

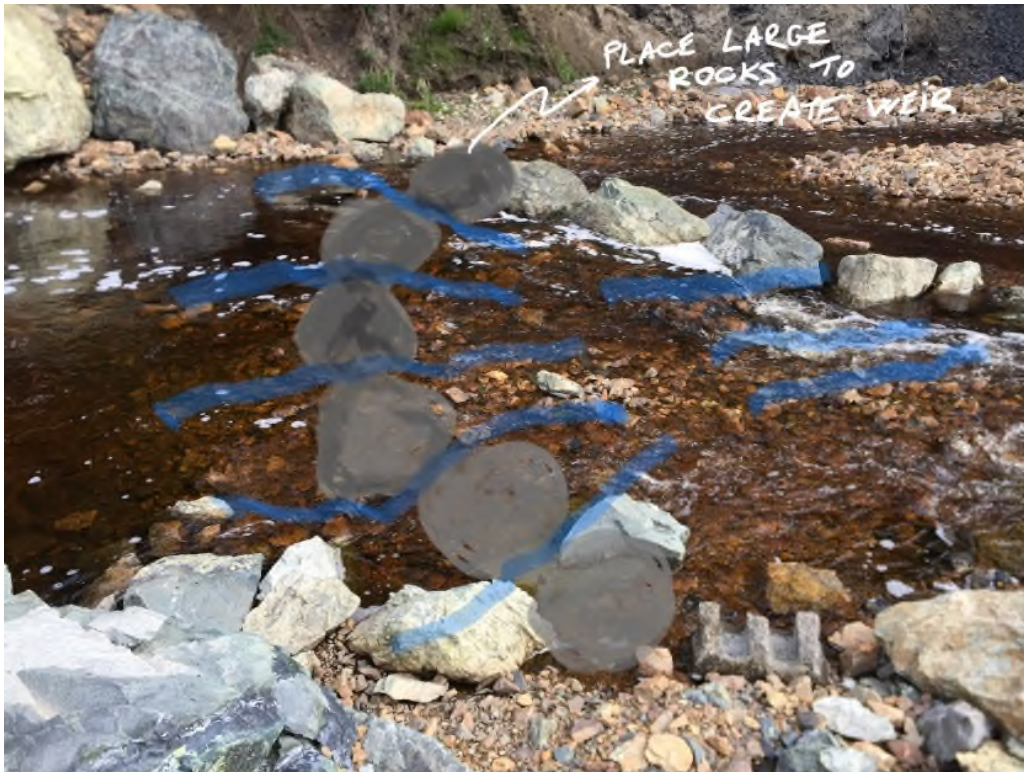
Figure 18: Proposed Rock Weir

In 2018 a series of boulders were used to formalize a weir downstream of DS4. Based on the field observations, some of the boulders have moved. We believe the intensity of the freshet has pushed some of these boulders allowing water to move unimpeded into the downstream pool. To reinstate the weir, we had proposed that a set of larger rocks be used to build a larger weir concentrating the flows towards the centre of the channel. Figure 18 provides an overview of the configuration of the proposed weir. Based on the ability of the system to survive the 2020 freshet, we believe this not to be a critical upgrade.
