# Colomac Remediation Project

## Major Civil Works

Lowell Wade, M.Sc., E.I.T. & Cam Scott, M. Eng., P.Eng.

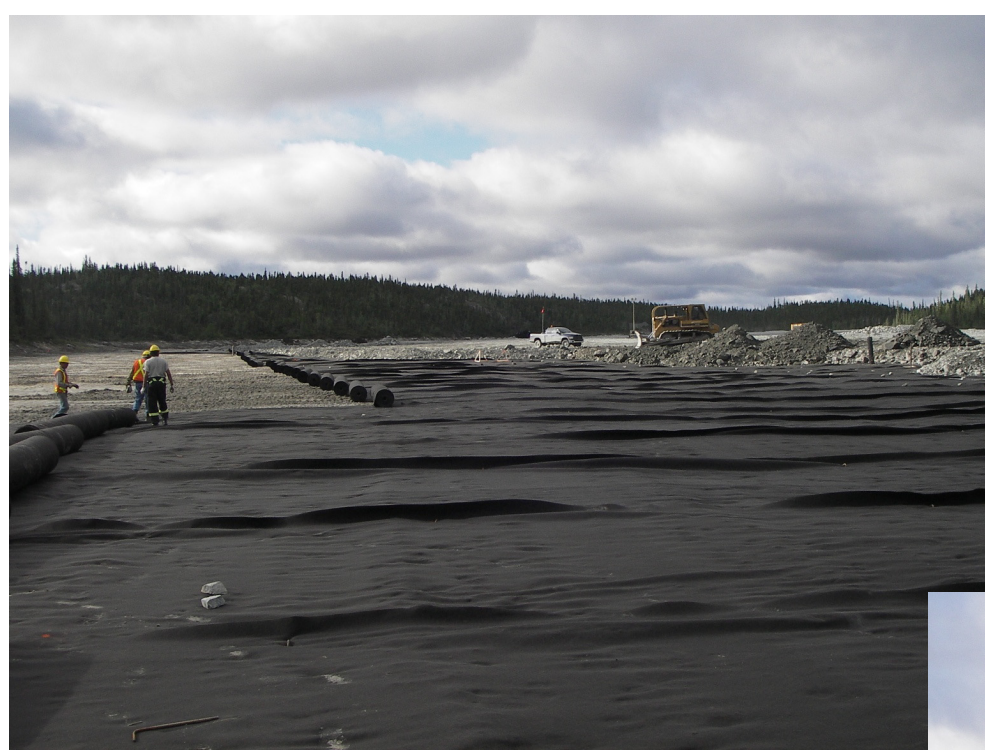
Wide working areas prevented repeated traffic over local areas causing liquefaction of the tailings

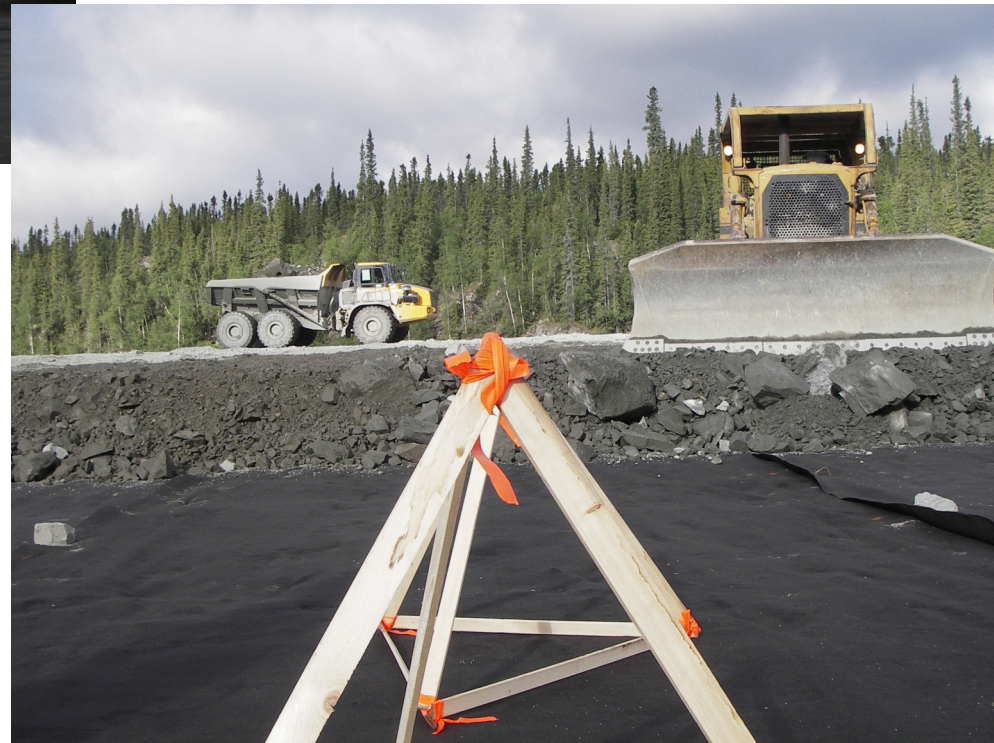
Uniform cover thickness was achieved using tripods constructed at the design height

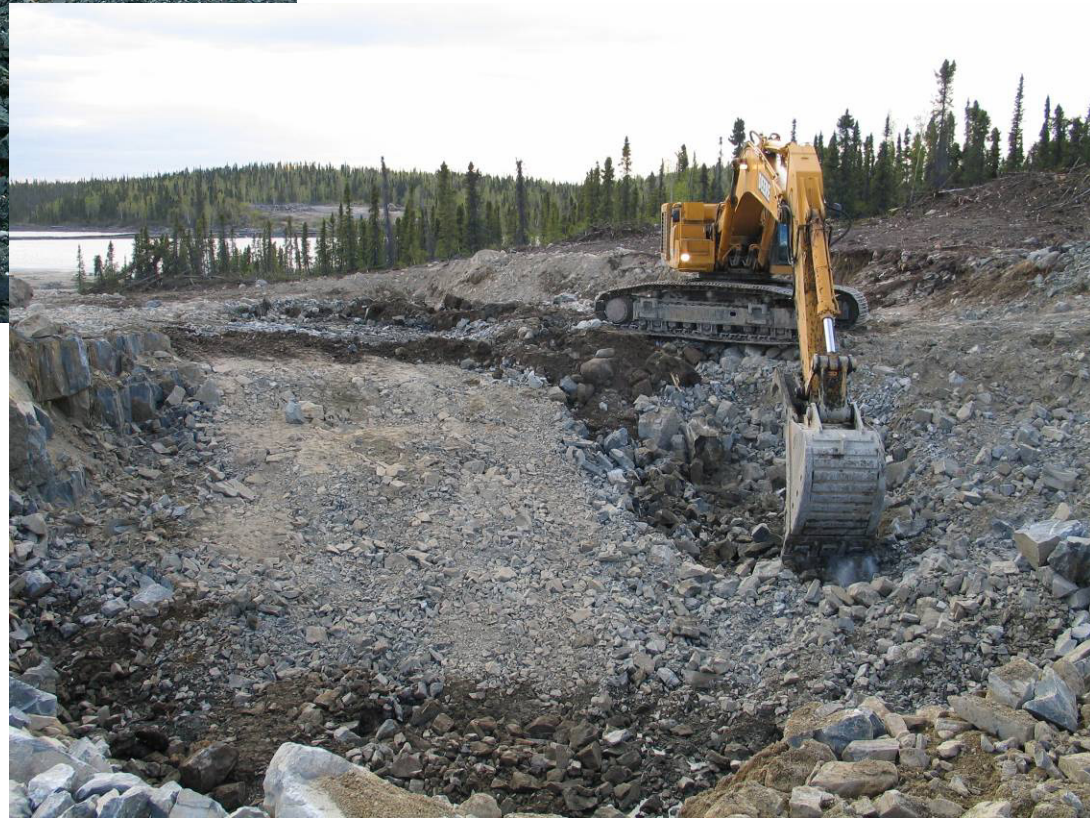
Start of Dyke 7 Spillway excavation with excavation and blasting of bedrock

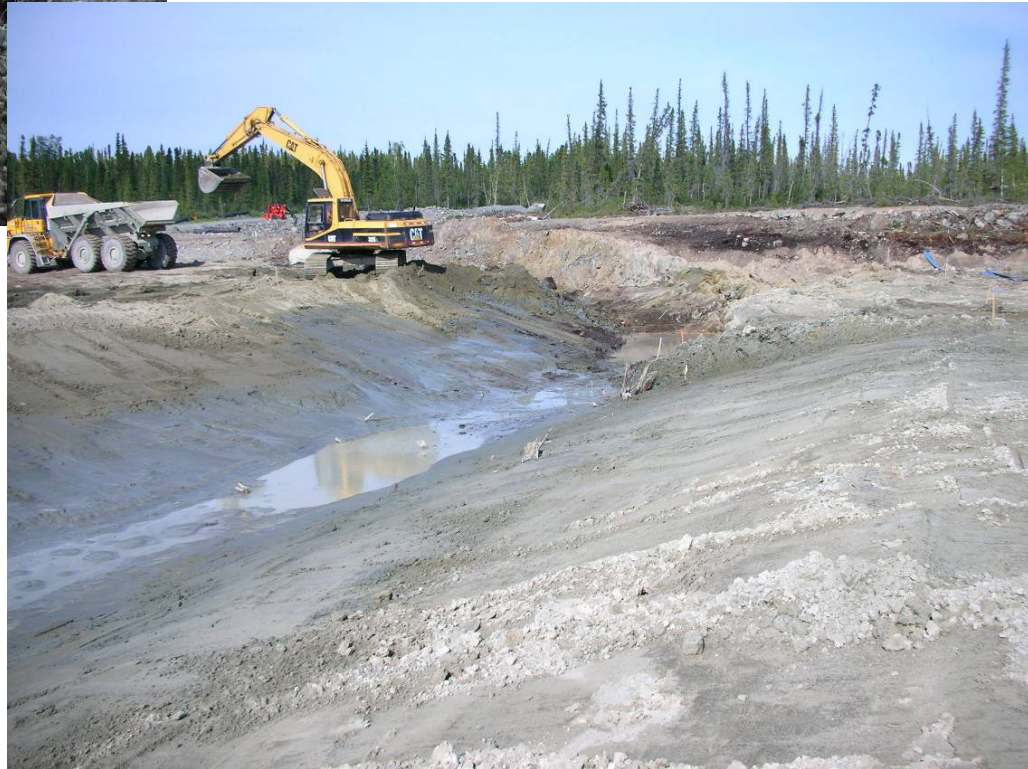
The Drainage Ditch and a Swale were tied into Spillway to manage surface water

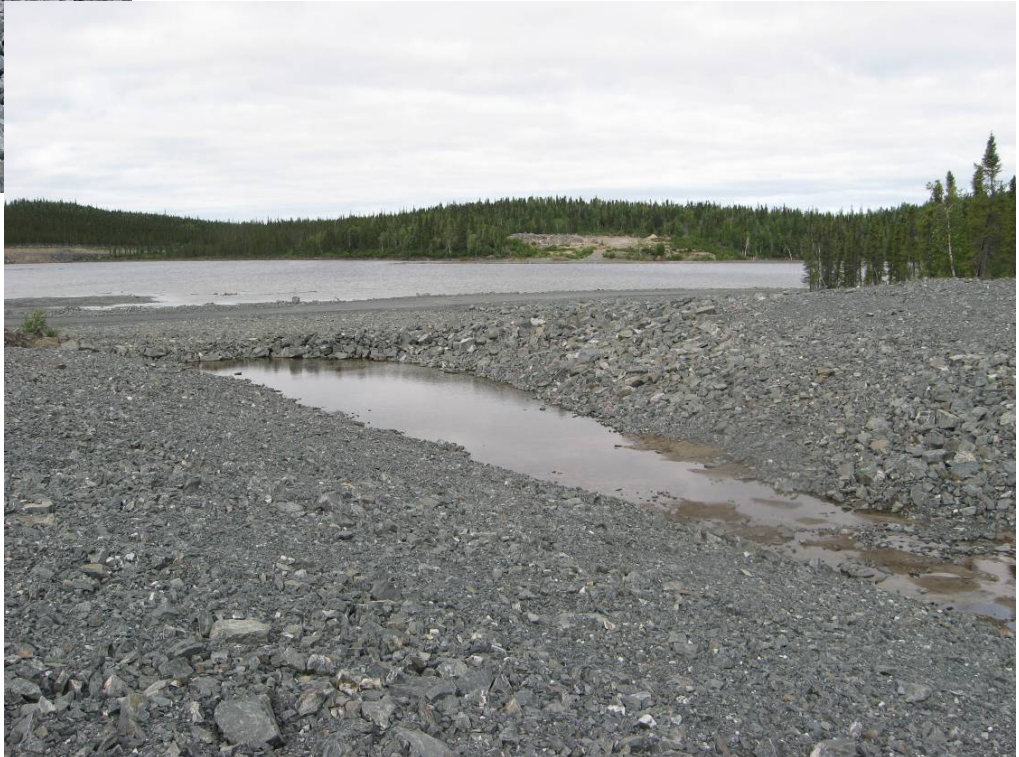
Spillway downstream of Dyke 7

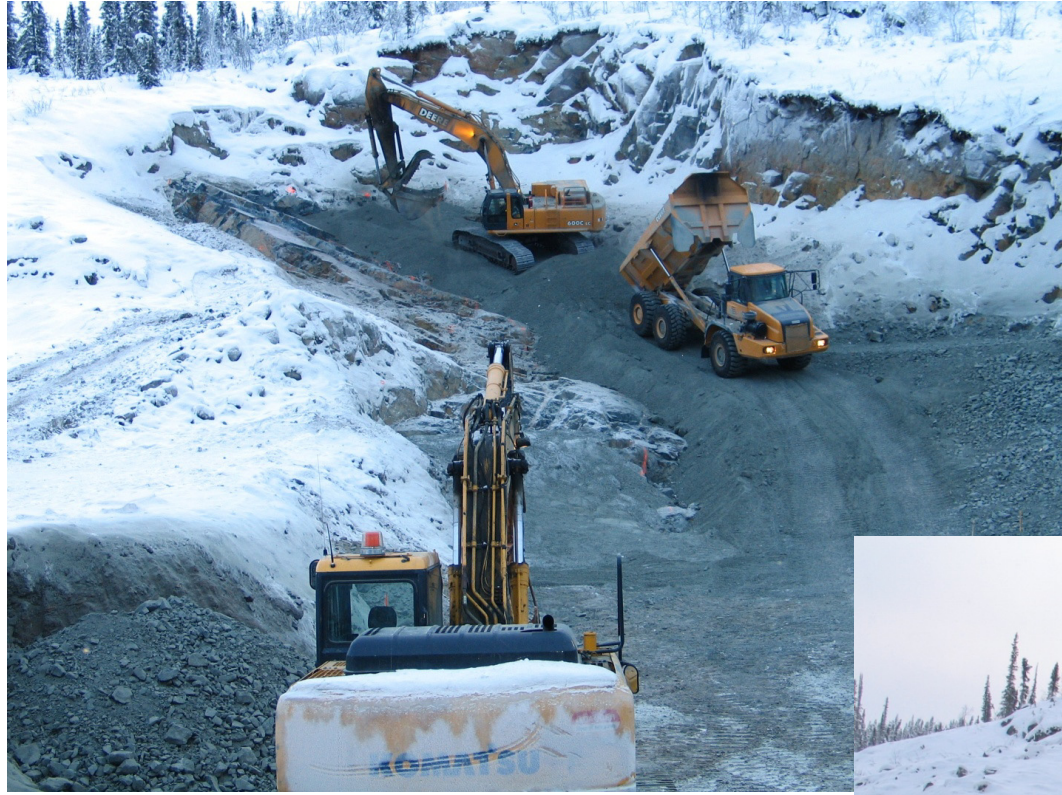
- Relief of the bedrock surface in the abutments was greater than expected.
- The rock surface was cleaned by hand prior to placing a leveling course of granular material

Placing the leveling course of granular material
