Forty Mile Cultural Resource Management Plan 2014

VOLUME II

9. UPDATED BUILDING CONDITION SURVEYS

Building 1 – Fish House, FMEB – 1, YHSI ID: 116C/07/003

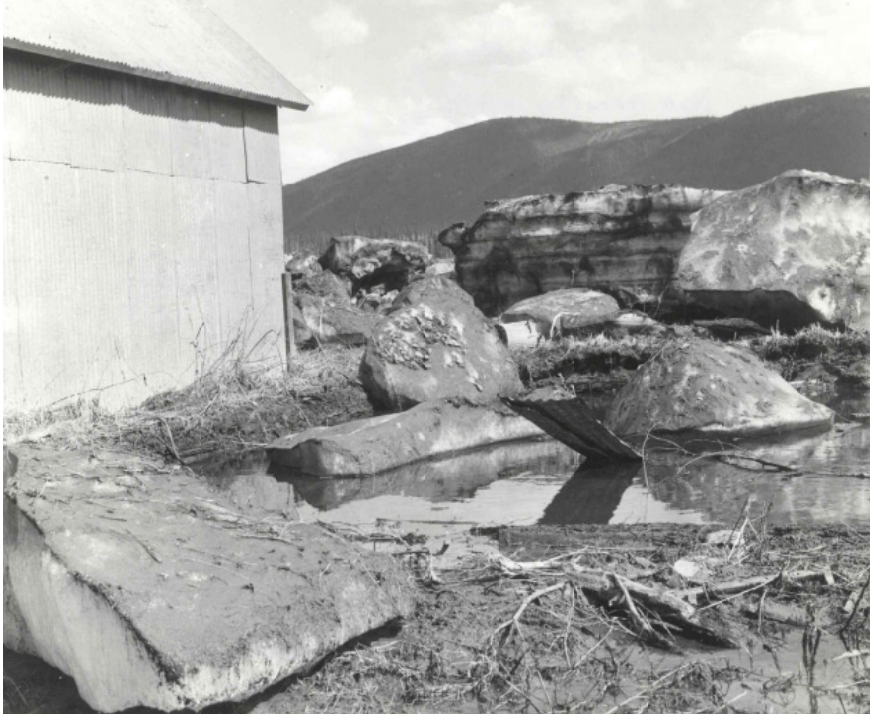
Photo: Bldg #1 – K.N.H.S. #1-22-5

1. Archival Photo: view from north east showing ice build up on site

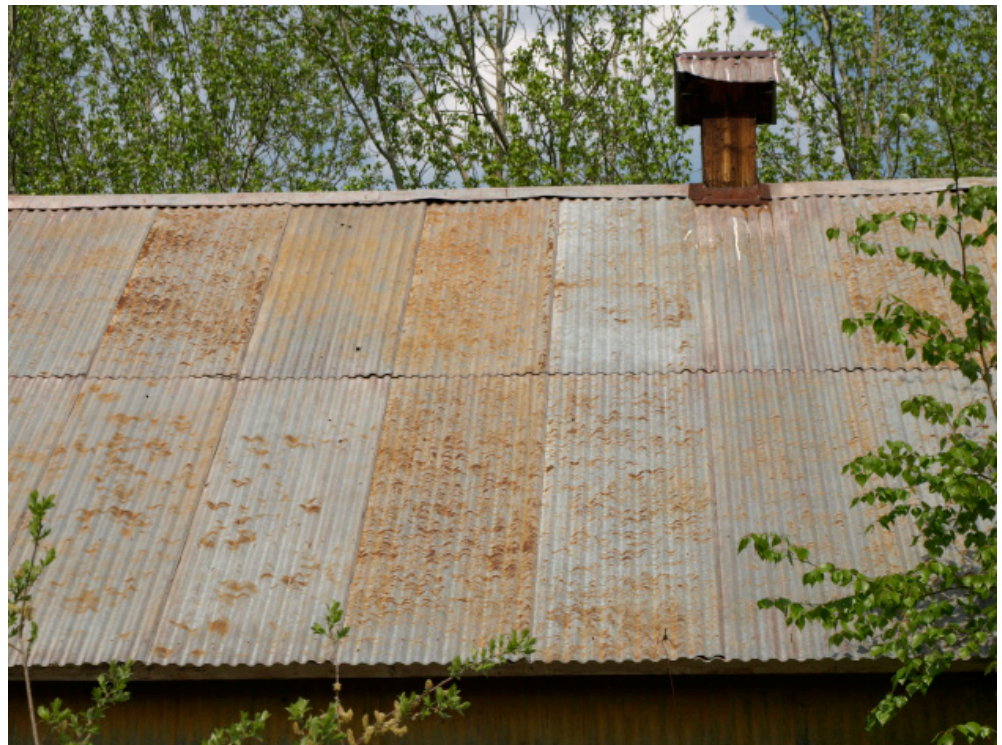
There has been no work done on this fairly robust building and it remains sound, despite the removal of half the ceiling ties and the fact that it has no wall sheathing. The steeply sloping and metal roof, resulting in low snow load, and sturdy metal wall siding are contributing factors to its longevity.

9. Roof

- i. replace the cross ties with similar rough sawn material
- ii. excavate the sill plates to confirm condition, undertake a repair/replacement program as required
- iii. rebuild the existing front door

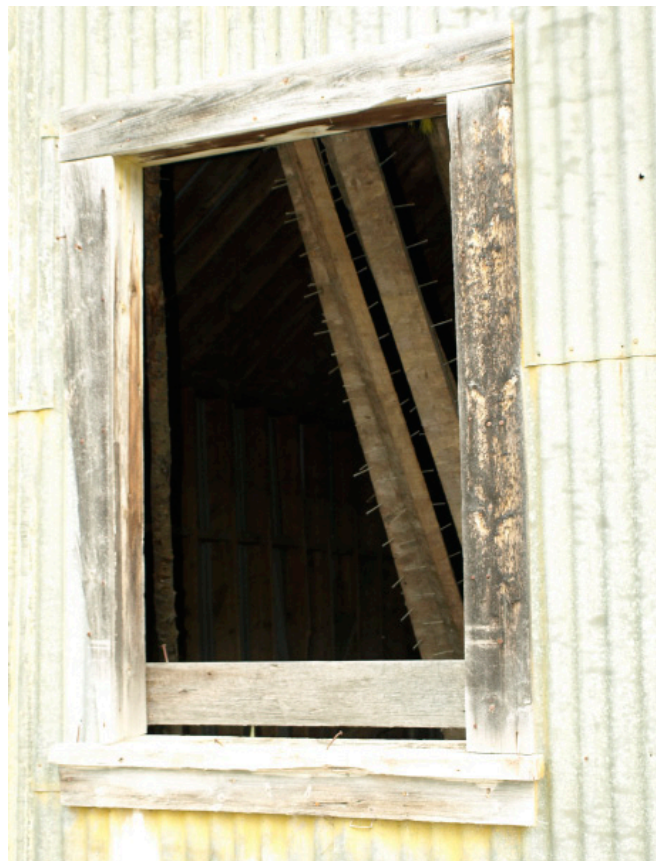
17. Exterior Photo: Window

If the building is to be put back into use, a new floor should be installed; this would be the floating type, independent of the exterior walls. Simple windows, would be installed.

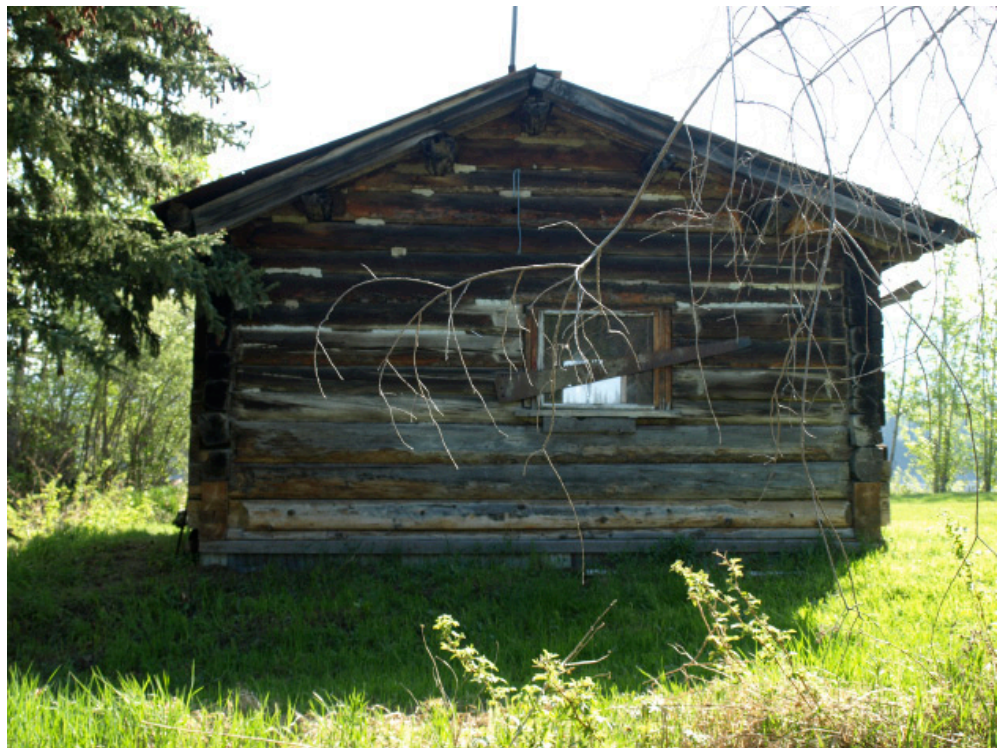
6. Rear (West) Elevation

This building was reconstructed with the typical PWF and lower log replacement described in Volume I, Section 4.4 and is subject to the same general concerns. In particular there is an animal hole into the foundation void on the west wall that should be investigated and monitored.

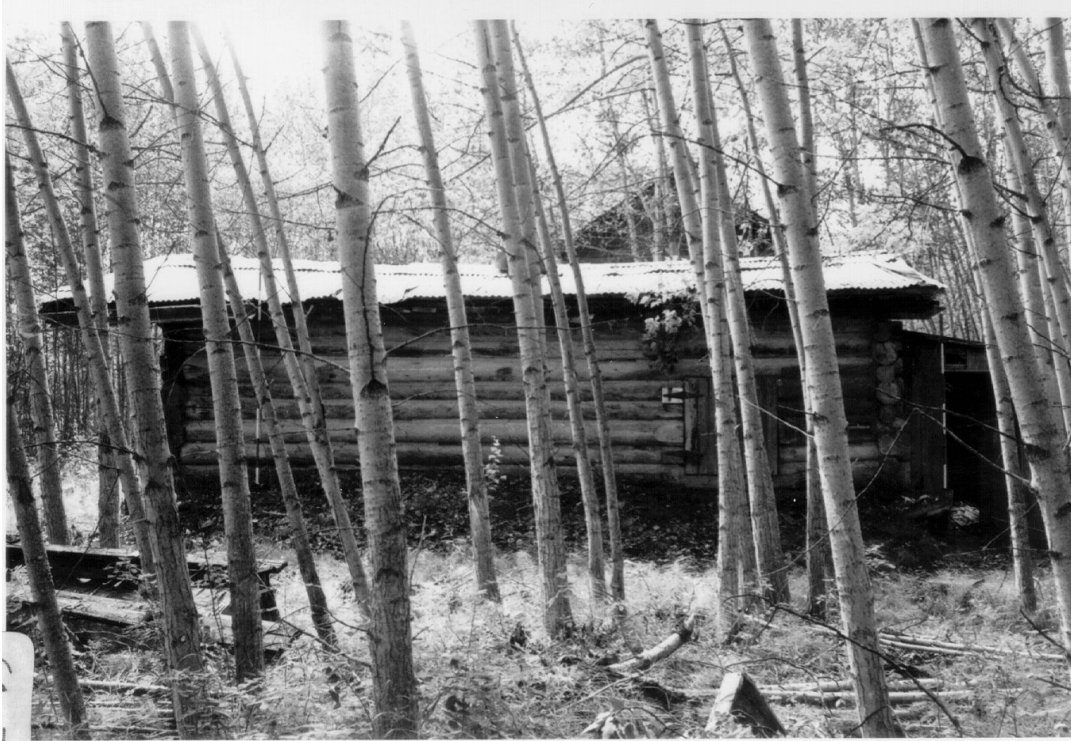
1. Archival Photo:

Photo: Yukon Water Survey Photo, 61-33

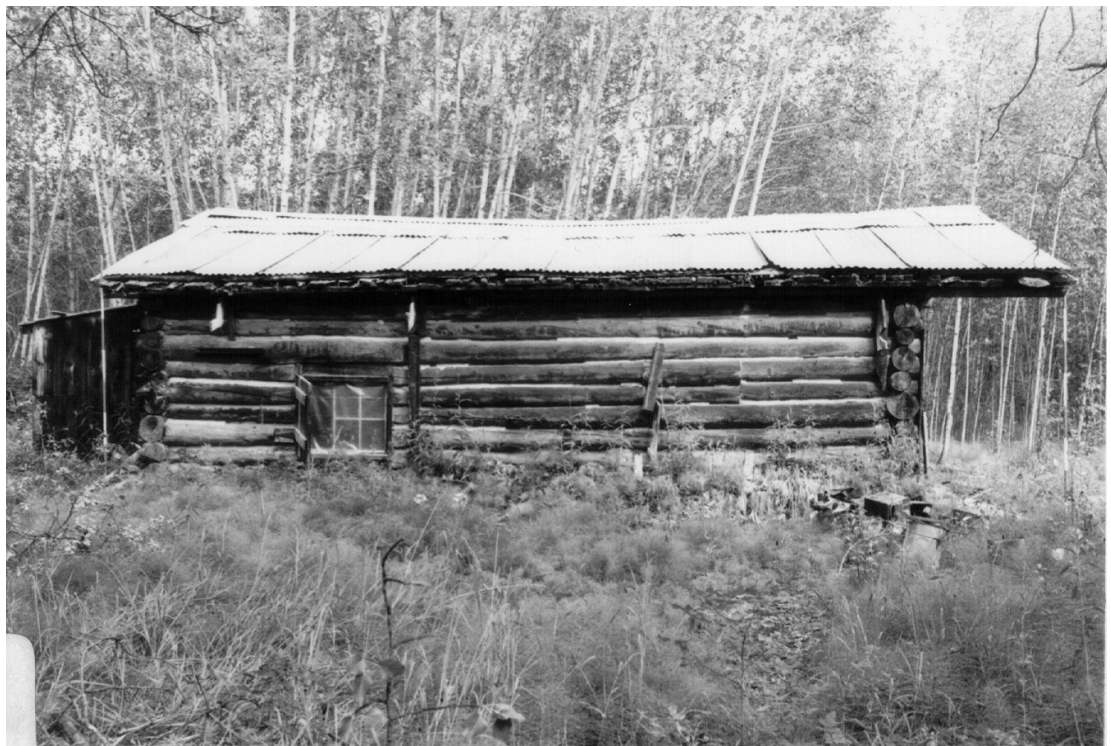
2. Archival Photo:

Photo: Yukon Water Survey Photo, 61-31

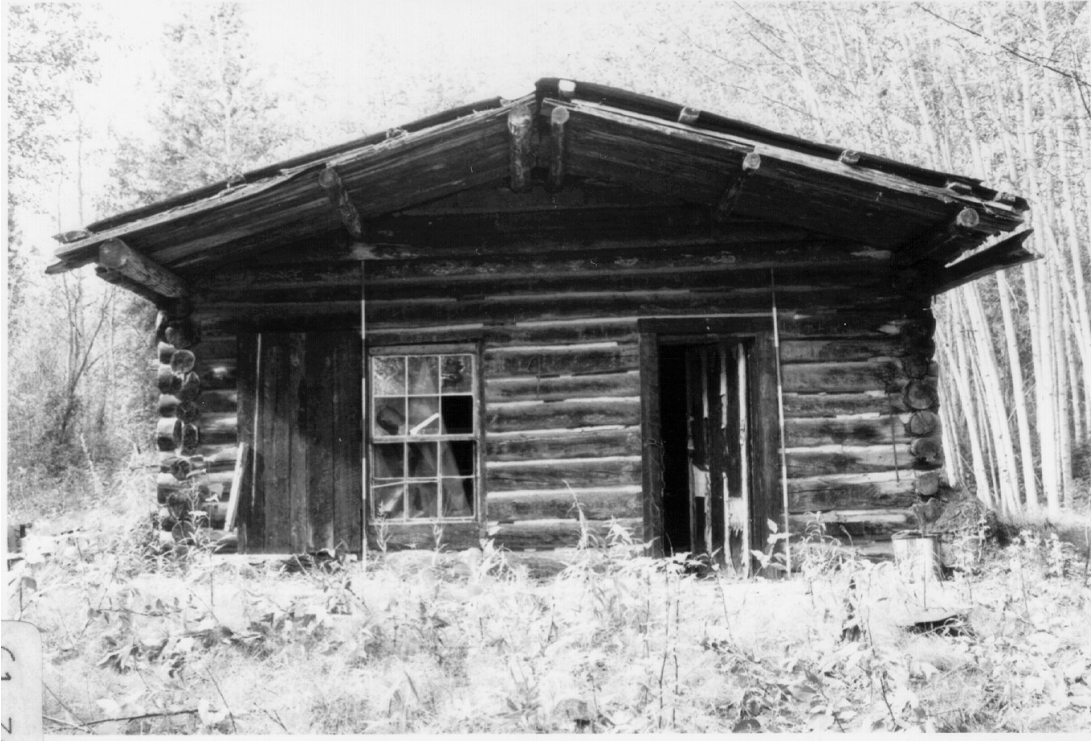
3. Archival Photo:

Photo: Yukon Water Survey Photo, 61-30

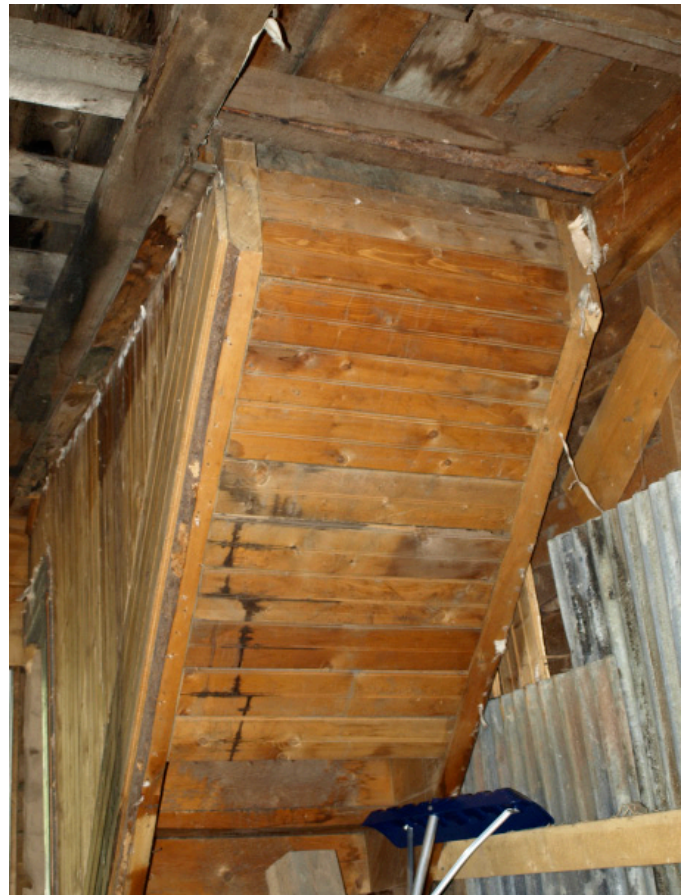
47. Interior Photo: Stair

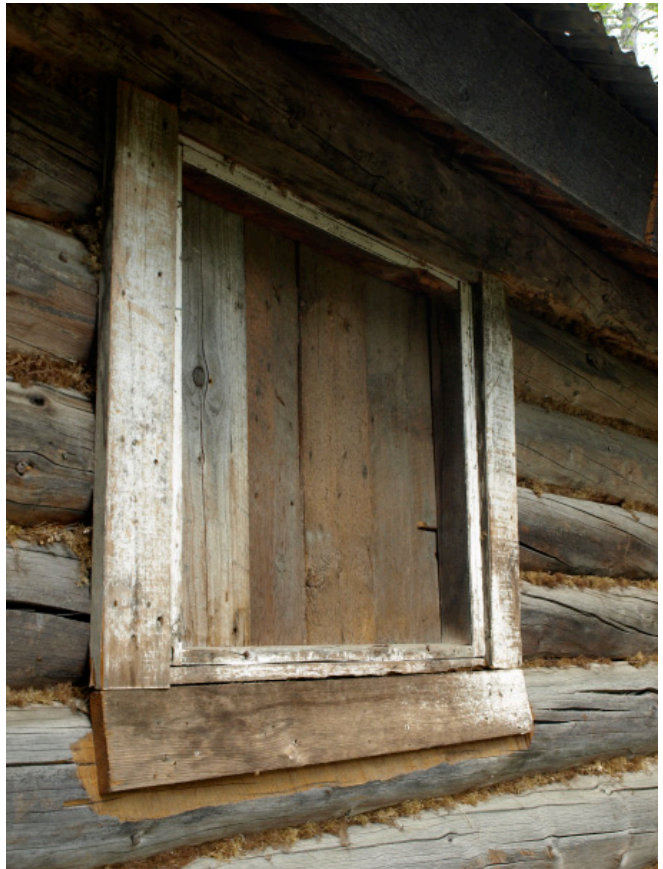
16. Exterior Photo: Window

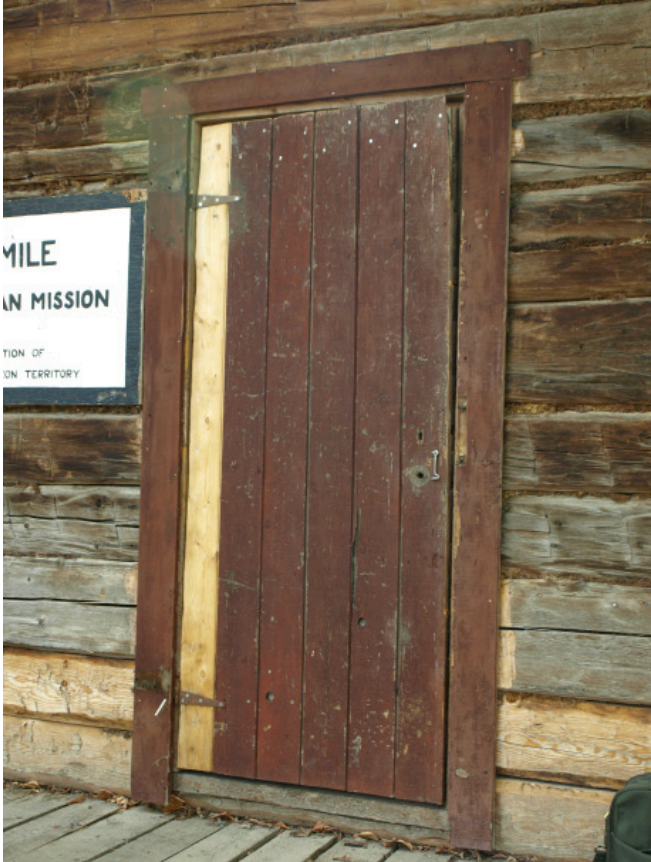
20. Exterior Photo: Front Door

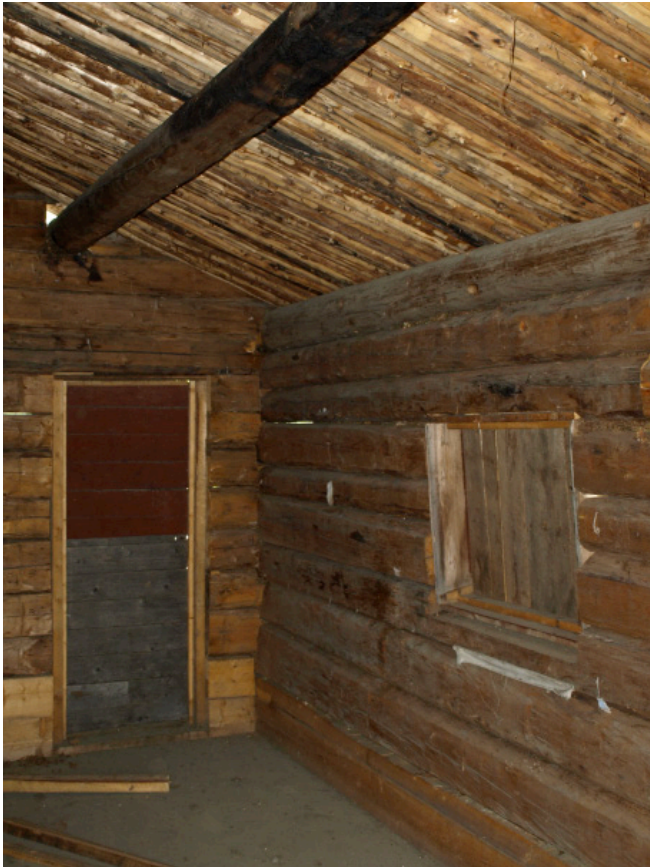
21. Interior Photo: facing rear door

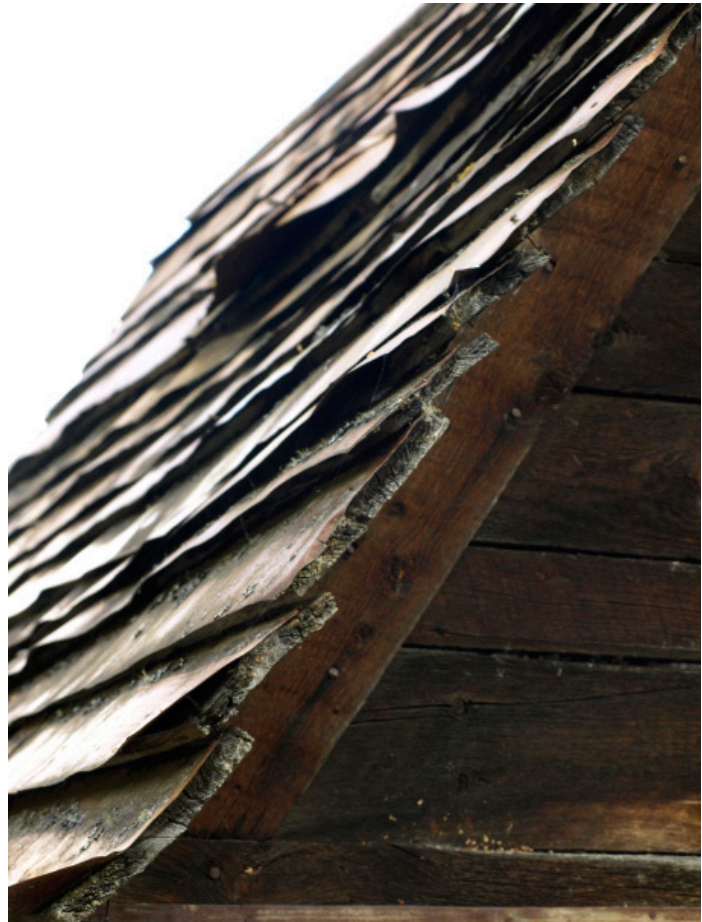
19. Exterior Photo: Roof Detail

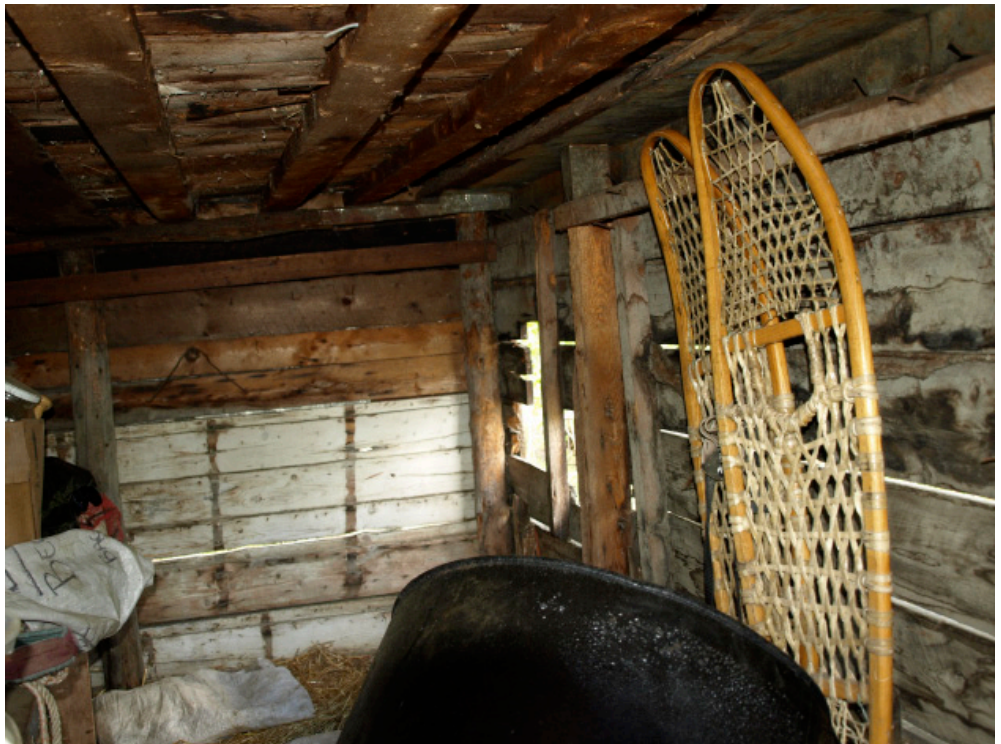
23. Interior Photo: Lower Floor

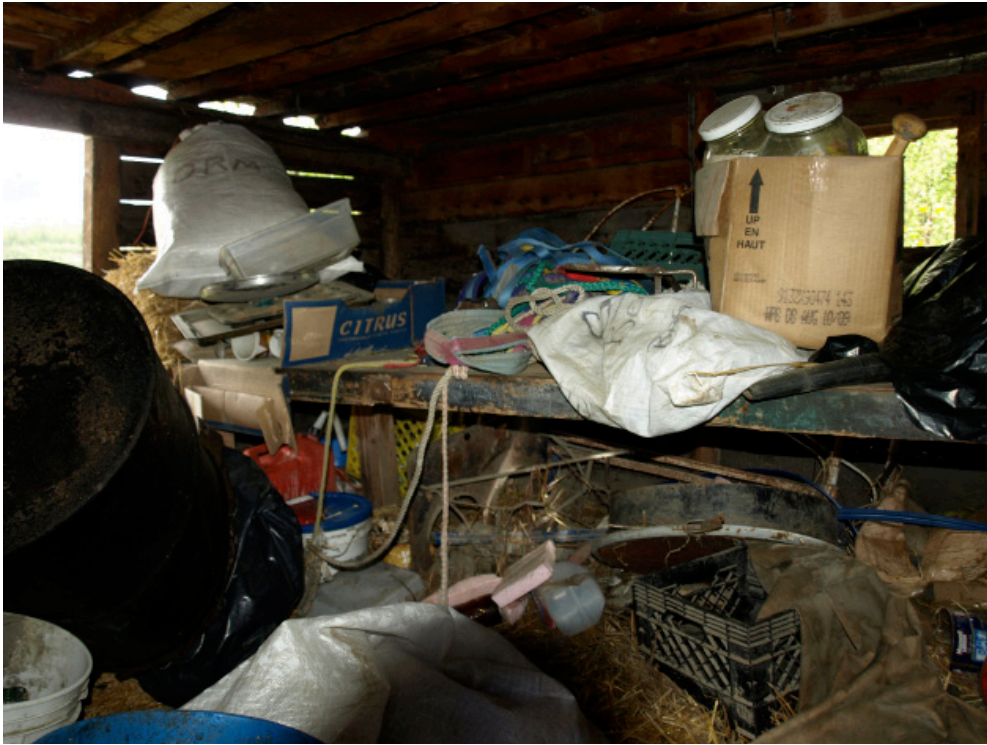
24. Interior Photo: Lower Floor

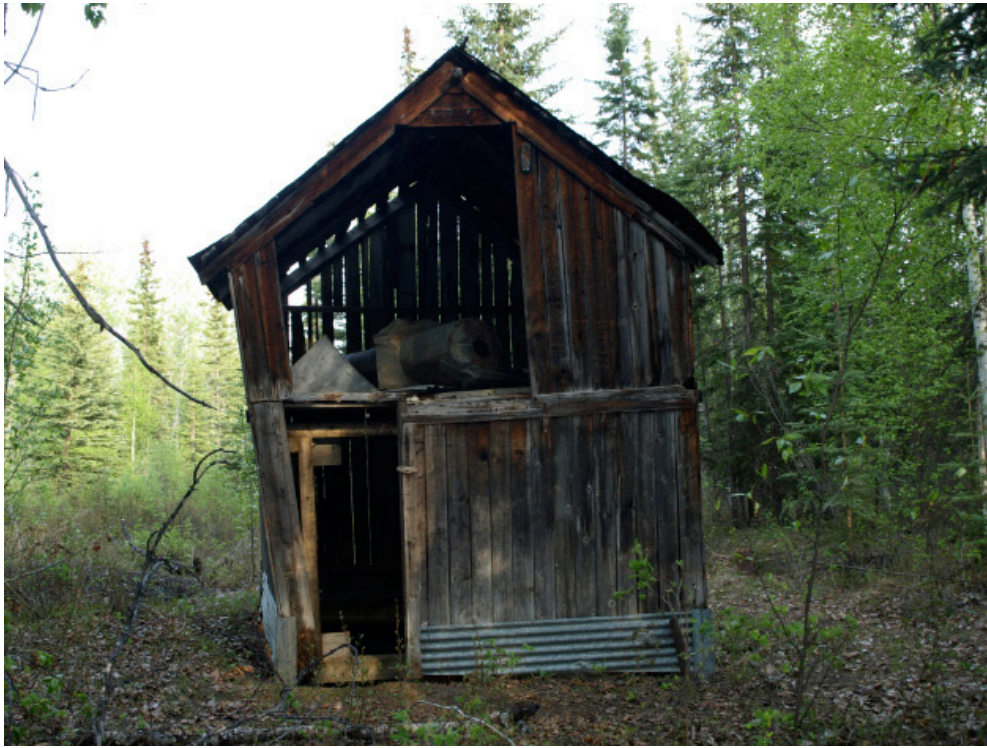
1. Side (North) Elevation:

The structure has been reinforced by an internal braced frame of 6x6 timbers, 2x6 cross-braces and plywood gussets. The structure is markedly out of plumb and would not withstand any straightening correction. Therefore we recommend nothing further be done from a structural standpoint. The roof is in fair condition, with the exception of one panel which needs refastening.

- i. repair roof panel
- ii. inventory radio equipment
- iii. monitor condition of building, determine whether to reconstruct

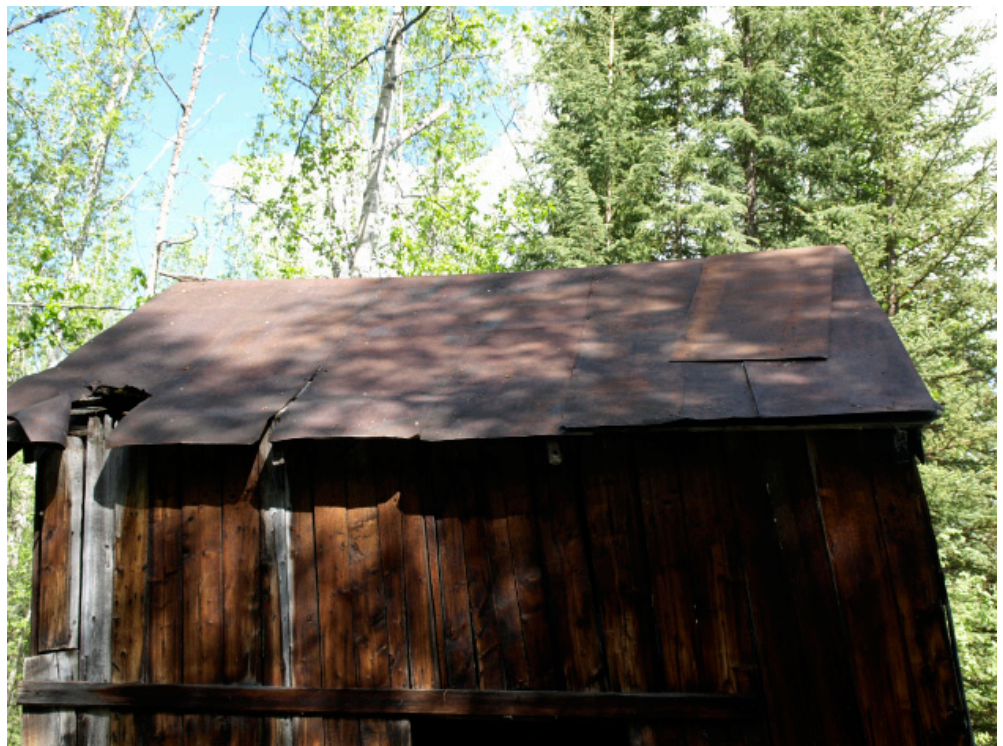
12. Exterior Photo: Roof

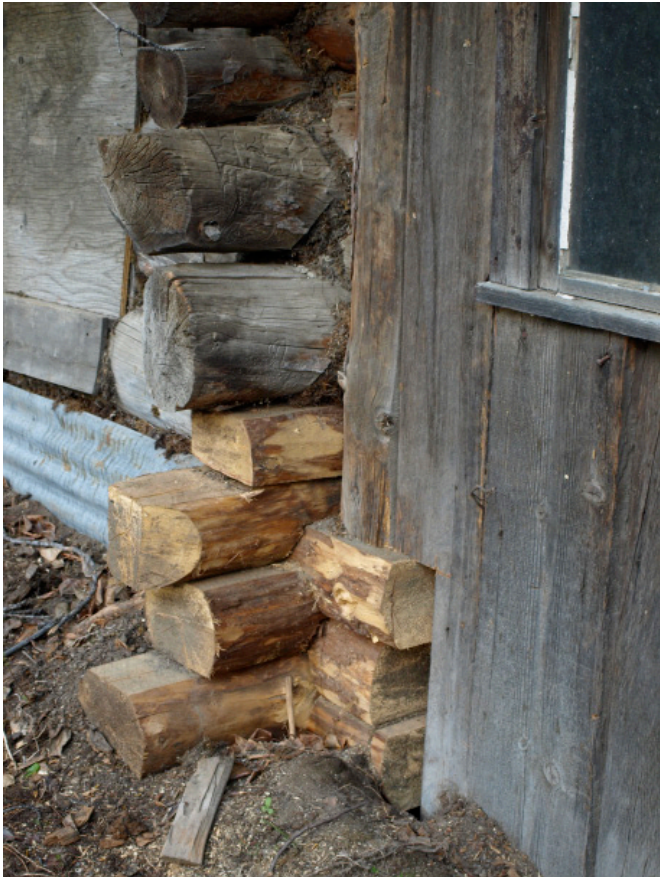
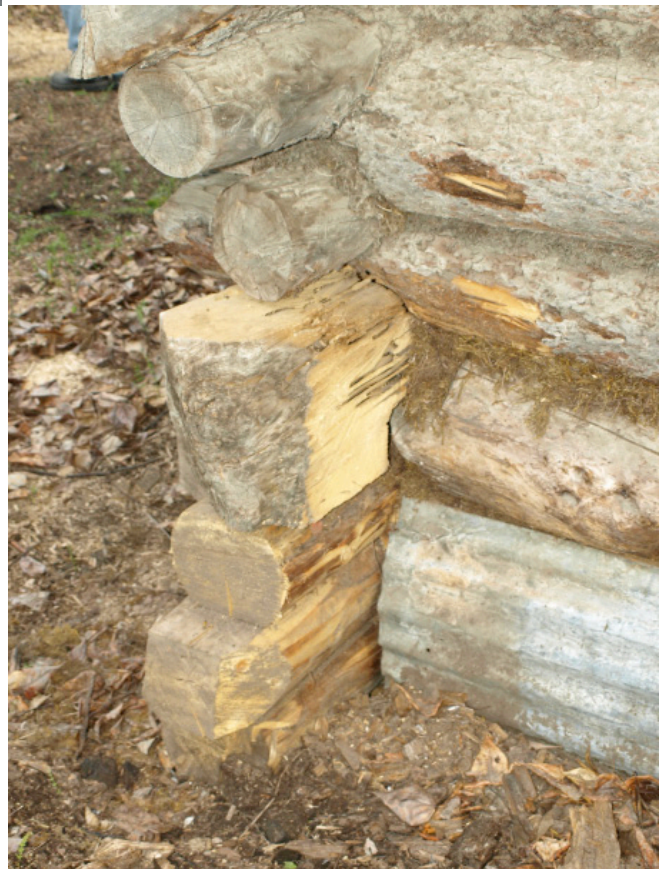
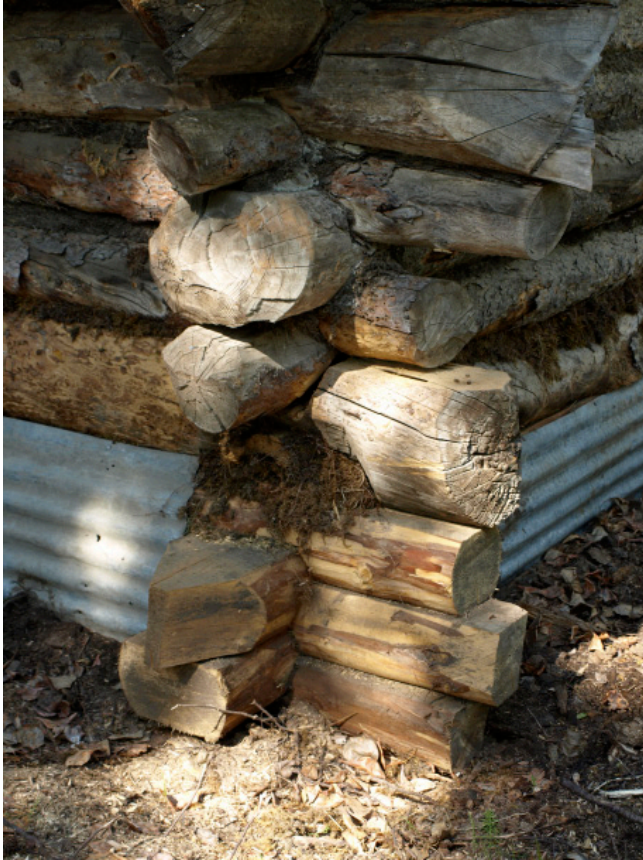
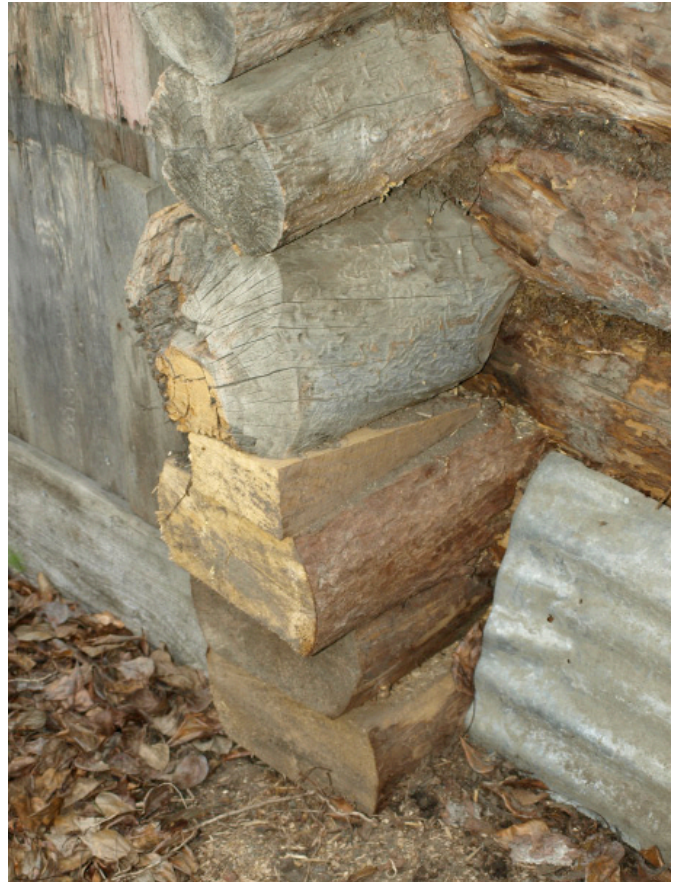
The approach to preservation of the DeWolfe cabin differs from the others in that a PWF was not used, and the floating floor was retained. Lower logs, the lowest of which rest on the ground were replaced with new part sawn timbers and horizontal corrugated metal panels are used to separate the buried 'logs' from earth backfill piled against the exterior walls. Although this may not bode well for the longevity of the work, it does more accurately show the typical construction of an original Yukon log cabin.

It is clear that the approach to the reconstruction work differs from that found elsewhere on site. In addition to the different lower wall/floor construction system described above, a few of the logs are not sound throughout their length, in particular log 3 on the east elevation. The roof has also been rebuilt in a manner not typical of buildings on the remainder of the site, with a combination of small logs which would have been typical of a sod roof, framing lumber, and corrugated metal. Without documentation of the building prior to the repair work it is impossible to ascertain the accuracy and extent of the reconstruction of this building, in other words whether the unusual construction is a reflection of the modifications made to the building over time.

- i. monitor condition of building to determine when to upgrade quality of repair work

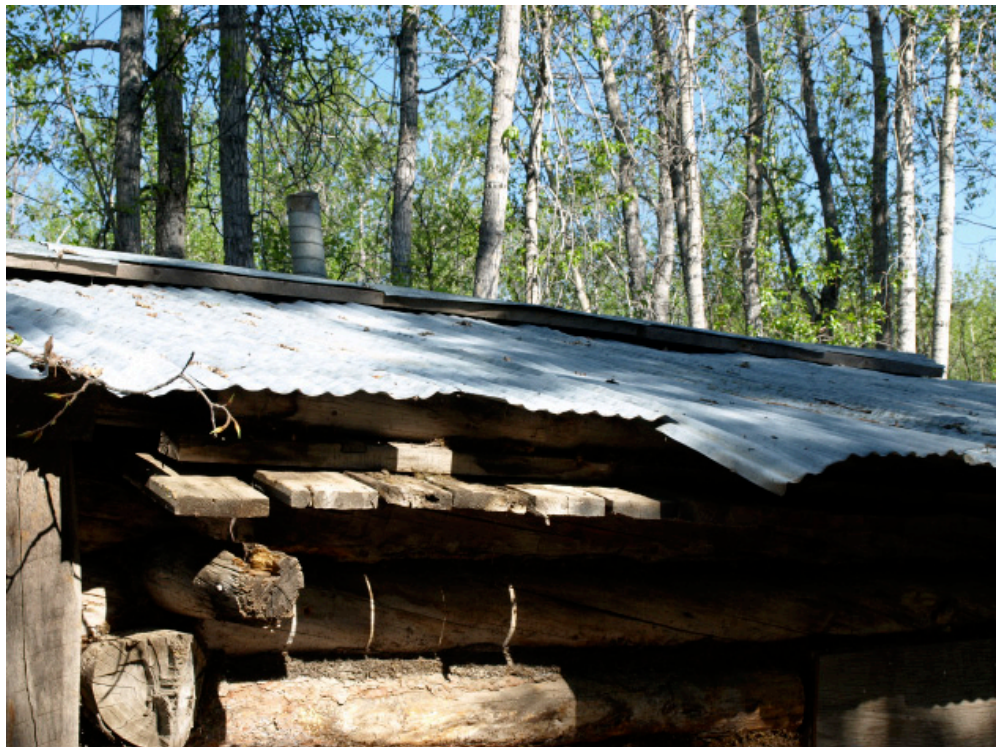
14. Exterior Photo: Roof

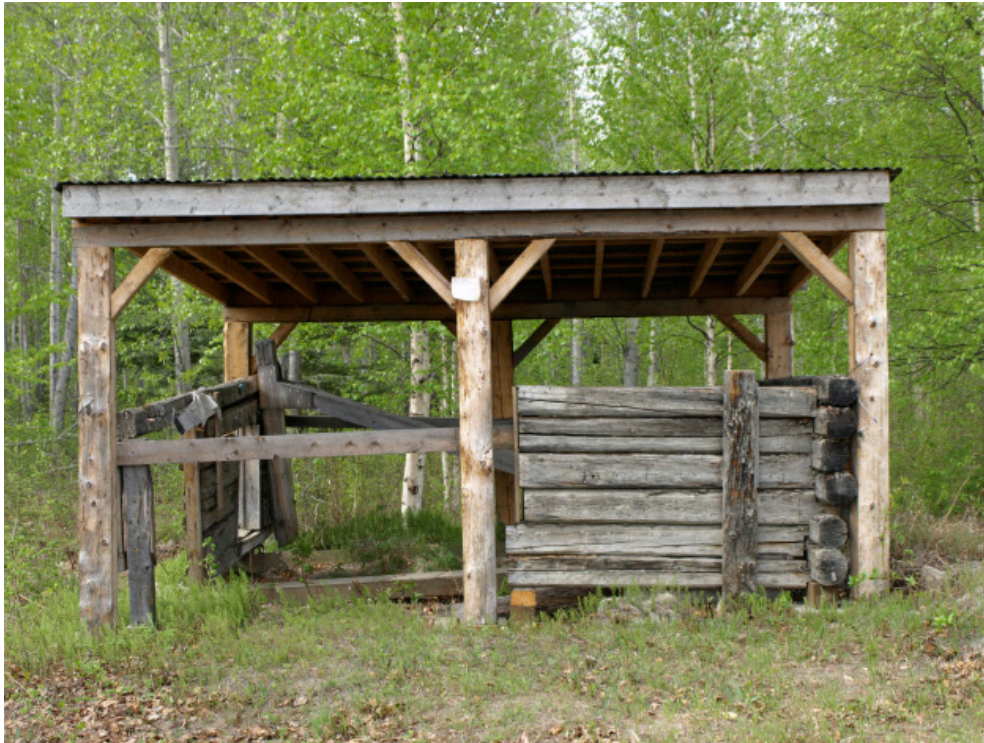
1. Front (East) Elevation:

A case can be made for reconstruction based on the remaining building fabric and the available archival information. The Management Plan (pg 40) recommends rebuilding, because of its connections to Harper and the AC Co.

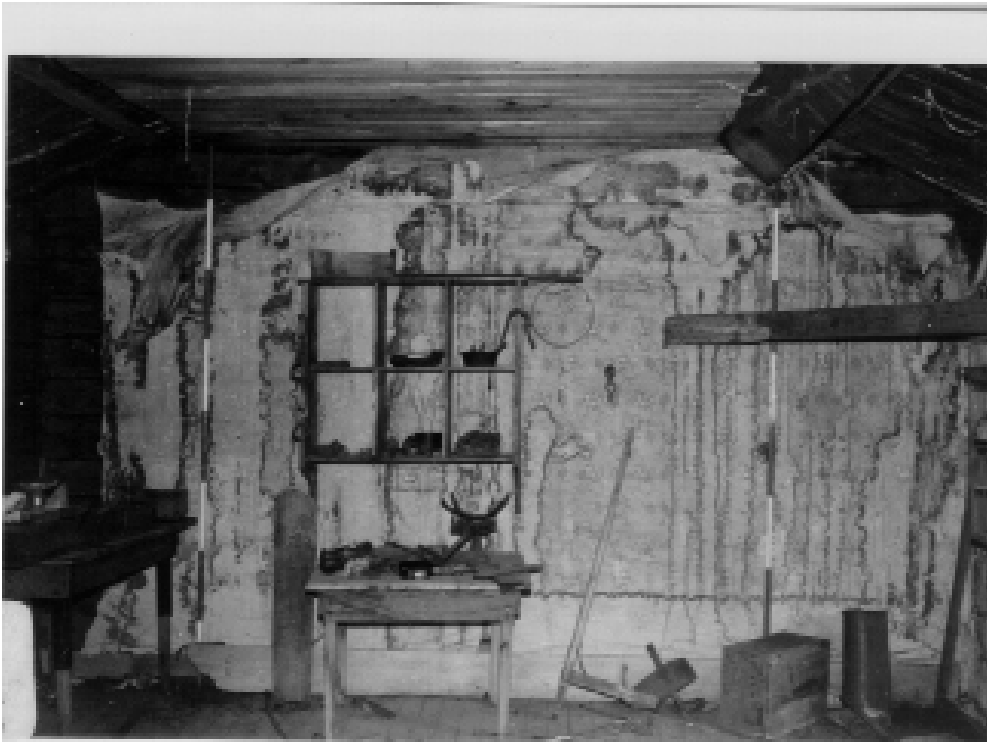
1. Archival Photo: 59-19

Both buildings, the frame barn and the log farm house, are in an advanced state of deterioration. The barn collapsed between 1972 and 1980. The farm house is assumed, based on some wallpaper samples, to have been constructed ca 1890's, and largely collapsed between 1984 and 1986. No work has been done on these buildings.

Based on an interpretive theme of farming in the interior of the Yukon, a case could be made for replicating the farmhouse, based on the remaining elements and the 1972 YWS photographs.
