### **2006 ANNUAL GEOTECHNICAL EVALUATION AND INSTRUMENT REVIEW**

### **VARIOUS FACILITIES AT FARO MINE, YUKON**

PROJECT NO.: 0257-039-05  
DATE: FEBRUARY 14, 2007

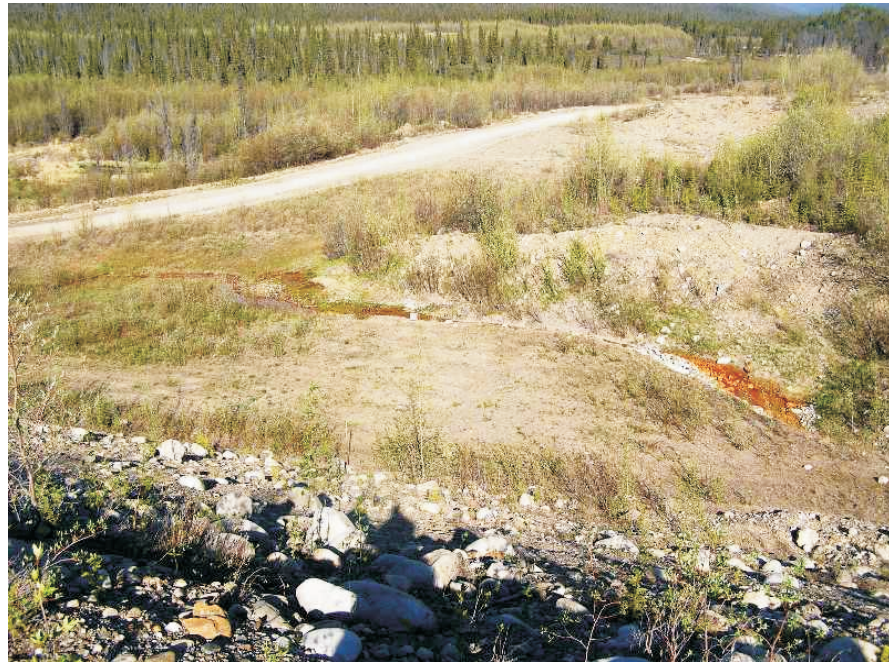
June: Looking at the seepage collection trench below the spillway.

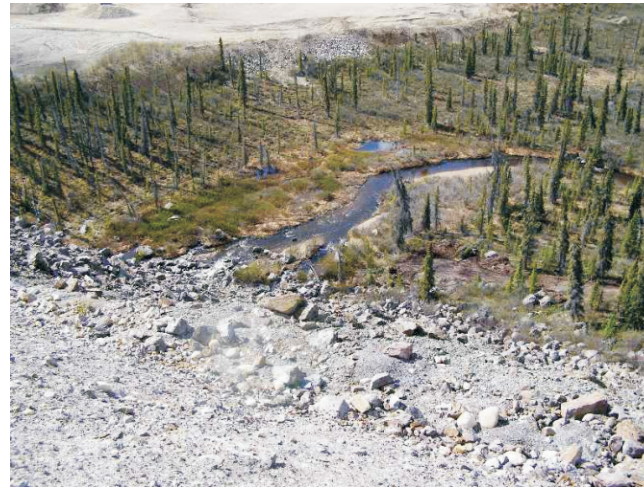
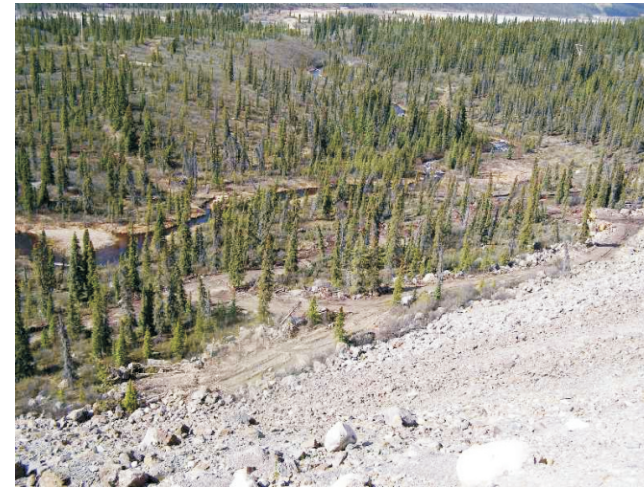
June: two shot panorama of downstream toe of Rock Drain.
