2008 ANNUAL GEOTECHNICAL EVALUATION AND INSTRUMENT REVIEW

VARIOUS FACILITIES AT FARO MINE, YUKON

PROJECT NO.: 0257-051-05
DATE: FEBRUARY 13, 2009

**RE: 2008 ANNUAL GEOTECHNICAL EVALUATION AND INSTRUMENT REVIEW
VARIOUS MINE WASTE FACILITIES AT FARO MINE, YUKON**

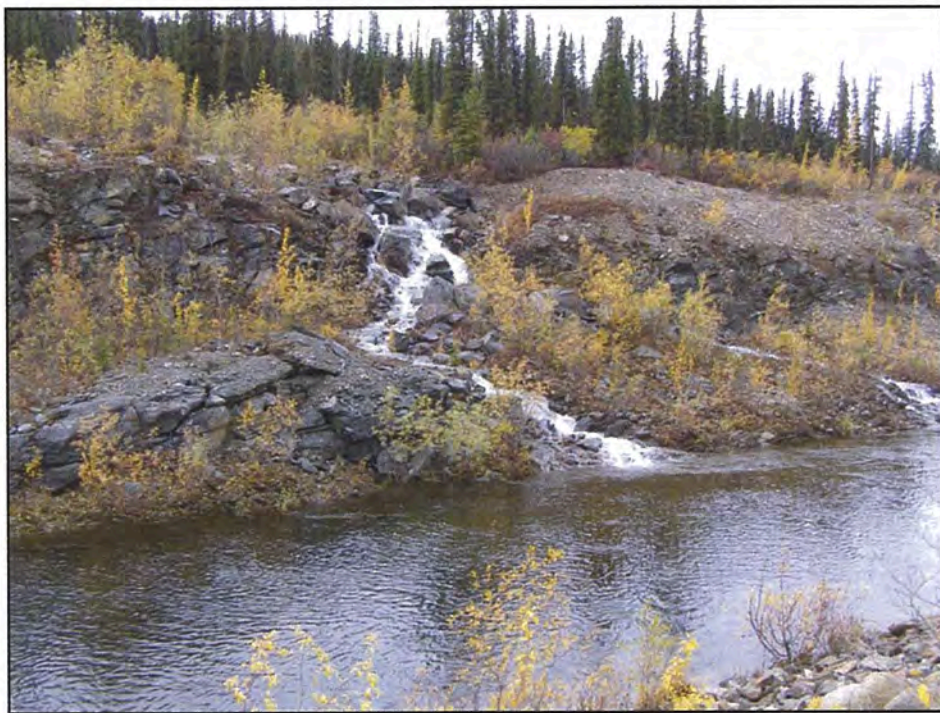
September: shows Goodall Creek discharge into the canal.

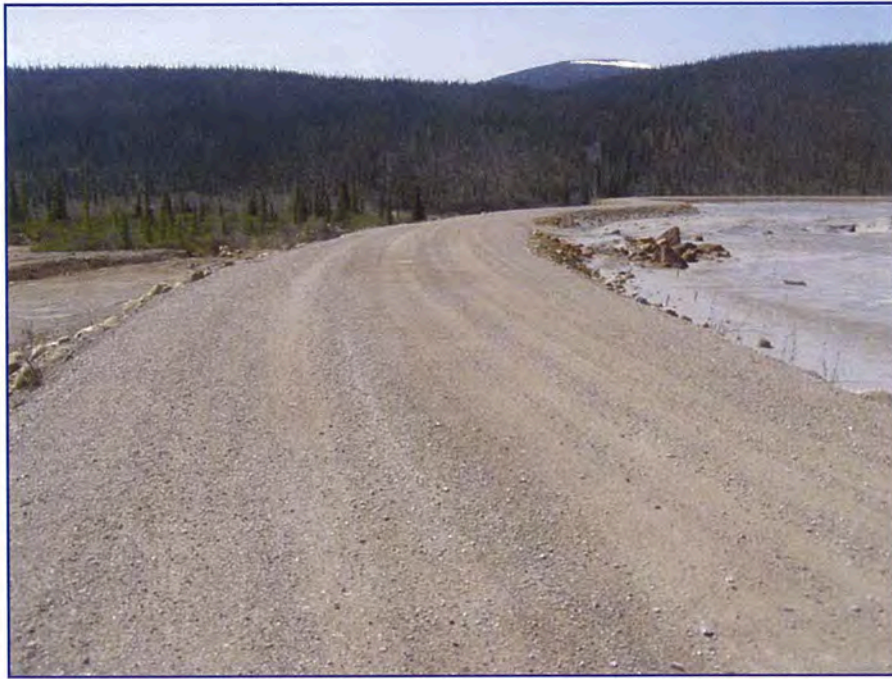
June: shows a view of the crest of the Secondary Dam.
