2009 ANNUAL GEOTECHNICAL EVALUATION AND INSTRUMENT REVIEW

VARIOUS FACILITIES AT FARO MINE, YUKON

PROJECT NO.: 0762-002-05
DATE: FEBRUARY 26, 2010

**RE: 2009 ANNUAL GEOTECHNICAL EVALUATION AND INSTRUMENT REVIEW
VARIOUS MINE WASTE FACILITIES AT FARO MINE, YUKON**

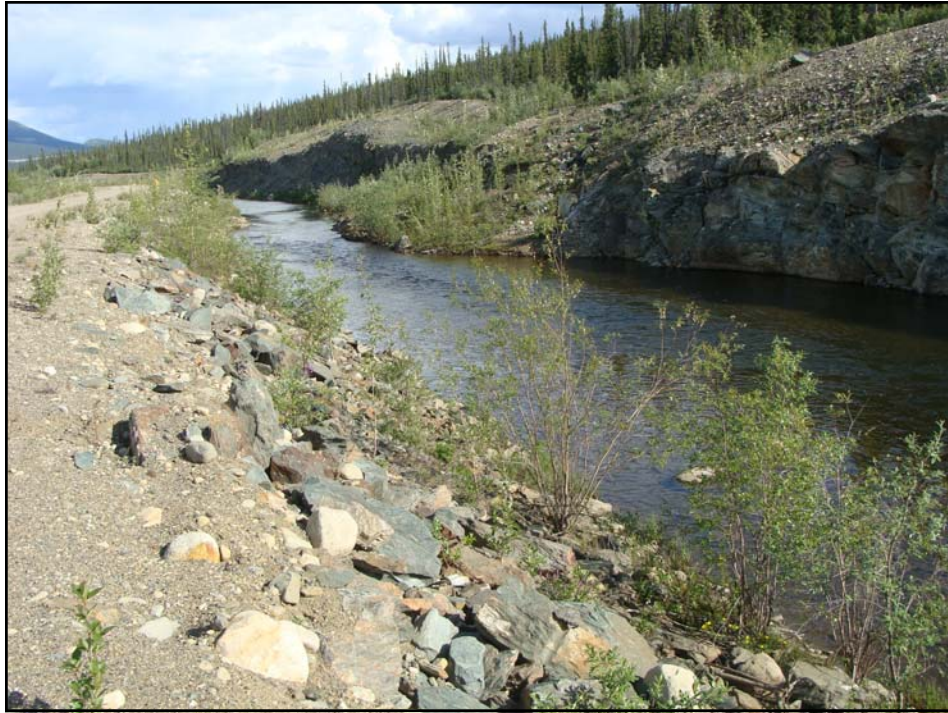
July: shows the water flowing in the channel section.

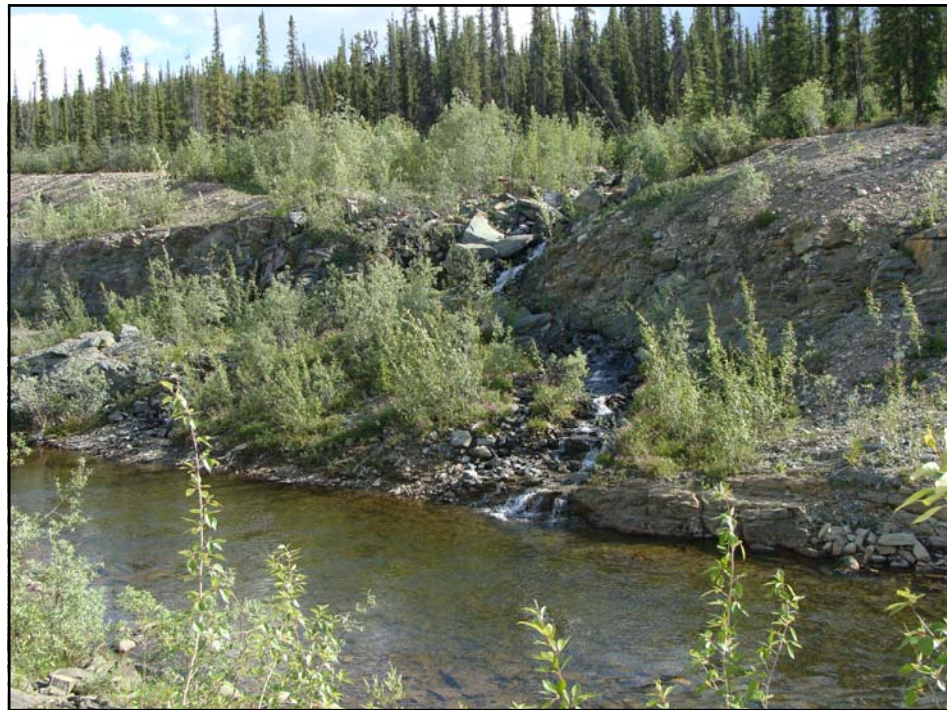
July: shows Goodall Creek discharge into the canal.

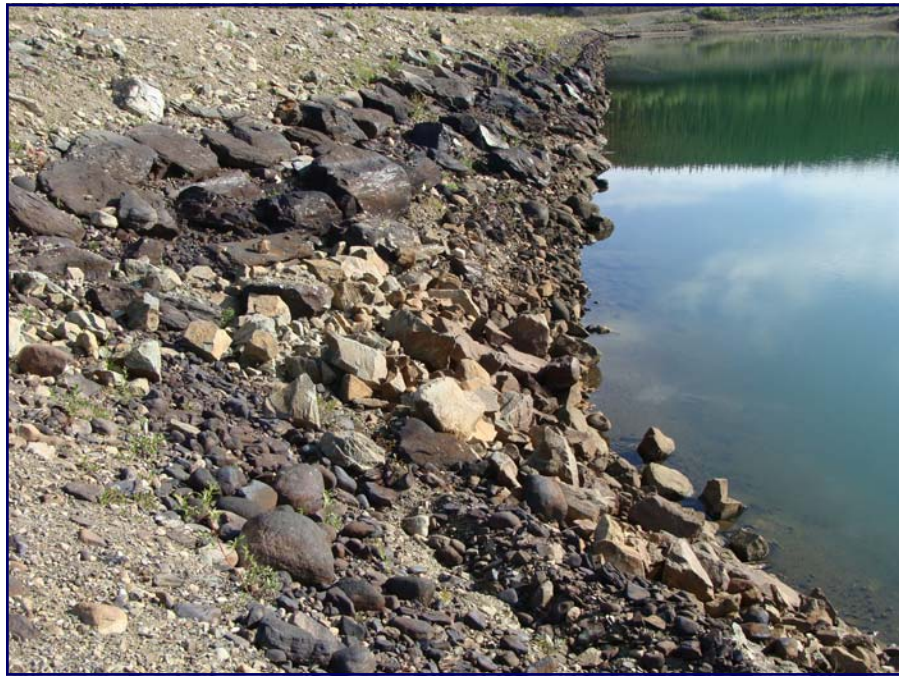
July: shows the upstream face of the Cross Valley Dam.

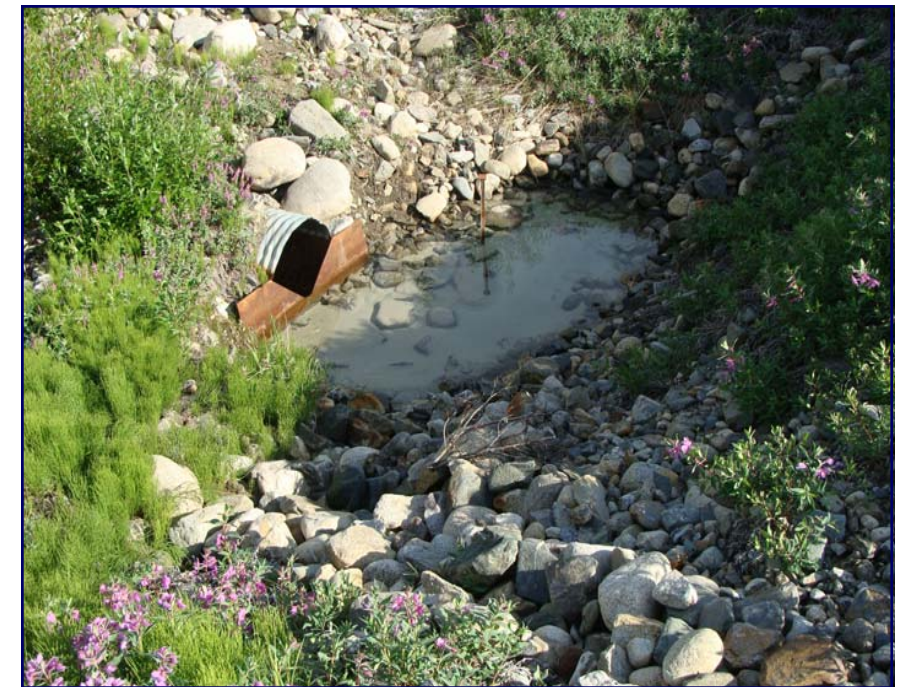
July: shows the seepage discharge weir and staff gauge.

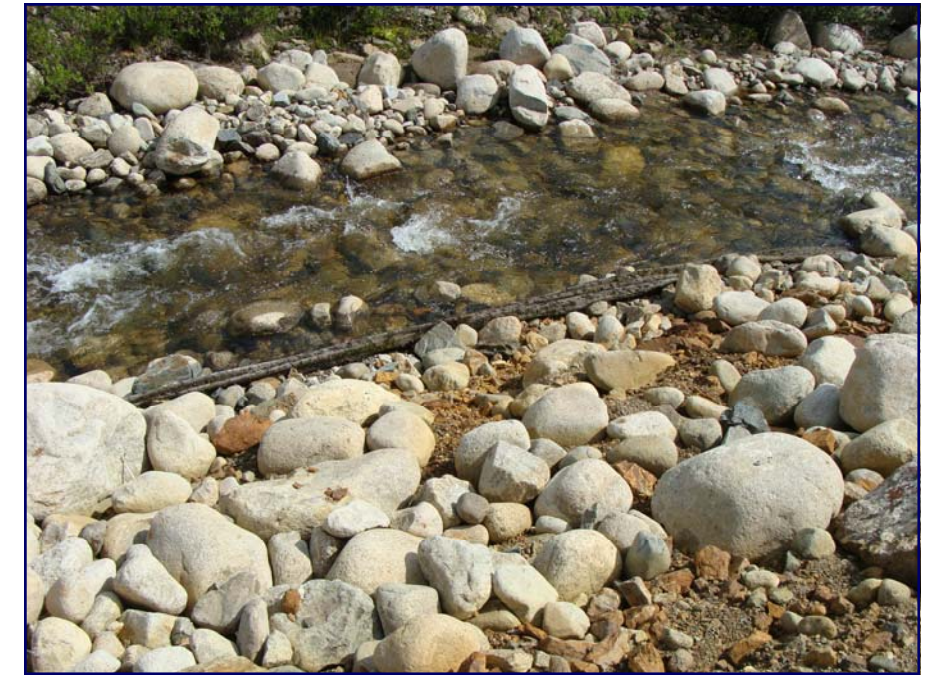
June: shows a view of an area with geotextile exposure.

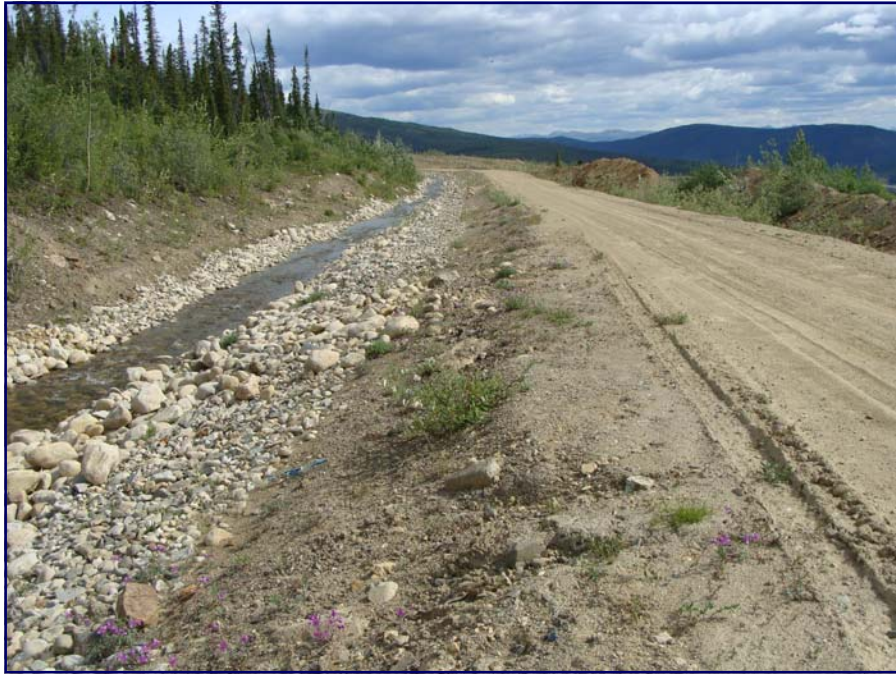
June: shows a view of Faro Creek Diversion Channel looking downstream.

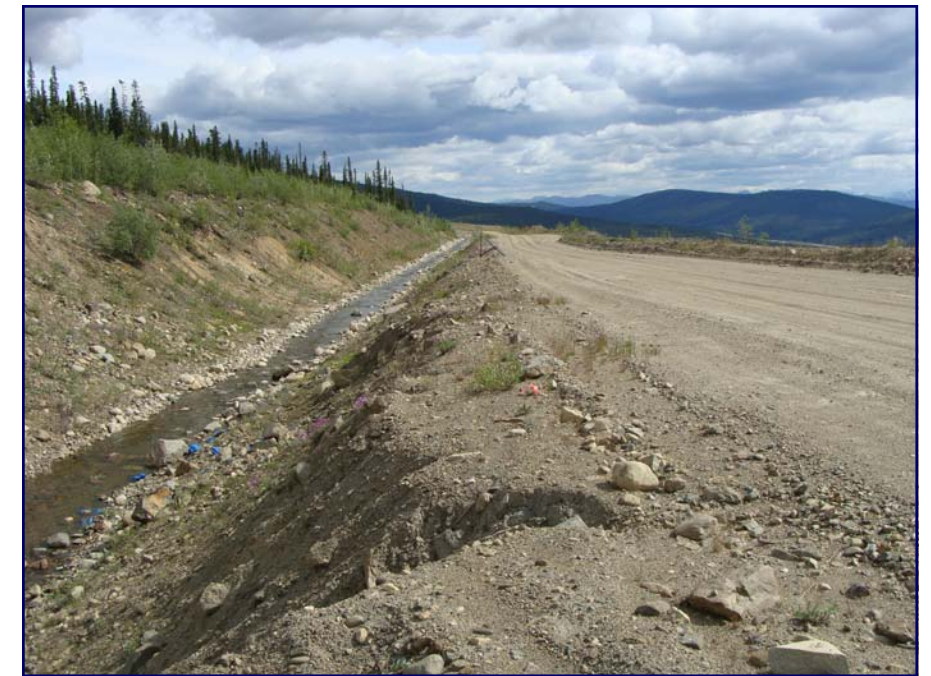
June: shows a downstream view of the canal and road.
