Klohn Crippen Berger

Faro Mine Complex

2012 Annual Geotechnical Review

March 28, 2013

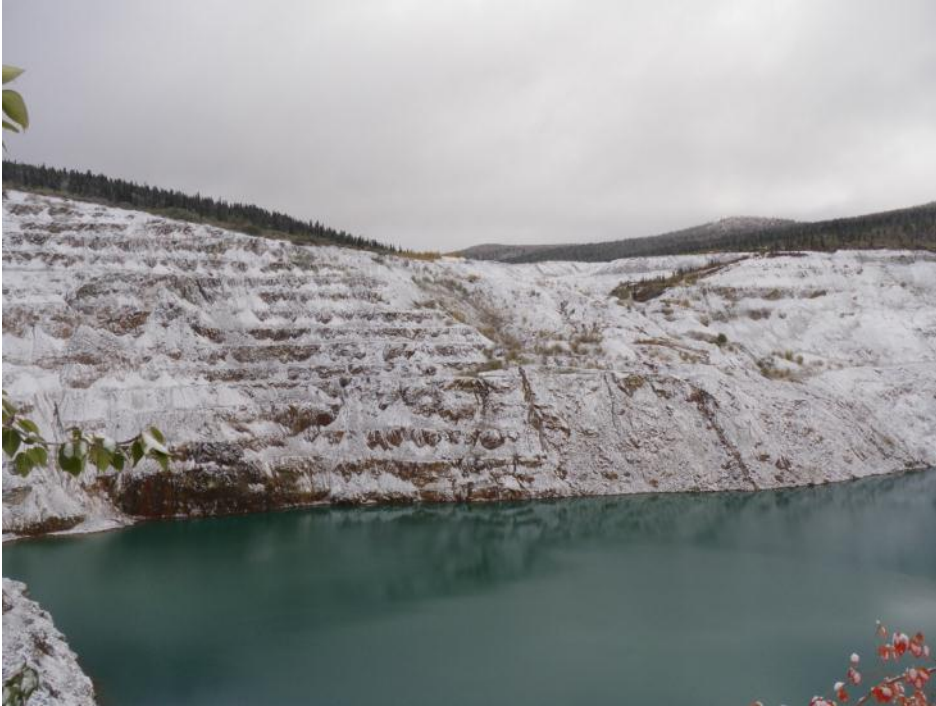
- No obvious changes on the east pit wall North and South Instability Zones were observed.

Photo 1 Faro Pit east wall as seen from “eye-in-the-sky” (September 11, 2012)

- Continue visual monitoring of pit wall conditions with photos taken at same vantage points.
- Continue monitoring distances between the pit brim and reference bars installed in the North and South Instability Zone as a means to monitor the safety of the Faro Creek Diversion Channel at these strategic locations.

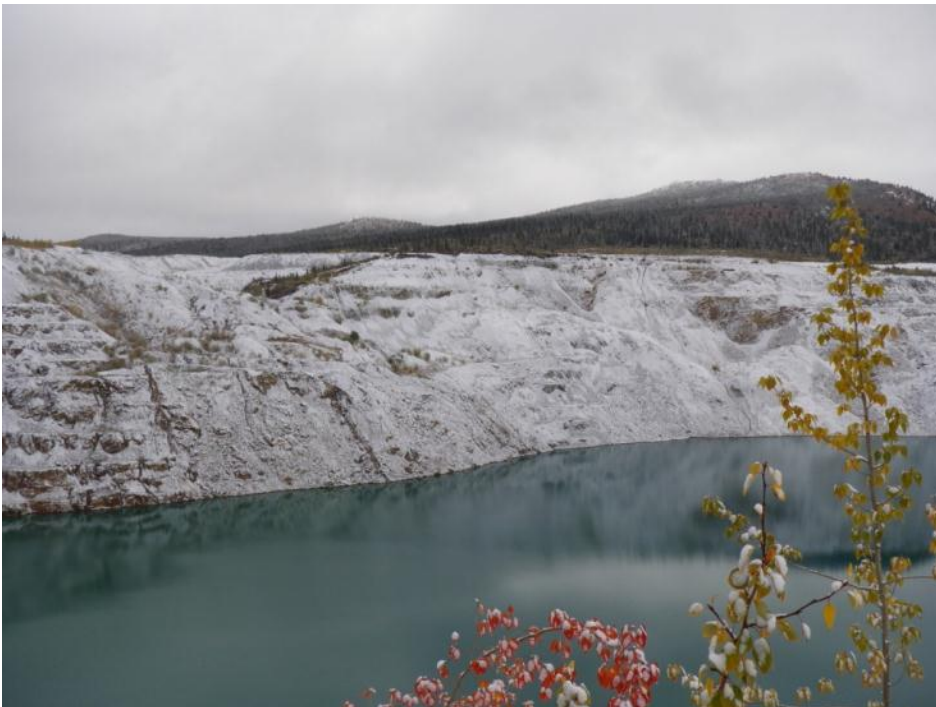
Photo 2 Faro Pit east wall as seen from “eye-in-the-sky” (September 11, 2012)

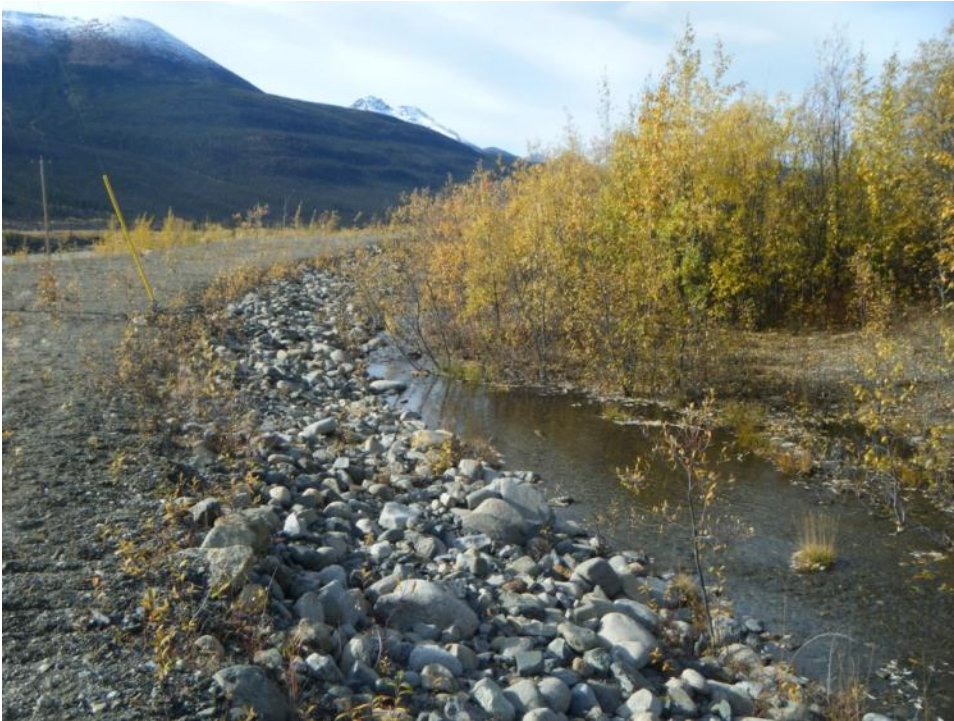
- Moderate flow in channel at time of inspection.
- The channel and side slopes appeared to be stable.
- Sedimentation deposition was observed both up and down gradient from the well-access road crossing.
- There was moderate to heavy vegetation growth in upper and middle constructed channel reaches.

Photo 9 Middle reach of Interceptor Ditch above Tailings Impoundment (September 19, 2012)

- Monitor channel sedimentation condition at the well-access road crossing, and remove sediments if the accumulation becomes excessive.
- Clear vegetation along the upper and middle constructed channel reaches. Clearing should also include the access road and berm along the channel to facilitate future inspection.

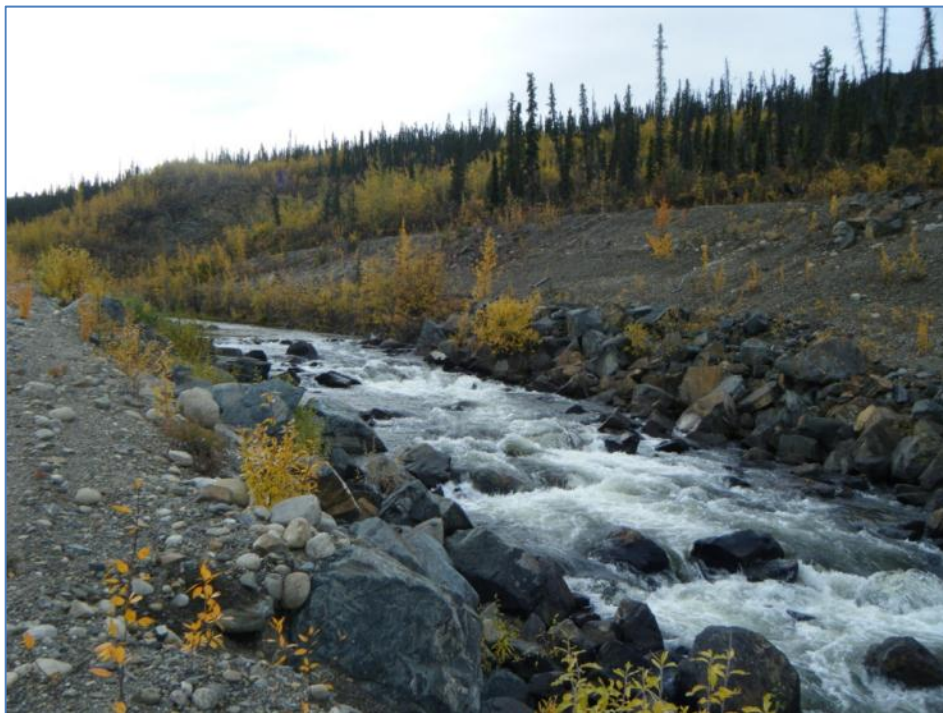
- Moderate flow in channel at time of inspection.
- The channel and side slopes appeared to be stable with satisfactory rock armour conditions.
- Moderate vegetation growth in lower channel reaches.
- Minor seepage from the RCDC at base of spoil piles into Polishing Pond was reported previously, but could not be located during the fall inspection.

Photo 15 **Rose Creek Diversion Channel near Cross Valley Dam - looking upstream
(September 19, 2012)**

- Continue to check and remove vegetation in the diversion channel periodically.
- Continue to monitor instrumentation on a regular basis.
- Conduct geotechnical inspection of the diversion channel during spring peak flow condition.

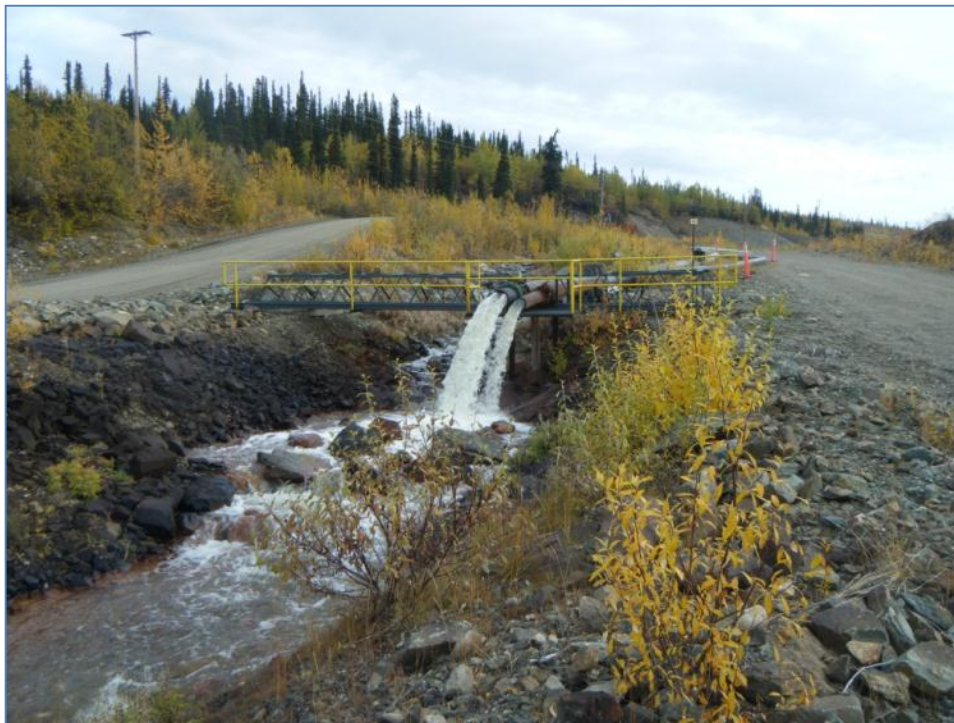
Photo 47 Cross Valley Pond siphon outlet discharge (September 19, 2012)

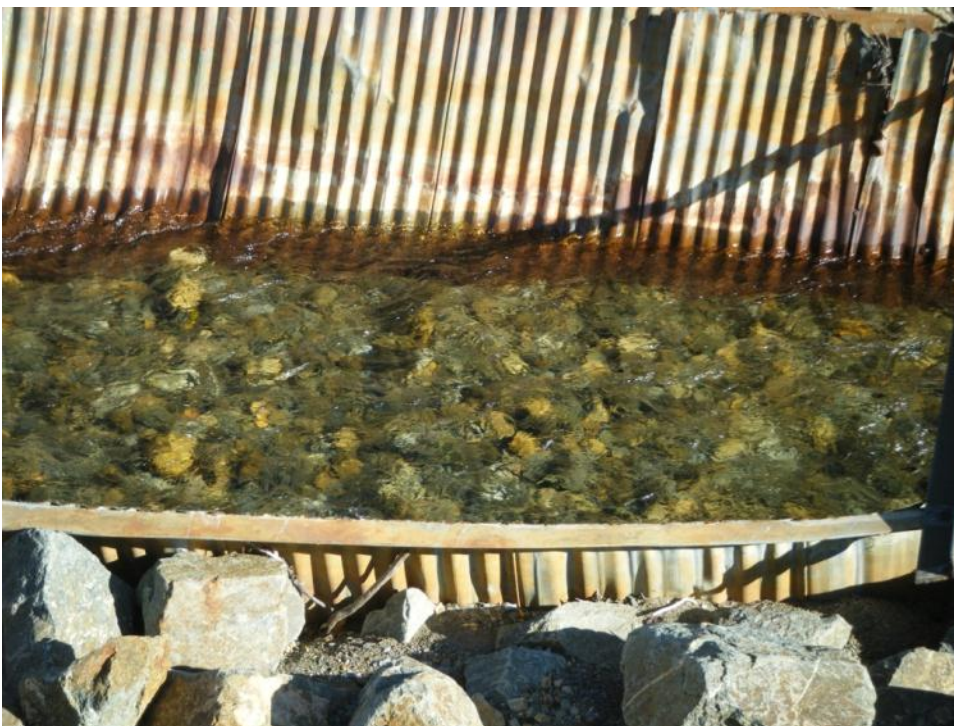
Photo 89 Remnant gravels in Flume (September 20, 2012)

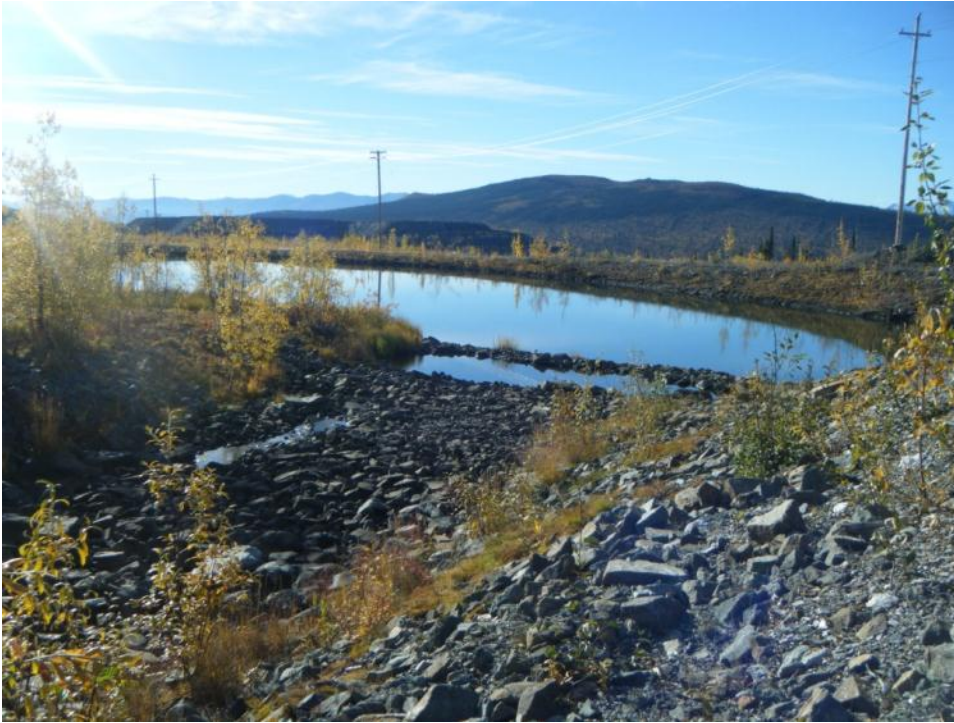
Photo 108 Upper Sheep Pad Sediment Pond (September 20, 2012)

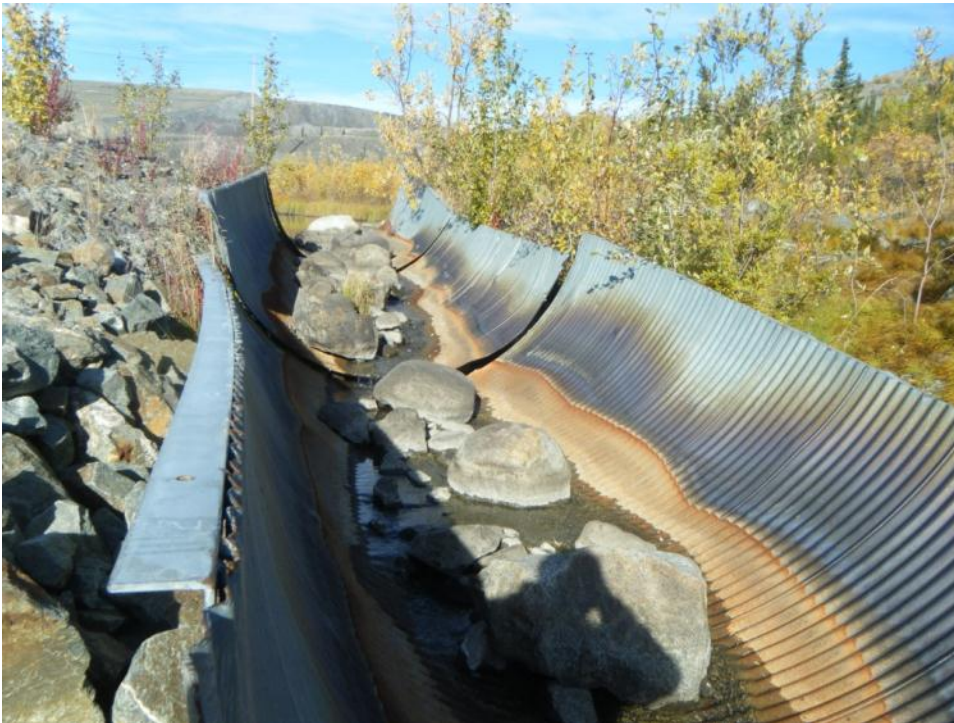
Photo 109 Flume connecting Upper and Lower Sheep Pad Ponds (September 20, 2012)

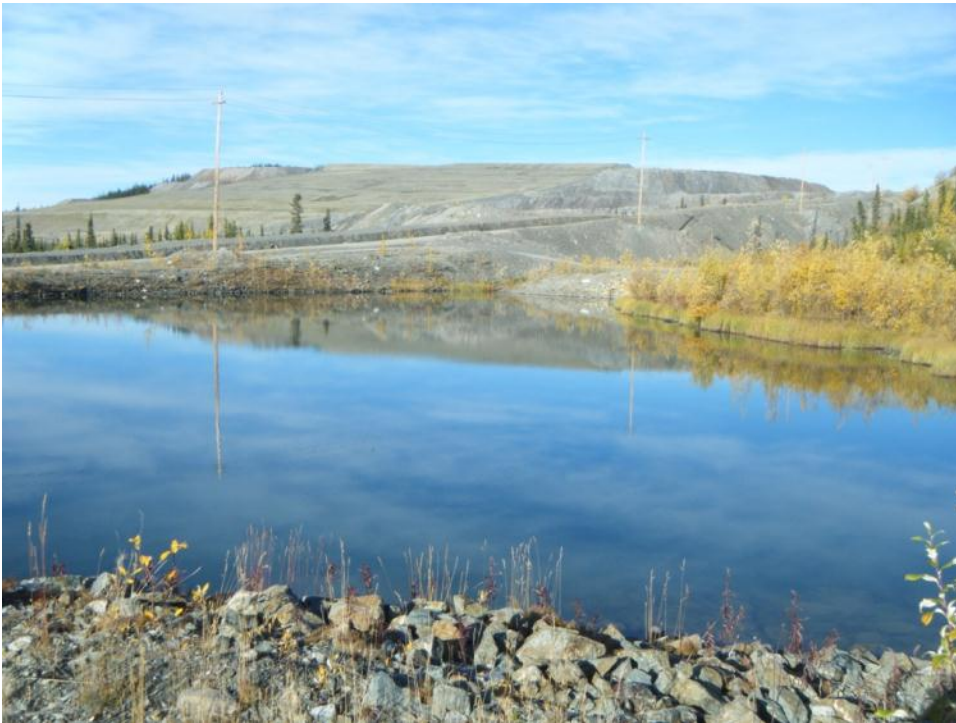
Photo 110 Lower Sheep Pad Pond (September 20, 2012)

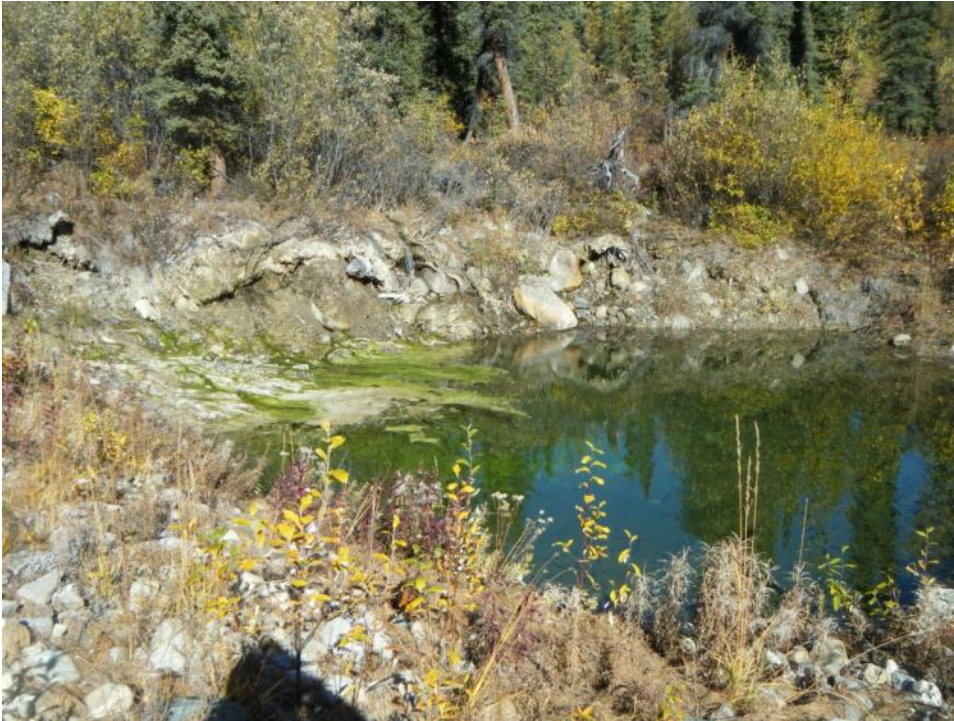
Photo 114 V-15 Pond (September 20, 2012)

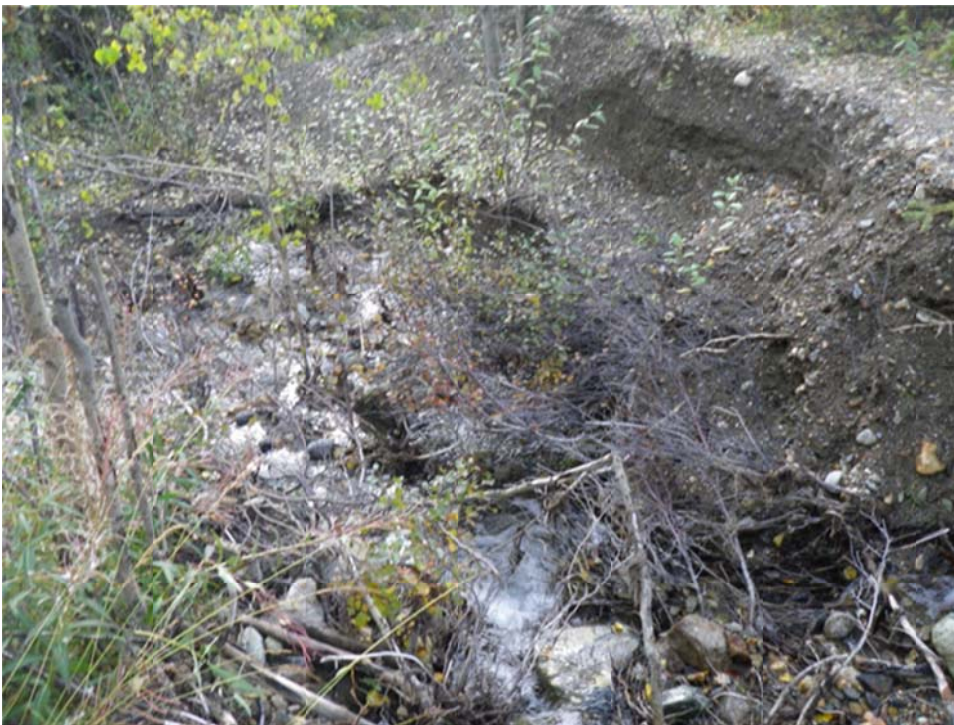
- 2011 excess inflow into Moose Pond caused the following changes: deposition of silt sediment (see Photo 120), raised pond level and slumps of the downstream slope of a retaining esker at the locations of 2011 raised seepage exit.
- Exfiltration from Moose Pond since 2011 has likely changed from the original pond bottom to bank slope at higher elevations. However, this change has not been verified by the comparison of Moose Pond levels before and after the 2011 excess inflow event.
- Significant erosion and slumping of the sides of the V-15 diversion channel was observed at the location where the ditch entered into a steep reach upstream of Moose Pond (see Photos 118 and 119).

Photo 119 Moose Pond bank slope near V-15 Ditch inflow (September 13, 2012)

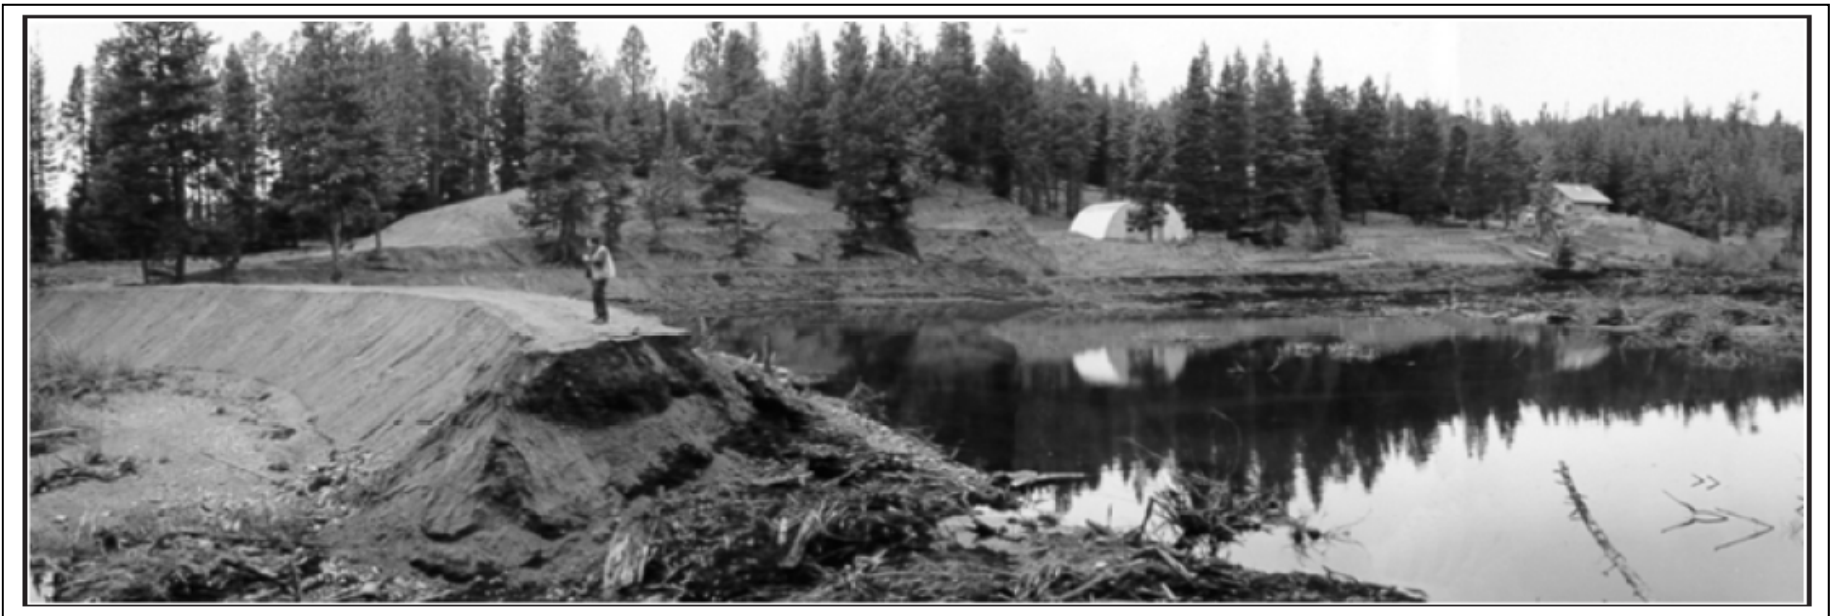
Figure 5 – Testalinden Dam Failure (near Oliver) June 13, 2010

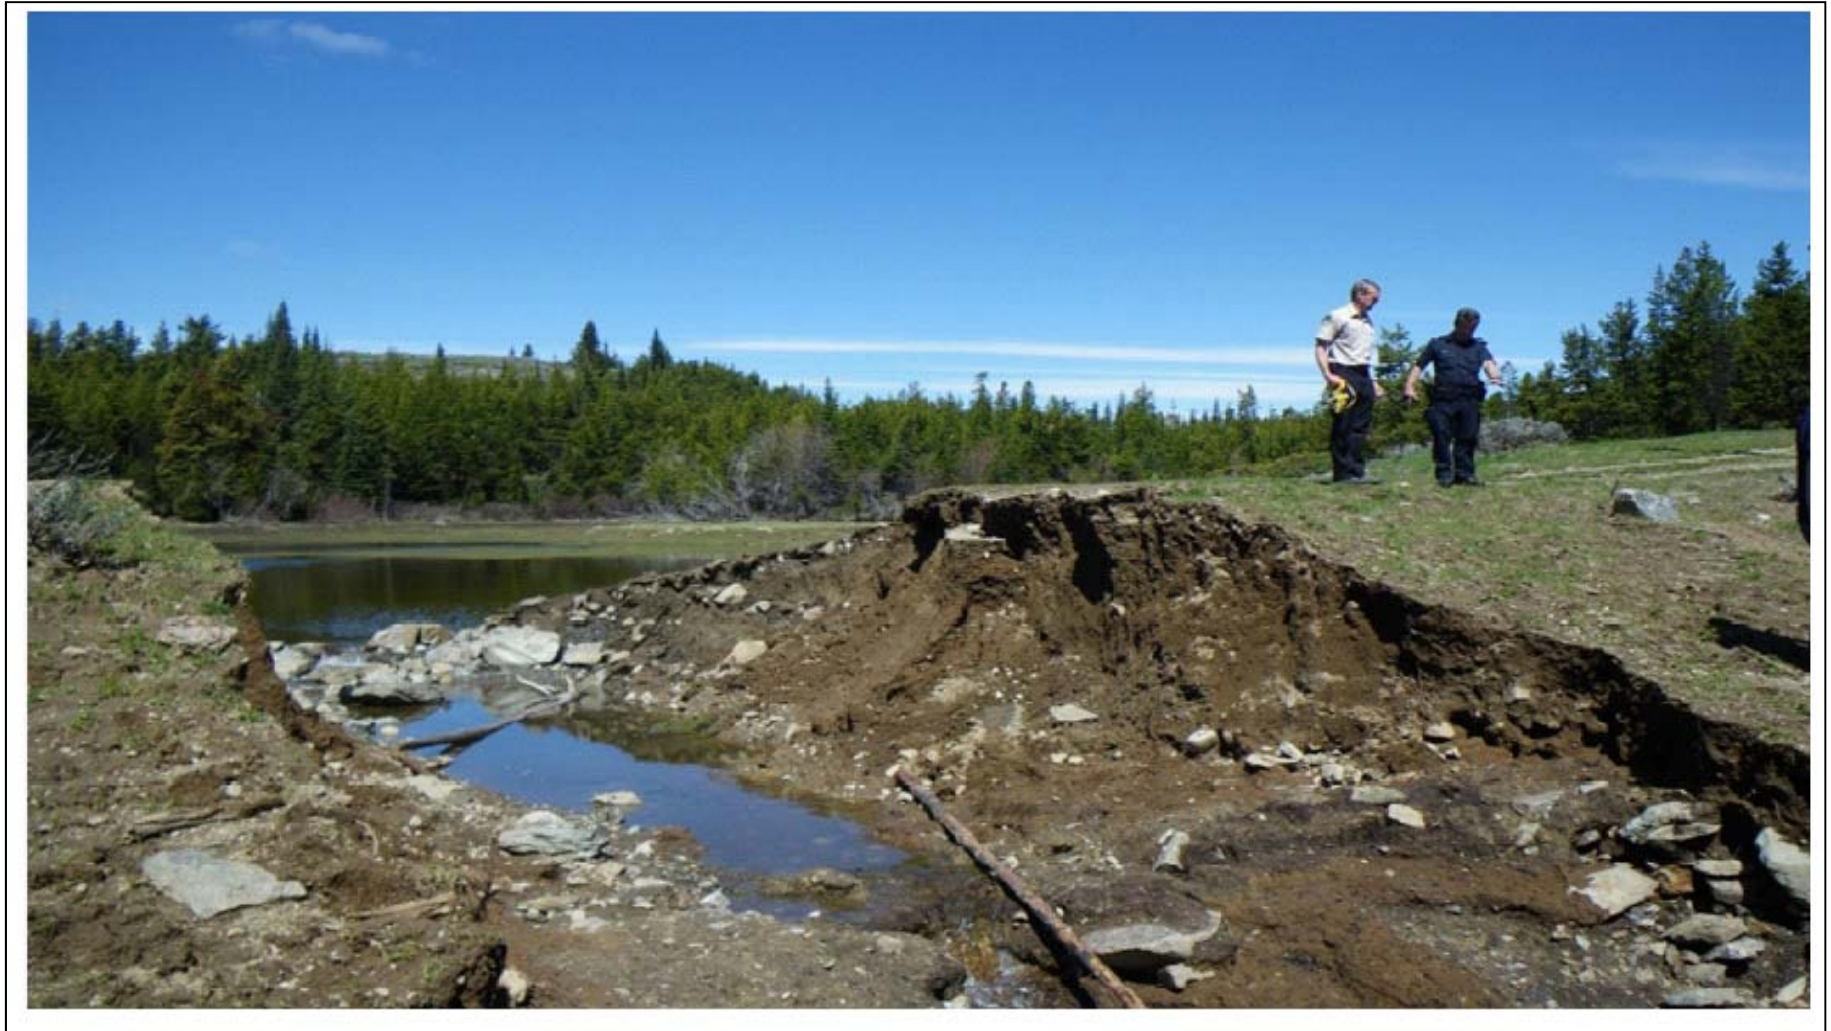
Figure 6 – Ellis Creek Dam Failure (near Penticton) 1941

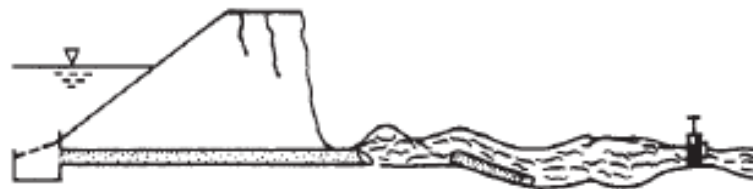
C - Reservoir drains through the conduit.

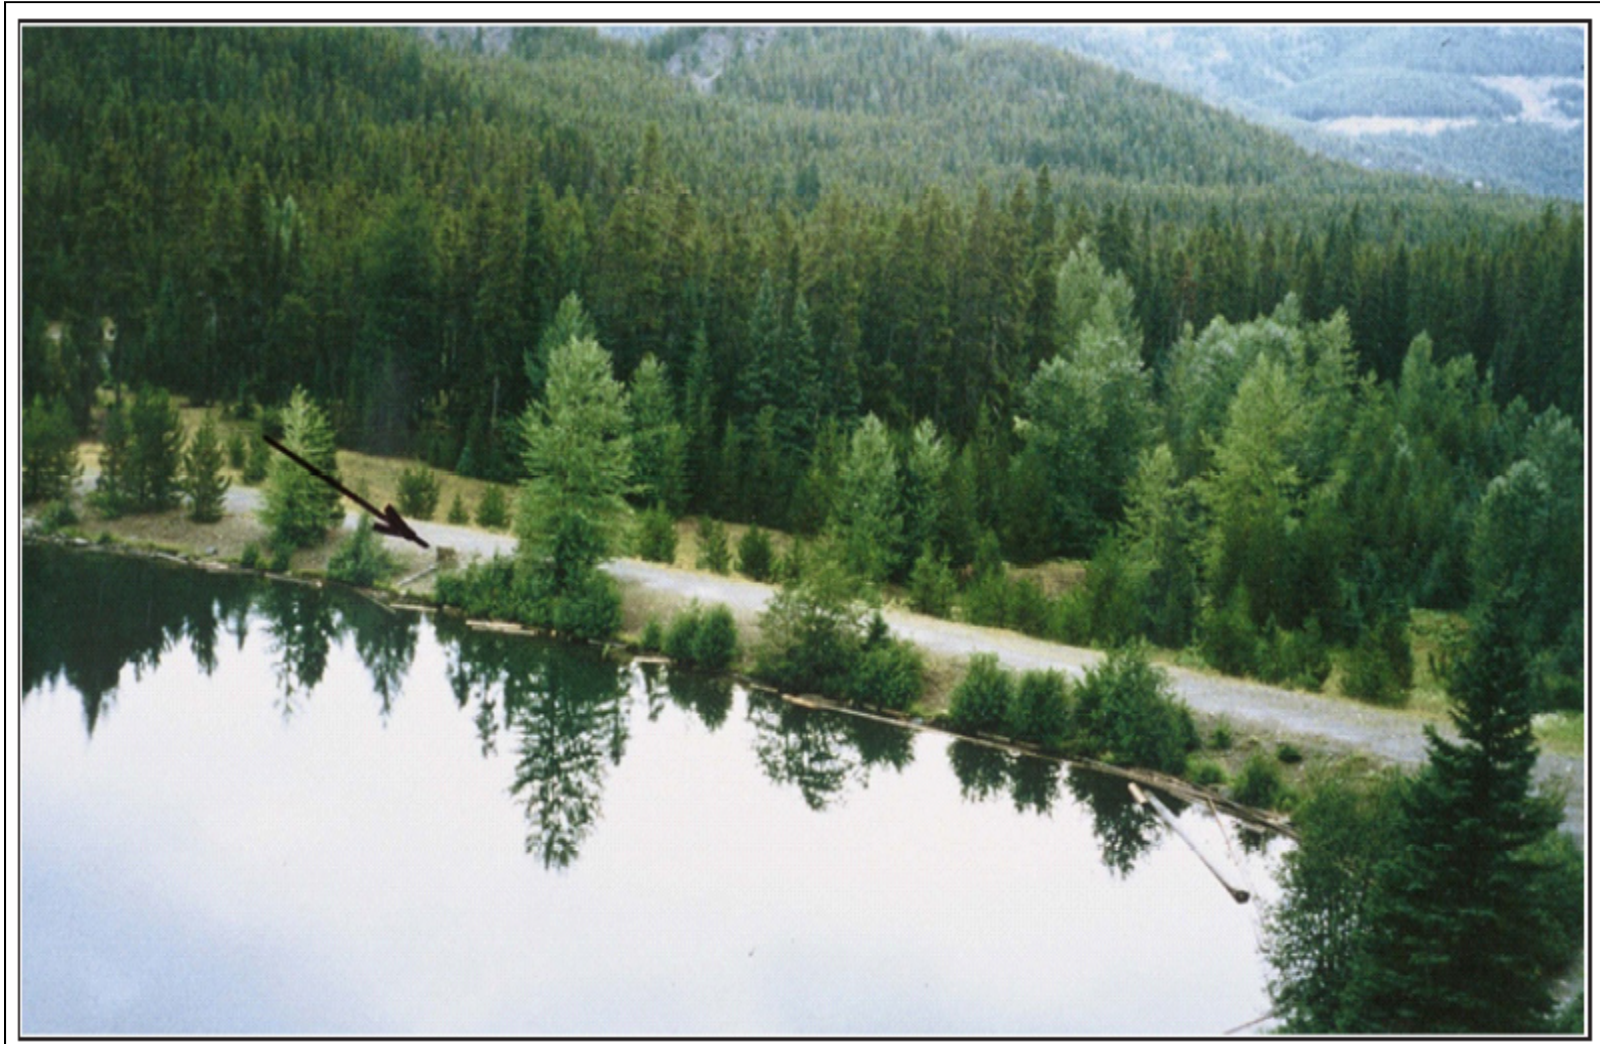
Figure 18 – Properly maintained

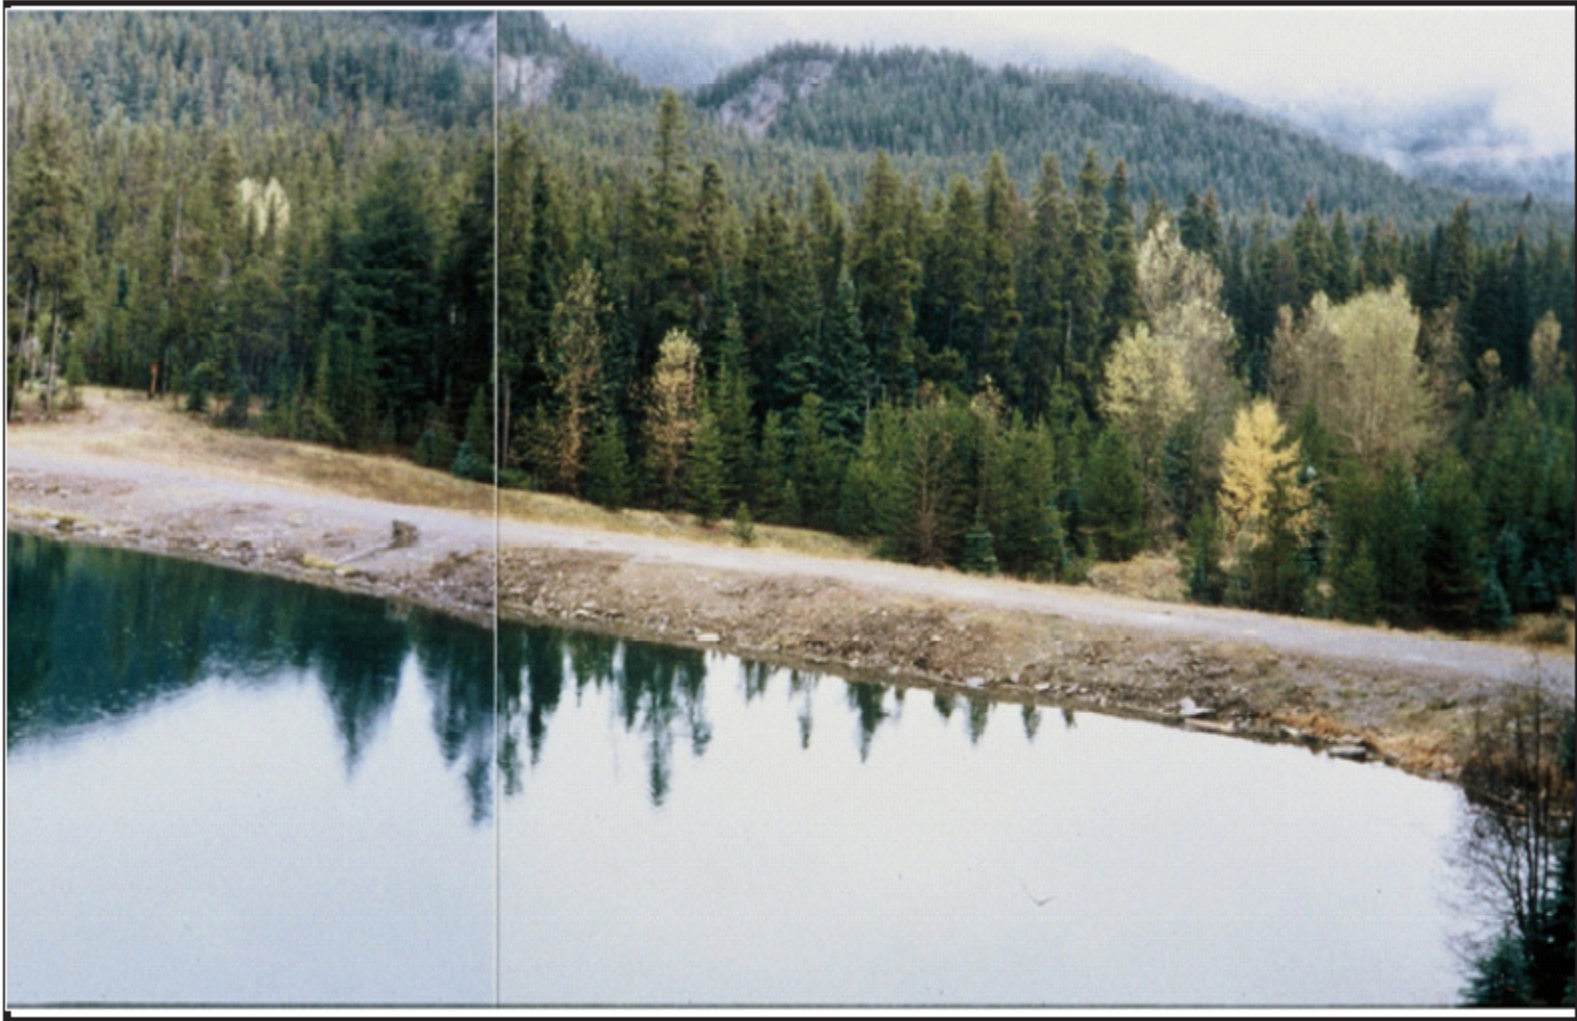
Figure 19 – Intake Control Access Structure Failure
