Klohn Crippen Berger

Faro Mine Complex

2016 Annual Geotechnical Review

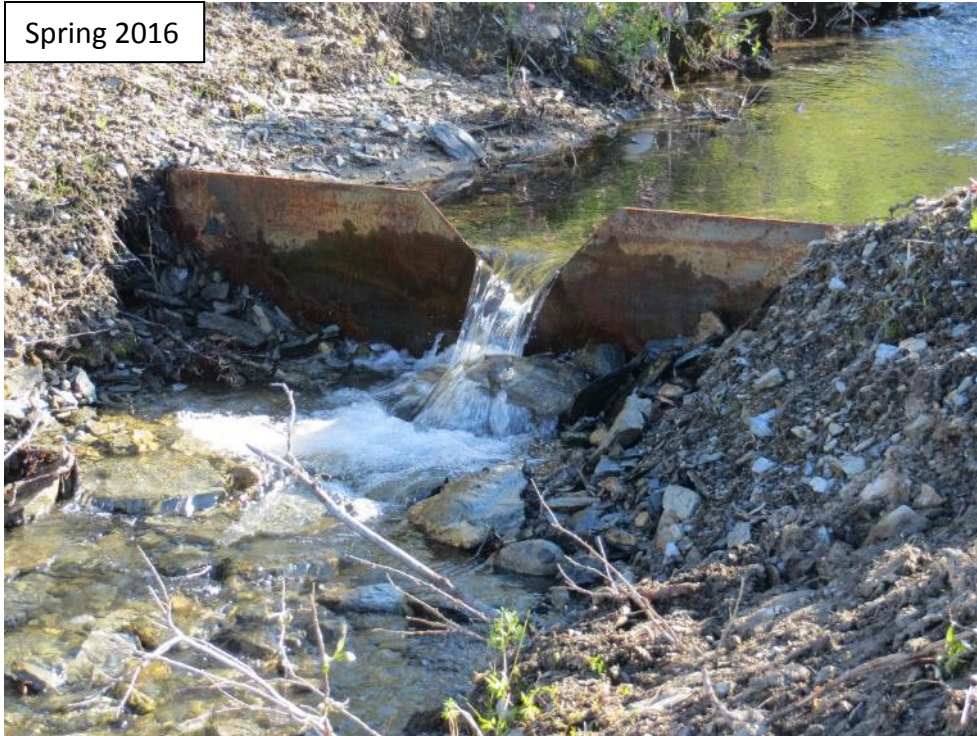
Photograph 6 Interceptor Ditch upstream of upper man-made reach at new weir location. Evidence of overtopping on right abutment.

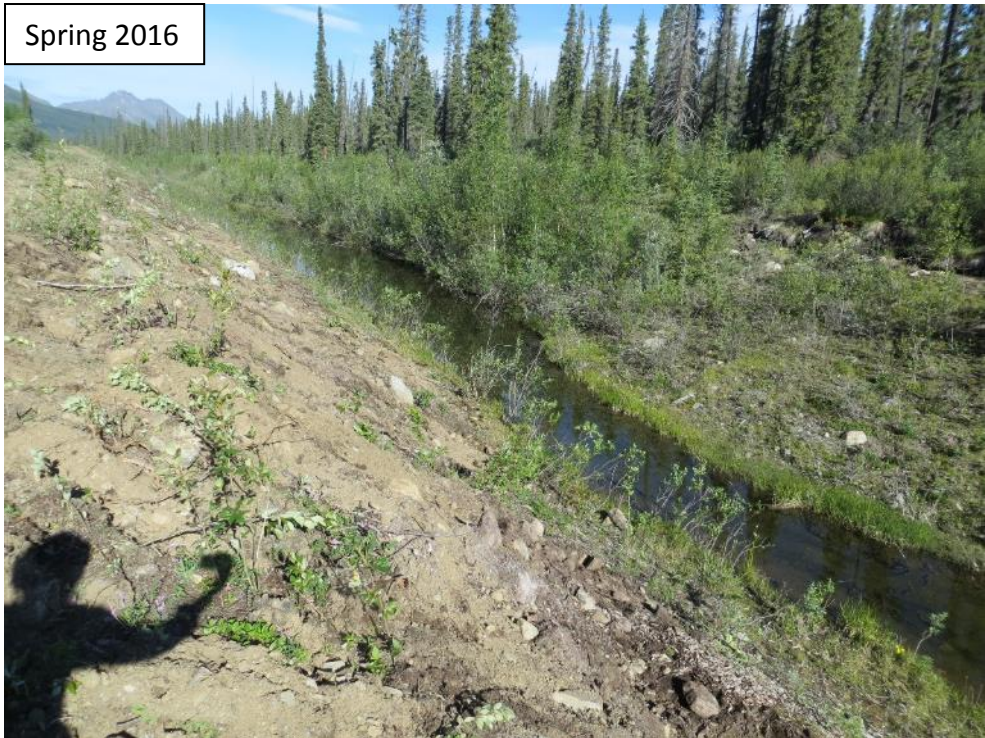
Photograph 7 Interceptor Ditch upper man-made reach - vegetation roots were removed in fall 2016. Erosion control measures should be implemented in spring 2017. Approximately 565 m from the diversion inlet.

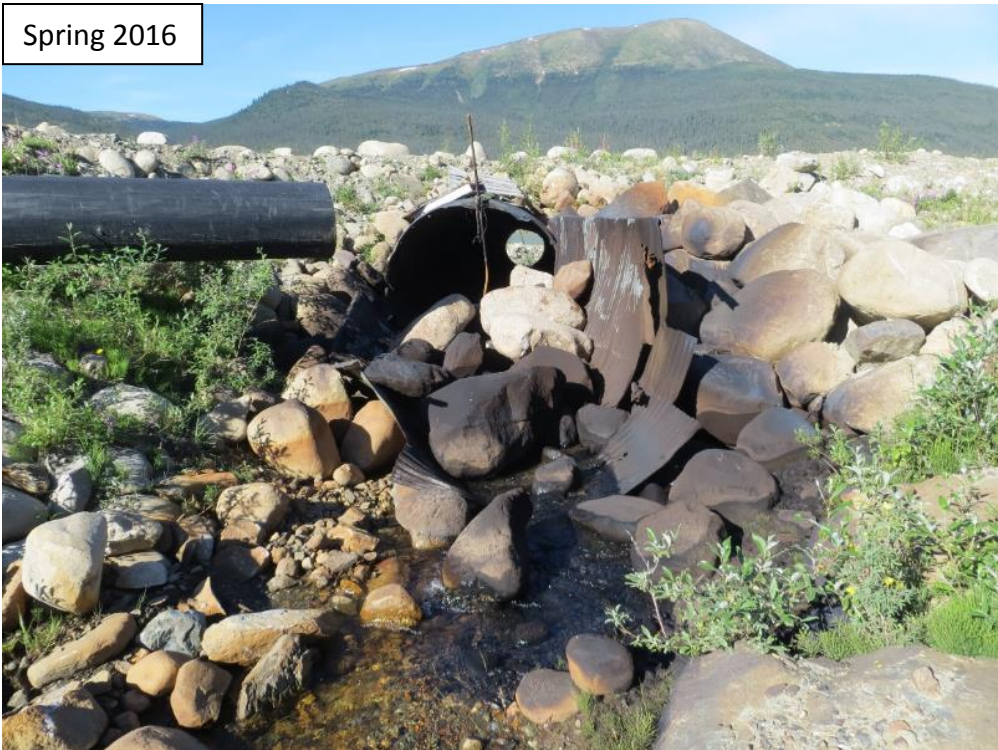
Photograph 11 Culvert between middle reach to lower reach of ditch – water treatment release pipeline. Direct discharge in fall. Approximately 2600 m from the diversion inlet.

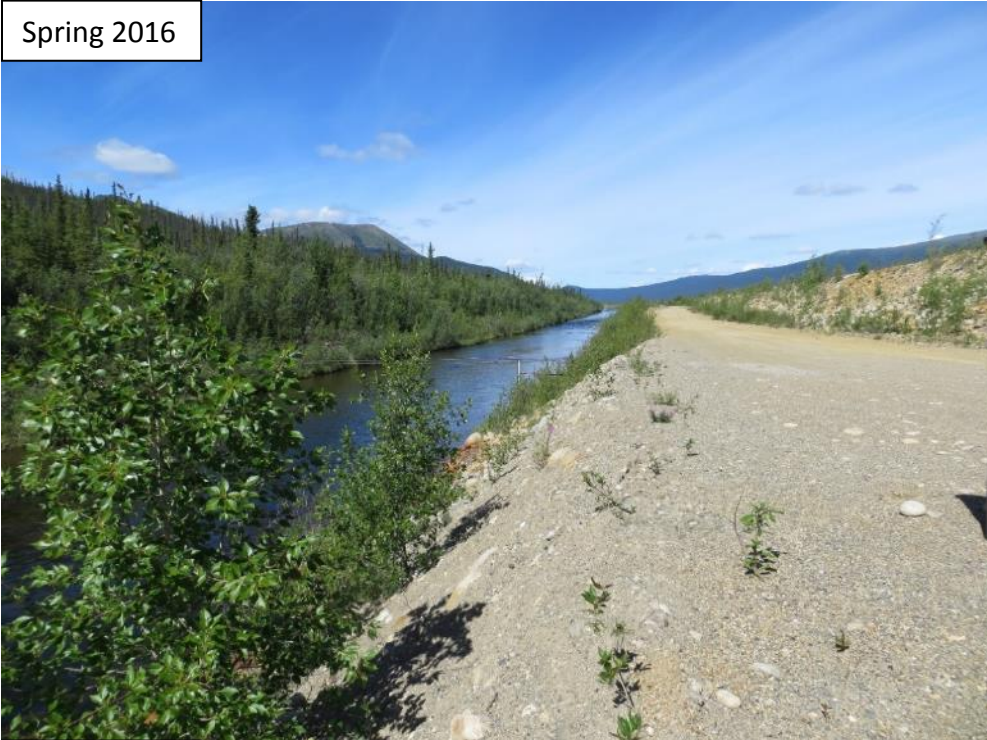
Photograph 12 Rose Creek Diversion Channel near Secondary Tailings Dam, looking downstream. Similar conditions in spring and fall.

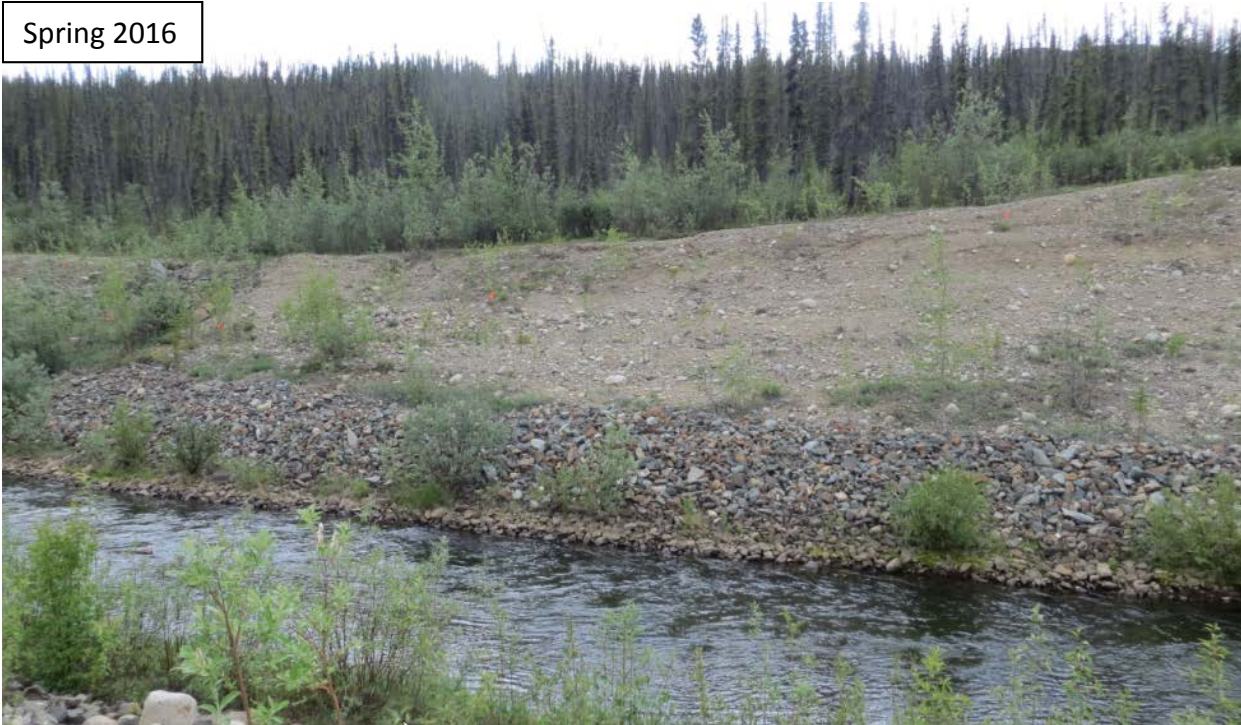
Photograph 13 Rose Creek Diversion Channel back-slope slumping. Similar conditions in spring and fall.

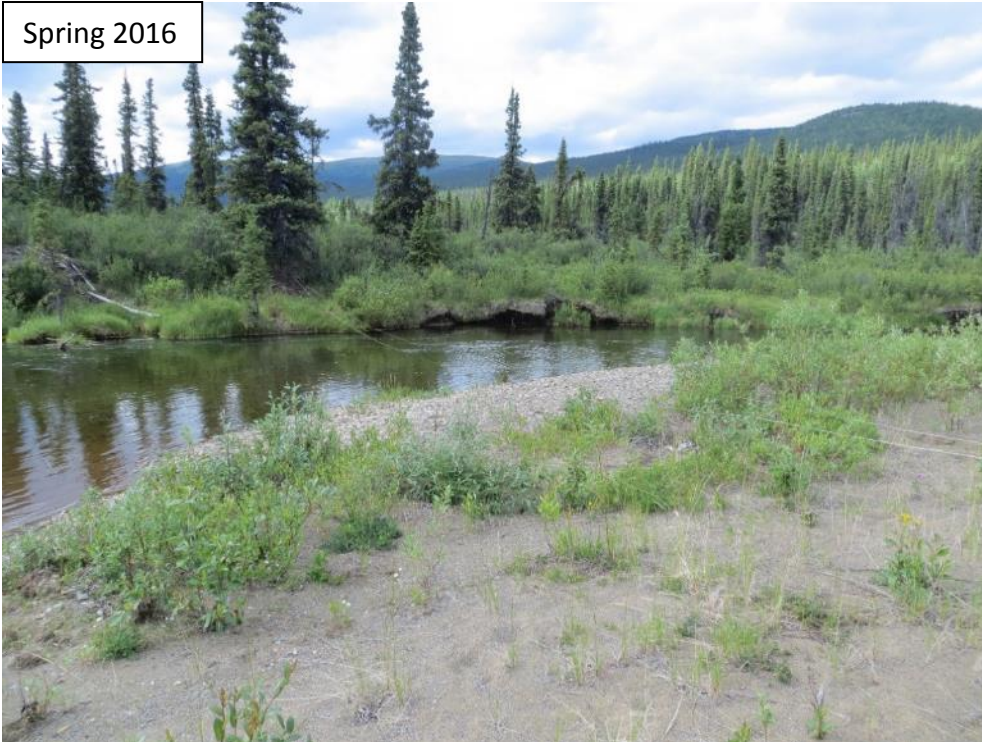
Photograph 14 Rose Creek Diversion Channel flow gauge station downstream of Tailings Facility. Satisfactory conditions.

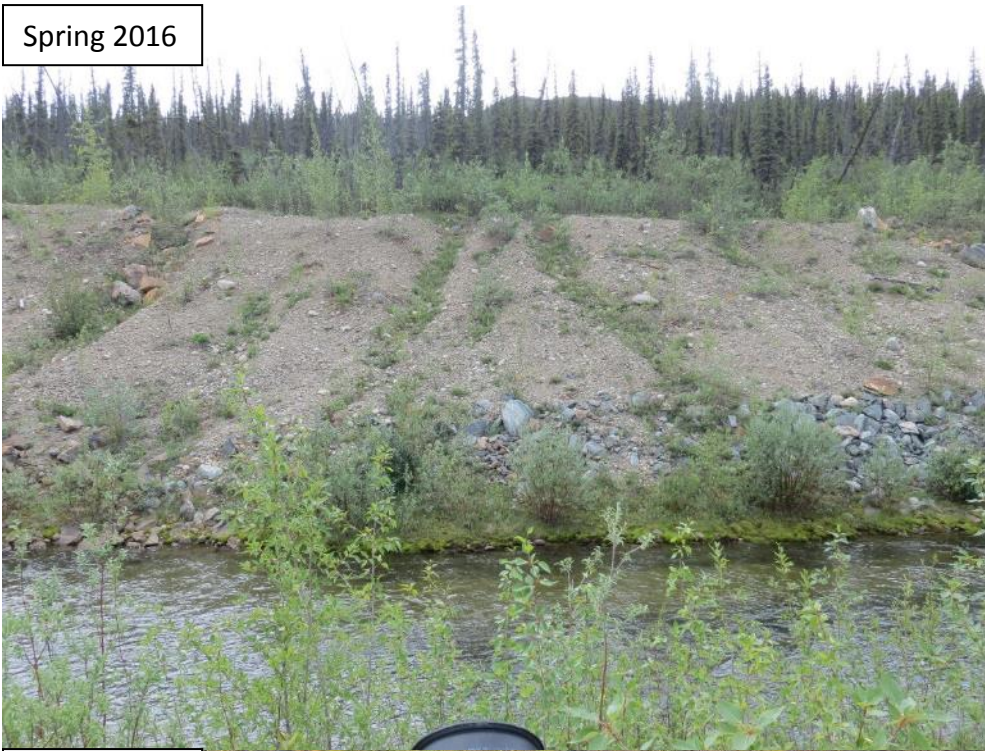
Photograph 18 Rose Creek Diversion Channel Proposed Back Slope Observation Location D. Conditions similar in spring and fall.

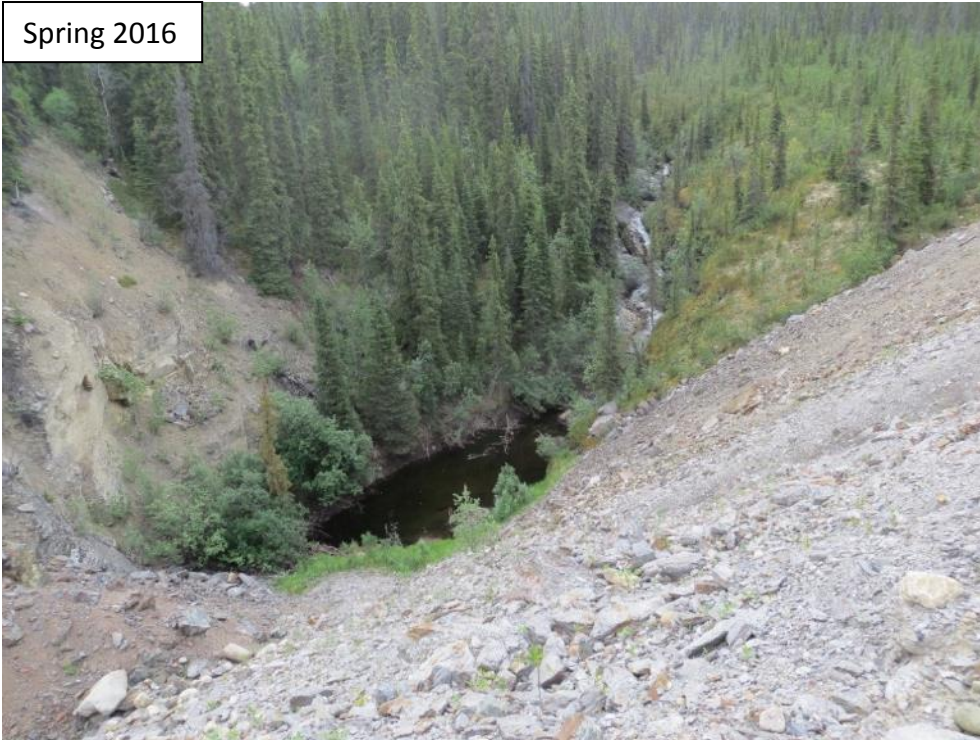
Photograph 21 K8 Rock Drain upstream pool. Satisfactory conditions.

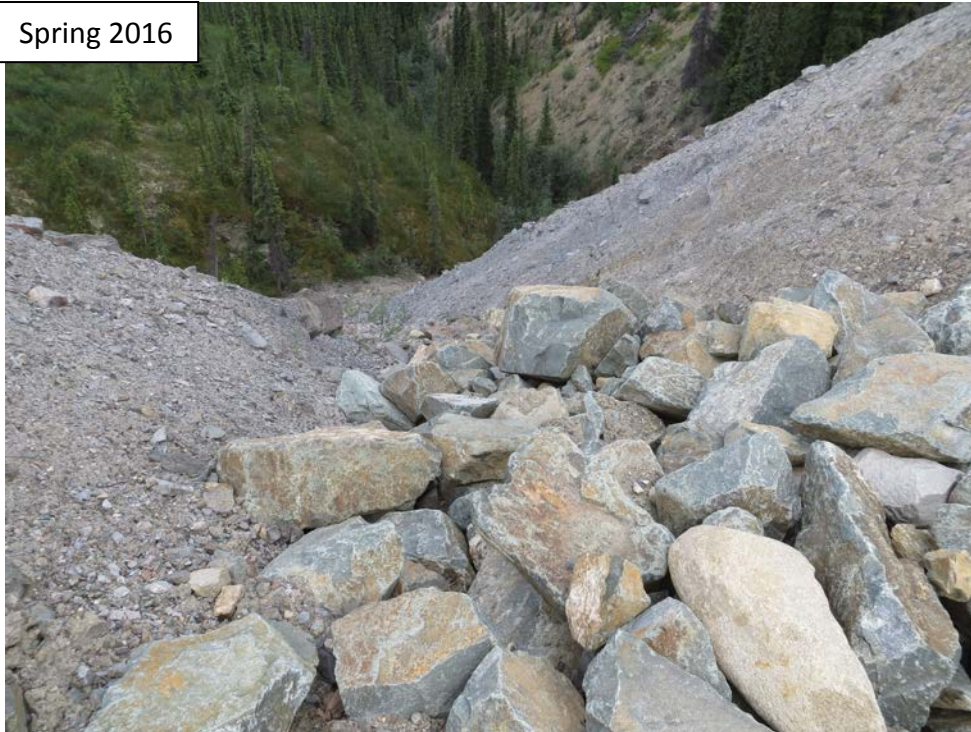
Photograph 22 K8 Rock Drain downstream outlet, looking down. Satisfactory conditions.

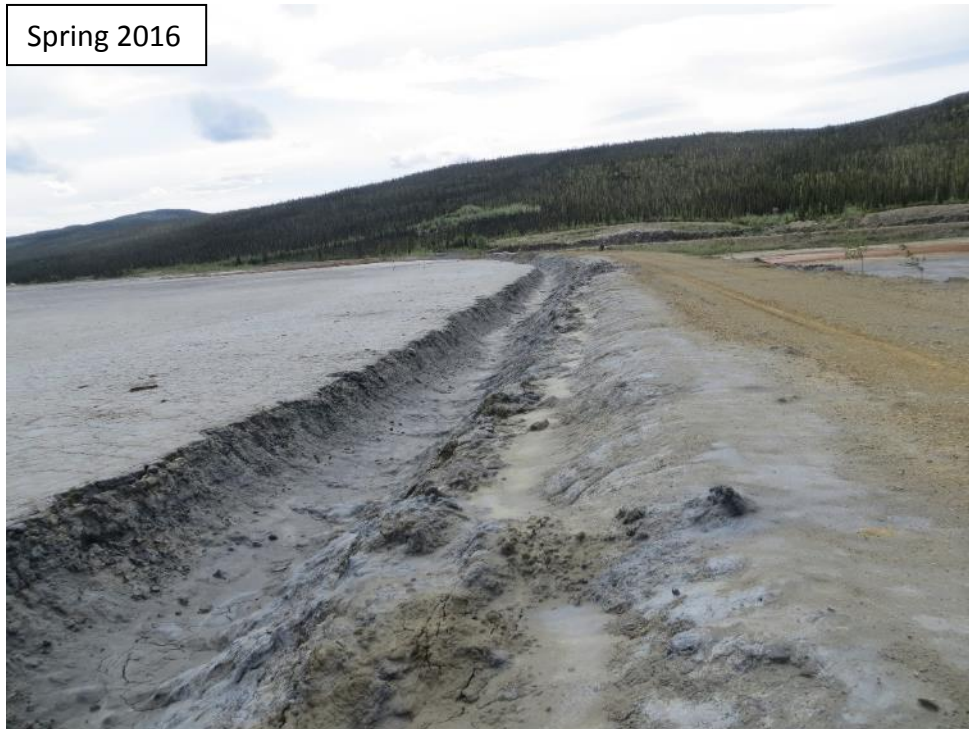
Photograph 23 Secondary Tailings Dam upstream ditch looking south. Ditch appears deeper since spring.

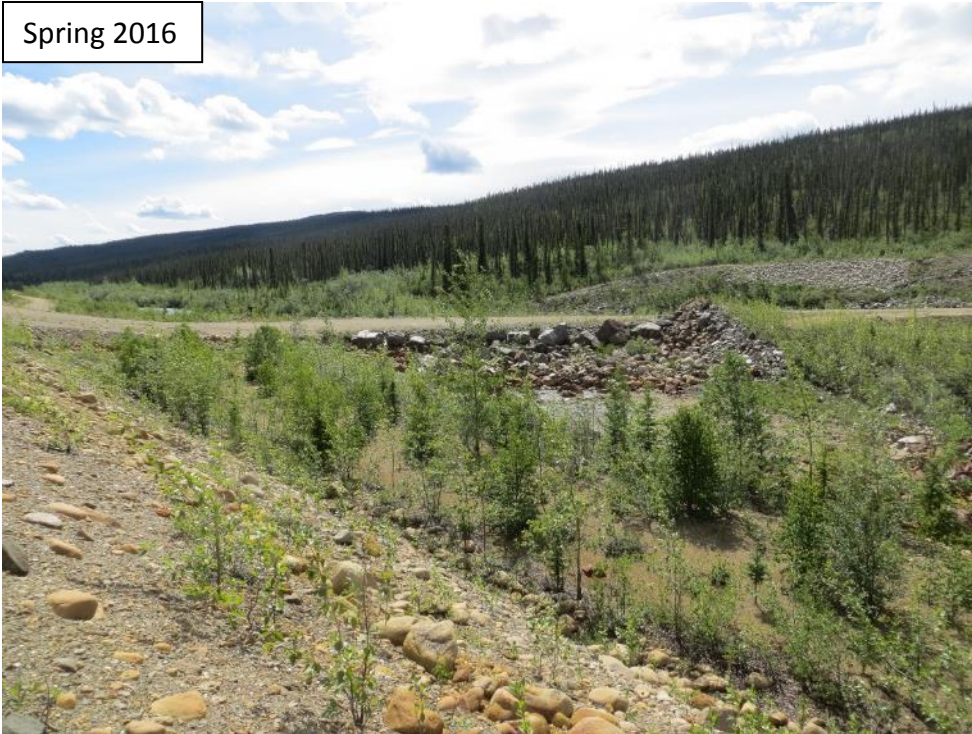
Photograph 24 Fuse plug of Canal Dyke, looking upstream. Vegetation on downstream slope of Secondary Tailings Dam should be removed.

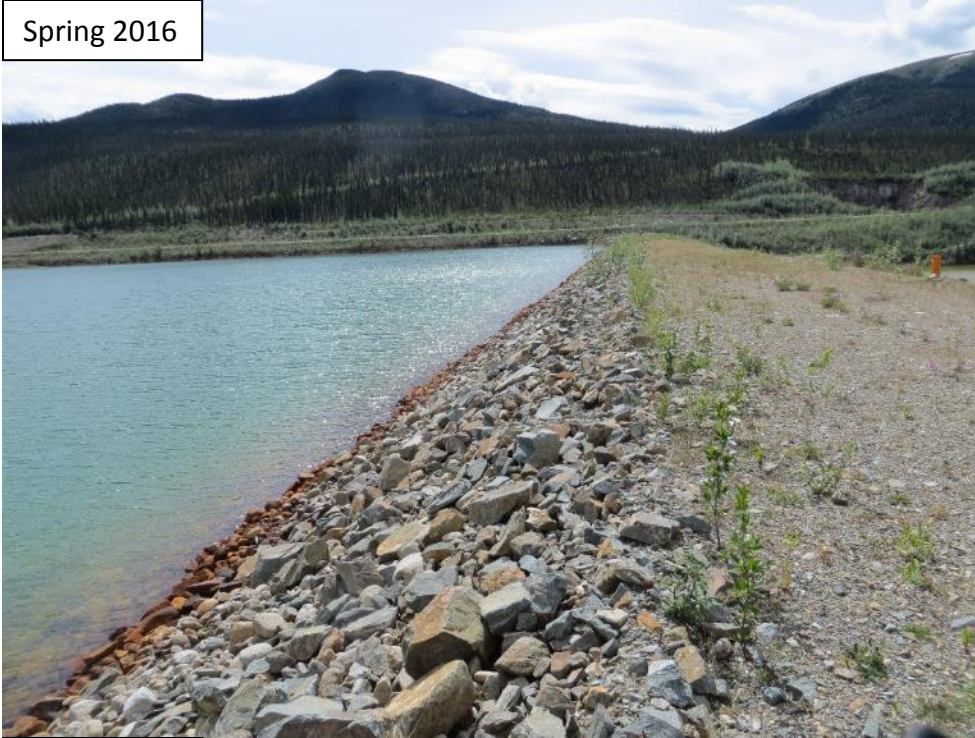
Photograph 25 Intermediate Dam from access road, looking south. Satisfactory conditions.

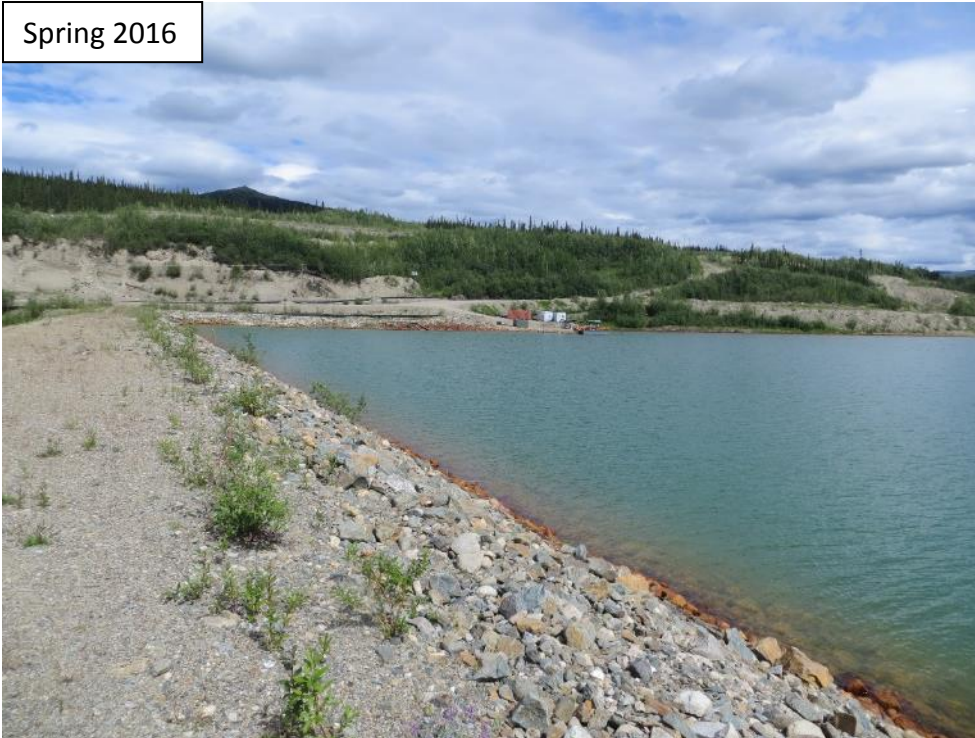
Photograph 26 Intermediate Dam crest and upstream slope, looking north. Satisfactory Conditions.

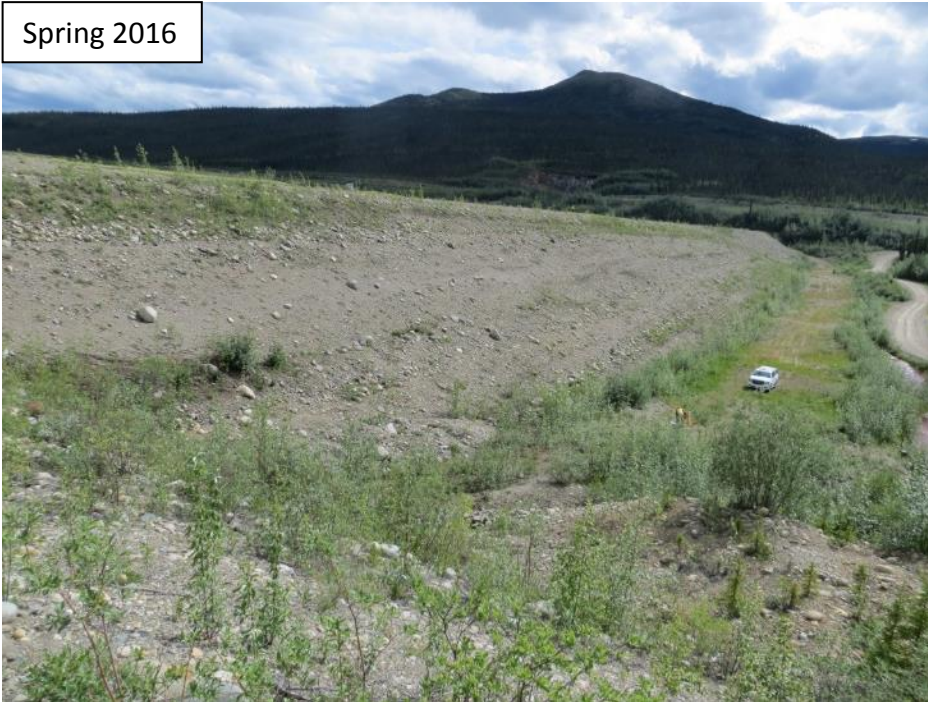
Photograph 29 Downstream slope of Cross Valley Dam looking south. Some minor rill erosion and vegetation on slope. Conditions are similar across the whole slope.

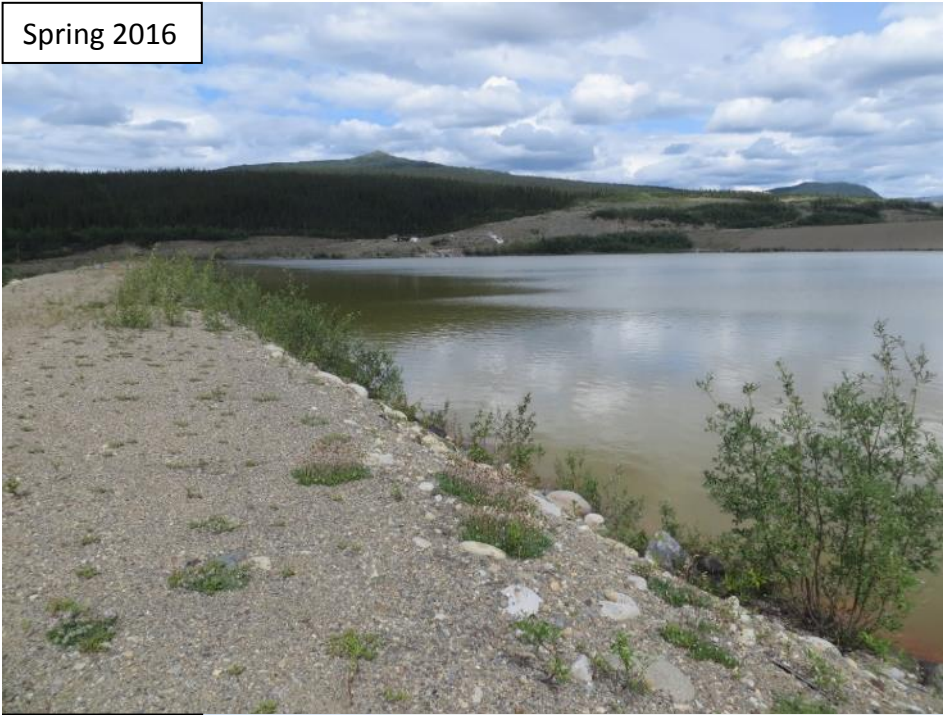
Photograph 31 Upstream slope (looking north), vegetation growth. Trees should be removed.

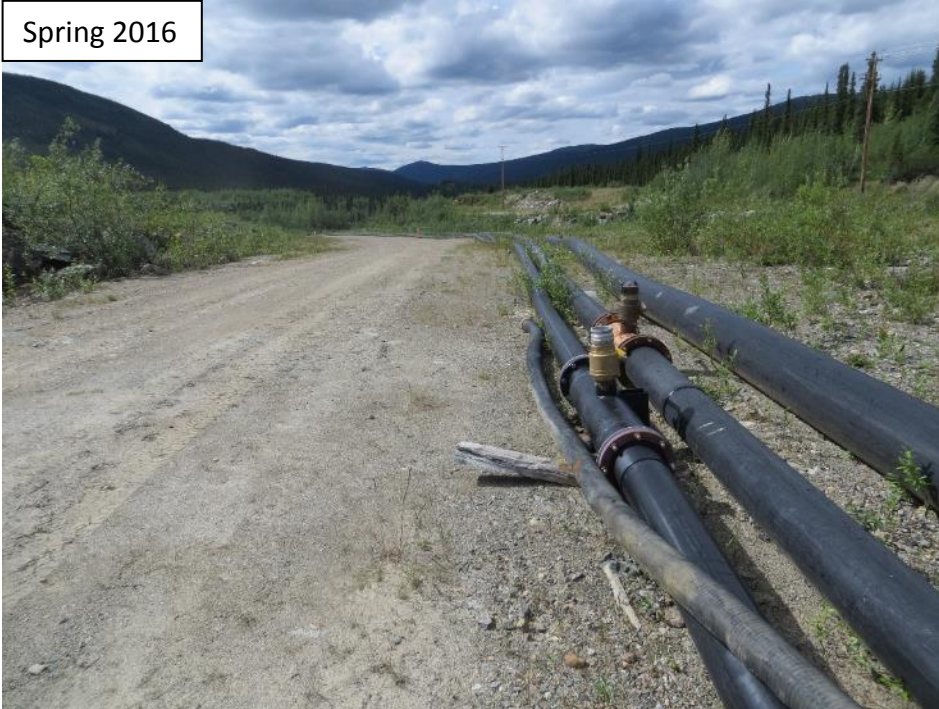
Photograph 32 Siphon pipelines in spillway, looking downstream

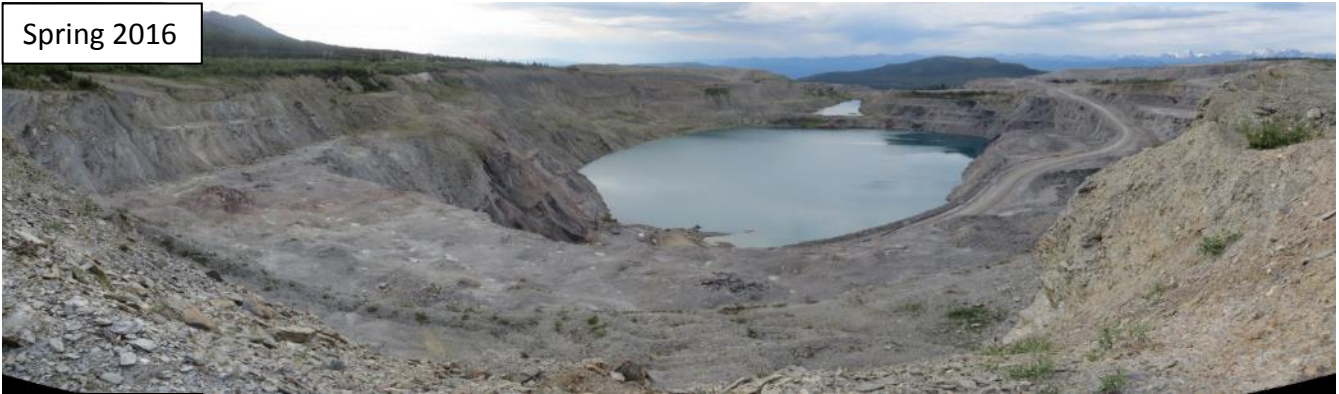
Photograph 33 Grum Pit (looking south, southeast). Similar conditions in spring and fall.

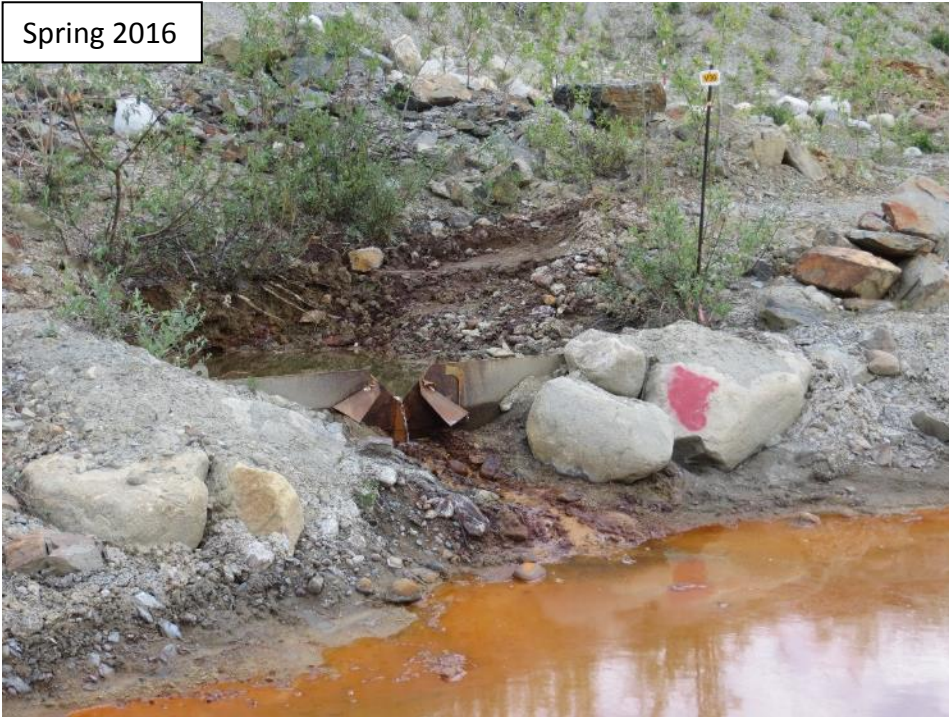
Photograph 37 Drain No. 3 (V30). Satisfactory conditions.

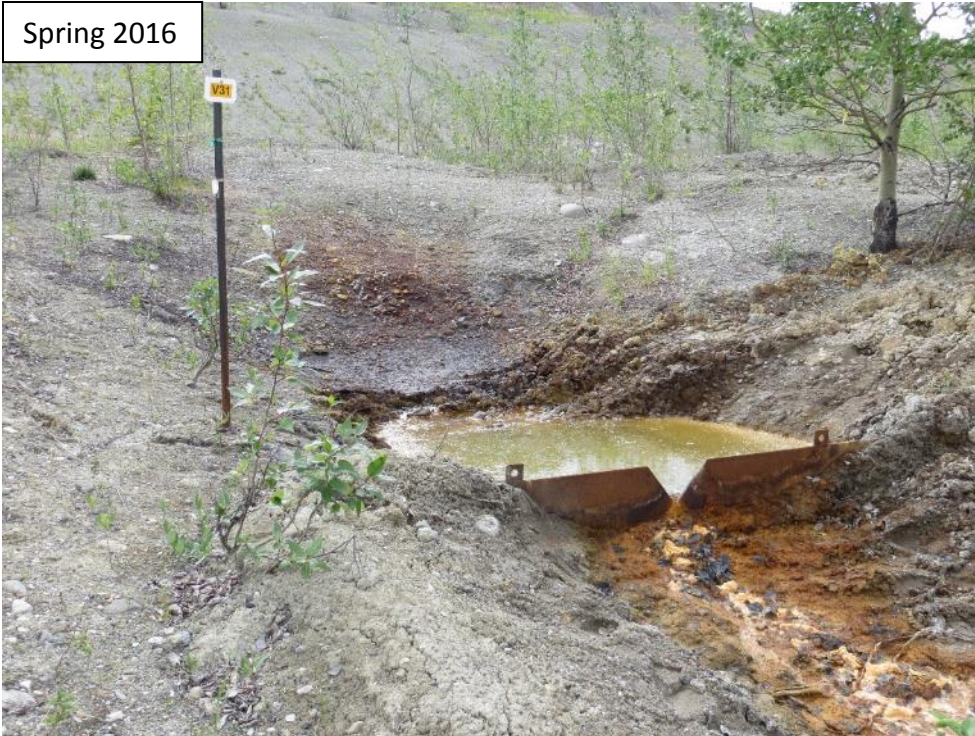
Photograph 38 Drain No. 4 (V31). Satisfactory conditions.

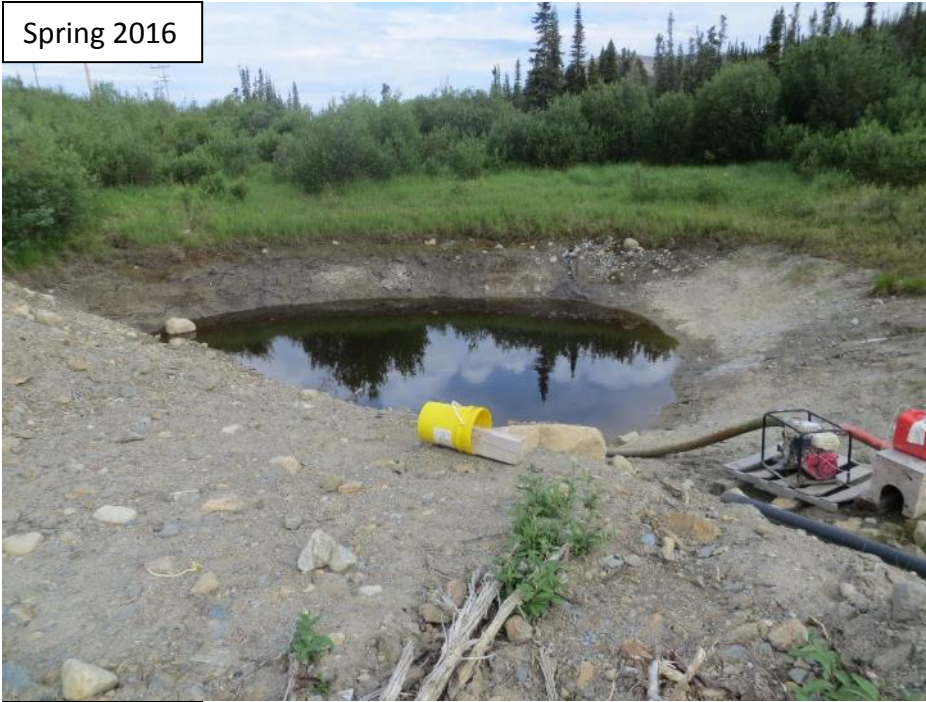
Photograph 41 Wes' Pond. Satisfactory conditions.

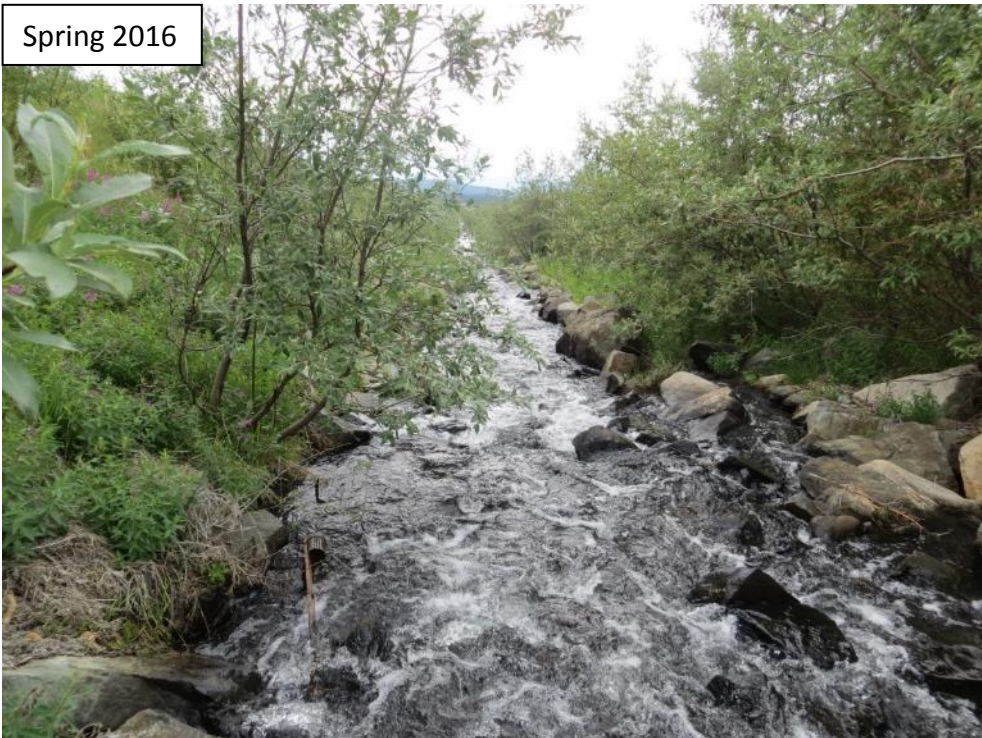
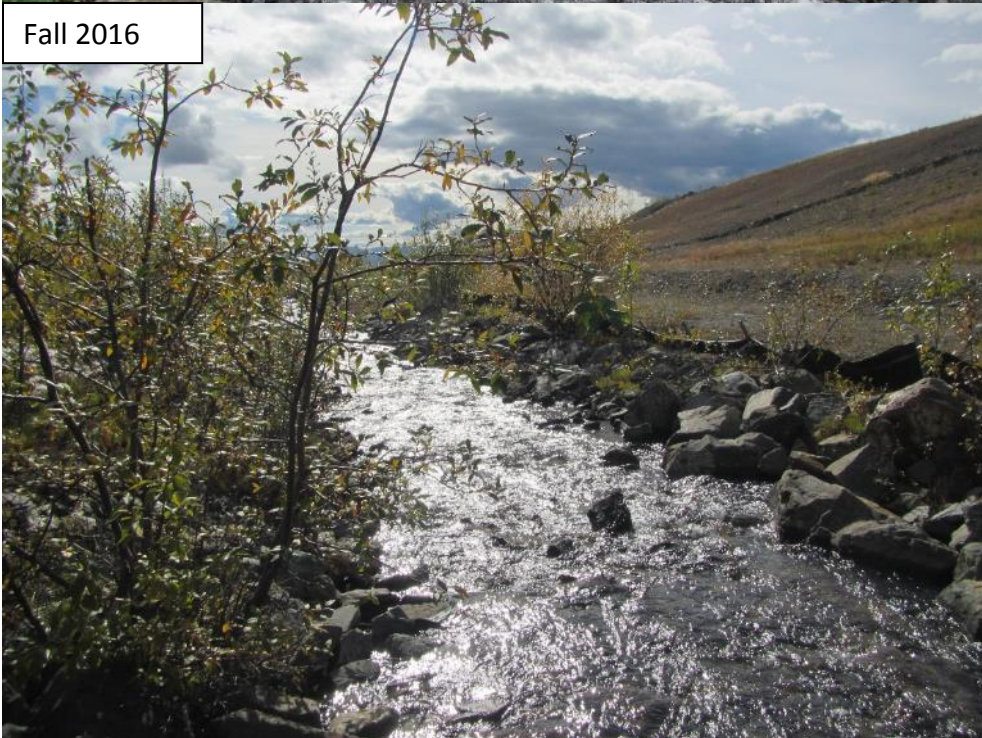
Photograph 43 **Vegetation in the diversion**

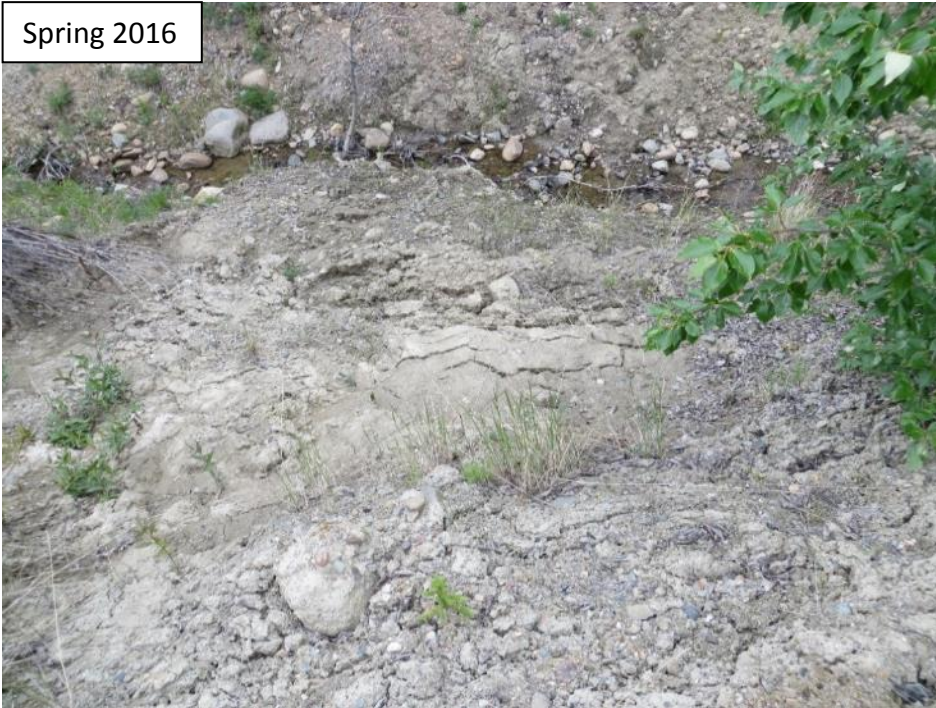
Photograph 44 Slumping on road slope. Progressed slightly since spring.

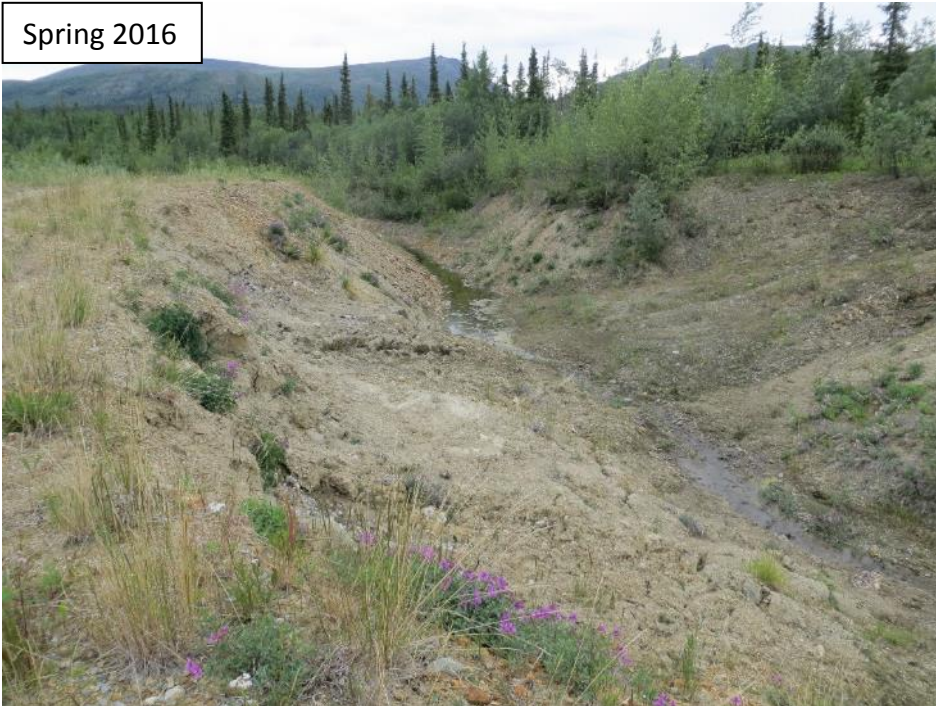
Photograph 45 Slumping of side slopes. Similar conditions in spring and fall.

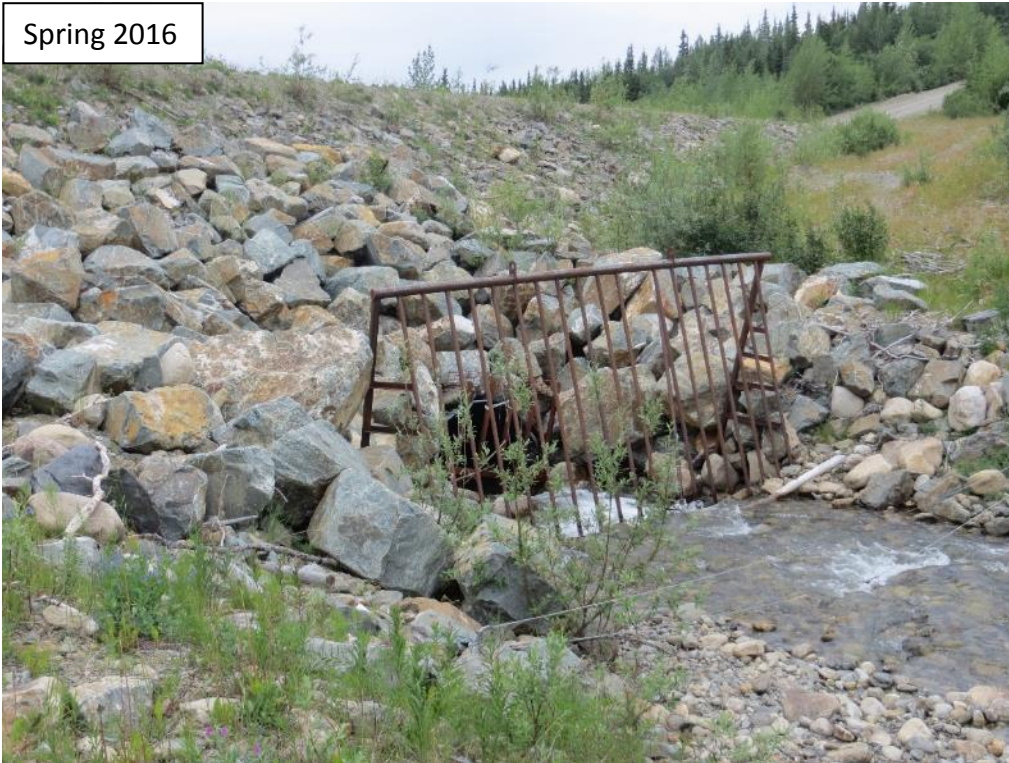
Photograph 47 Vangorda Flume intake culvert upstream trashrack. Satisfactory conditions.

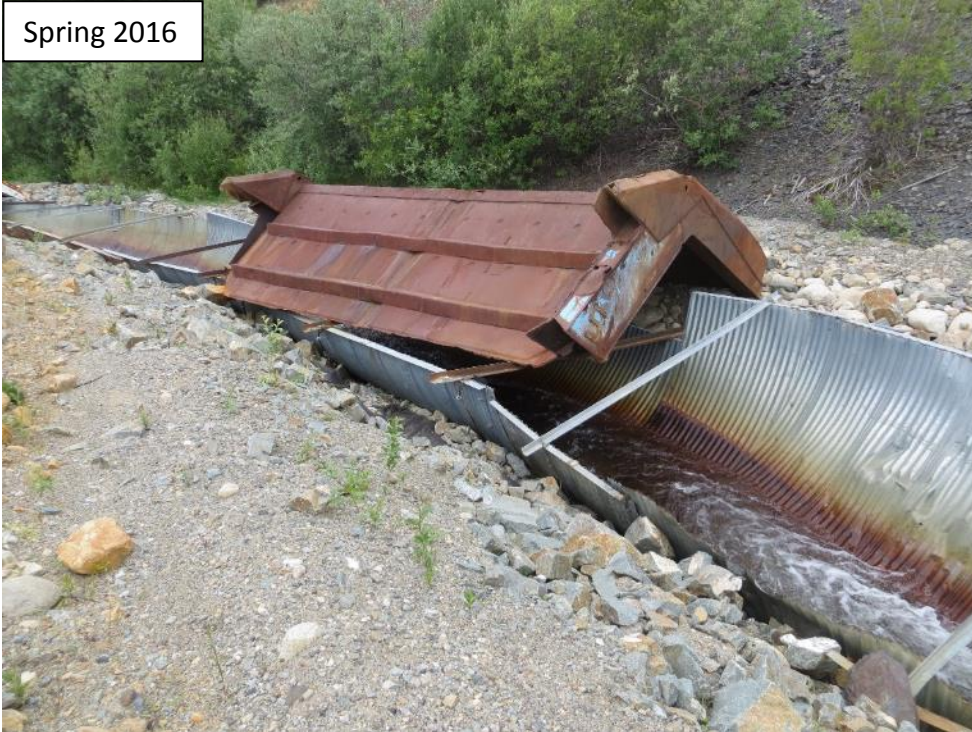
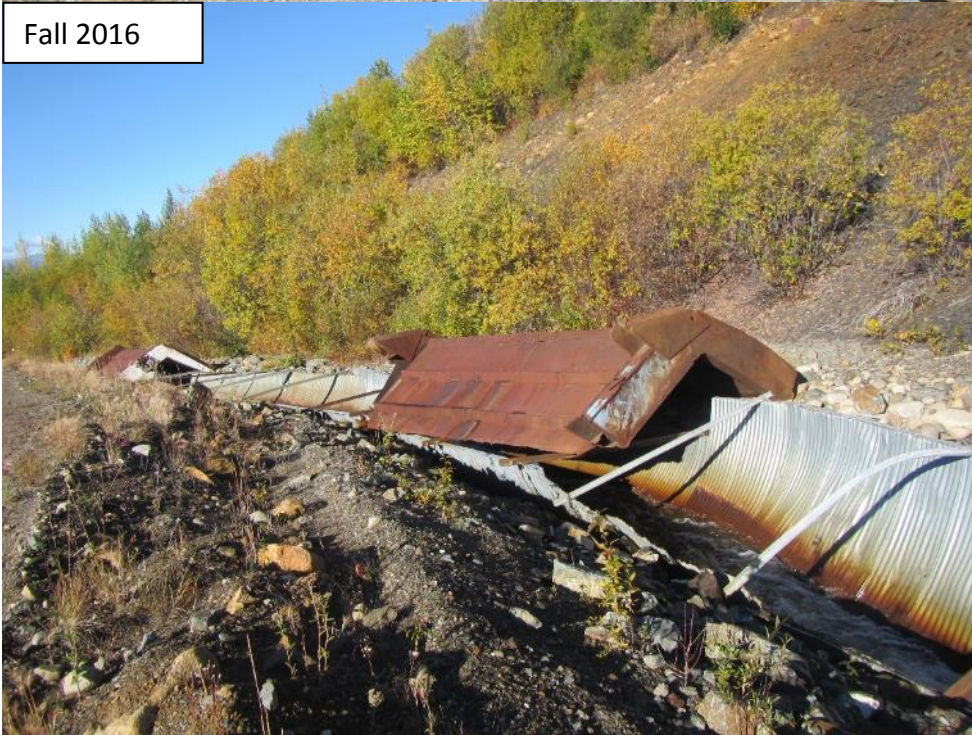
Photograph 49 Weight added to flume for anchoring

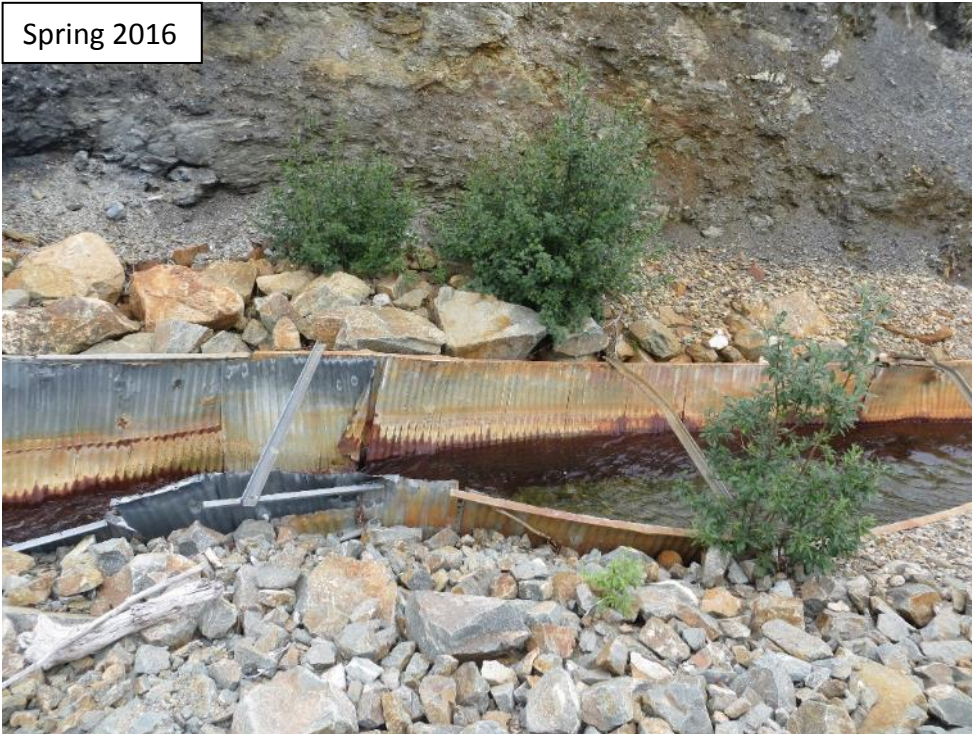
Photograph 50 Damaged flume, flat slope, and constricted channel

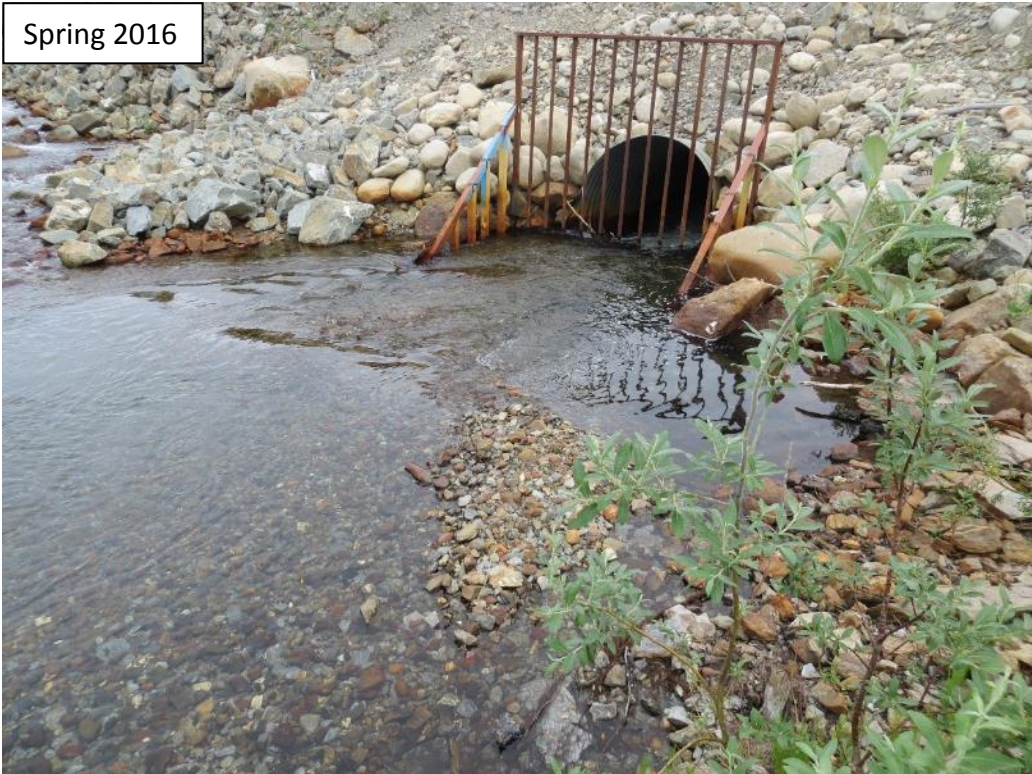
Photograph 52 Outlet to Flume Plunge Pool - trash rack. Leaves and woody debris accumulate on the trash rack and need to be removed as part of regular maintenance.

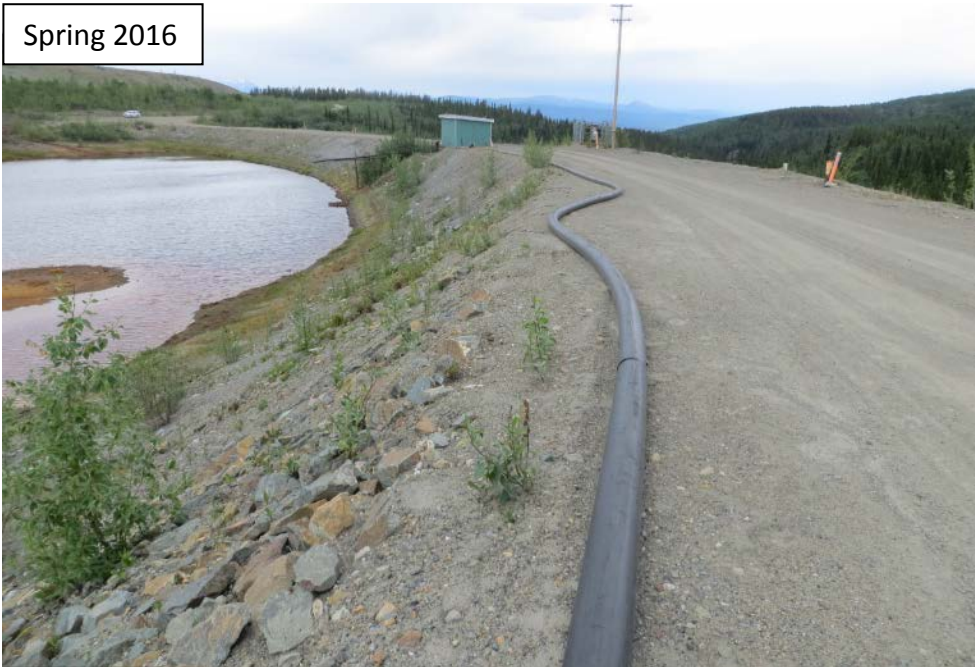
Photograph 53 Little Creek Dam from the access road (looking west). Satisfactory conditions.

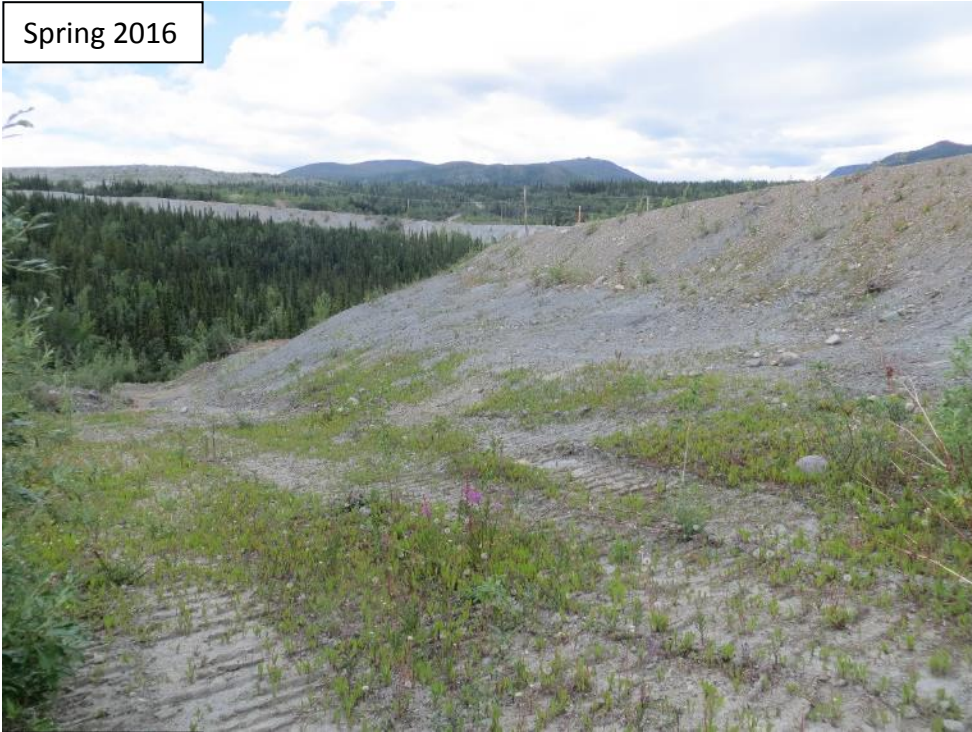
Photograph 54 Little Creek Dam downstream slope after vegetation removal (on left abutment, looking north).
