Klohn Crippen Berger

Faro Mine Complex

2016 Annual Geotechnical Review

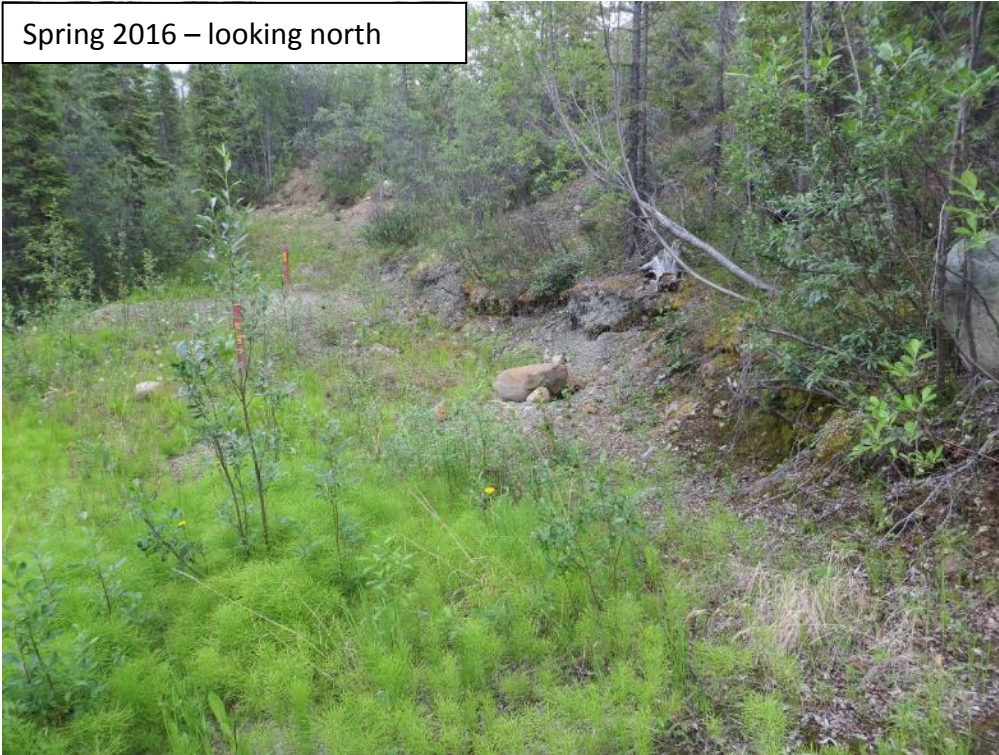
Photograph 55 Little Creek Dam downstream toe. Vegetation has been removed since spring. Slope is subject to erosion and should be repaired and stabilized.

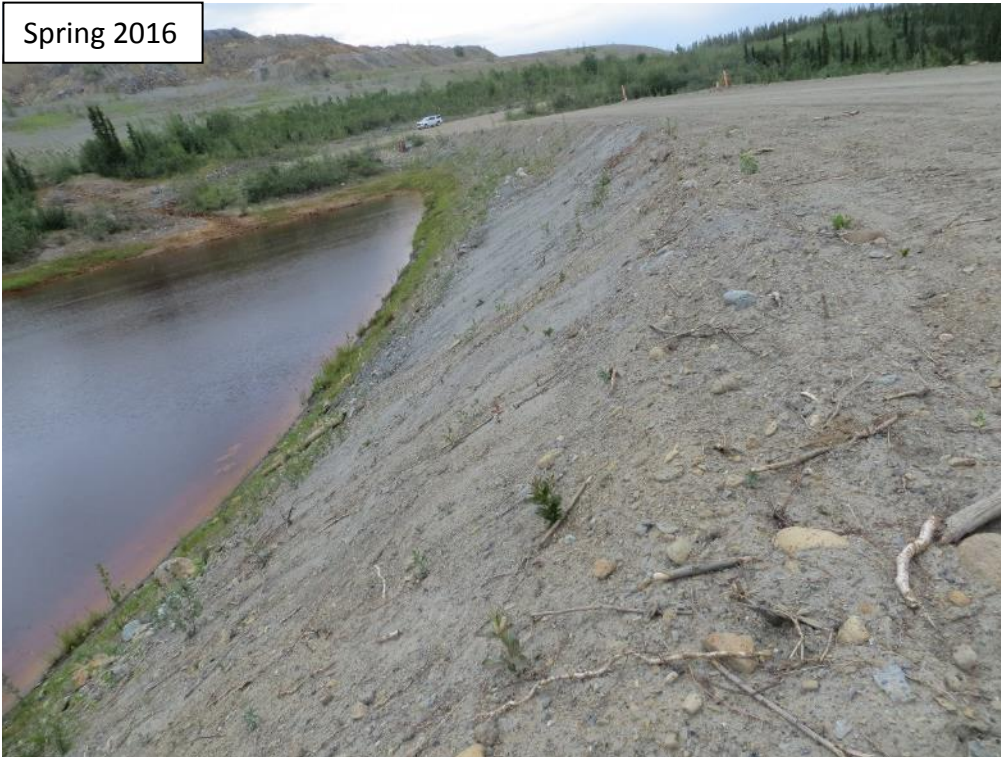
Photograph 56 Little Creek Dam upstream slope, repaired rill erosion. Minor vegetation.

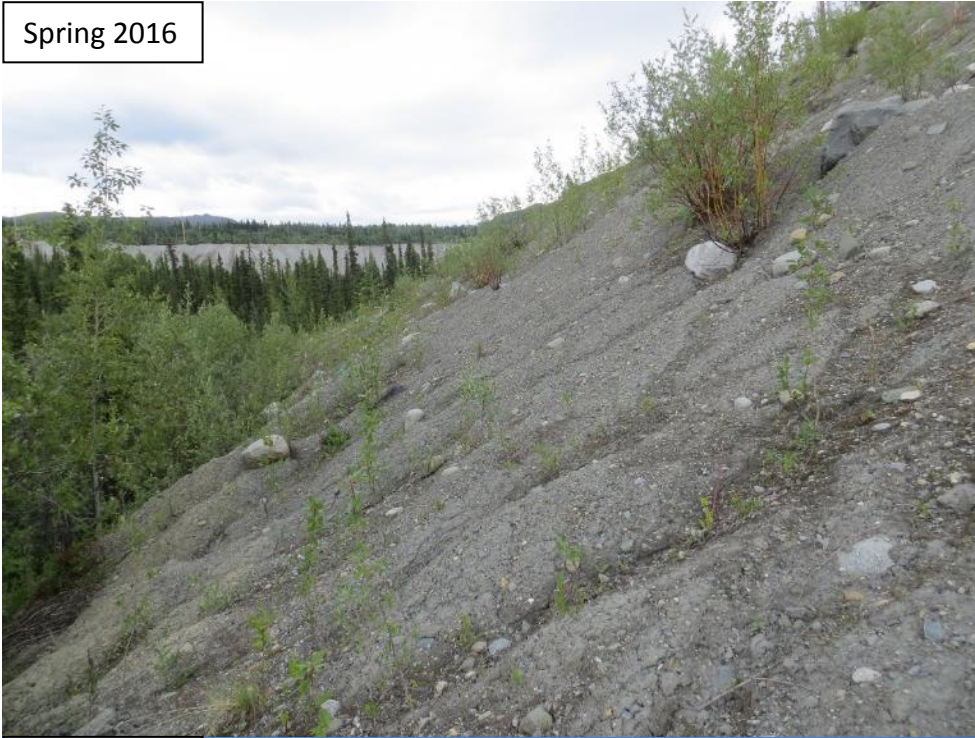
Photograph 57 Rill erosion on downstream berm slopes. To be graded in the fall and revegetated in the spring.

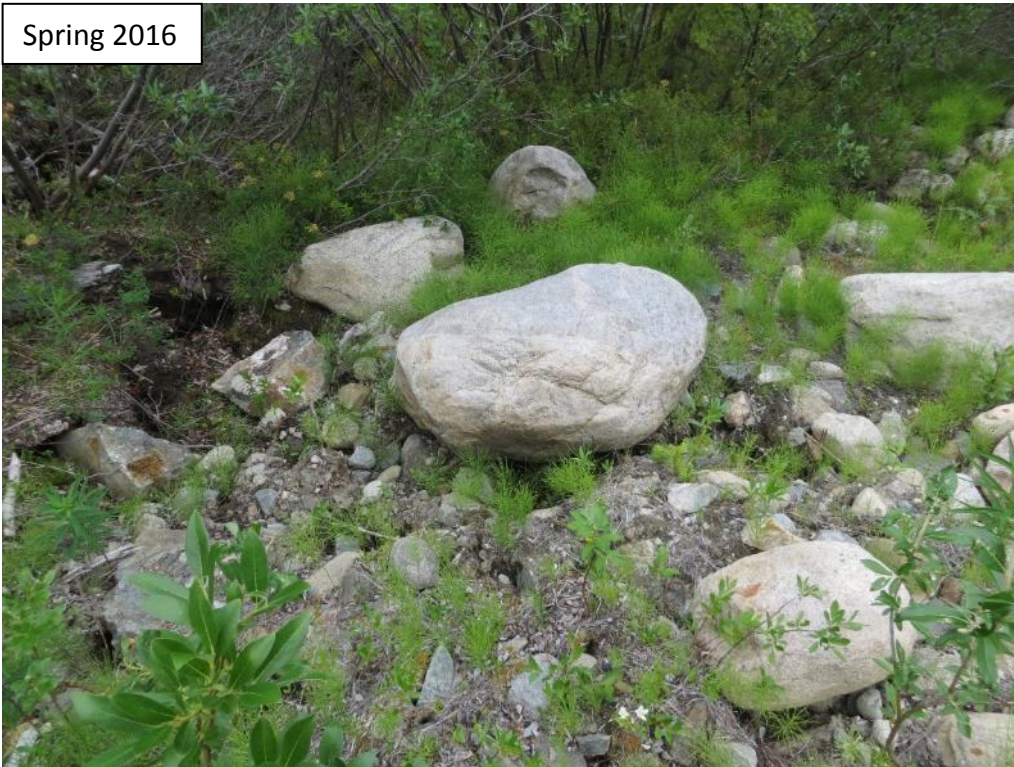
Photograph 58 Ground slope crack across downstream spillway channel near discharge end. Similar conditions in spring and fall.

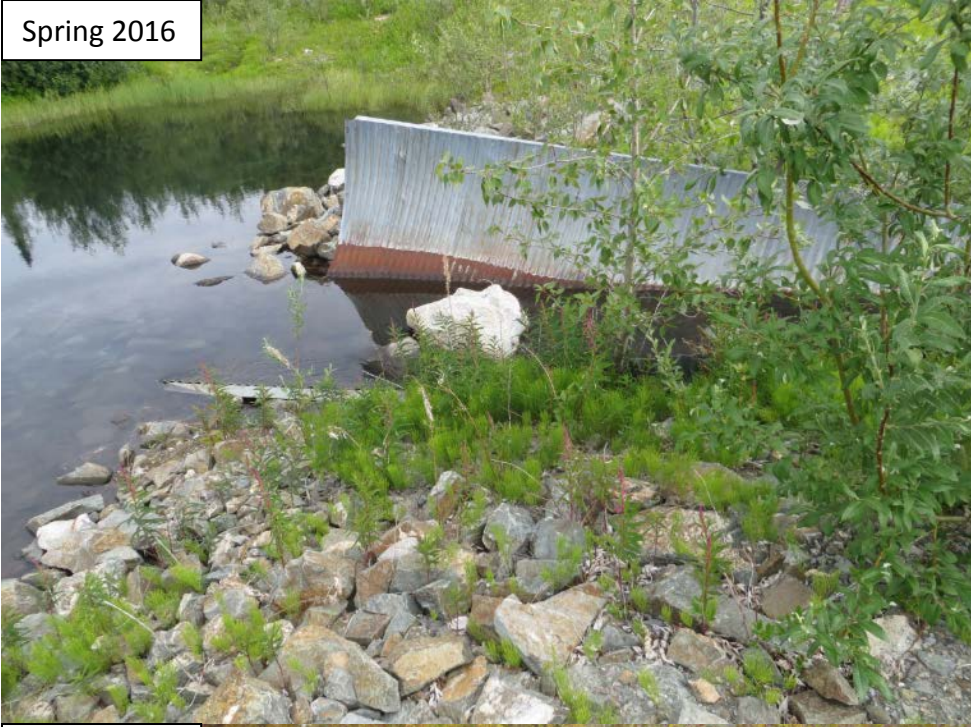
Photograph 59 Upper end of spillway from the Upper to Lower Sediment Pond. Boulders impeding flow.

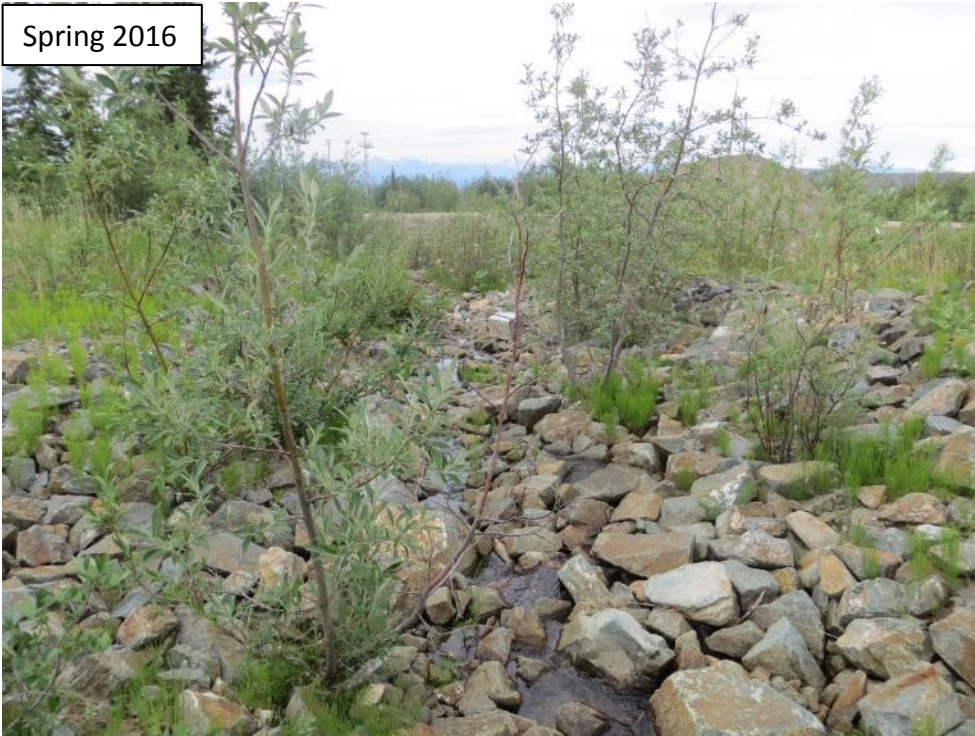
Photograph 61 Pond spillway channel, looking downstream towards Grum Interceptor Ditch. Trees on embankment and in spillway should be removed.

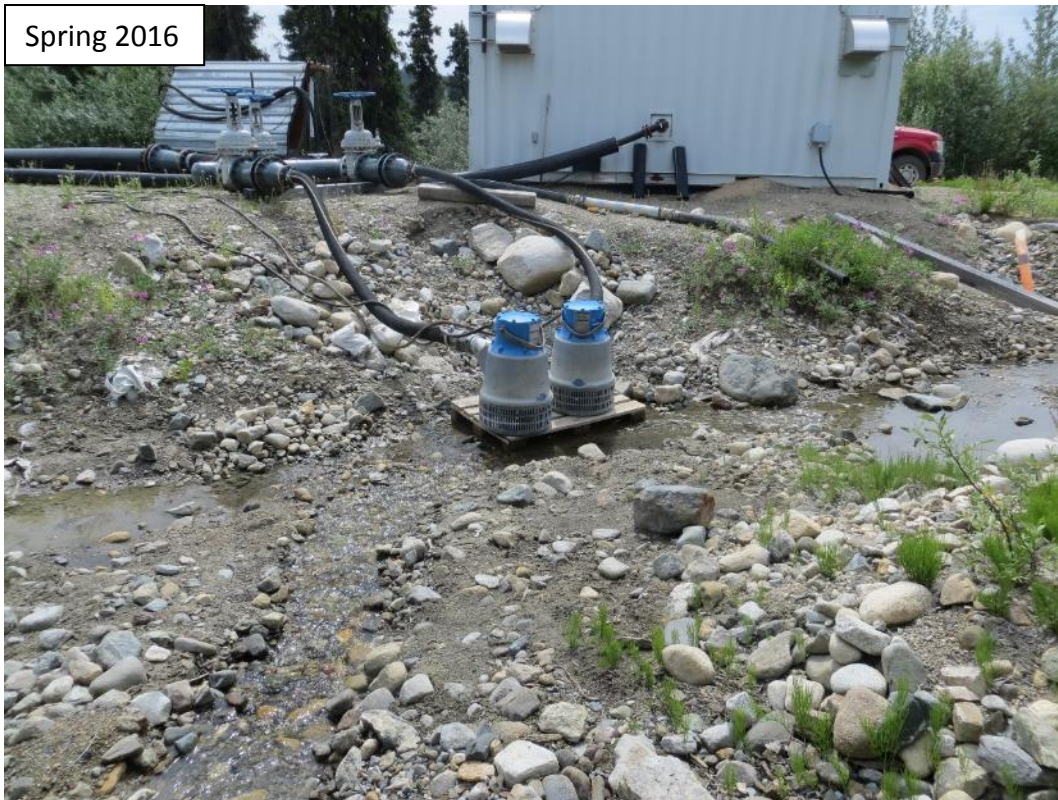
Photograph 63 V-15 ditch and pumps, water pumped out before reaching Moose Pond

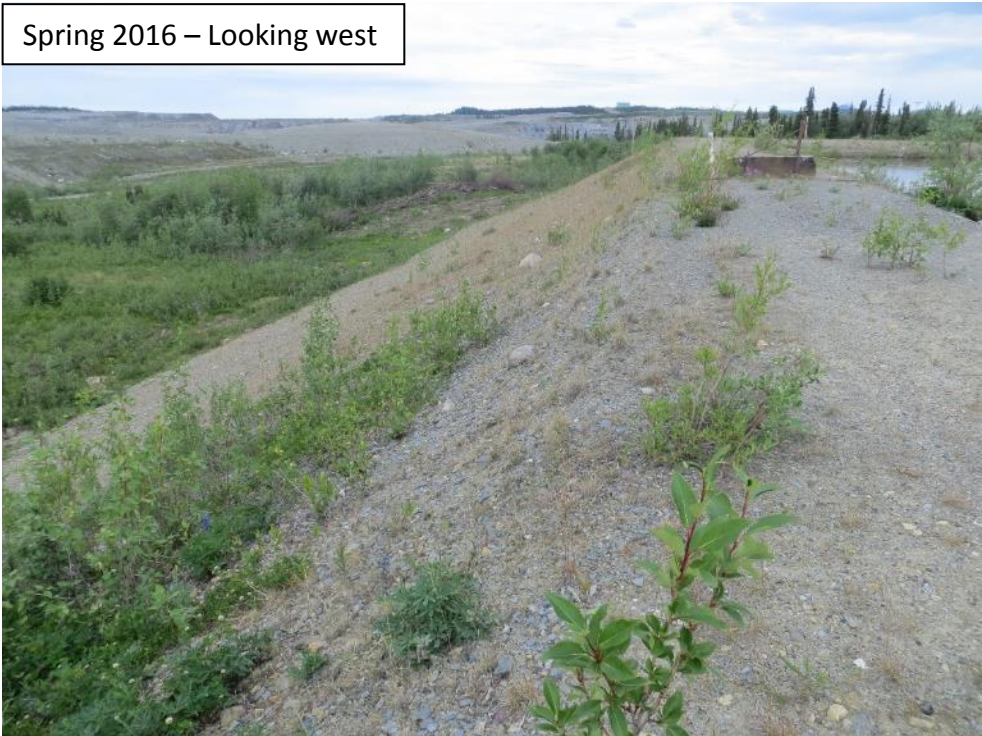
Photograph 66 Clarification pond, dyke crest and downstream slope. Some trees to be removed.

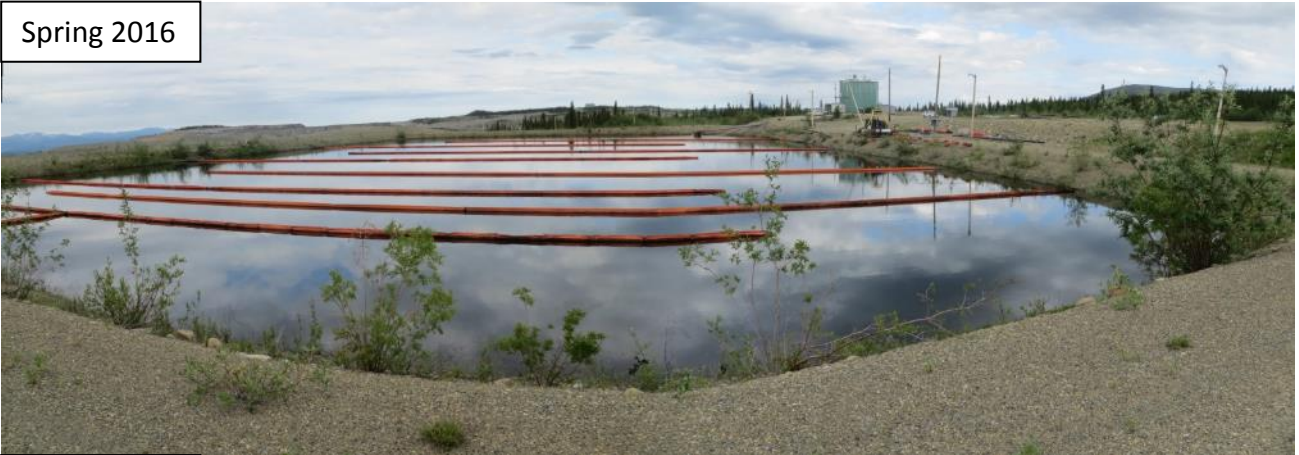
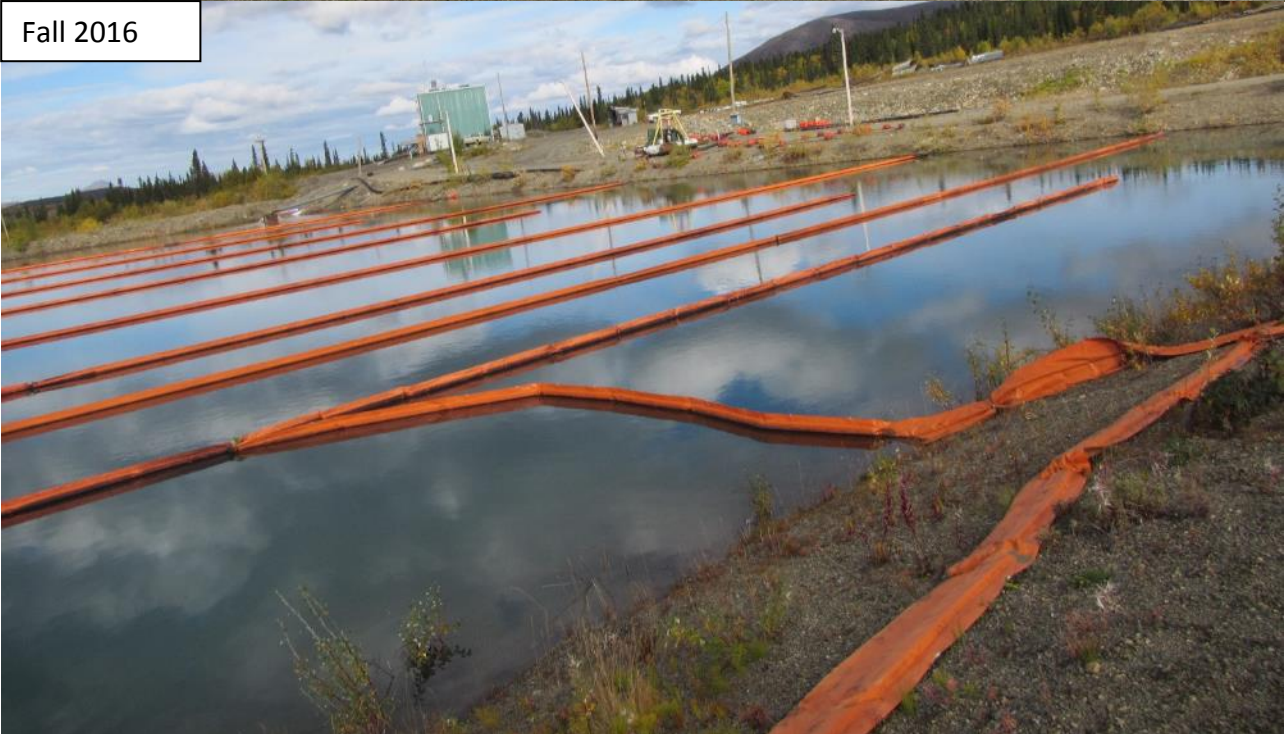
Photograph 67 Clarification pond upstream slope (looking west)
