2011 Geotechnical Inspection Waste and Water Management Facilities Vangorda/Grum Faro Mine Complex, Yukon

Denison Environmental Services

SRK Consulting (Canada) Inc.
1CD009.005
August 2011

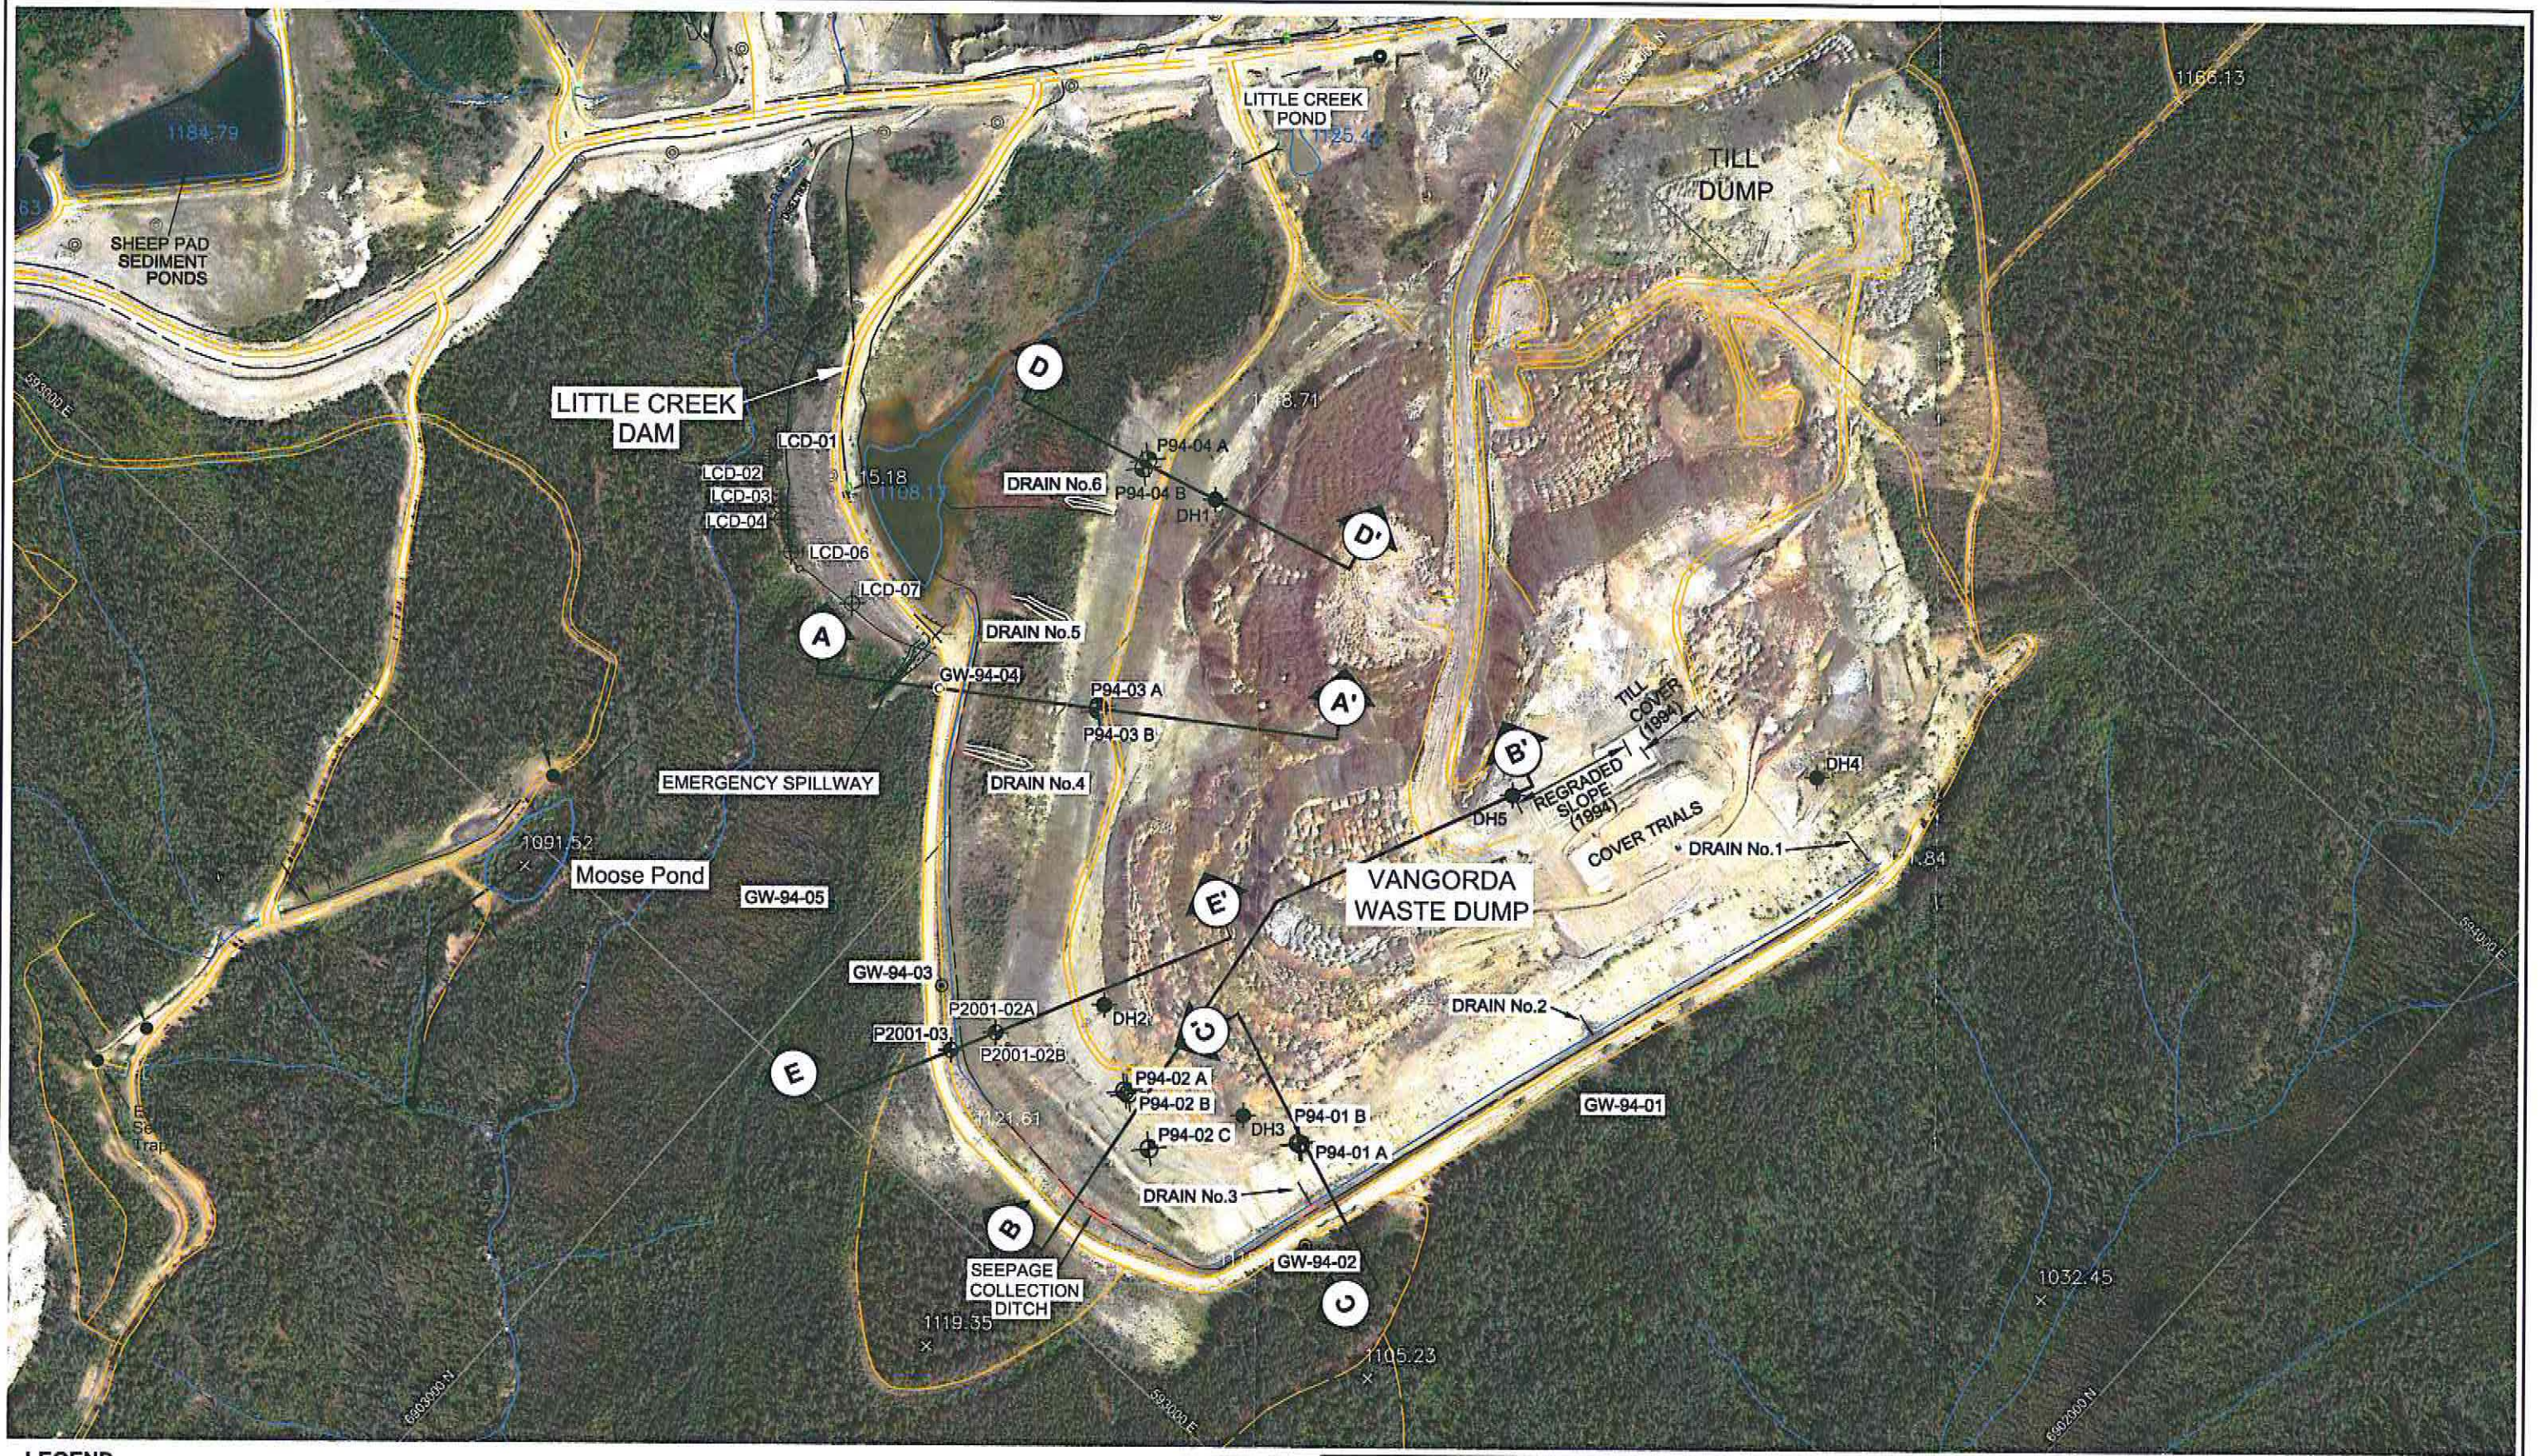
General Arrangement Plan
 Vangorda Waste Rock Dump

SRK also recommends the installation of five shallow piezometers located at the toe of the till dyke around the Vangorda Waste Rock Dump. The piezometers would be located at the approximate area of the five sections shown on Figure 4.

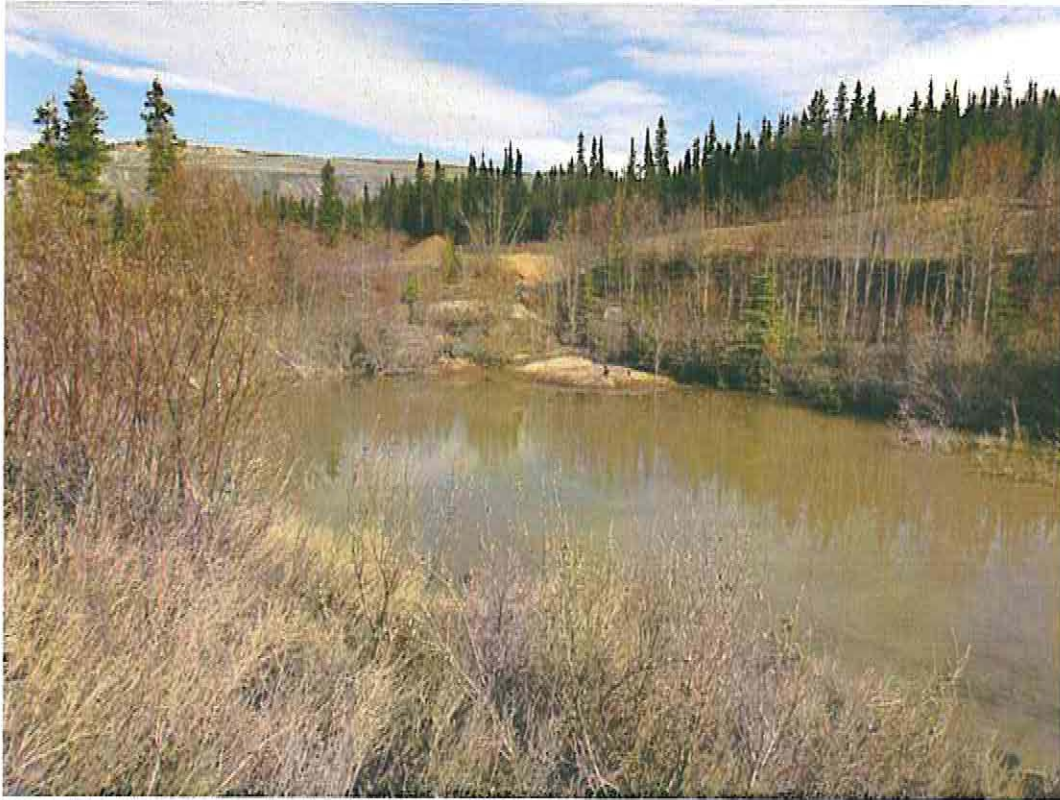
Photo 31: Moose Pond with Silt from GSC

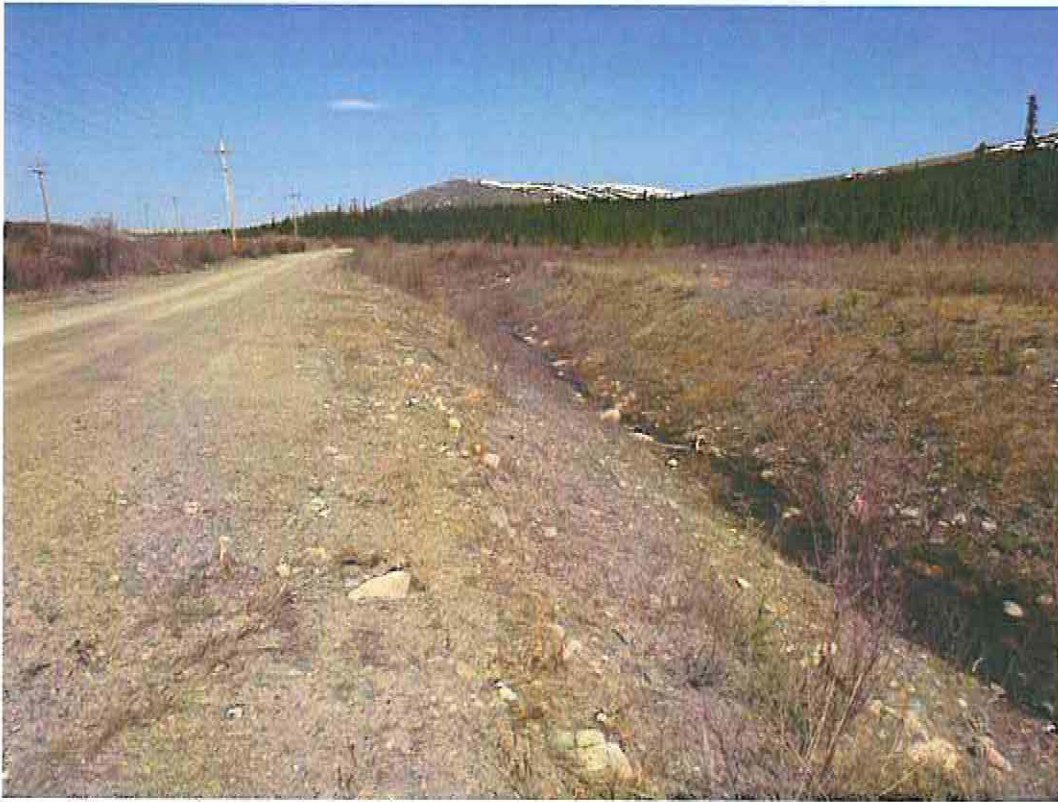
Photo 37: Grum Interceptor Ditch

In the upper reaches of the GID (Photo 37), the ditch slopes remain stable and the vegetation continues to provide effective erosion control of the ditch sideslopes. However, debris and the odd boulder are beginning to partly block culvert outlets and entrances along the route.

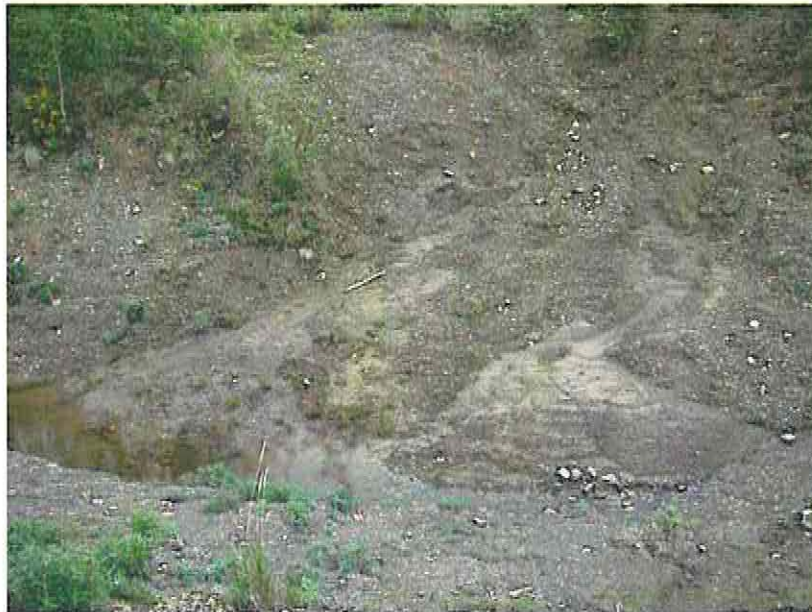
*Photo 3: Vangorda Interceptor East Diversion
(June 26, 2011)*

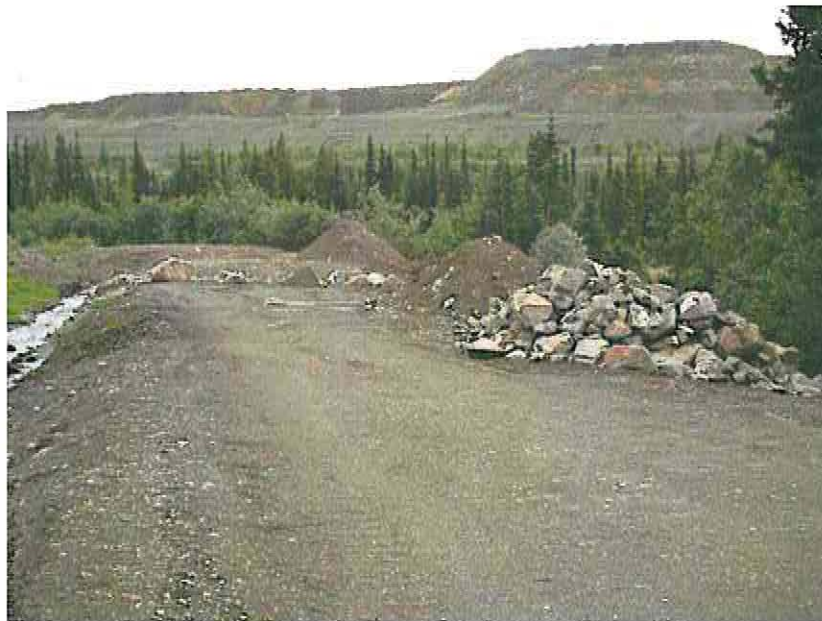
*Photo 4: Approach to Moose Pond;
(June 26, 2011)*

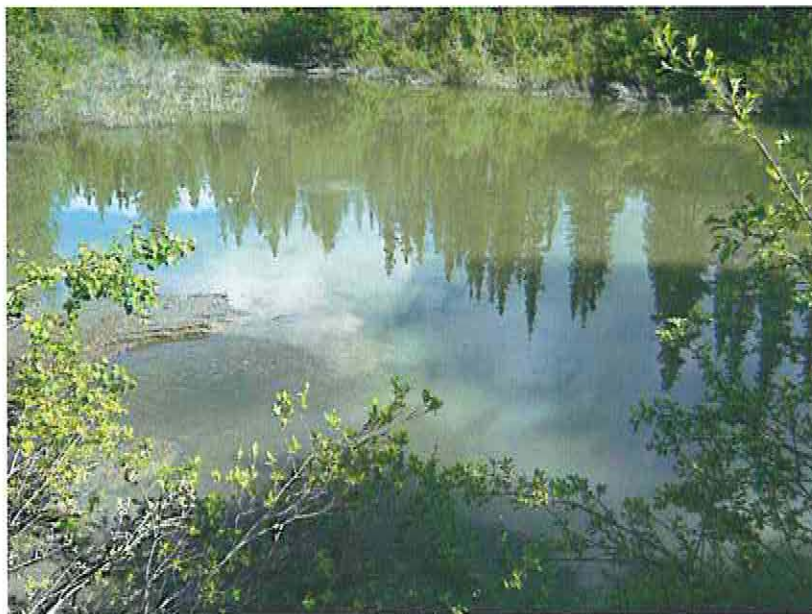
Photo 7: Moose Pond (June 28, 2011)
