February 7, 2013

REPORT ON

Faro Mine Complex Annual Pit Slope Stability Inspection

Project Number: 1214260031-001-R-Rev0-6000

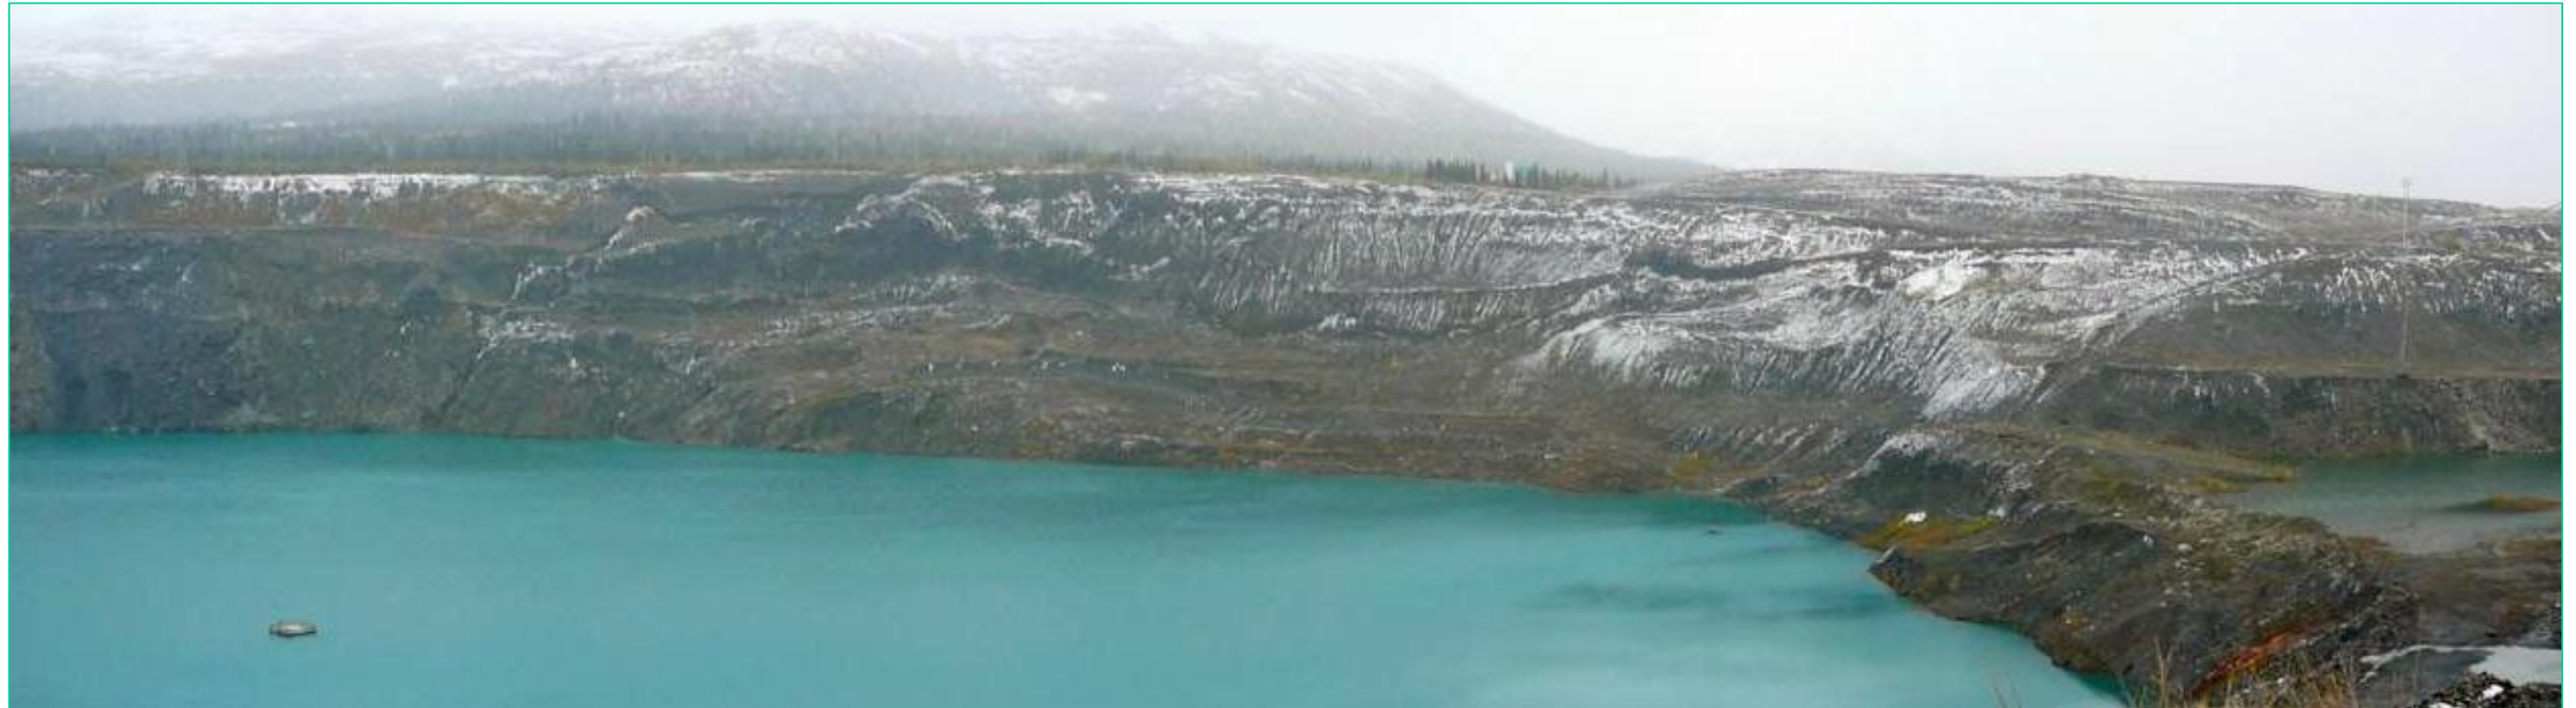
Photograph D-1
Grum Pit east wall and instability zone. View looking east.

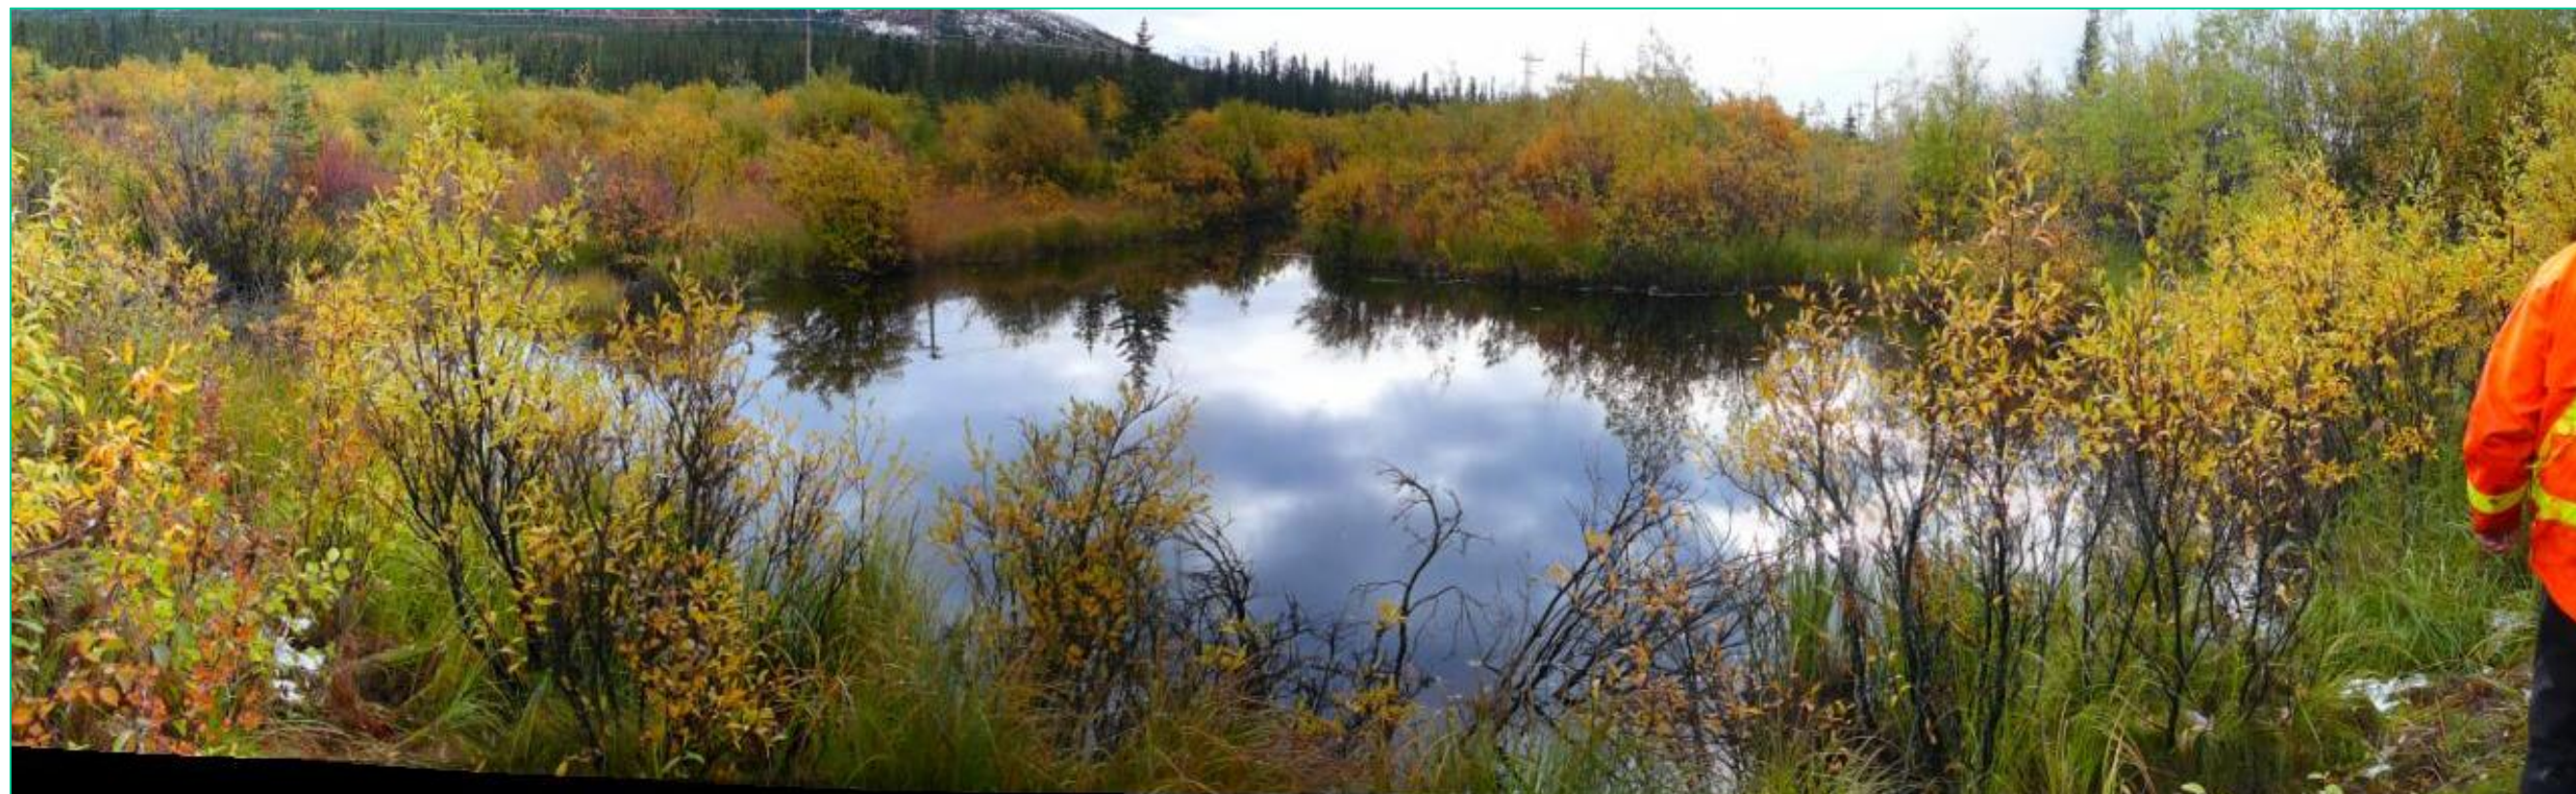
- In addition, a significant pond of water was observed behind the crest, shown on Photograph D-16. This large pond was also marked with GPS and is indicated on Figure 3.

Photograph D-16
Grum Pit – large pond behind crest. View looking southeast.

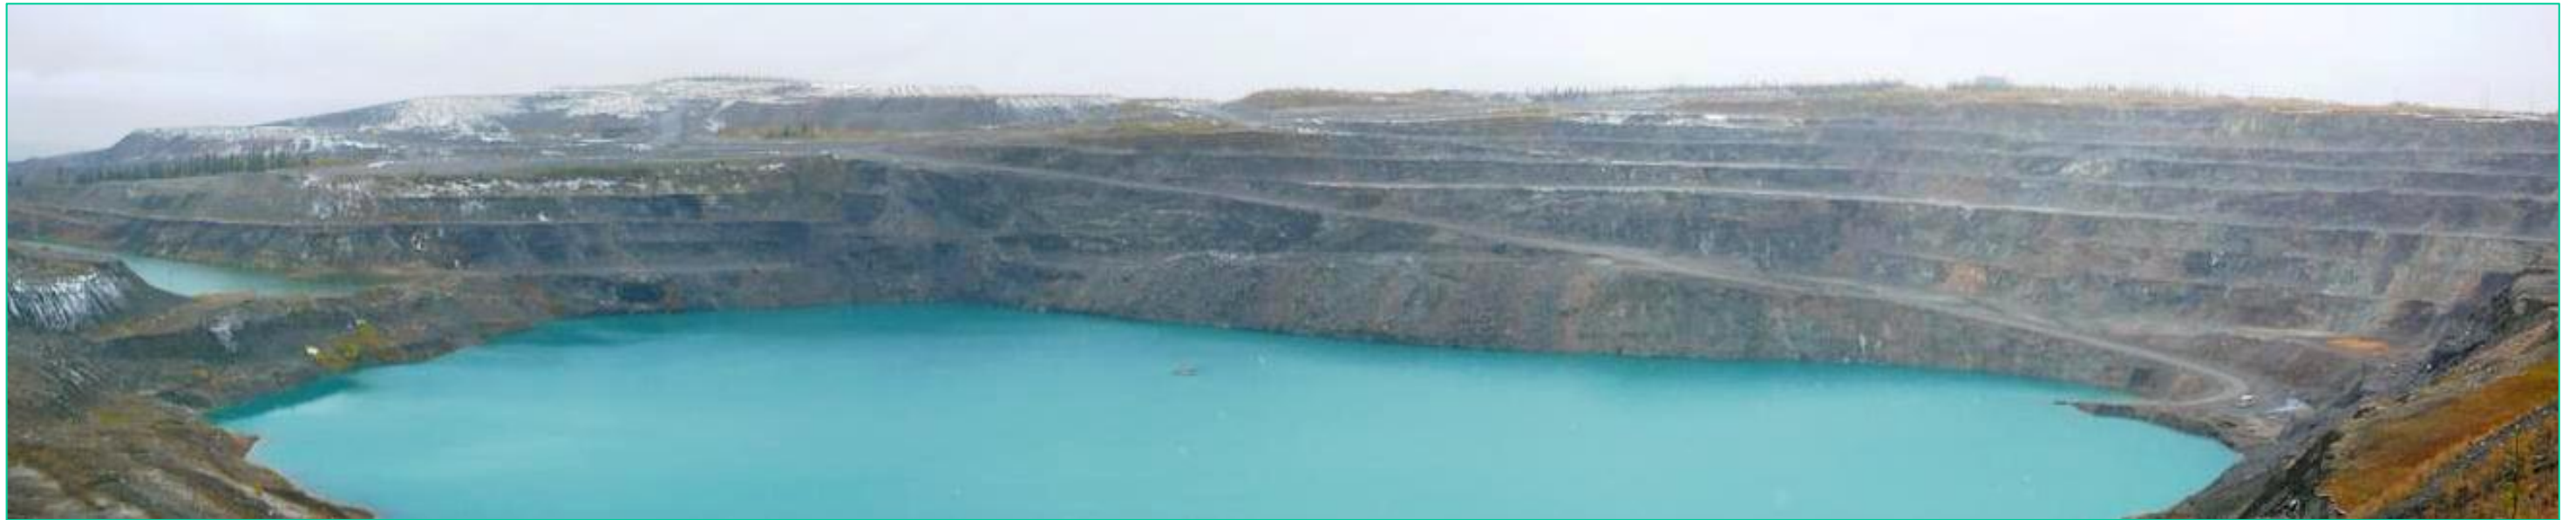
Photograph D-20
Grum Pit south, west and north walls. View looking southwest.

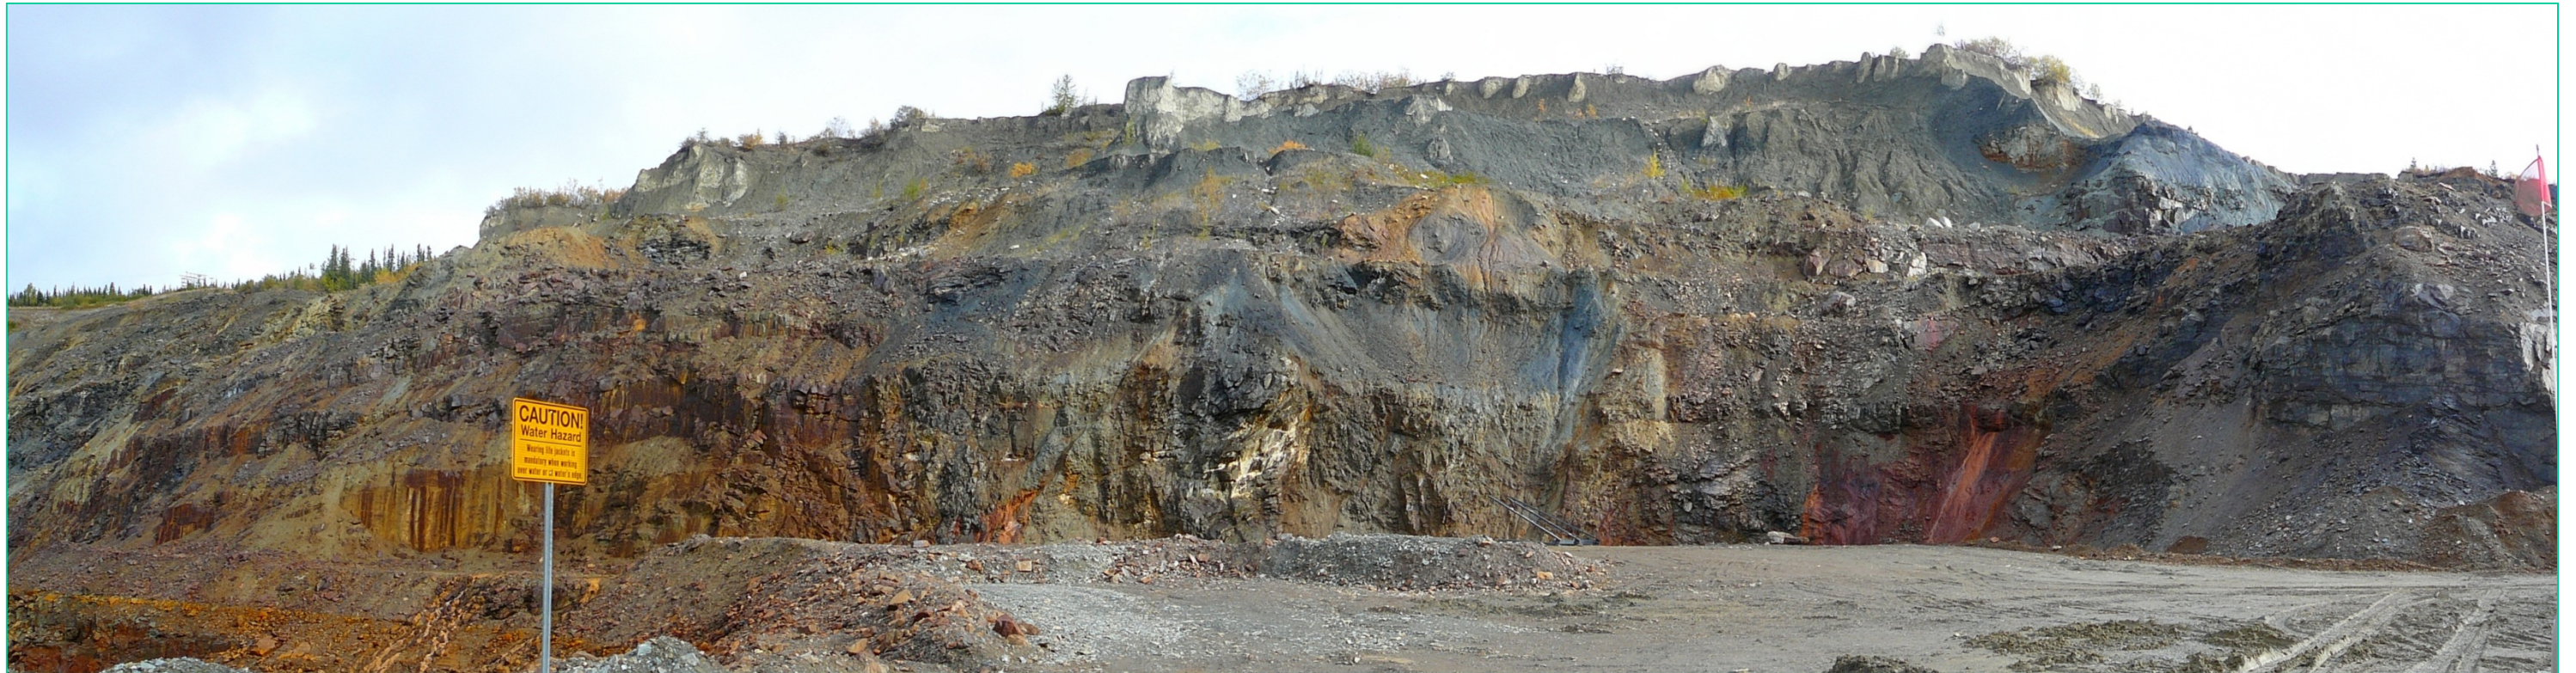
Photograph E-4
Vangorda Pit – Mapping Station 2. View looking north.

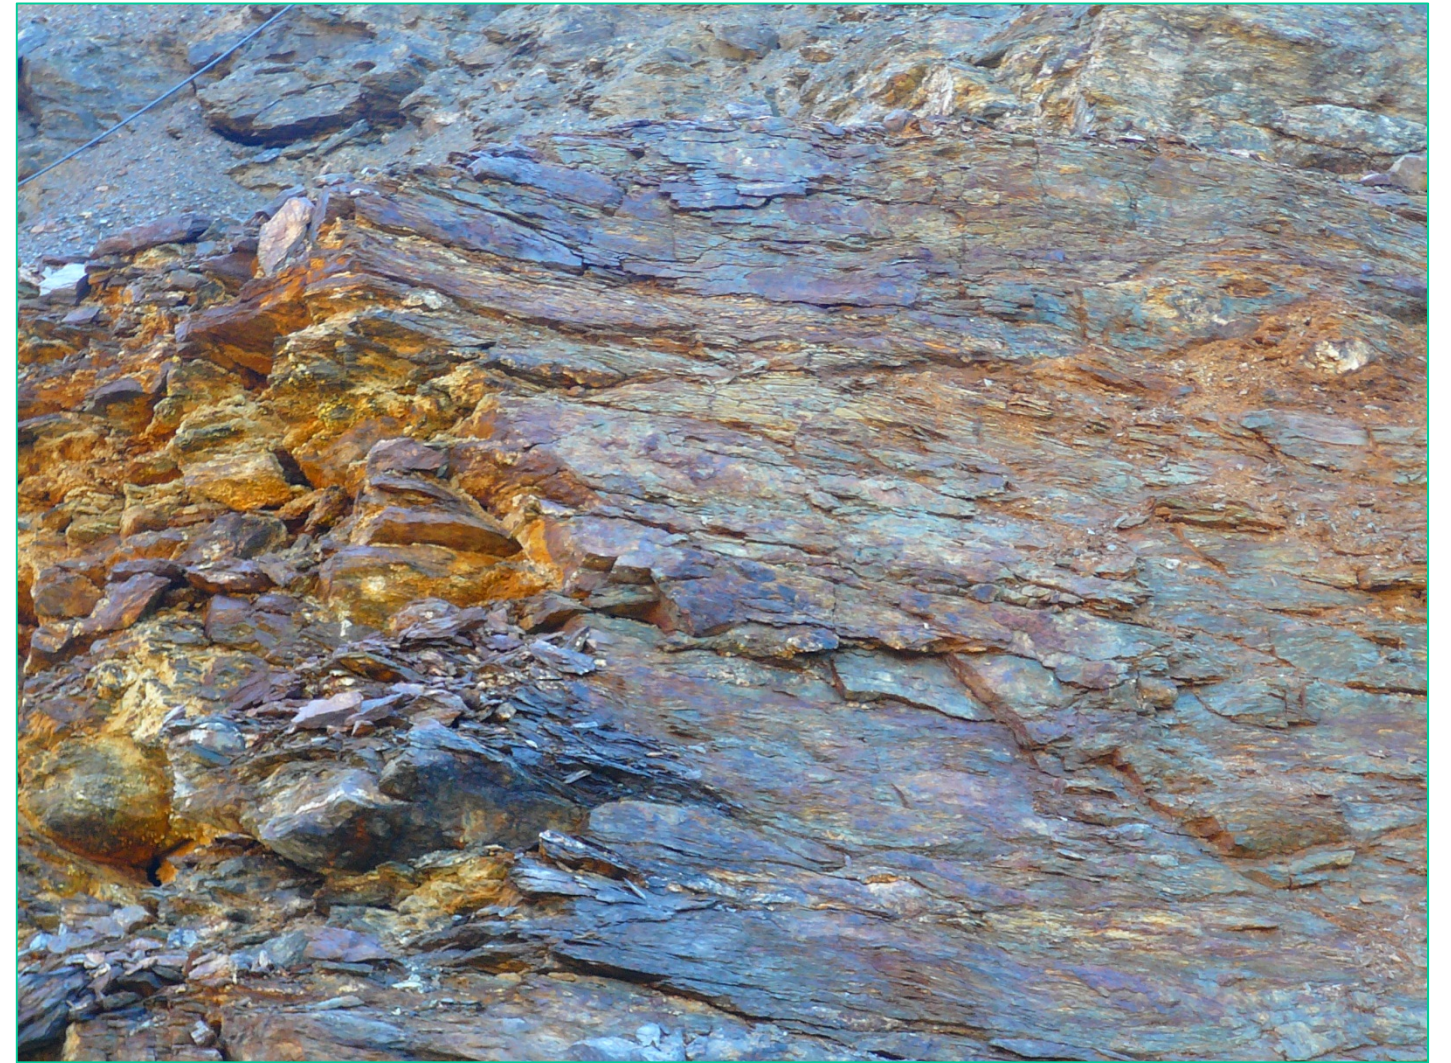
Photograph E-6
Vangorda Pit – Mapping Station 3. Close up view of foliation.

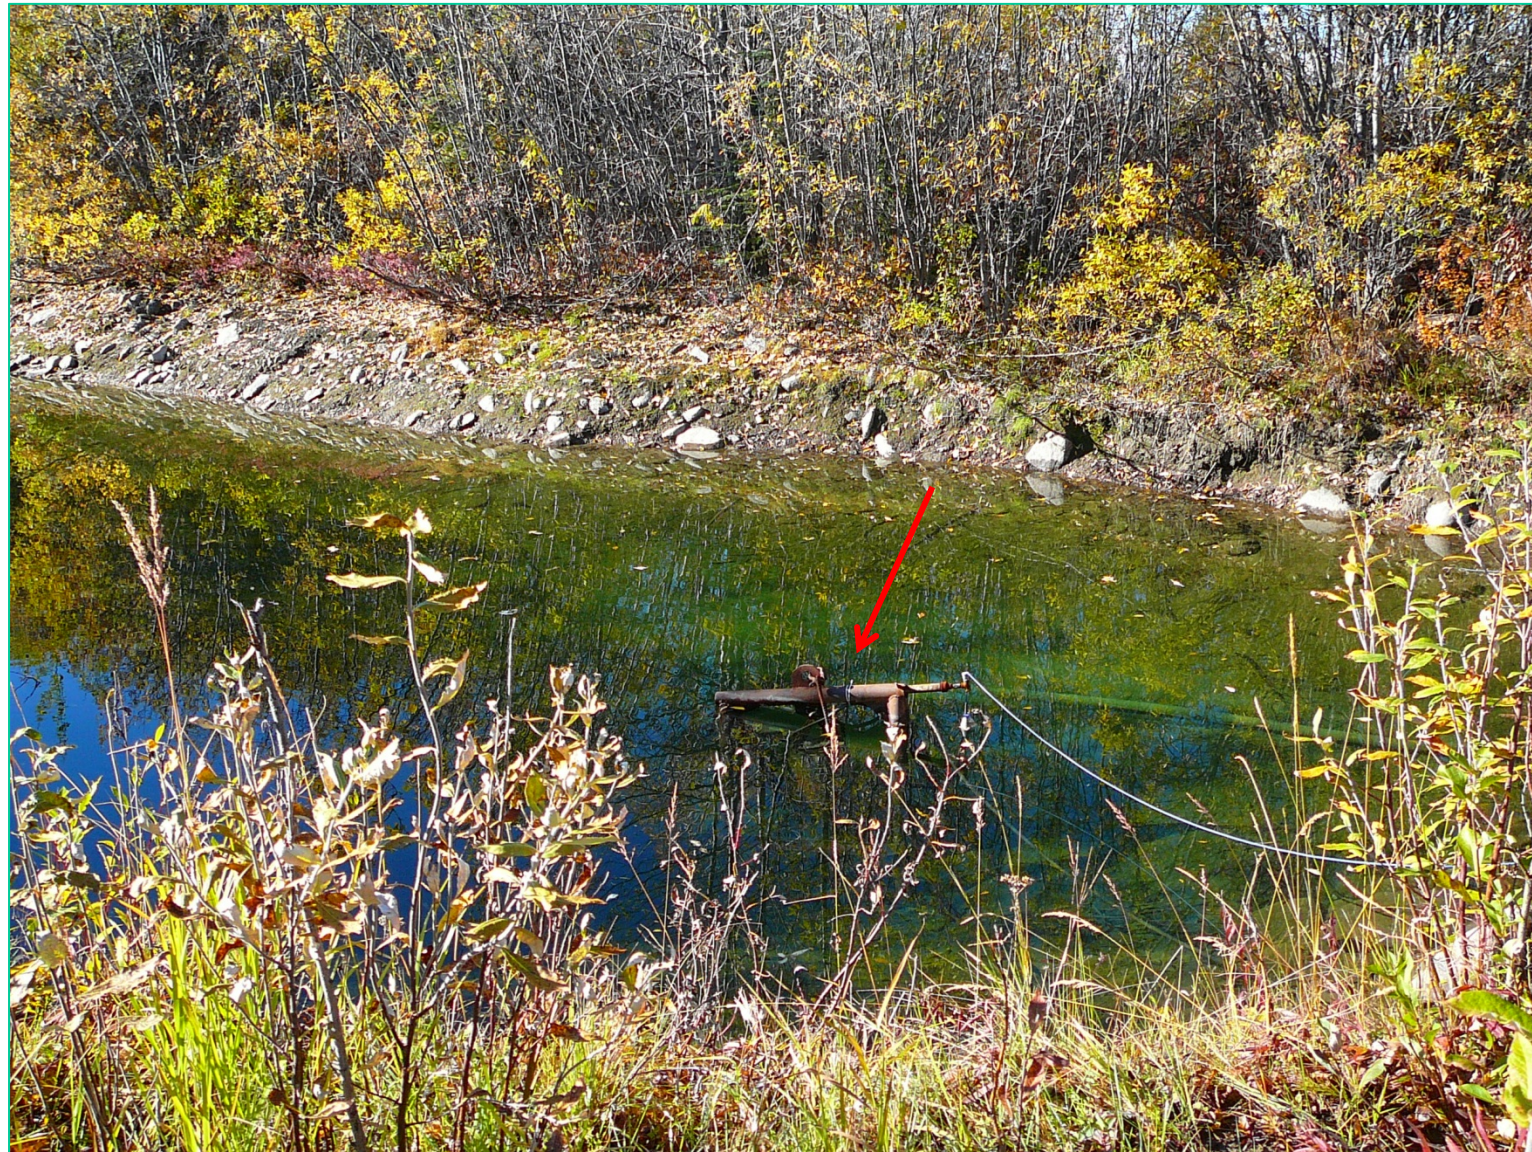
Photograph E-12
 Vangorda Pit – original Vangorda Creek channel,
 behind east wall of pit. Pump is activated at a
 certain water elevation, and water is pumped
 across the road to the flume. View looking west.

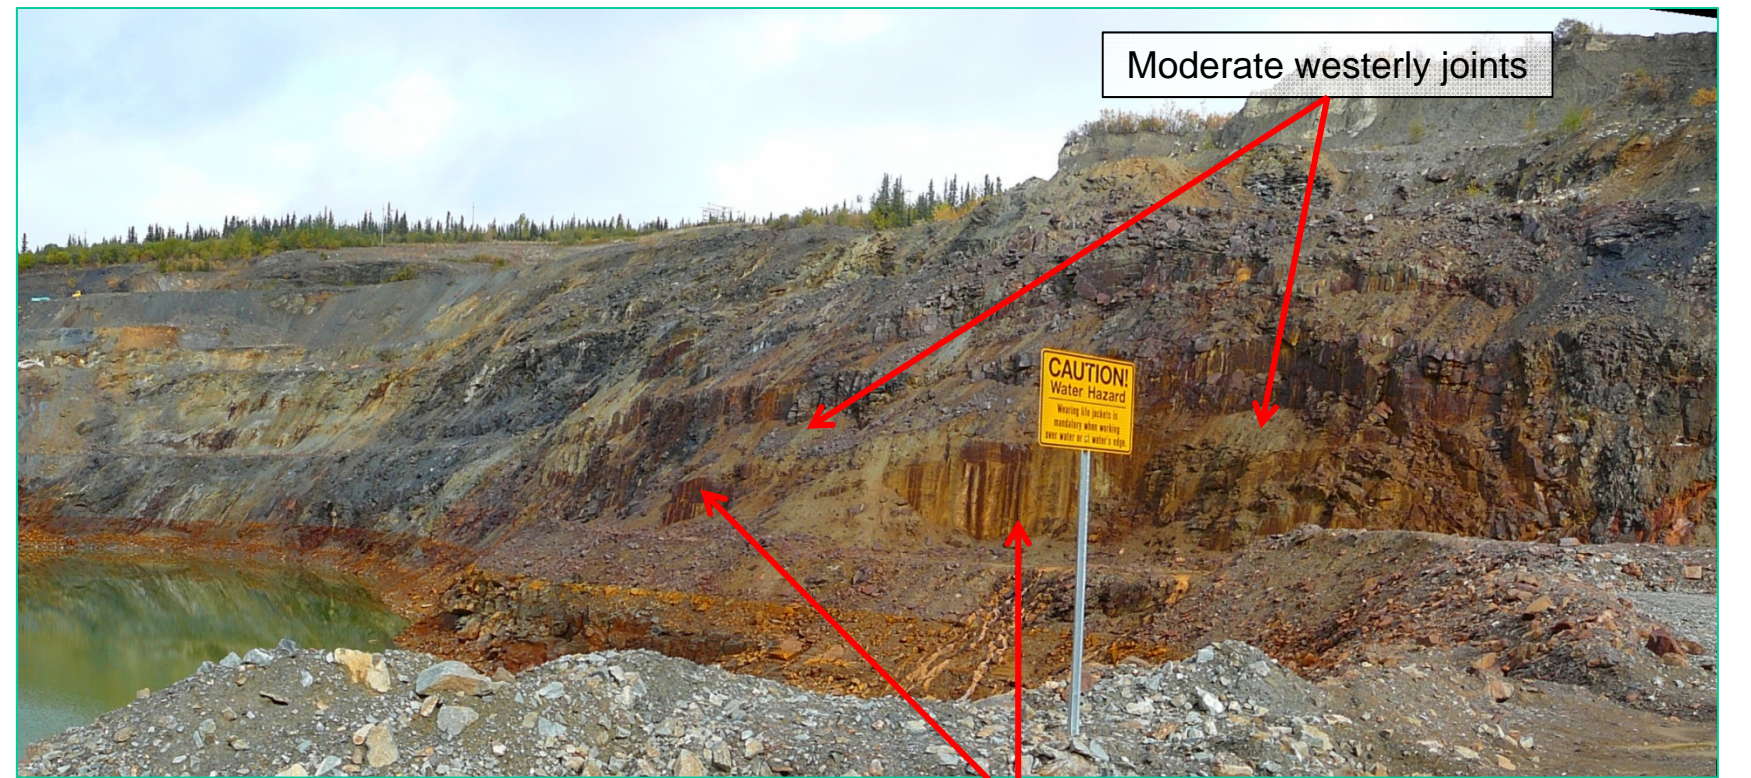
Photograph E-19
Vangorda Pit northeast wall.
View looking north-northeast.

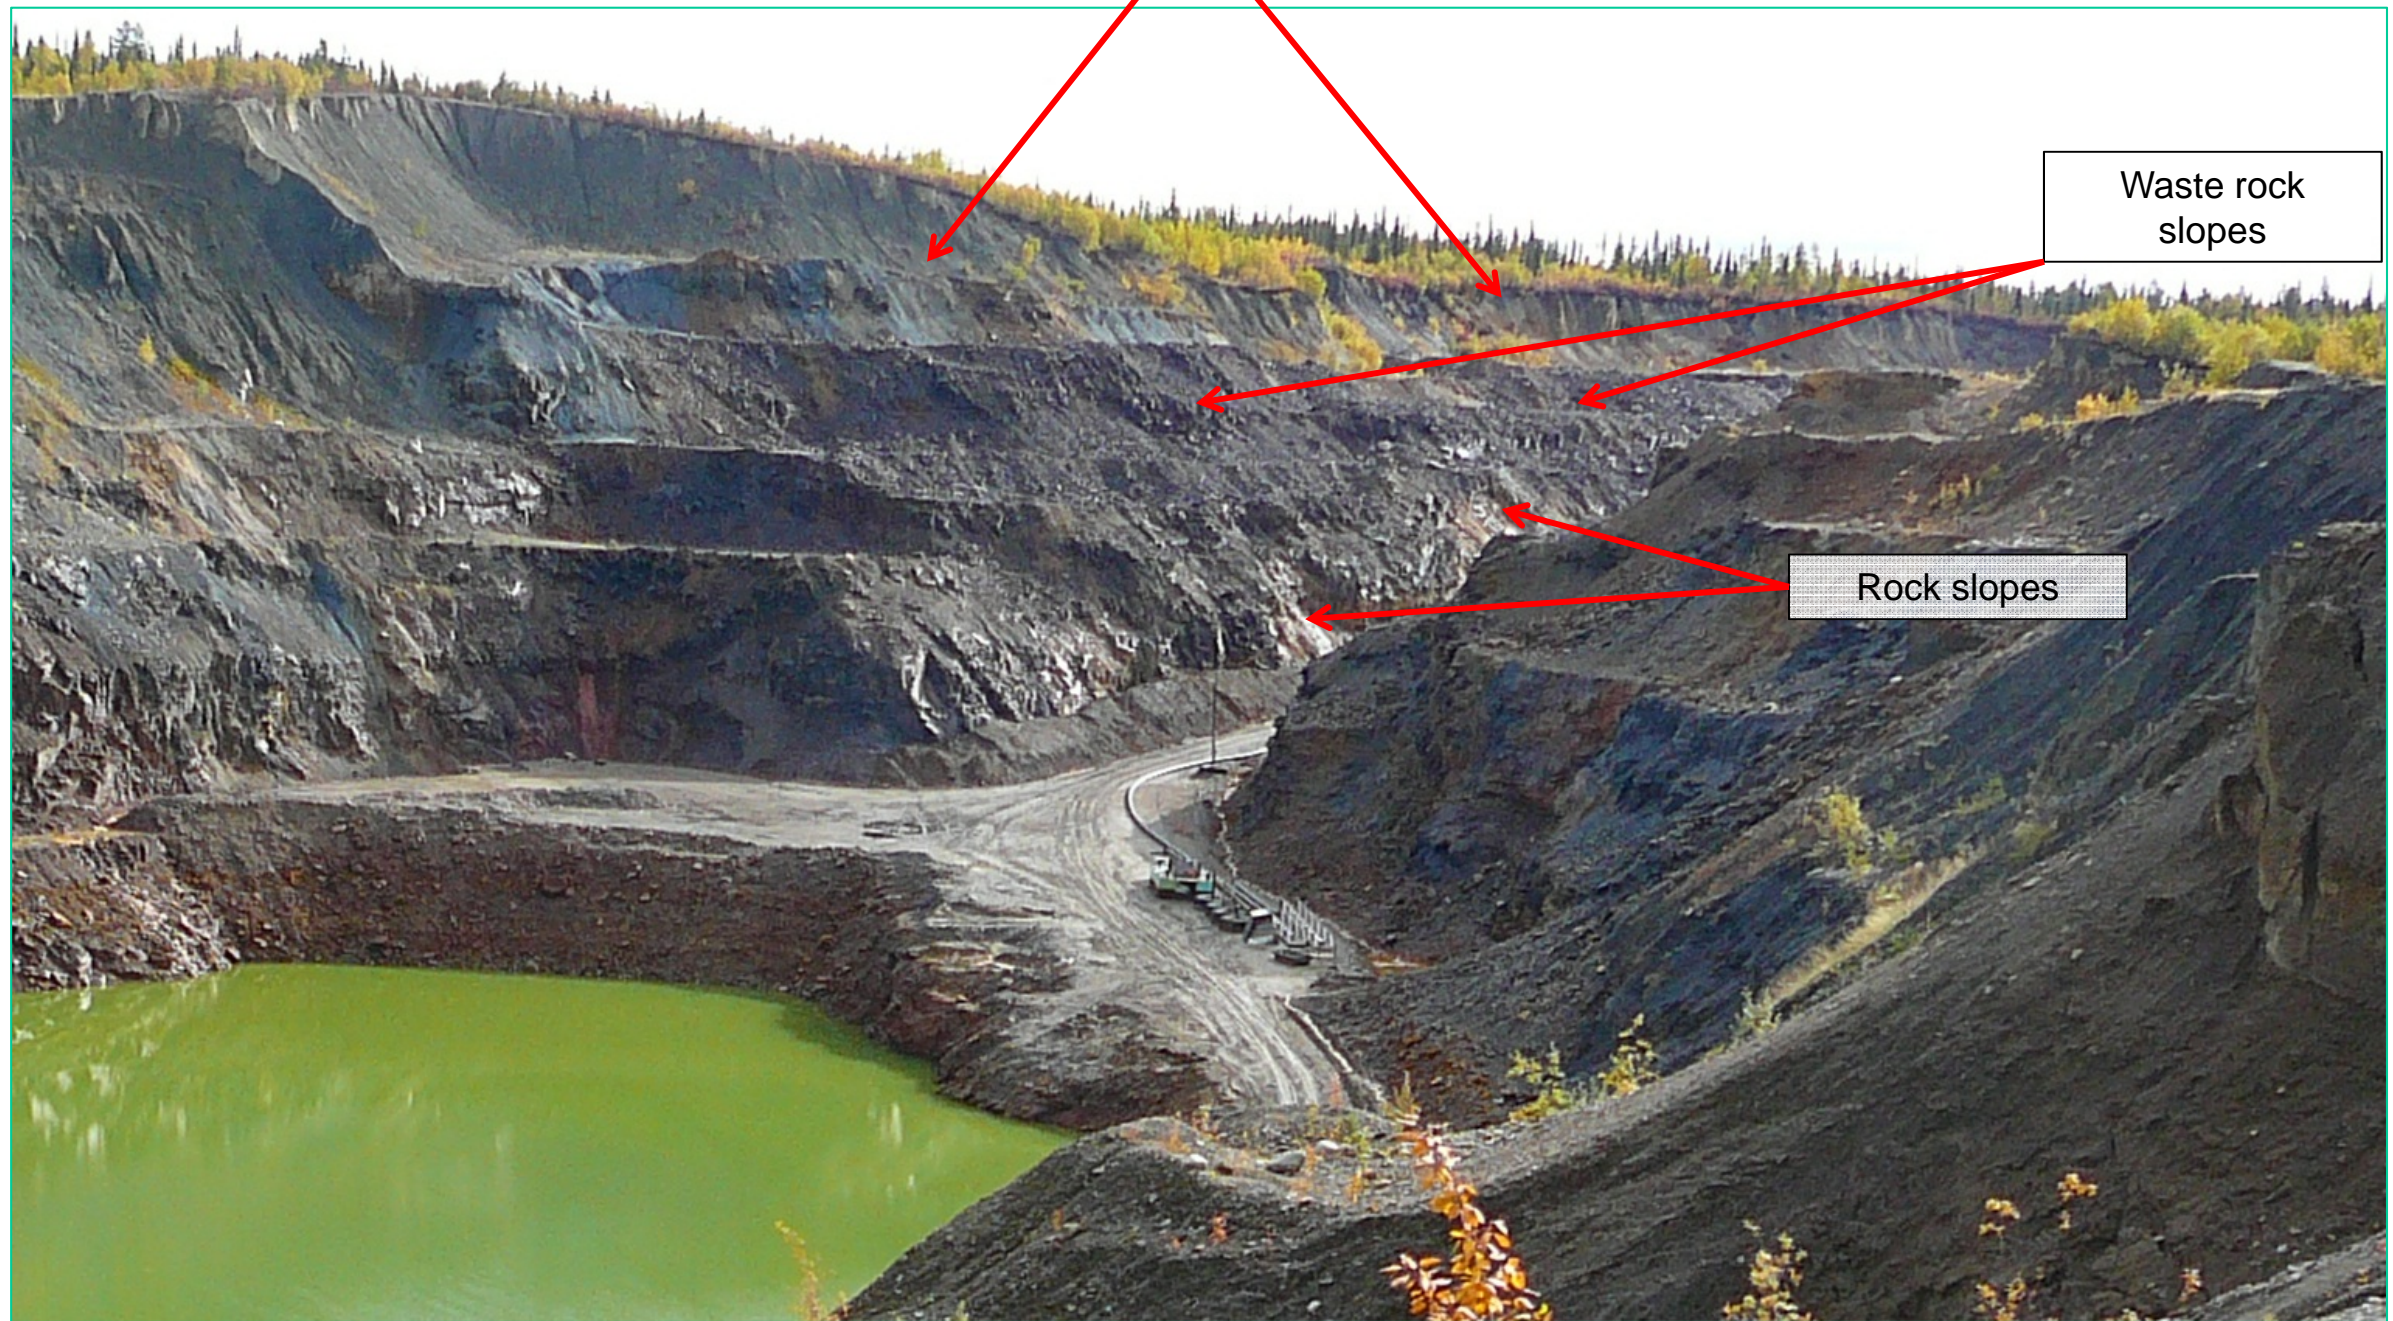
Photograph E-20
Vangorda Pit southeast wall. View looking east-southeast.

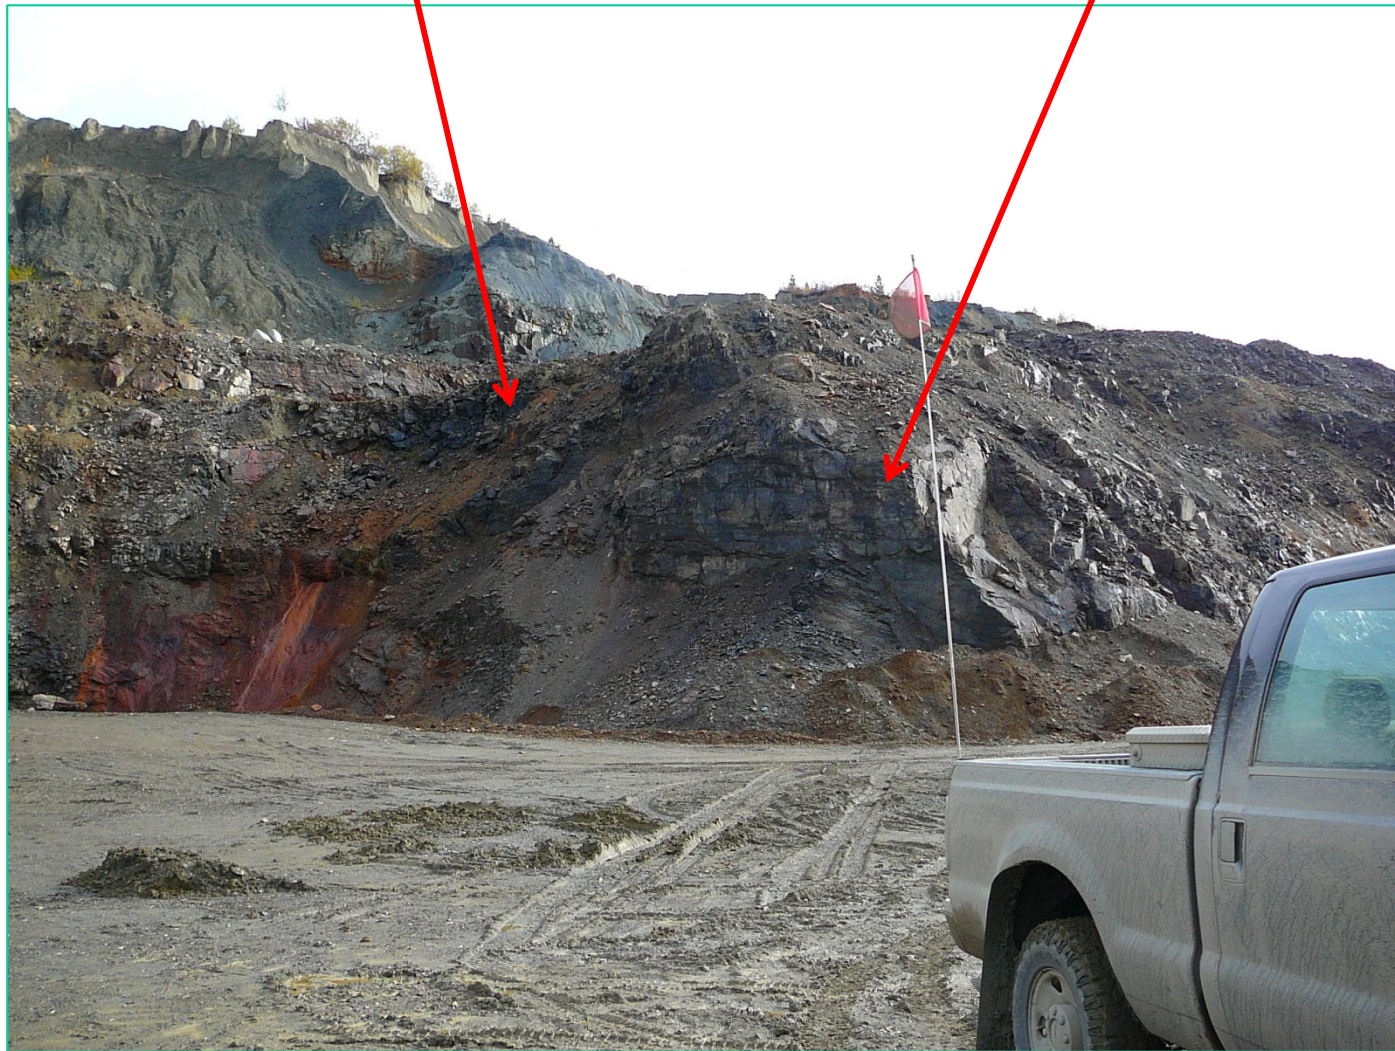
Photograph E-22
Vangorda Pit southeast wall. View looking west.

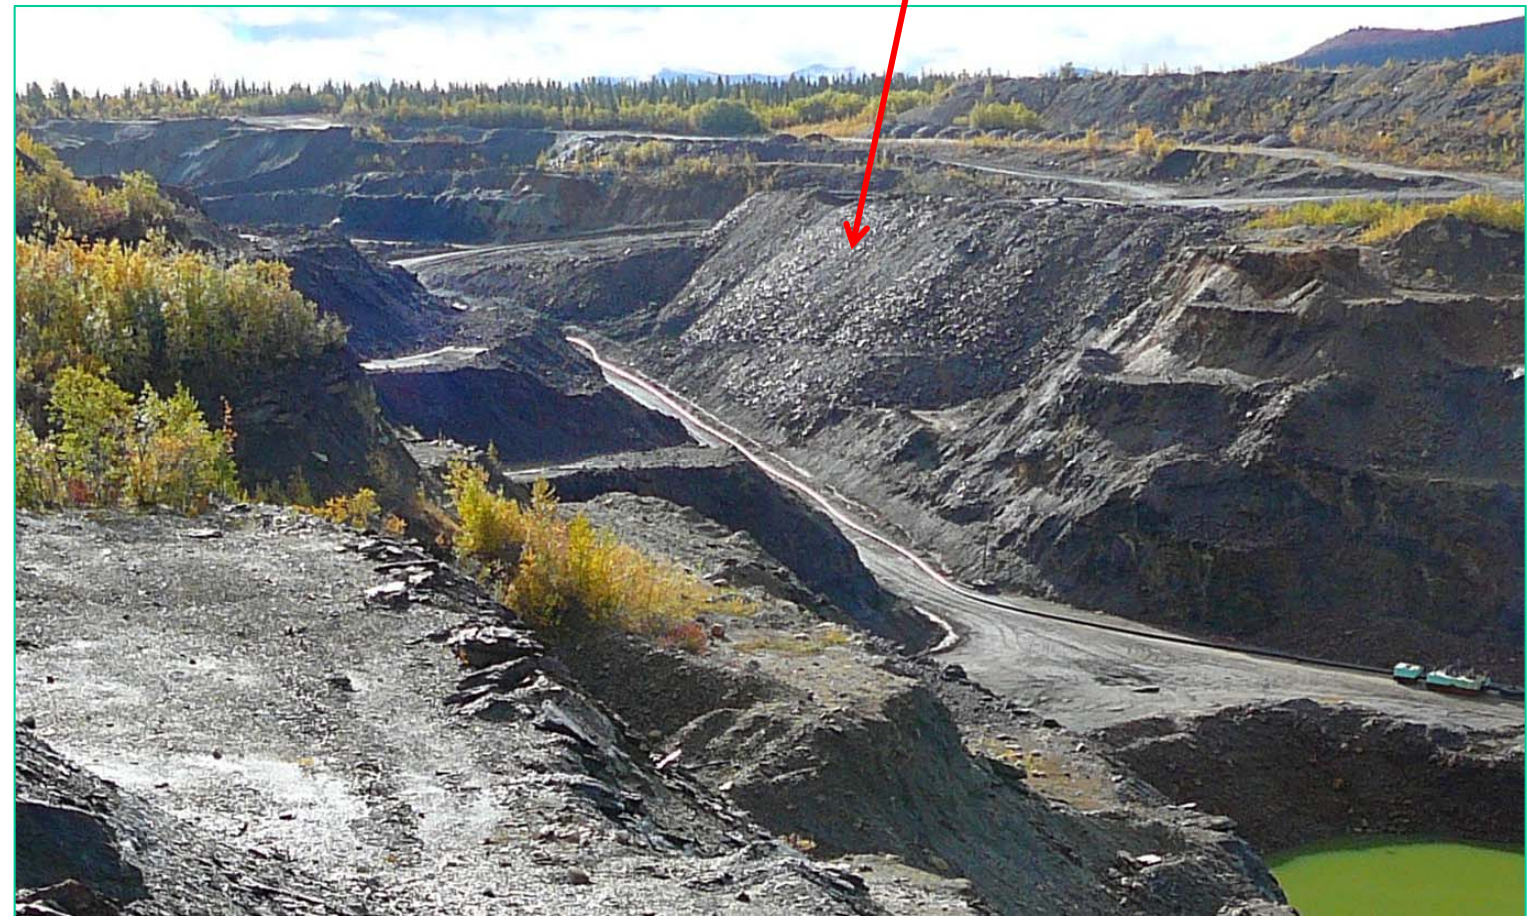
Photograph E-23
Vangorda Pit – West slope of access road. View looking south.

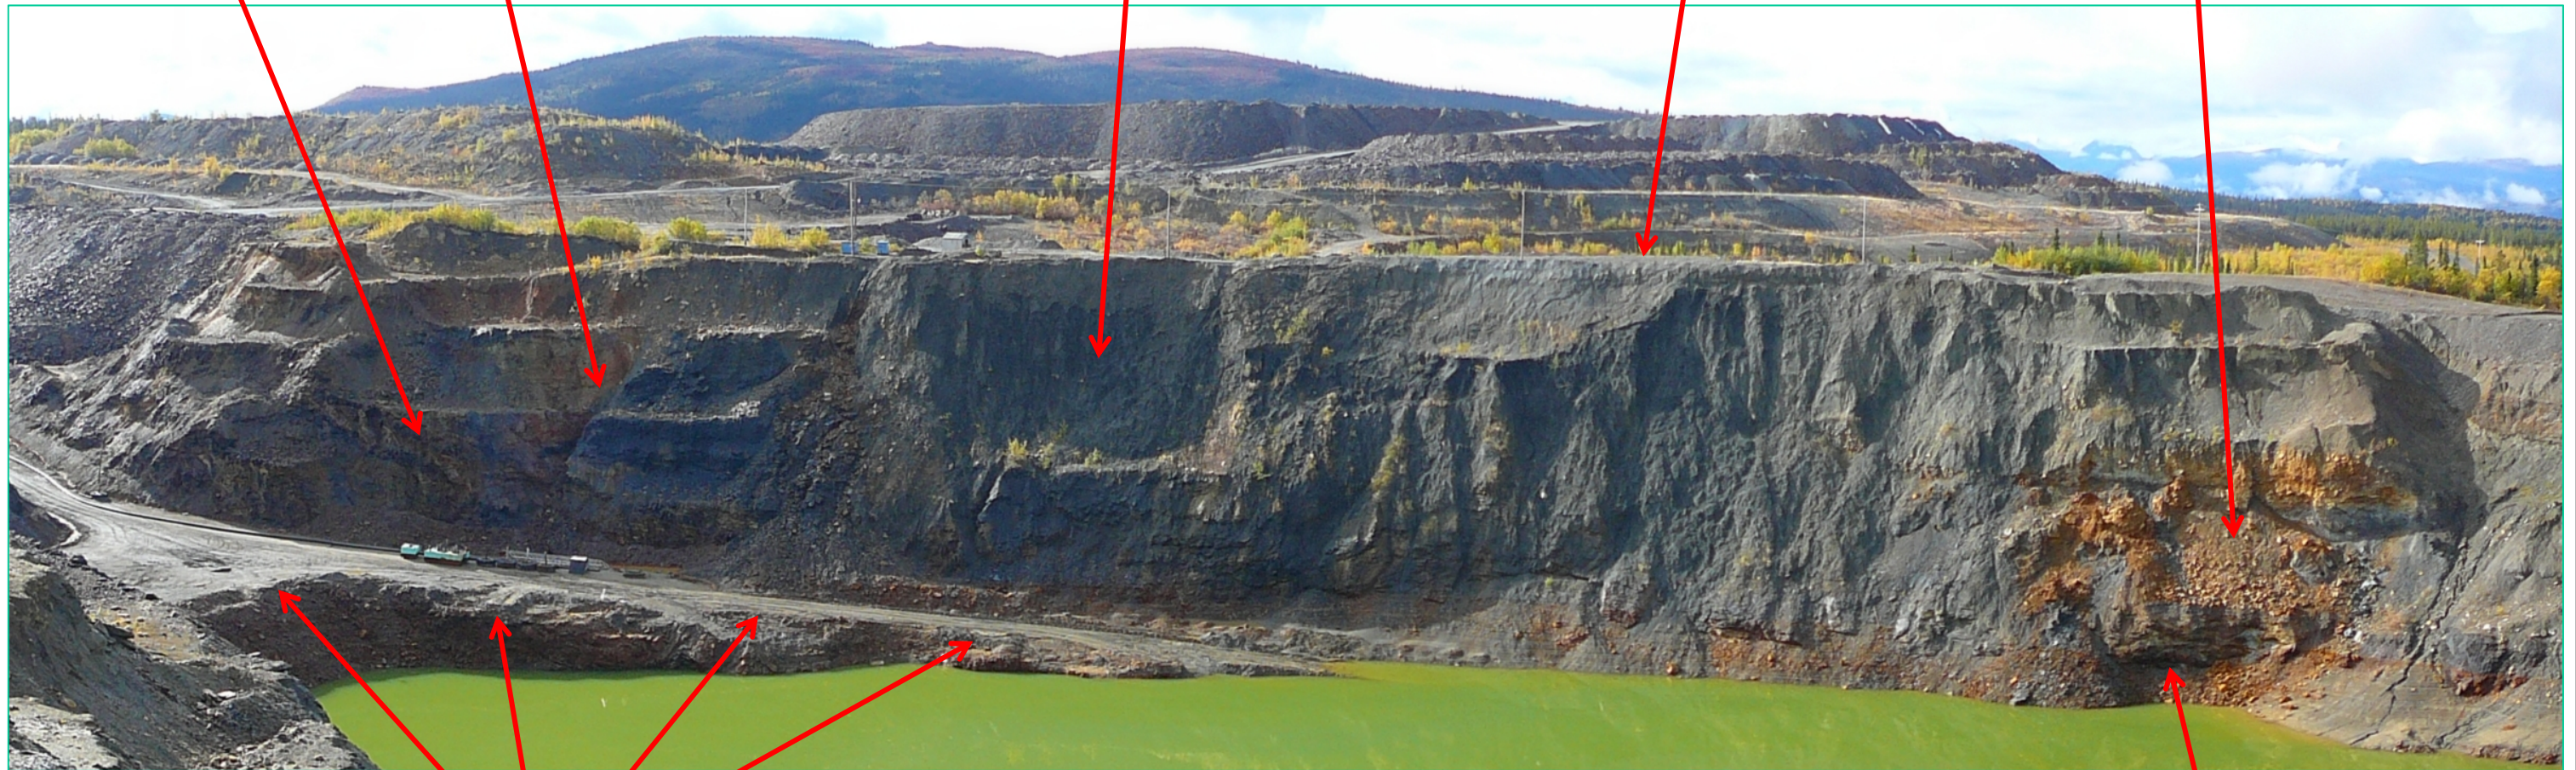
Zone of oxidized rock

Seepage observed in wall

Photograph E-25
Vangorda Pit access road, west slope. View looking northwest.

Pit	Recommendation	Frequency
Vangorda	Fix leaks in flume of the Vangorda Creek Diversion Channel, particularly where flume is located behind the crest of the northwest wall, to reduce seepage.	Ongoing.
	Continue visual inspections, particularly of the northwest wall. Look for undercut portions of the slope that could slump, and cracks in the slope face or behind the crest.	Daily.
	Maintain a distance of 10 metres if working below the walls where a rockfall berm cannot be placed.	Ongoing.
	Construct rockfall berms on either side of the access road. Berms should be approximately 1.5 metres high, with a catch ditch between the berm and the toe of the slope. The berm should include the portion below the southeast wall shown in Photograph E-26. Clean the ditch below this portion of the wall.	N/A
	Construct a vehicle control berm at the bottom of the ramp, above the pit lake as indicated in Photograph E-25.	N/A

Use material at toe to make a berm. Leave a catch ditch between the berm and the slope. Do not undercut toe of slope.
