**GOVERNMENT OF YUKON ENERGY, MINES AND RESOURCES -  
ASSESSMENT AND ABANDONED MINES**

# **Clinton Creek Engineering Review and Assessment**

## **Part 1**

307071-00997-00-SS-REP-0001

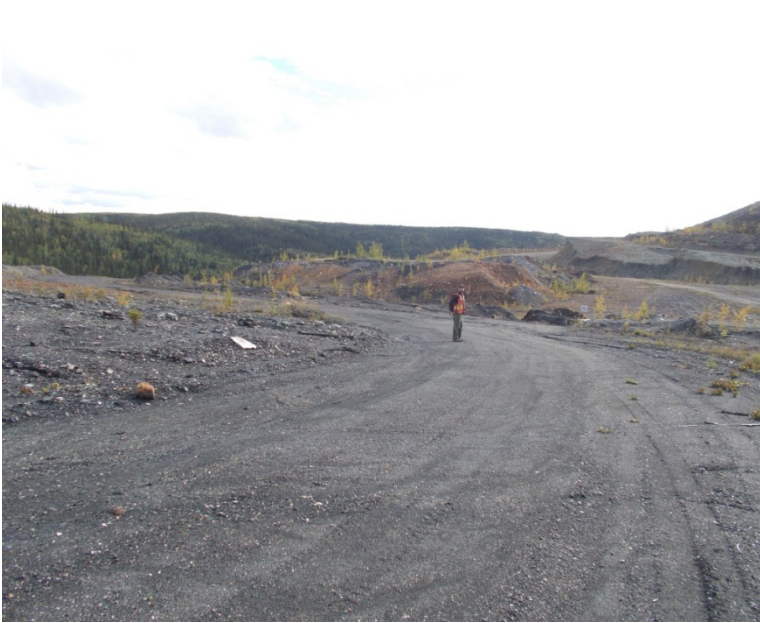
**Photo 1: Access Road north of Porcupine Pit looking east.**

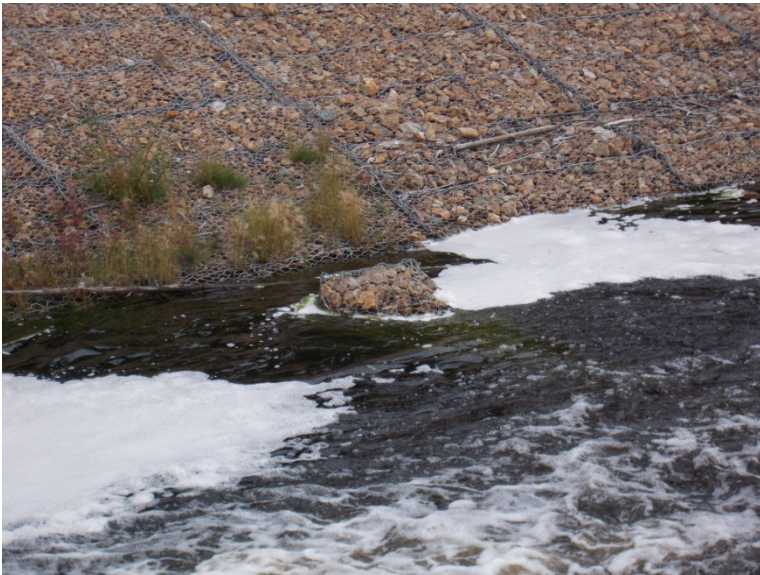
**Photo 29: Vertically displaced gabion basket at DS3 looking northeast.**

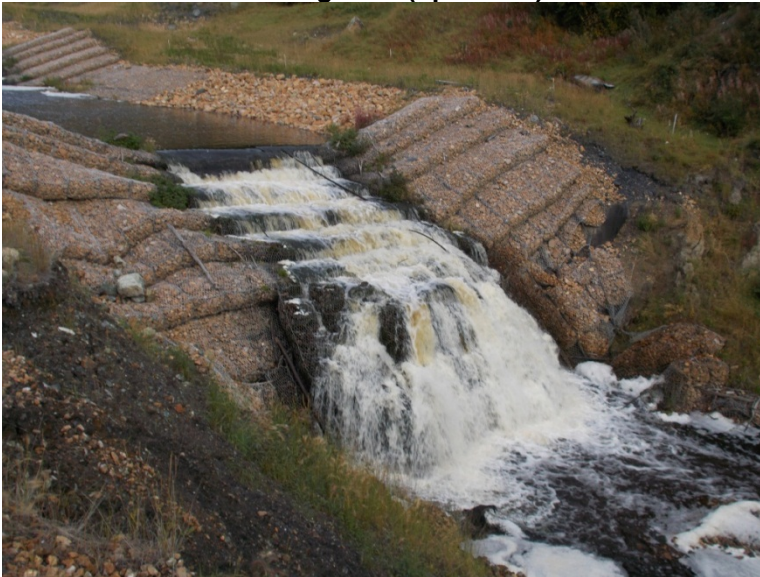
**Photo 37: DS4 looking northwest.**

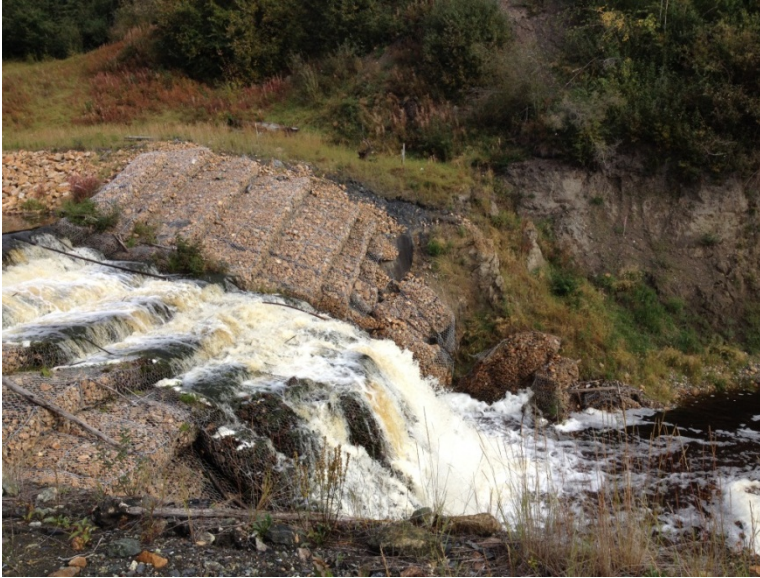
**Photo 38: DS4 looking north.**

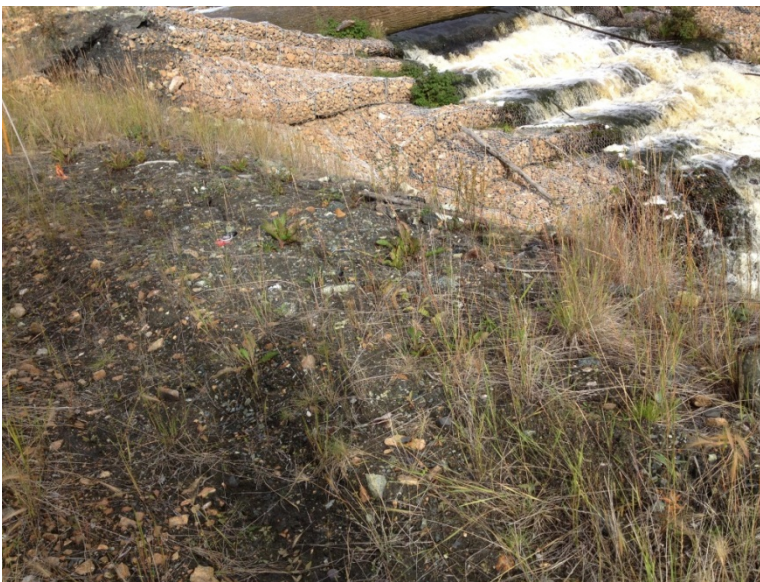
**Photo 39: DS4 looking northwest.**

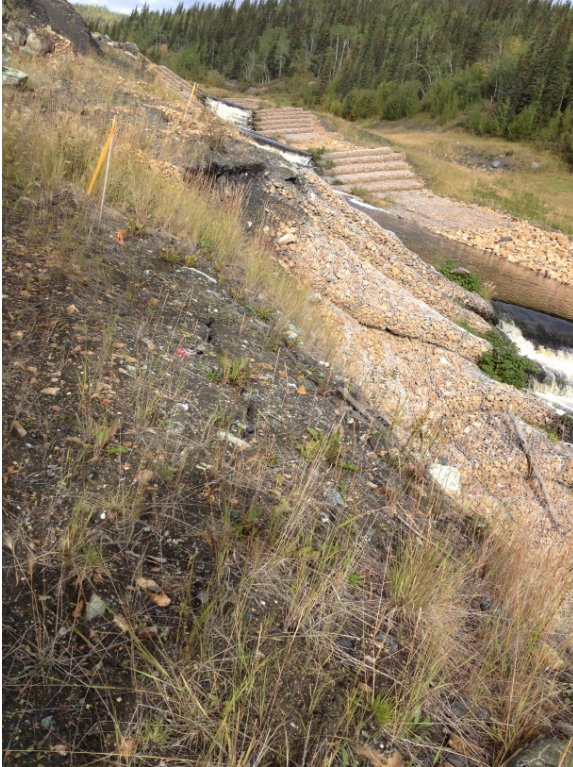
**Photo 40: DS4 looking northwest.**
