**GOVERNMENT OF YUKON ENERGY, MINES AND RESOURCES -  
ASSESSMENT AND ABANDONED MINES**

# **Clinton Creek Engineering Review and Assessment**

## **Part 2**

307071-01014-00-SS-REP-0001

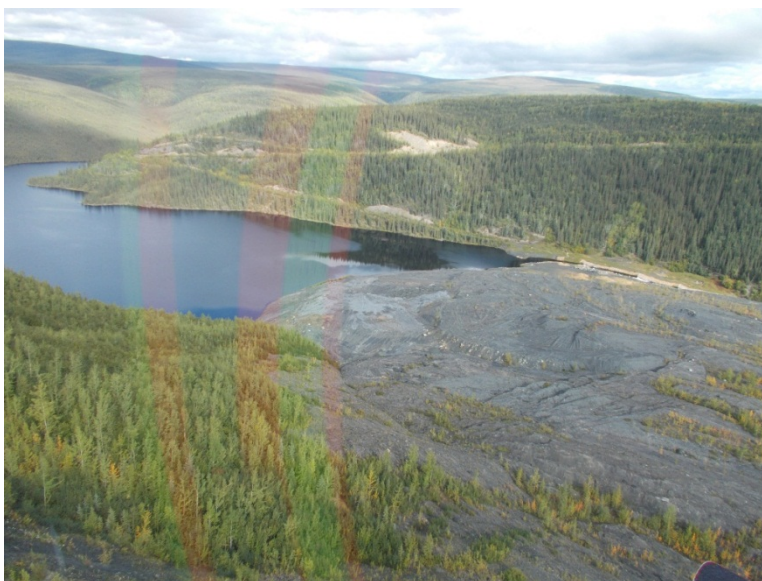
**Photo 47: Waste dump looking northwest.**

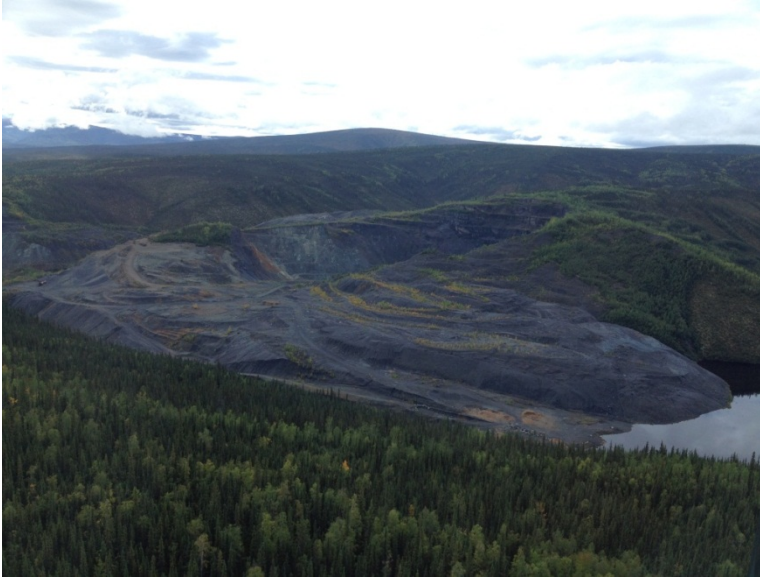
**Photo 48: Waste dump looking southeast.**

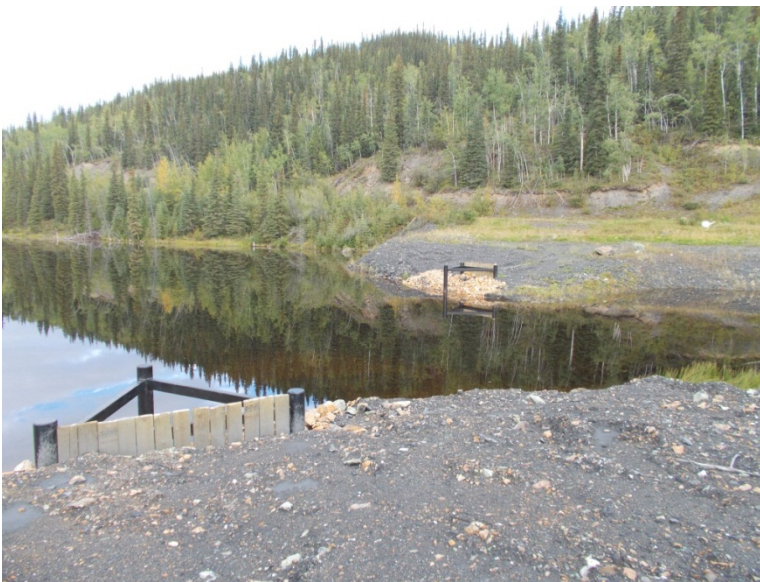
**Photo 49: Hudgeon Lake outlet looking northwest.**

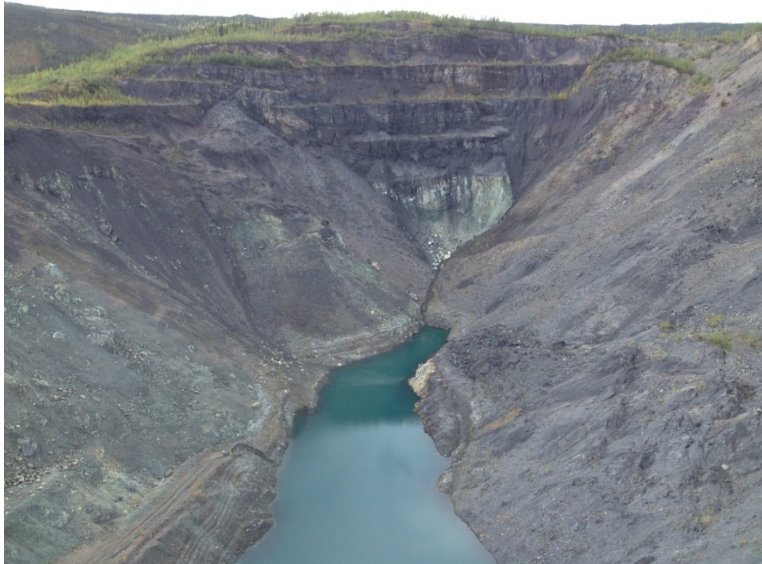
**Photo 52: Porcupine Pit looking southwest.**

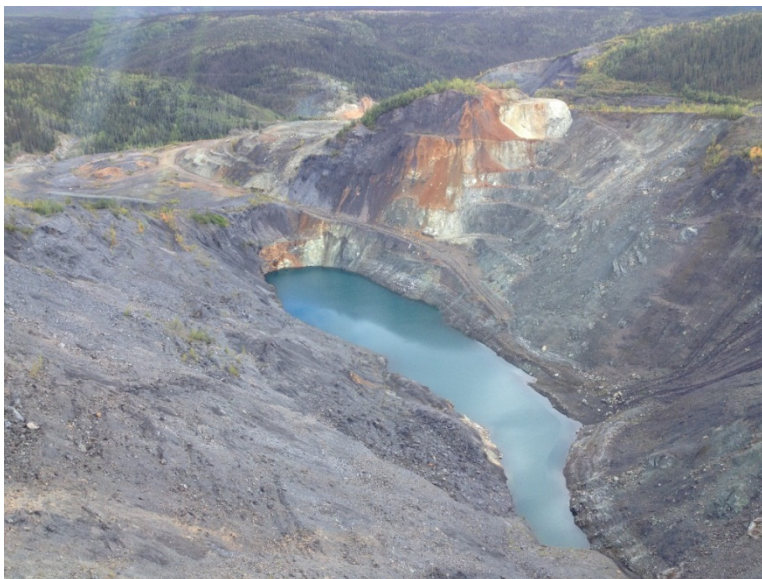
**Photo 53: Porcupine Pit looking northeast.**

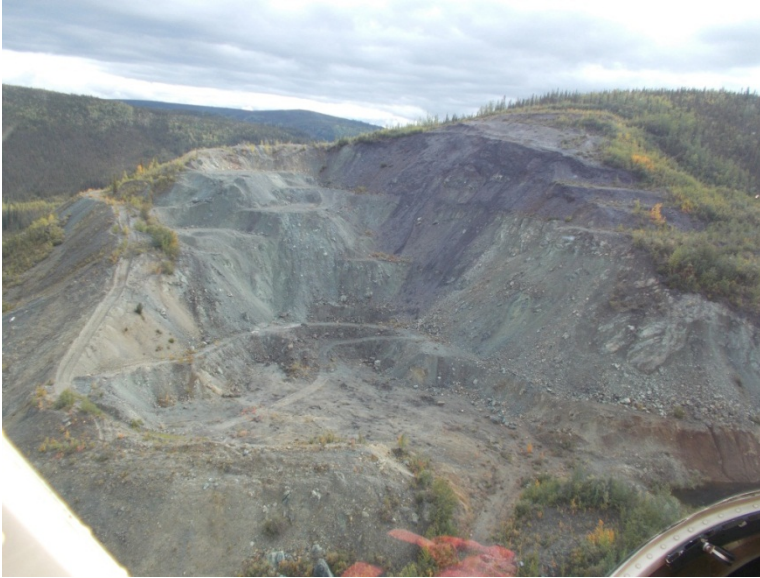
**Photo 54: Snowshoe Pit looking south.**

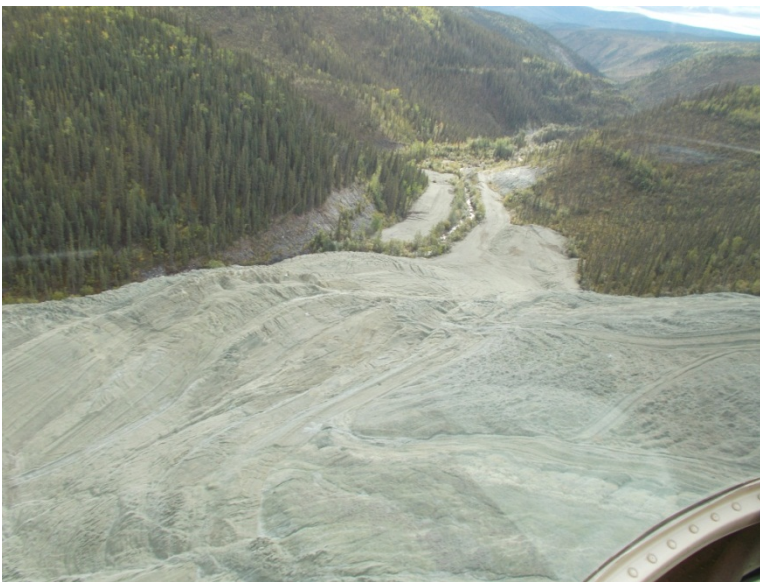
**Photo 57: Tailings slope looking southeast.**

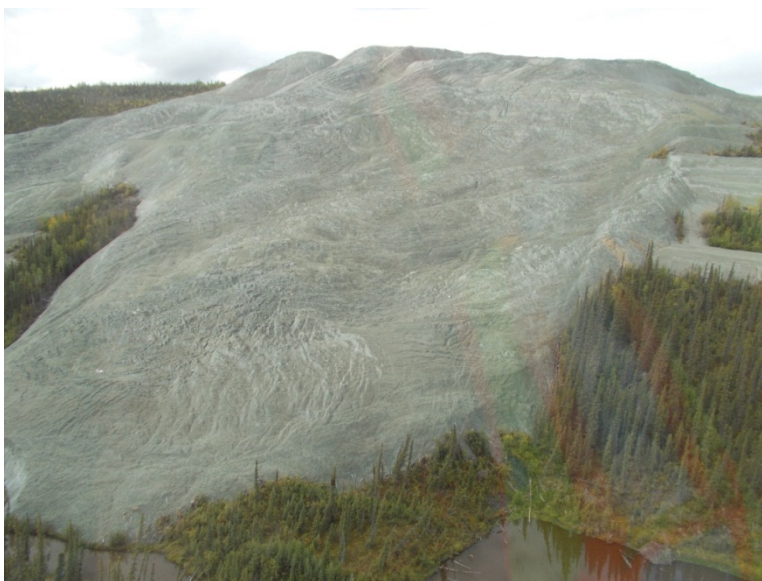
**Photo 61: Tailings slope looking west.**

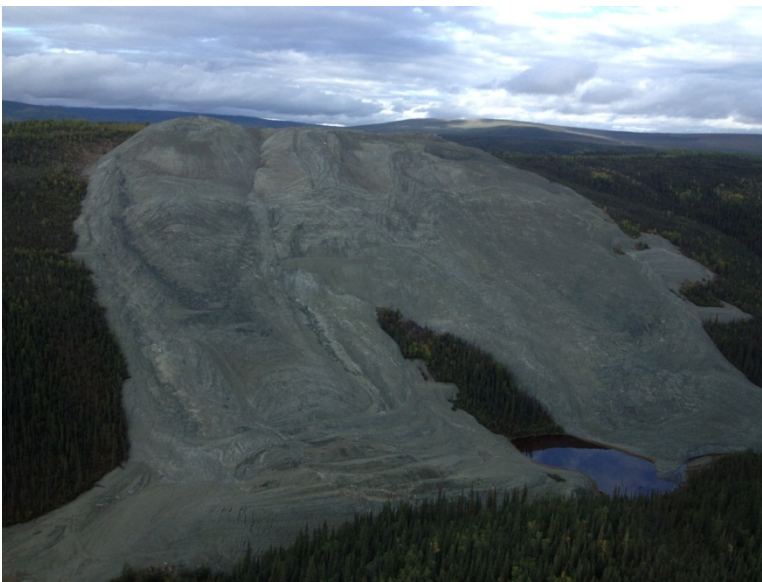
**Photo 63: Tailings slope and tailings pond looking west.**

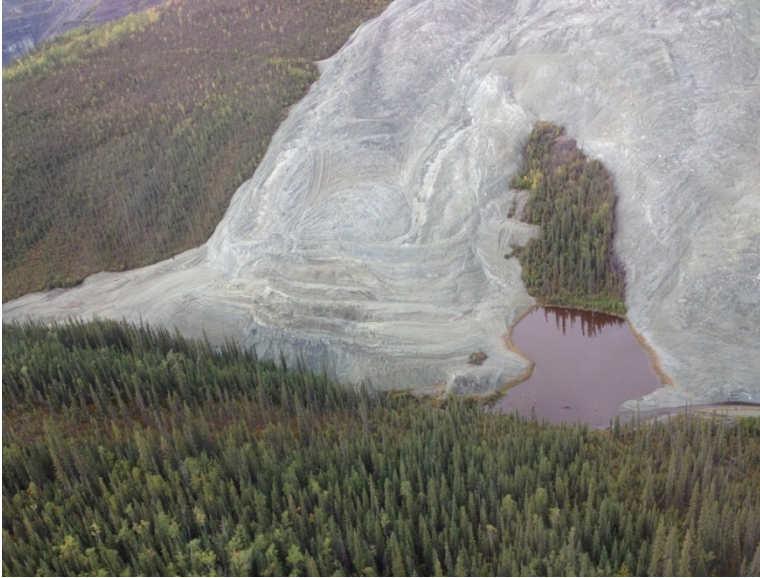
**Photo 64: Tailings slope and tailings pond looking west.**

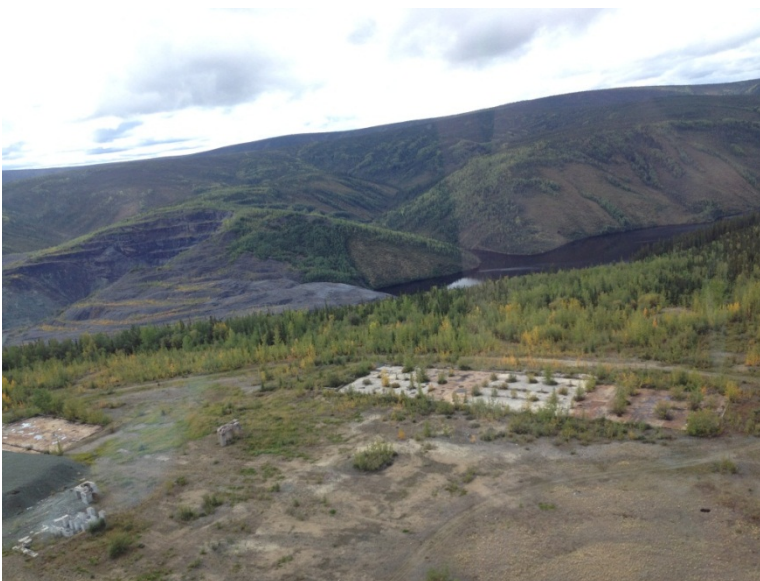
**Photo 67: Mill site looking south.**

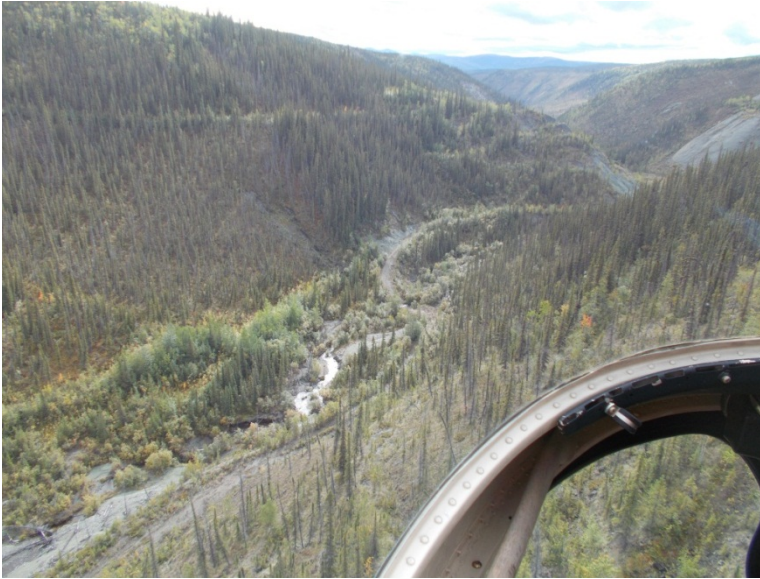
**Photo 68: Wolverine Creek looking southeast.**

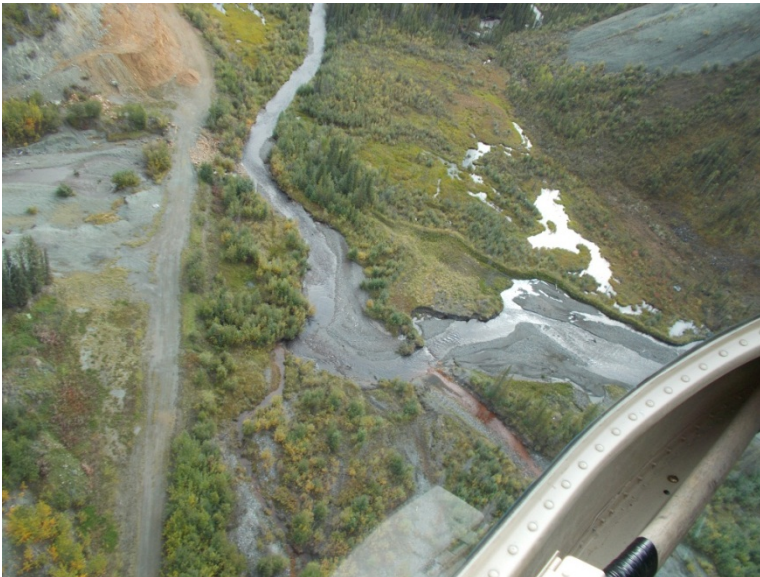
**Photo 69: Wolverine Creek at confluence with Clinton Creek looking east.**

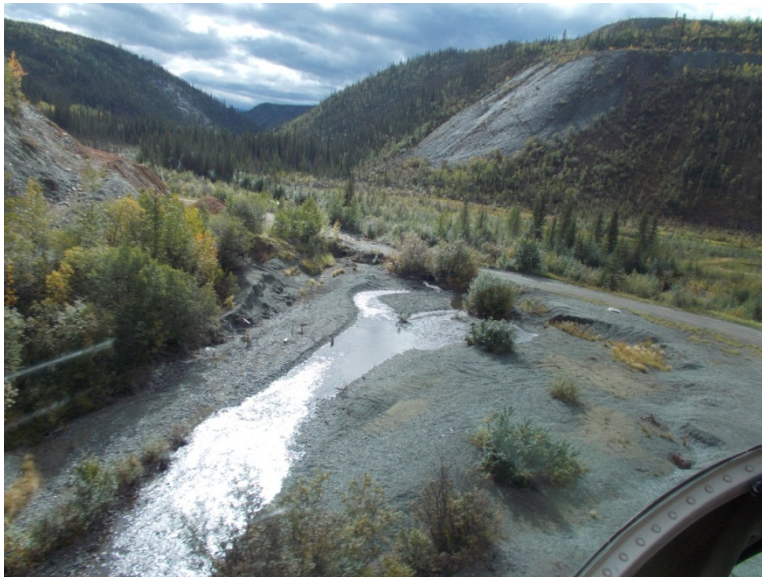
**Photo 71: Wolverine Creek at confluence with Clinton Creek looking southeast.**

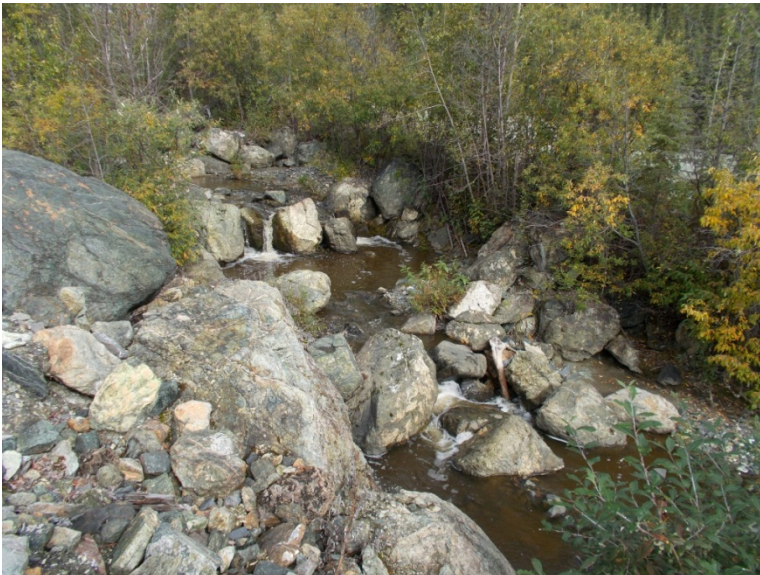
**Photo 73: Wolverine Creek north of confluence with Clinton Creek looking north.**

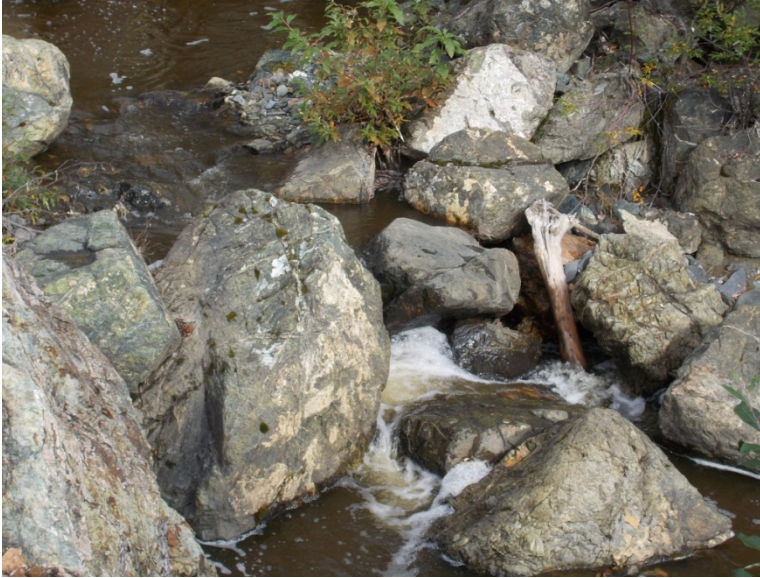
**Photo 74: Wolverine Creek north of confluence with Clinton Creek looking northeast (upstream).**

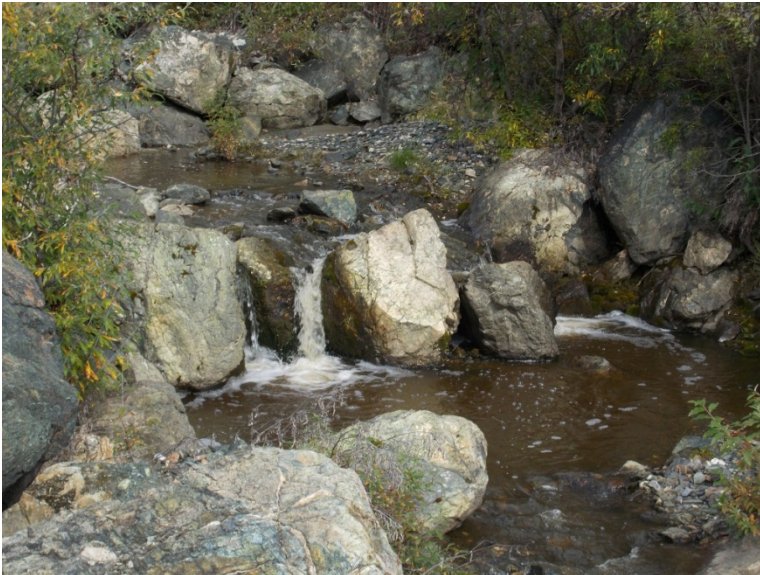
**Photo 75: Wolverine Creek north of confluence with Clinton Creek looking north (upstream).**

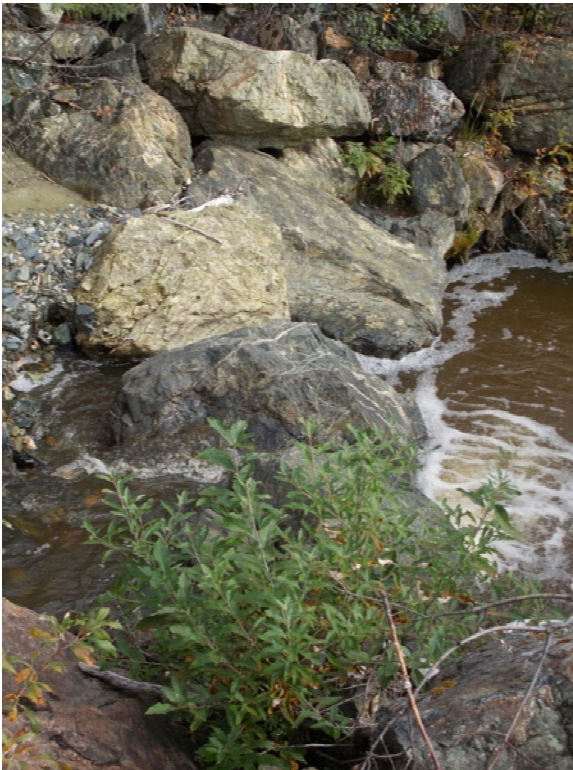
**Photo 76: Wolverine Creek north of  
confluence with Clinton Creek  
looking east.**

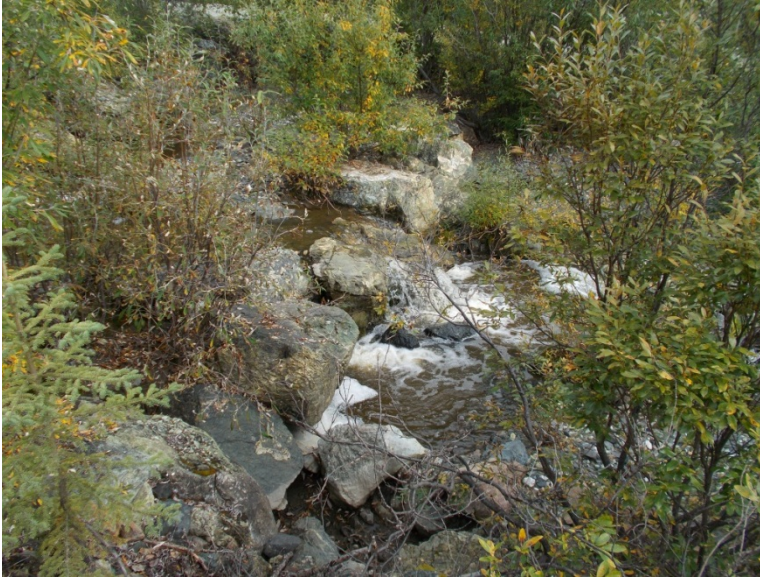
**Photo 79: Wolverine Creek north of confluence with Clinton Creek looking east.**

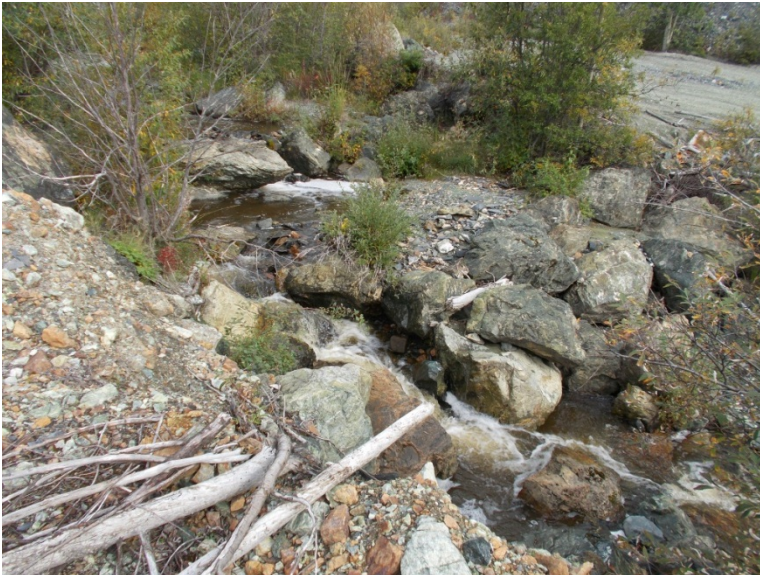
**Photo 80: Wolverine Creek north of confluence with Clinton Creek looking northeast.**
