Clinton Creek Long-Term Performance Monitoring Program

2016 Survey Results

December 12, 2016

307071-01132-00-GT-REP-0001

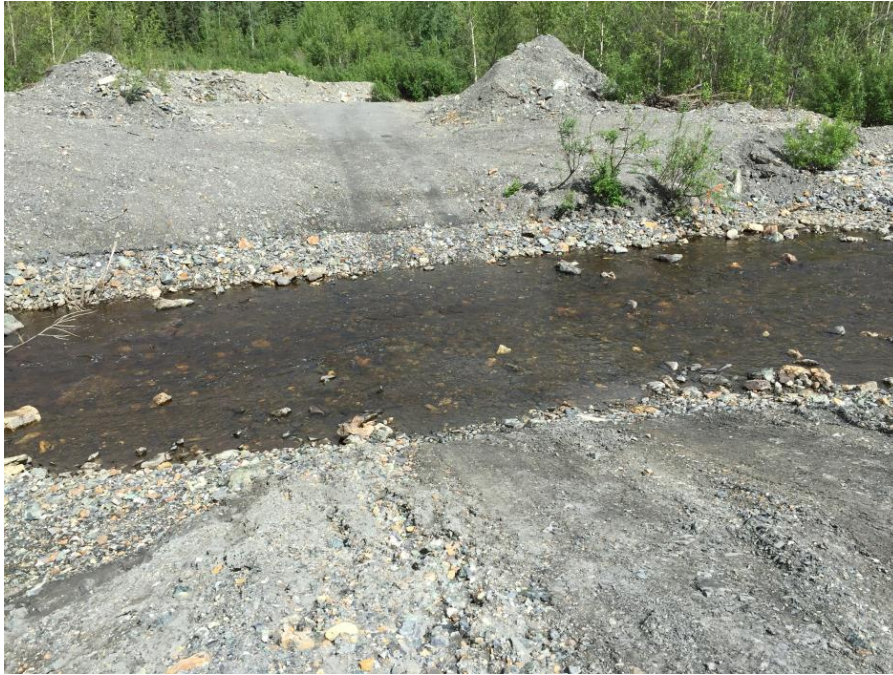
Photo 5 **Fording No. 1 looking north**

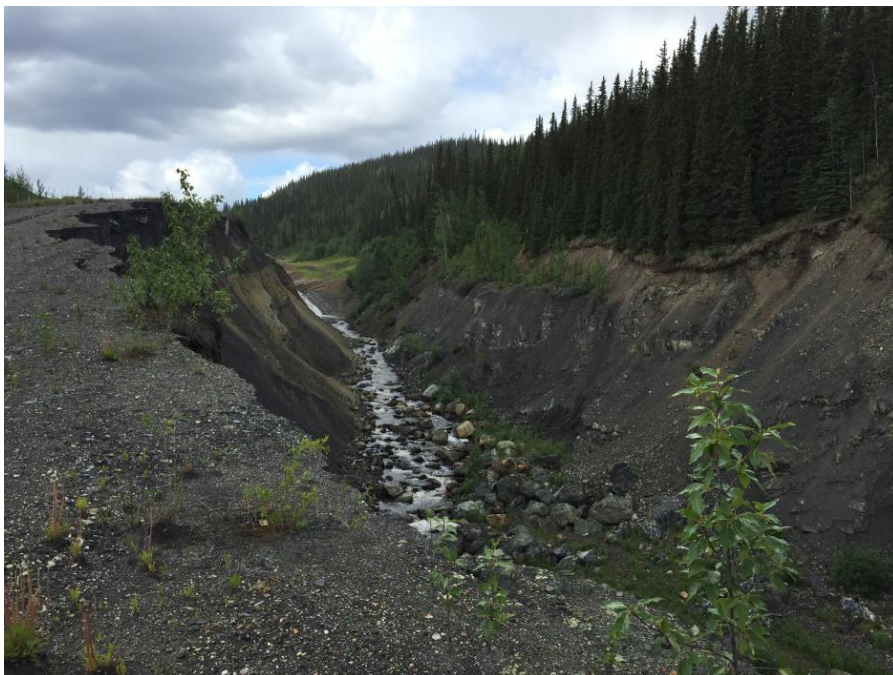
Photo 28 Closed portion of Access Road, looking upstream

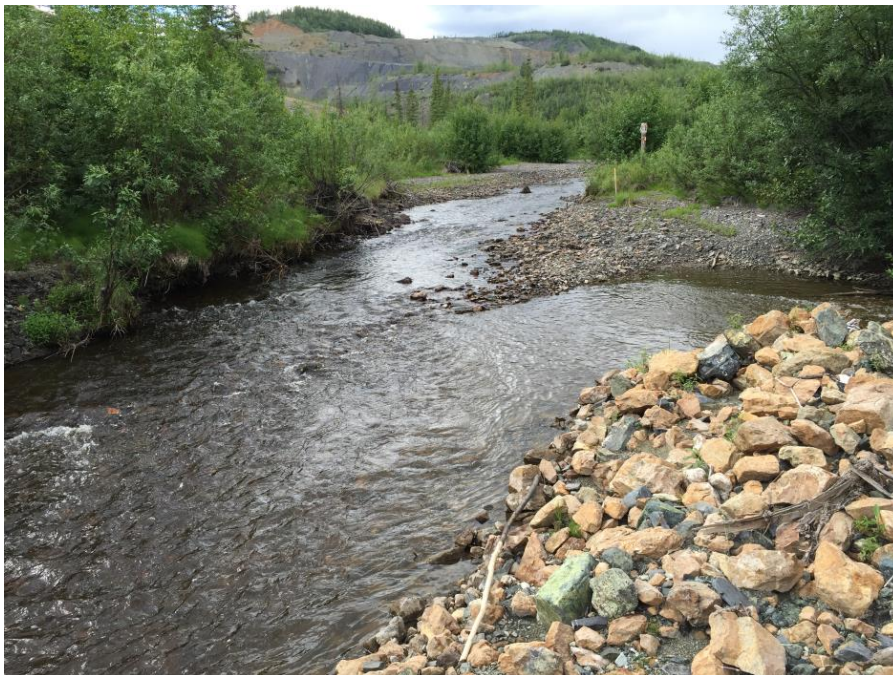
Photo 32 **Confluence with Wolverine Creek, looking upstream**

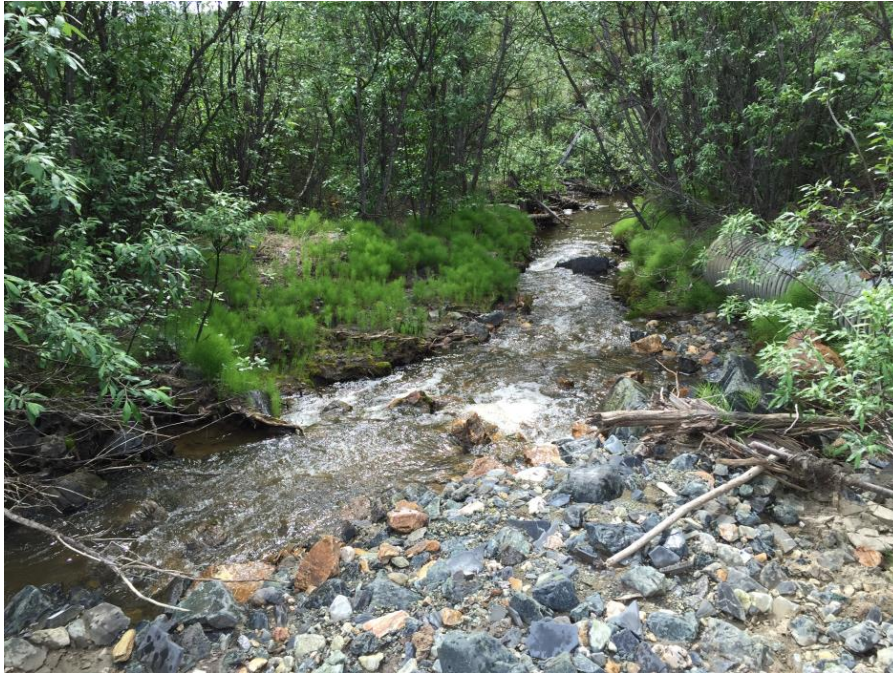
Photo 37 Lower Wolverine Creek looking downstream

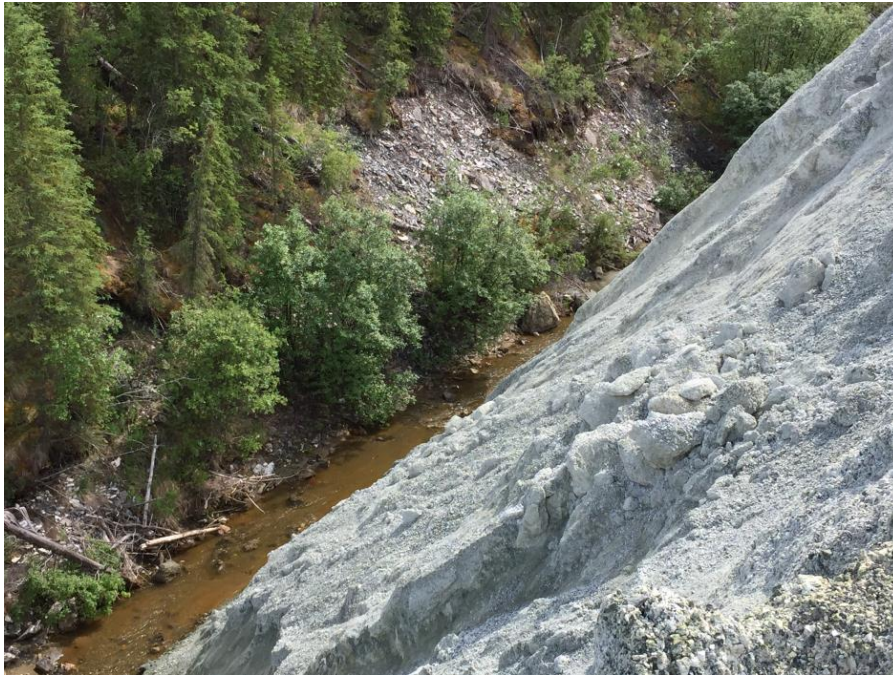
Photo 39 Upper Wolverine Creek looking downstream (South lobe)

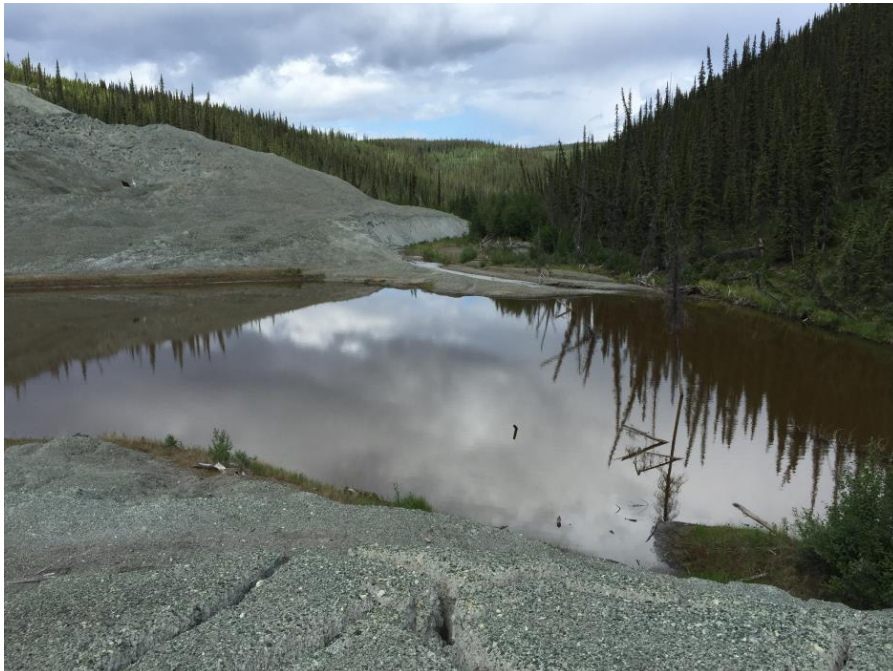
Photo 40 Wolverine South Pond looking north

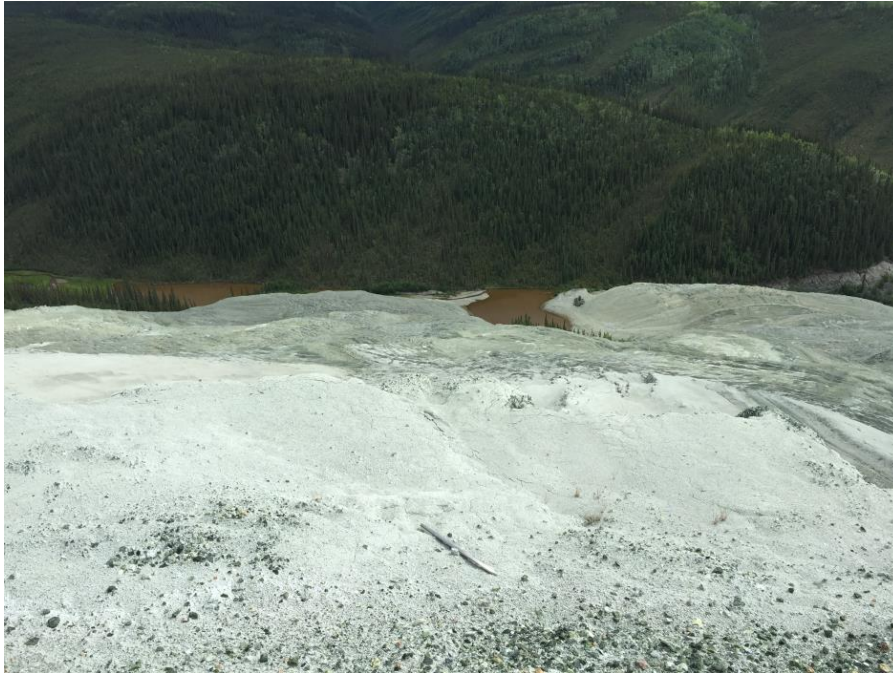
Photo 41 **Wolverine North and South Ponds looking east**

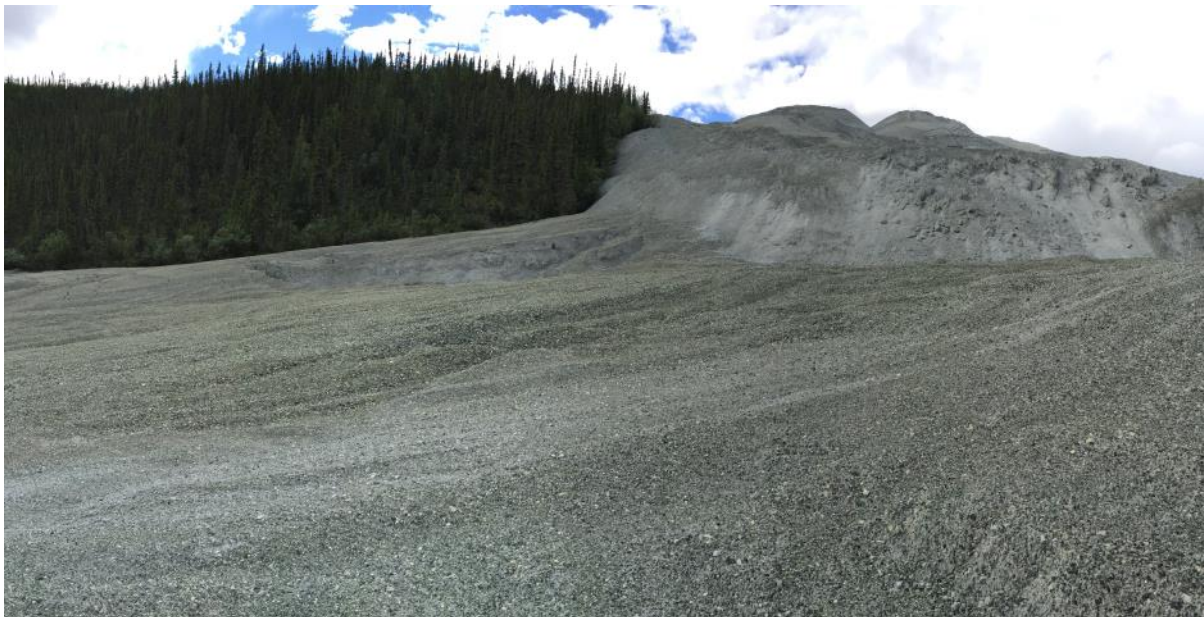
Photo 43 Tailings Pile looking west near Wolverine Creek (South lobe)

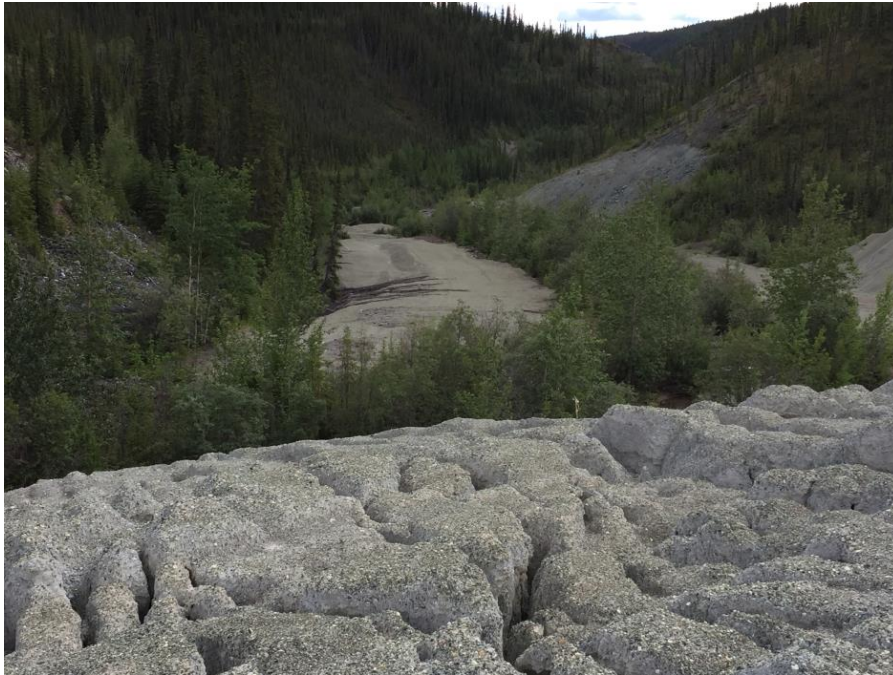
Photo 44 Tailings Pile looking south at Wolverine Creek (South lobe)

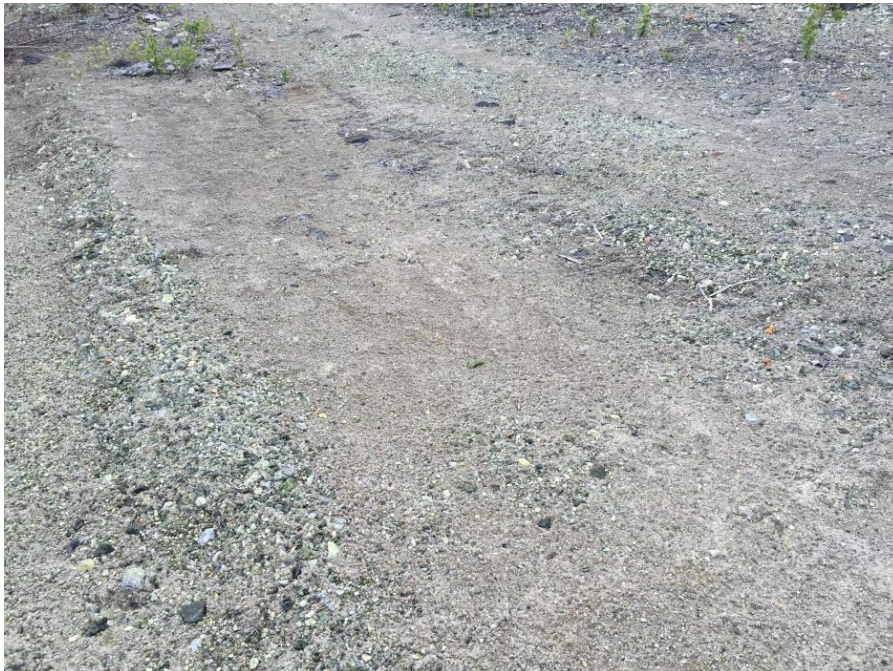
Photo 45 Concentrated asbestos fibres at surface of tailings near Wolverine Creek

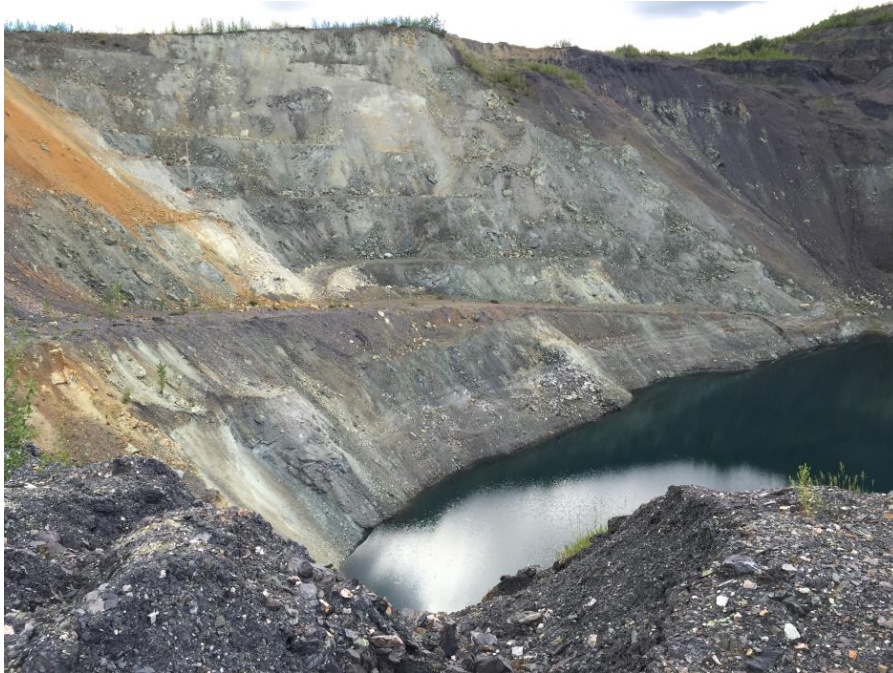
Photo 46 Porcupine Pit looking south

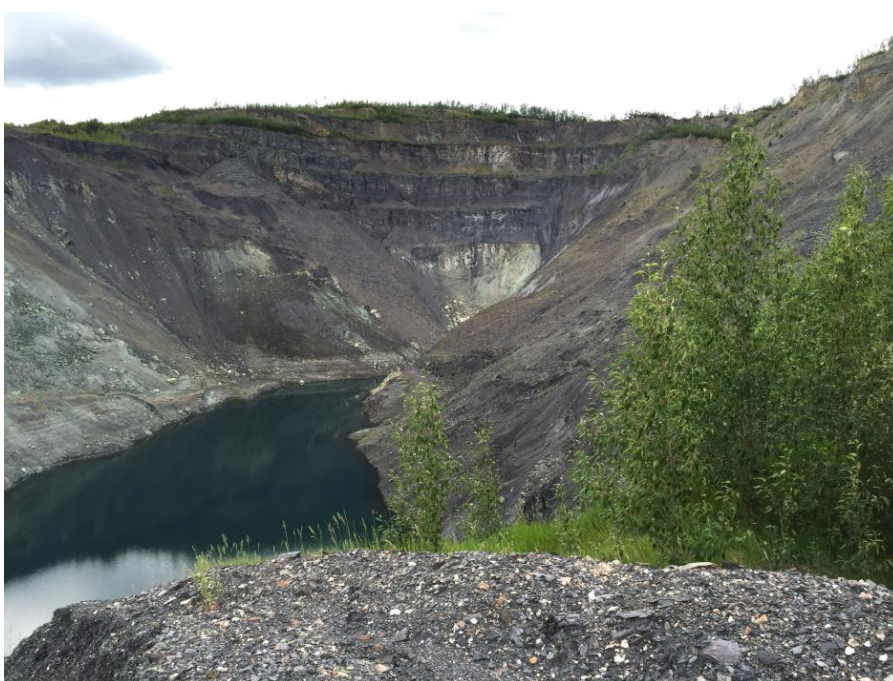
Photo 47 Porcupine Pit looking south

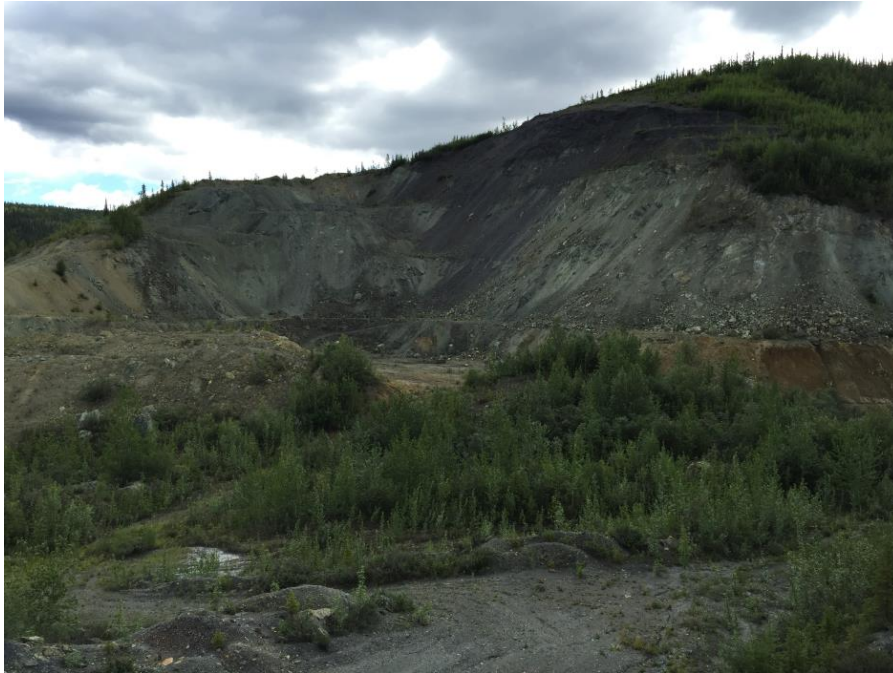
Photo 48 **Snowshoe Pit looking southeast**
