# Faro Mine Complex Care & Maintenance

**Tlcho Engineering and Environmental Services**  
**Quarter 1 Performance Report**  
**August 2012**

## **Q1 Performance Presentation**

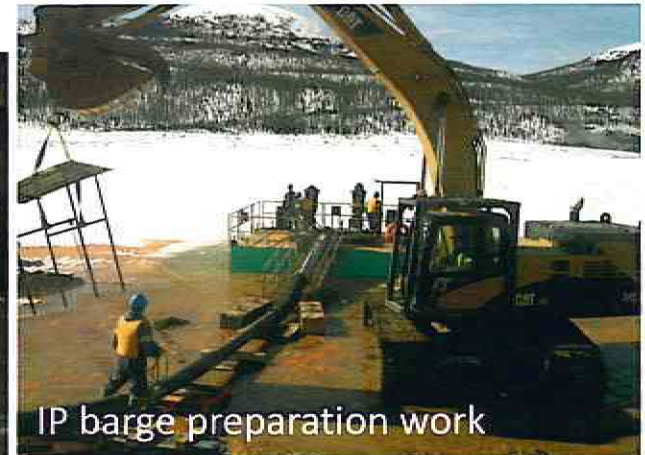
IP barge preparation work

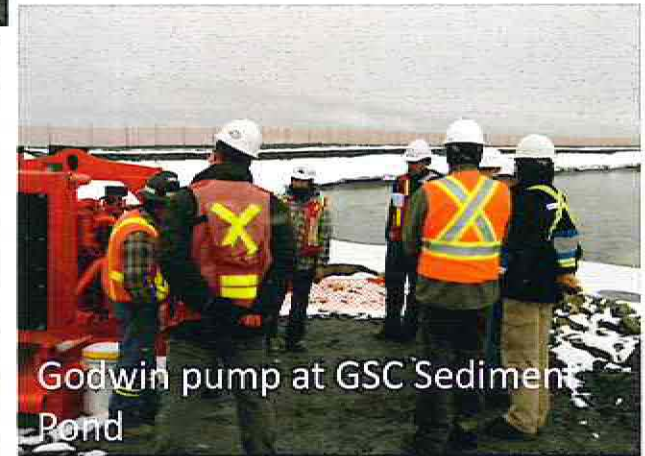
Godwin pump at GSC Sediment  
Pond

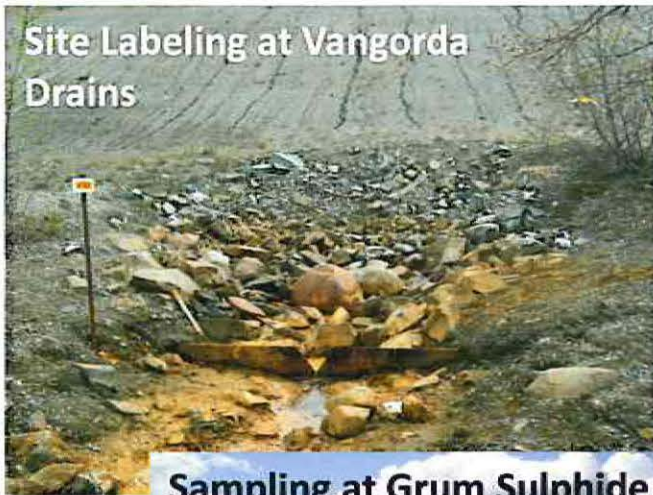
Site Labeling at Vangorda  
Drains
