Report To  
CYPRUS ANVIL MINING CORPORATION  
On  
1982  
PERFORMANCE MONITORING  
Of The  
DOWN VALLEY TAILINGS PROJECT  
Faro Yukon

February, 1983

822-2021

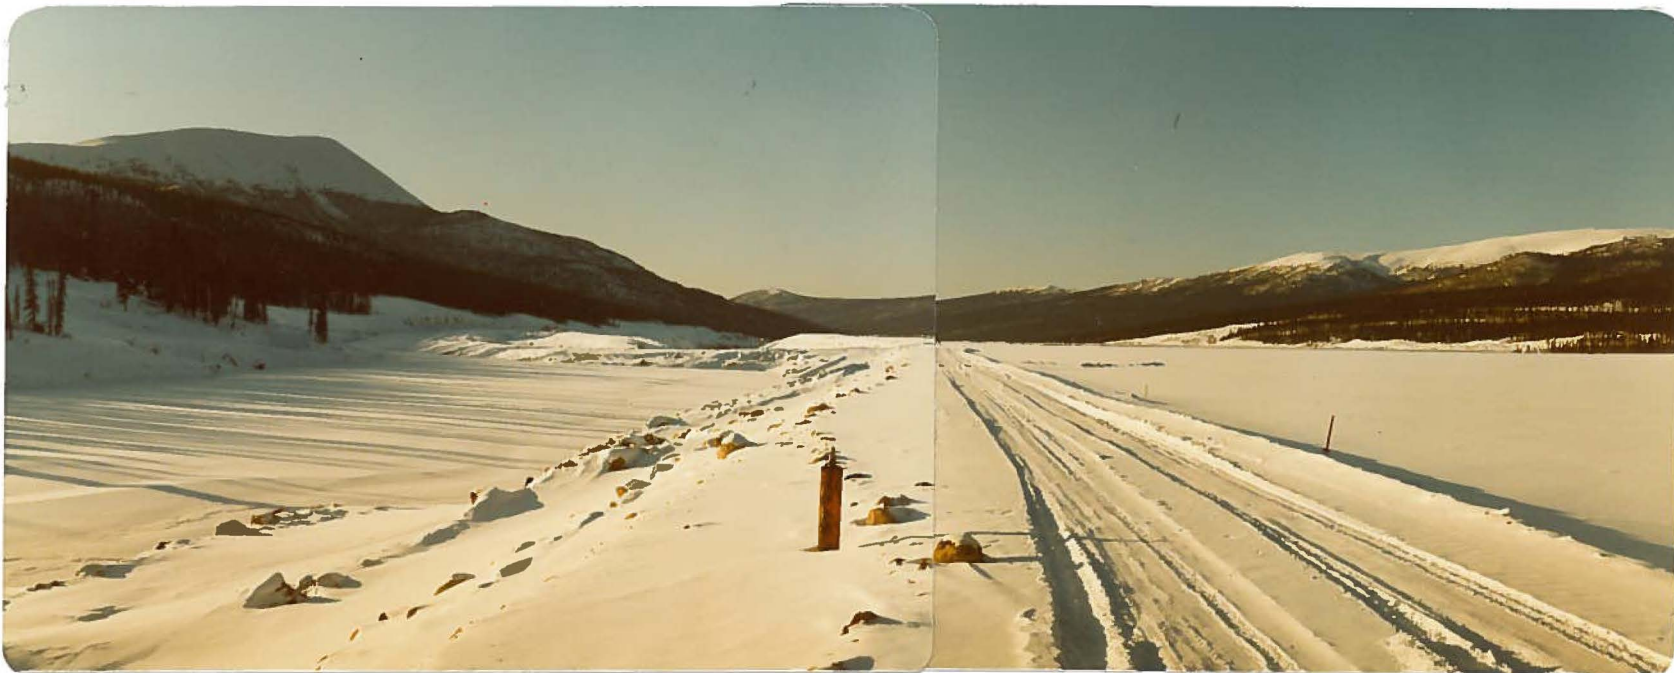
View looking west showing old tailings dyke and new diversion dam headpond.

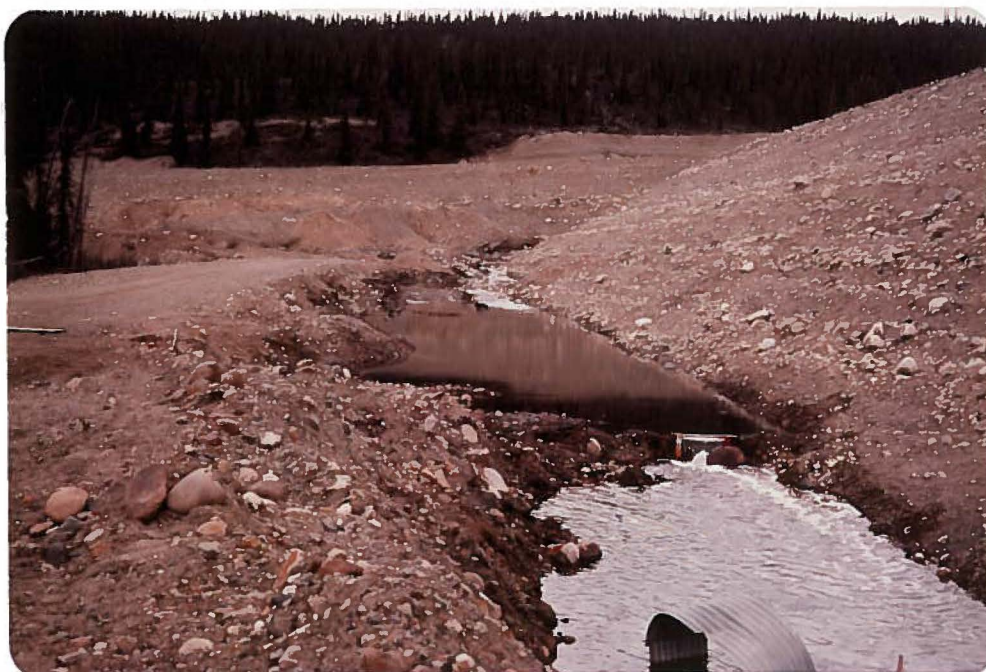
View NNE showing toe drain CVD (c. 1 June)

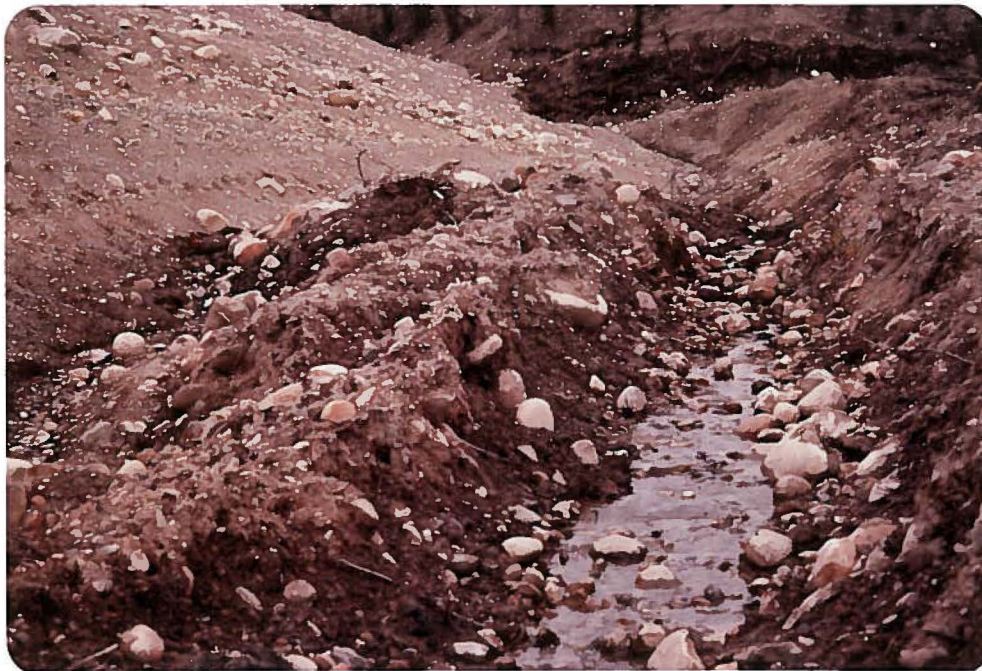
View south from approx. Sta 0+500 (c. 1 June 1982) showing toe drain.

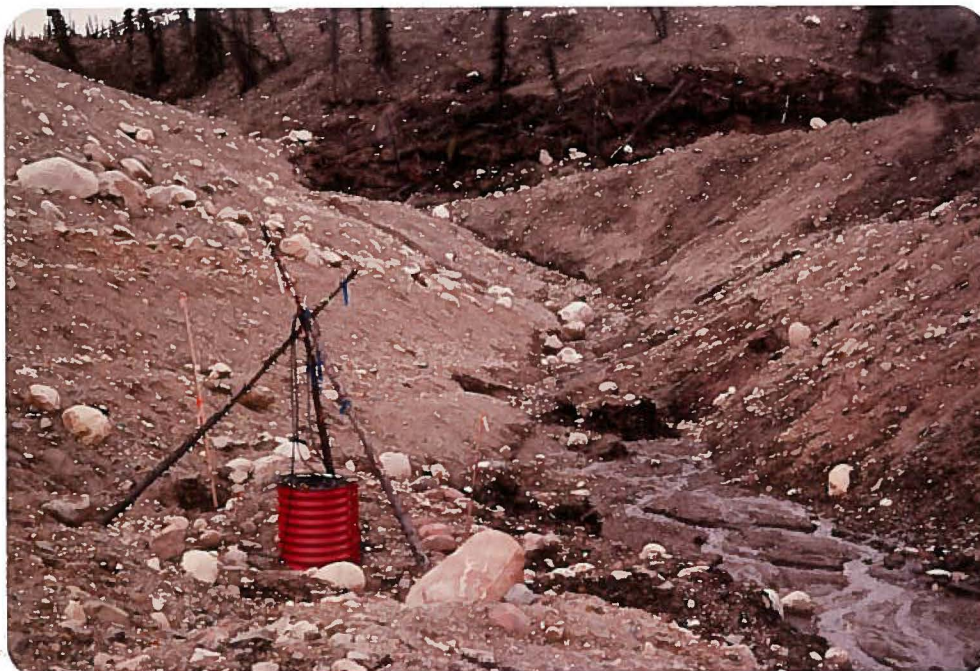
Closeup of above photo showing south abutment area.

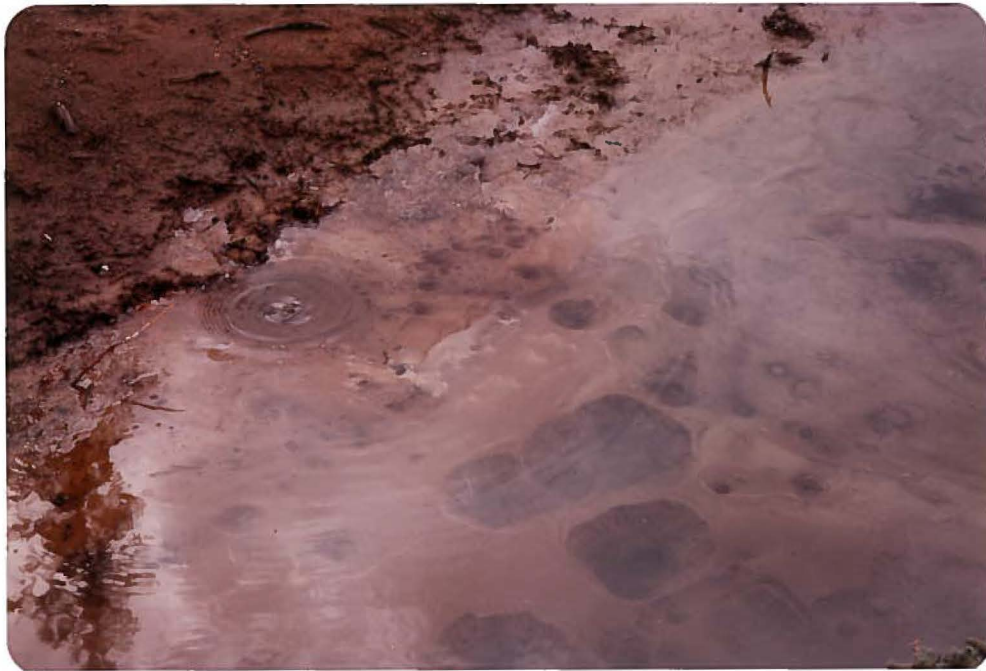
Seepage boils in abandoned meander of Rose Creek. Note active sand boil and craters from previous activity. Such boils are not a present concern.

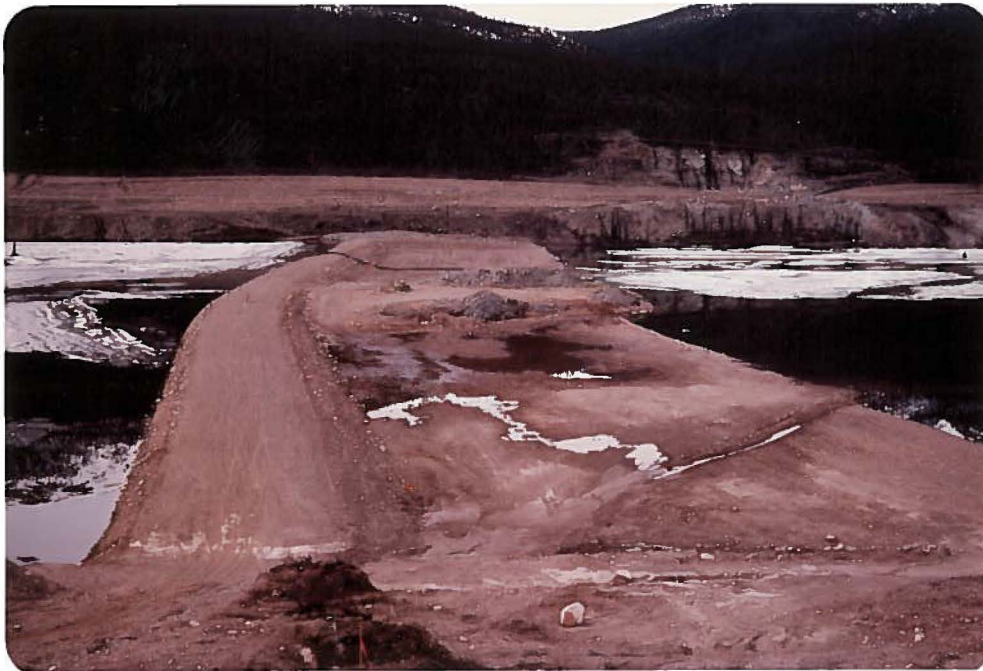
View SSW of Intermediate Dam at full impoundment. Note surface of seepage at downstream toe of embankment from approx. Sta 0+220 to Sta 0+350 (c. 1 June 1982)

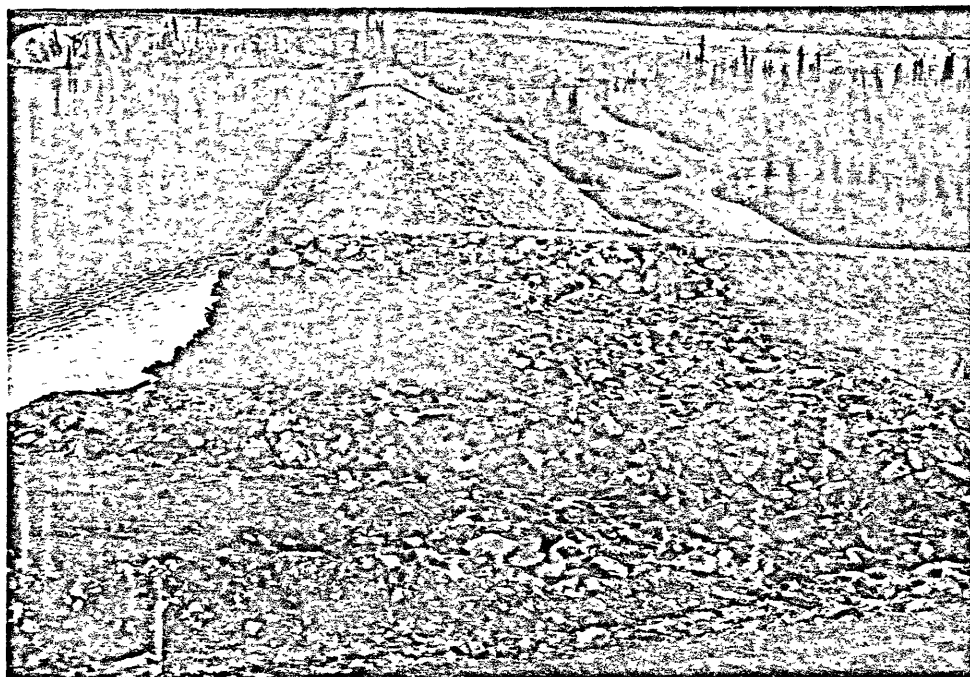
PHOTO 13

Looking across the Cross Valley Dam.
