Preliminary Environmental Investigation

~~BC 96~~ **Site 30 - North of Burwash Landing**

~~HS 49~~ **Site 39 - Kathleen River Crossing**

~~HJ 11~~ **Site 44 - Marshall Creek Road**

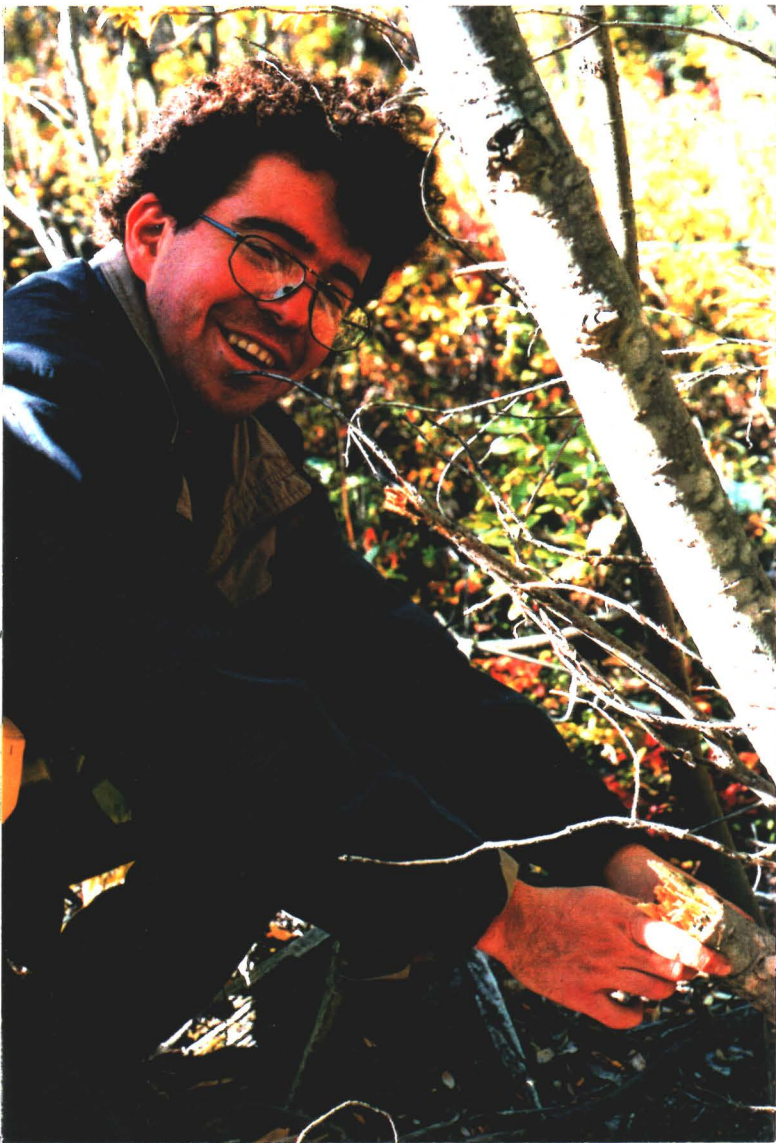
Photograph 30-P13: Vegetation being sampled near site 30-S15.

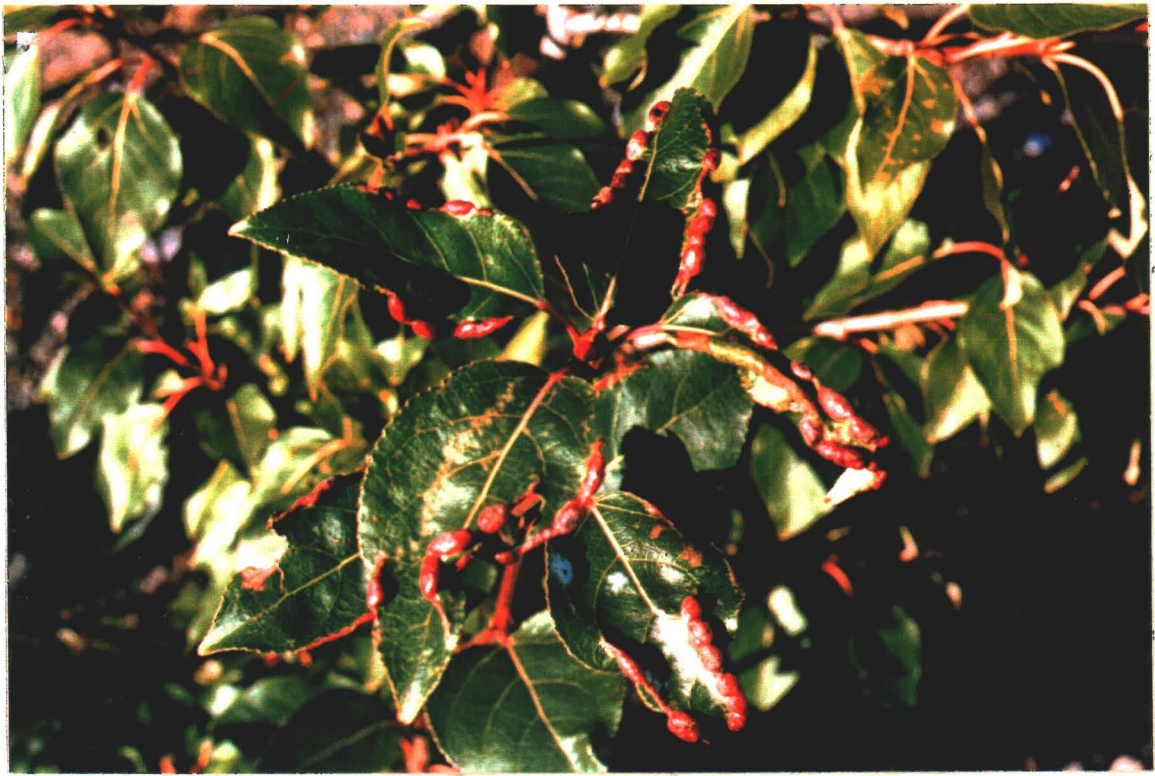
Photograph 39-P7: Poplar leaves near 39-TP1

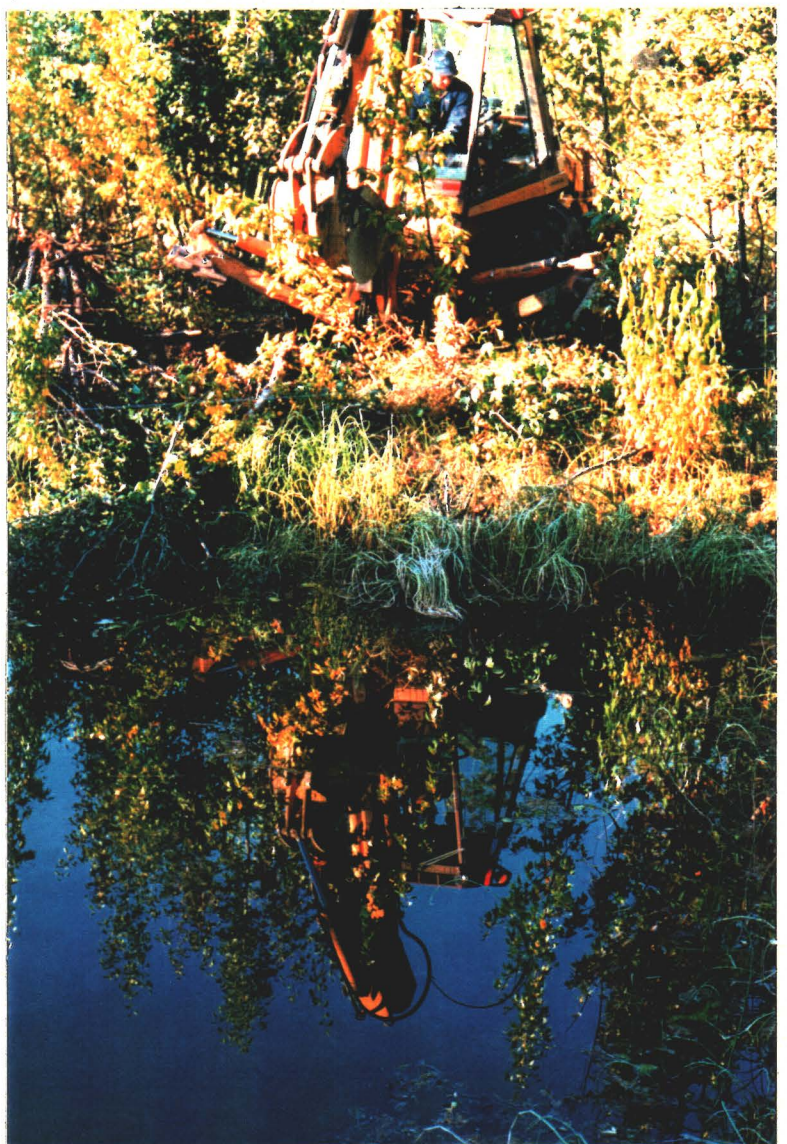
Photograph 44-P10: Backhoe on west bank of the east pond.

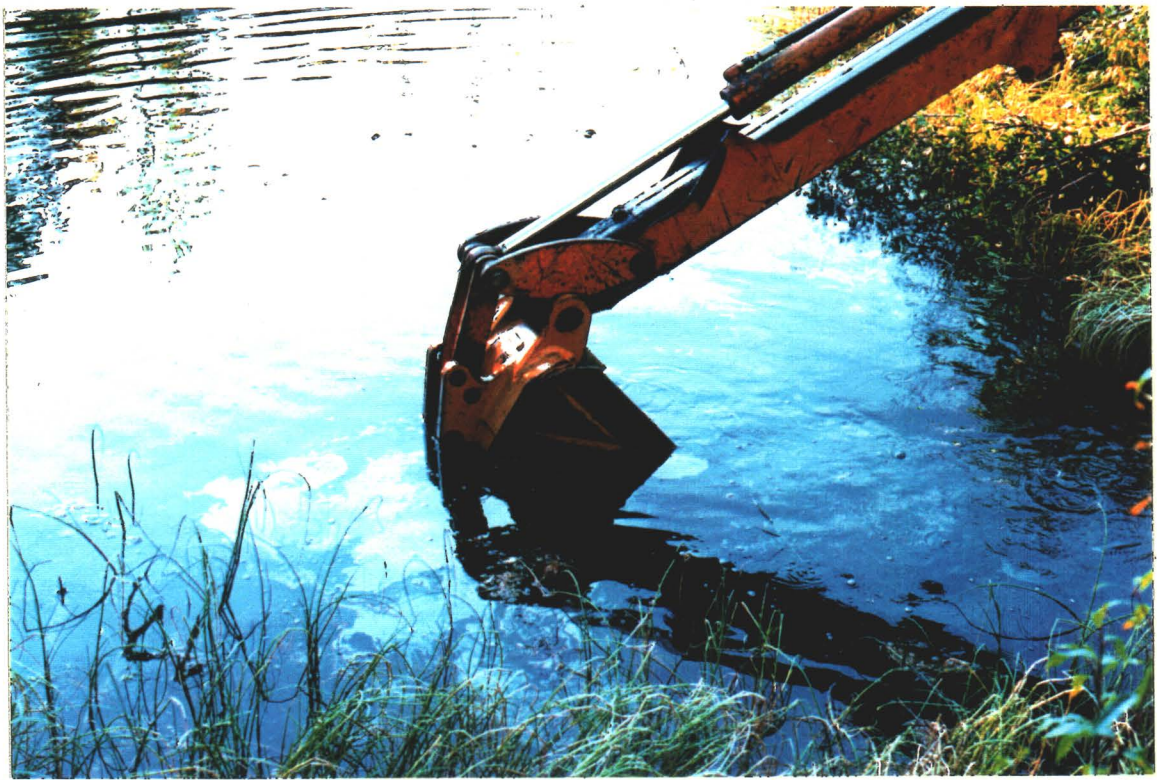
Photograph 44-P11: Backhoe on the west bank of east pond with its bucket in pond.

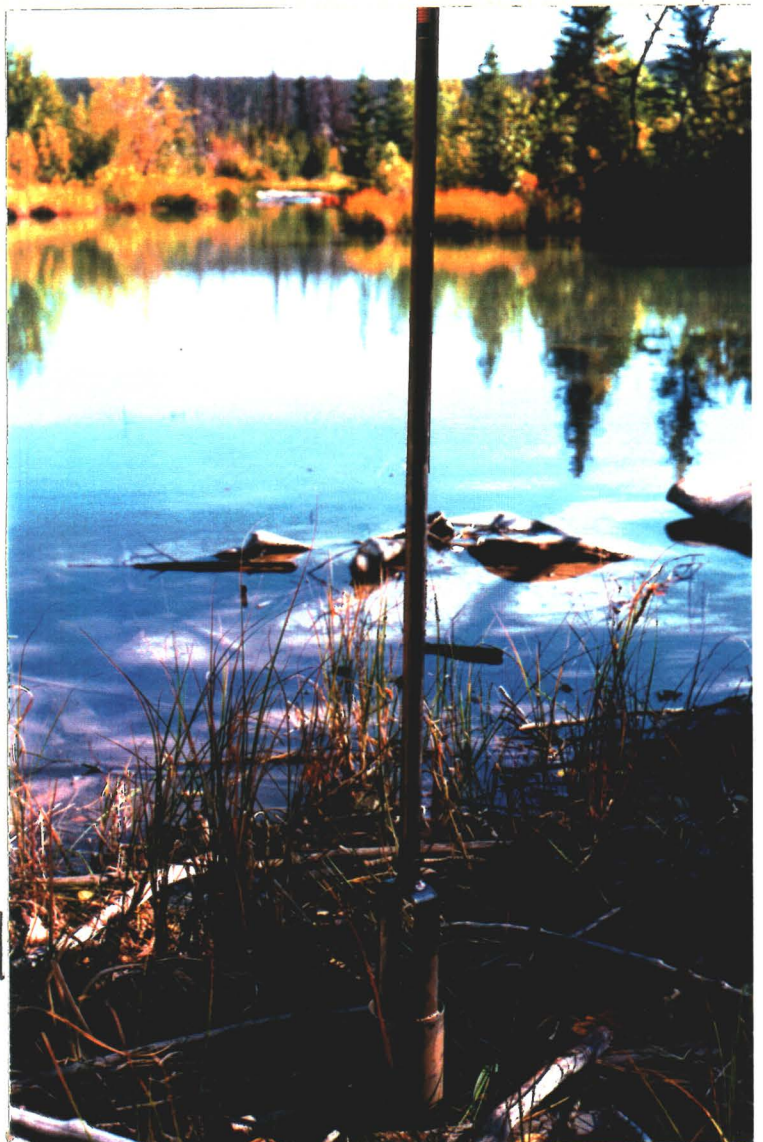
Photograph 44-P12: South facing view of west pond. 44-S4 is in the background.

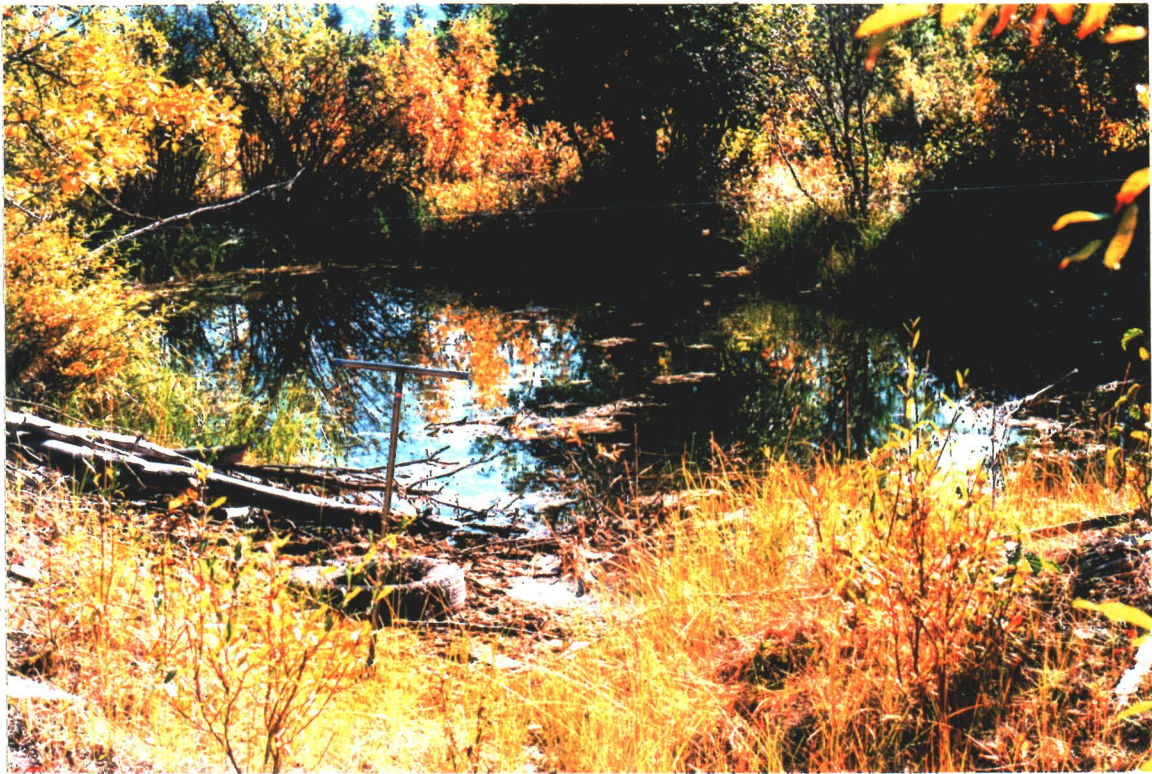
Photograph 44-P13: South facing view of east pond. 44-S9 is in the foreground.

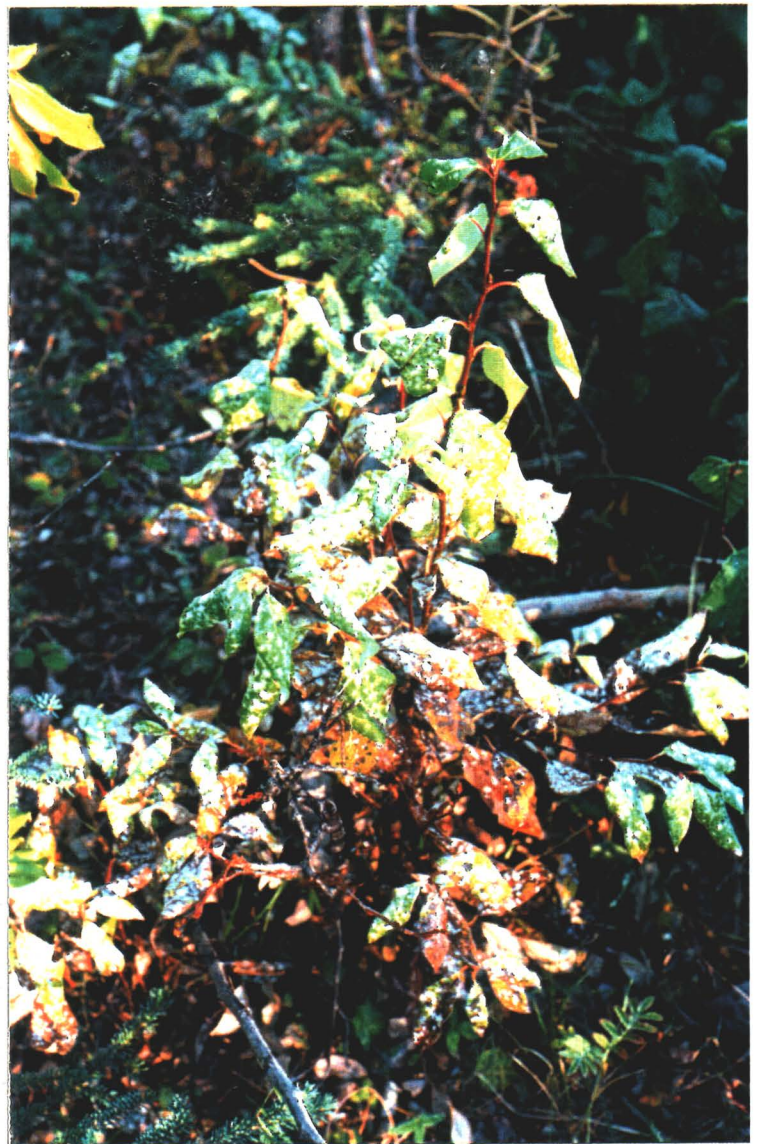
Photograph 44-P16: Poplars near 44-TP2.
