**INDIAN AND NORTHERN AFFAIRS CANADA
ABANDONED CLINTON CREEK
ASBESTOS MINE
1998 SITE RECONNAISSANCE**

APRIL, 1999

**PREPARED BY
UMA ENGINEERING LTD.
ENGINEERS AND PLANNERS
1479 BUFFALO PLACE
WINNIPEG, MANITOBA
R3T 1L7**

Reference: Abandoned Clinton Creek Asbestos Mine – 1998 Site Reconnaissance

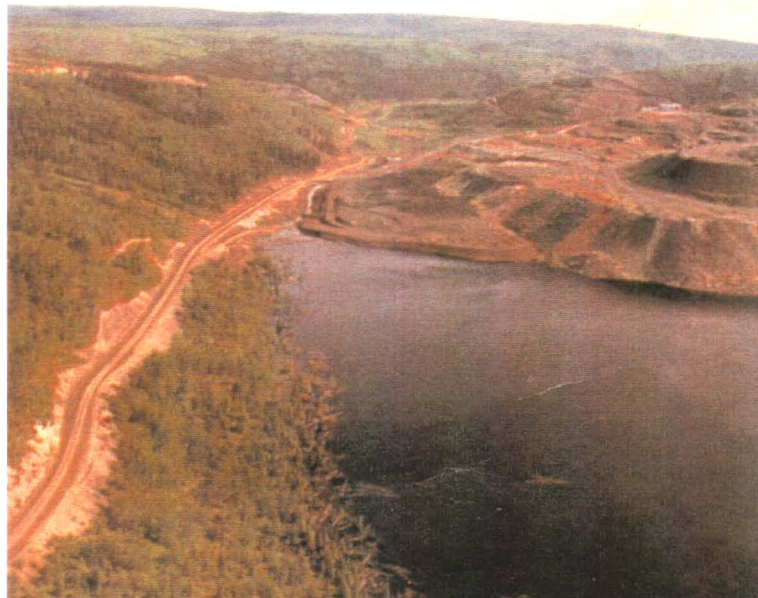
No photographic or written records are available from when the mine first opened until the waste rock dump forced the alignment of Clinton Creek against the north valley slope and ultimately impounded Hudgeon Lake. Photo CC-02 is the earliest available photograph of Hudgeon Lake, looking east at the waste rock dump, lake outlet, and the creek channel. Initially (1974), the creek channel flowed between the waste rock dump and the mill access road located on the north valley slope (Photo CC-03). However, as the water level in Hudgeon Lake increased, the unprotected channel eroded (down-cut) and migrated laterally to the north, eventually washing out the road (Photo CC-09).

Photo CC-02: Access Road and Hudgeon Lake Outlet at Clinton Creek (1974)

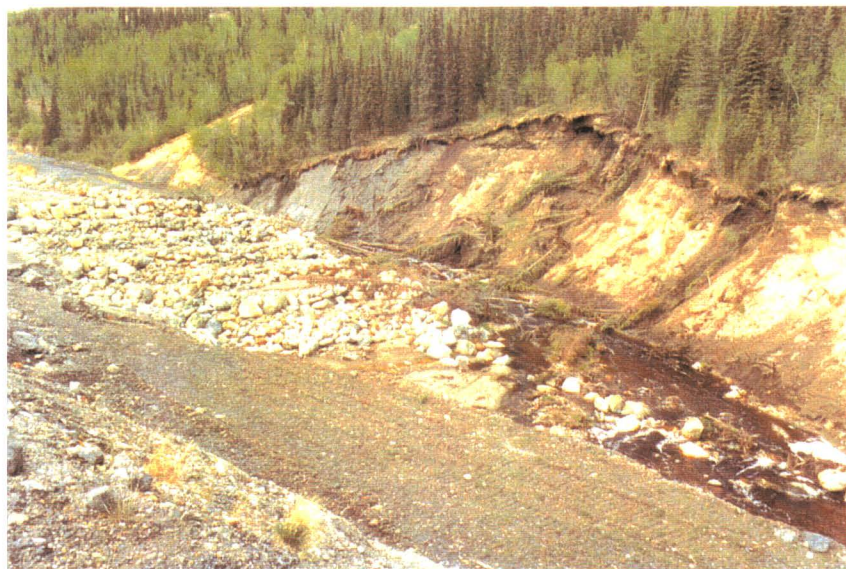
During the summer of 1979, an attempt was made to reduce channel erosion and undercutting by constructing rock weirs and armouring the banks of the channel immediately downstream of the lake outlet. Over the next few years, however, the creek flow bypassed the rock weirs on the north side causing significant erosion (Photo 3 Hardy Associates Ltd, July 1982). By 1983, channel flow had completely bypassed the weirs substantially increasing valley slope erosion as seen in Photo 3 (Klohn Leonoff, August 1983).

Photo 3: Valley Erosion (1983)

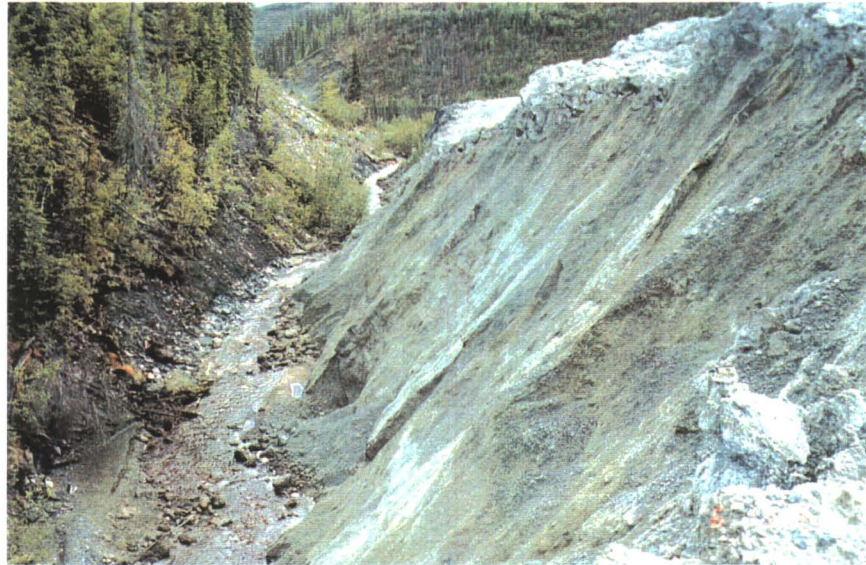
As the tailings continue to move down-slope, they are eroded and transported downstream. A comparison of the position of the leading edge of the tailings in Photo 12 taken in June, 1988 by Geo-Engineering with UMA Photo 5-20 indicates the gradual advancement of tailings into the creek channel.

Photo 12: Toe of South Lobe in June (1998)
