**Inventory of Equipment, Machinery,
Major Fixtures and Hazardous Materials
at the Destruction Bay Pumping Station,
Yukon Territories.**

**Prepared for
Indian and Northern Affairs Canada**

August, 1998

**Prepared by
Arctic Environmental Services Ltd., and KO KEN General Contractors**

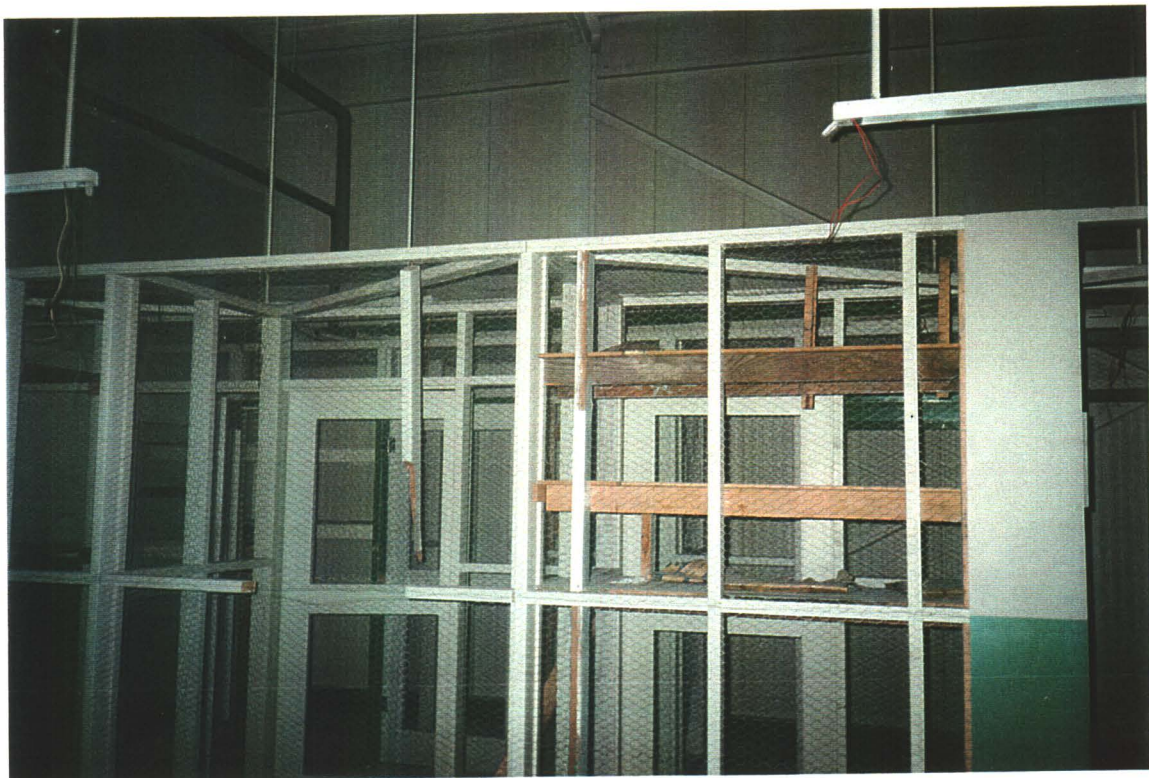
Store Room. Fenced storage units.

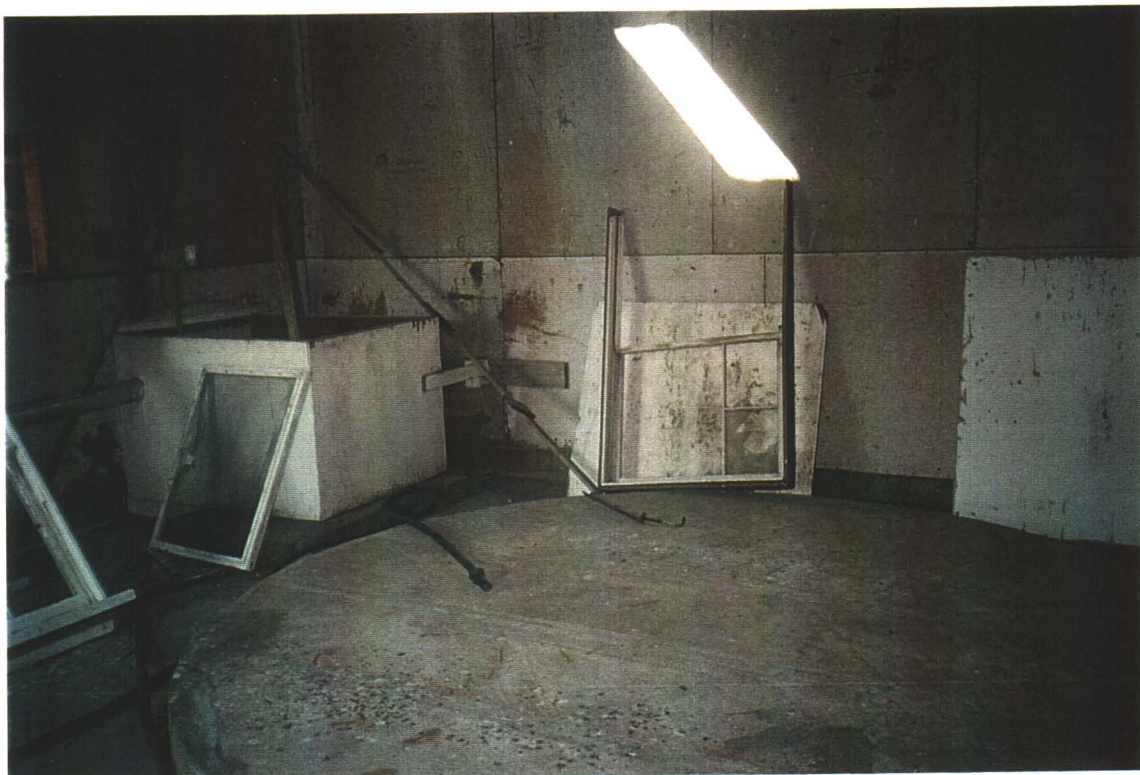
Pumphouse Building interior. Note significant concrete pad structure.

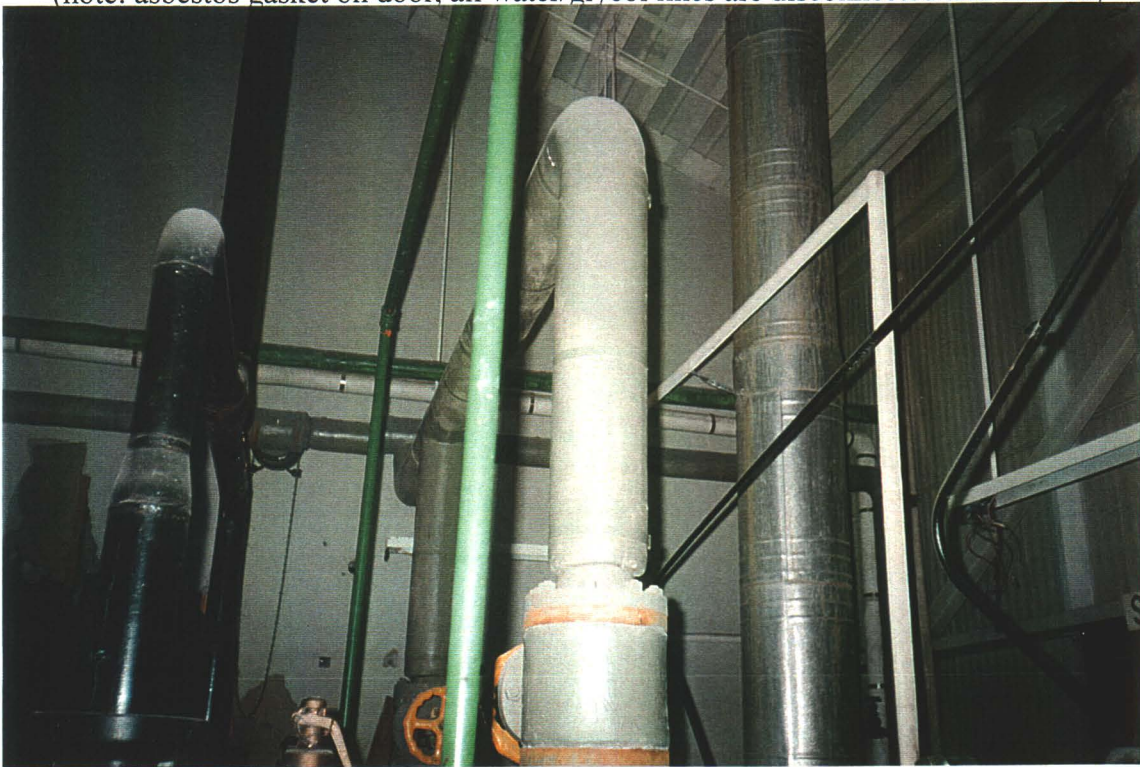
Boiler Room. Top of boiler #1.
(note: asbestos insulation is present in stack)
