**KENO VALLEY/DUBLIN GULCH  
ENVIRONMENTAL BASELINE ASSESSMENT**

**VOLUME IV: Keno Valley Sites #41 to #66, #68 to #70**

Prepared for  
Waste Management Program  
Indian and Northern Affairs Canada

March, 2000

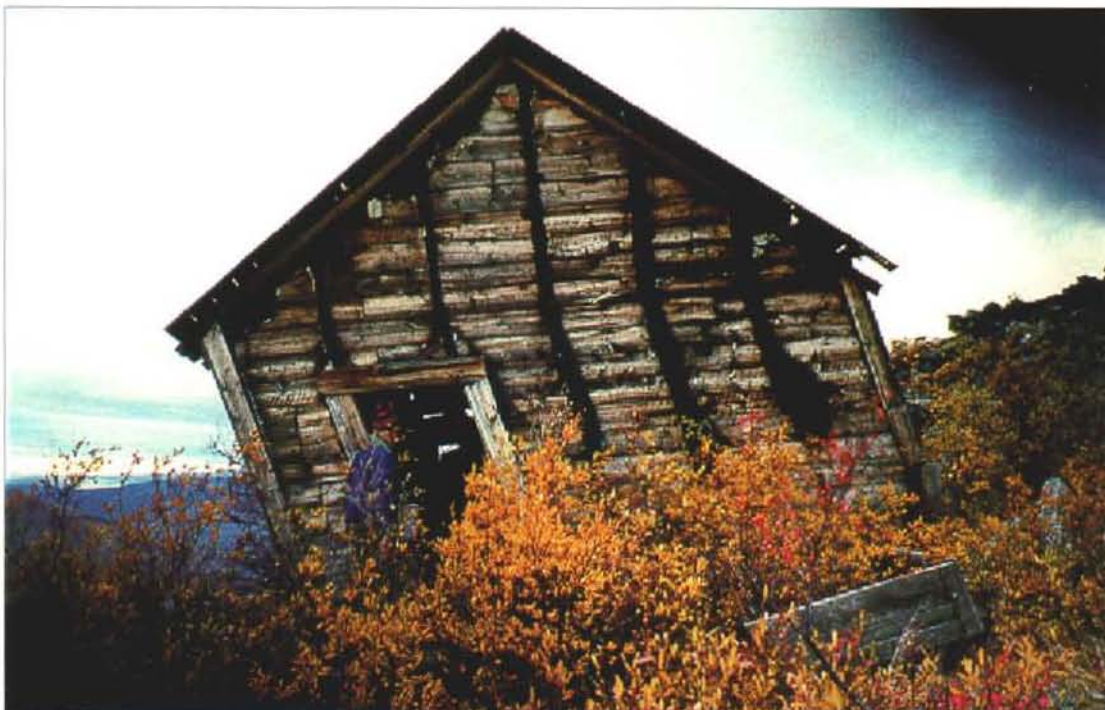
### **6.1 Building 41A (photo 41-2)**

Photo 41-2 : Devon. Building 41A, located 10m south of the Adit.. (Azimuth  $280^{\circ}$ )

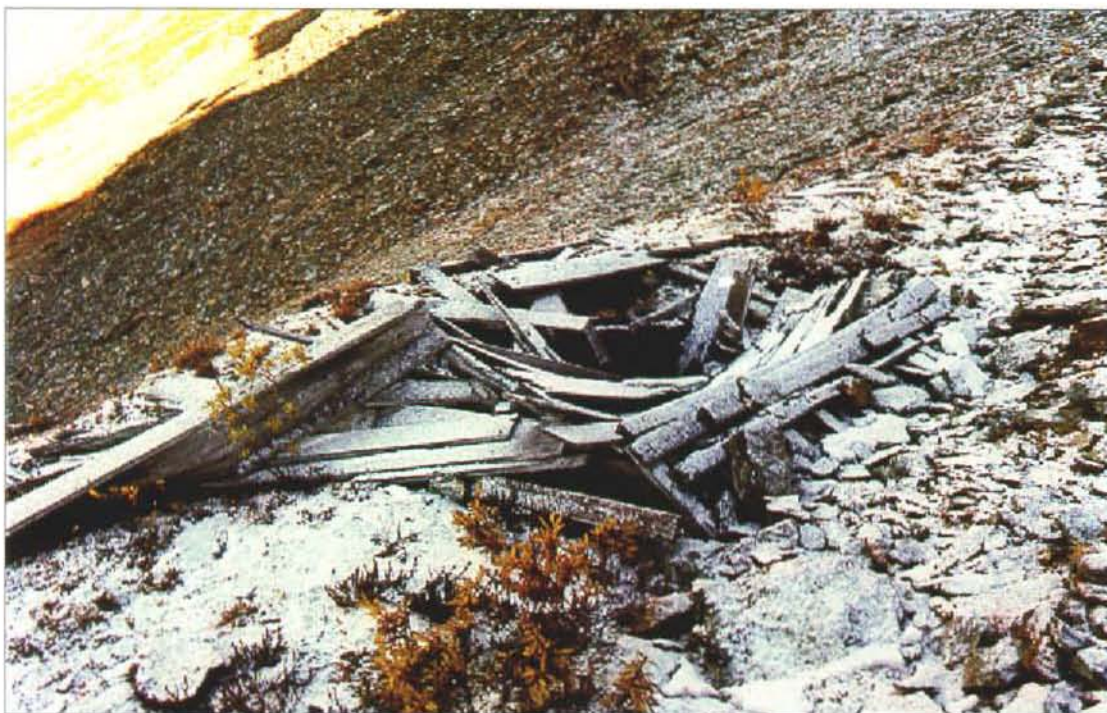
### Shaft (photo 43-1)

The shaft is located roughly 90m vertically below the rim of the cirque. It has collapsed approximately 1m below the collar. There is a windless and broken log cribbing at the entrance to the shaft.

Condition: The shaft is collapsed approximately 1m below the surface.

Photo 43-1 : Duncan. Collapsed shaft with windlass still in place across the top. (Azimuth  $\sim 090^\circ$ )

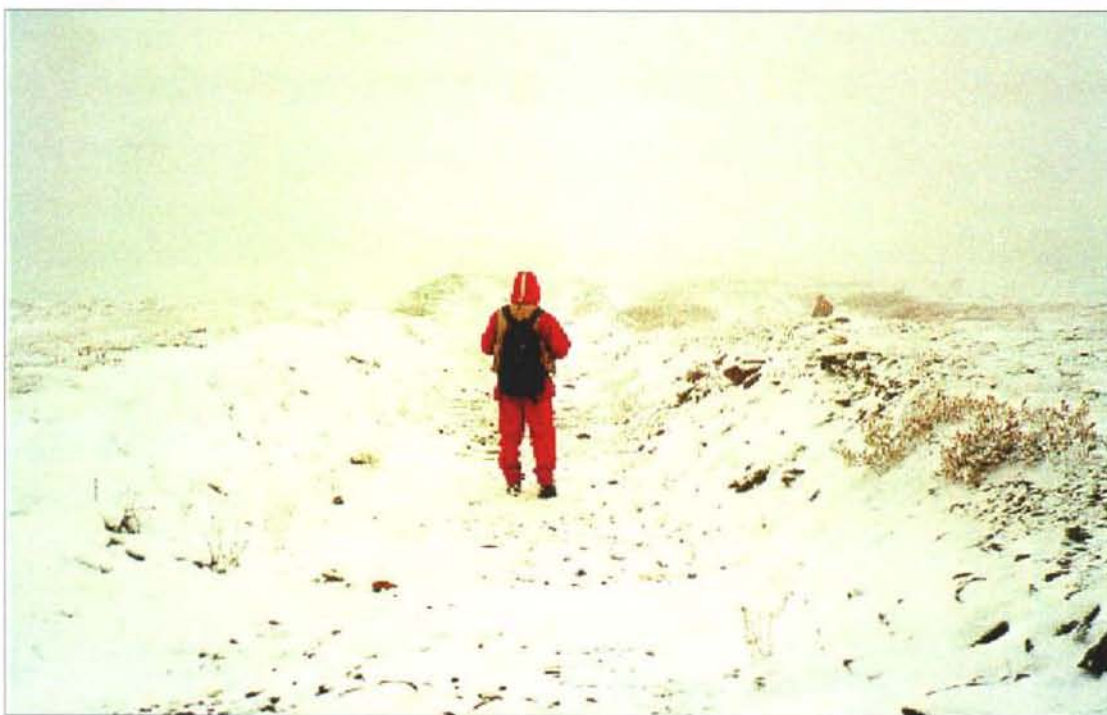
#### Trench #3 (photo 43-2)

Condition: The trench appeared stable at the time of the site visit.

Photo 43-2 : Duncan. Trench #3 with waste rock pile at the end. (Azimuth  $215^\circ$ )

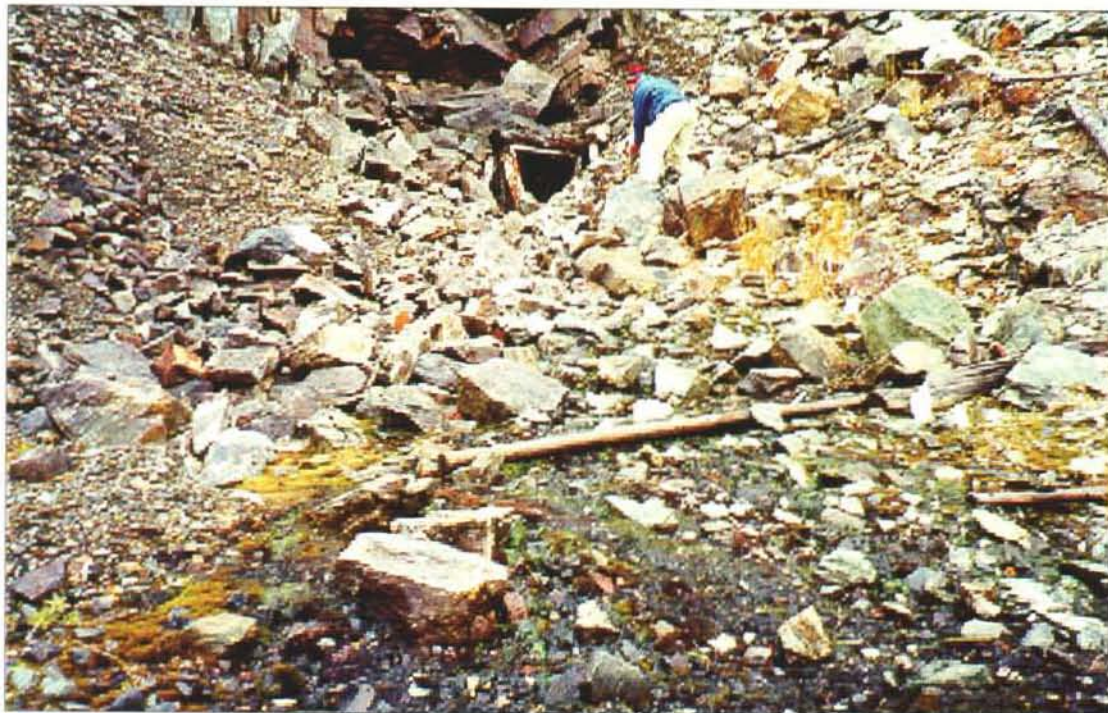
### **Gold Queen Adit (photo 44-1)**

Condition: The adit is in fair condition.

Photo 44-1 : Gold Queen. Entrance to the Gold Queen Adit. (Azimuth 190 °)

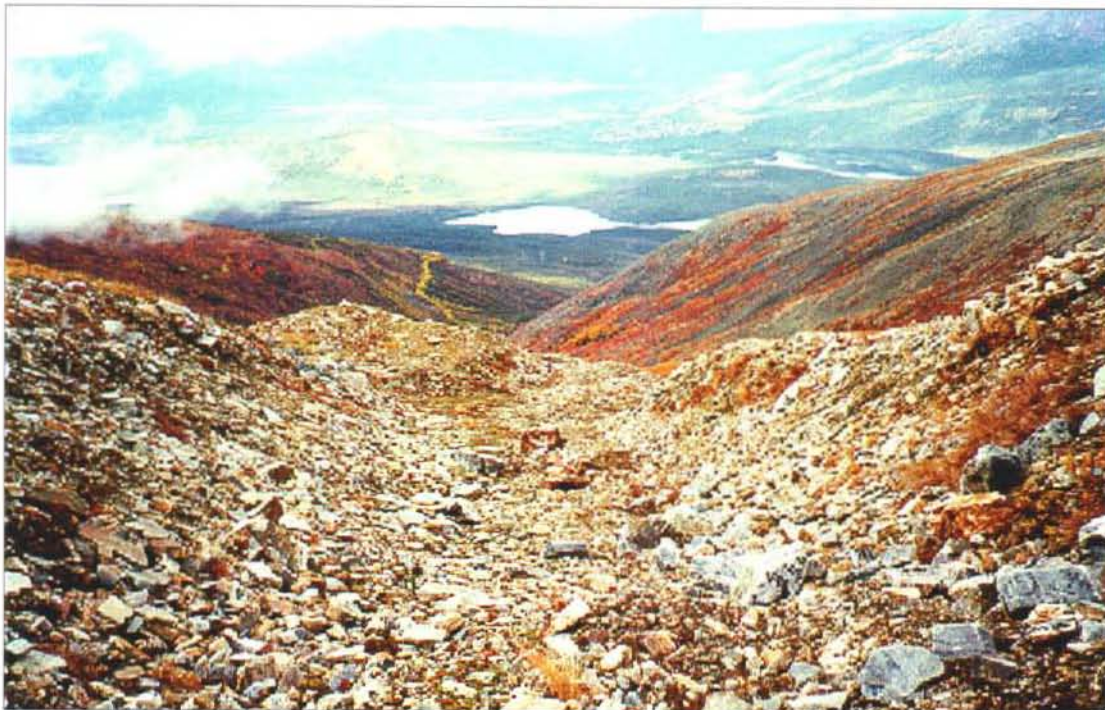
###### **Trench #1 (photo 45-2)**

Photo 45-2 : Silver Basin. View of Trench #1 with ponded water at the north end. (Azimuth 005<sup>o</sup>)

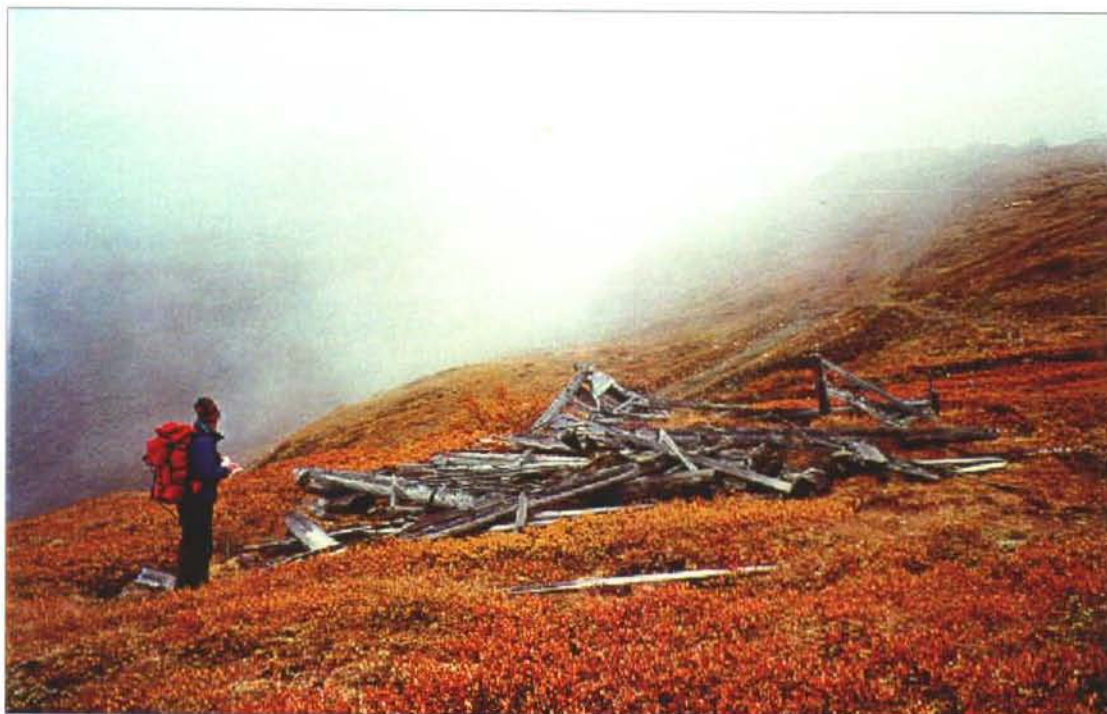
### **6.1 Building 45A (photo 45-4)**

Photo 45-4 : Silver Basin. Collapsed log and timber cabin beside Silver Basin Gulch Trail.  
(Azimuth  $\sim 180^{\circ}$ )

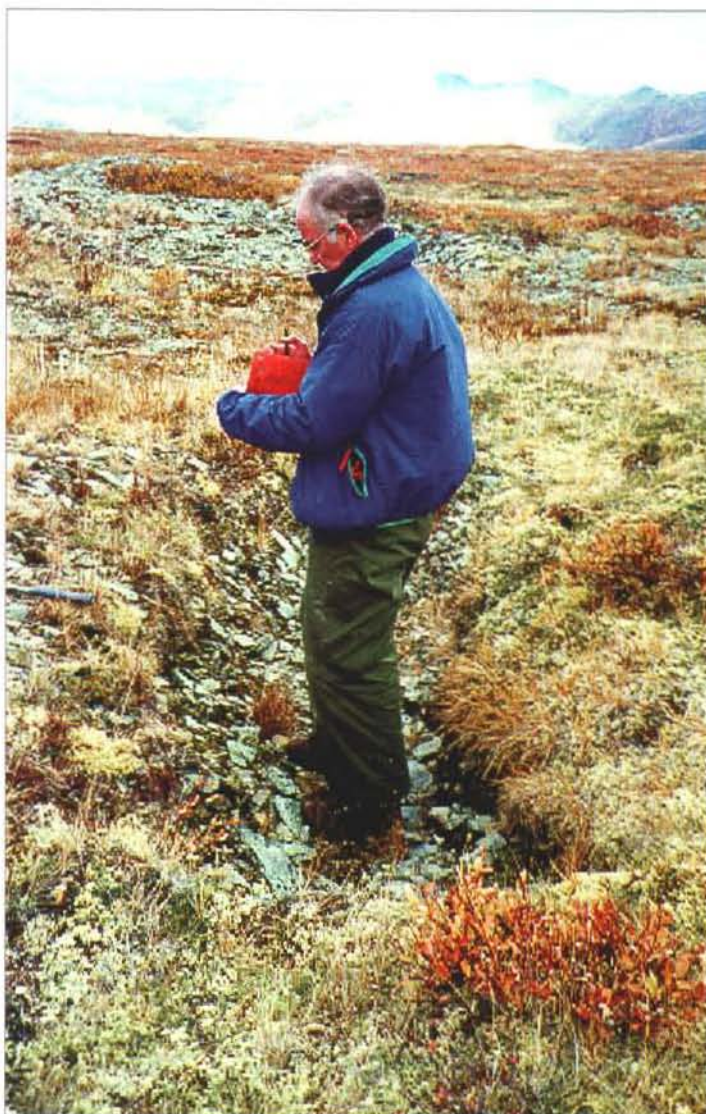
### **Trench #2 (photo 46-1)**

Photo 46-1 : Nabob. Small hand trench dug into overburden. (Azimuth 010 °)

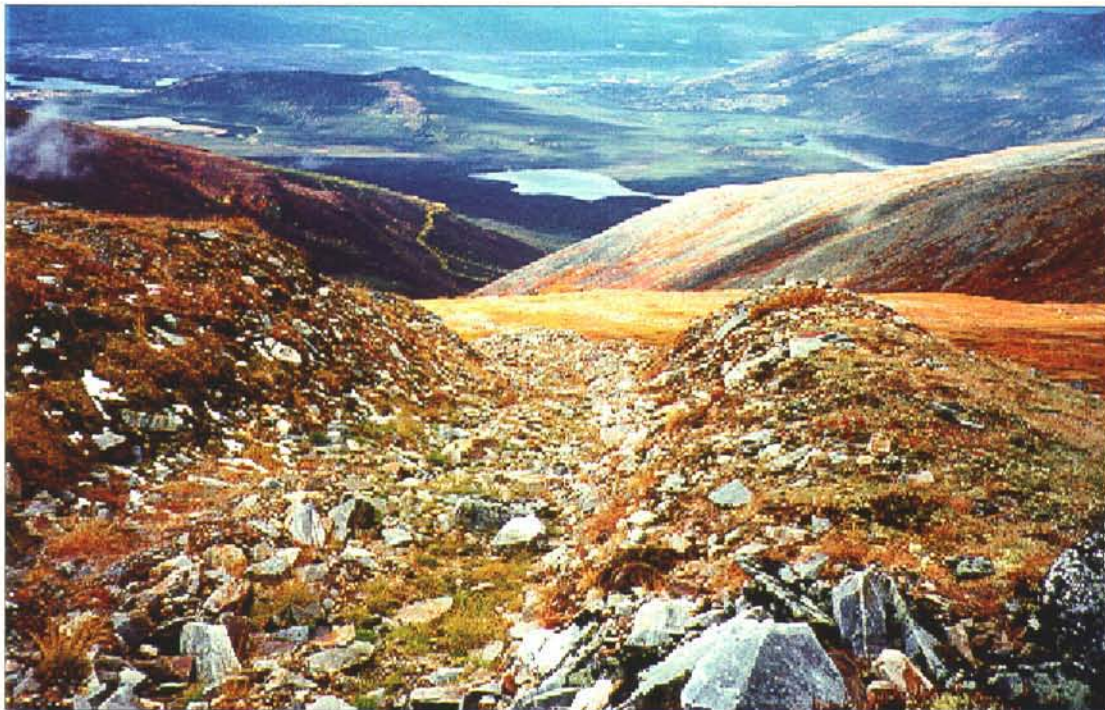
### Trench #4 (photo 47-2)

Photo 47-2 : Monument and Ladue Fraction. View of Trench #4, Gambler Lake is in the background. (Azimuth  $318^{\circ}$ )

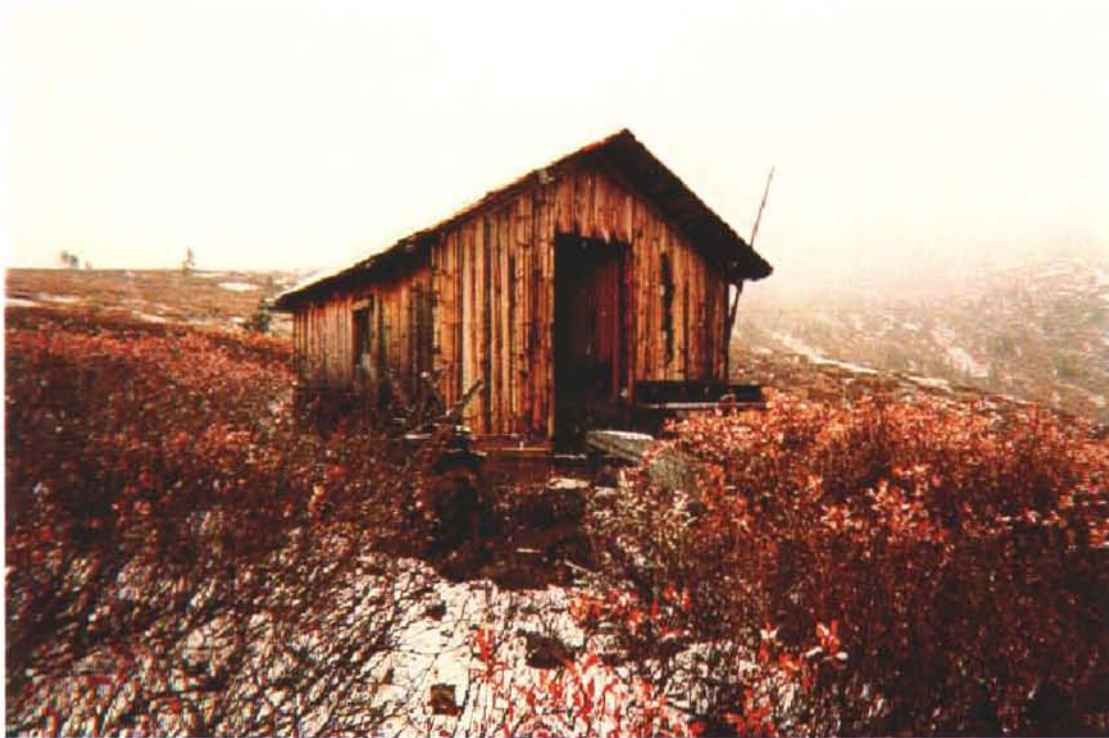
Building 48A (photo 48-3)

Photo48-3: View of abandoned wood cabin located at Apex site. (AZ 200)

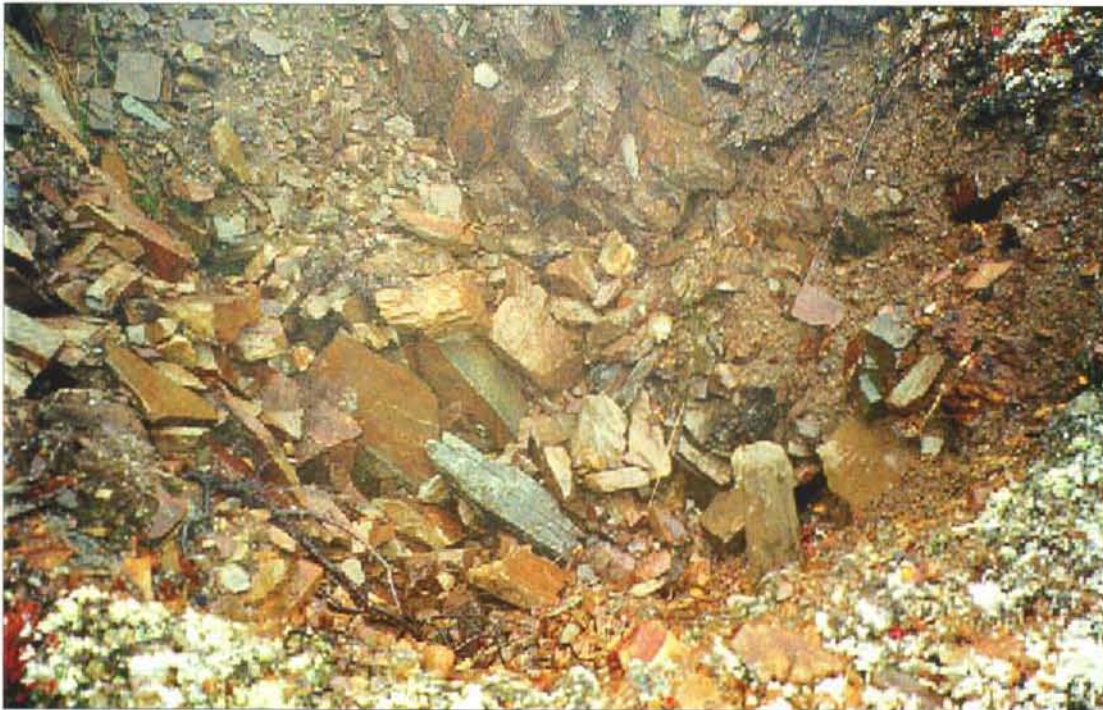
###### **Shaft #2 (photo 49-1)**

Photo 49-1 : Vanguard. Shaft #2 has collapsed 1m below surface, the timber post in the bottom right hand corner is all that marks the location. (Azimuth 110°)

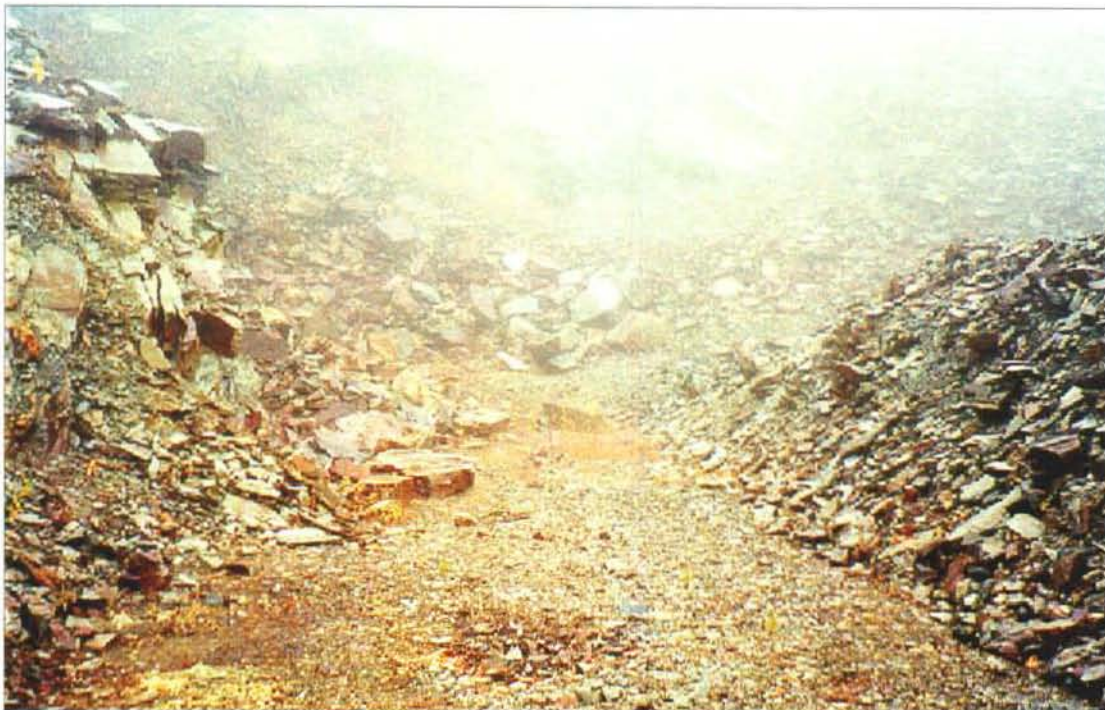
Photo 49-5 : Vanguard. View of Trench #1, looking to the northwest. (Azimuth 040<sup>o</sup>)

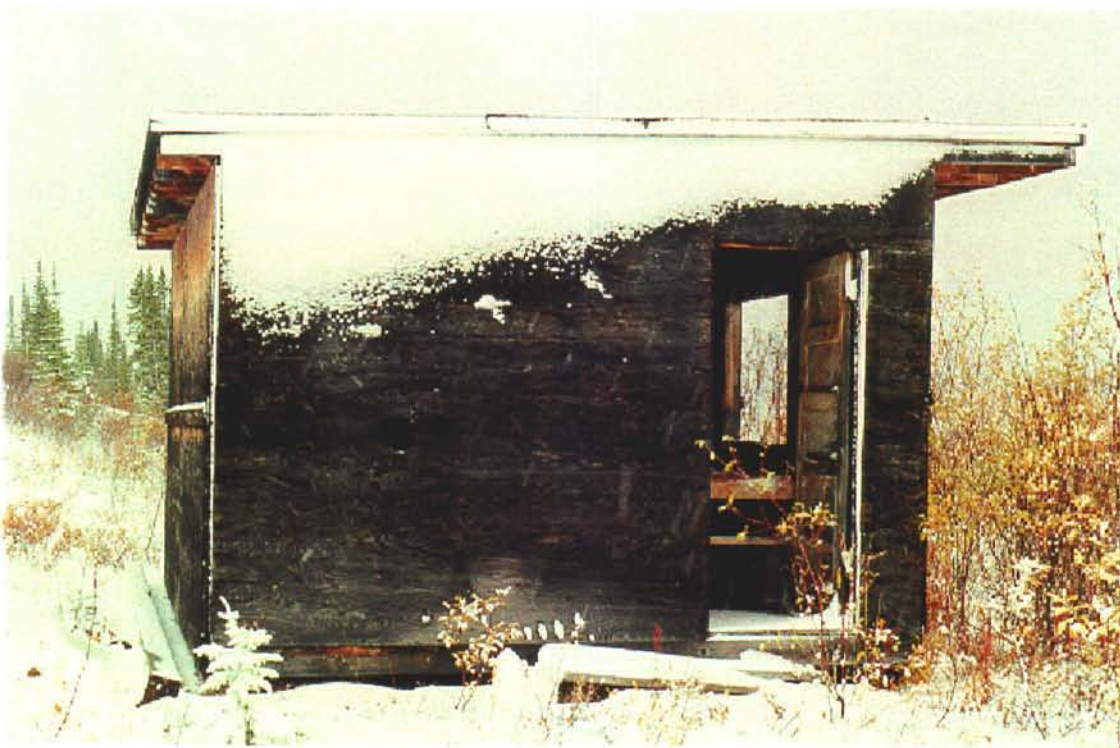
#### **Building 50B (photo 50-7)**

Photo 50-7: Building 50B, the table is visible through the doorway. (Azimuth 270°)

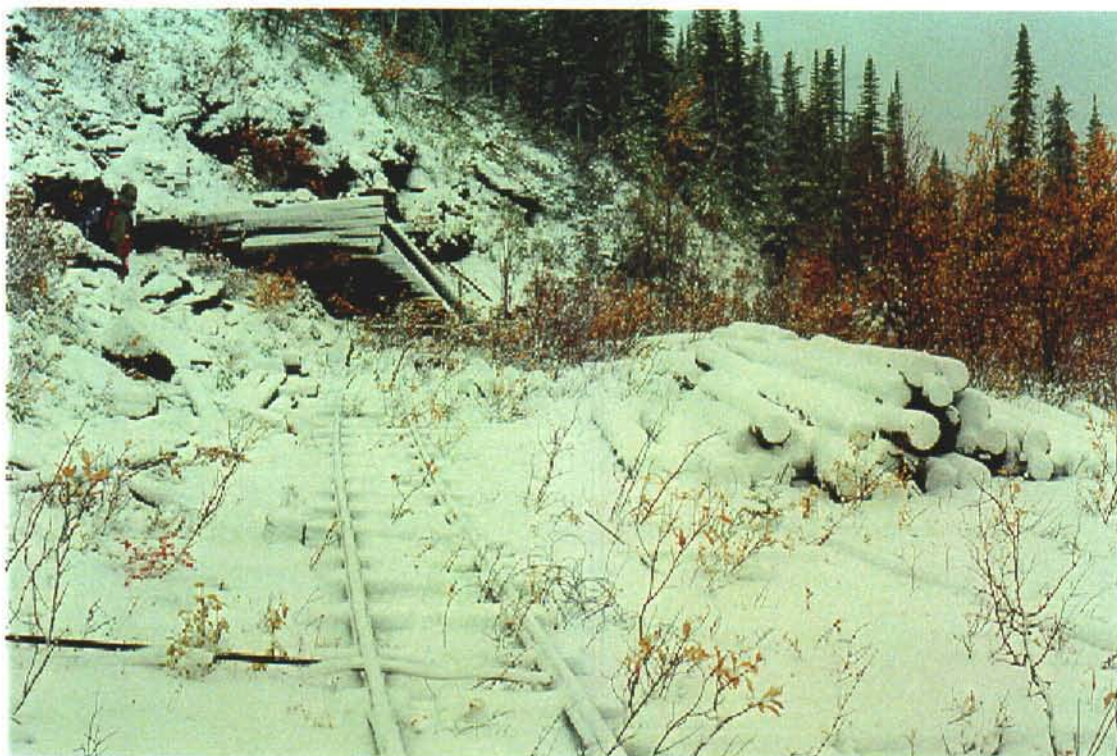
## **6.3 Rail and Trestle (photo 50-8)**

Photo 50-8: Rail and ties, old poles on right and portal to adit in the background. (Azimuth 270°)

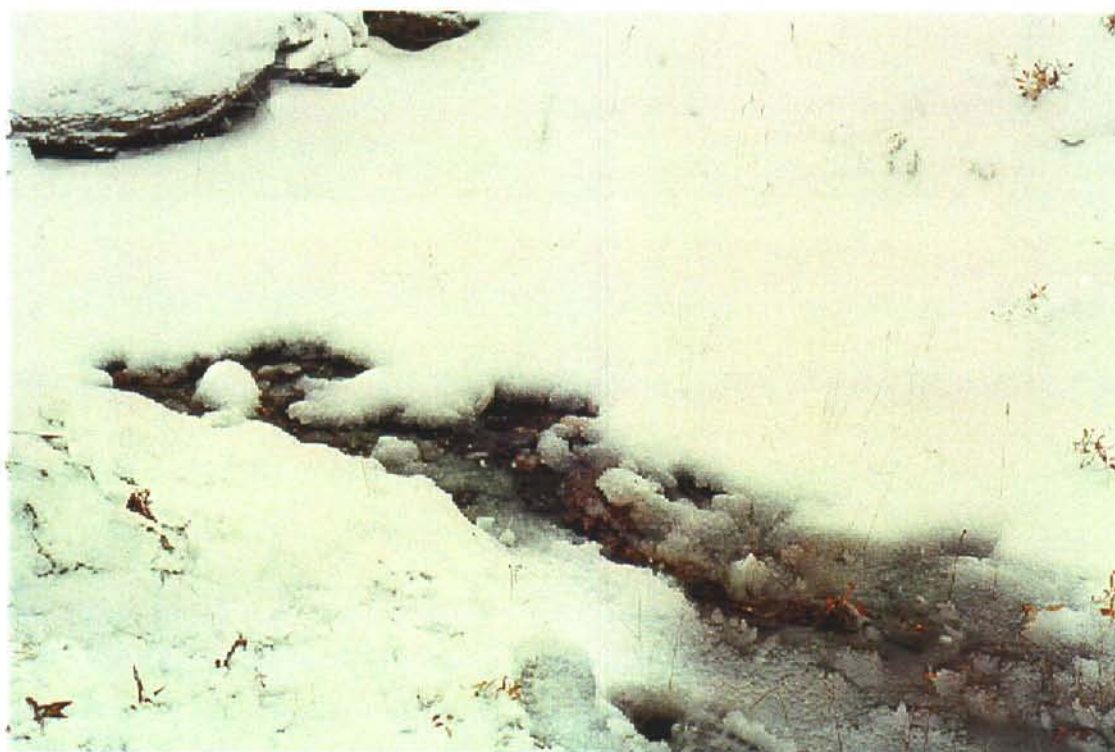
There were two small streams encountered at this site. The beginning of one stream seeps out of the top of Trench 1, following the base of the trench before seeping back into the ground 30m later (photo 50-9). A water sample (Home-WQ-US-01) was collected at the top of the stream. The water had no visible particulates and did not appear to be depositing any sediment. The flow rate was less than 1 L/s (visual estimation). The second stream exits the Homestake portal flowing at a rate of less than 1 L/s (visual estimation). A sample was collected (Home-WQ-02) from just outside the portal. The water has no visible particulates and does not appear to be depositing sediment. The stream continued downhill.

Photo 50-9: Water sample site for HOME-WQ-US-01 (Azimuth 240°)

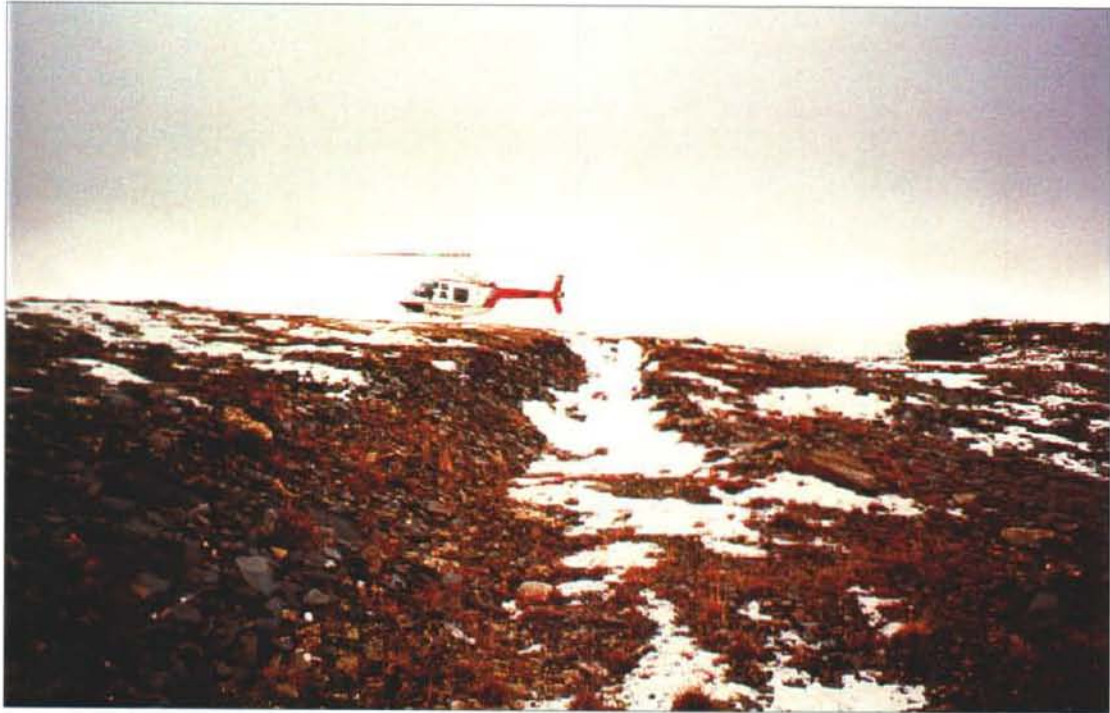
Trench 1 (photo 51-1)

Photo 51-1: View along length of Trench 1 at Christine site. (Azimuth  $130^{\circ}$ )

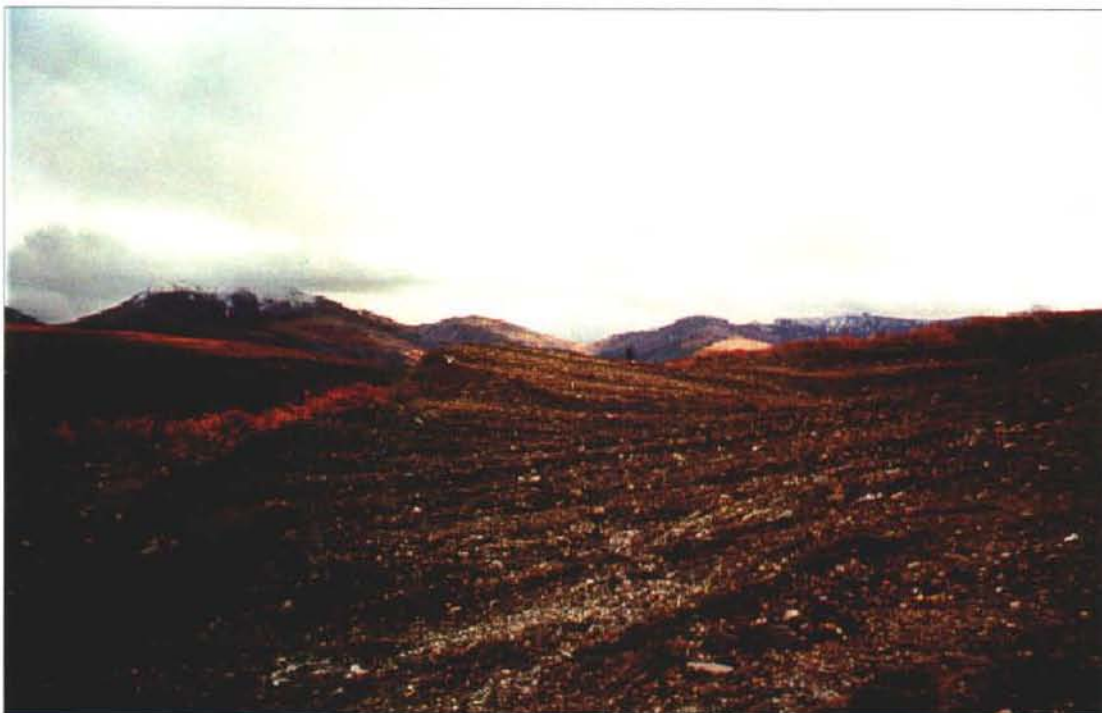
The major displacement of material from the trenching in this area has made it difficult to distinguish waste rock from overburden. Material has been piled and graded in several places to make level areas and roads (photo 52-1). Significant revegetation has occurred in the area. The extent of natural reclamation ranges from 20 to 60 percent depending on the quality of the soils.

Photo 52-1: Large area of displaced material at south end of Windy and Casy workings.

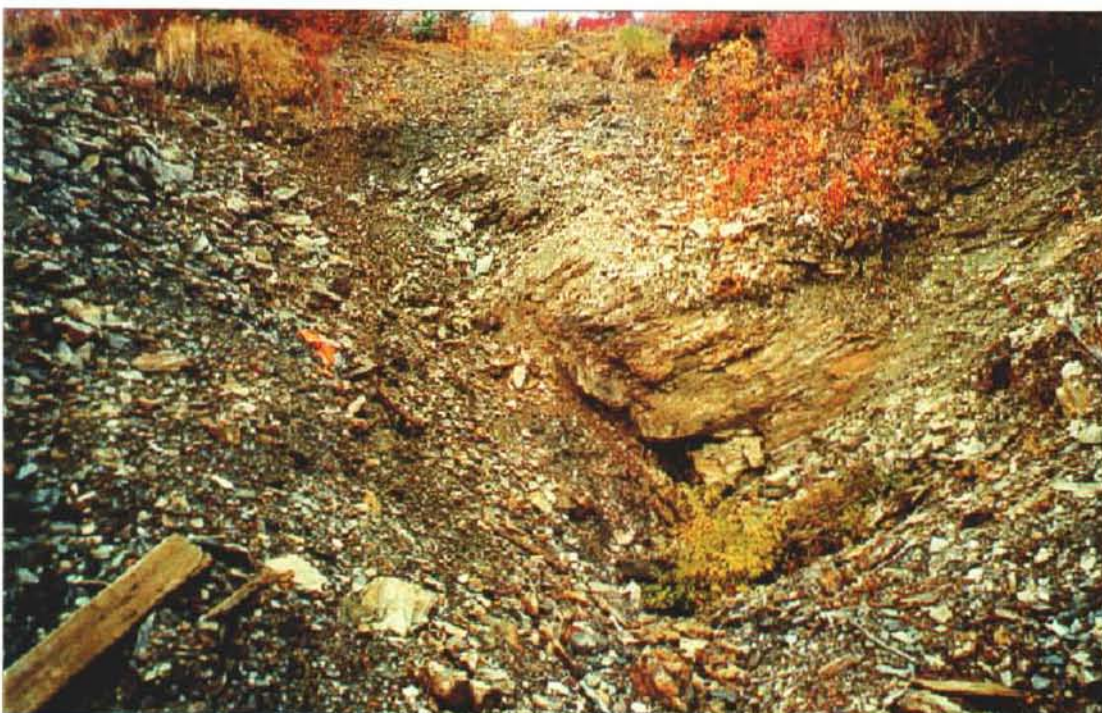
#### **Pit 1 (photo 52-2)**

Photo 52-2: View of Pit1 at Windy and Casy workings.

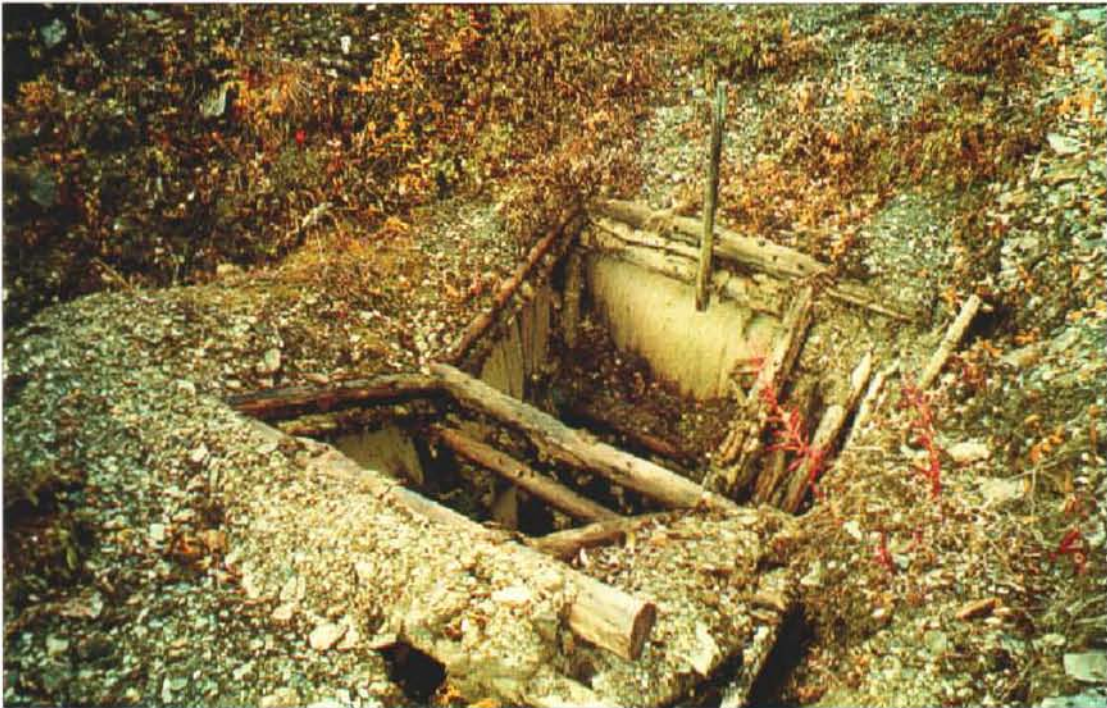
#### **Shaft 1 (photo 52-3)**

Photo 52-3: View of Shaft 1 at Windy and Casy workings.

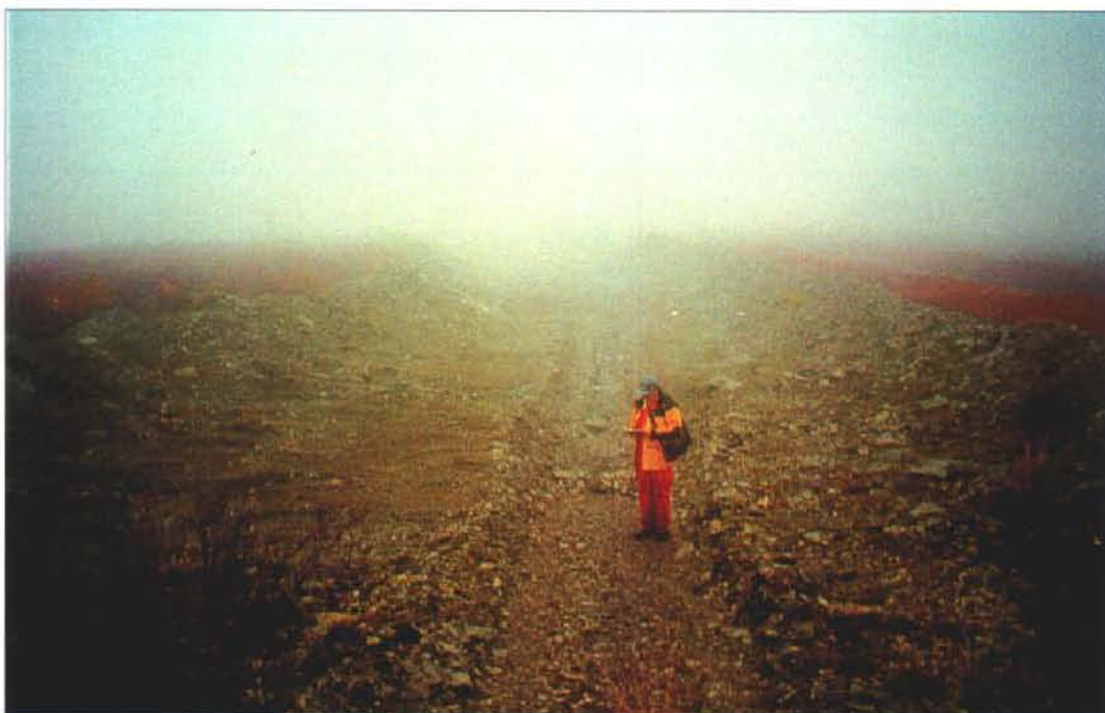
#### **Trench 1 (photo 52-7)**

Photo 52-7: View along length of large trench (Trench 1) located 2 km south of Windy and Casy workings on Bob claim. (AZ 138°)

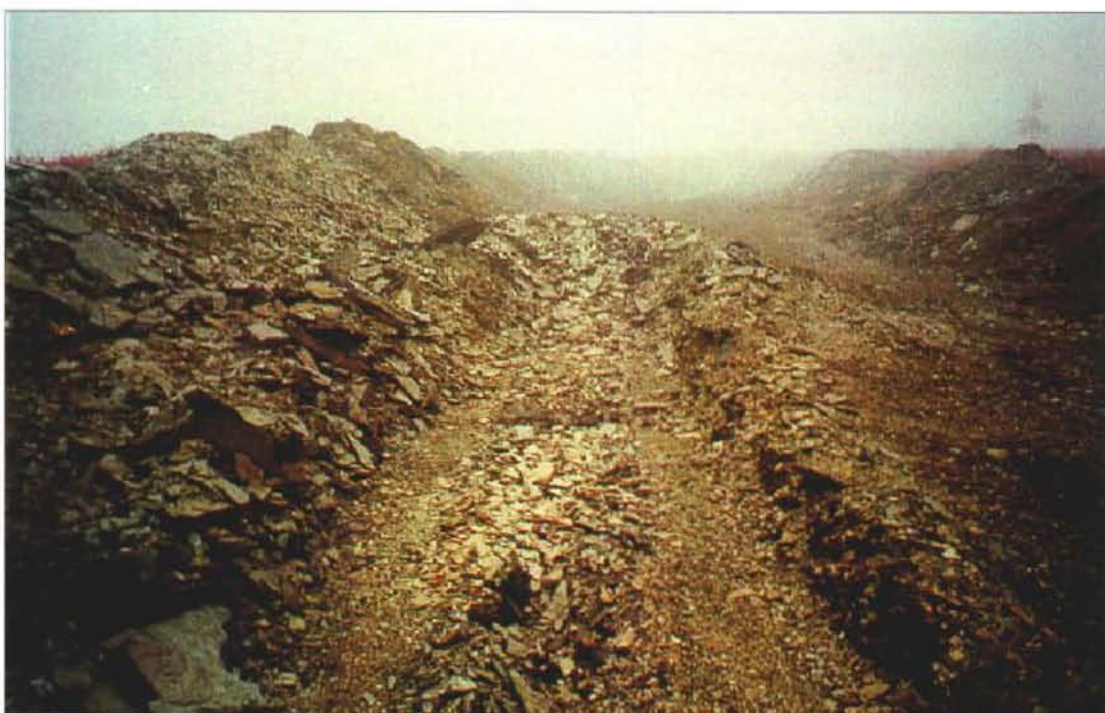
Photo 52-8: Area of digging at the bottom of Trench 1.

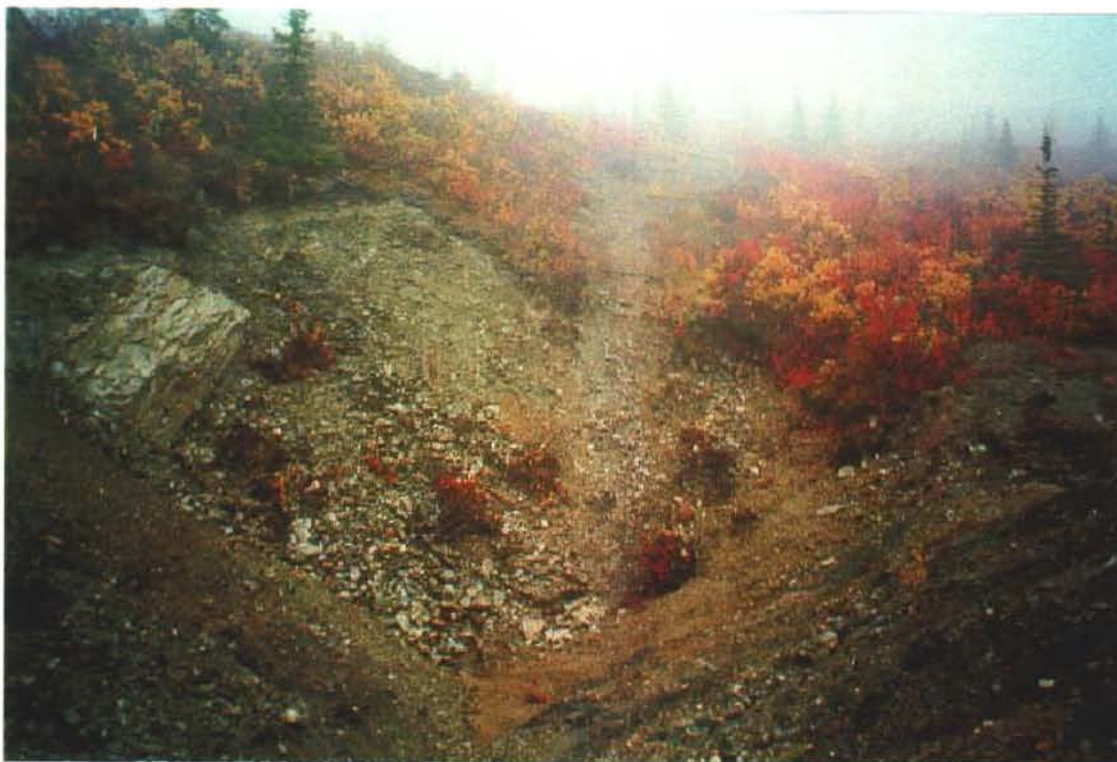
Pit 2 (photo 52-9)

Photo 52-9: View of Pit 2 at Boogla claim located 2.4km south of Windy and Casy workings showing exposed bedrock. (AZ 070°)

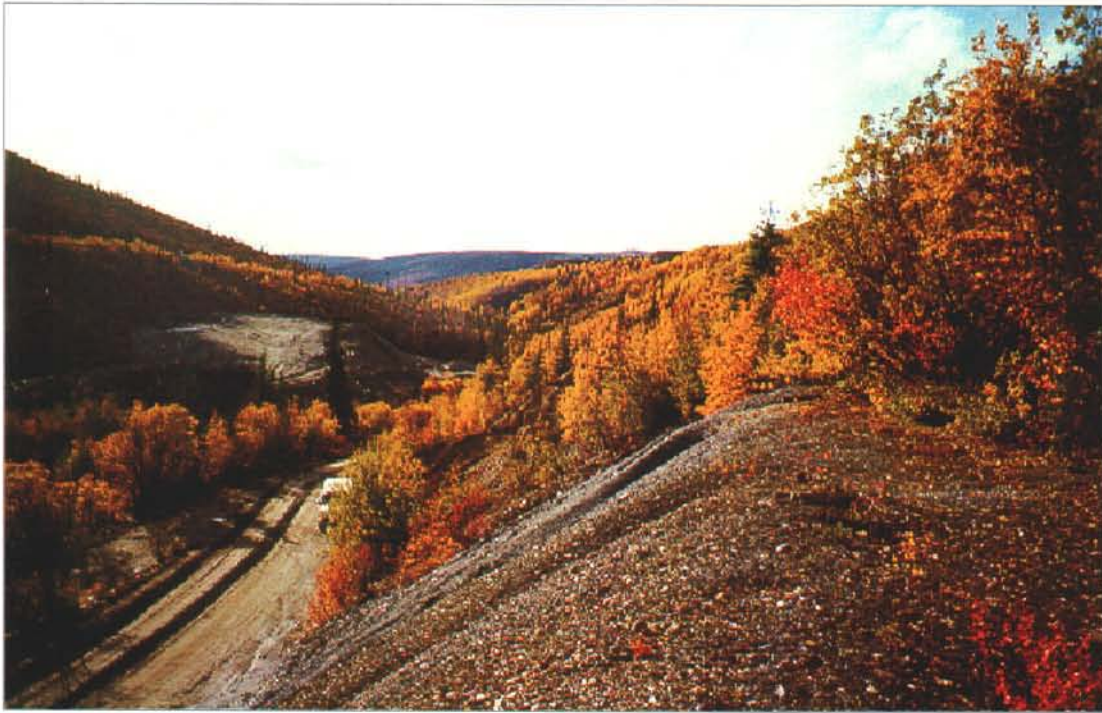
A large waste rock pile about 75 m long, 9 m wide and 7 m high is located at the side of Lightening Creek Road (photo 54-1). It lies directly below Adit 1. The rock in the pile consists mainly of grey quartzite with minor disseminated pyrite. Some sections of the dump are moderately limonitic. The pile can be divided into 4 zones based on the colouration.

Photo 54-1: View along the top of waste rock piles at Hogan site. (AZ 275)

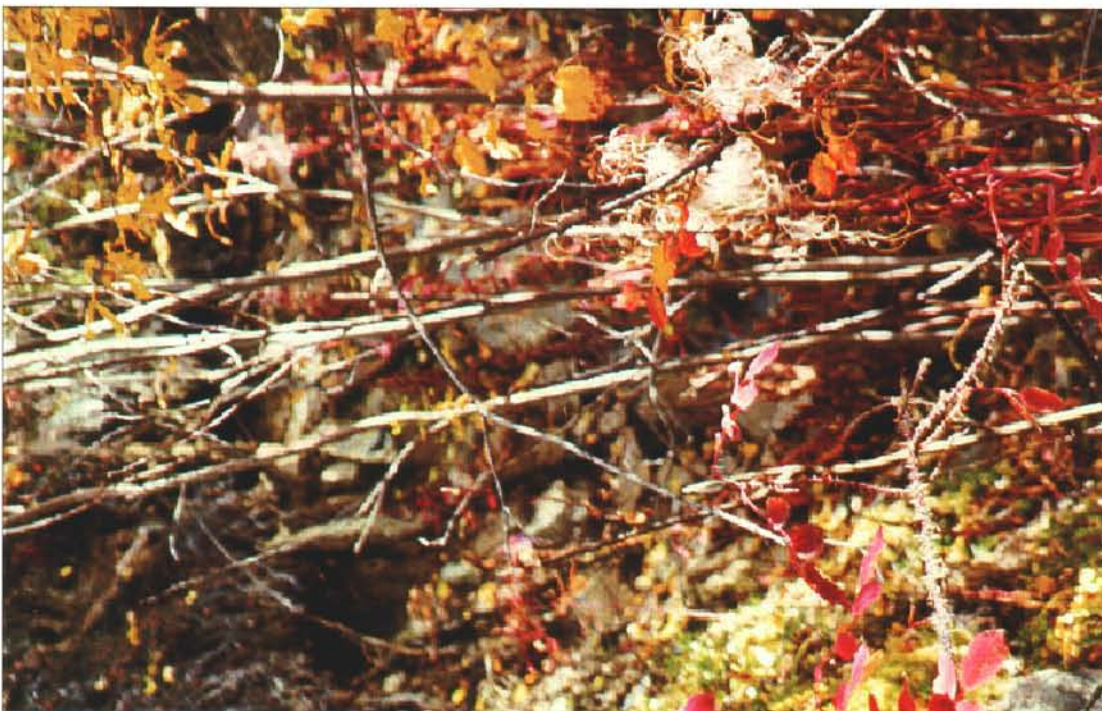
Condition: adit is collapsed

Photo 54-2: Obscured view of collapsed adit (Adit 1) at Hogan site.

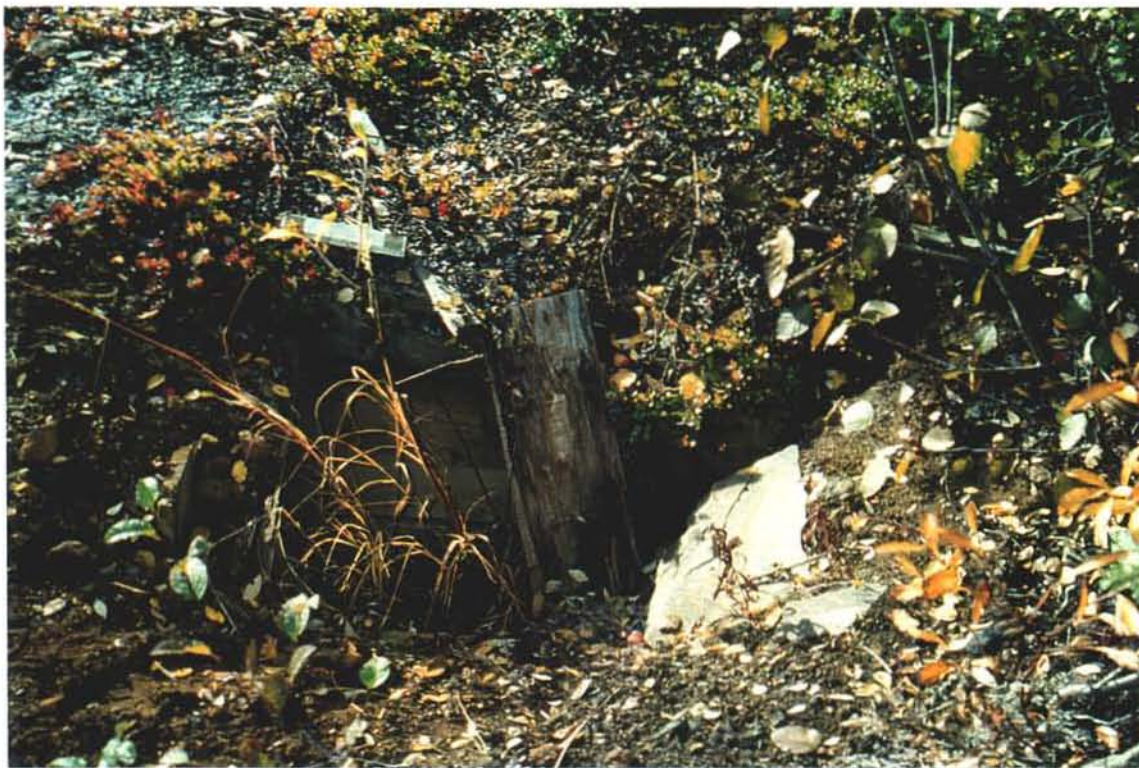
Condition: filled in

Photo54-3: View of Shaft 1 at Hogan site. 6 inch ruler appears for scale.

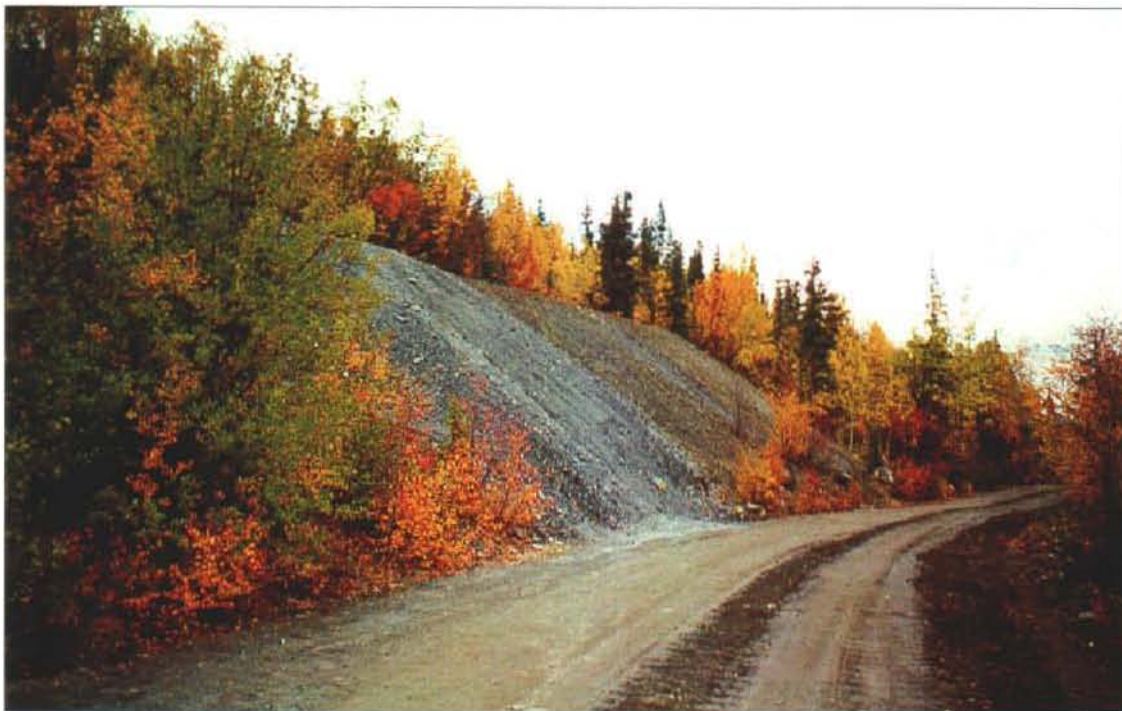
The most eastern section of the waste rock pile had characteristics similar to the westernmost section. It was grey in colour with moderate rusting on the surface. Waste rock sample 99-HO-1-3 was taken from this section. The field paste pH of this sample was 3.6. The field conductivity of this sample was 2.68 mS/cm.

Photo 54-5: View of east side of Hogan waste rock dump. Highly acidic material appears in a zone that is light grey in color.

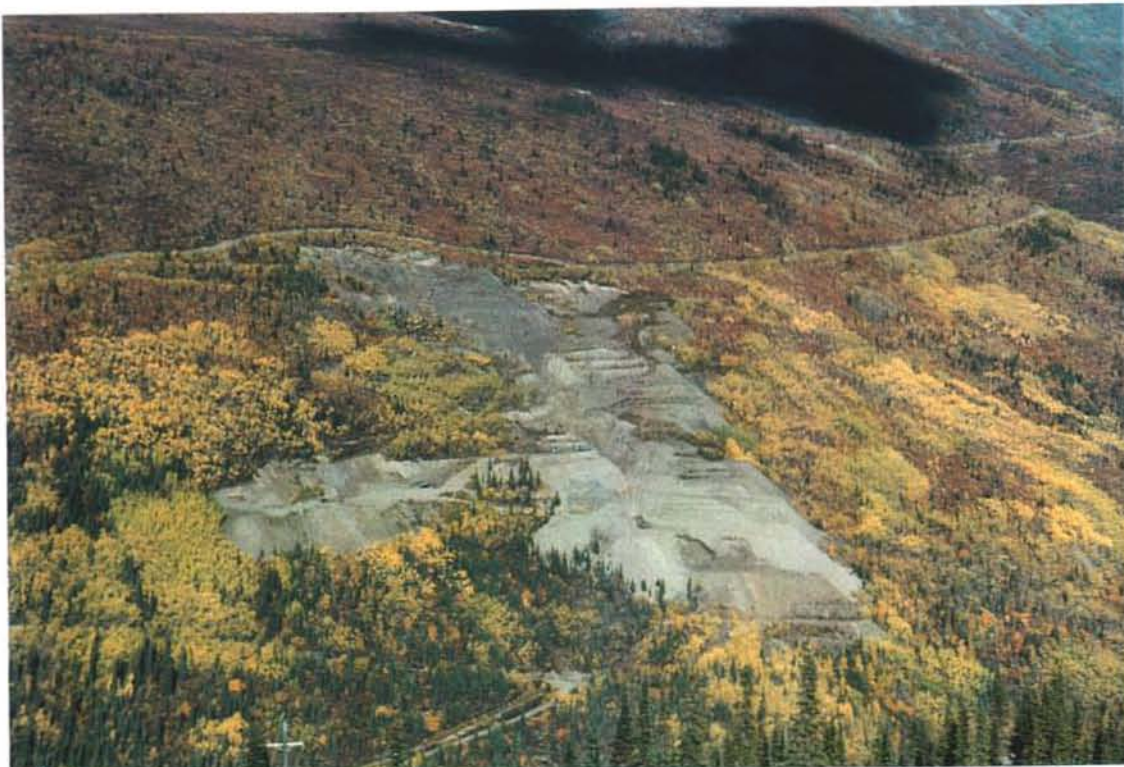
Photo 55-2: View of Runer site from Bunker Hill.

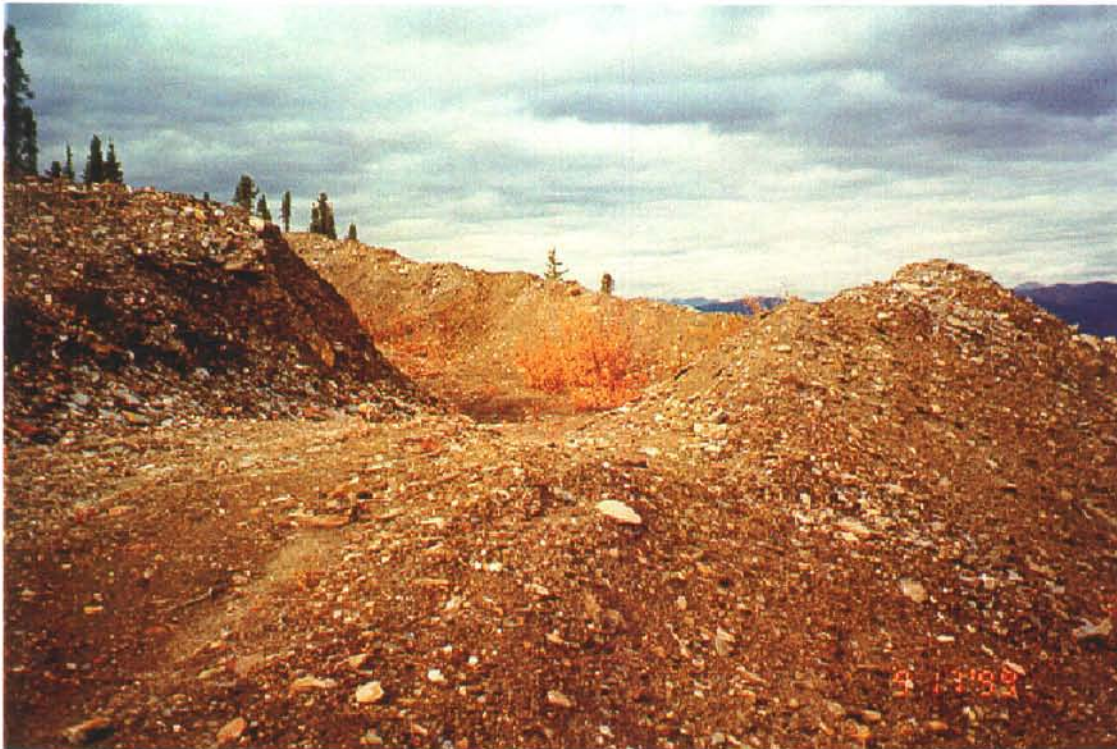
Photo 57-3: Site road formed in waste rock at upper workings.
