**KENO VALLEY/DUBLIN GULCH  
ENVIRONMENTAL BASELINE ASSESSMENT**

**VOLUME IV: Keno Valley Sites #41 to #66, #68 to #70**

Prepared for  
Waste Management Program  
Indian and Northern Affairs Canada

March, 2000

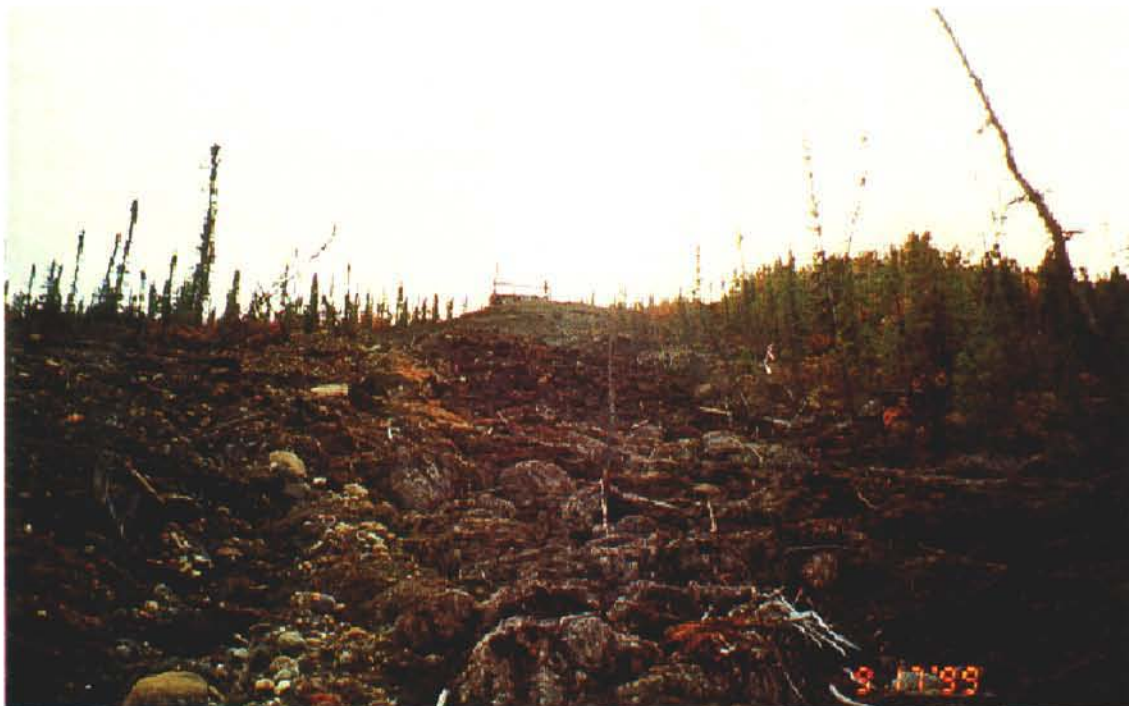
Photo 57-4: Waste rock below lower workings. Note extensive vegetation kill zone.

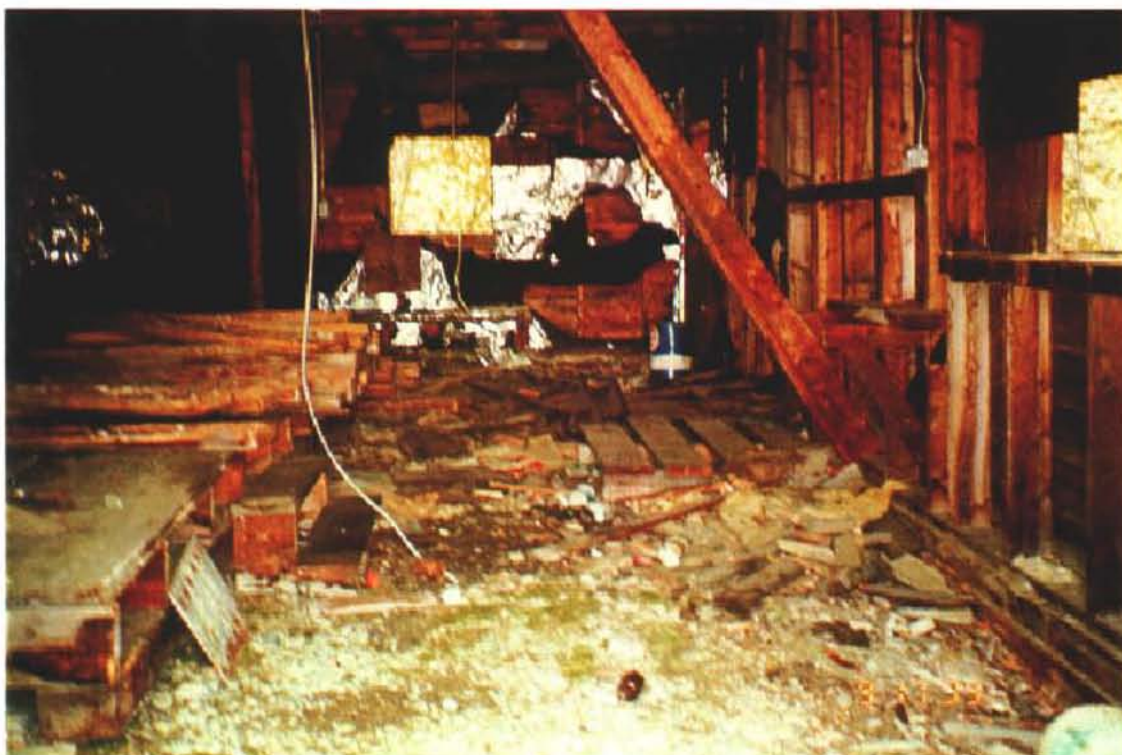
Photo 57-6: Interior of core shack at upper workings.

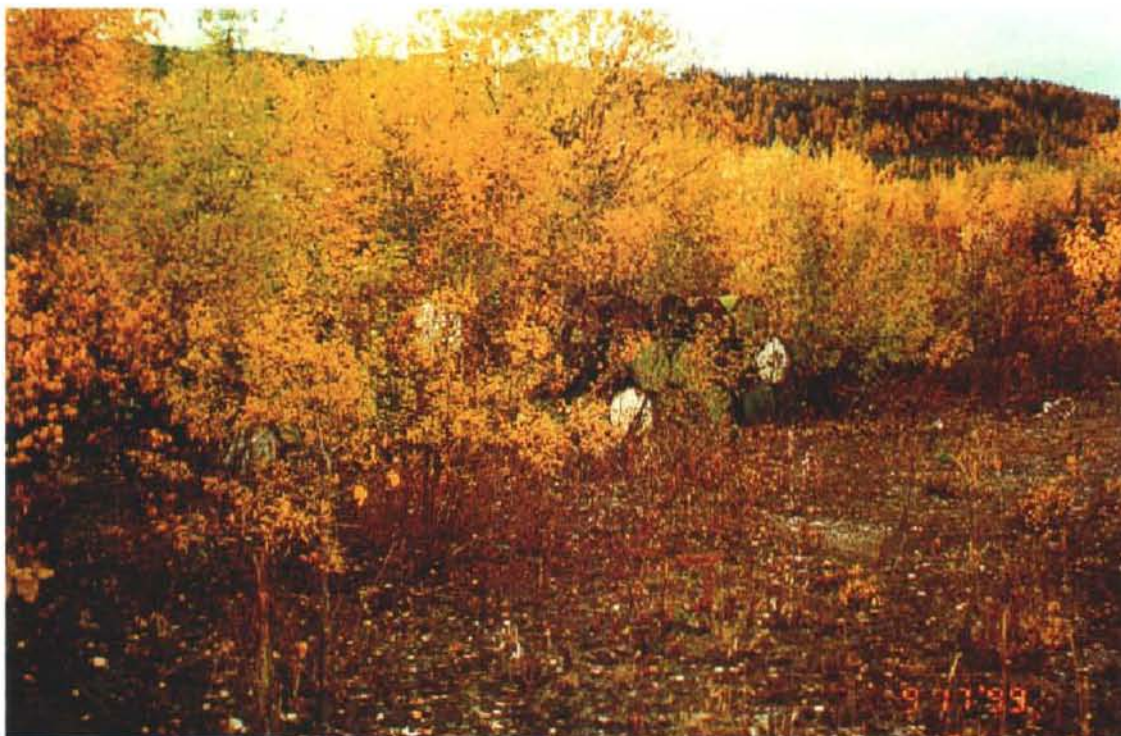
Photo 58-1: Barrel storage area to north of main sites.

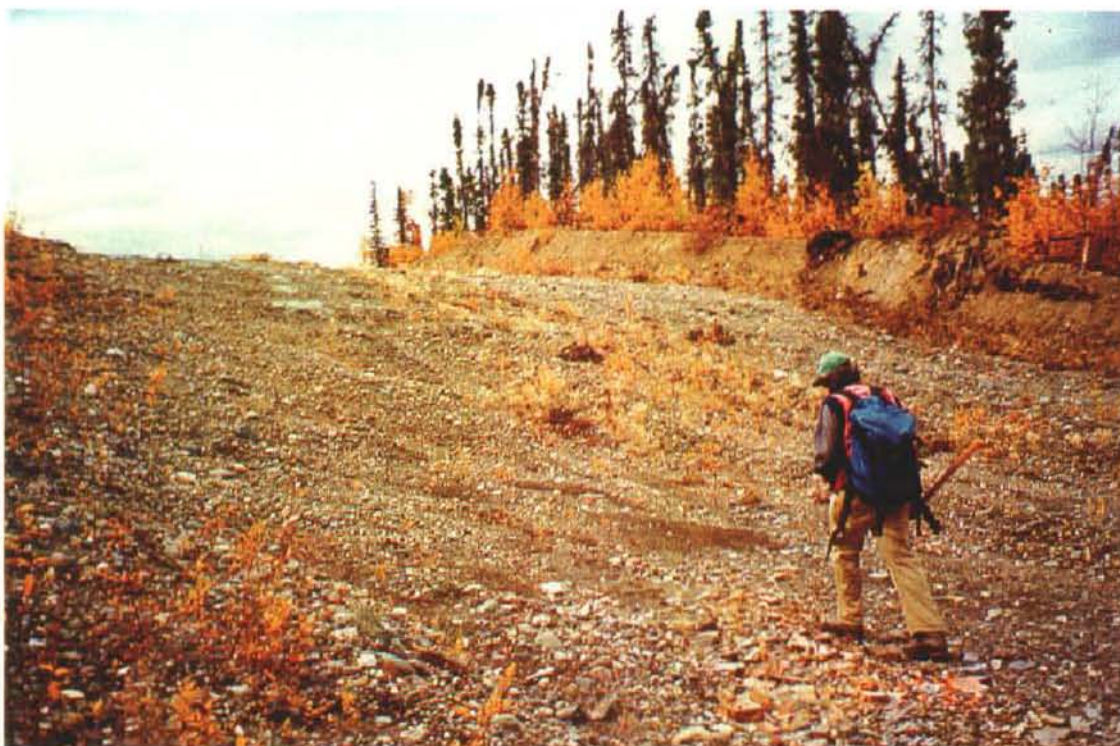
Photo 58-3: Trenched area to north west of main site.

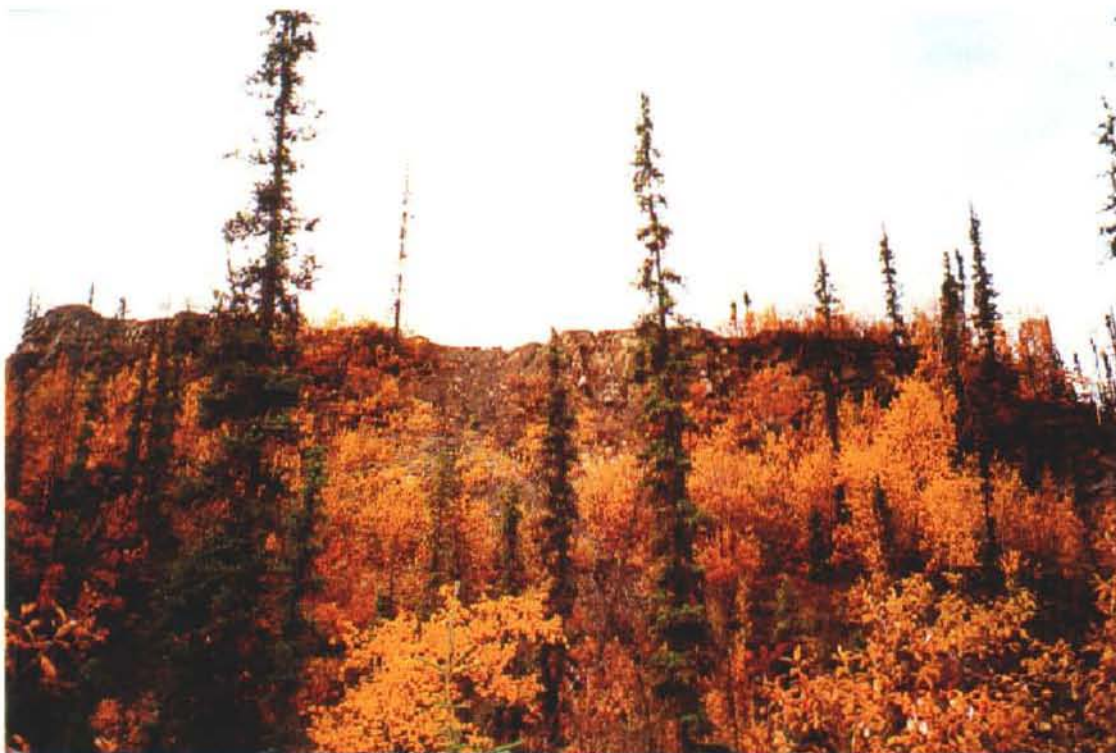
Photo 58-5: Trenched area visible from Christal Creek canyon below.

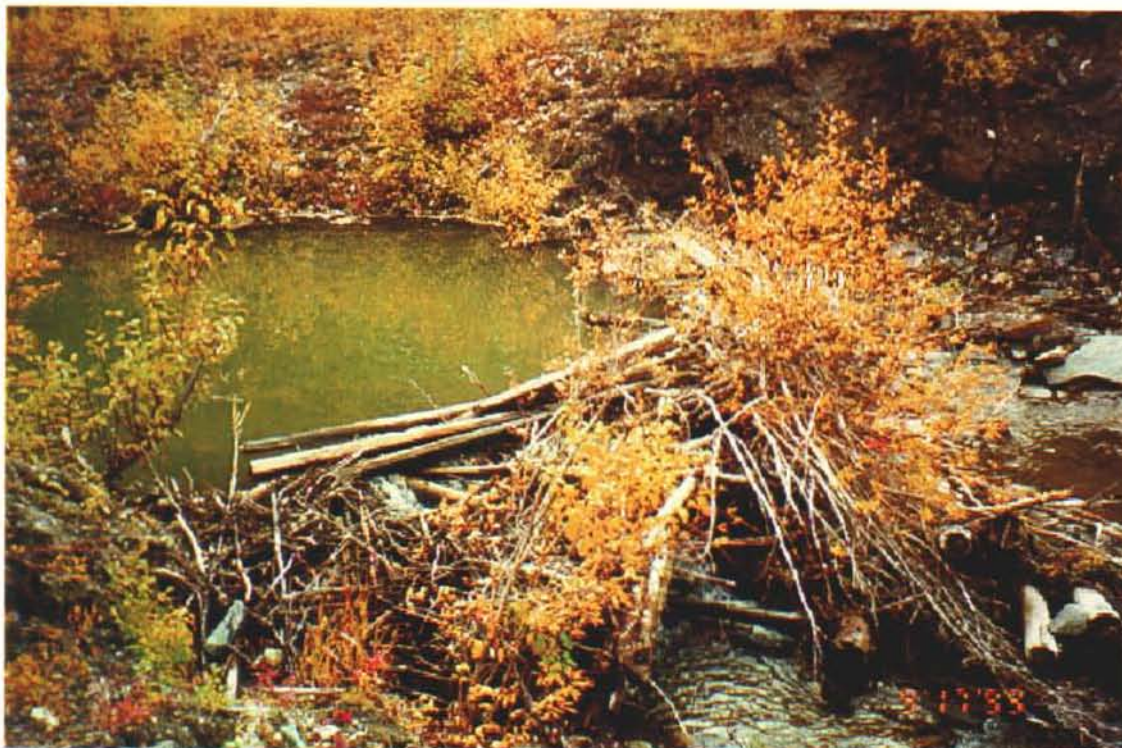
Christal Creek was sampled upstream of the site immediately upstream of a beaver dam (photo 58-8) constructed at the collapsed bridge (58-WQ-StrCD-02). The beaver dam was not identified in previous assessments and is probably of recent construction. Christal Creek was also sampled downstream of the site, immediately upstream of the north collapsed bridge (58-WQ-StrCD-01) at a location similar to previous sampling programs (photo 58-9).

Photo 58-8: Beaver dam immediately downstream of site.

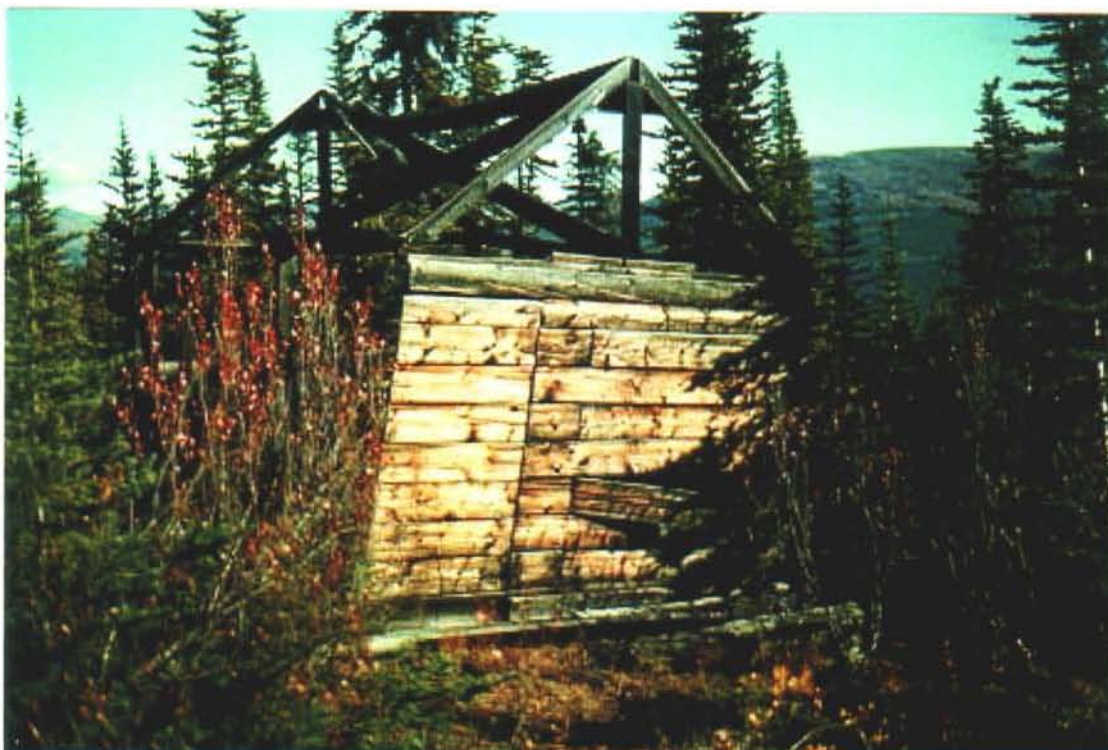
Photo 59-4. Wooden cabin.

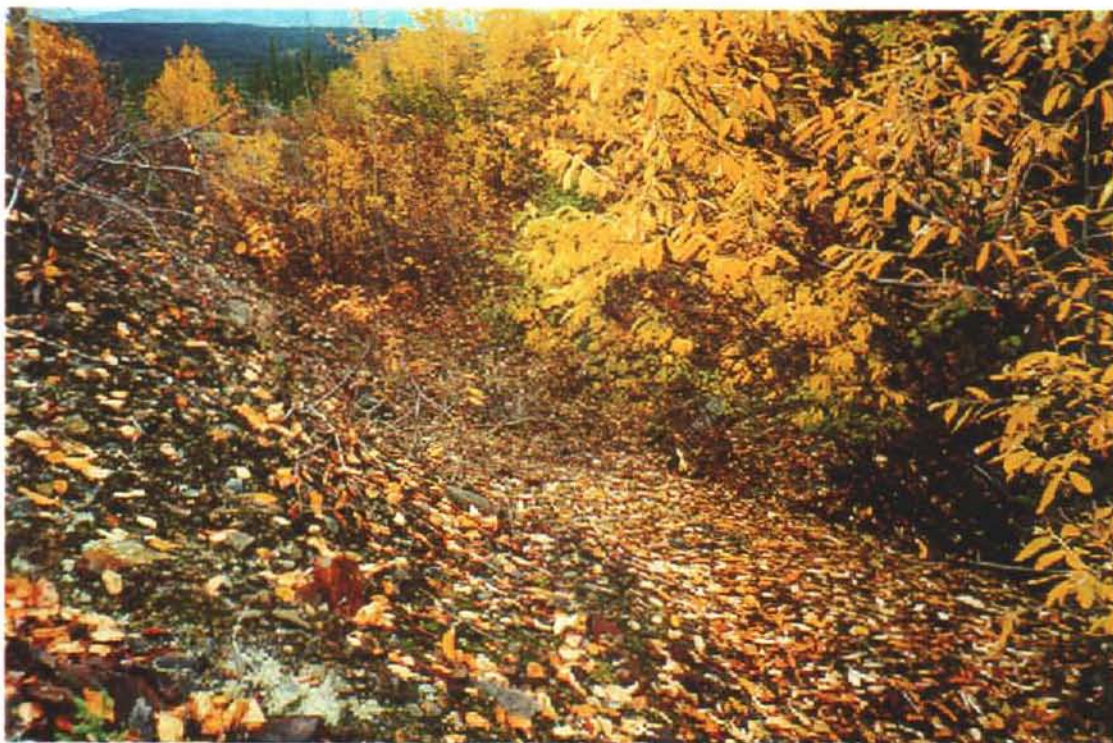
Photo 63-1: Trench 1 with waste rock pile #2 on left side. (Azimuth 070°)

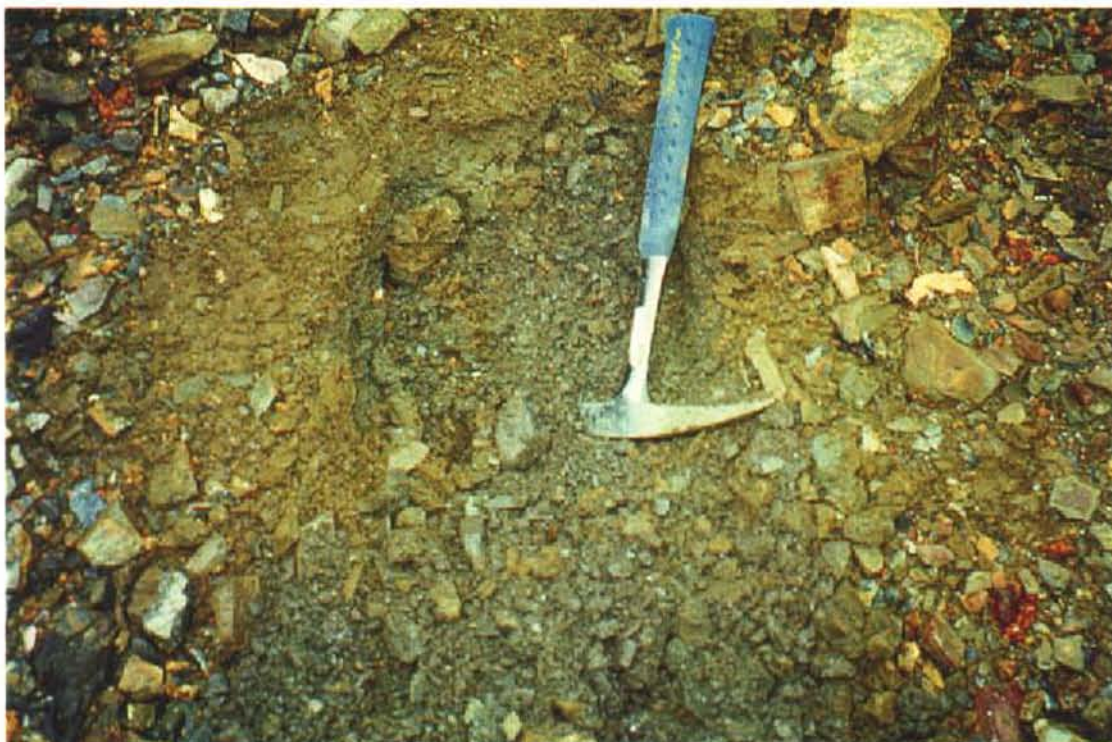
Photo 63-5: Test pit from waste rock pile #3. Note the oxidation at the surface of the pit.  
(Azimuth 240°)

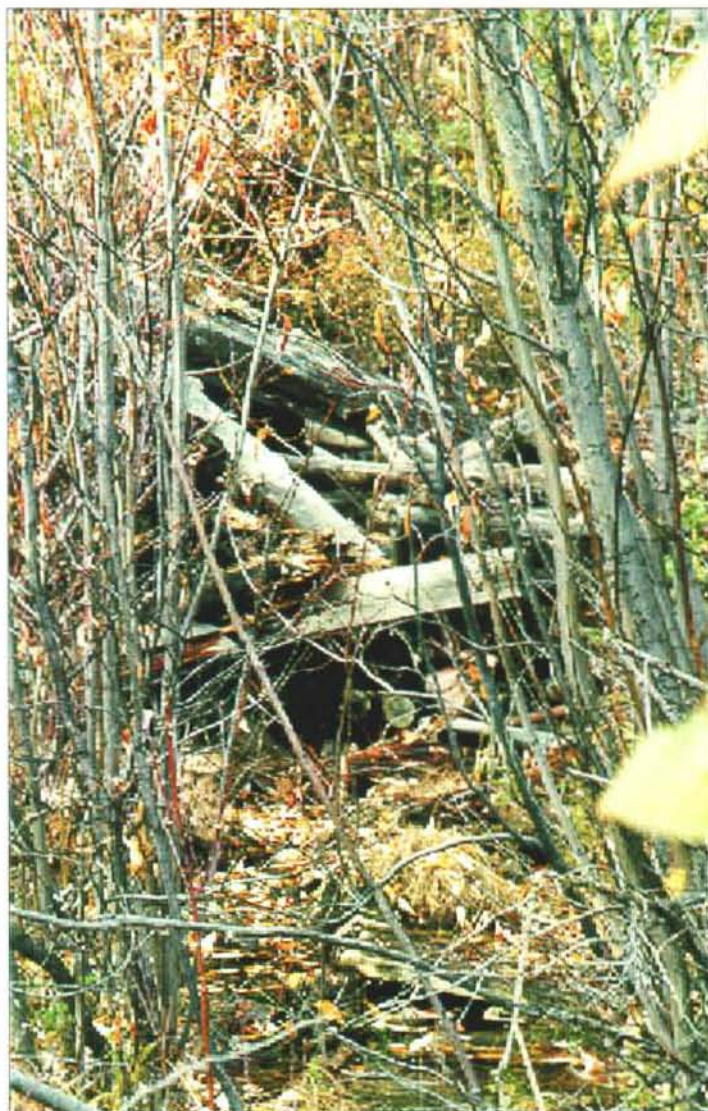
Photo 65-1 : Shanghai. Collapsed Main Adit with water flowing. (Azimuth 340°)

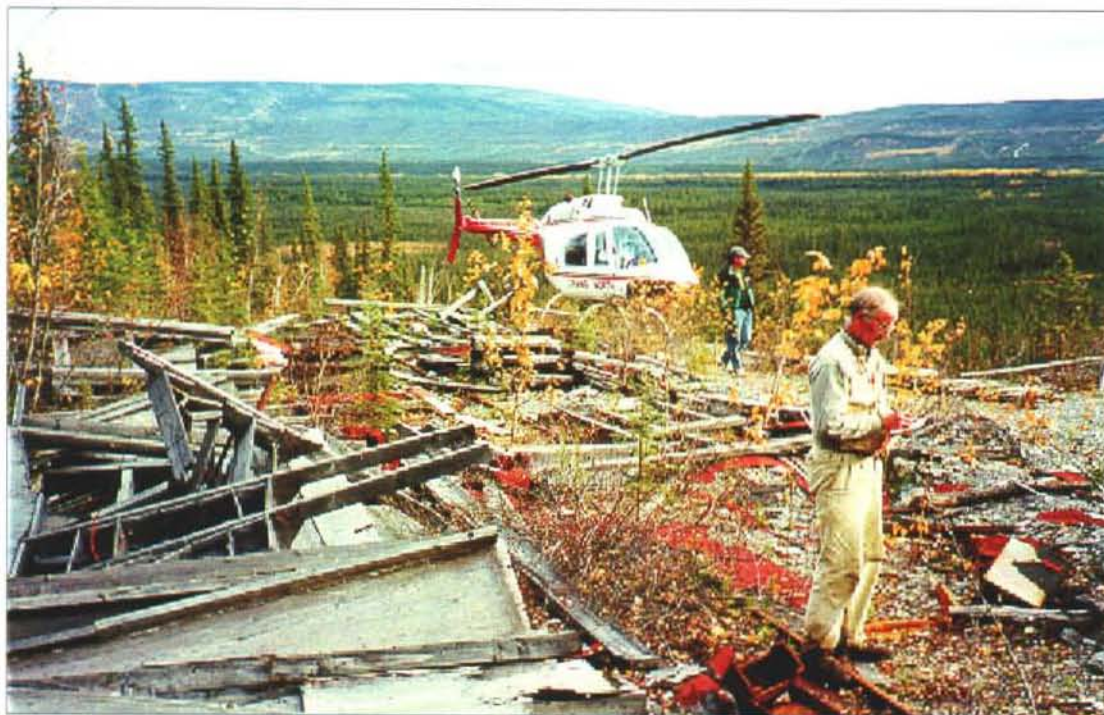
Photo 65-2 : Shanghai. Aerial view of waste rock pile and mine site debris. (Azimuth 120°)

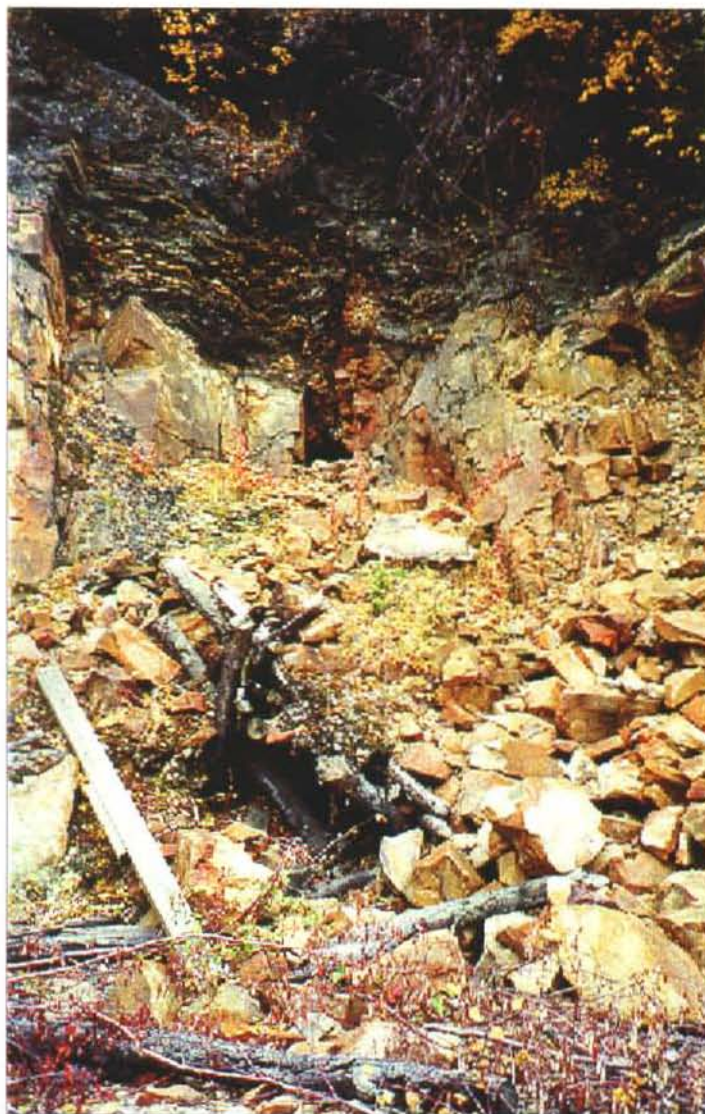
### **Moon Adit (photo 66-1)**

Condition: The log cribbing is broken up and has collapsed. The first 10m of the adit has caved-in. The ground above the remainder of the adit appears stable.

Photo 66-1 : Moon. The first 10m of the portal structure into the Moon adit has collapsed. (Azimuth 216°)

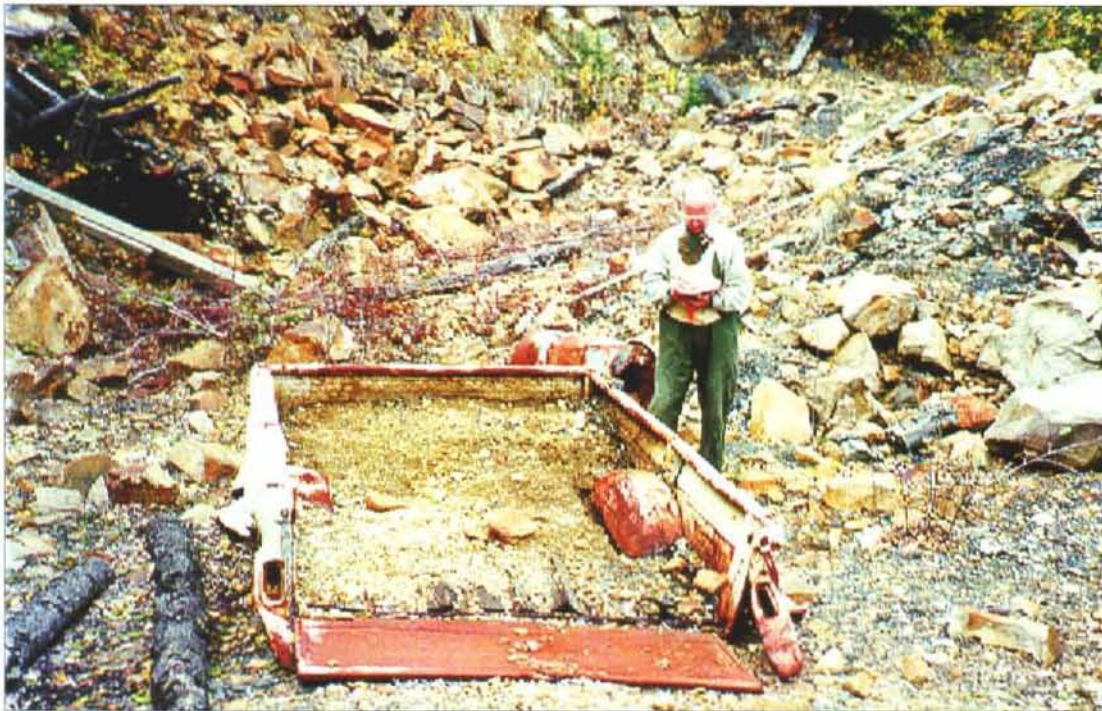
## **5.2 Waste Rock Disposal Areas (photo 66-2)**

Photo 66-2 : Moon. Ore stockpiled in a truck box, portal structure in the background. (Azimuth 275°)

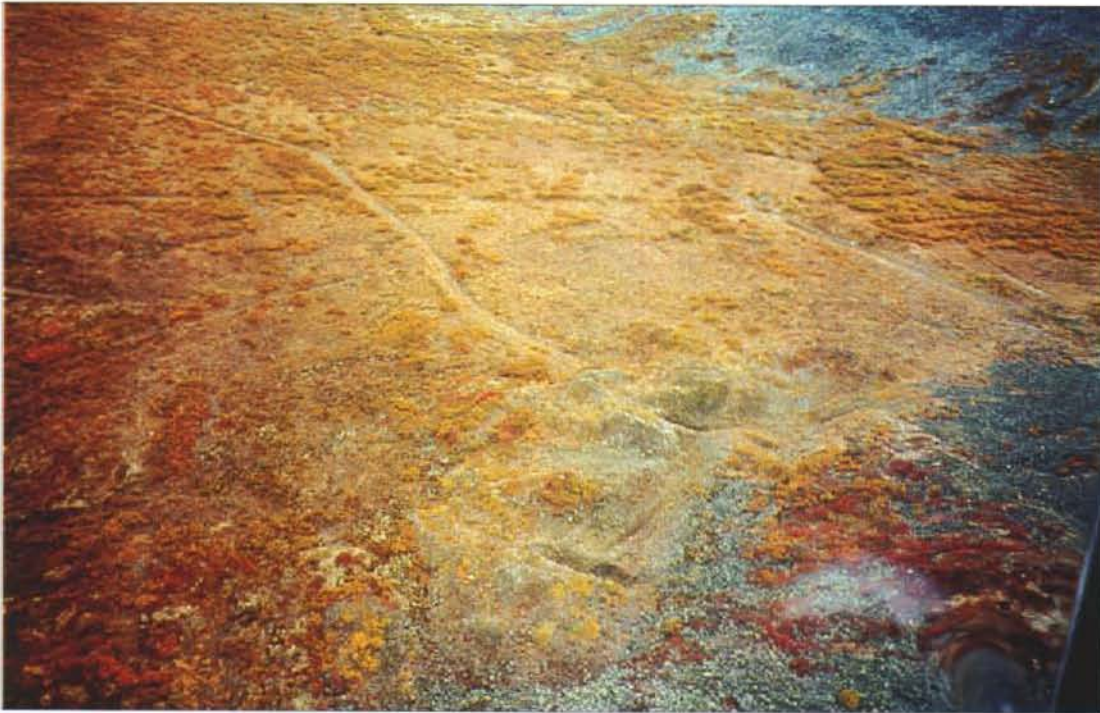
Photo 69-1: Aerial photograph of Avenue site showing western trenches. Pit 1 and Trench 4 are clearly visible just below centre of photograph. Trench 2 can be seen in upper righthand corner. Trail leading up southeastern slope of Keno Hill enters photograph from upper lefthand corner.

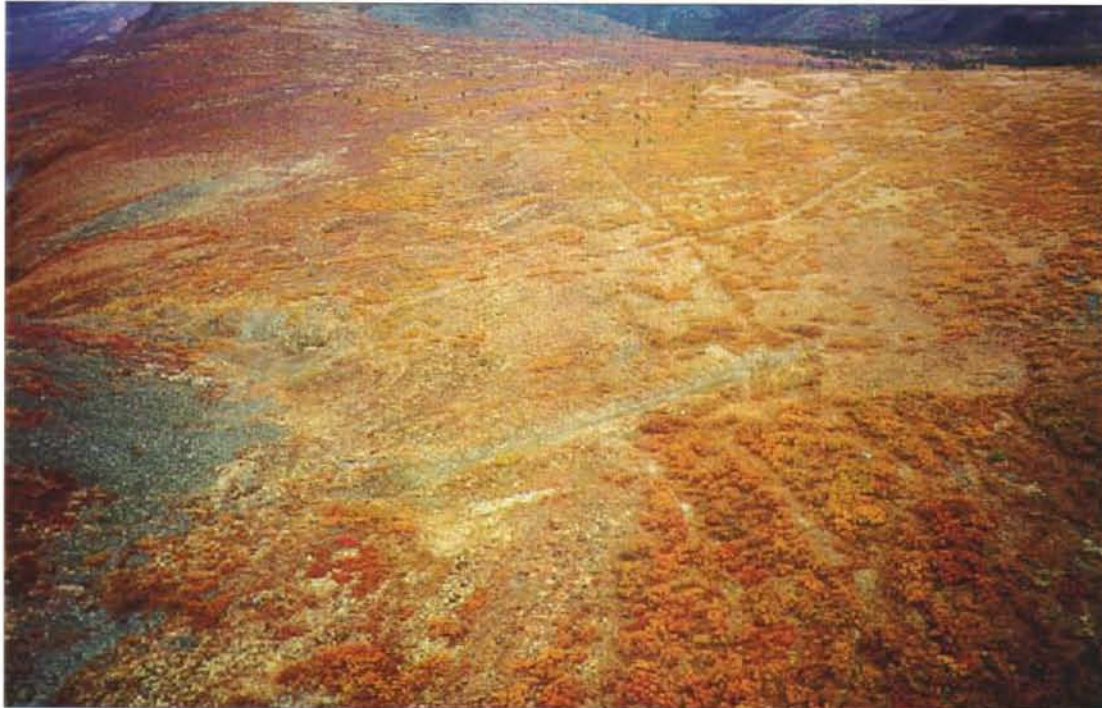
Photo 69-2: Aerial photograph of Avenue site with a good view of plateau. Trench 2 is visible just below centre of photograph.

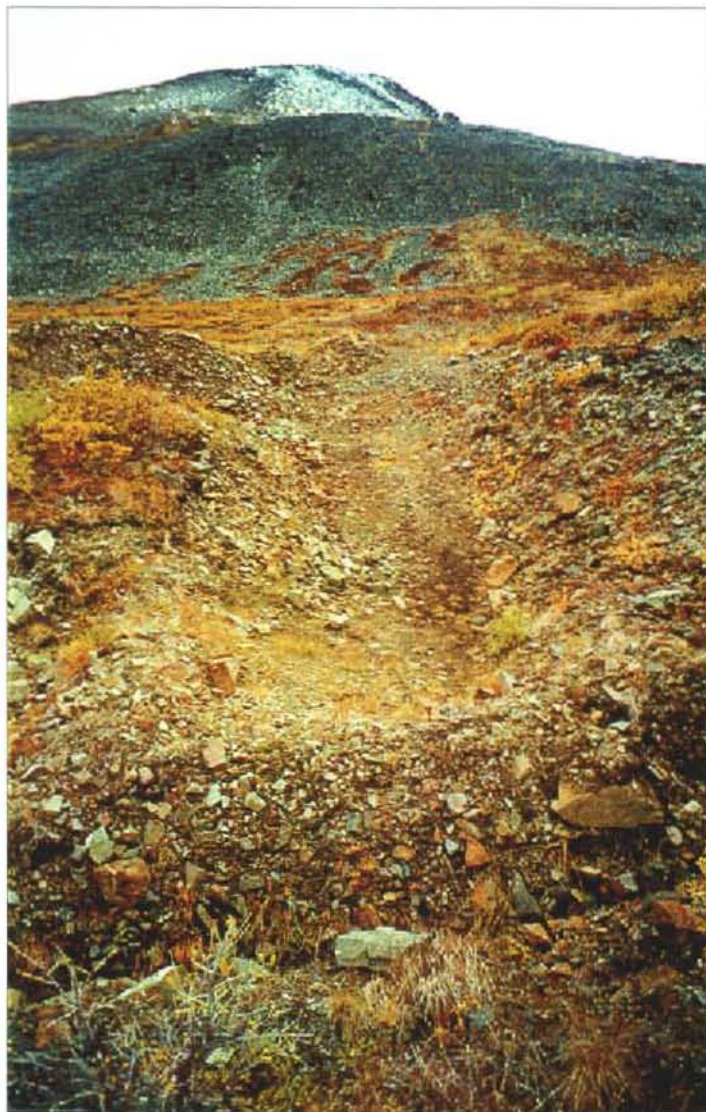
#### Trench 3 (photo 69-5)

Condition: stable - 20% revegetated

Photo 69-5: View along length of Trench 3 with Trench 4 crossing it in foreground. (AZ 219)

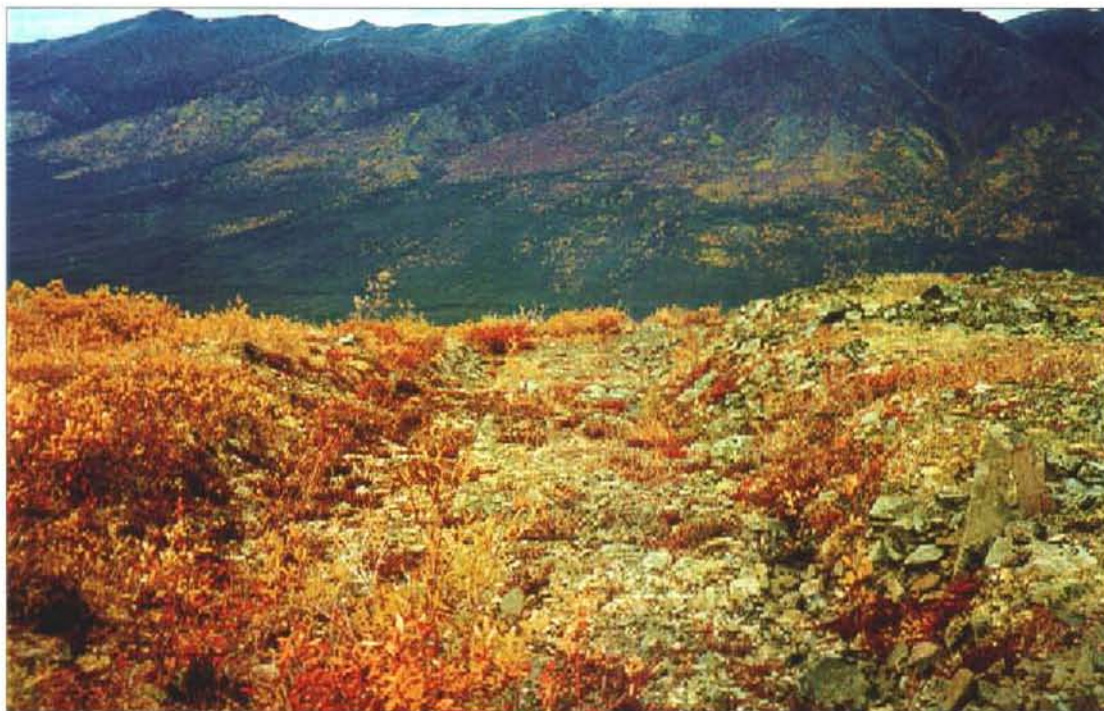
Trench 6 (photo 69-6)

Photo 69-6: View about NNW along length of Trench 6.

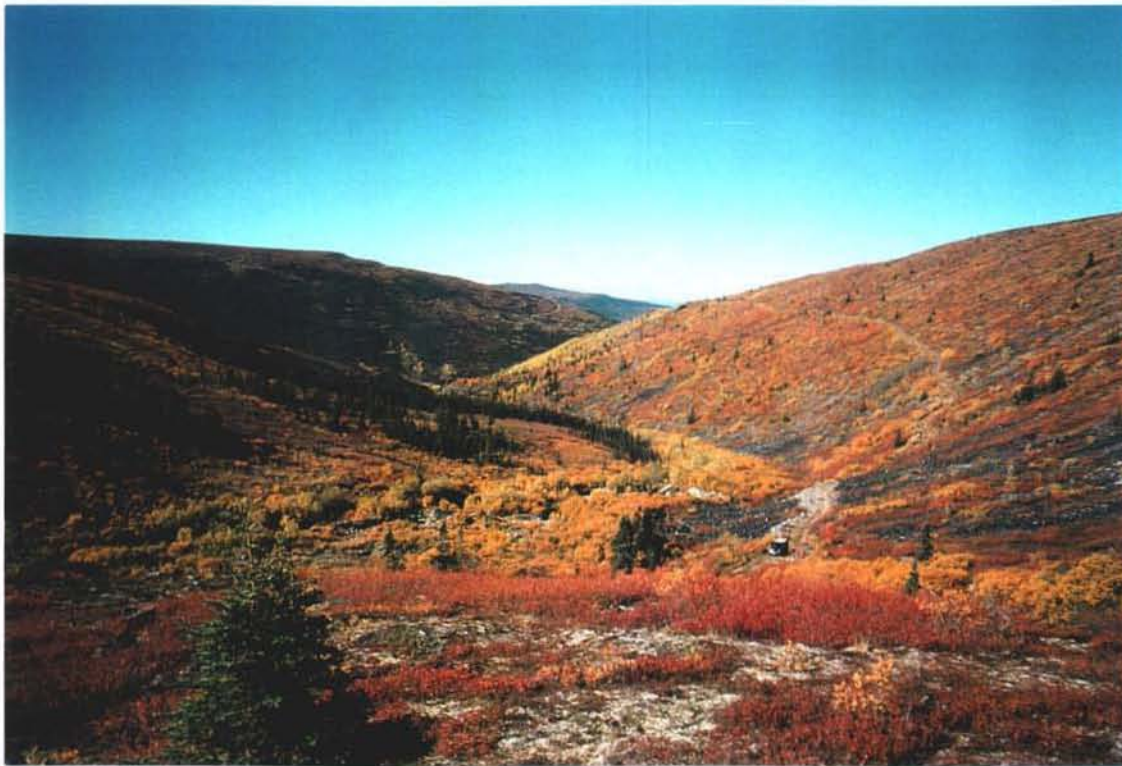
Photo 70-1 View from east of Thunder Gulch and access to Yono site. Sourdough Hill is visible in lefthand background.
