**Small Public Water System Assessments  
Yukon Government Maintained Buildings**

***NORTHERN REGION  
DRAFT REPORT***

**EBA Project No. 1260002.004**

**March 2006**

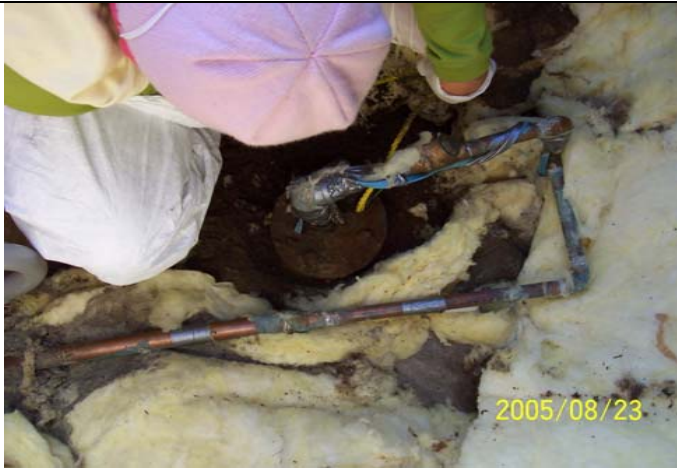
**Photo 385:** M0026 Wellhead.

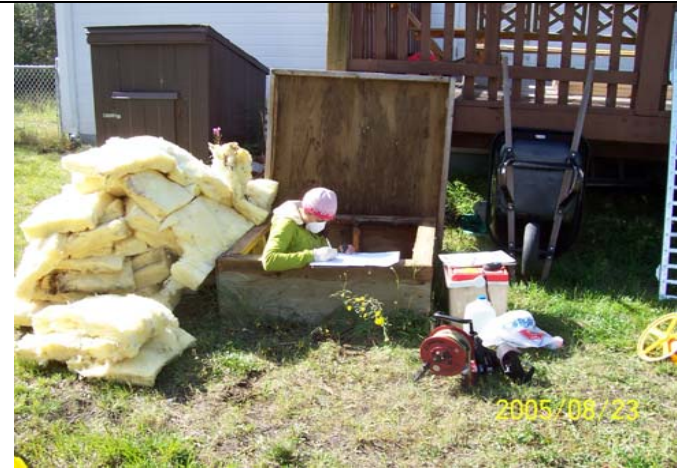
**Photo 386:** M0026 Well enclosure.

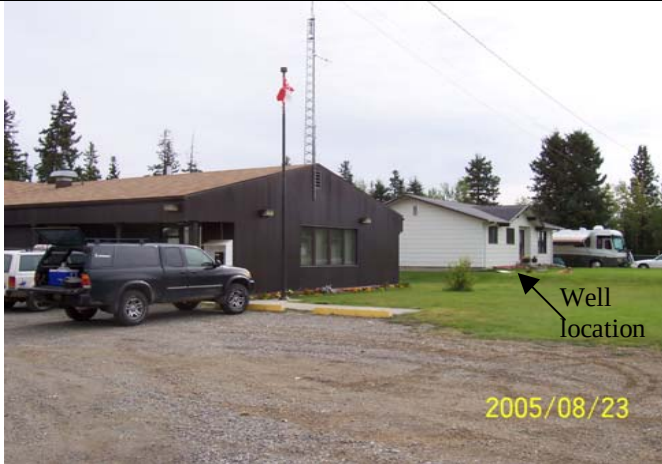
**Photo 381:** M0156 Pelly Crossing RCMP detachment. (left) Residence M0226 on (right).

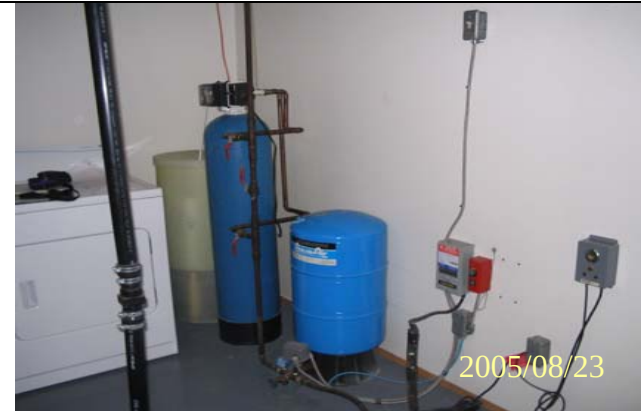
**Photo 199:** M0156/M0226 Water System (pressure tank, pump controls, softener).

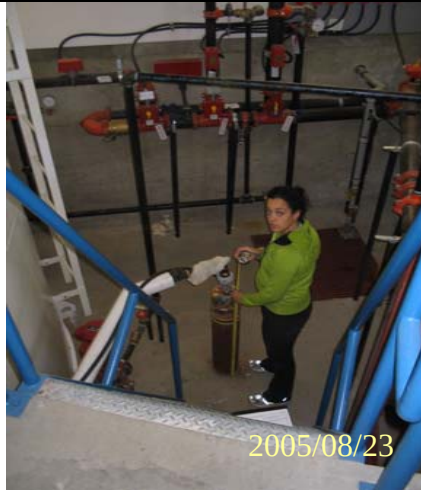
**Photo 203:** 5676 Wellhead.

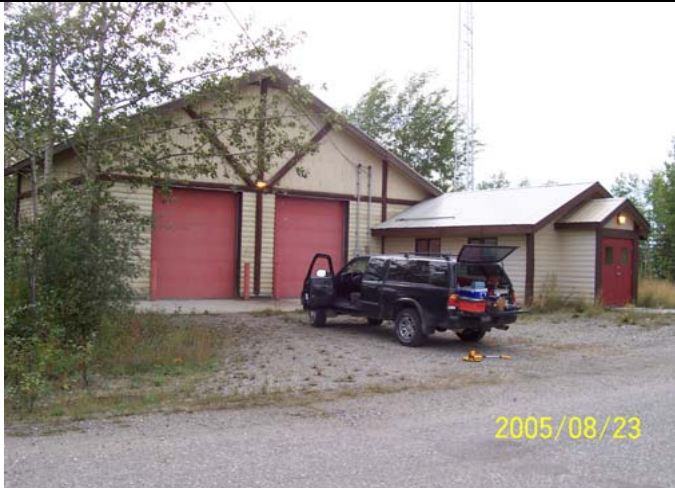
**Photo 405:** 5678 Pelly Crossing Fire hall. (looking west)

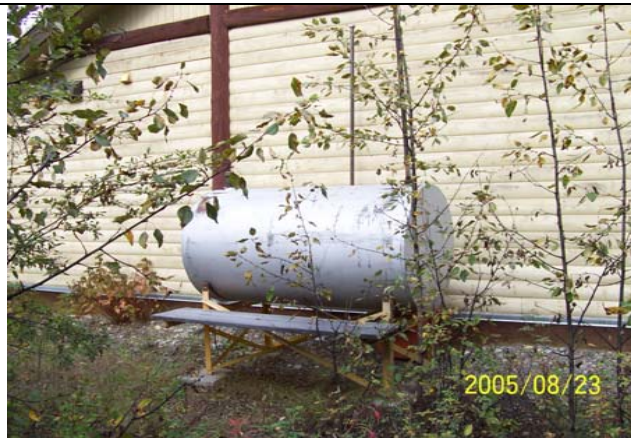
**Photo 403:** 5678 On site AST on west side of building.

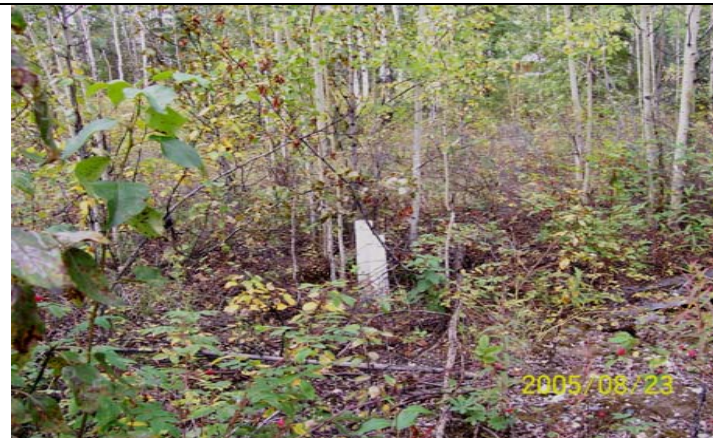
**Photo 406:** 5678 Septic system.

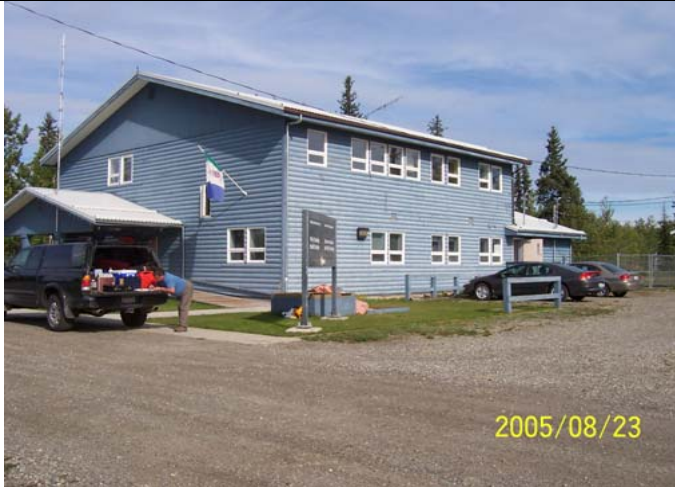
**Photo 393:** 5987 Pelly Crossing nursing station. (looking northeast)

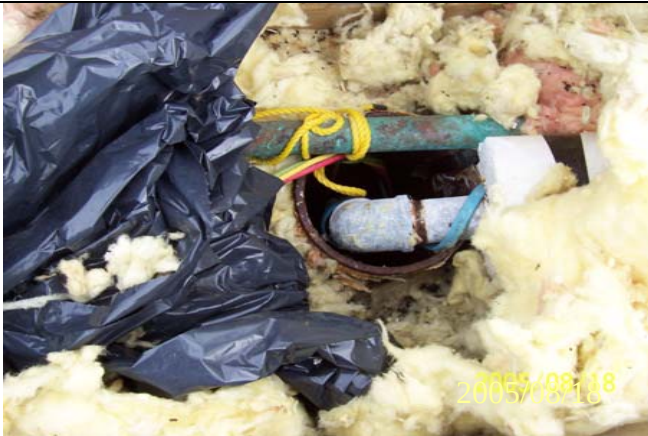
Entrance by animals? ☐ Yes ☒ No  
*Access possible. Mouse droppings observed. No cap on well*

- i. Is the well head below grade? describe in detail ~0.15 m above grade
- ii. Are there signs of ponding on the enclosure(e.g. water stains, etc.)? ☐ Yes ☒ No
- iii. Is the wellhead enclosed by fiberglass insulations? ☒ Yes ☐ No
- iv. Any evidence of rodents? Specify Yes. Mouse droppings in insulation
- v. Does the well casing have a proper seal cap? ☐ Yes ☒ No
- If no, describe condition None present. Well is open

**Photo 065:** 2600 Wellhead – note that at the time of the assessment there was no well cap and evidence of mice around the wellhead.

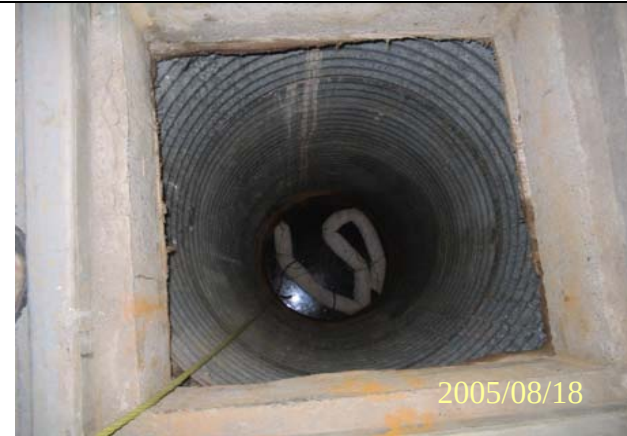
**Photo 196:** 2600 Abandoned dug well.

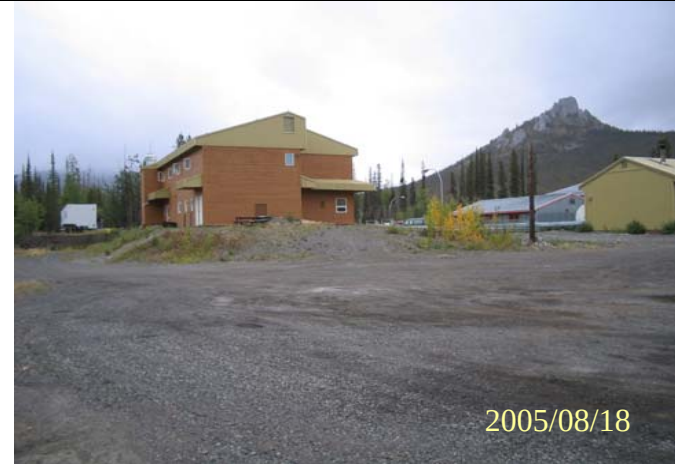
**Photo 205:** 2665 Olgilvie living complex.

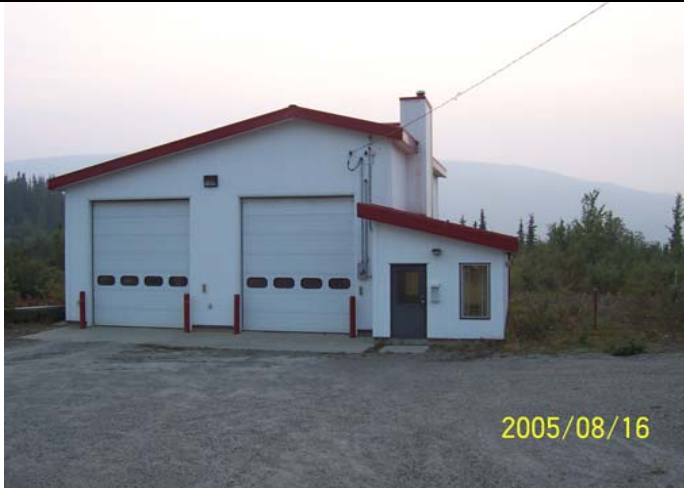
**Photo 015:** 5622 Keno Fire Hall facing west.

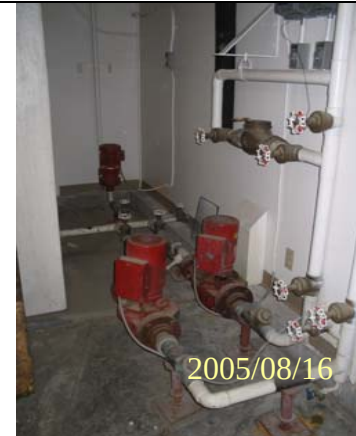
**Photo 184:** 5622 Booster pumps.
