**Small Public Water System Assessment  
Yukon Government Maintained Buildings**

***WHITEHORSE REGION***

**EBA Project No. 1260002.001**

**March 2006**

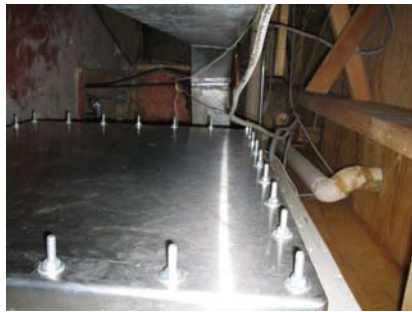
**Photo 0500:** 1134 Storage Tank

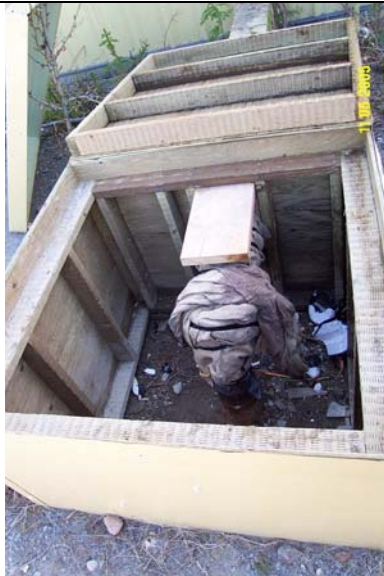
**Photo 0131:** 1153 Well Head

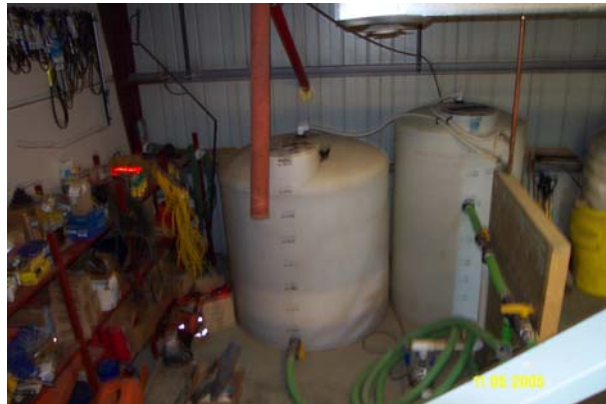
**Photo 0135:** Water Tanks/Brine Tanks

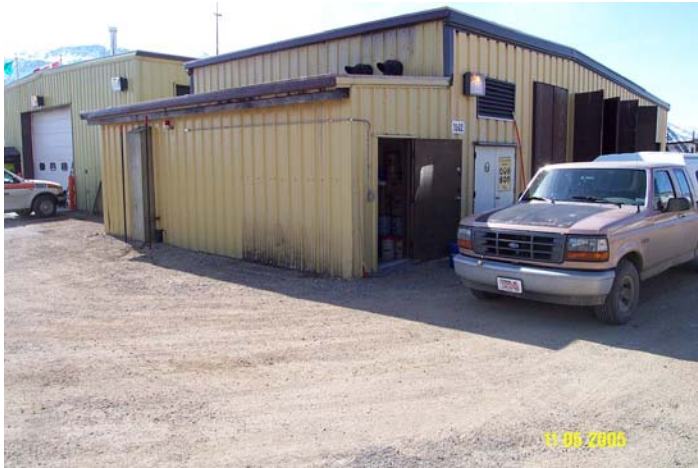
**Photo 0111:** 1500 Maintenance Garage with access to Water Equipment Room

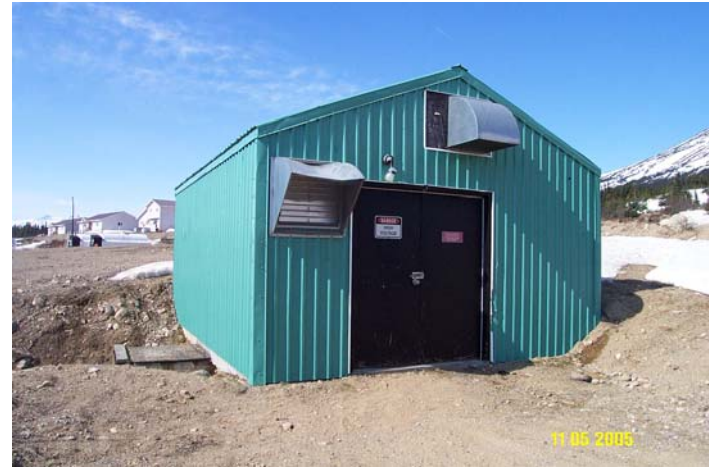
**Photo 0112:** 1500 Hydroelectric Generating and Penstock Station

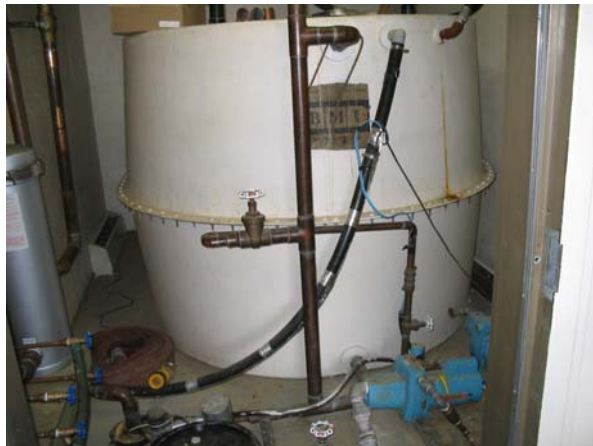
**Photo 0484:** 1500 Water Storage Tanks

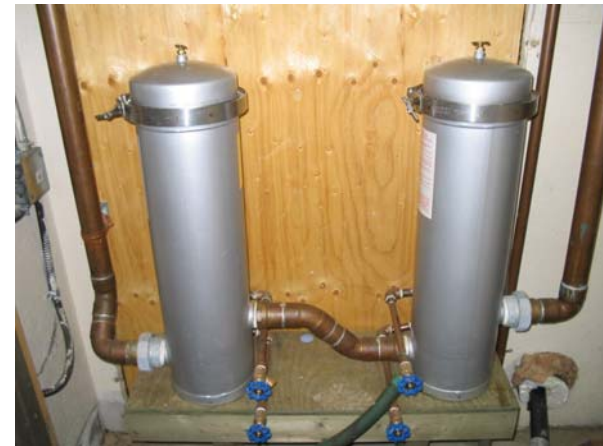
**Photo 0486:** 1500 Filter System, 1 Micron Filter (left) and 10 Micron Filter (right)

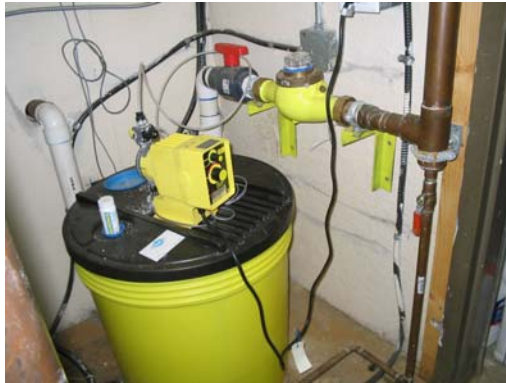
**Photo 0485:** 1500 LMI Chlorinator

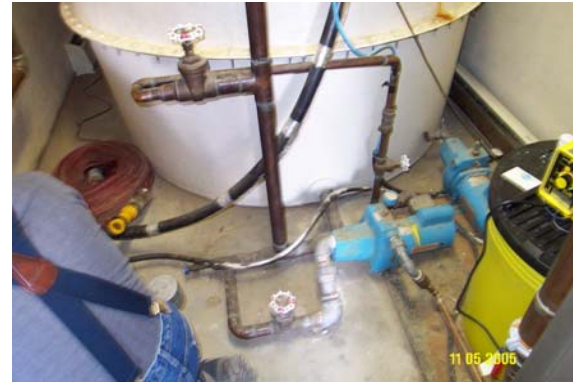
**Photo 0109:** 1500 Jet Pump and Backup Water Reservoir

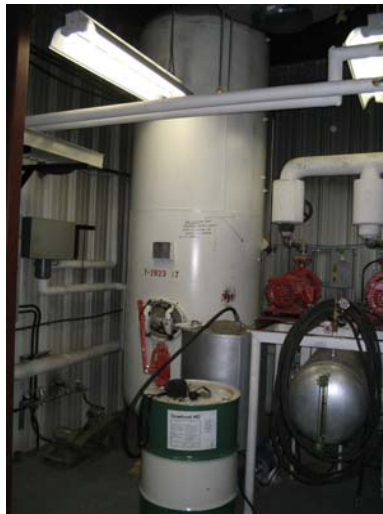
**Photo 0489:** 1500 Pressure Tank

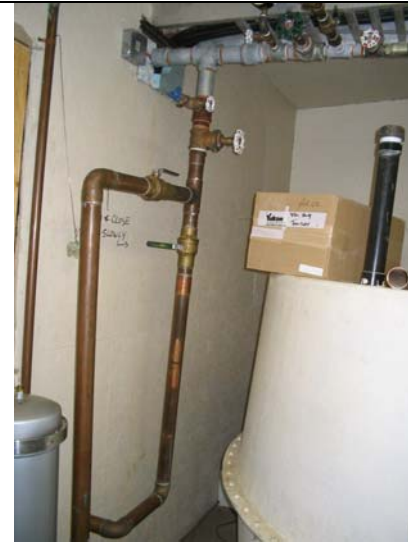
**Photo 0487:** 1500 Penstock Feed

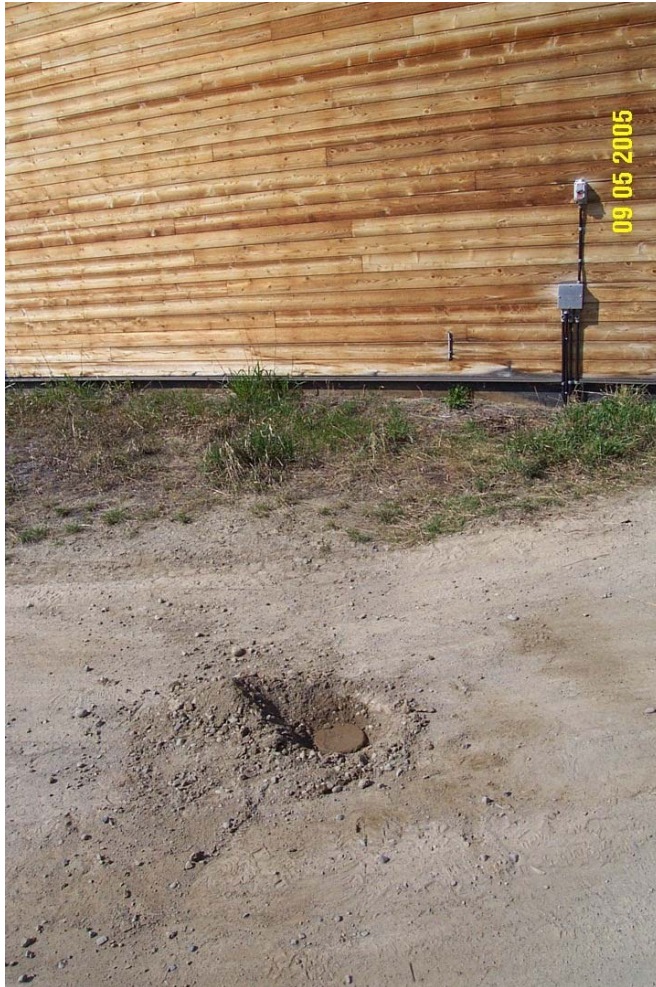
**Photo 0082:** 1322 Wellhead

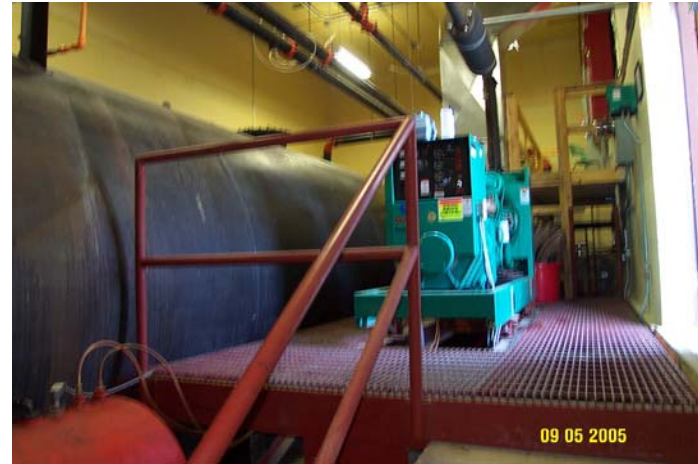
**Photo 0084:** 1322 Water Tank

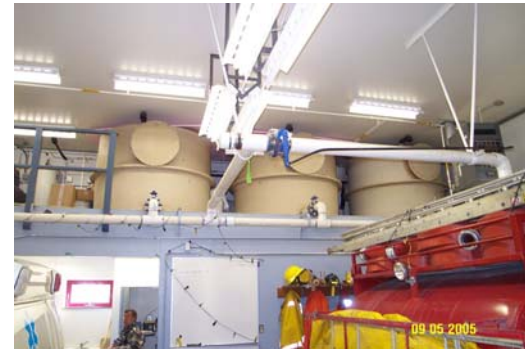
**Photo 0074:** 1334 Tanks and Truck Fill (domestic tank far right)

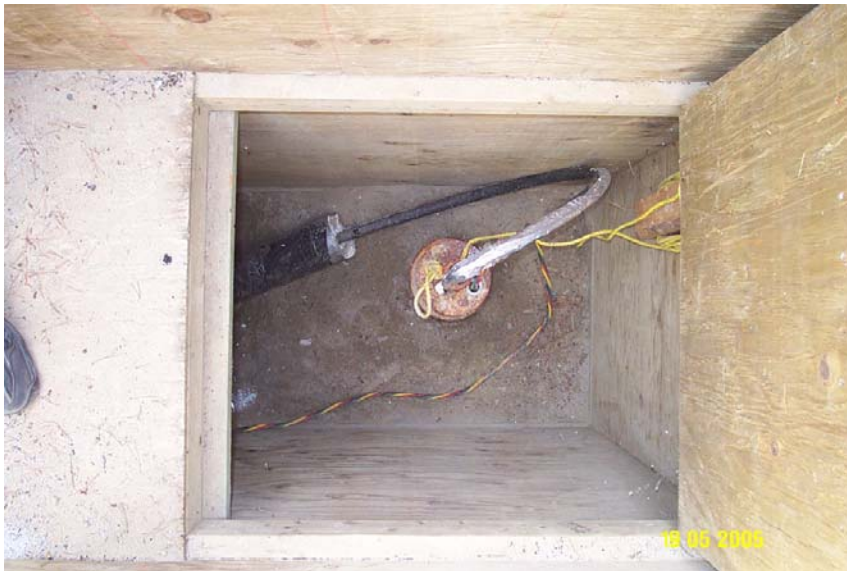
**Photo 0190:** 1391 Well Head

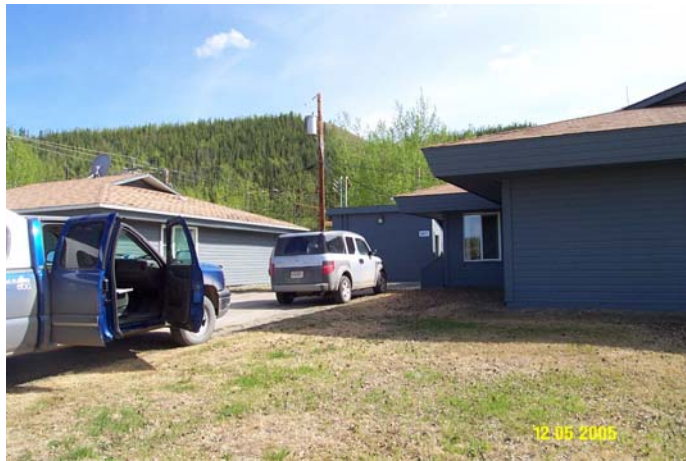
**Photo 0137:** 6975 Health Center (right), Wellhouse (center) and Nursing Residence (left)

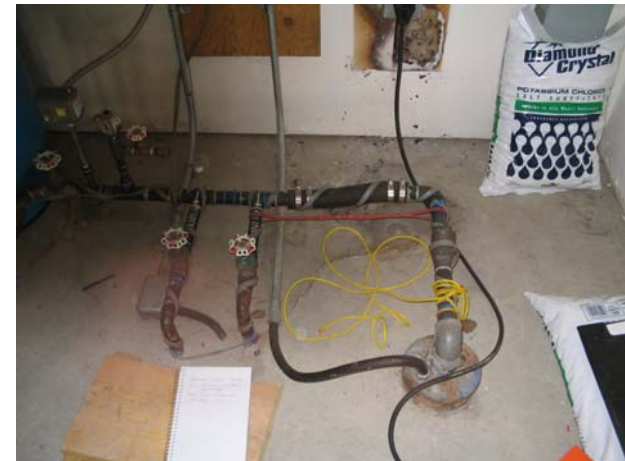
**Photo 0002:** 6975 Wellhead

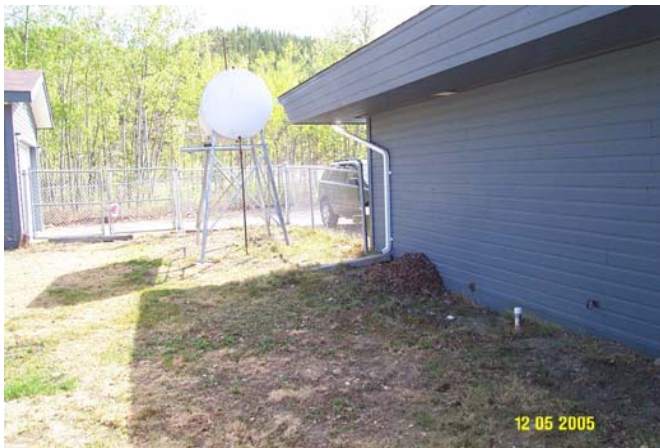
There was a leak from the AST in the line running to the station. Some soil contamination

**Photo 0138:** 6975 Above Ground Fuel Storage Tank and Hydrocarbon Spill Site

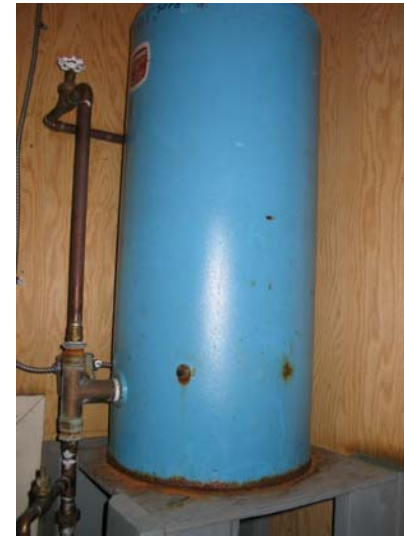
**Photo 0022:** 6542 Pressure Tank

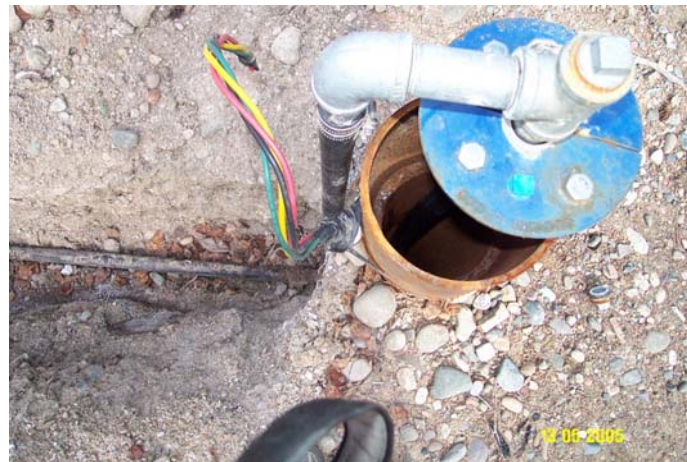
**Photo 0164:** 6536 Wellhead

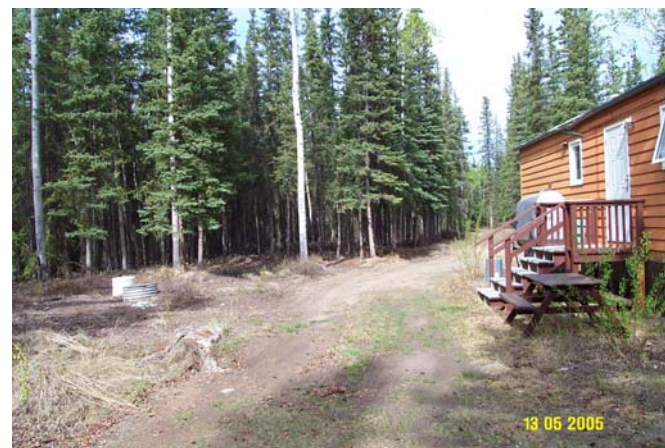
**Photo 0165:** 6536 Septic Field (left) and Forestry Crew Quarters (right)

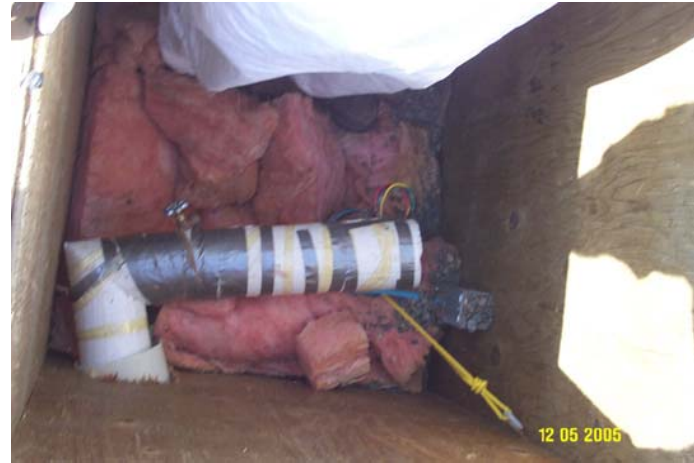
**Photo 0149:** 6522 Wellhead

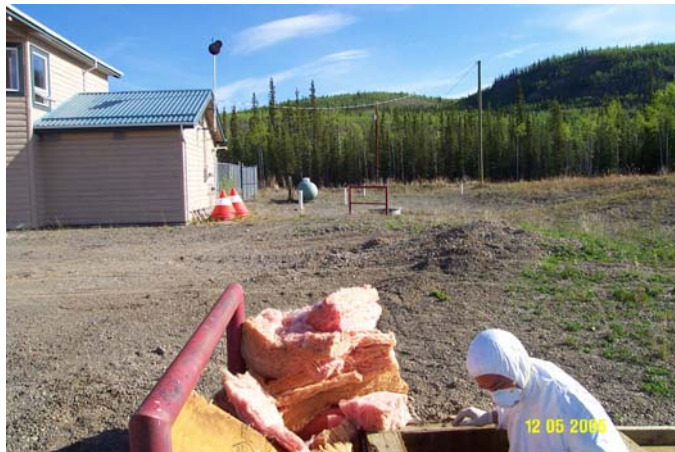
**Photo 0150:** 6522 Wellhead Enclosure (pitt, front), Carmacks Airport Terminal Building (back left), and Septic Field (back center)

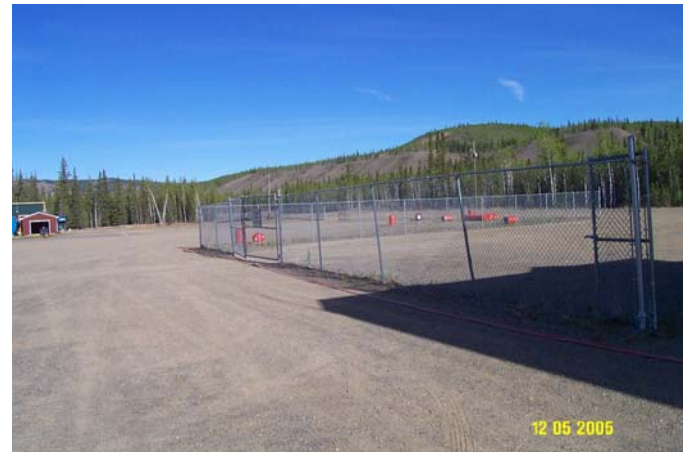
**Photo 0153:** 6522 Aviation Fuel Drums

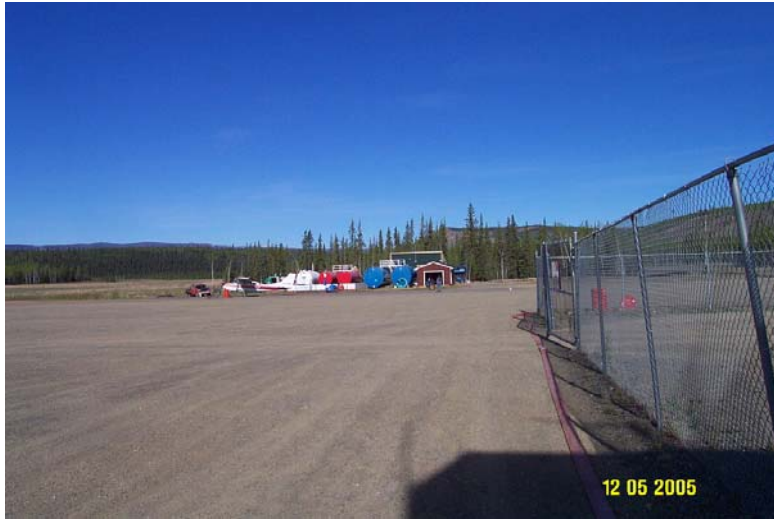
**Photo 0151:** 6522 Fueling Station

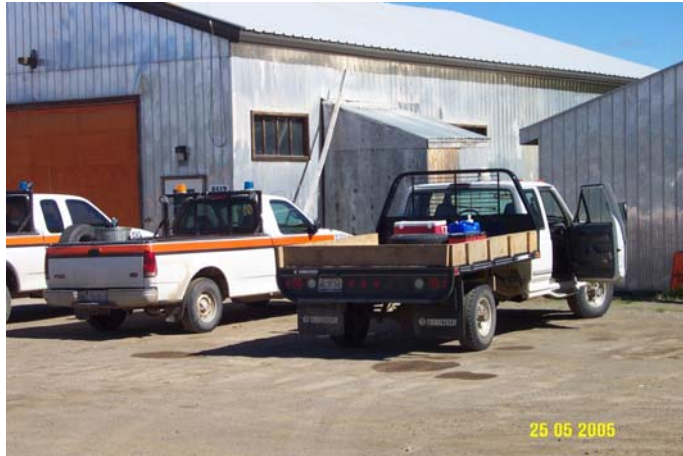
**Photo 0196:** 6512 Carmacks Grader Station and Well house Addition (back), Parking (front)

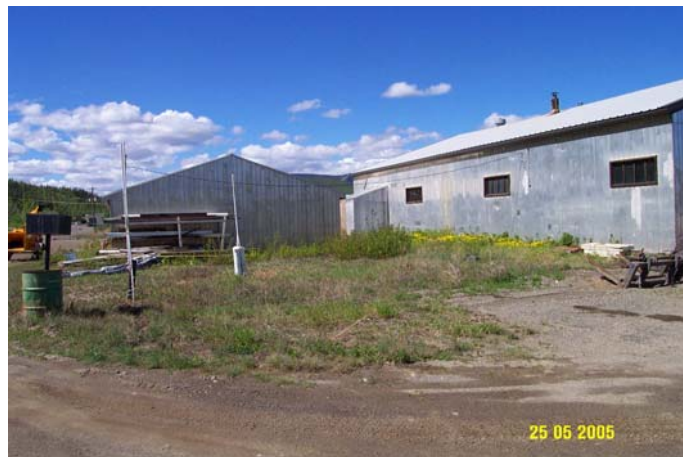
**Photo 0205:** 6512 Septic Field and Rock Pit (left), Carmacks Grader Station (back right)

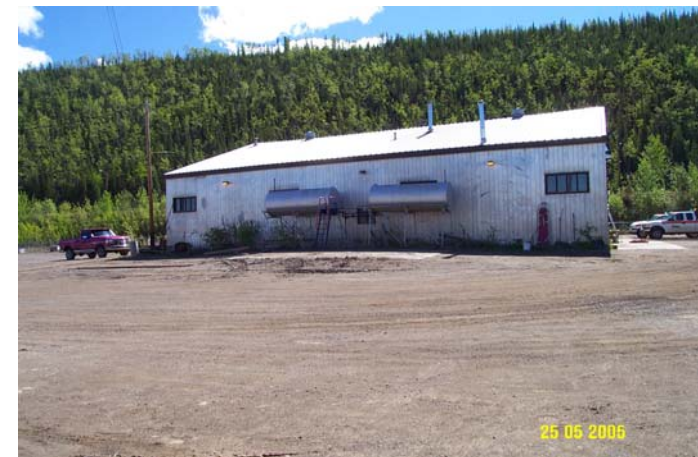
**Photo 0202:** 6512 Above Ground Fuel Storage Tanks (2) and Carmacks Grader Station (behind)

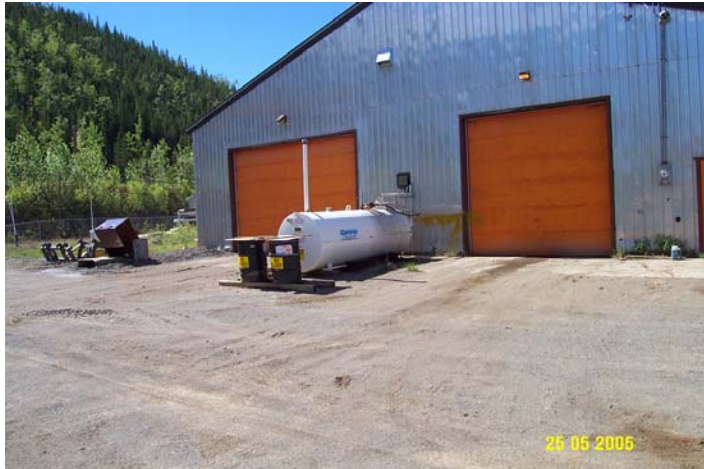
**Photo 0204:** 6512 Used Oil Tank, Used Antifreeze Drum and Used Solvent Drum, Carmacks Grader Station (behind)

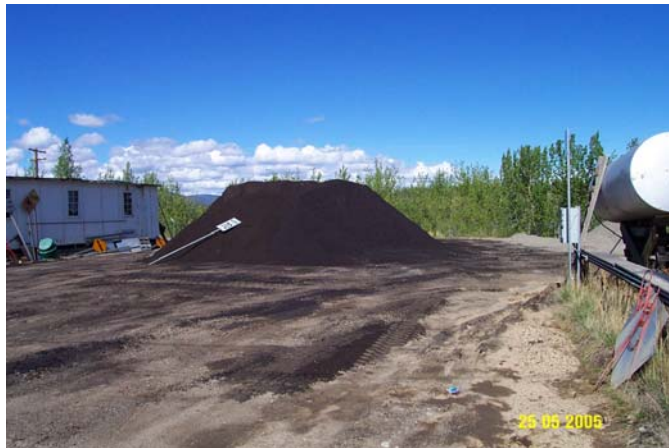
**Photo 0200:** 6512 Ash Fault Pile

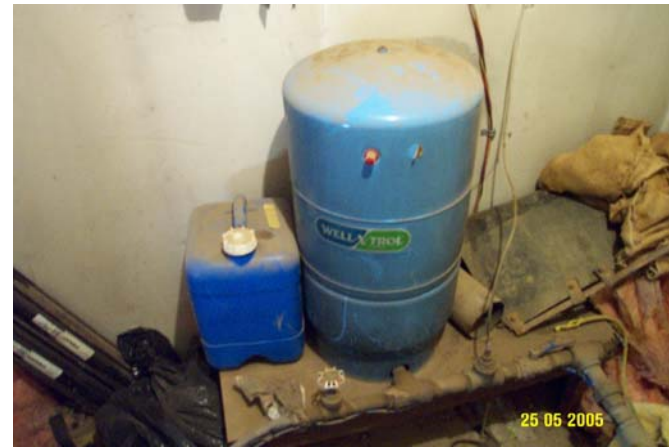
**Photo 0198:** 6512 Pressure Tank

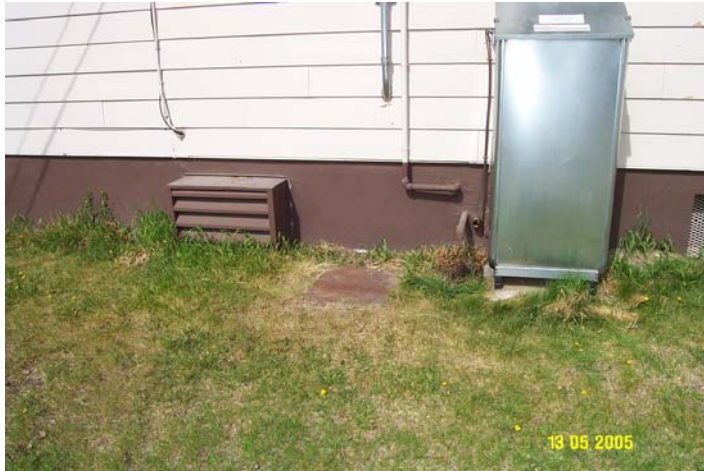
**Photo 0162:** 6511-A Main School Wellhead (underneath panel at center) and Above Ground Fuel Storage Tank (right)

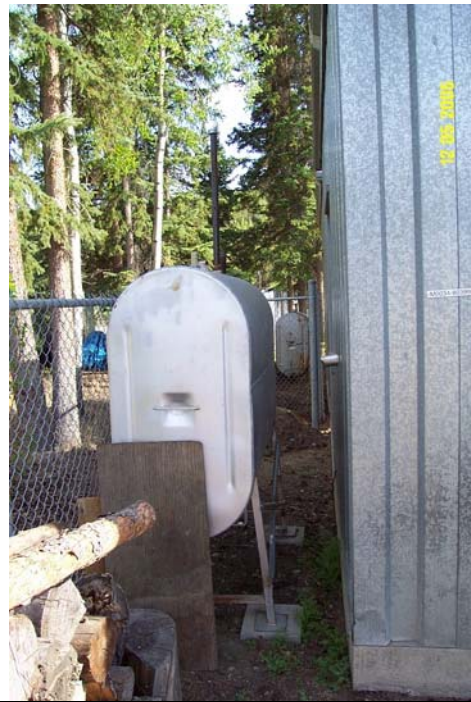
**Photo 0147:** M0064 and M0094 Above Ground Heating Fuel Storage Tank

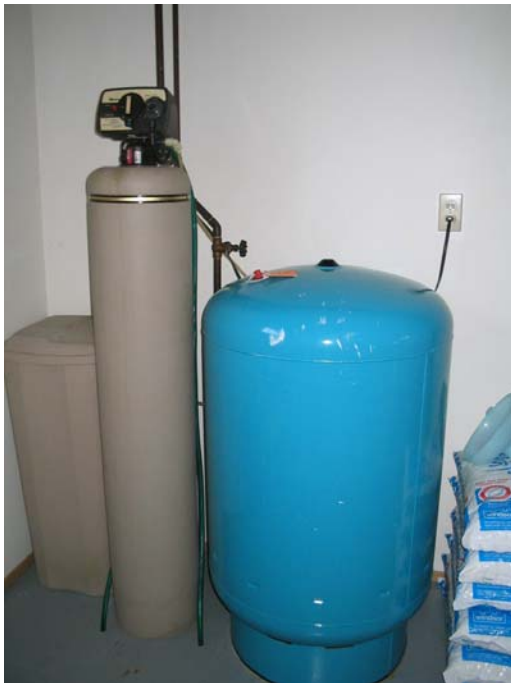
**Photo 0011:** M0094 Water Softener (left) and Pressure Tank (right)

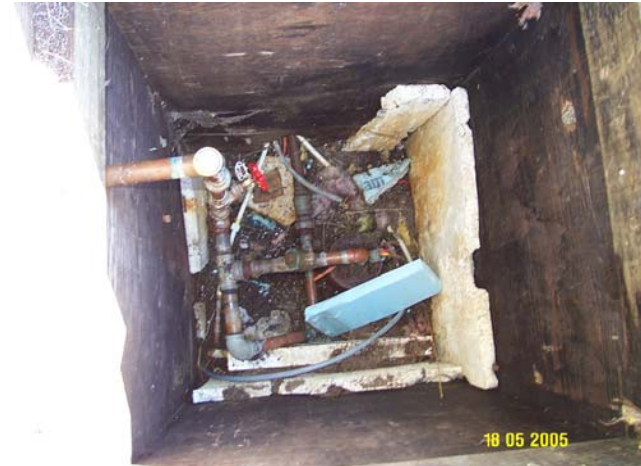
**Photo 0173:** YWP-A Well Head

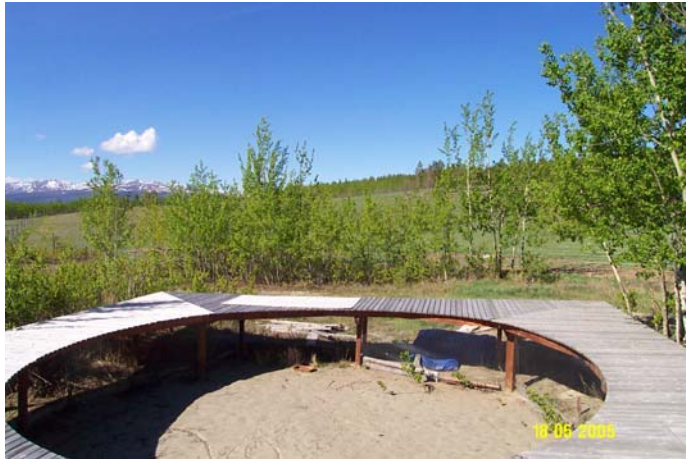
**Photo 0176:** YWP-A Muskox Pen (back)

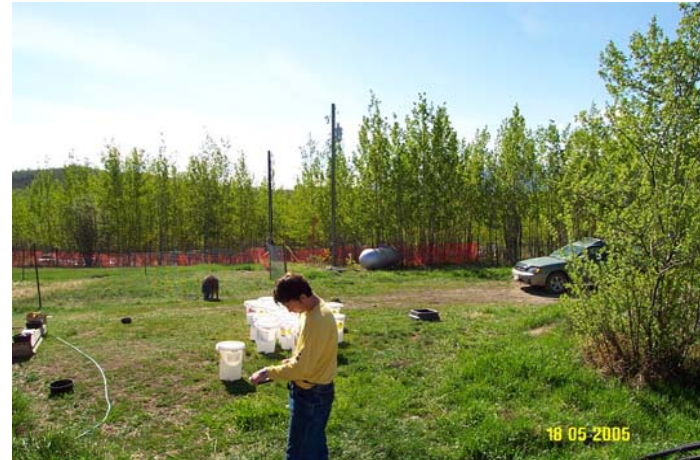
**Photo 0177:** YWP-A Baby Muskox Pen (left), Animal Feed Storage Area (behind)

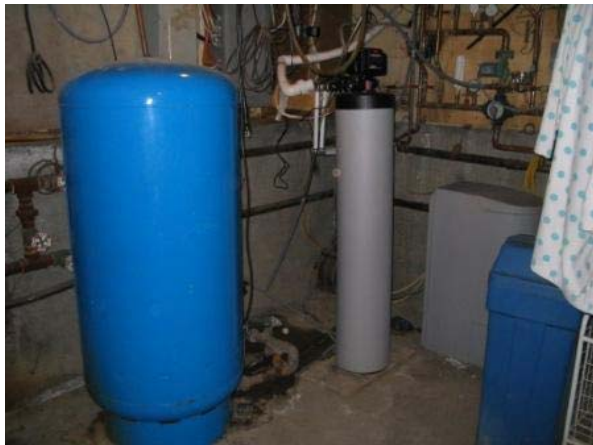
**Photo 0004:** YWP-A Pressure Tank (left) and Water Softener (right)

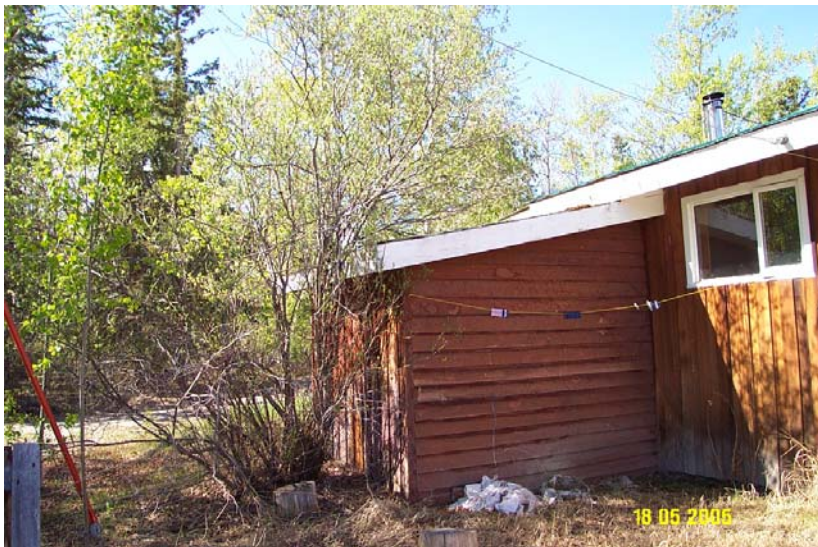
**Photo 0183:** YWP-B Preserve Staff Building and Well House Addition

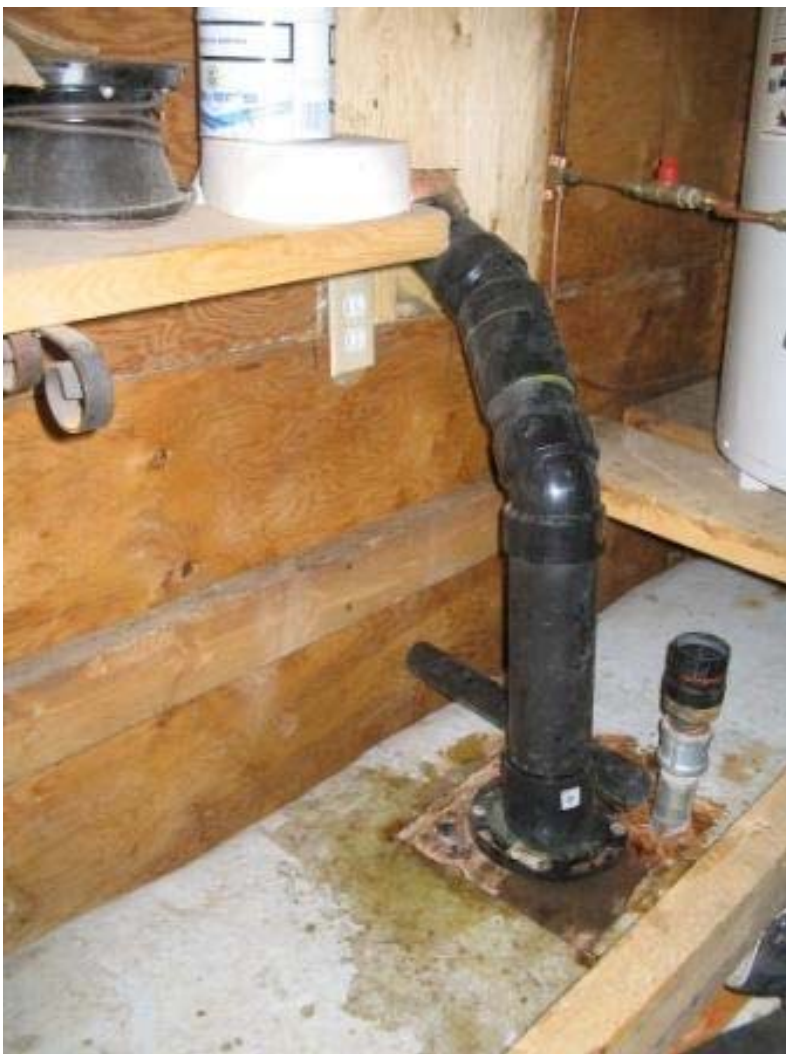
**Photo 0182:** YWP-D Piping

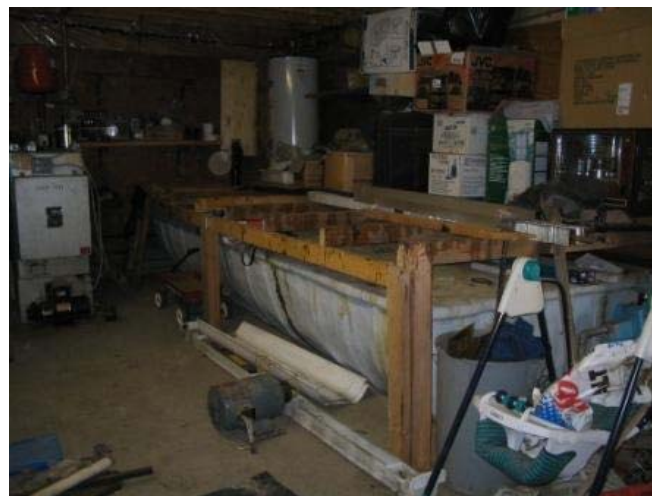
**Photo 0006:** YWP-D Water Storage Tank

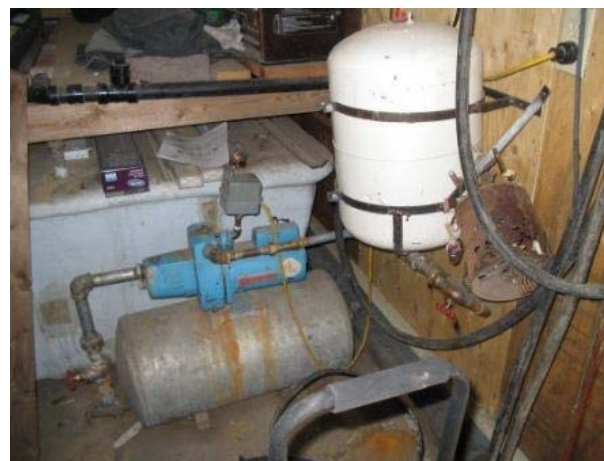
**Photo 0184:** YWP-D Jet Pump and Pressure Tank

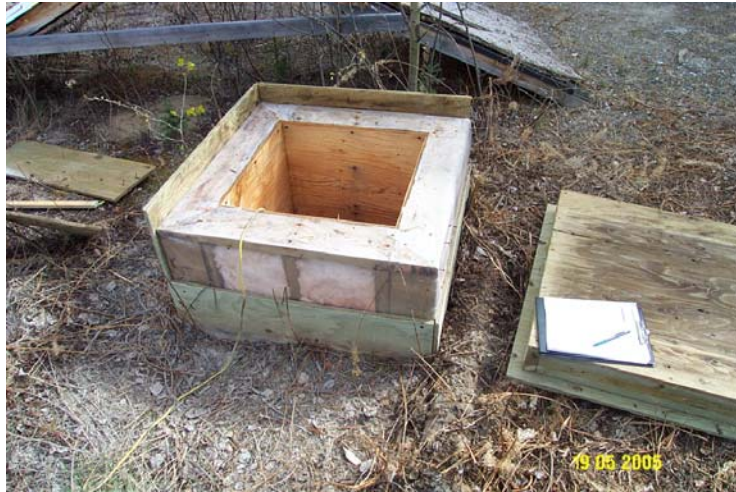
**Photo 0192:** 1955 Well Head Enclosure

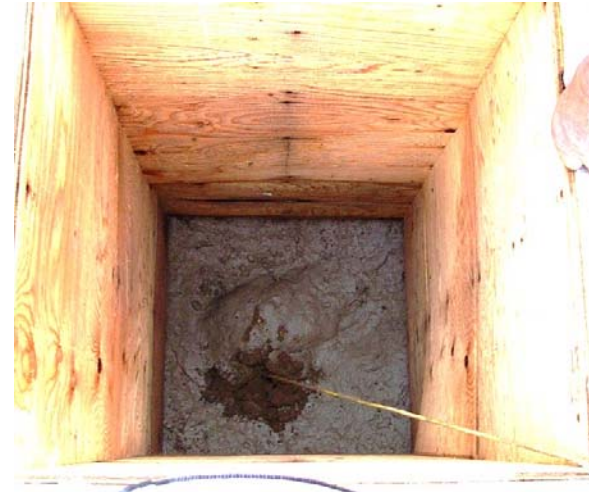
**Photo 0191:** 1955 Well Head

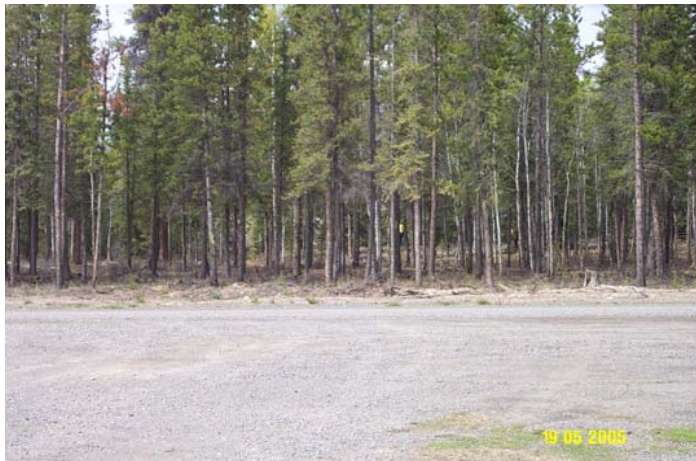
**Photo 0193:** 1955 180 Meters to Landfill Site

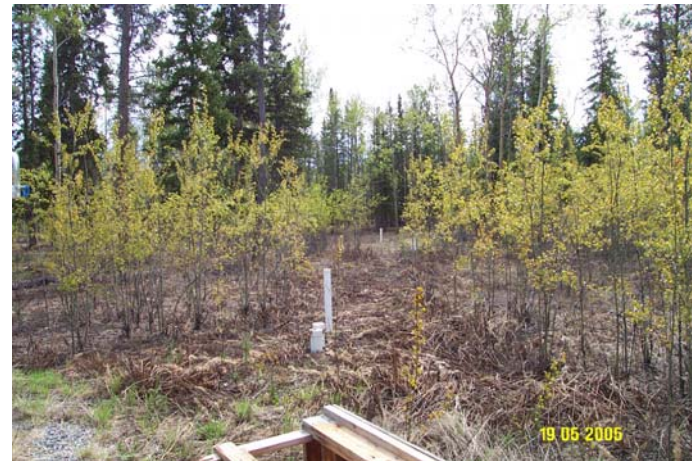
**Photo 0194:** 1955 Septic Field

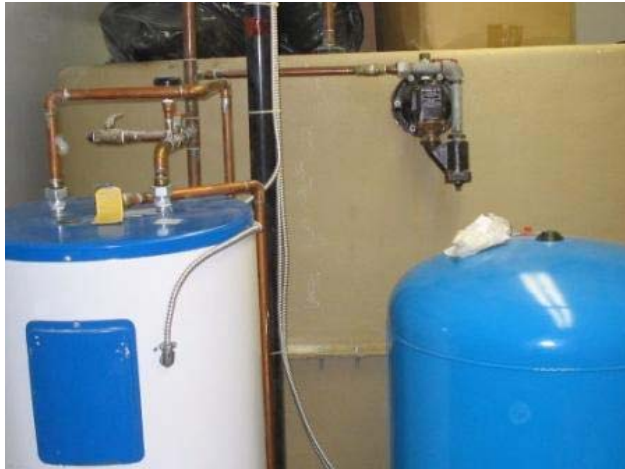
**Photo 0018:** 1955 Hot Water Tank (left) and Pressure Tank (right)

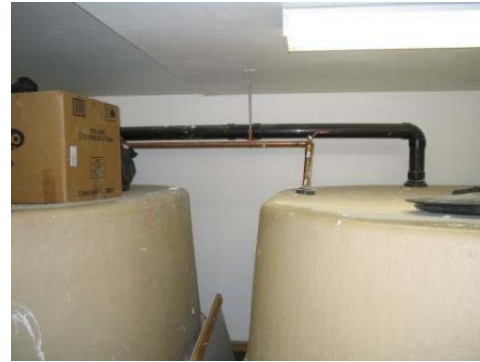
**Photo 0021:** 1955 Water Storage Tanks

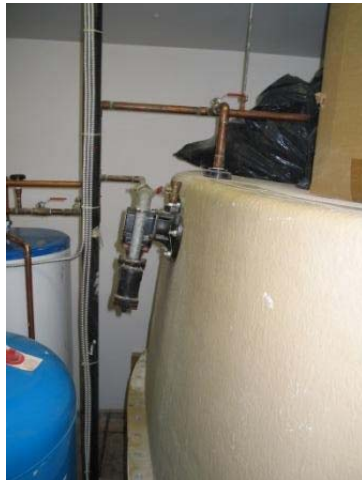
**Photo 0020:** 1955 Fill Control

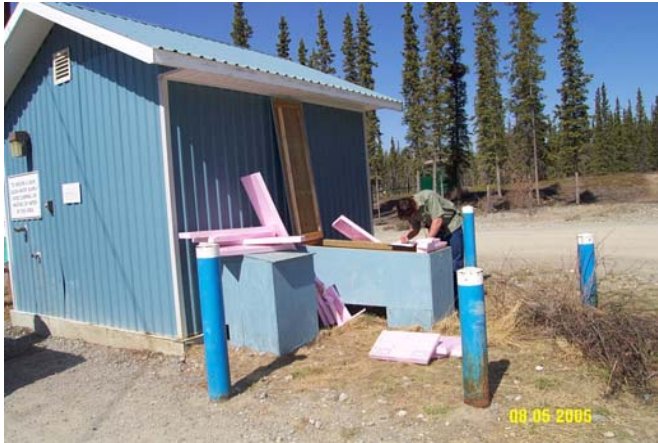
**Photo 0062:** 1953 Well Enclosure (right) and Pumphouse

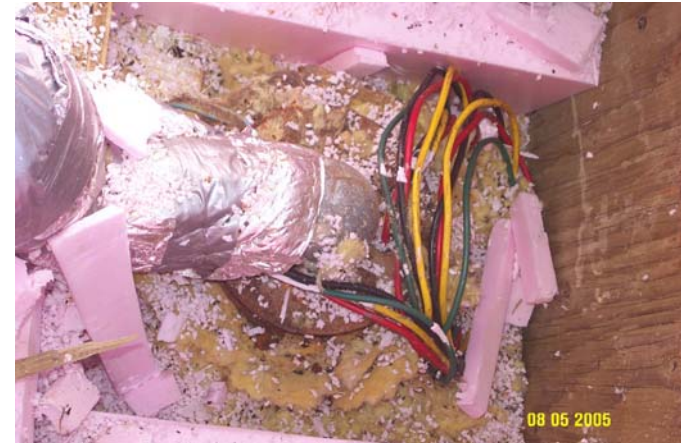
**Photo 0059:** 1953 Well Head

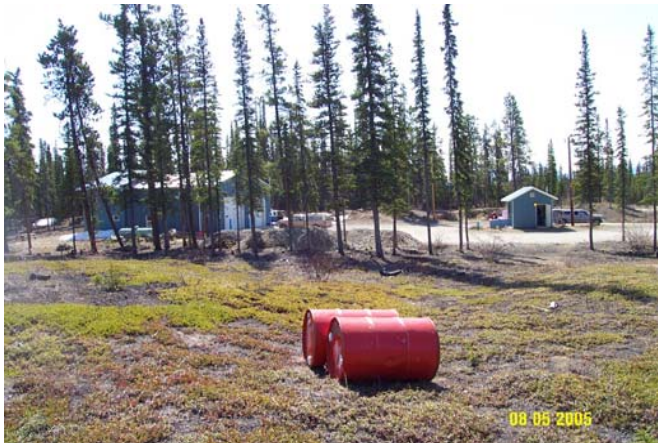
**Photo 0061:** 1953 45 gal. Aviation Fuel Drums (front), Pumphouse (back right), and Firehall (back left)

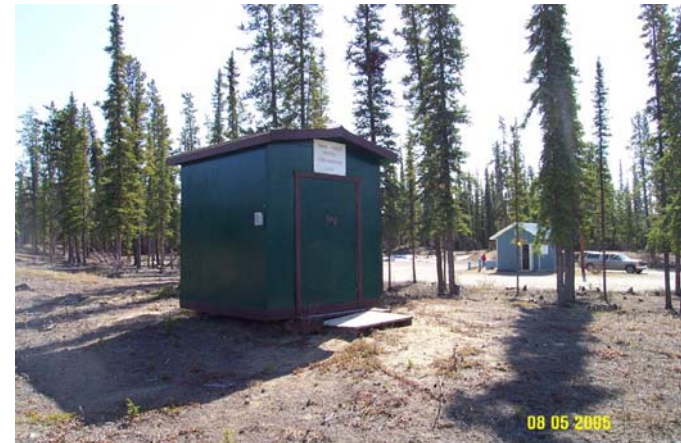
**Photo 0060:** 1953 Fire Equipment Cache (front), Pumphouse (back left)

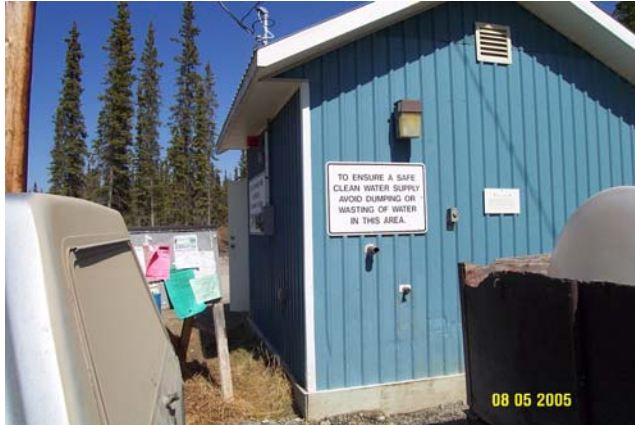
**Photo 0063:** 1953 Fill Station

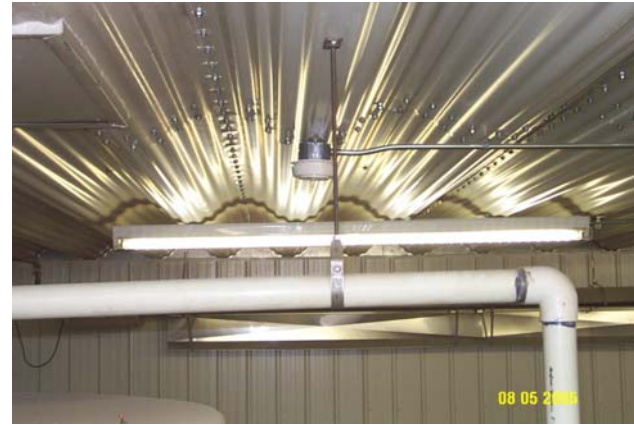
**Photo 0067:** 1953 Pipe Hangar – Potential Location for Solenoid

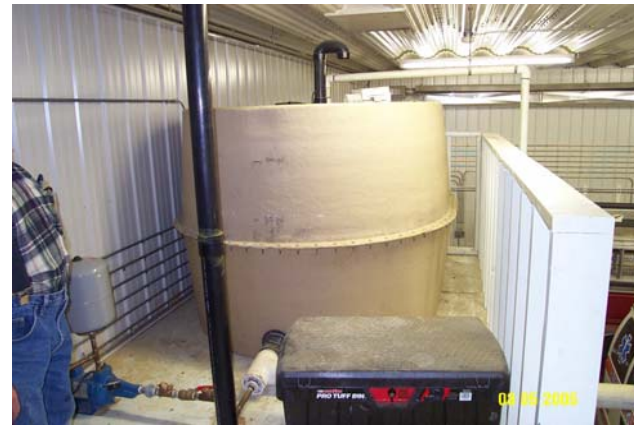
**Photo 0066:** 1953 Firehall 1250gal Water Storage Tank

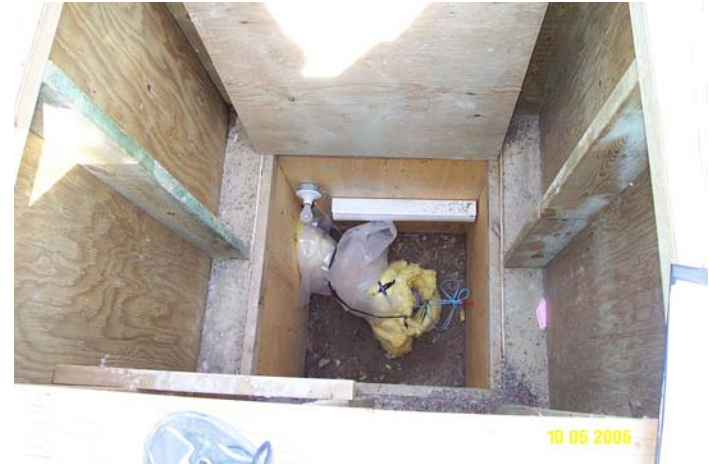
**Photo 0099:** 1950 Wellhead

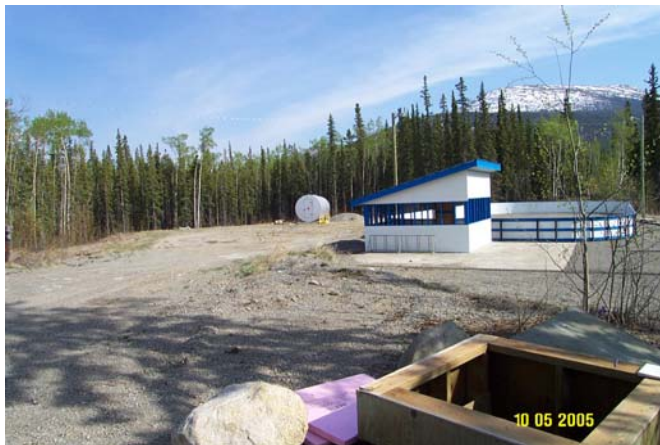
**Photo 0101:** 1950 Well (front), Skating Rink and Above Ground Oil Storage Tank (back)

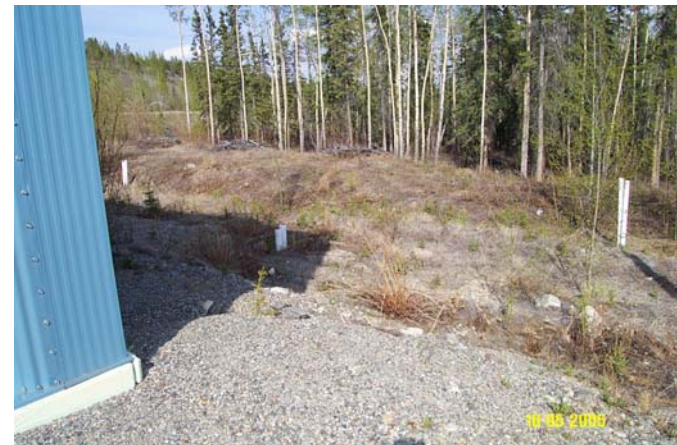
**Photo 0102:** 1950 Septic Field

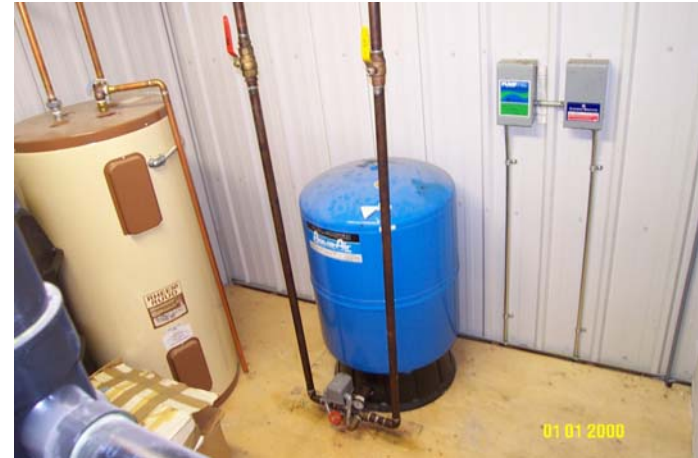
**Photo 0106:** 1950 Pressure Tank

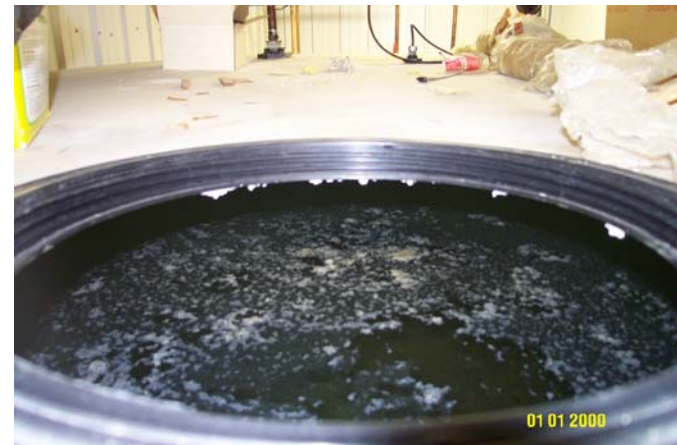
**Photo 0105:** 1950 Scum on Surface of Well Water Storage Tank

Are there signs of staining or biofouling? ☒ YES NO

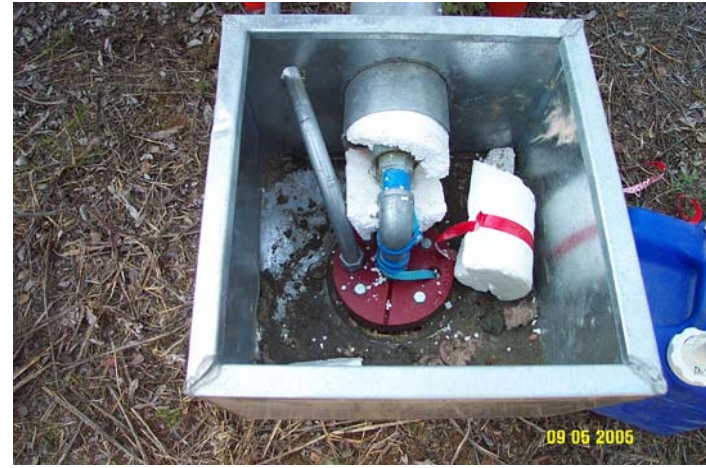
**Photo 0079:** 1924 Wellhead

- i. Is the well head below grade? describe in detail No, 43cm above grade, 26cm above concrete floor
- ii. Are there signs of ponding on the enclosure(e.g. water stains, etc.)? ☐ Yes ☒ No
- iii. Is the wellhead enclosed by fiberglass insulations? ☒ Yes ☐ No  
The well house is well insulated and heated
- iv. Any evidence of rodents? Specify There is no evidence, however it appears that the wellhouse is regularly cleaned, No mouse traps
- v. Does the well casing have a proper seal cap? ☒ Yes ☐ No

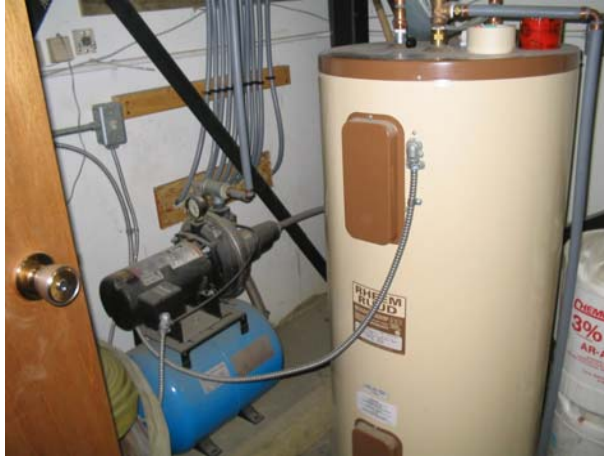
**Photo 0469:** 1924 Pump System

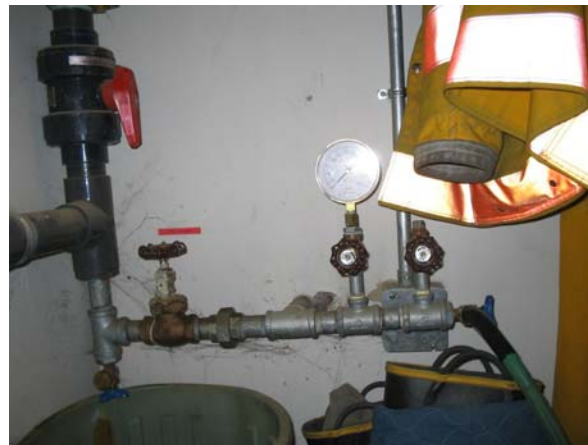
**Photo 0465:** 1924 Tank Fill Solenoid Valve and Bypass

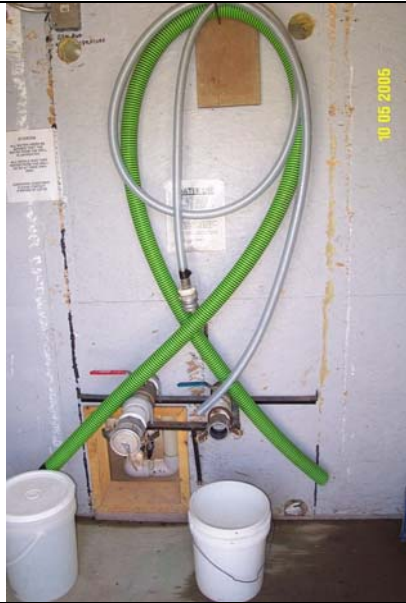
**Photo 0089:** 1421 Water-Pickup

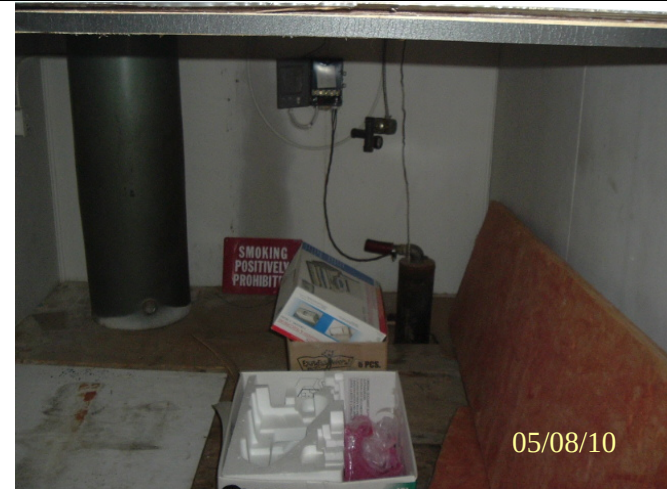
**Photo 027:** 1131 Abandoned well.

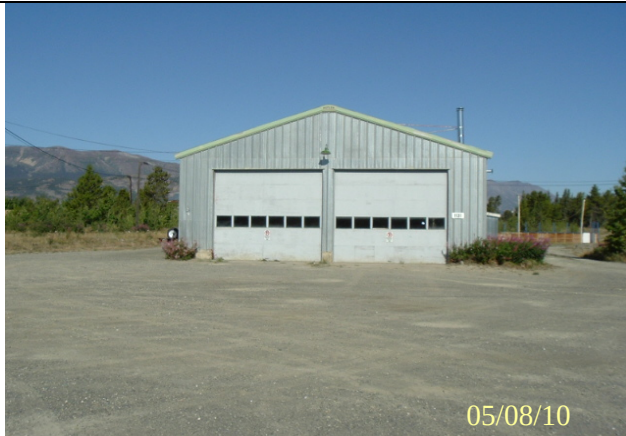
**Photo 029:** 1131 Carcross search and rescue building (former grader station).
